**Current Conditions
Inventory Report**

**Dry Creek:
Warm Springs Dam to
Russian River**

Sonoma County, CA

December 2, 2010

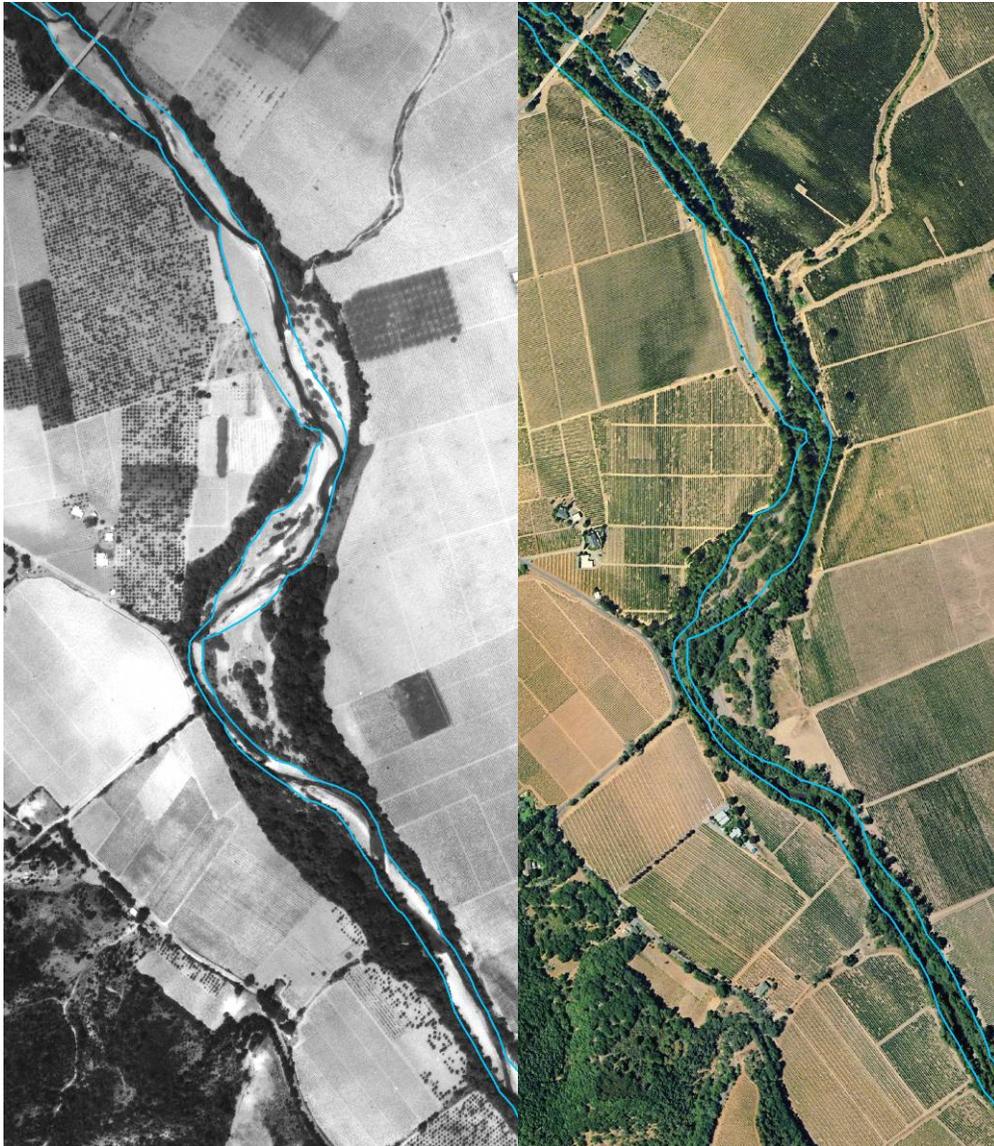
Figure 15: Example of vegetative encroachment near Yoakim Bridge. Yoakim Bridge (RM 10.7) is seen at upper left of each frame. Dry Creek flow is from top to bottom of each frame. Left frame is from 1976, right frame is from 2004. Light blue line is estimated limit of active fluvial features in 1976.

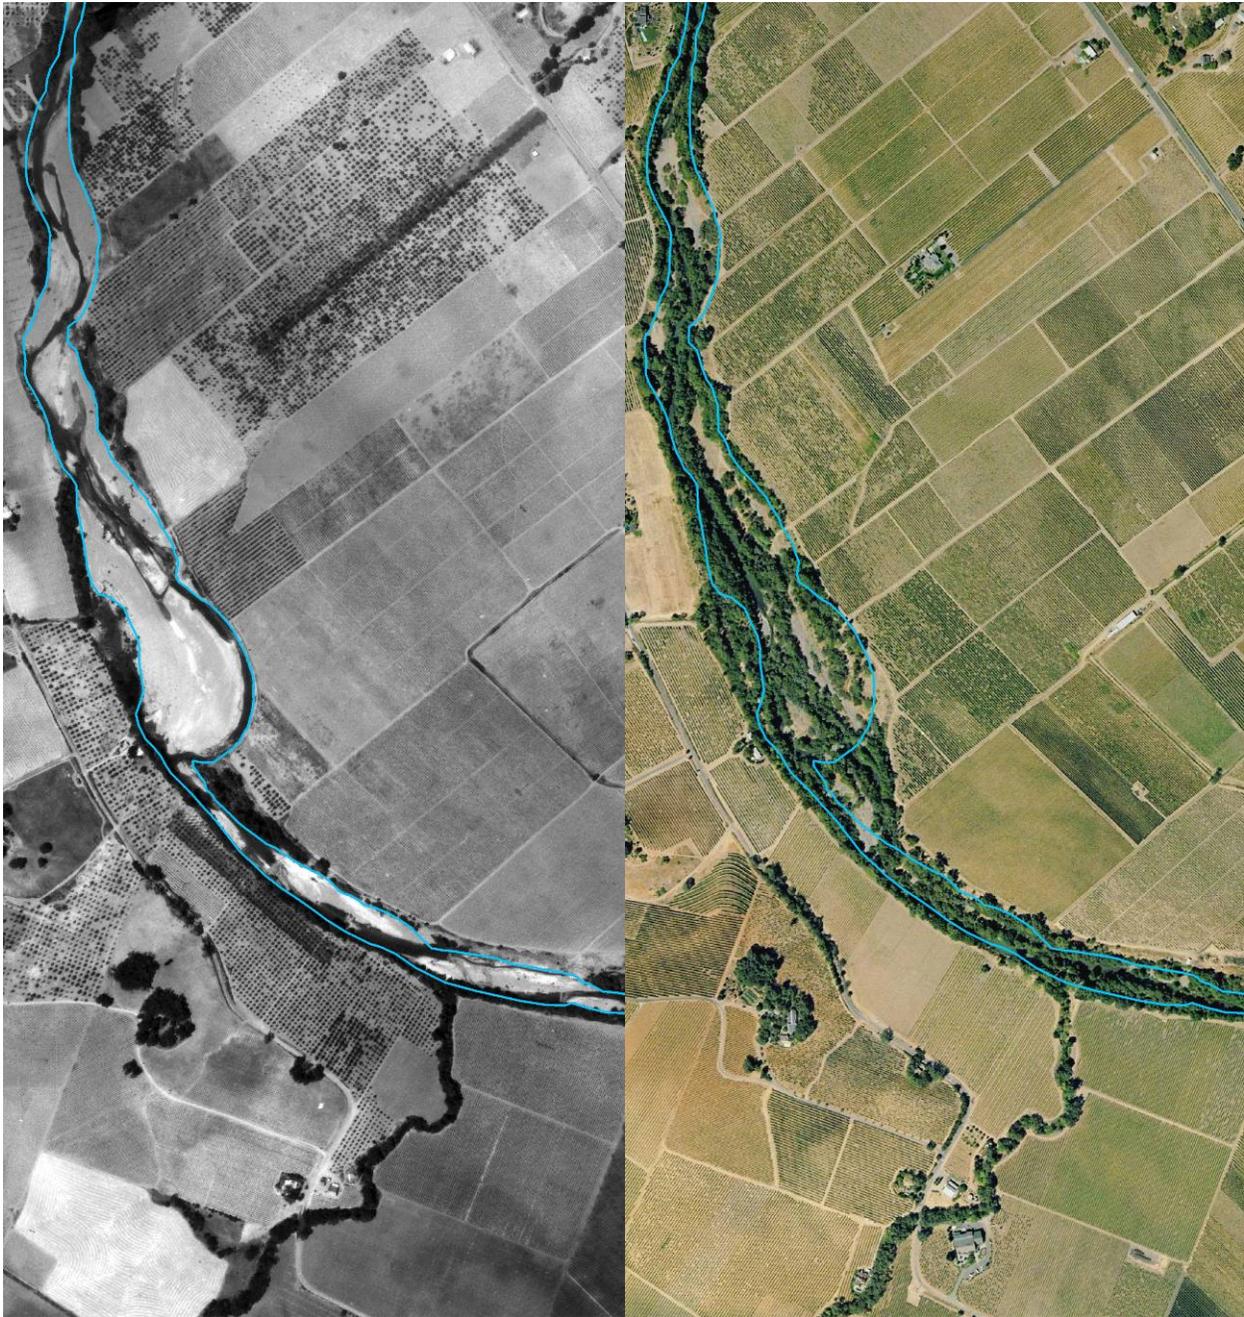
Figure 16: Example of historic bank erosion leading to relatively wider area of channel corridor near confluence of Grape Creek (RM 7.3). Grape Creek is seen at bottom center of each frame. Dry Creek flow is from top to bottom. Left frame is from 1976, right frame is from 2004. Light blue line is estimated limit of active fluvial features in 1976.

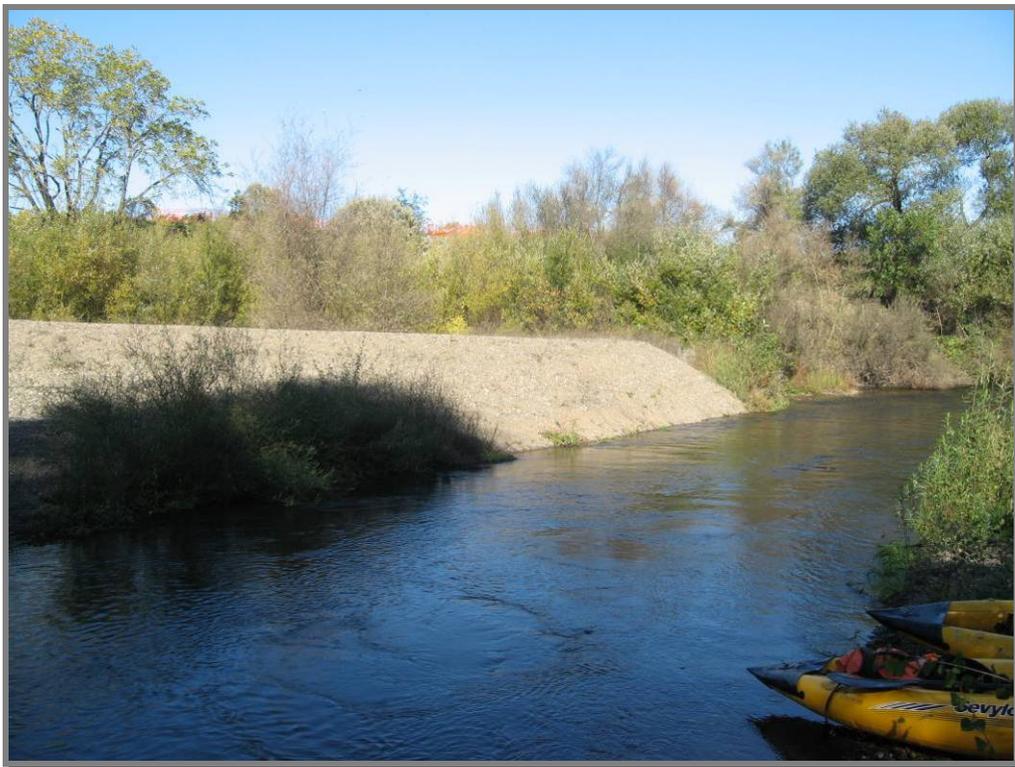
Photograph 10: Deposit of gravel across from Mill Creek confluence (RM 0.6), reflecting backwater influence of Russian River.

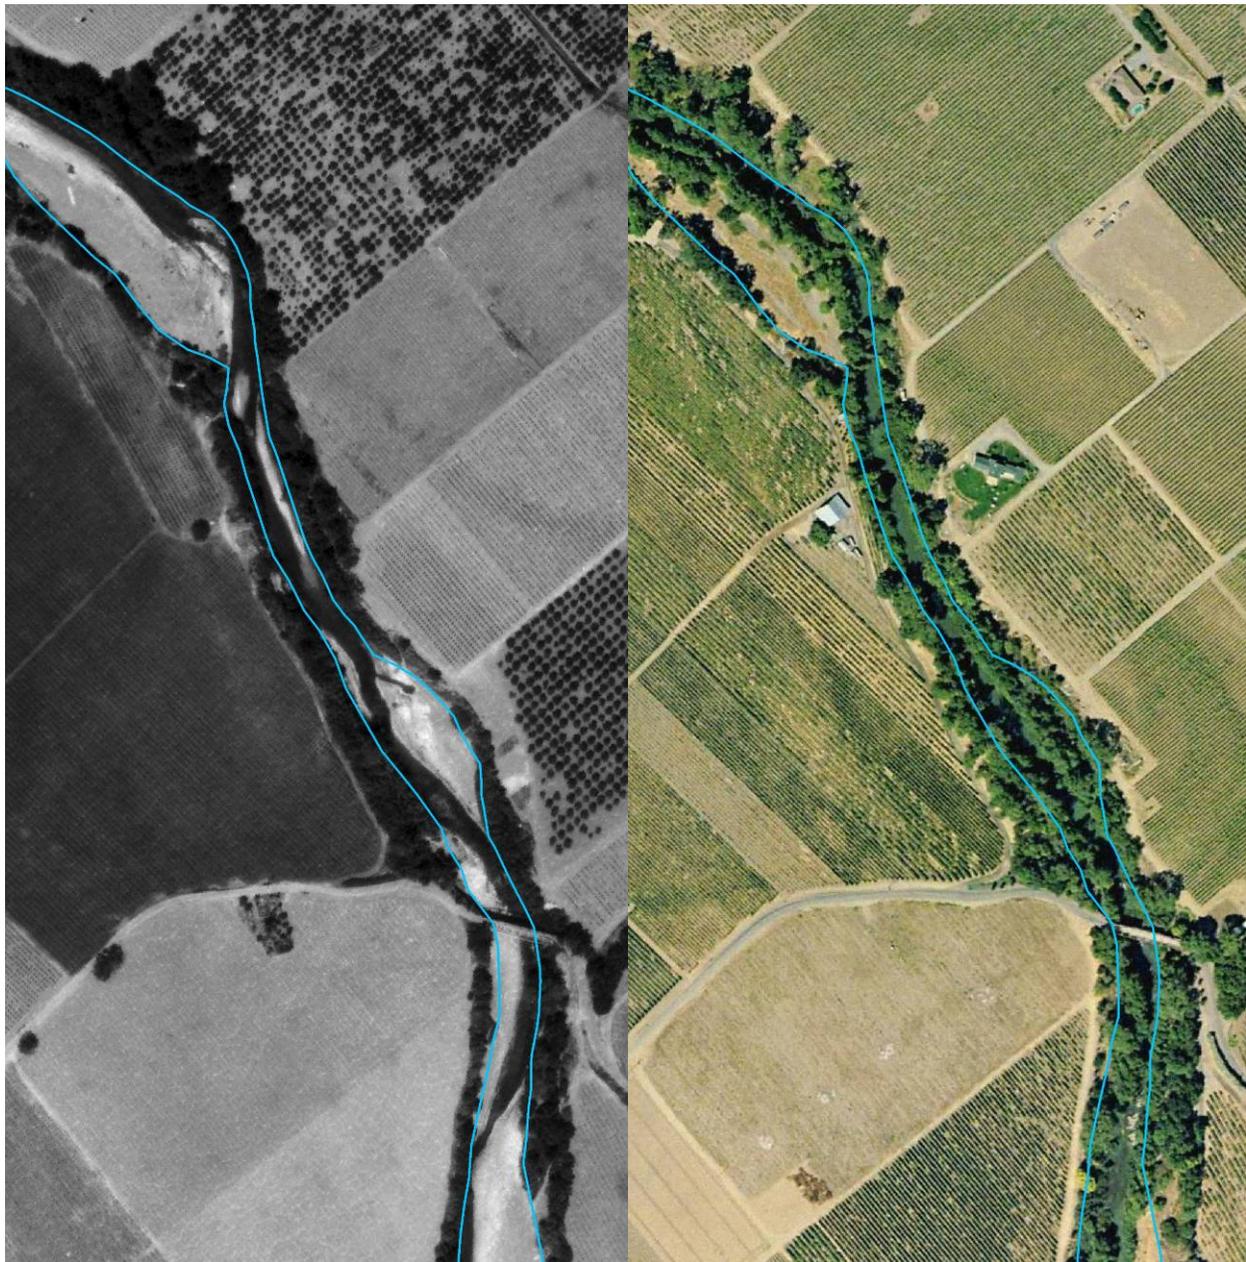
Figure 17: Example of vegetative narrowing of channel corridor near Lambert Bridge (RM 6.6). Lambert Bridge is seen at lower right of each frame. Dry Creek flow is from top to bottom. Left frame is from 1976, right frame is from 2004. Light blue line is estimated limit of active fluvial features in 1976.

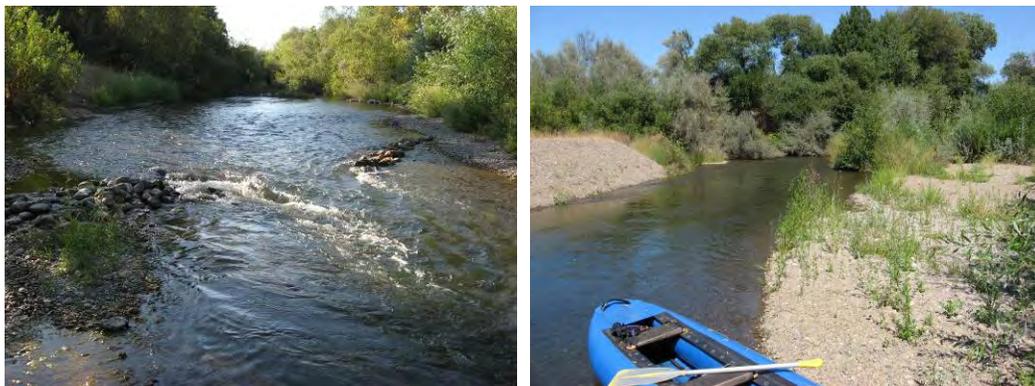
Figure 2: (left) A hand-built cobble dam across Dry Creek, (right) Unvegetated streambanks at the Mill Creek confluence.

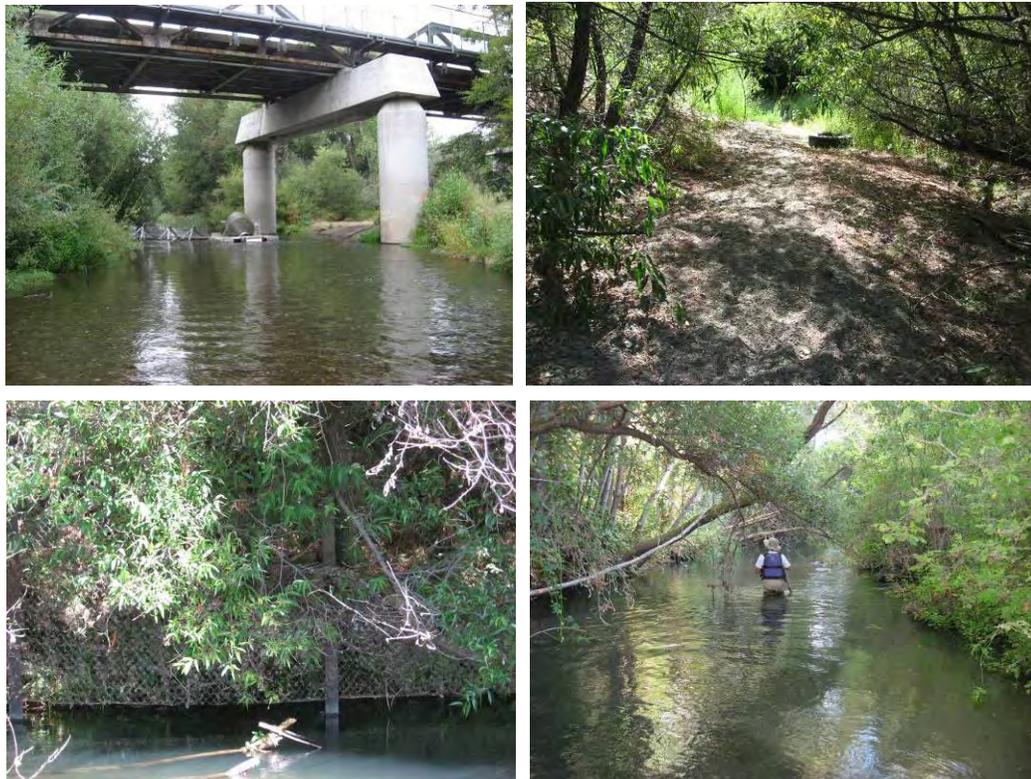
Figure 12: (upper left) Westside Road bridge and screw trap, (upper right) mouth of intermittent stream, (lower left) failed I-beam and chainlink bank armor, and (lower right) side channel pool.

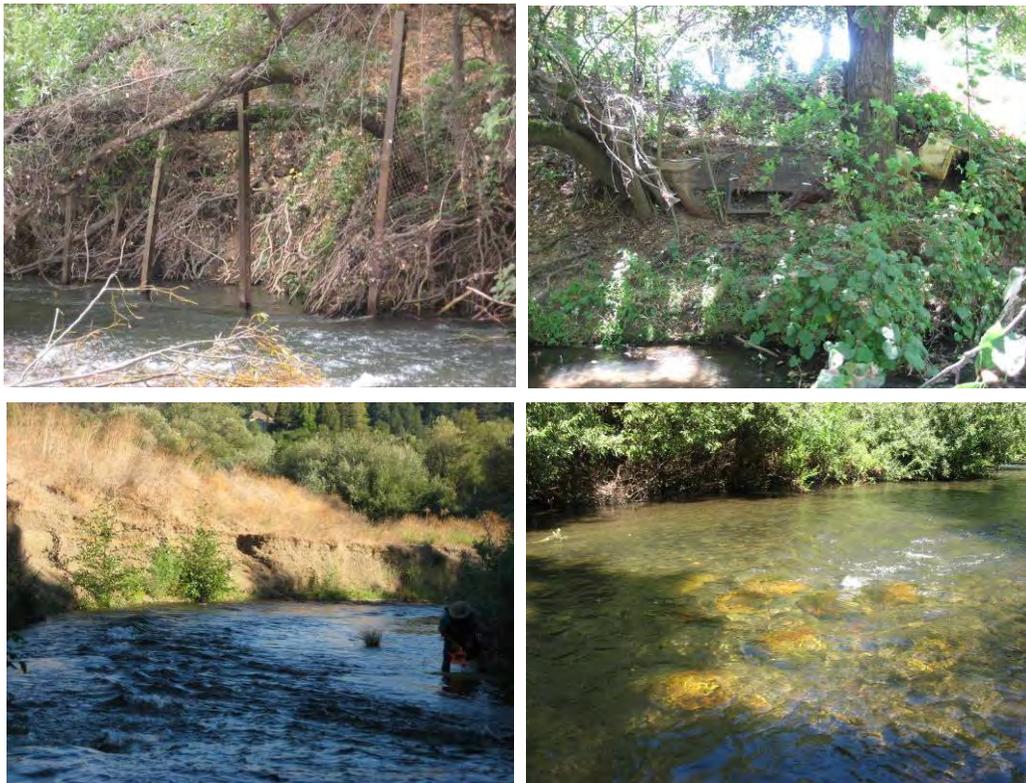
Figure 34: (upper left) Failed I-beam and chainlink fence stabilization efforts, (upper right) car bodies in the banks, (lower left) erosion along an outside bend, (lower right) a triangular boulder cluster in Dry Creek.

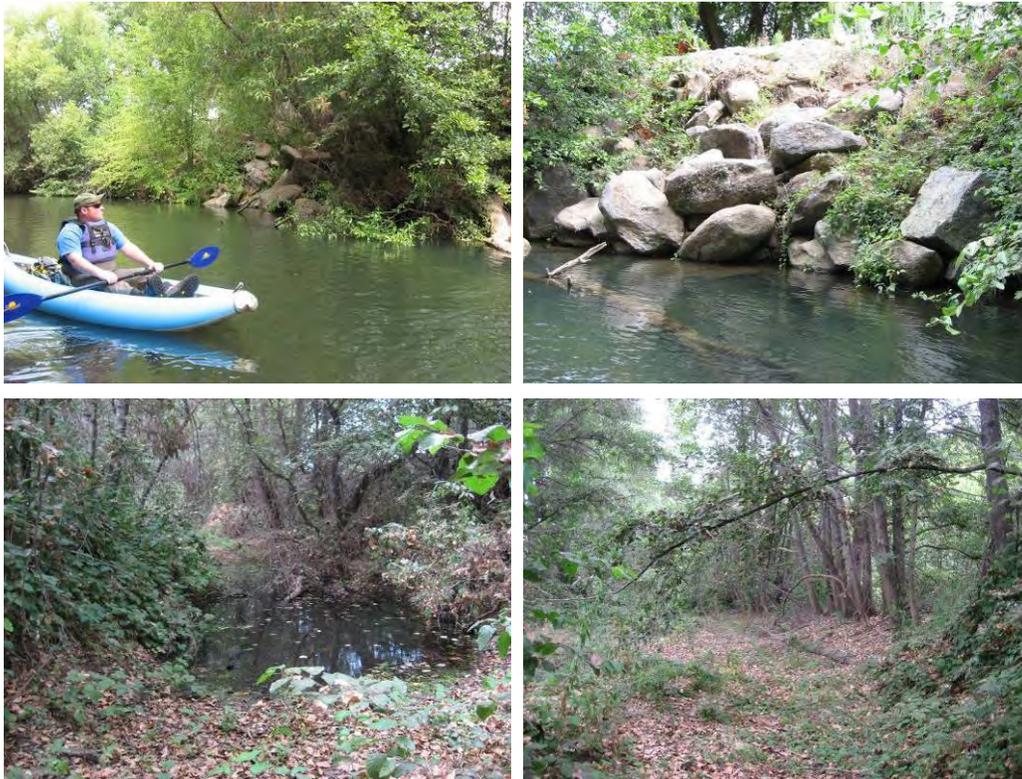
Figure 45: (upper row) pool habitat with riprap bank protection, (lower left) alcove habitat, (lower right) former channel along left bank, protected by a long, straight berm vegetated by even-aged alders.
