Figure 4-6

Mark West Subbasin

Wikiup Creek – Reach 1

Fulton Creek – Reach 1

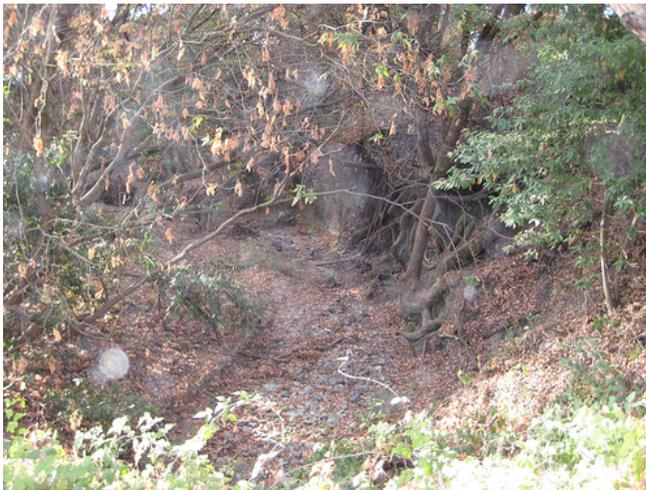
(b) Looking downstream from Candlelight Road crossing. Note exposed roots and bank erosion along right bank (September 25, 2008).

Bank structure: banks are earthen and nearly vertical in some locations. Bank slopes generally range from 2:1 to 1:1, and are approximately 10 ft high from the channel bed. High flows in 2006 heavily eroded banks mid-reach and landowner placed gabion baskets around meander bend.

Channel processes: channel meanders eroding around bends and gravel bars forming on opposite banks (photos b and c). Meandering may be influenced by culvert at Wikiup Drive which is set at a 45-degree angle to the creek channel.

Riparian corridor and canopy closure: mature riparian vegetation provides 75% canopy cover along the reach. Various oak, bay, willow, and alder trees are established along the top of banks (Photo b).

The 6 ft corrugated metal culvert at the Candlelight Drive crossing is functioning and in good condition. Flow and debris passing freely from upstream to downstream. A few locations of unstable banks are present between Candlelight Drive and Wikiup Drive. Landowners have resolved issues themselves, but construction should be monitored for impacts upstream or downstream. Erosion noted in photo (b) should be monitored closely because the root mass of the large oak is almost halfway exposed and the tree may fall into the channel soon. The creek appears to be cutting through the meander bend and the tree is in this pathway.

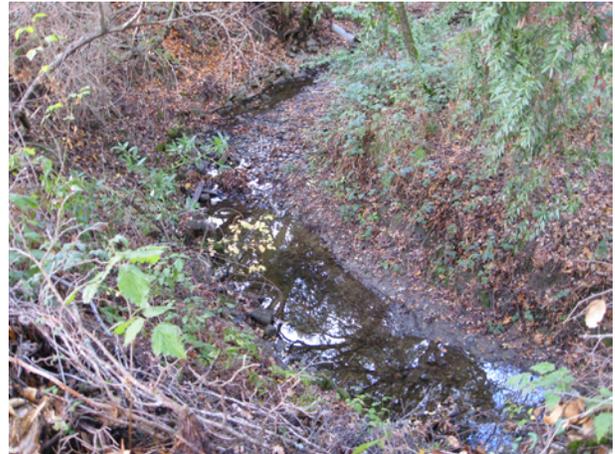
(a) Pool upstream of Candlelight Road crossing. (December 16, 2008).

Vegetation composition: limited ruderal vegetation is found along the banks, and predominantly includes invasive ivy and blackberry. Vegetation in channel is sparse; approximately 3% emergent wetland vegetation observed (Photos a and c).

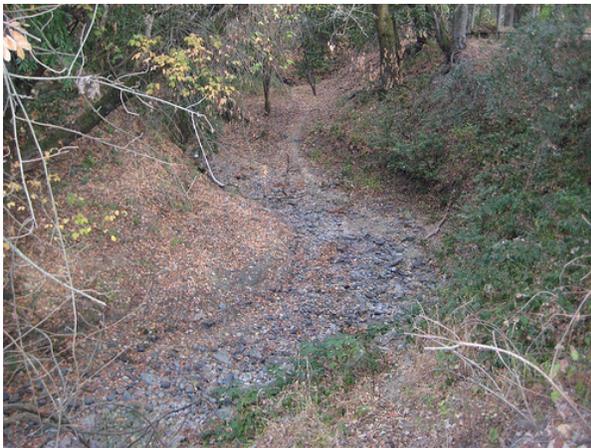
(c) Looking downstream in upper portion of reach. Note cobbles in streambed (September 25, 2008).

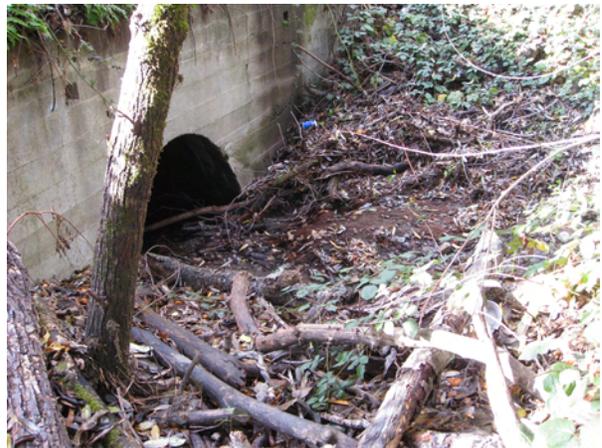
(d) Looking to Wikiup Drive culvert. Culvert too small to allow LWD to pass. Sediment accumulating upstream of culvert, especially on left bank (December 16, 2008).

The culvert at Wikiup Drive is undersized. Neighbor mentioned that winter flows often rise higher than the top of the culvert, and flow over Wikiup Drive in large storm events. The culvert is not designed to provide the best flow and sediment management transport for the stream. However, in the immediate future, sediment and debris should be cleared from the upstream end of the culvert. Consider encouraging the creek to bend slightly to the south to better align with the angle of the culvert. Also a downed willow was observed spanning the channel just upstream of the Wikiup Road crossing. This willow could impede high flows if left unattended.

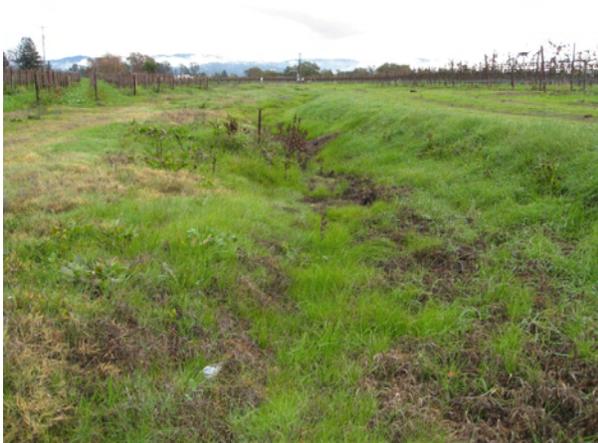
(b) Looking upstream from Laughlin Road. Note vineyards on both sides of the creek and lack of riparian vegetation, other than grasses, within and around the channel (Dec. 16, 2008).

Channel processes: runoff and fine sediment are transported directly from adjacent agricultural lands into the channel. Lack of crowned bank top above adjacent lands leads runoff directly to channel (photo b). Some bank sloughing observed upstream of photo b.

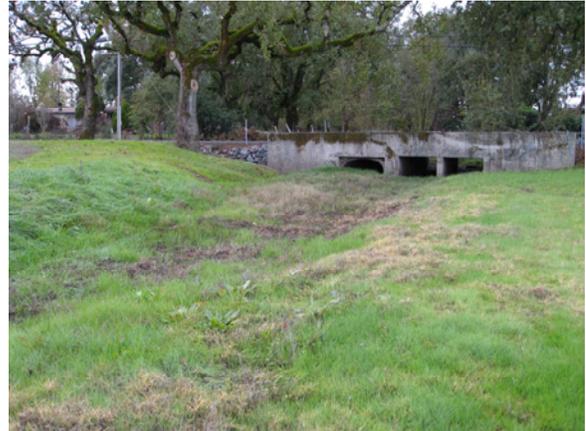
(a) Standing upstream of Reach 1, looking downstream to Laughlin Road and culverts. Trapezoidal channel upstream of culverts shows up to 2 ft of deposited sediment in front of culverts. (Dec. 16, 2008).

Management considerations at Fulton Creek, Reach 1 are limited. Over time, deposition upstream of Laughlin Rd. should be monitored. Downstream of Laughlin, reach should be monitored for potential thinning of emergent vegetation, especially blackberry, but this is not critical at this time. There may be potential to work with upstream landowner to undertake erosion controls actions and opportunities to detain/retain vineyard runoff onsite.

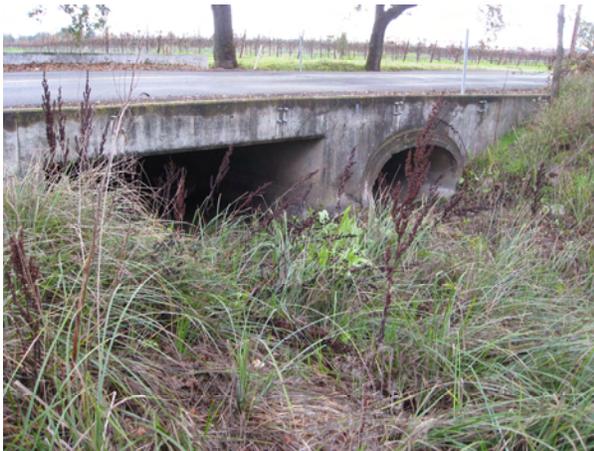
Vegetation composition: emergent and riparian vegetation fills the channel from bank to bank. As shown in photos c and d, blackberry and harding grass dominates the channel and likely slows flow velocity.

(c) Downstream end of the culverts under Laughlin Road. Culverts were clear of sediment inside (Dec. 16, 2008).

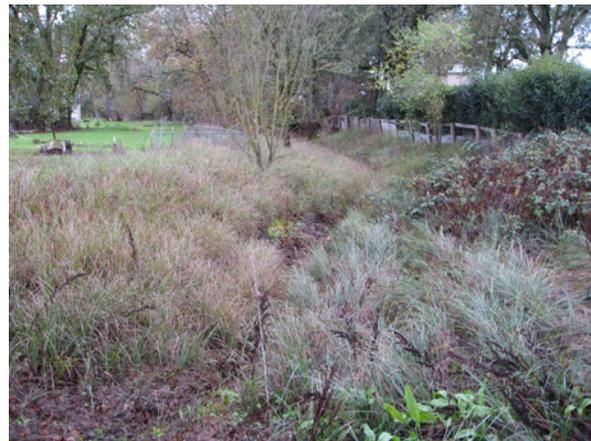
Bank structure: trapezoidal channel has 4 ft. high earthen banks, generally sloped at 2:1 (photo d)

(d) Looking downstream from Laughlin Rd. Note the variety of emergent and riparian vegetation downstream versus upstream of the Laughlin Rd. crossing. Oaks and alders in the background extend throughout the reach (Dec. 16, 2008).
