Figure 4-42

Petaluma River Watershed

FIGURE 4-43

Reaches and Vegetation Zone 2A (1 of 5)

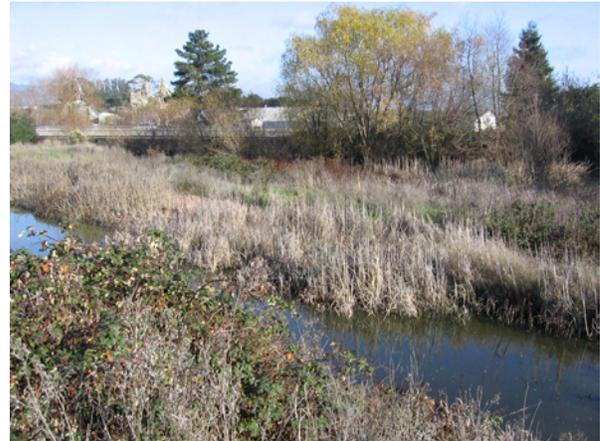
(a) Lichau Cr. upper Reach 3, looking upstream to Redwood Hwy. crossing. Water in near ground from adjacent Lichau pond to left; Lichau Cr. channel in distance to right beyond cattails; note broad channel bed with cattails between pond and creek channel (Jan 9, 2008).

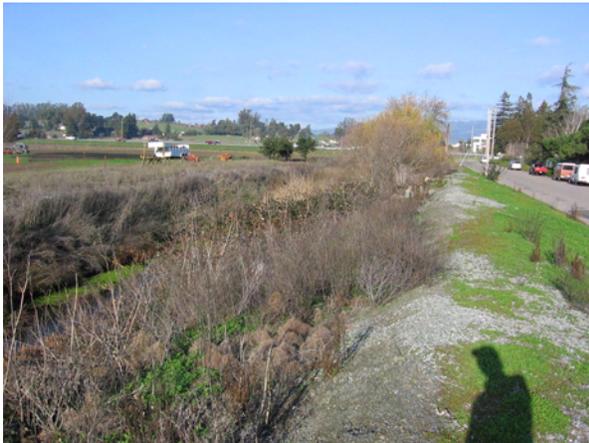
(b) Lichau Cr looking upstream from near Stony Point Rd.; linear and incised channel conditions continue through reach downstream of photo a to photo b site; riprap seen along both northern and southern banks, with gravel augmented southern top-of-bank area seen to right (Jan. 08, 2009).

Immediate management considerations at Lichau Cr. Reaches 3 and 2 focus on vegetation management, with the selective thinning and removal of cross limbs that border the low-flow channel (photo b) and are found throughout the bench-floodplain north of the low-flow channel. Floodway appears large enough, and McDowell Blvd. bridge set high enough that loss of channel capacity does not appear to yet be an issue. However, over the longer-term sediment accumulation will continue on the bench-floodplain, so hydraulic conditions and available flood capacity should be evaluated annually. Other considerations include the shearing and vertical sections of the southern bank, which may need stabilization over time. The southern bank throughout Reaches 3 and 2 should be annually inspected for further erosion and bank retreat. The lower section of Reach 2 becomes narrow and incised heading toward Hwy. 101. This section should similarly be inspected for additional bed and bank erosion.

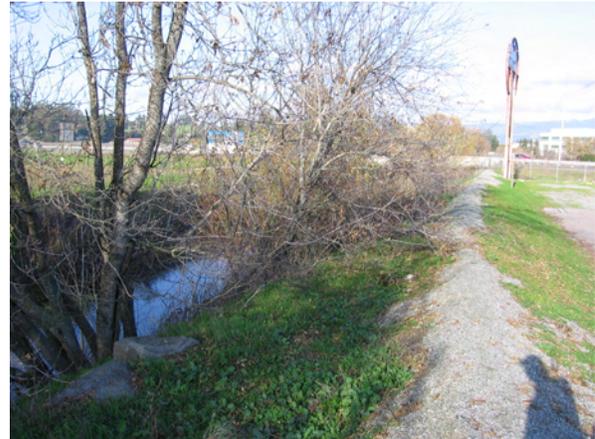
(a) Lichau Cr. upper Reach 1 looking upstream toward Hwy 101 from top of southern bank; channel is linear and deep within hardened incised banks; riparian trees grow along toe of southern bank inset within channel; top of southern bank has been augmented/heightened 5 ft. with additional gravel placement, seen to right (Jan 08, 2009).

Active channel: active channel is wide (20-25 ft) incised within overall channel, 15-20 ft. deep below top-of-banks in upper reach (photo a) and 10-15 ft. deep in lower reach (photo c), slow moving water, depths 1-3 ft. observed in Jan. 2009.

Management considerations of Lichau Cr. Reach 1 focus on the potential flooding to the neighborhood immediately south of the channel. The southern channel bank has been heightened 5 ft. with placement of gravel, though this gravel is unconsolidated. No cross limb vegetation is observed in the channel. Some moderate development of cattails at the lower end of reach near Stony Point Rd. crossing. These cattails and any accumulated sediment depositing there should be evaluated for potential removal if conveyance capacity is reduced. Riparian tree plantings along the top of the northern and southern banks would benefit by making the riparian vegetation corridor denser and linking the corridor between the Petaluma River mainstem downstream and the wider riparian sections of Lichau Cr. observed upstream in Reaches 3 and 2.

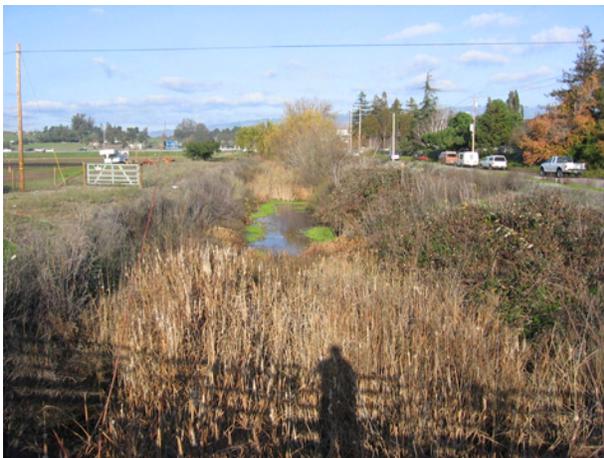
Bed sediments/texture: some sands observed along lower banks of upper reach, and finer sediments and silts observed within emergent vegetation in lower reach (photo c).

(c) Looking upstream from Stony Point Rd. crossing; note steep near vertical banks to left (north) and banks to right (2:1) not quite as steep; rip-rap supports banks to both sides; riparian trees seen inset within channel in distance, in near ground more emergent in-stream channel vegetation; in Jan 09, channel flows are generally less than 2 ft. deep (Jan. 08, 2009).

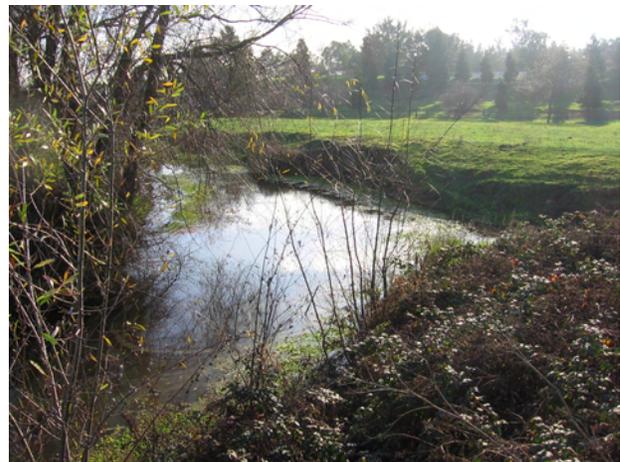
(d) Lichau Cr. confluence with Petaluma River, downstream of SCWA maintenance reach (Jan. 08, 2009).

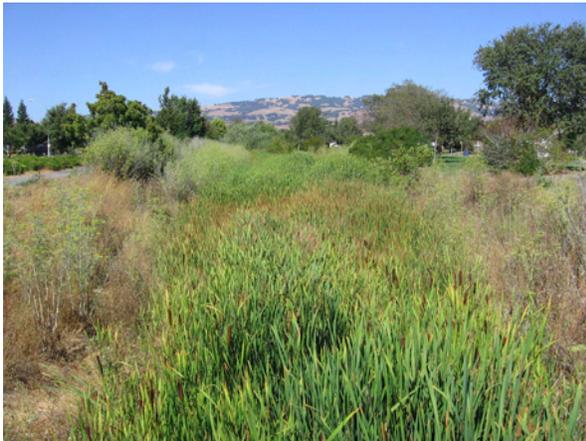
(b) Lower Reach 7 looking upstream from Telford Lane; similar to upper Reach 7, abundant cattail vegetation in linear channel; lack of canopy cover with no woody riparian vegetation along banks (August 26, 2008).

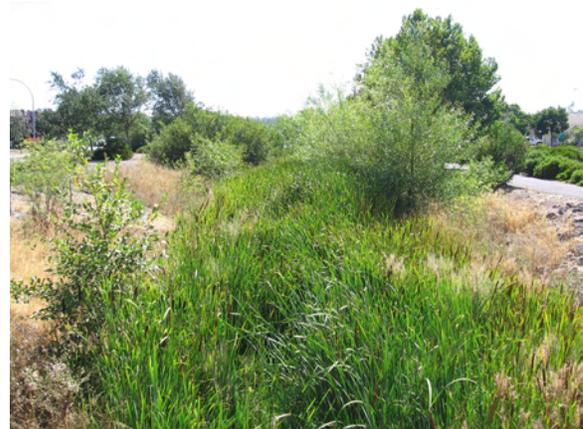
(a) Upper Reach 7 looking downstream from N. Ely Road; linear trapezoidal channel with abundant in-channel emergent vegetation growth of cattails; banks have willow scrub and grass vegetation (August 26, 2008).

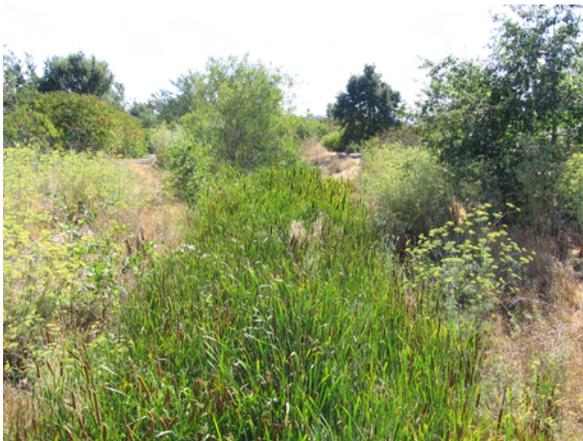
(c) Upper Reach 6 looking downstream from Telford Lane; similar to upstream in Reach 7, in-channel abundant cattail conditions continue in Reach 6 (August 26, 2008).

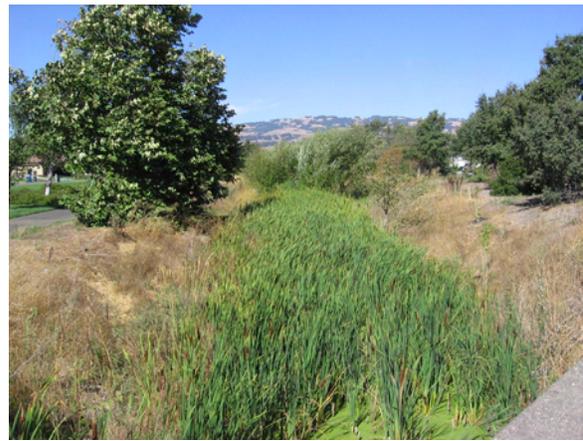
Water quality: perennial in both reaches with flows exhibiting good water clarity observed on August 26, 2008. Stagnant areas within cattails encourage growth of algae (photo d). Earthen bed and banks provide some filtration of runoff.

(d) Reach 6 looking upstream from Sonoma Mountain Pkwy. Similar to upstream reaches, abundant cattail growth continues through Reach 6. Note algae growth around the cattails (bright green in the channel) toward the crossing (August 26, 2008).

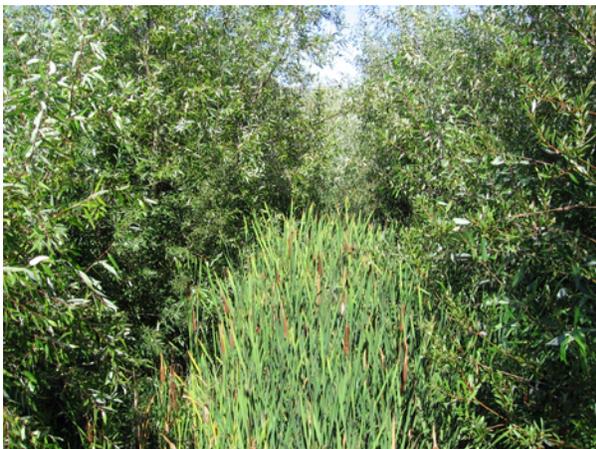
(b) Mid Reach 5 looking upstream at pedestrian footbridge; dense cattail growth through the channel bed with thick willow growth at the toe of the stream banks and the channel margin (August 26, 2008).

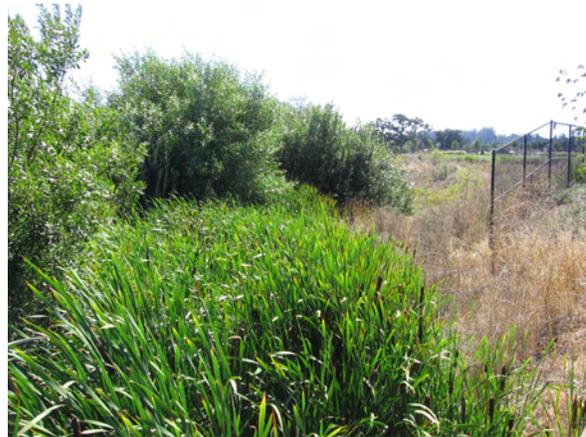
(a) Reach 5 looking downstream from Sonoma Mountain Parkway crossing; like upstream reaches, large stands of cattails in channel, but unlike upstream reaches, now with willows too (August 26, 2008).

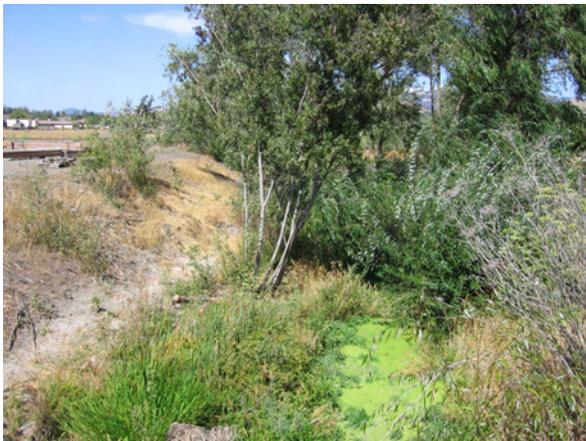
(b) Reach 2 looking downstream from the N. McDowell Blvd crossing; riprap covers the bank walls at the crossing and trees provide shade (August 26, 2008).

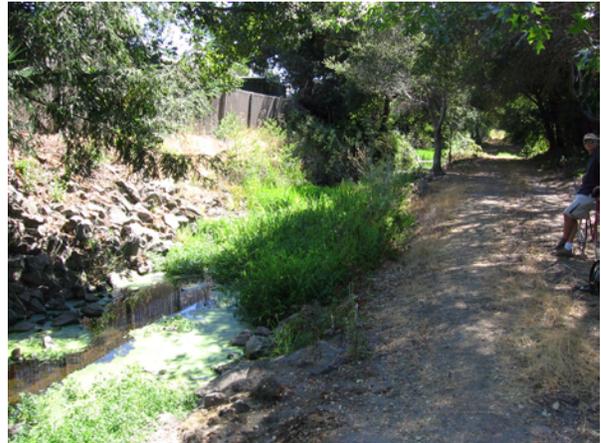
(a) Reach 3, looking upstream from the N. McDowell Blvd. crossing; note pooling, dense willow scrub and in-channel vegetation (August 26, 2008).

Management considerations include selective bar grading/skimming where necessary, but should include alternating bar forms that provide sinuosity as currently observed in Reach 1. Other considerations include removal of cattails and planting of more riparian vegetation (if capacity allows) to provide additional shade to inhibit cattail growth where no canopy cover currently exists.

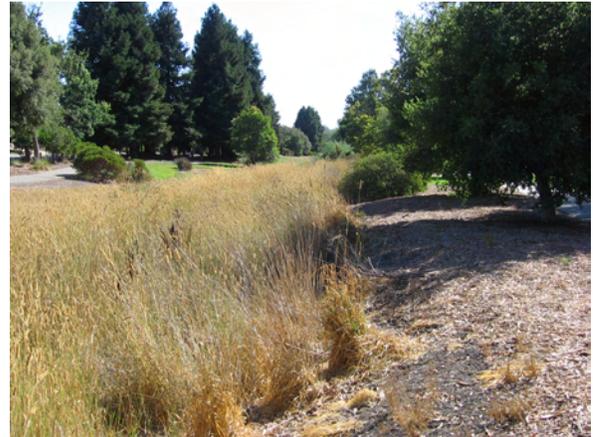
(a) Reach 4 at Sonoma Mountain Pkwy, looking downstream; Wide channel easement, with gently sloping banks; channel is ephemeral and dry, but abundant emergent vegetation in the channel indicates shallow groundwater or high soil moisture (August 26, 2008).

Active channel: Channel bed is 6-12 ft and 3-4 ft. below top of banks; channel is shallow with no pools, but retains shallow groundwater at the base of the channel, as noted by abundant emergent vegetation (photos a/d).

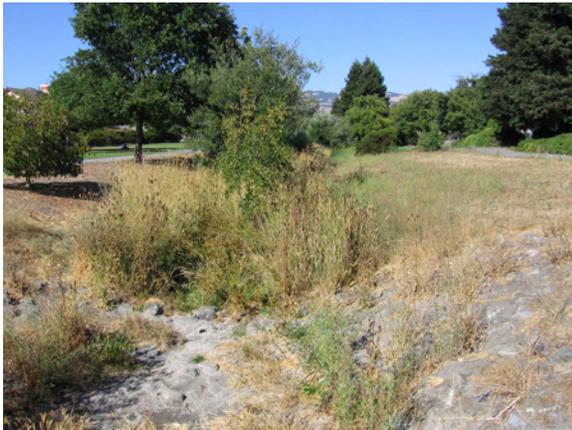
(b) Reach 4 at Maria Drive, looking upstream; willow scrub observed along banks of the entire reach, note sand, gravel, and cobble in streambed (August 26, 2008).

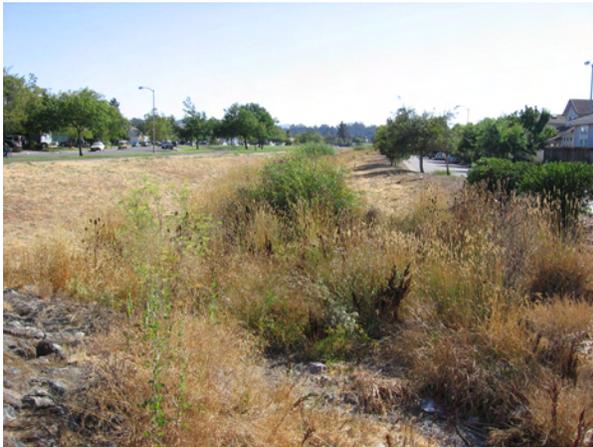
(c) Reach 3, looking downstream from Maria Dr.; very wide channel easement, gently sloping banks, and in-channel scrub willow vegetation, with a lack of any woody riparian canopy over the channel (August 26, 2008).

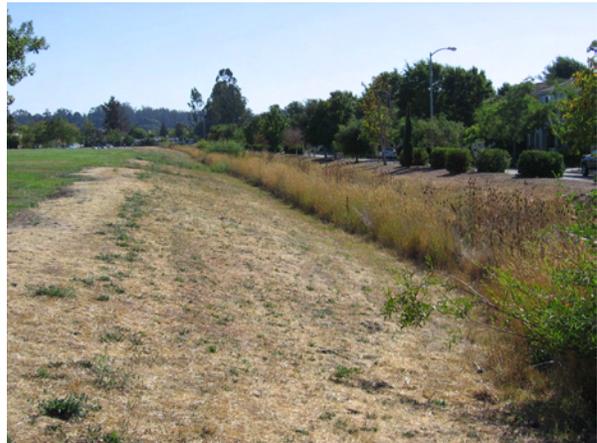
(d) Mid Reach 3 looking downstream; linear channel alignment and wide gently sloping banks (August 26, 2008).

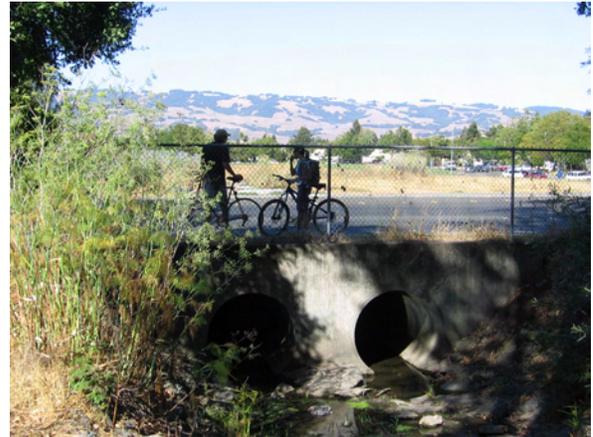
(a) N. McDowell Blvd. crossing of parallel culverts entering Reach 2; looking upstream to reach Capri 3 and headwater areas (August 26, 2008).

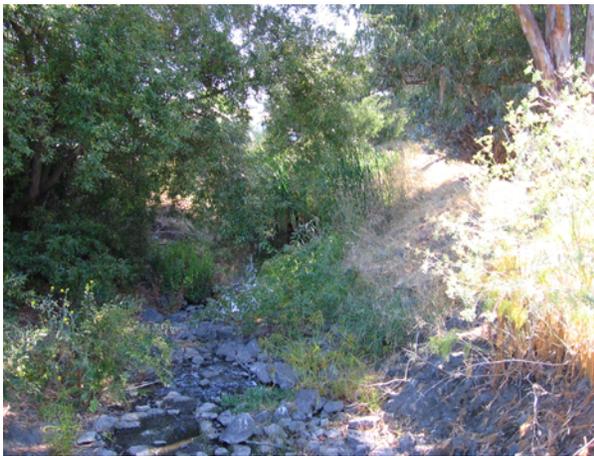
Bed sediments/texture: sands and silts collecting in patches with some loose riprap cobbles that have locally eroded (photo c).

(c) Mid Reach 2 looking downstream, locally eroded riprap found on channel bed and banks of the trapezoidal channel (August 26, 2008).

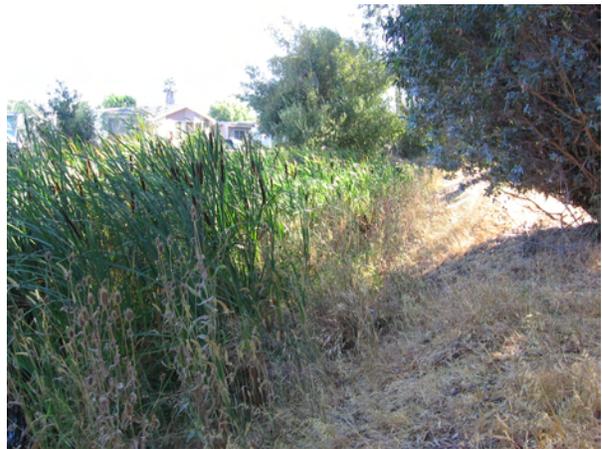
Channel processes: linear channel alignment with flows contained within engineered banks; cattail growth and associated sedimentation in sequences; southern bank observed to be undercut in one location; (photo d).

(d) Reach 2 at railroad crossing, looking upstream. Dense cattails and emergent wetland vegetation fill the channel; ruderal grasses and shrubs are established along bank areas (August 26, 2008).

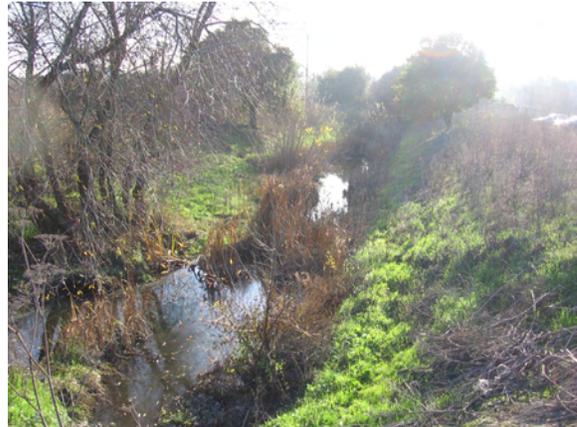
(a) Capri Cr. Reach 1, looking downstream from culvert outfalls just downstream of Hwy 101 (at factory outlet mall); trapezoidal channel with cattail growth and some bars of fine sediment deposited; deep channel within steep banks (Jan 8, 2009)

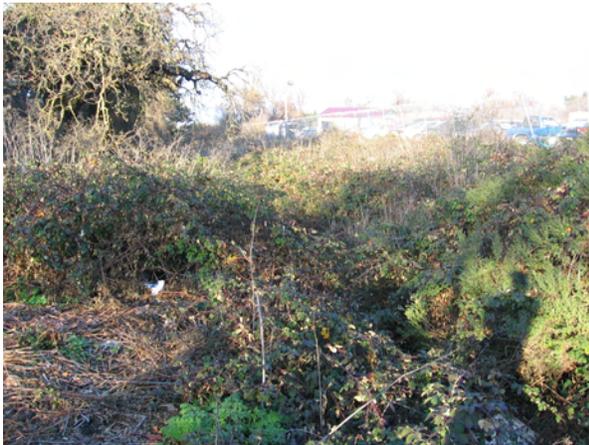
(c) Jessie Lane Creek, near Petaluma Blvd. looking downstream; abundant blackberry covers banks and the entire channel; auto shop to right is potential source of trash and refuse that enter the channel (Jan 8, 2009).

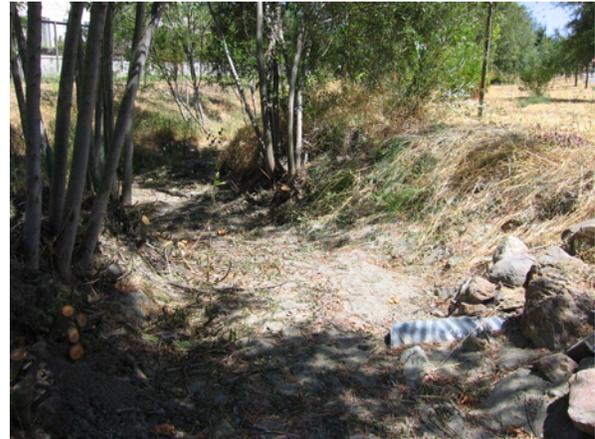
(a) (May 06, 2008)

Management considerations for Reach 7 Washington Creek focus on the sections of the upper reach where abundant sand deposition has buried some drainage culvert outfalls (photo a). Some sediment removal may be necessary to clear these outfall locations. Some of the in-channel willow clusters mid-reach should be observed for potential channel blockage, but at the current time, this issue does not appear pressing (photo b). Over time the planted riparian trees in the mid-channel section will mature and provide additional shade and cover. Additional planting opportunities for the lower reach which does not have any appreciable mature riparian cover should be evaluated (photo c).

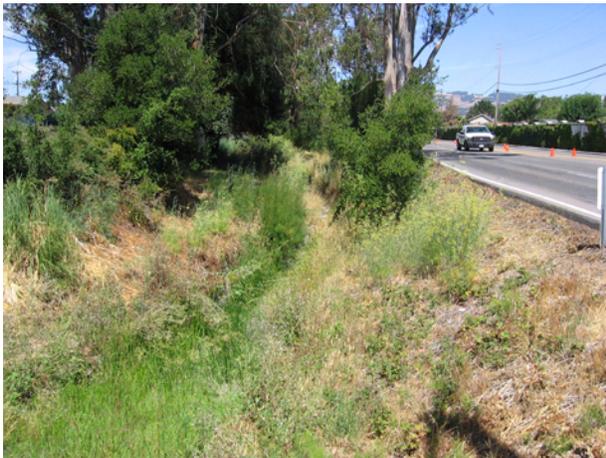
(b) Lower Reach 6 looking upstream from Maria Dr.; photo shows how creek is directly adjacent to E. Washington Blvd.; banks are steep and the channel is linear without much internal complexity (Aug 26, 2008).

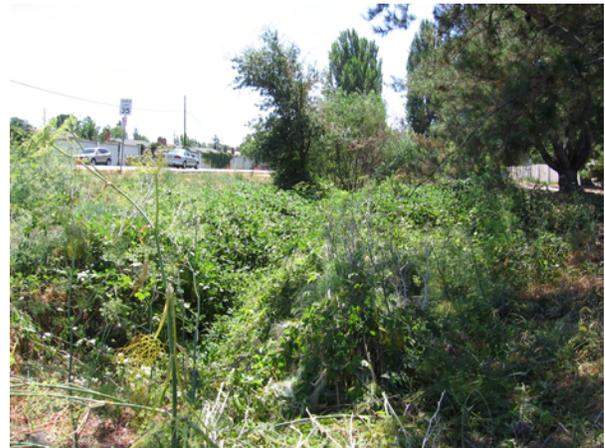
(a) Reach 6 looking downstream from below Sonoma Mtn. Parkway crossing. Trapezoidal linear channel parallels E. Washington Blvd. along southern bank (left). Much of Reach 6 has riparian woodland with up to 75% canopy; but photo shows an open section with mostly blackberry and scrub/grass banks. (Aug. 26, 2008).

Management considerations for Reach 6 of Washington Creek focus on sediment management in the open, non riparian woodland sections of the reach (photo a) where blackberry dominates some bank and channel sections. Overall, sediment deposition in Reaches 6 and 5 is not abundant and does not appear to be problematic. In lower Reach 5, downstream of the E. Washington Cr. confluence, water quality conditions appear poor due to stagnant flow conditions with algae collecting. E. Washington Cr. introduces finer sediments to Washington Cr. but deposition is not accumulating. Apparently sediments are being transported through Reaches 6 and 5 and are being deposited in Reaches 4 and 3 downstream (see those sheets for reference).

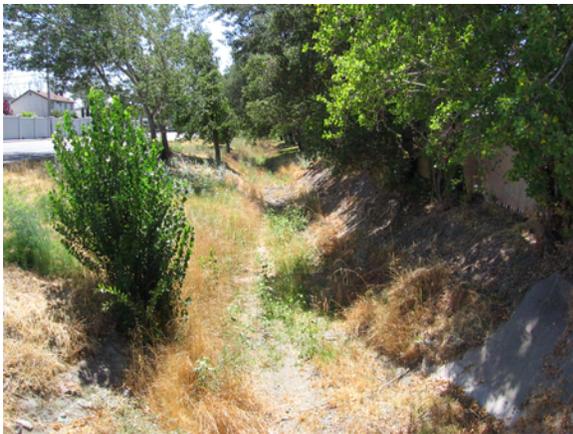
(c) Upper Reach 5 looking downstream from Maria Dr. Compared to Reach 6 upstream, upper Reach 5 is shallower. Upper Reach 5 is dry (Aug. 26, 08), but becomes wet in its lower section (photo d), presumably from collective urban flows, and input from confluence of East Washington Creek, downstream of this photo, and upstream of photo d.

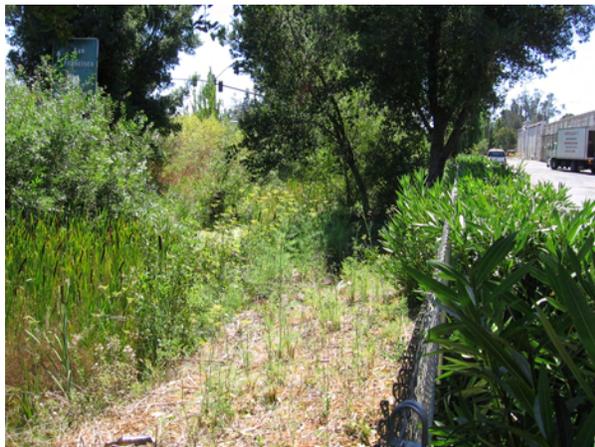
(b) Reach 4 looking downstream, just downstream of photo a; this area flooded in 2005/06 into the parking lot and Big 5 store to the right; in-channel emergent vegetation of cattails and water plantain has vigorously returned, along with some renewed sediment deposited (Aug. 26, 2008).

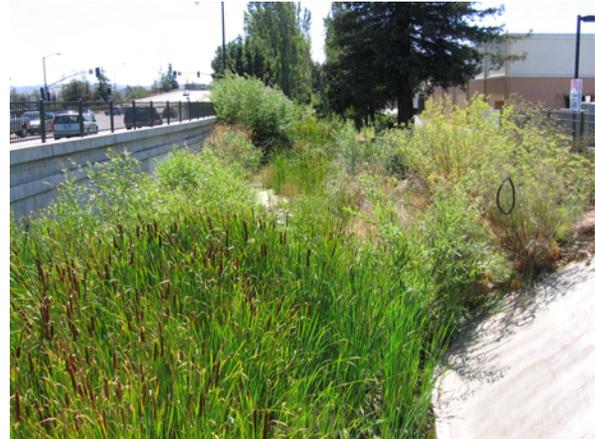
(a) Reach 4 looking downstream from N. McDowell; this section has experienced past flooding in 2005/6 with overbank flows out of channel to right into parking lot and Big 5 store; channel was cleared of sediment and vegetation in 2006, cattail growth and some sediment has returned (Aug. 26, 2008).

Management considerations for Reach 4 of Washington Creek focus on sediment removal immediately downstream of the N. McDowell crossing and further downstream throughout the reach. As described above, this reach is historically depositional (possibly due to the gentle gradient upstream of the large drop structure downstream in Reach 3) and has experienced past flooding (2005/06); due to this heightened propensity to collect sediment and flood, this reach requires careful evaluation each season. Current recommendation is to remove sediment throughout the reach including at the upper end just downstream of McDowell, but also at the lower end of the reach near Hwy. 101.

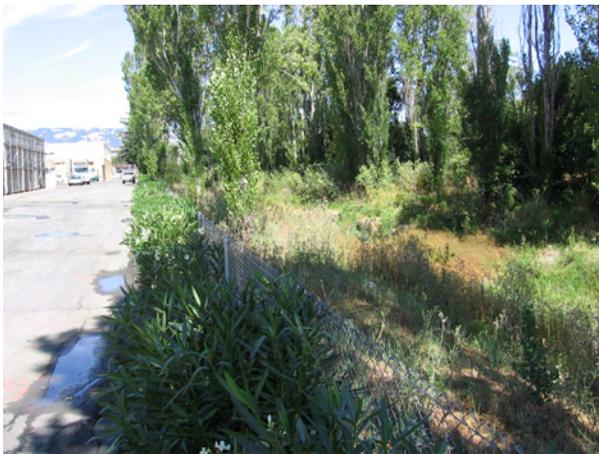
(c) Lower Reach 4 looking upstream; tall Lombardy poplar trees seen in distance; in the lower reach the low-flow channel is less defined, and recently deposited sediments are distributed more evenly across the entire channel bed; willow scrub and ruderal vegetation fill channel bed (Aug. 26, 08).

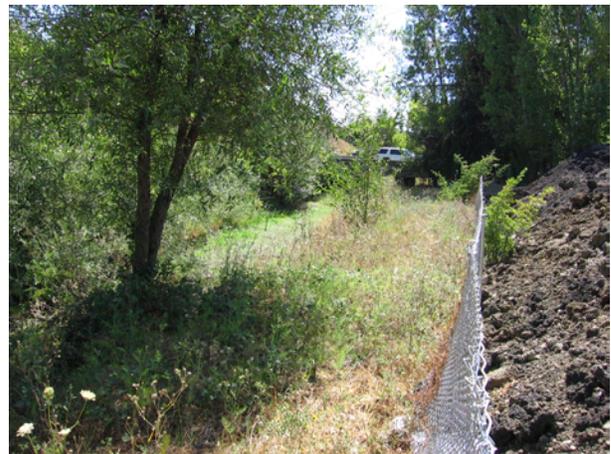
(d) Lower Reach 4 looking downstream to Hwy. 101 crossing; soil to right is from a non-SCWA transportation project during the summer of 2008; sediment has been collecting in channel to left (Aug. 26, 2008).

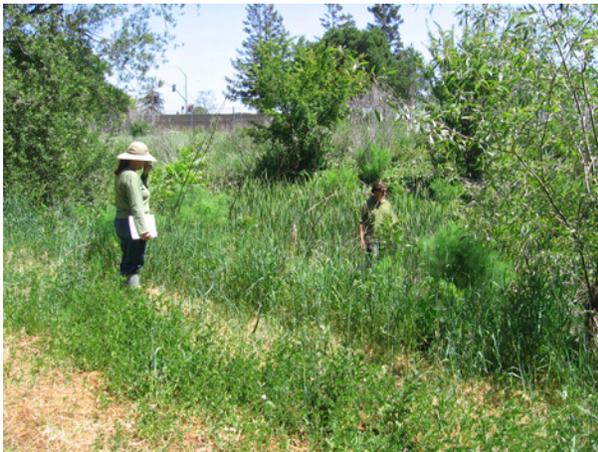
(b) Mid Reach 3 at westward bend in channel, bend zone characterized by much deposition along bed and abundant cattail growth. Man on right of photo is standing on 2-4 ft of accumulated sediment on channel bed (May 06, 2008).

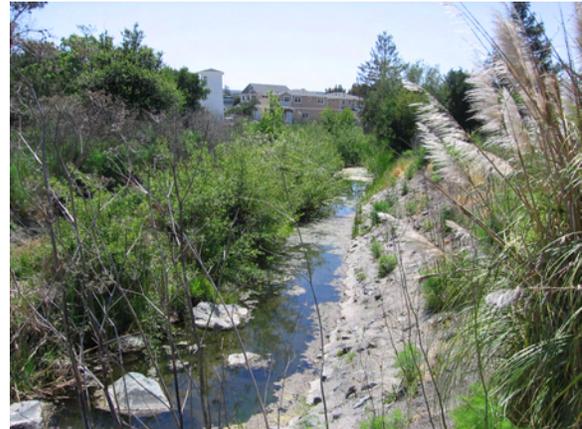
(a) Upper Reach 3 downstream of Hwy 101 off ramp - looking downstream. Note grouted riprap and steep bank; 12-15 ft channel width at bed, stagnant water with algae (May 06, 2008)

Water quality: reach is impacted from stagnant water, algae growth, and large trash items (couches and computer monitors in creek or along banks) (observed 5/06/08).

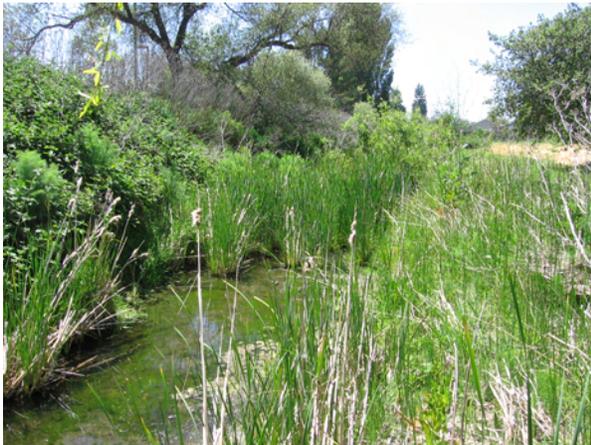
(c) mid Reach 3 looking downstream, exemplifies typical reach section with dense cattail stand blocking flow creating a stagnant pool in channel, steep bank to left covered in blackberry, most of bank to right covered in grasses with occasional riparian woodland like oak tree seen to right (May 06, 2008).

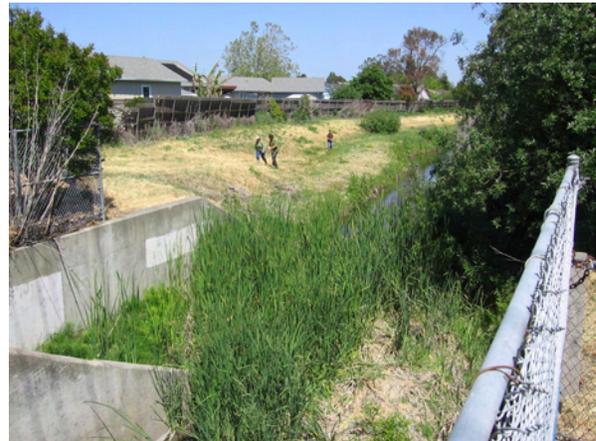
(d) lower Reach 3, looking upstream from Madison St., abundant sediment and vegetation shown upstream of crossing causes partial blockage of culvert entrance; in distance access road provides bench and shows evidence of flows exceeding the low-flow channel (May 06, 2008).

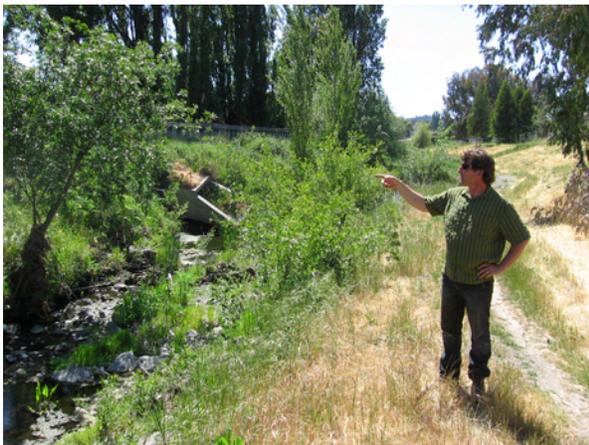
(b) Mid Reach 1, man is pointing toward failed culvert outfall that is destabilizing southern bank, sheet-piled flood wall runs along southern bank above failed culvert, on northern banks, grassy access road area provides overbank capacity, with recently deposited sands observed beneath man (May 06, 2008).

higher streamflows emerging above bank on to northern bench, failed culvert (photo b) causing flow deflection and bank erosion on opposite bank.

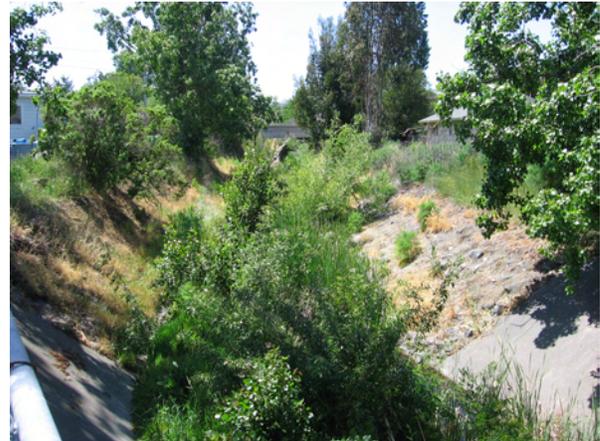
(a) Reach 2 looking downstream from Madison St. crossing to Holly Lane crossing. Note in channel willow growth and sediment accumulating at downstream end of crossing, hardened banks (May 06, 2008)

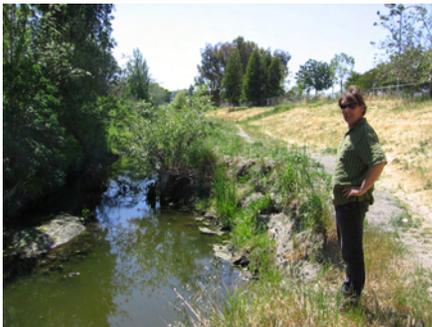
(c) mid Reach 1 looking downstream, bank erosion next to man caused by flow deflection from failed culvert seen in photo b (May 06, 2008).

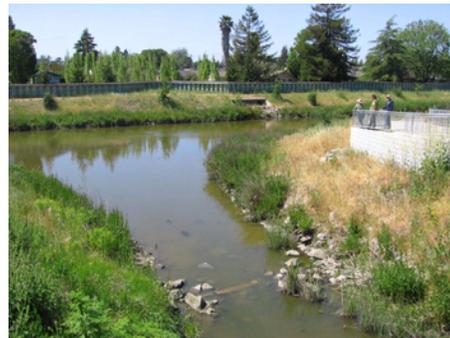
(e) lower Reach 1 at confluence of Washington Creek and Petaluma River, flood wall protection of Petaluma River seen in distance above opposite bank (May 06, 2008).

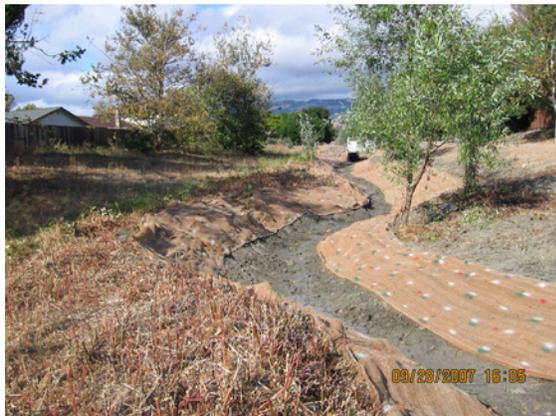
(e) Reach 4 looking upstream to Garfield Dr. (9/28/07); photo taken after maintenance activities in Sept. 2007 removed accumulated sediment from culvert and channel, thinned in-channel vegetation, and excavated low-flow channel. Note channel sinuosity and preserved riparian trees following maintenance activities.

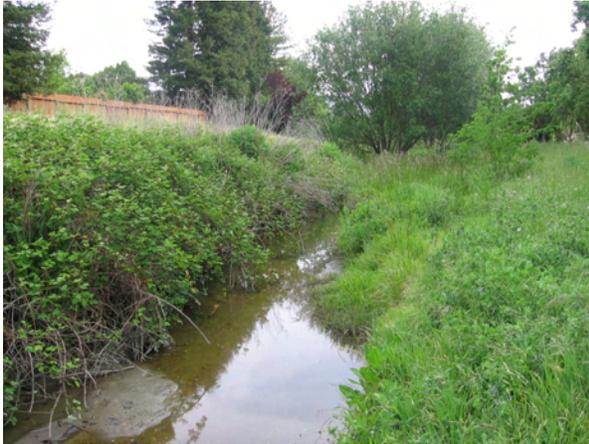
(f) Lower Reach 4 looking upstream from Ely Blvd. (May, 2007); open low flow channel emerges in lower reach; channel slope appears to steepen toward Ely Blvd. crossing; reaches 5 and 4 both have wide easements.

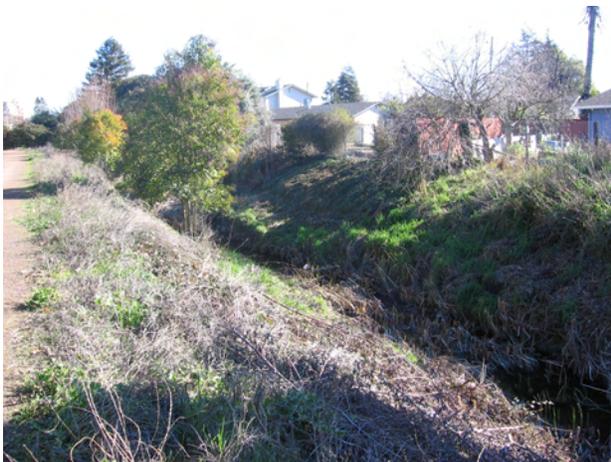
(b) Reach 3 looking upstream; note steep banks undercut at base provides potential for bank slumping and failure, sequences of cattails and sediment bars, overall narrow easement and close proximity to homes and backyards (Jan. 2007)

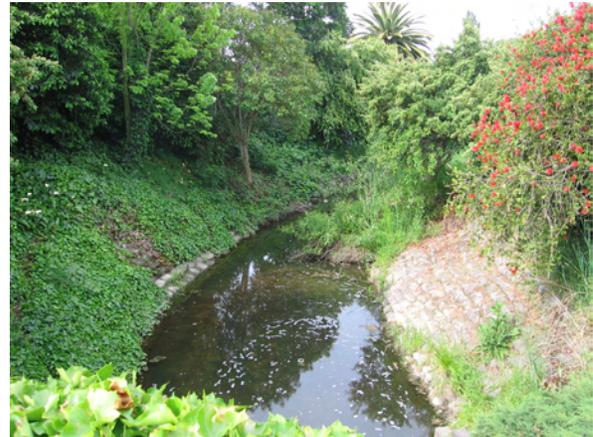
(a) looking downstream from Ely Blvd.; note armored banks, steeper trapezoidal channel, and much narrower easement width than Reach 4 upstream (Jan. 2007).

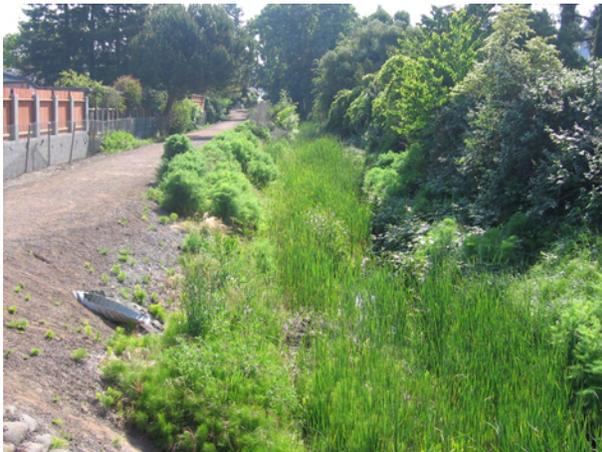
(c) mid Reach 2 looking upstream from McGregor Ave. note steep banks beneath access road and in-channel sediment and vegetation; in terms of depth and height of banks, mid Reach 2 is transitional between the deeper channel upstream (photo b) and the shallower channel downstream (photo d) (May 2007).

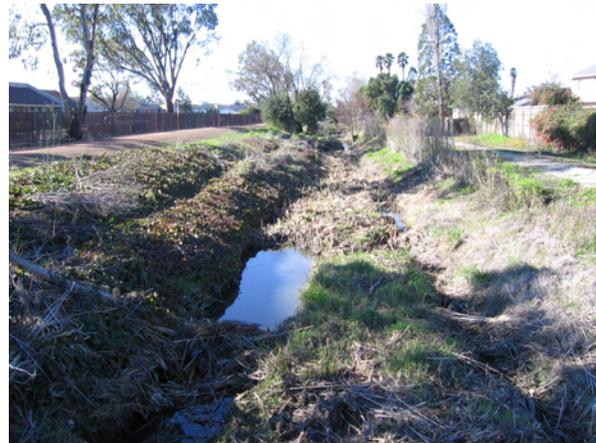
(d) lower Reach 2, looking downstream from Maria Dr.; channel cross section shallowed and filled from abundant deposition; finer sediments (sands, silts, mud) accumulate here compared to coarser sediments upstream; cattails and other vegetation recently cut, but stalks show return (Jan. 2007)

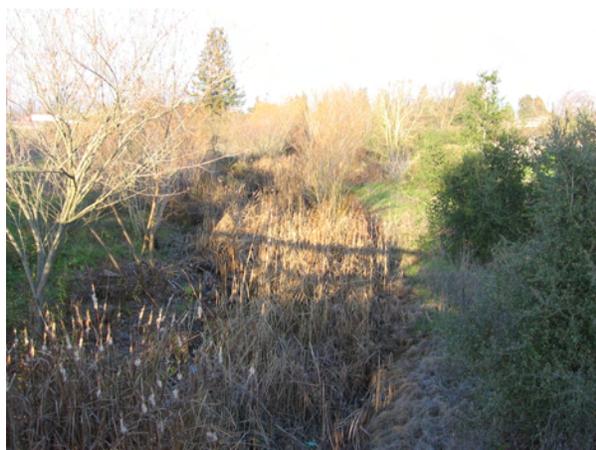
(b) Stagnant water between areas of in-channel vegetation growth. Mid-reach, looking upstream (October 26, 2008).

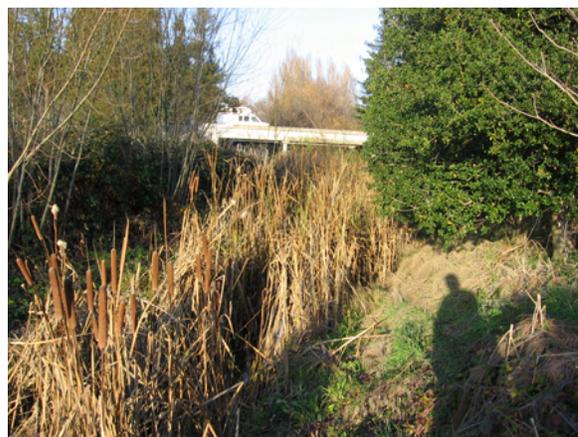
(a) Lynch Cr. Reach 1, upper reach looking upstream to Hwy 101 crossing; abundant cattail growth blocks channel bed; steep banks and relatively deep channel (Jan. 8, 2009).

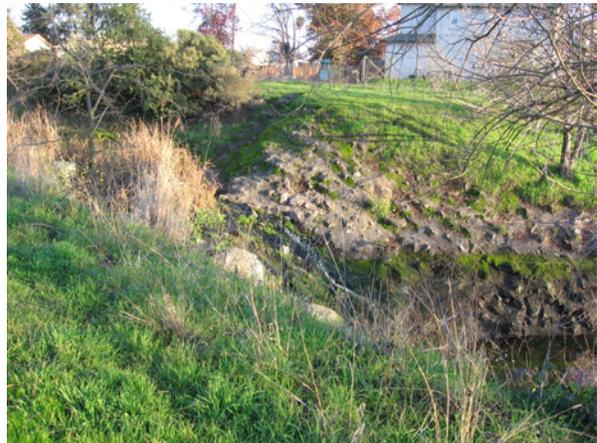
(d) Looking downstream at banks and canopy cover near upstream end of reach (October 26, 2008).

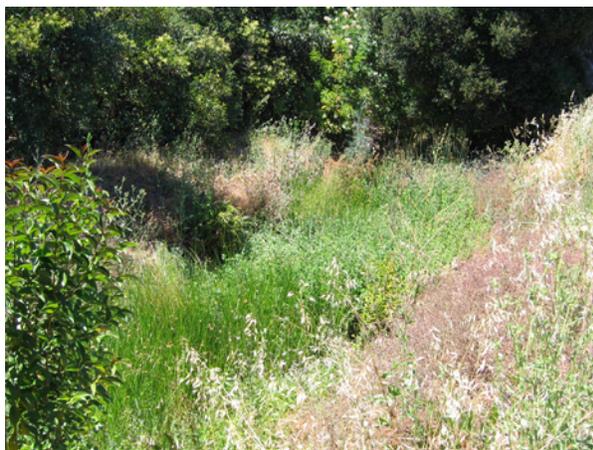
(b) Mid Reach 2 looking upstream. The active channel is distinguished by the green band of rushes, sedges, and grasses. There was shallow surface water flowing through the dense emergent vegetation in this section of the reach (Aug 2008).

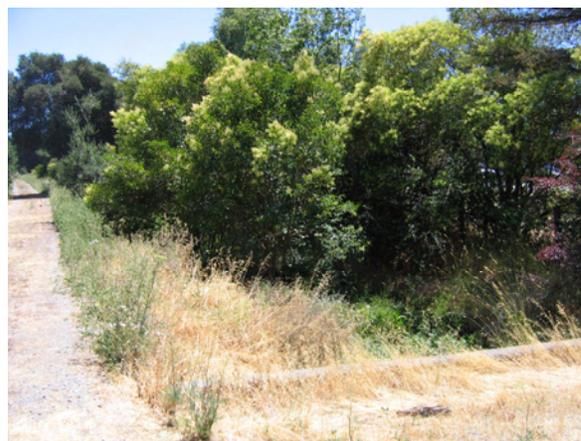
(a) Top of Reach 2, looking downstream. The concrete beam in the foreground is the top of the culvert system that marks the beginning of "daylighted" McDowell Cr. Channel is straight and confined between an access road on east side and Hwy 101 on the west side (Aug, 2008).

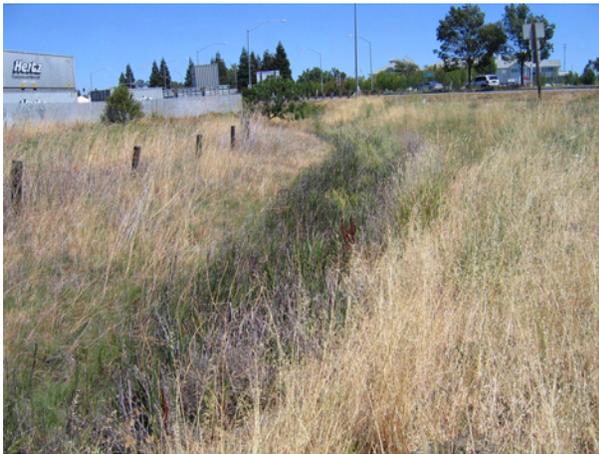
(c) Reach 2 downstream of the confluence with the East Fork of McDowell Cr, looking downstream. Active channel is distinguished by the green tules, sedges, and grasses. This part of the Reach supported shallow surface water in August 2008, which was diffused through the dense vegetation.

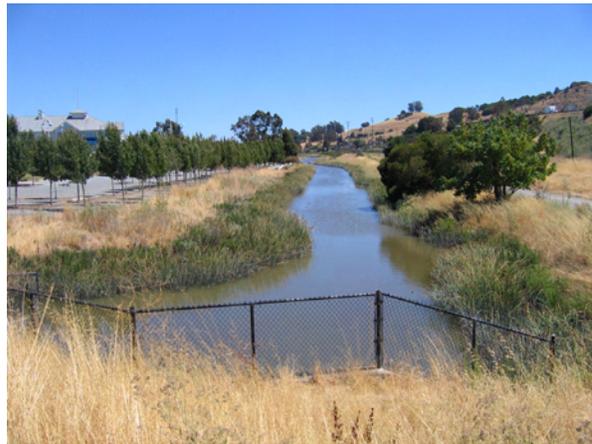
(d) Reach 1 looking downstream from above the tide gates. Channel form and vegetation in this reach reflects tidal processes and is much different than the upstream channel forms which are protected from tidal action by the tide gates. SCWA ordinarily does not perform maintenance activities in the area subject to tides below the tide gates (Aug 2008).

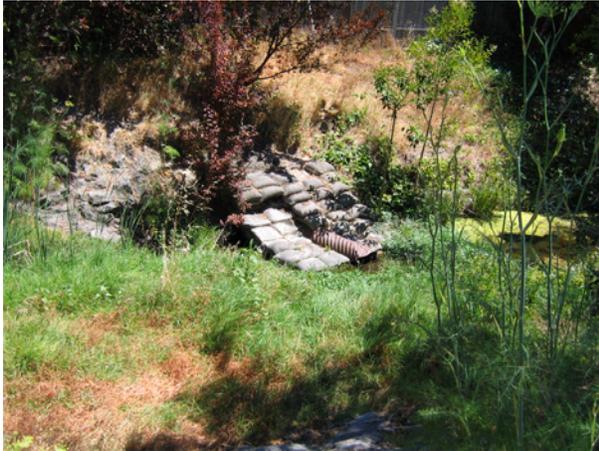
(b) Middle of East Fork Reach 1 looking across the channel. This was just one of a few storm drain outfalls entering the channel from both sides. Most of the outfalls are surrounded by sacrete or grouted rip-rap (Aug 2008).

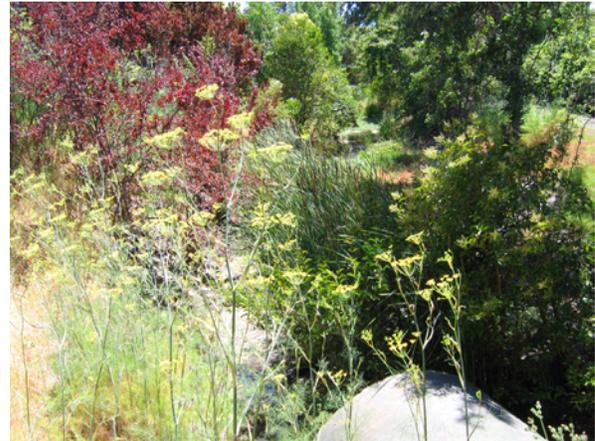
(a) East Fork looking downstream from pipe at the top of Reach 1 near St. Francis Dr. This pipe is the conduit for all flows into the reach and appears to be 60" in diameter. Note the dense vegetation all around the pipe outlet. In August 2008, a steady trickle of water was coming from the pipe and feeding the downstream channel,

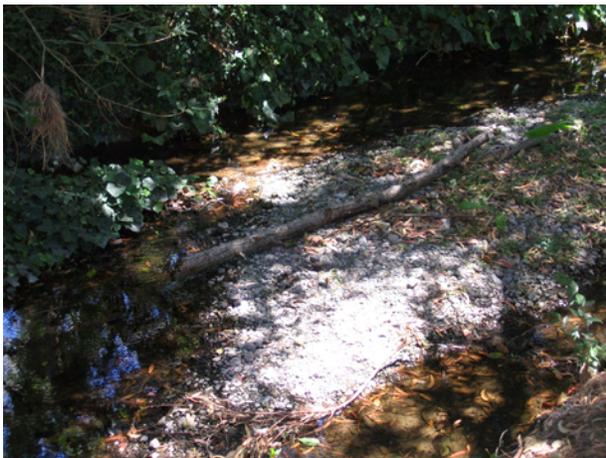
(c) Middle of East Fork Reach 1 looking downstream at a small mid-channel gravel bar. Three small bars, including this one, were observed along the Reach 1 during surveys in August 2008.

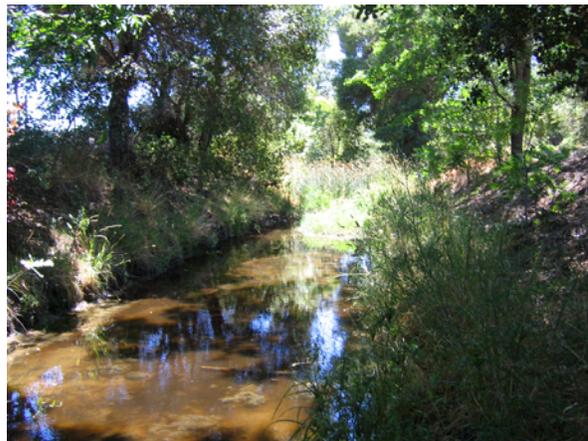
(d) Lower East Fork Reach 1 just upstream from the confluence with McDowell Creek Reach 2. Note both the wide flat channel and amount of water in the channel. The lower portion of the East Fork appears to be controlled by the sediment wedge at the confluence with McDowell Cr. which seems to be backing-up water from the East Fork (Aug. 2008).

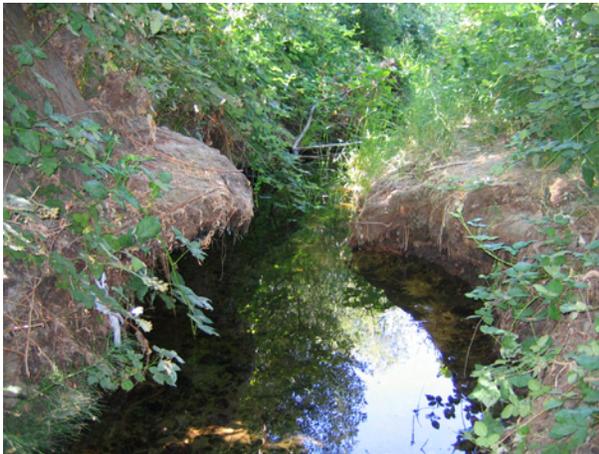
(b) Looking downstream approximately 500 ft from the top of Reach 4. Although most of both Reach 4 and 3 are dry, both reaches support a handful of pools, this being the longest (approx 50 ft long) and deepest (max 3 ft). Three foothill yellow legged frogs were observed in this pool on 07/03/08. Just downstream the channel goes dry again.

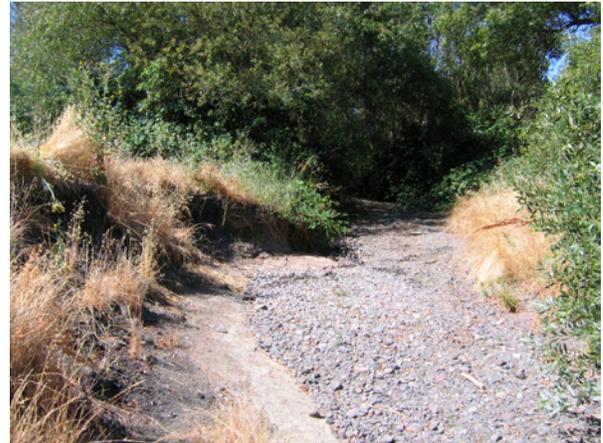
(a) Top of Reach 4 looking downstream into the area where SCWA's maintenance easement begins (after the bend). Stream bed comprised of gravel, cobbles, coarse sand. Channel is dry with shallow subsurface flows likely. Bedrock outcrop observed to left (07/03/08).

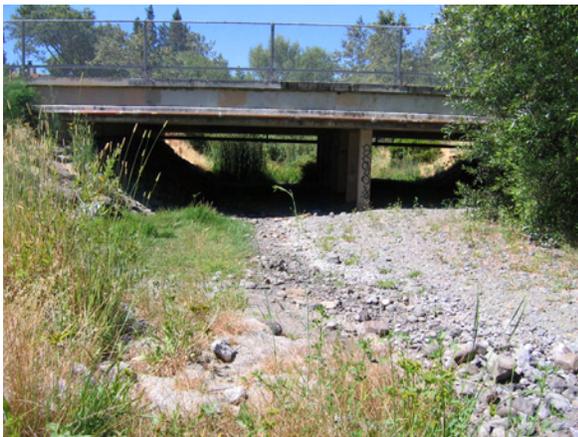
(c) Lower Adobe Cr. Reach 4 looking downstream at Sartori Bridge and into upper Reach 3. Coarse gravel and cobbles are seen along the drier low flow channel upstream of the bridge, downstream of the bridge a large mass of cattails and willows are observed (background) (07/03/08).

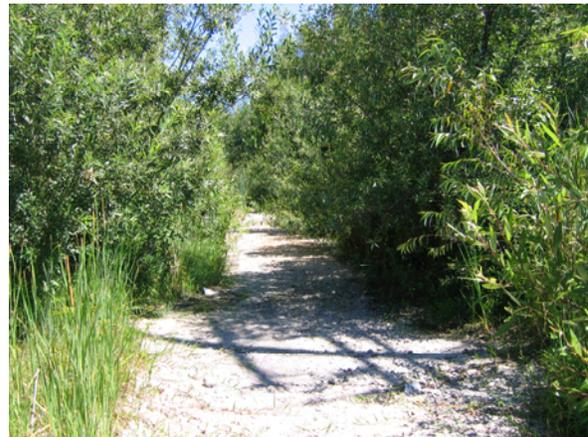
(d) Adobe Cr. Reach 3 looking upstream from the Lakeville Hwy bridge. About 200 ft upstream of Lakeville Hwy the channel transitions from a gravel and cobble dominated system to a sand dominated system. Note the uniform wide, flat, bed at the bottom of reach (07/03/08).

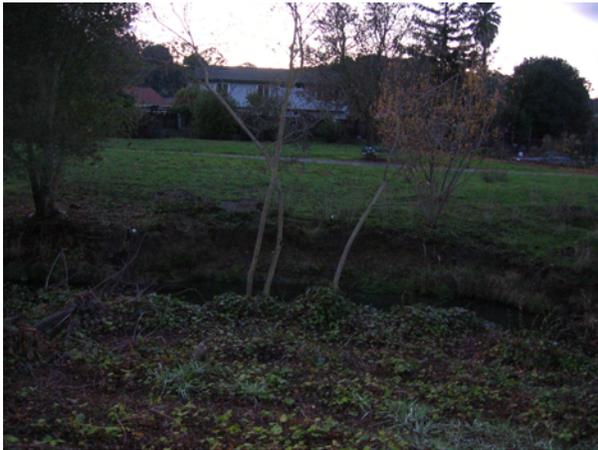
(b) Upper Reach 1, downstream of photo (a); actively eroding bank seen with 5 ft. vertical face; this section of upper reach is steeper than the middle and lower reach sections downstream (Dec. 16, 2008).
