Figure 4-23

Roseland/Colgan Subbasin

FIGURE 4-24
Reaches and Vegetation
 Roseland/Colgan (1 of 6)

Roseland Creek – Reaches 6 & 5

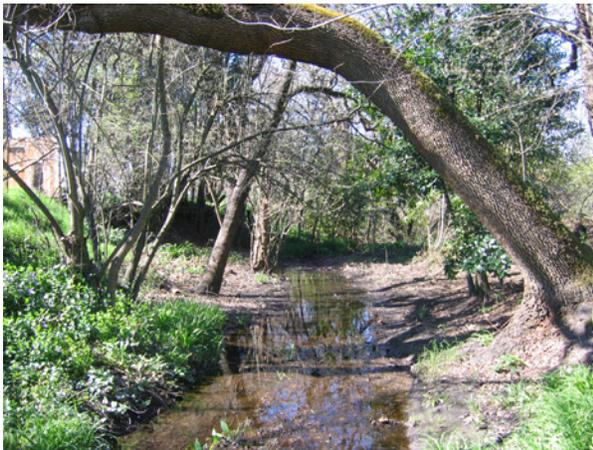
(b) Reach 6, looking downstream below Goodman Ave. Channel void emergent vegetation, good canopy development. Channel bed is a mix of mud and decaying leaves, present for a number of weeks or months. Surface flow is minimal with very shallow conditions 1-4" deep. (3/5/08)

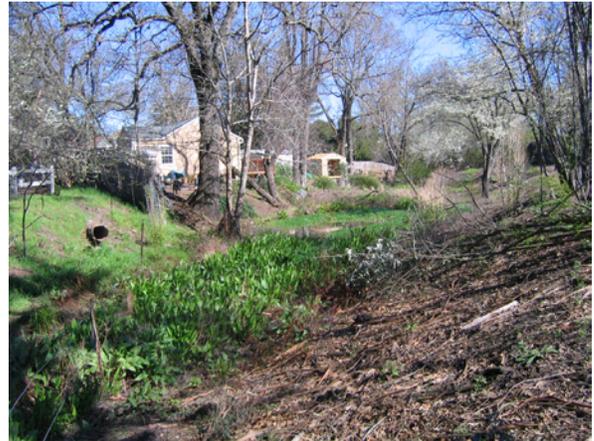
(a) Reach 6, looking upstream near Goodman Ave. Note in-channel pool in background, emergent vegetation in foreground, perched stormwater culvert to left, gently sloping banks, and line of woody trees providing 50%-75% canopy closure. (3/5/08)

Bank structure: earthen and gently sloped (< 3:1) in Reach 6 (photos a and b) and earthen banks with 2:1 slopes in Reach 5 (photos c and d).

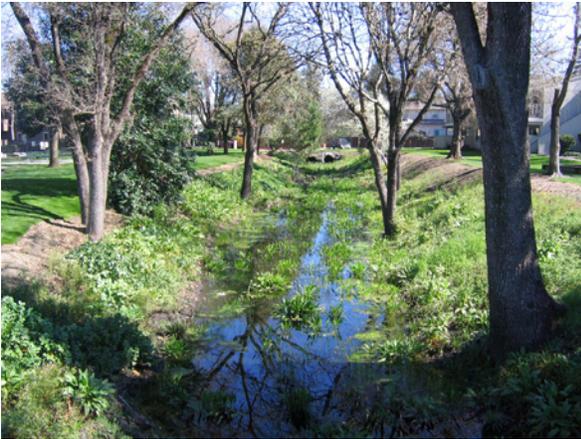
(c) Reach 5, looking upstream from crossing at apartment complex. Note linear trapezoidal channel, line of woody riparian trees along the toe of the slope, and the grassy lawns above the bank. Homes on both sides relatively close to creek (3/5/08).

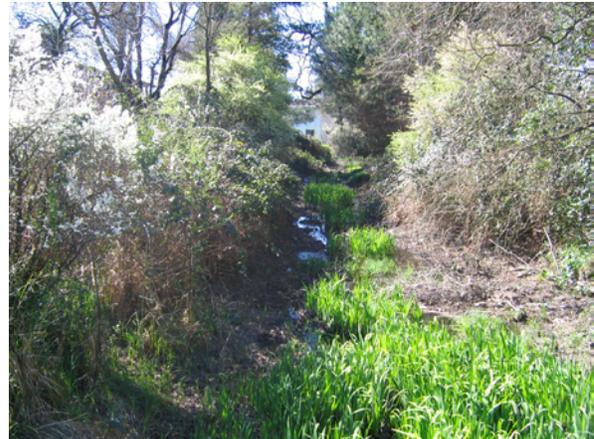
(d) Reach 5, looking downstream toward McMinn Ave. from below apartment complex. Channel x-section has narrowed, more emergent vegetation, and the banks are heavily vegetated with a woody thicket of shrubs (3/5/08).

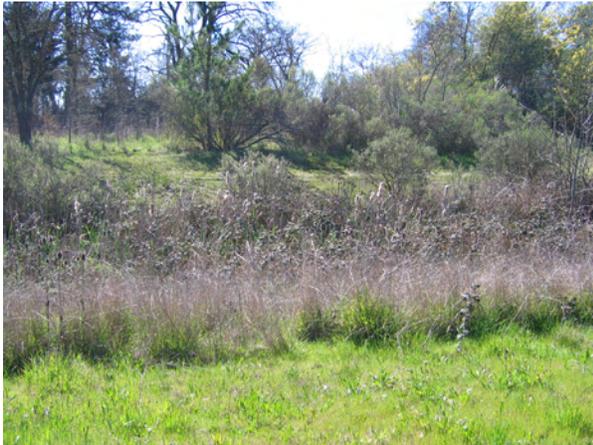
(b) Mid Reach 4, note - large natural buffer to the east (background), lack of woody riparian canopy at immediate channel, and somewhat incised active channel marked by dense emergent vegetation (March 2008).

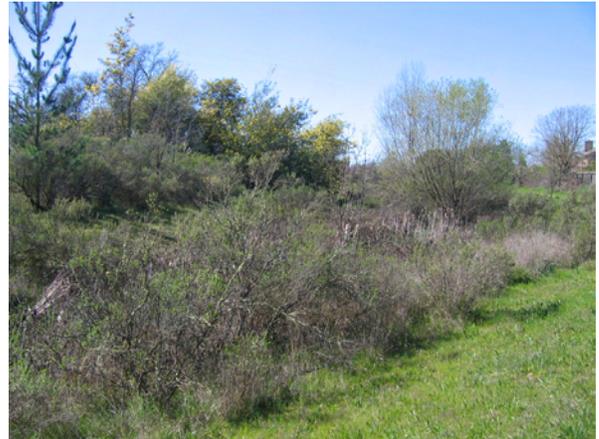
(a) Upper Reach 4, looking downstream from Comalli St. Channel is not constrained by development and still maintains a wide (75-100 ft) buffer between the channel and new developments to the west. Channel is heavily vegetated with small willows, thistle, teasel, etc and almost no riparian canopy (March 2008).

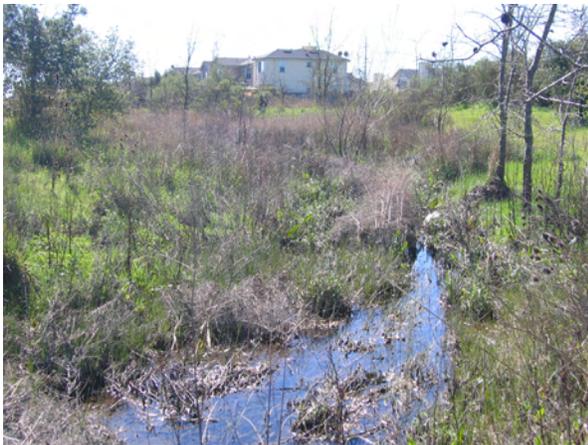
(c) Mid Reach 4 looking downstream, photo taken about 150 ft downstream of photo b and shows the channel much less incised with a wider, flatter profile. Flows are still moving through a heavily vegetated active channel with very little canopy (March 2008).

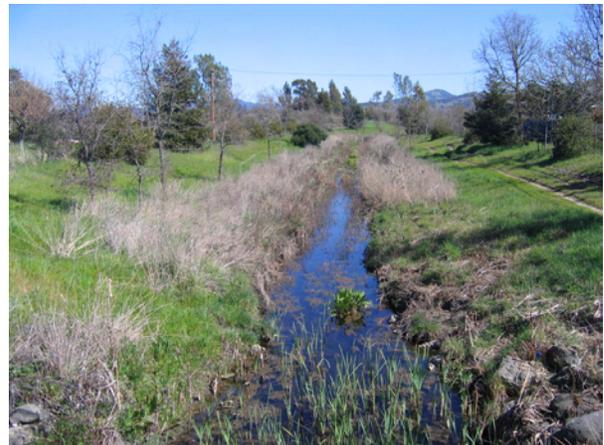
Water quality (qualitative): moderate to poor, with many areas of open water containing significant algae growth (photo d) in March 2008.

(d) Reach 4, looking upstream from Stony Point Rd. Linear trapezoidal alignment with gentle banks, narrow low flow channel inset into a wider and shallow stream bed. Channel pinches at downstream end due to a growing bar on the west/left. Note high level of algae growth in active channel (March 2008).

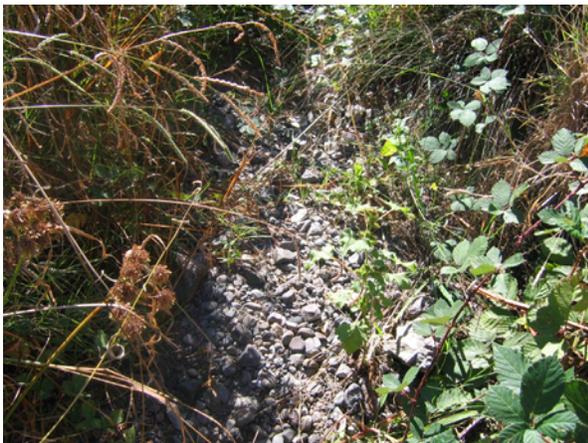
(b) Upper Kawana 1 looking downstream; Note the defined low flow channel with gravel bed and heavily vegetated banks. This naturalistic channel changes drastically as Kawana moves downstream and into Colgan 7 (see photos c and d) (Oct 2007).

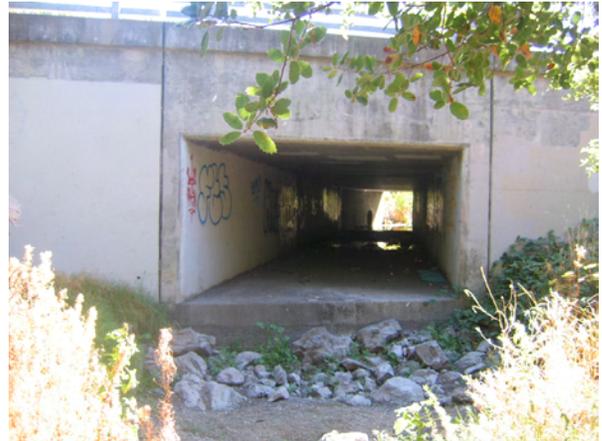
(a) Looking upstream into box culvert at Petaluma Hill Rd (top of Kawana 1); Culvert is 2+ ft above channel grade and is clean of sediment (Oct 2007).

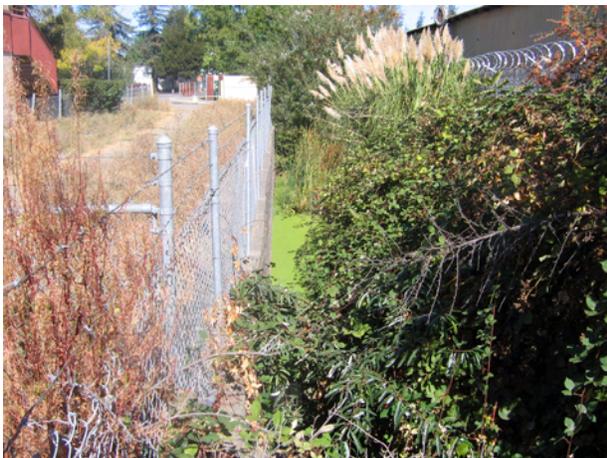
(c) Lower Kawana 1 after it emerges from ~500 ft long underground pipe into industrial area adjacent to Colgan Ave. Channel is contained by 3 concrete walls (bed and banks) there is substantial growth of emergent and floating vegetation in the channel (Oct 2007).

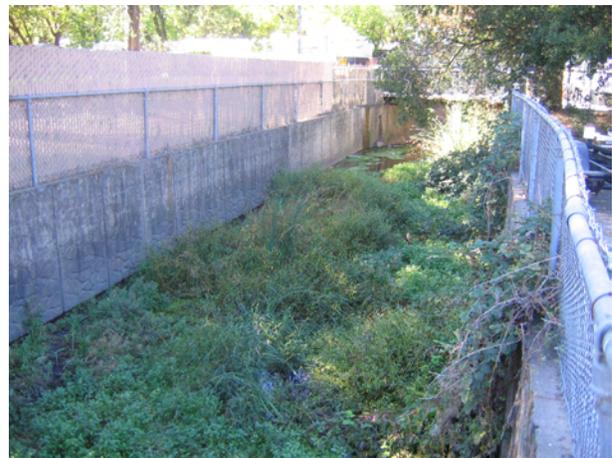
(d) Colgan 7 looking downstream toward 101 crossing. Like the bottom of Kawana 1, the channel is confined by concrete on 3 sides; both fine muds and herbaceous vegetation cover the entire channel bottom (Oct 2007).

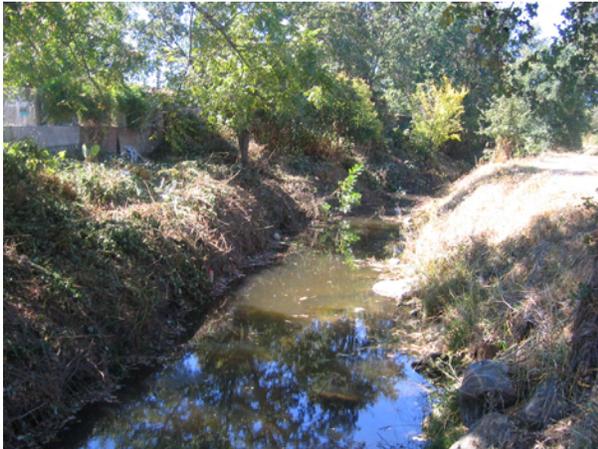
(b) Mid Reach 6, looking downstream. Banks are steep and composed of earth and rip-rap; this is a straight section with limited in-channel deposition and open water; most of this reach looks more like photos a, c, and d, with open areas scattered in between (10/2007).

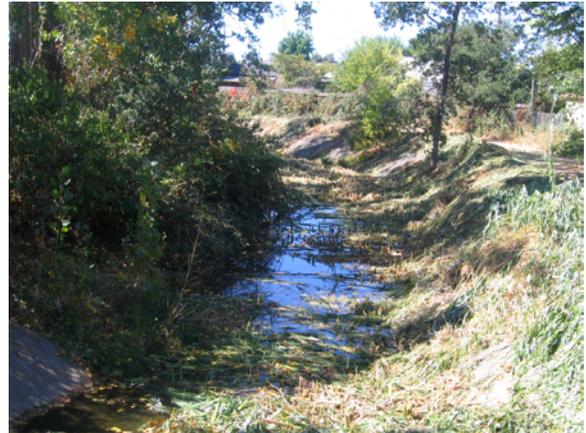
(a) Top of Reach 6, looking downstream from Corby Ave. In-channel cattails have been recently cut (photo from 10/5/07) and that the banks are concrete.

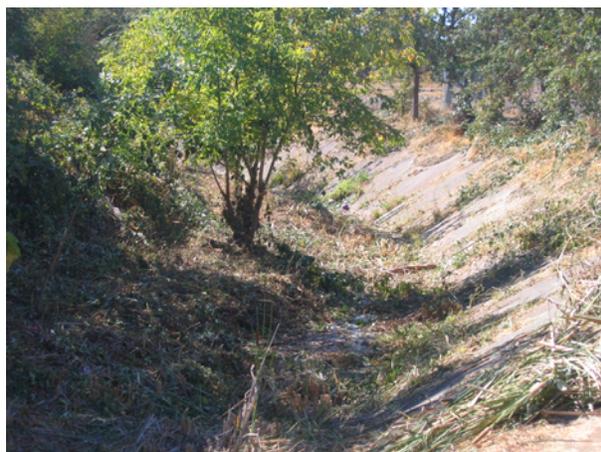
(c) Mid Colgan Cr. Reach 6 looking downstream. Banks are hardened with concrete (at bends), cattails across the channel bottom have just been cut back, and a depositional bar is forming on the inside of the bend (Oct 2007).

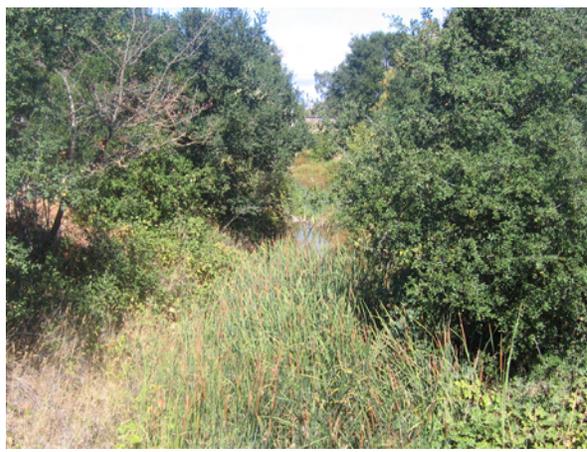
(d) Lower Colgan Cr. Reach 6, looking upstream from Hearn Ave crossing. Channel is choked with cattails in the foreground with a backwater pool upstream in the background (Oct 2007).

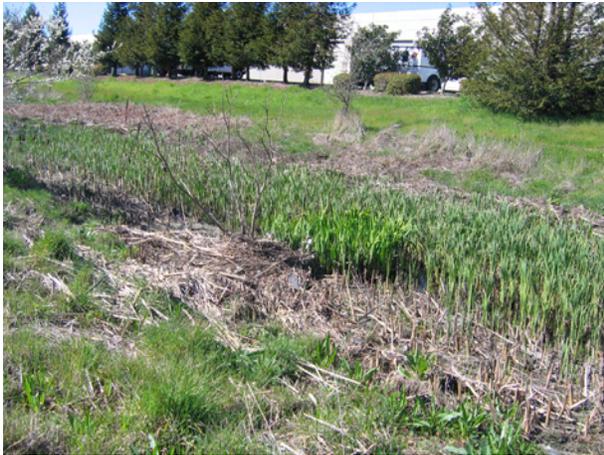
(b) Mid Reach 3, looking downstream, low flow channel is completely choked by cattail vegetation and flow is shallow and diffuse (March 2008).

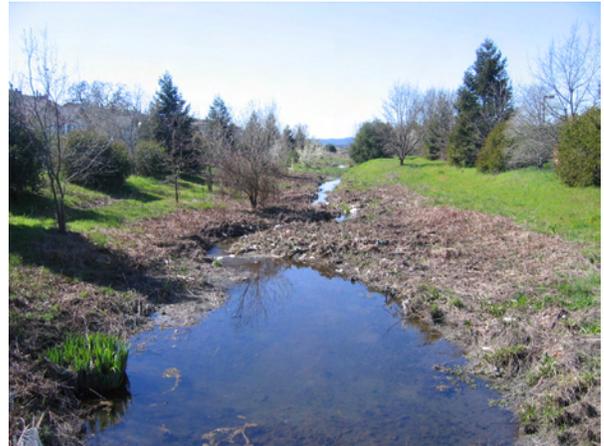
(a) Reach 3, looking downstream from Stony Point Rd. Dense blackberries along banks recently removed by SCWA, depositional bar downstream of pool confines low flow channel. In distance, channel maintains a confined geometry as it meanders across sediment bars on both banks (March 2008).

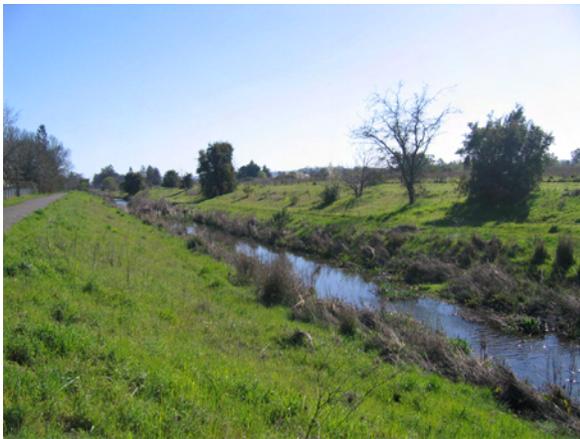
(c) Lower Mid Reach 3, looking downstream; unlike photo (b), here channel is straight and maintains its trapezoidal open flowing condition. The straightened channel appears to have a slightly higher gradient and is more effective at transporting sediment than other sections of this reach. This section is adjacent to DFG Ecological Reserve and appears to drain that reserve (March 2008).

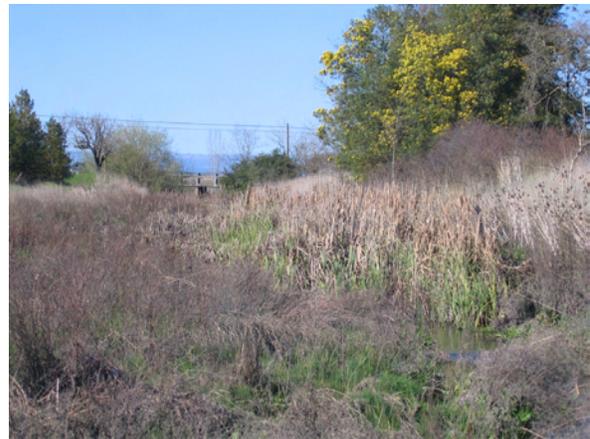
(d) Reach 2, looking downstream toward Ludwig Ave. crossing. Reach 2 is similar to Reach 3 in having a wide floodplain, alternating sections that are choked by cattails and sections with open, unobstructed flow through a single low flow channel. For example, remnant pool in the foreground flows into a section choked by willows. This pattern is common in many of SCWA's engineered channels (March 2008).

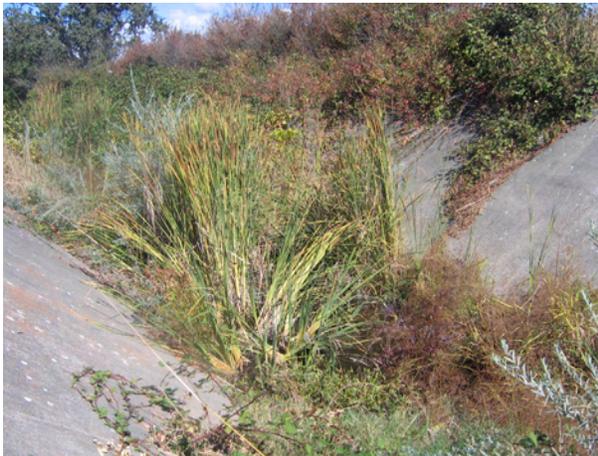
(b) Mid Reach 5, looking upstream. Concrete banks narrow the channel, vegetation growing throughout low flow channel. Just downstream of this site there are 2 access roads (one on each bank) that enter the stream channel (Oct 2007).

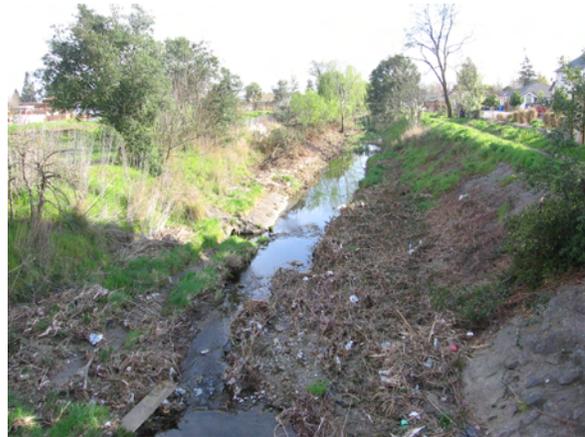
(a) Looking downstream from Hearn Ave. Banks are hardened with grouted rip-rap. Recent blackberry removal (2007) exposes a wedge of sediment along the toe-of-bank on right (Oct 2007).

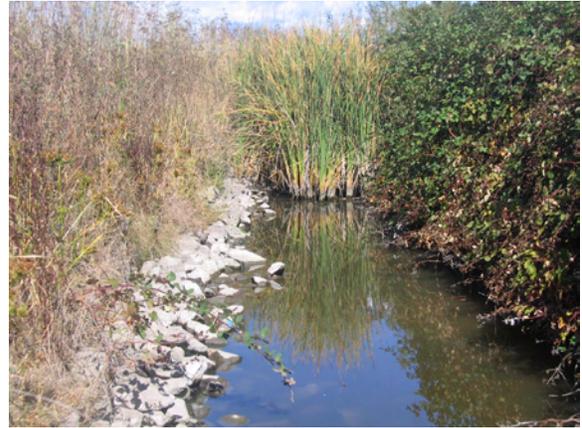
(c) Mid-reach, looking upstream, downstream of photo b. Typical non-concrete section of Reach 5. Note rip-rap at the toe of slope on the left and the steep blackberry covered bank on the right. Cattail choked section in the background and open-water in the foreground. This sequence is common throughout the reach (Oct 2007).

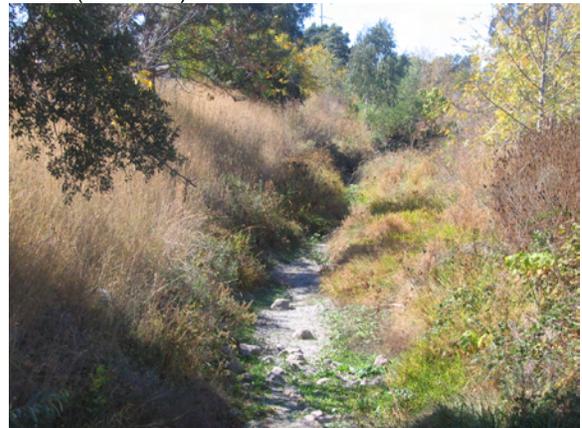
(d) Lower Colgan 5, looking downstream from Dutton Meadow crossing, near the High School. The channel is dry in this section and the low flow channel is clearly defined by a fine sand and caked mud substrate. Notice that the banks are wider and more gently sloped in this section than upstream.

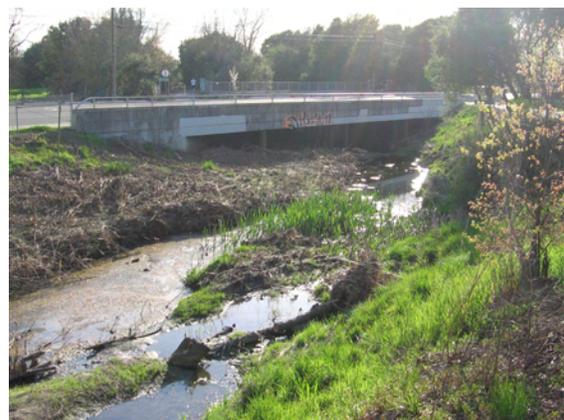
Photo (e) at right: Lower Colgan 5, looking downstream to Bellevue Ave. crossing near the High School. Aggrading sediment along bank to left and in mid-channel bar block entrance to box culverts beneath Bellevue Ave.

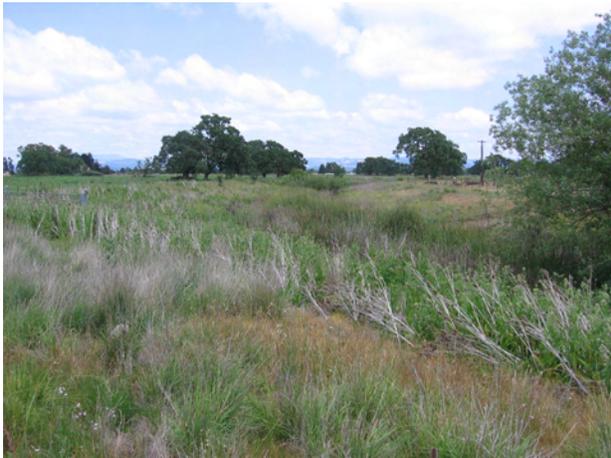
(b) Approx. 1000 ft upstream of Llano Rd. Similar to photo (a) cattails are growing across the lower wet channel area, the channel banks are gently sloping, no significant riparian canopy (March 2008).

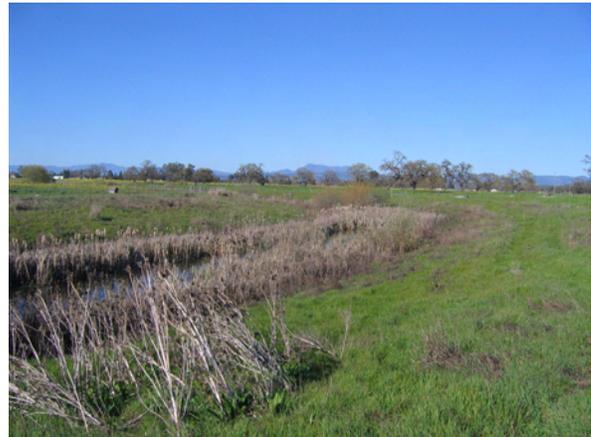
(a) Approx. 2500 ft upstream of Llano Rd. Creek is a broad trapezoidal channel, with gentle sloping banks, grassy banks have little to no woody vegetation, in-channel vegetation dominated by cattails (March 2008).

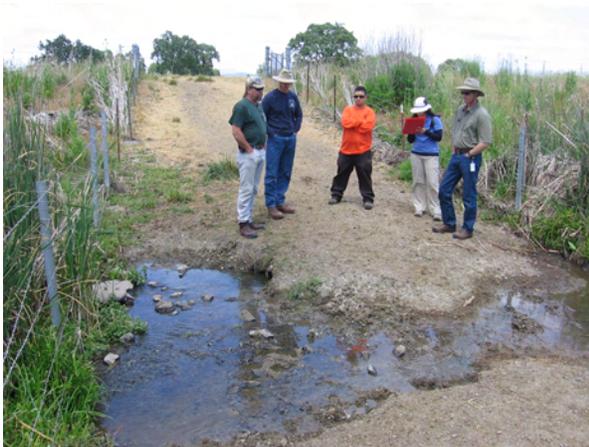
Water quality (qualitative): flow was relatively clear in March 2008; observed again in May 2008, fencing keeps cattle to within the crossing corridors (photo c), but instream crossings mean cattle do actively cross the channel,

(c) Reach 1 approximately 2500 ft upstream of Llano Rd. Reach 1 includes 6 cattle crossings similar to photo (c). Culverts are typically clogged with sediment, compacted from the load of the road crossing, and many of the culverts are broken open and are posing safety threats to the cattle (as shown in photo) (March 2008).

Management considerations for Roseland Reach 1 focus on the replacement of the existing culverts at the 6 cattle crossings that are damaged, broken open, or filled with sediment. Options could include removal of existing culvert and replacement with a larger culvert set at the new bed elevation and/or the potential reduction in number of crossings. Vegetation maintenance will be necessary at the Llano Rd. bridge to ensure that high flows can move effectively through the crossing. High water marks were observed in March 2008 within a few feet of the road surface. This reach has great potential for restoration. Adjacent habitat supports a wide variety of grassland and savannah species and observations indicate that riparian planting would provide high quality habitat for a suite of riparian birds and related wildlife.

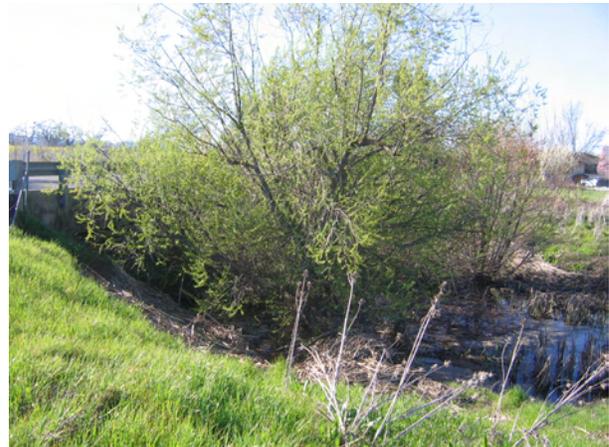
(d) At Llano Rd Bridge. Two large willows and stumps impede flow and block the Llano crossing. Recent high water marks (observed 03/08) indicate that conveyance through crossing is reduced by the current vegetation growth (March 2008).

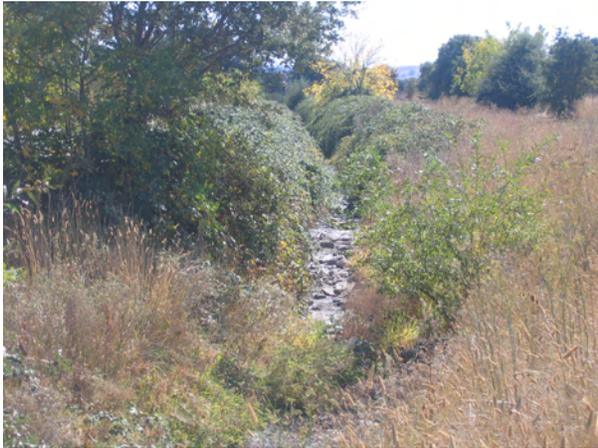
(b) Mid Reach 4, looking upstream. Channel is dry with exposed channel bed dominated by rip-rap (angular rocks). Low flow channel is clearly delineated and banks are steep and covered with annual grasses or blackberries. (Oct. 07)

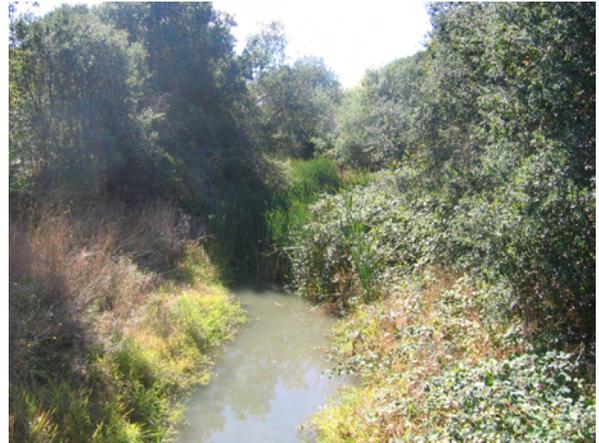
(a) Reach 4, looking downstream from Bellevue Ave. crossing. Water observed, dry upstream in Reach 5. Open water is murky, but banks have increased riparian cover and shade. (Oct. 07)

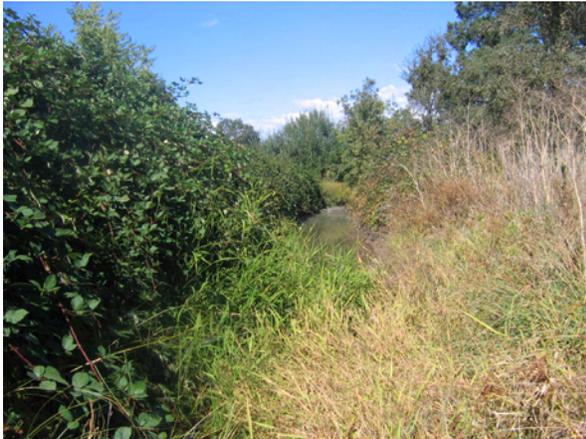
(c) Mid Reach 4, looking upstream, downstream of photo b. Channel in near ground blocked with cattails, then becomes open water section in distance, then blocked again with cattails - with pattern repeating through reach. Banks are steep and completely covered in blackberry. (Oct. 07)

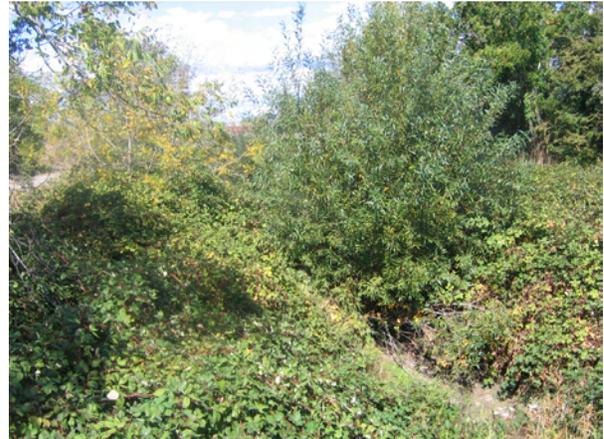
(d) Colgan 3, looking upstream from Todd Rd. channel is dry. Low flow channel is obscured by willows and emergent vegetation. Where vegetation opens, the low flow channel is defined, mix of gravel, fine sand and caked mud. (Oct. 07)

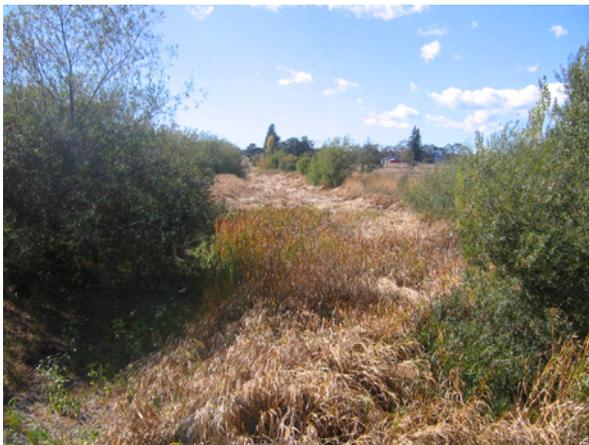
(b) Reach 2, looking upstream from Walker Rd. Channel is dry and filled with cattails and annual grasses. Notice the shallow, wide, and straight channel configuration (Oct 2007).

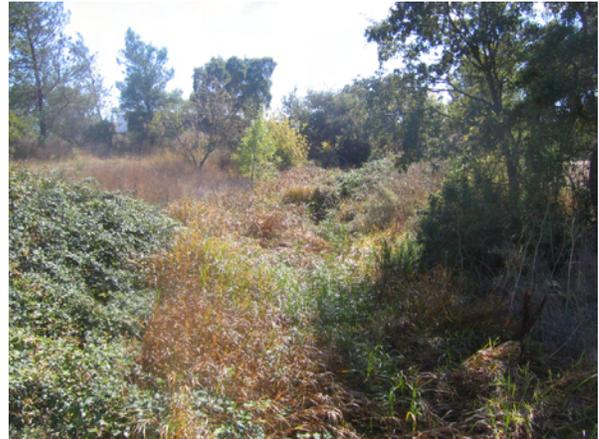
(a) Top of Reach 2 looking downstream from Todd Rd. Channel is dry and covered bank to bank with annual vegetation (grasses and forbs). Channel cross-section is much wider with long sloping banks than upstream Reaches 3/4. In Reach 2, Colgan Cr. begins to take on more of a wider Laguna type channel form (Oct 07).

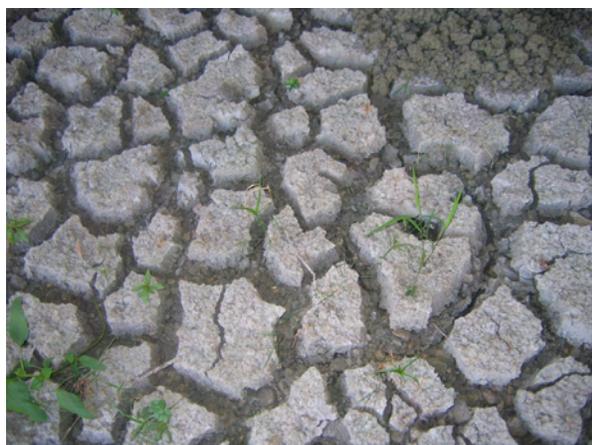
(c) Lower Reach 2, under Walker Rd. Bridge. Exposed channel desiccated with dried mud blocks. (Oct. 07)

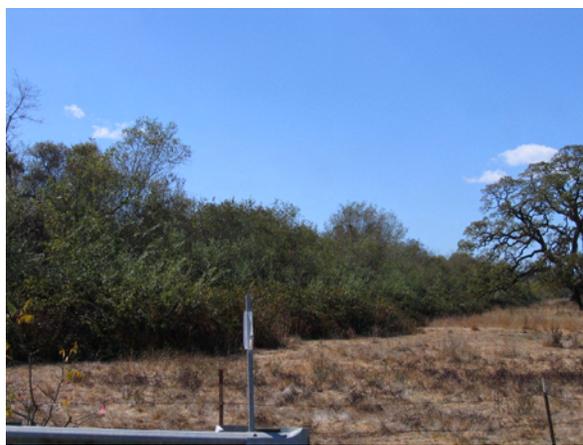
(d) Looking downstream from Llano Rd. to non-SCWA maintained lower Colgan Creek. This section maintains a dense riparian corridor until it reaches the Laguna proper approximately ½ mile downstream. The channel was dry in October, 2007 from the top of Reach 2 to the bottom of Reach 1 (Oct 2007).
