Santa Rosa Subbasin

FIGURE 4-10
Reaches and Vegetation
Santa Rosa (1 of 13)

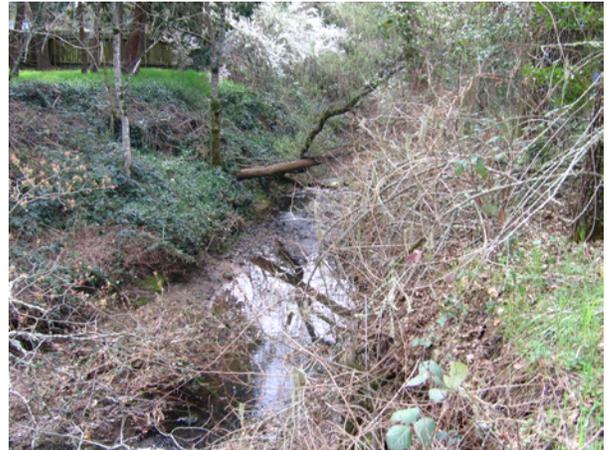
(a) Middle Brush Reach 2, ~1000 ft downstream of reservoir looking downstream. Channel appears to be deeply incised with steep sloped banks. The channel also supports formation of gravel bar features (foreground left) and is actively recruiting woody debris (background left) (March 2008).

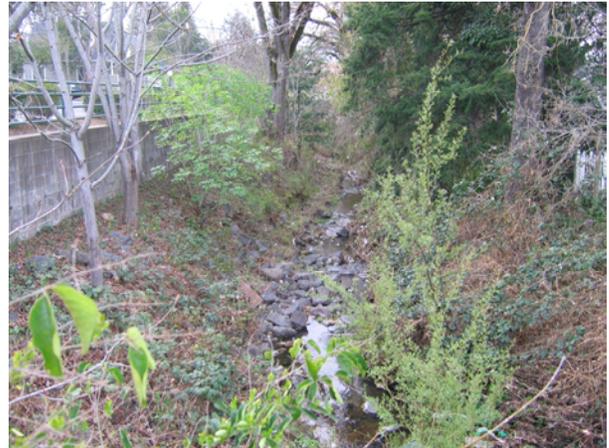
(a) Looking downstream from Boas Dr., channel is narrow and confined by rip-rapped banks on both sides. Sloughed rip has eroded in many places and is now part of the stream bed, creating small cobble riffles (March 2008).

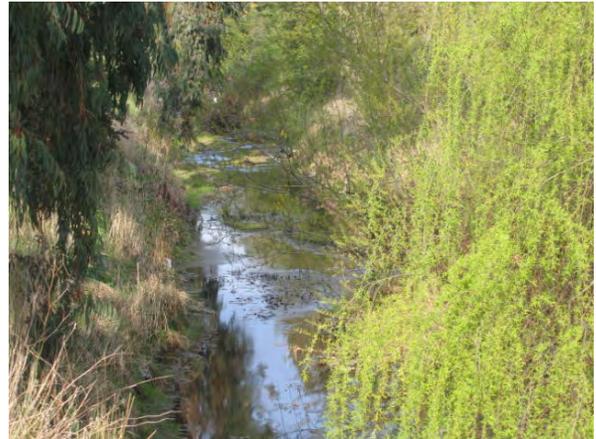
(a) Reach 2 looking downstream from Middle Rincon Rd. Vegetated sediment bars form in the middle of the channel and stretch across the channel in the background. Channel x-section is trapezoidal and linear (March 2008).

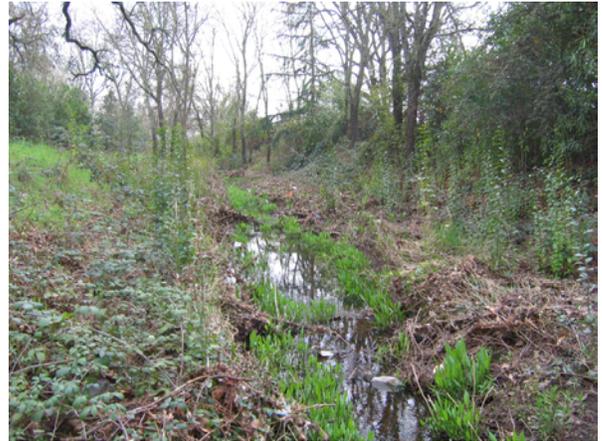
(a) Reach 2 looking downstream from Middle Rincon Rd Crossing (top of reach). Notice the narrow low flow channel with sediment and debris deposits along the channel margins. Also, note the x-section reveals gently sloping banks with moderate canopy development (Photo taken 3/6/08).

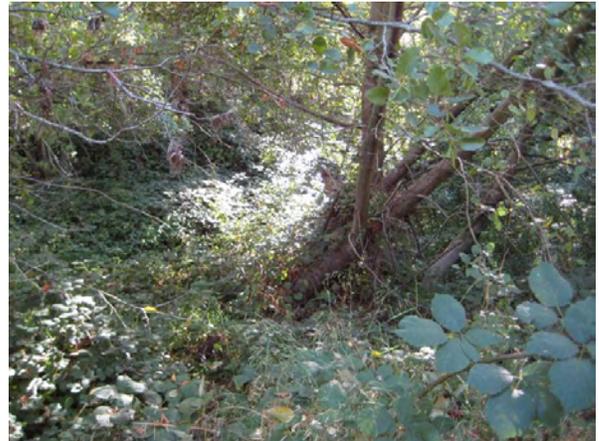
(a) Upper end of Santa Rosa Diversion Reach: Canopy is dense with heavy vegetation throughout channel (October 8, 2008).

Management considerations at the Santa Rosa Diversion focus on the continued maintenance of the weir facility. This facility traps abundant sediment and requires routine sediment removal that includes removal of emergent vegetation that establishes in the deposited sediment. The frequency of sediment removal at the weir facility is dependent upon climatic conditions with large rainfall years typically leading to stronger deposition at the facility. In the lower reach, vegetation management could focus on blackberry removal.

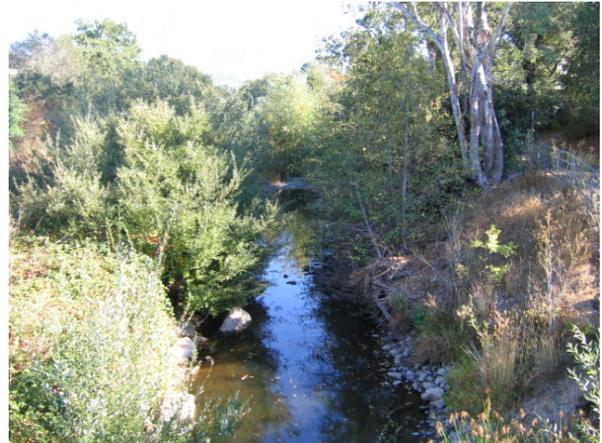
(a) Looking downstream from Hwy 12 crossing. This is the only portion of the channel that maintained surface flow in October 2008. The channel maintained this appearance for approximately 150 ft until the surface flow hits a large gravel bar and goes subsurface until it reemerges at the confluence with Santa Rosa Creek.

Management considerations for Brush Creek Reach 1 focus on removal or modification of the sediment bar/wedge just downstream of the Hwy 12 crossing. Other than this, the reach appears to be in good condition from both a flood control and habitat perspective.

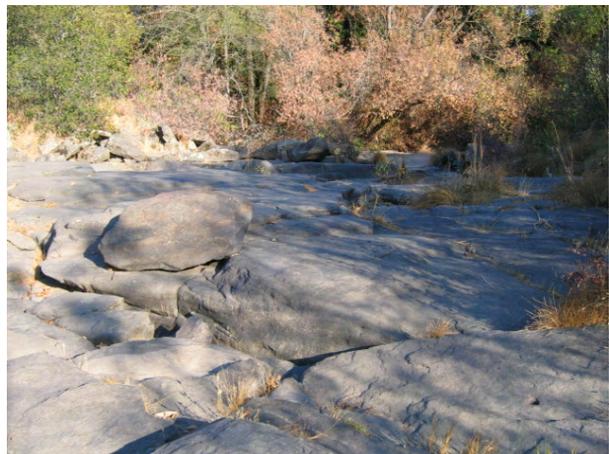
(d) Just upstream of the confluence of Brush Creek and Santa Rosa Creek. At the confluence, Brush Cr flows over a surface of flat rocks before it enters Santa Rosa Creek. Aside from the surface water observed in the first 75 ft of Reach 1, the only other surface water observed in October 2008 was at the downstream edge of the rock outcrop at the confluence with Santa Rosa Creek.

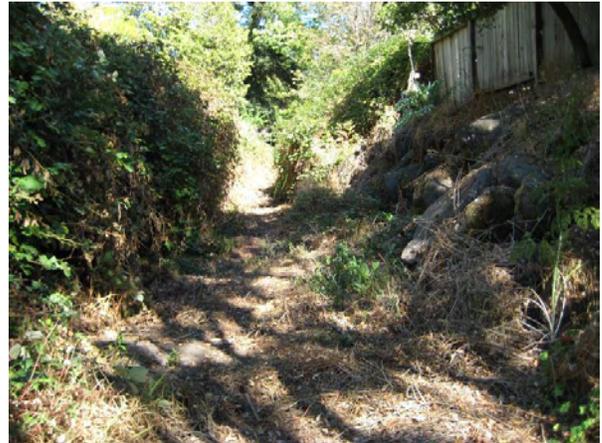
(a) Mid-reach view upstream. Note riprap along south bank and dense blackberry growth on north bank (October 8, 2008).

Continue to maintain channel free of vegetation, especially at culvert inlets and outlets. Monitor streambed for accumulation of fine sediments between cobbles, which could reduce infiltration. Consider installing a low flow channel to encourage sorting of bed sediments.

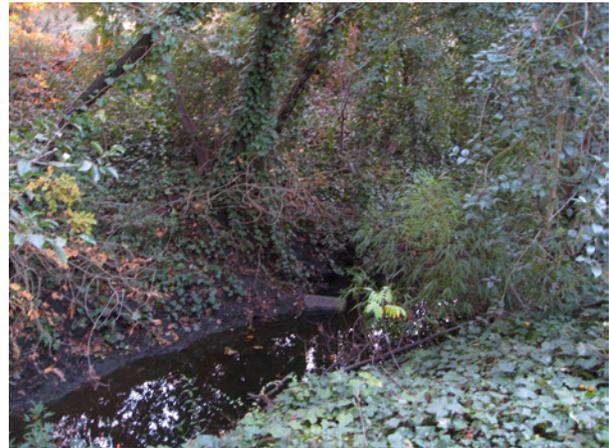
Water quality: clear flows and slow moving water observed on December 16, 2008 after 2 days of moderate rain. Large articles of trash, including garbage bags, oil drums, and buckets observed in channel (photos c and d).

(d) Downstream end of reach, looking downstream. Note rusty oil drum in the channel (December 16, 2008).

Stream management in Spring 1 should focus on the removal of in-channel trees with horizontal limbs that are overhanging and crossing the channel (photo c). Such limbs can increase water levels due to their catching of debris and vegetation during higher storm flows resulting in flow blockage. Over the longer term, reach should be managed for removal of abundant invasive plants, particularly observed on the floodplain benches shown in photos c and d. SCWA crews can also remove trash as needed during periodic reach inspections.

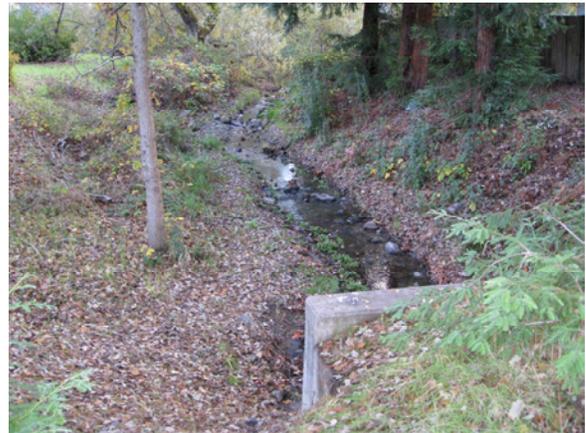
(a) Looking upstream from Siskiyou Road (upstream of Reach 3). Stream enters large 10 ft wide by 3 ft tall box culvert. Culvert was clear of sediment. (December 16, 2008).

Removal of the sediment wedge at Siskiyou Road is recommended, but not urgent. Removal of blackberry throughout the reach, but particularly near the Siskiyou Road crossing is recommended. Consider planting native emergent and riparian plants throughout.

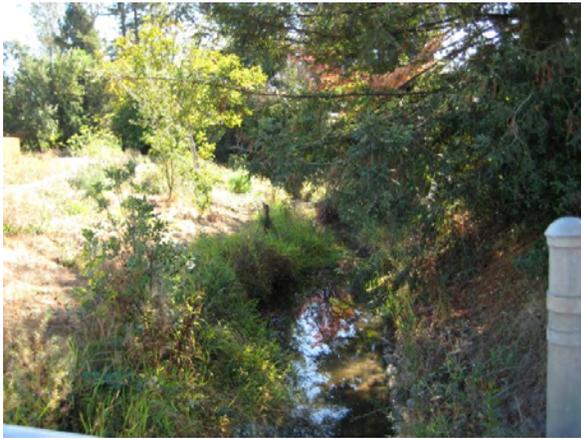
(c) Looking upstream from Hoen Ave., downstream from photo (b). Bank is lined with riprap immediately upstream of the culvert at Hoen Avenue. Good water quality and flows were observed on October 8, 2008.

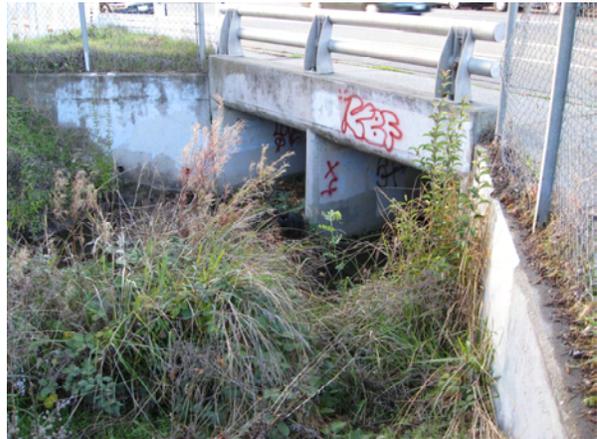
(d) Looking downstream to Hoen Avenue culvert. Sediment and emergent vegetation accumulating on right bank, but does not obstruct flow in the active channel (December 16, 2008).

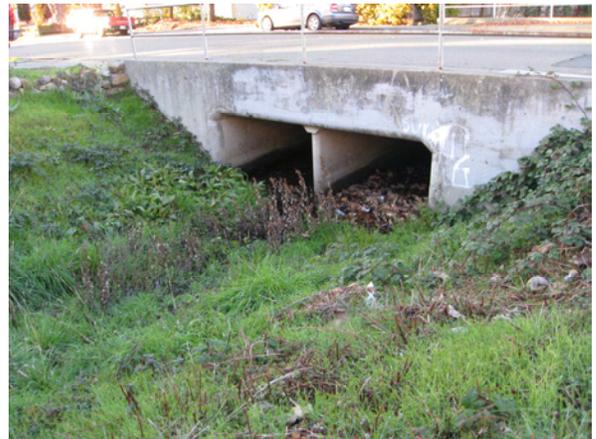
(a) Mayette Avenue culvert at Reach 2, looking downstream. Box culverts were clear of sediment but trapped lots of trash (December 16, 2008).

Water quality: water was not observed in these reaches, except some standing water at the Mayette Avenue crossing. Accumulated trash at the Mayette Avenue culvert. Many feral cats observed on 12/16/08 which may negatively influence water quality.

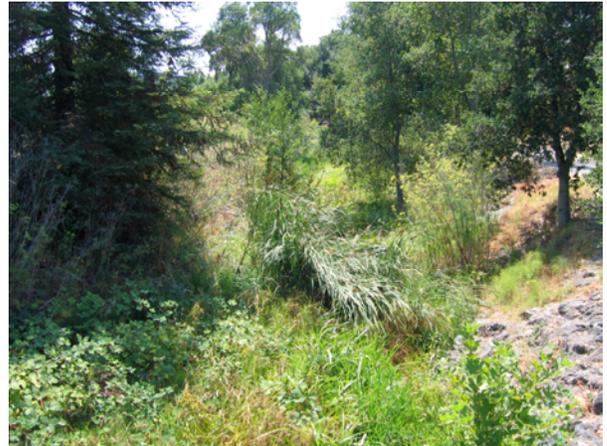
(a) Upper Reach 6 looking downstream from Hopper Ave bridge. Sediment deposit observed upstream of Hopper Ave (Reach 7) extends into Reach 6 (August 2008).

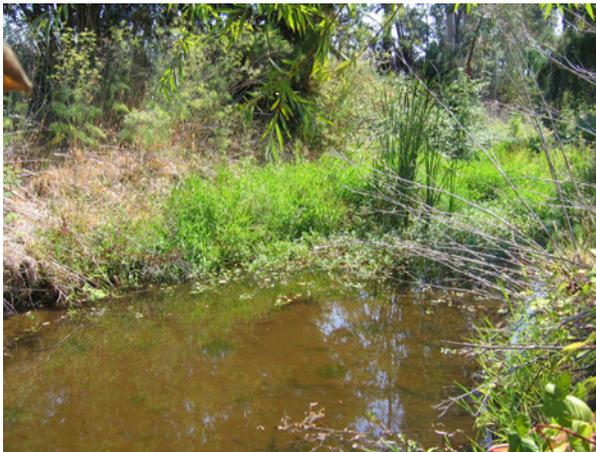
(c) Lower Reach 6, looking downstream. Example of bar/pool sequence, where bar again seems to be related to slow sloughing of the bank above. Also note the brown stagnant water upstream of the bar in foreground (August 2008).

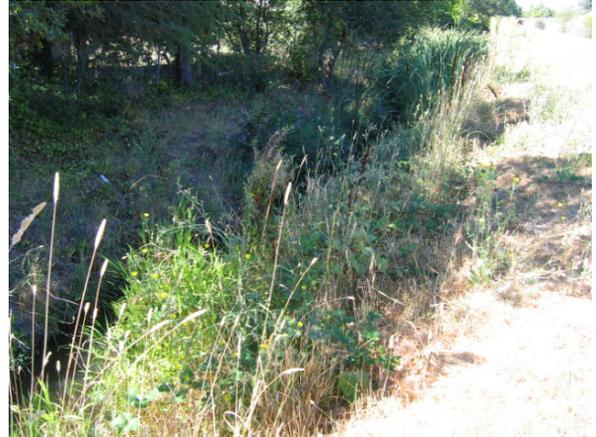
(a) Mid Reach 2, looking downstream toward Hwy 101. Right bank is slumping into channel, this condition is observed throughout reach. Access road seen to right (August 2008).

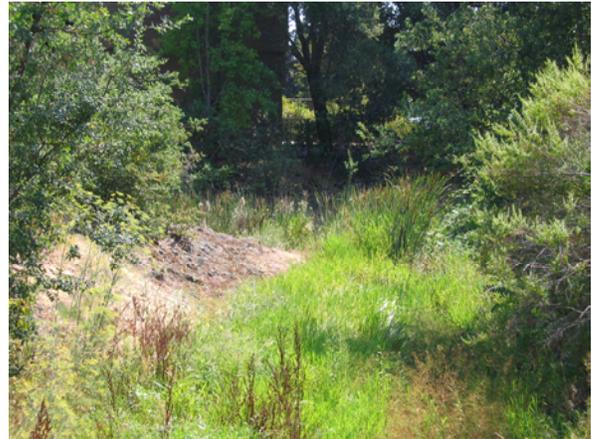
(a) Reach 5, looking downstream from Piner Rd. crossing. Active channel is clogged with herbaceous vegetation; cattails and sediment fill the channel upstream of the Russell Cr. confluence (which is grouted rip-rap) (August 2008).

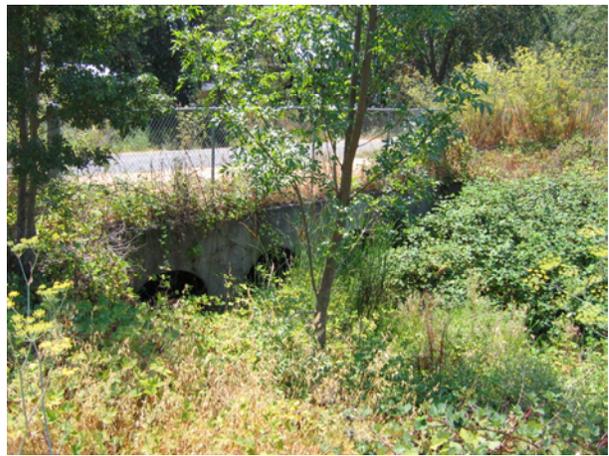
(d) Lower Coffey Cr at culverts that cross access road and enter Piner Creek Reach 4. A large, deep, and heavily vegetated sediment wedge is deposited upstream of the culverts. There is a large pool upstream of this wedge (photo c) and surface flow appears to be almost completely blocked by the sediment wedge during low flow conditions (August 2008).

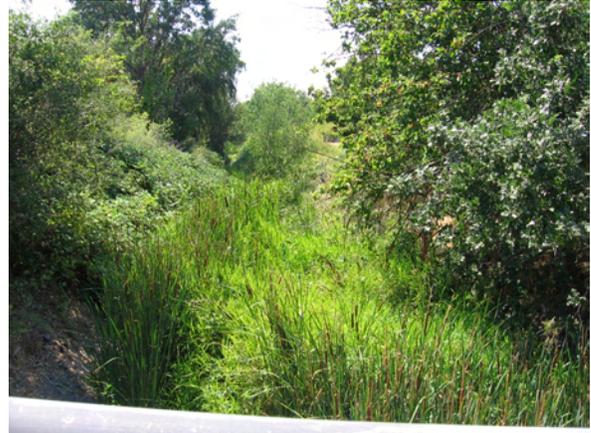
(a) Reach 6 – looking downstream from McBride Lane, channel contains deposited sediment wedge extending to mid-distance, cattails and other herbaceous/emergent vegetation fill channel developing in the recent deposits (Aug. 12, 2008).

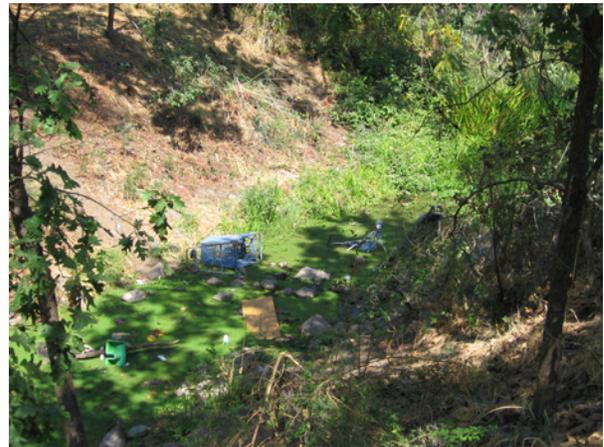
(d) Reach 5 – dumped trash includes shopping carts, wood, and other household refuse, pollutants include paints, other household materials, etc. (Aug. 12, 2008).

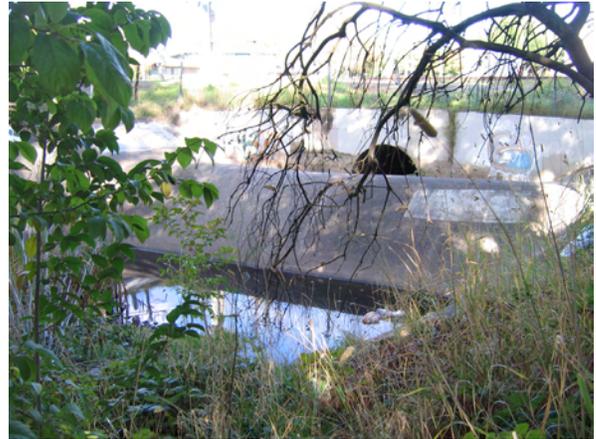
(a) Looking upstream to culvert and drop structure - energy dissipater at 90° turn at Guerneville Rd. A large pool has formed downstream of the structure, the structure does not appear in need of immediate maintenance (Nov. 2007).

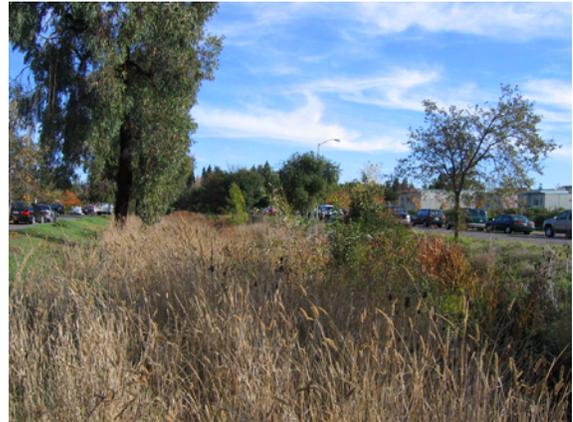
(a) 75 ft upstream from Gamay St. crossing, looking upstream. Note lack of riparian canopy and that the trapezoidal channel bottom is completely choked with annual grasses (foreground) and cattails (background) (Nov. 2007).

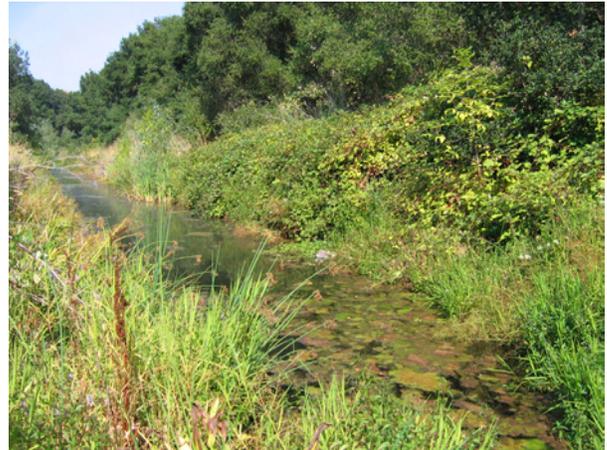
(a) Mid Reach 2, looking upstream from a sediment deposit spanning the channel and creating stagnant water conditions. Dense growth of green and brown algae (August 2008).

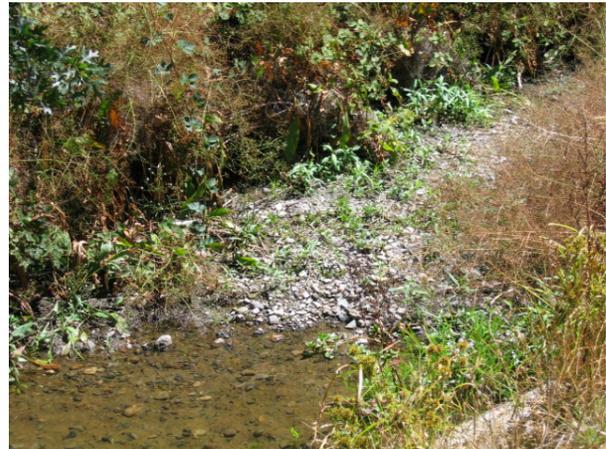
(d) Lower Reach 2 looking downstream near Guerneville Rd. Note gravel bar and pool sequence which is typical to Reach 2. Also notice that the left bank is undercut and appears to be contributing sediment to the gravel bar. This situation was observed in several locations along the reach (Sept. 2008).

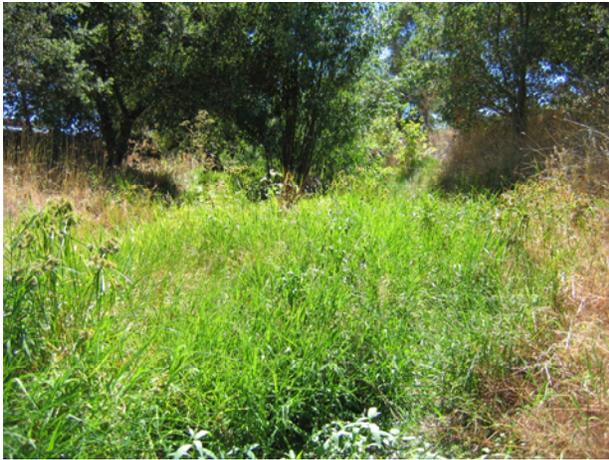
(b) One of many large in-channel bars observed in this reach. These wedges are scattered throughout the reach and are between 50-150 ft long and between 1-3 ft high. While the scoured channels between these wedges appear to be coated in a fine white silt with limited vegetation growth (photo a), these bars are composed of sand and silt and support dense, lush growth (Sept. 2008).

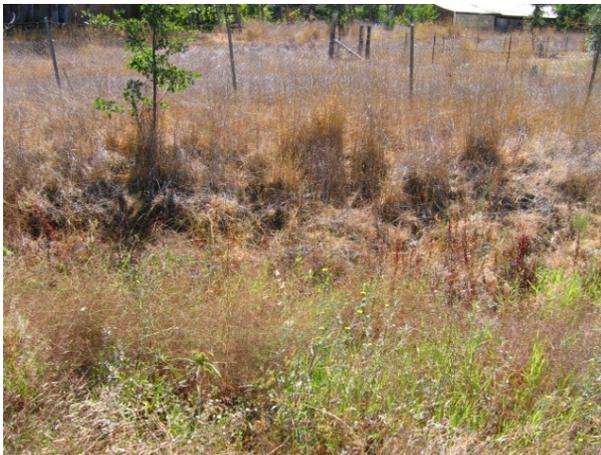
(c) Reach 2, looking across the channel. The bank sloughing on the far bank is distinguished by a horizontal line of bare dirt. In this section, sloughed sediment from banks contributes to channel aggradation, and results in vegetated in-channel bars with non-wetland species.

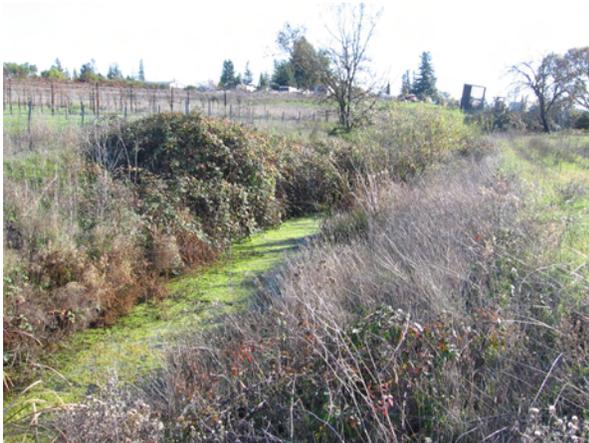
(b) Mid Reach 2 looking downstream; note channel is inset 8-10 ft. below top of banks, abundant blackberry on left bank; flow is stagnant with dense algae due to cattails blocking channel (in distance) causing stagnant flow conditions (Nov, 2007).

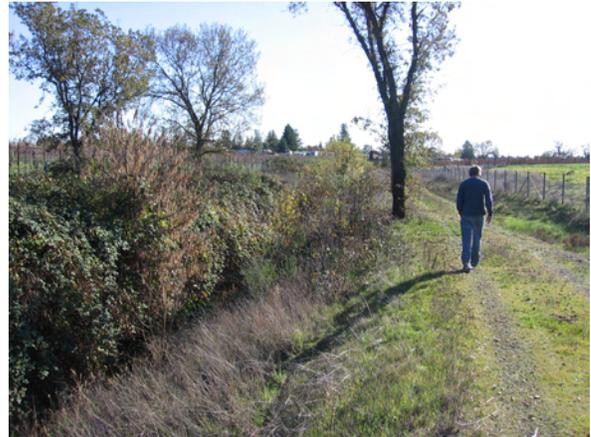
(a) Upper Abramson Reach 2, looking downstream (south); steep banked trapezoidal channel with blackberry encompassing entire left bank, right bank has eroded (to left of person) and requires stabilization (Nov, 2007).

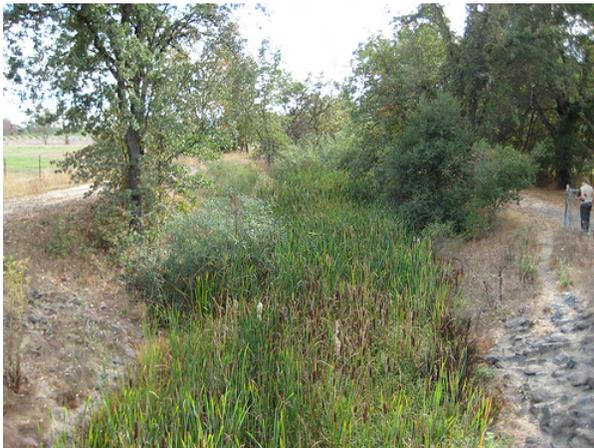
(c) Abramson 1 looking downstream from Guerneville Rd. crossing, cattails become abundant downstream of crossing, crossing has grouted riprap downstream for bank stabilization, (Oct. 2, 2008).

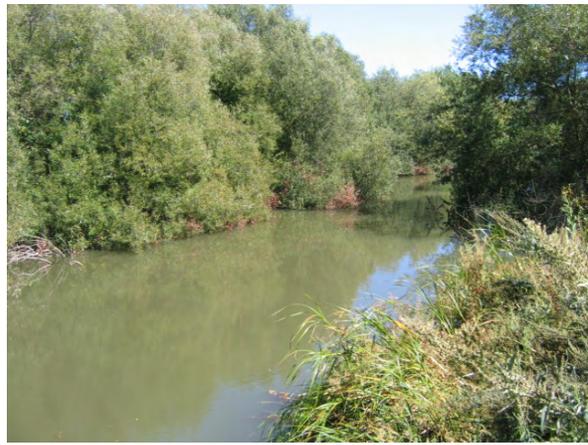
(d) Lower Reach 1, looking upstream at a typical open section where flow is nearly stagnant and condition reflect a strong backwater, lagoonal channel geometry (8/21/08).
