Figure 4-30

Upper Laguna Subbasin

FIGURE 4-31
Reaches and Vegetation
 Upper Laguna (1 of 11)

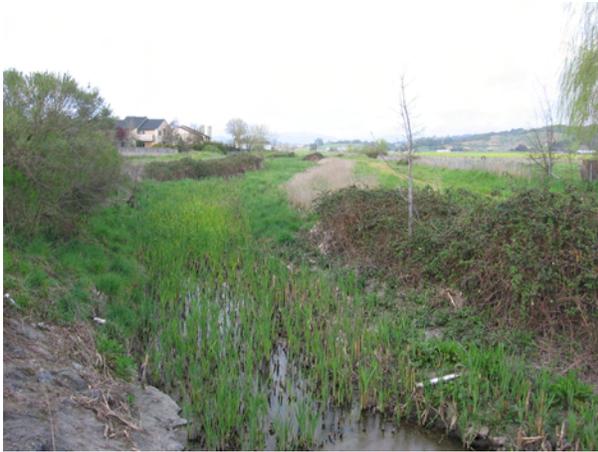
(b) Todd Creek Reach 5 looking upstream (north) from Dolores Ln. bridge; channel is clogged with abundant cattails and water plantain growth; low bench right of channel (east) shows signs of recent inundation and deposition during 2007 and 2008 winters. Reach has been observed during 2006-2008 period with continued cattail growth and deposited sediment (March 19, 2008).

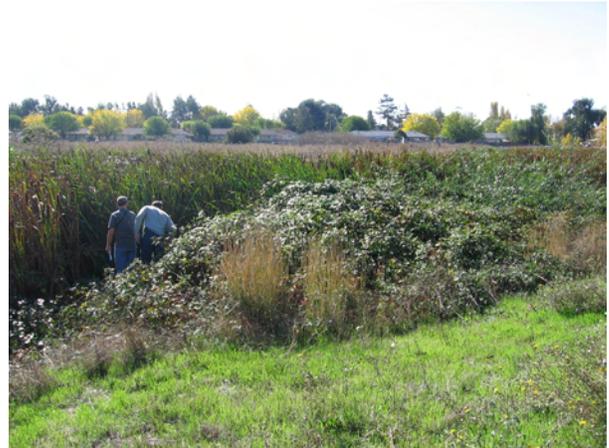
(a) Todd Creek Reach 5 looking downstream from outfall of Santa Rosa – Bellevue Ave. Conduit pipe (right of people shown, beneath blackberry mass); Reach 5 experienced much sediment deposition and associated cattail growth; sediment removal and restoration activities occurred at Reach 5 in summer 2008 (March 19, 2008).

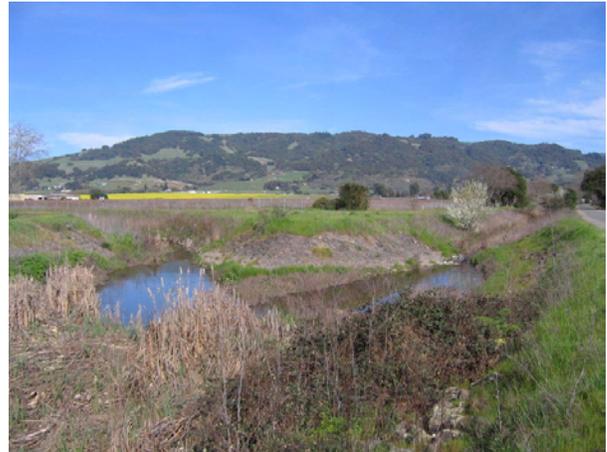
(a) Todd Cr. and Hunter Cr. confluence; photo from Todd Cr. Reach 3 looking upstream to Reach 4 (left) and Hunter Cr. Reach 1 (right); note large vegetated sediment wedge in foreground downstream of confluence; sediment source areas on Sonoma Mtn. seen in distance (March 14, 2007).

Management considerations for Todd Creek, Reaches 1, 2, and 3 focus on flow capacity and opportunities to improve water quality and riparian/aquatic habitat. At both the upper and lower reaches, the key confluences showed high deposition and vegetation growth. Conditions in these sections should be monitored closely to evaluate if these sediments wedges reduce flow capacity below acceptable standards. Flow capacity issues seem exacerbated at crossings where future maintenance may be required to clear accumulated sediment and debris. Observed high water marks for 2007 were within a few feet of the top of bank. Water quality and habitat conditions in this reach appear to be sub-par (relative to other SMP channels) with generally poor circulation, poor bank conditions, and poor tree

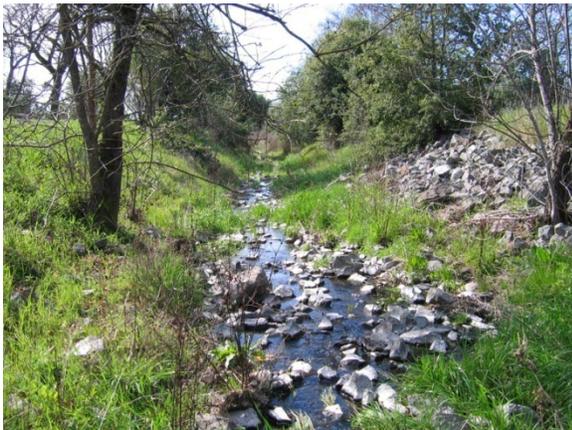
(b) Mid Reach 2 looking downstream: note past bank repair work with riprap to right; sloughed riprap falls into channel and forms a lower bank cobble bar (March 14, 2007).

Management considerations at Hunter Creek Reaches 2 and 1 focus on potential bank erosion and channel capacity issues. These reaches demonstrate historic bank instability (photo b) and sloughing type erosion (photo d). It is uncertain whether bank stability issues are a function of the earthen materials the banks are made from, channel flow conditions and potential undercutting of banks, some type of animal burrowing, or other reasons. Future activities might consider development of a more defined low-flow channel that also directs flows away from banks in sections with historic bank problems. A low flow channel with more persistent flow throughout year may also alleviate problems of stagnant water observed. Additionally, planting of riparian and upland woody species may provide additional canopy and reduce growth and colonization of emergent vegetation within channel.

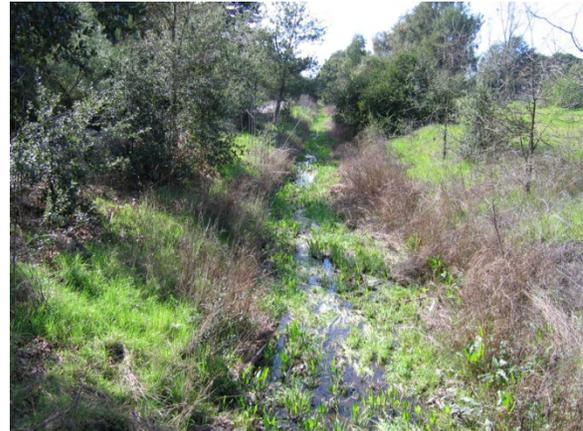
(a) Hunter Creek Reach 2 looking downstream: Channel width increases from Reach 3 upstream and channel becomes broader; note proliferation of emergent vegetation across channel (March 14, 2008).

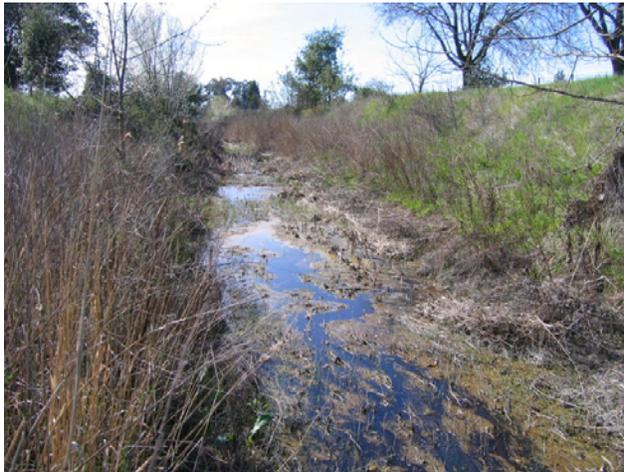
(c) Reach 1 looking downstream: note transition from coarser bed upstream; the lesser gradient results in shallow stagnant pools; grassy vegetation seen along steep banks (March 14, 2007).

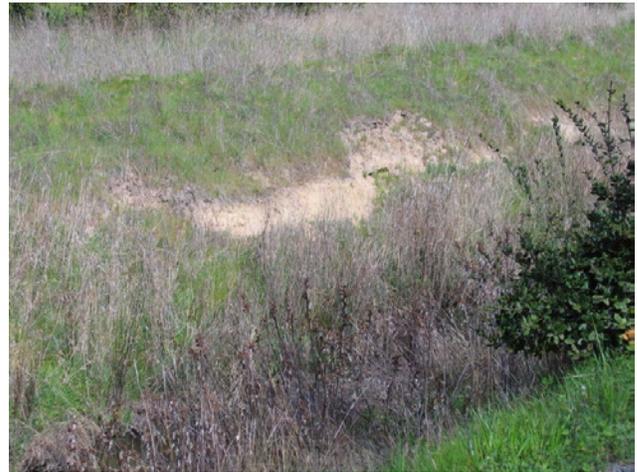
(d) Sloughing bank along Hunter Creek in area with earthen banks. This channel at this site is straight and clogged with vegetation (March 14, 2007).

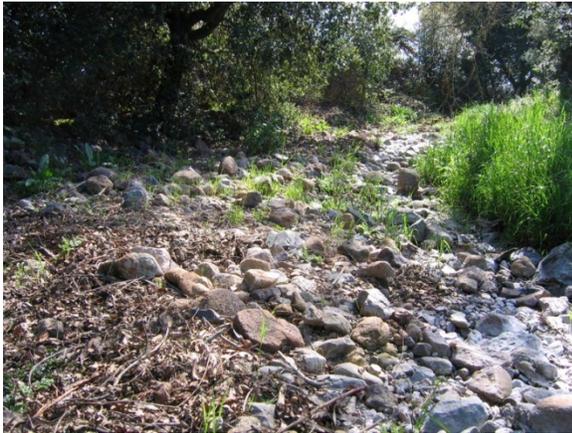
(b) Reach 3 looking downstream at westward channel bend: coarse cobble bed stream has widened from upstream; cobble bar features noted with a higher bar (left) and channel thalweg (right), white rock marks indicate calcification and flow levels; oak canopy increases downstream (March 14, 2007).

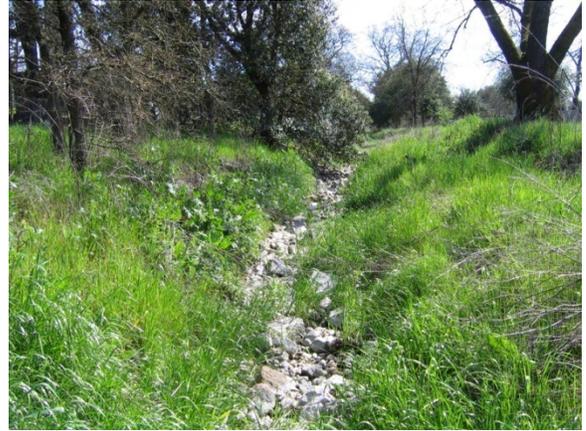
(a) Upper Reach 3, looking downstream (south): narrow channel with coarse pebble and cobble bed; banks are gentle and heavily covered with grasses with an open canopy of oaks. (March 14, 2007).

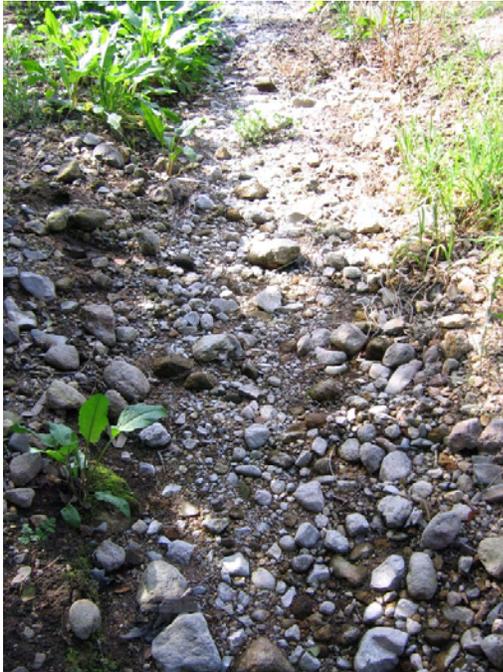
(c) Downstream of main bend, the transition between subsurface and daylighting flows is observed. Channel is wet with no visible surface flow. Channel bed becomes more fine downstream from cobbles toward gravels and coarse sands (March 14, 2007).

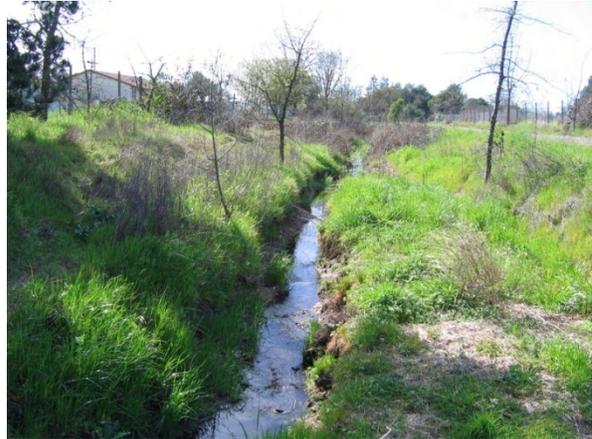
(d) Looking downstream along the straightened and wetted section of lower Reach 3. Note difference to coarse cobble sections upstream. Flat benches flank low flow channel on both sides of stream with steep (1:1) bank above. Woody species become isolated and occasional (March 14, 2007).

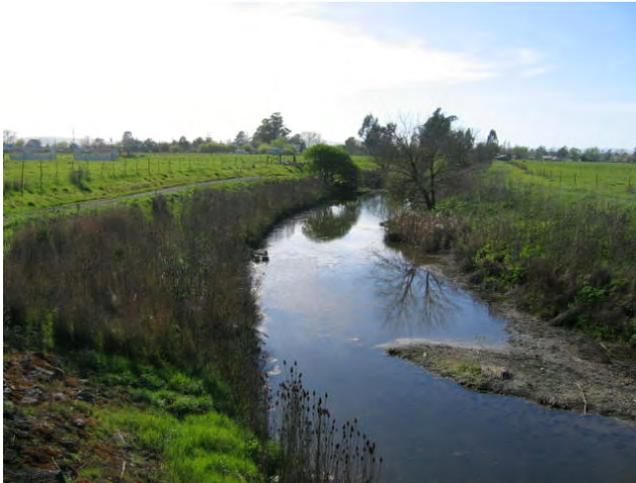
(b) Reach 4 looking downstream from first bend at railroad crossing; note wide channel, 10-12 ft below banks, with small point bar forming at inside of meander bend; riprap seen along outside bank (lower left); flow depth is 1-2 ft deep (March 14, 2007).

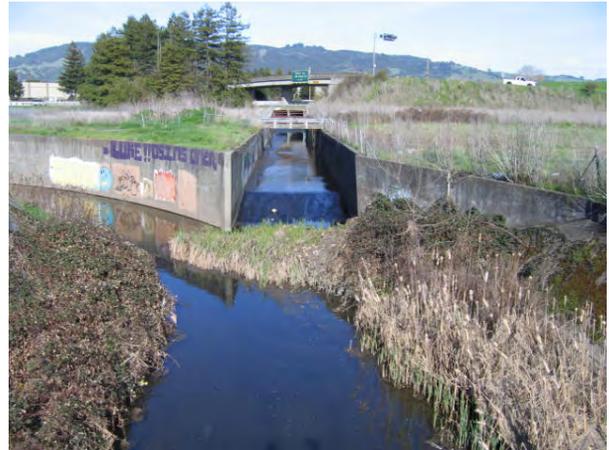
(a) Upper end of Reach 4, looking upstream to Todd Cr Reach 1 (left) and Wilfred Cr (at center); note drop structure at base of Wilfred Cr. and sediment wedge at confluence (March 14, 2007).

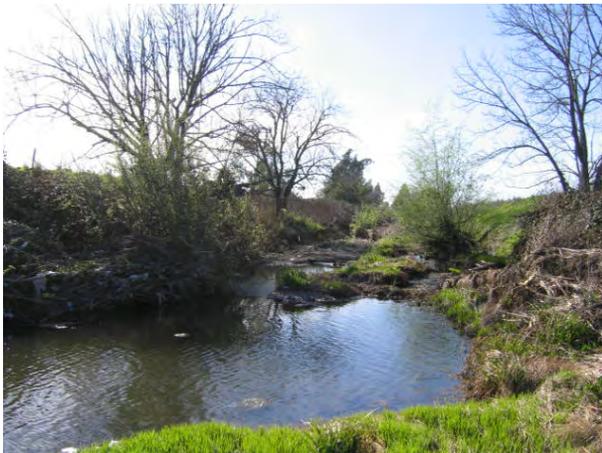
(c) Mid Reach 4 looking downstream; note pool formed by large sediment and debris wedge blocking flows. Pool depths are in excess of 6 ft (March 14, 2007).

Management considerations and opportunities for Bellevue-Wilfred Reach 4 are not extensive. There is a large sediment and debris blockage in the middle of the reach (photo c) but this dam and pooling do not appear to be creating any immediate flow hazard. This blockage should be monitored and may eventually require some clearing. Upper Reach 4 appears to have a steeper gradient than the lower Reach 4. The upper reach has some sinuosity and stream velocities under lower-flow conditions appear to be adequate to prevent settling and enable transport of finer sediments downstream. Besides the potential removal of sediment/debris at the blockage noted above, another opportunity includes enhancing the woody riparian corridor which is often lacking. Planting of riparian trees along the upper banks could benefit water quality and enhance habitat for a suite of species. Trash, plastic and other debris are observed in the lower reach and may need removal.

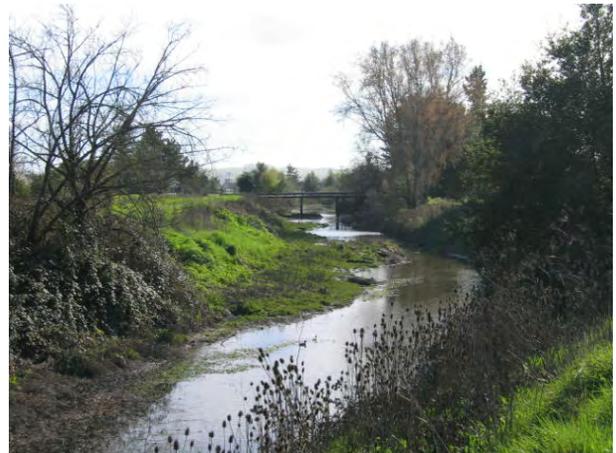
(d) Lower Reach 4 looking downstream to Millbrae Avenue; note large "D-shaped" bar along base of left bank where sediments collect on inner bend of channel (March 14, 2007).

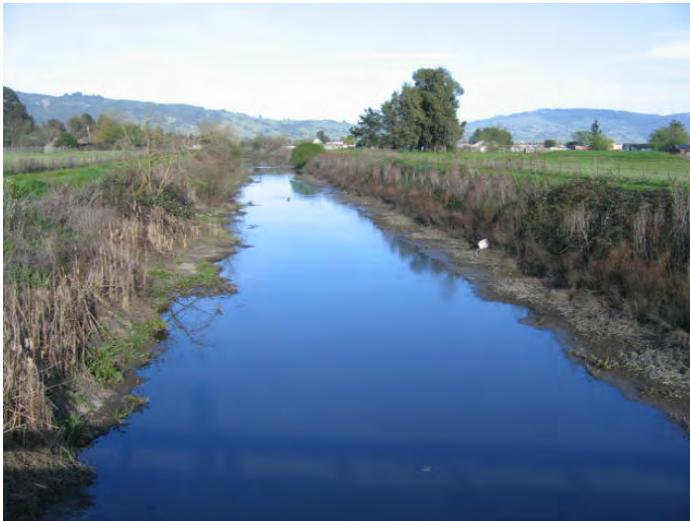
(b) Reach 3 looking upstream from Whistler Ave Bridge; note channel widens moving downstream; extensive mud deposits flank both side of the channel (March 14, 2007).

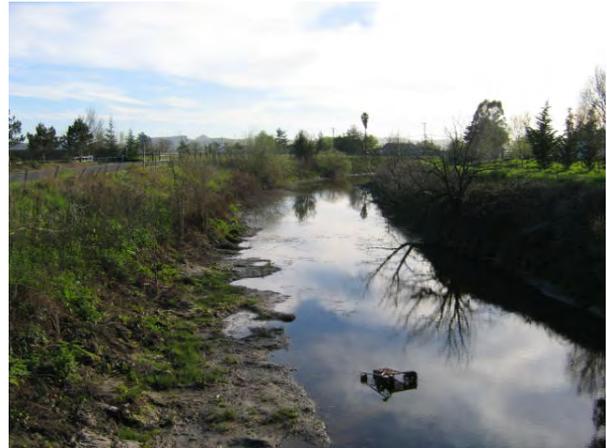
(a) Reach 3 looking downstream from Millbrae Ave Bridge; low gradient stream with mud deposits collect along banks (lower left) (March 14, 2007).

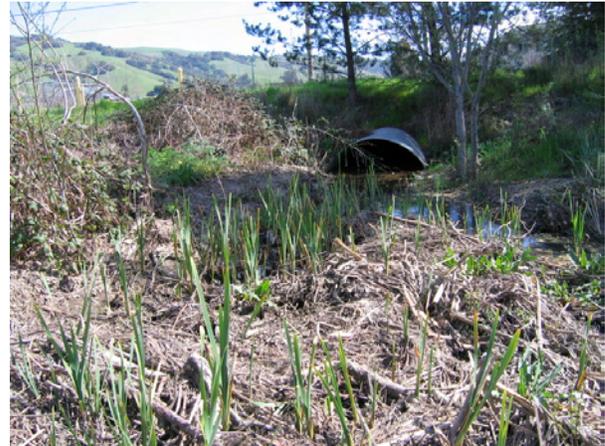
(a) Wilfred Creek just downstream of Snyder Lane crossing and culvert; note abundant deposition in channel with over 50% of culvert passage blocked; note headwater areas of Wilfred Creek in distance (March 14, 2007).

For Wilfred Creek Reach 1, the key maintenance consideration in the upper reach is the removal of sediment from the Snyder Lane culvert and area immediately downstream. There may also be an opportunity to design an appropriately sized low flow channel that would create a more defined channel capable of conveying finer sediments under smaller flows. Considering this reach's location in the watershed and the observed sedimentation, this reach may benefit from erosion control opportunities in headwater areas.

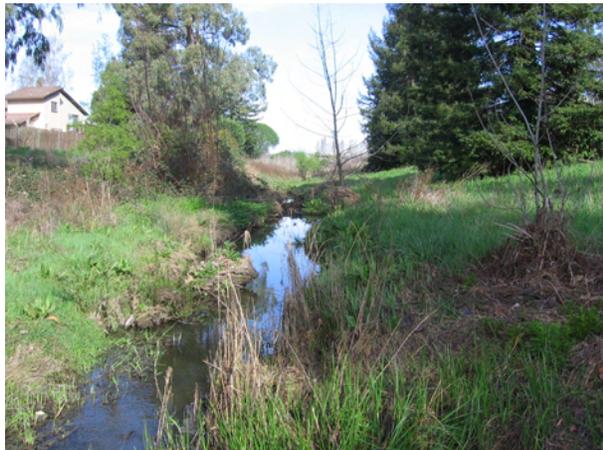
(b) looking downstream near Fauna Drive; turbidity that was observed nearer to golf course upstream now lessens, low flow channel is narrower (2-4 ft) with low sinuosity, upper banks are gently sloped, lower banks drop 1-2 ft into channel and are earthen, riparian canopy is sporadic (March 14, 2007).

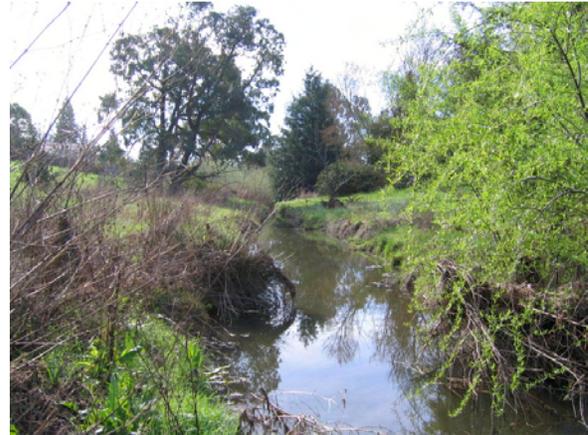
(a) upper end of Wilfred Extension looking upstream toward golf course; note lack of depositional features, moderate turbidity, steep immediate channel bank dropping into channel with a gently sloping upper bank providing a wide easement area (March 14, 2007).

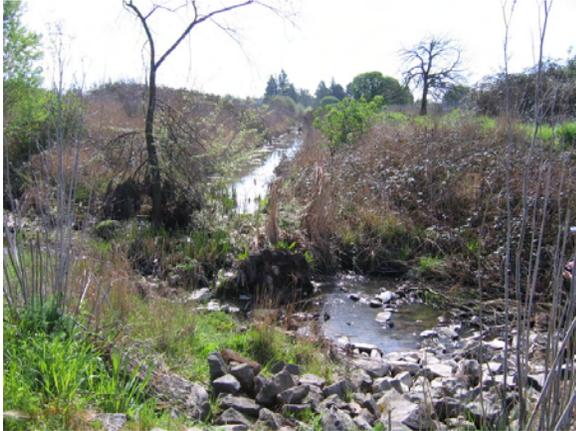
(e) looking upstream from Wilfred Cr into linear channel of lower Wilfred Extension; note deeper channel than observed upstream (photos, a, b, c); deposition and blockage at the confluence was the only major depositional feature observed in the reach (March 14, 2007).

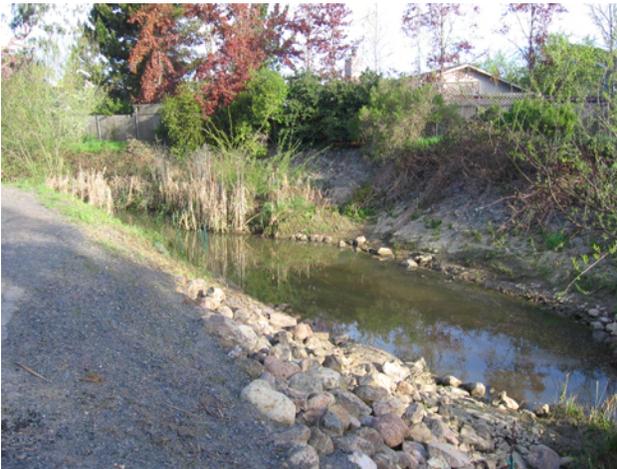
(b) confluence of Cook Creek and Coleman Creek, looking downstream along rip-rapped bank (March 14, 2007).

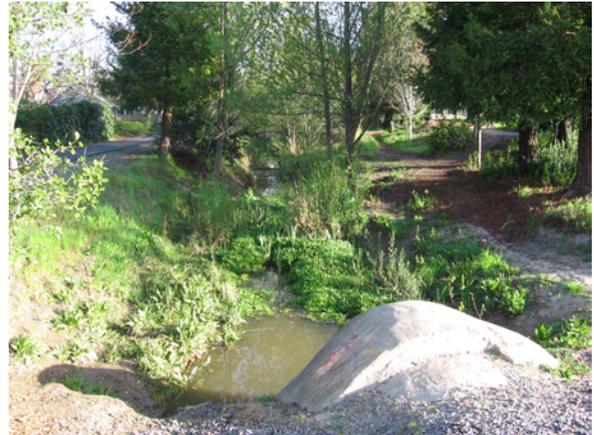
(a) looking downstream from Cook Creek outlet at upper end of reach in Golis Park; note in-channel sedimentation and vegetation directly downstream of outlet (March 14, 2007).

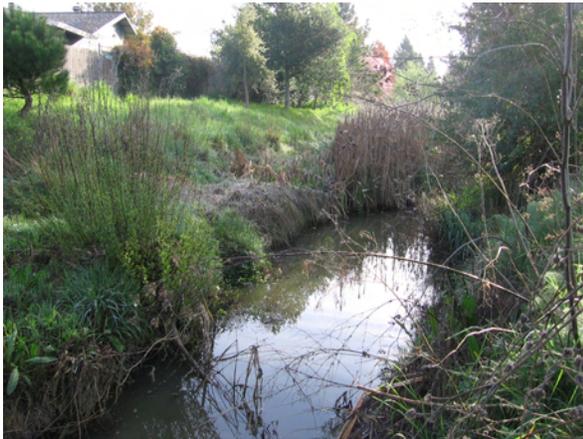
(c) looking upstream; about 300 ft downstream of Cook/ Coleman confluence and 1000 ft upstream of the Snyder Lane crossing; channel narrows around toe of bank sediment bars (2-3 ft high and 3-4 ft wide), attracting cattails and trapping additional sediment above bar onto bank (March 14, 2007).

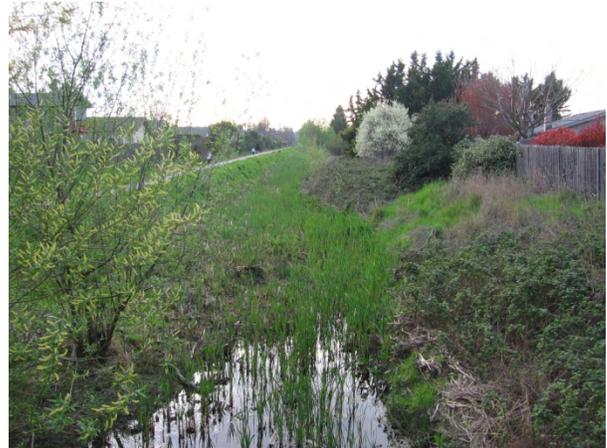
(a) looking downstream from Snyder Lane crossing; abundant in-channel sedimentation and cattail growth (March 19, 2008).

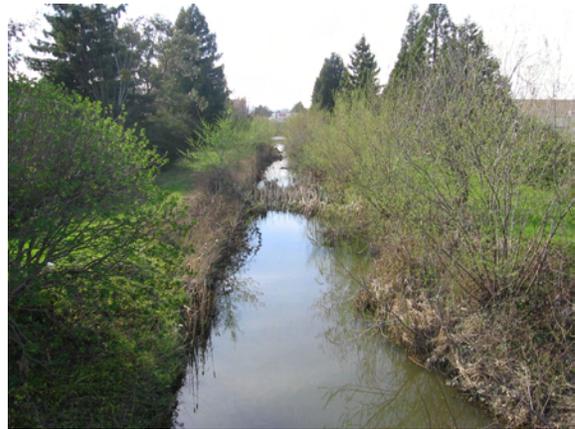
(a) looking downstream from upper end of Reach 3 at Commerce Blvd; note very linear and symmetrical channel; gradient is gentle in alluvial plain zone; Highway 101 crossing seen in distance (March 6, 2007).

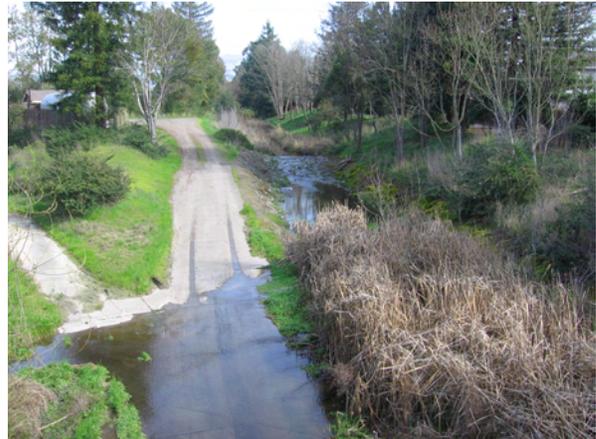
(a) downstream end of Reach 7 looking upstream at confluence with Crane Creek; Hinebaugh 7 reach is to the right (south) of the paved access road; note rocky drop structure in mid-distance and pooling across access road where Hinebaugh and Crane creeks join; Hinebaugh flows are relatively clear compared to Crane Creek flows which are turbid with suspended sediments (Mar 6, 2007).

Water quality (qualitative): flows are somewhat turbid with suspended sediments (observed 5 days after storm event); suspended sediment arriving from Five/Crane creek tributaries and not Hinebaugh tributaries which appear clearer (photo a).

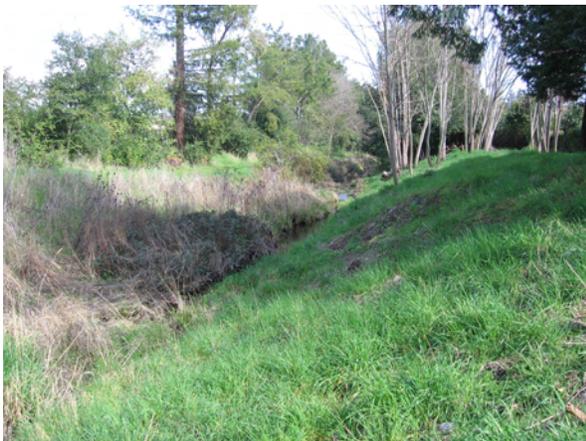
(c) Reach 6 middle zone looking upstream; trapezoidal banks approx 2:1 sloped comprised of small riprap with grass above; channel widening in downstream direction; instream cattail vegetation (Mar 6, 2007).

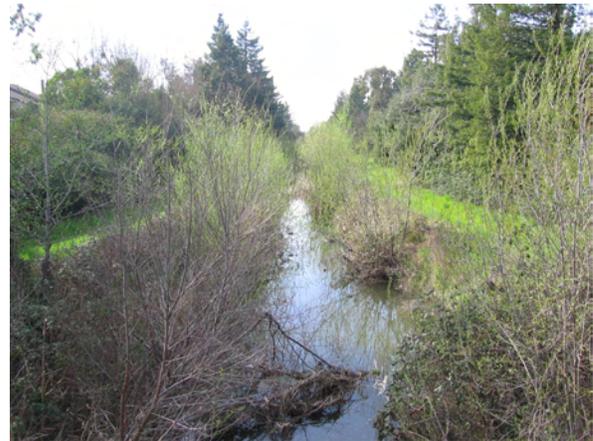
(a) looking downstream from Country Club Dr.; linear channel with symmetrical cross section and access roads on either side; (March 6, 2007).

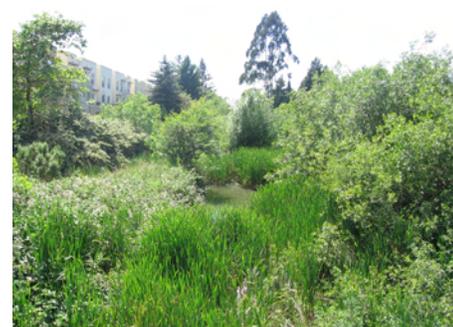
May 29, 2007

(c) Looking downstream of railroad crossing; some in channel sedimentation observed, exacerbated by rapid in-channel willow growth happening during spring months.

(d) Looking downstream of State Farm Dr.; sediment is observed accumulating in bars and bank adjacent wedges; note prominent cattail and willow growth during spring months essentially blocking channel.

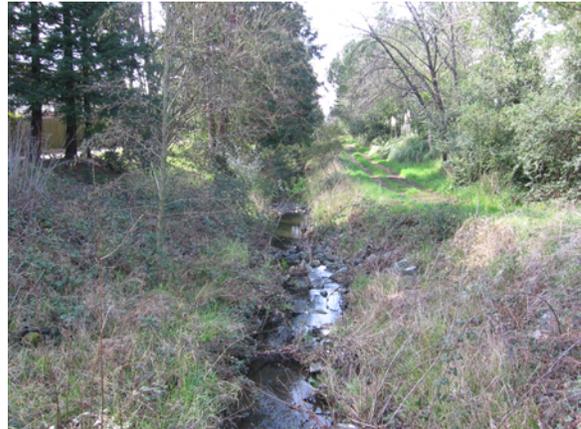
(a) Reach 2 looking downstream from Snyder Ln crossing; note coarser load and clearer water than Five Creek tributary nearby to the north (March 6, 2007).

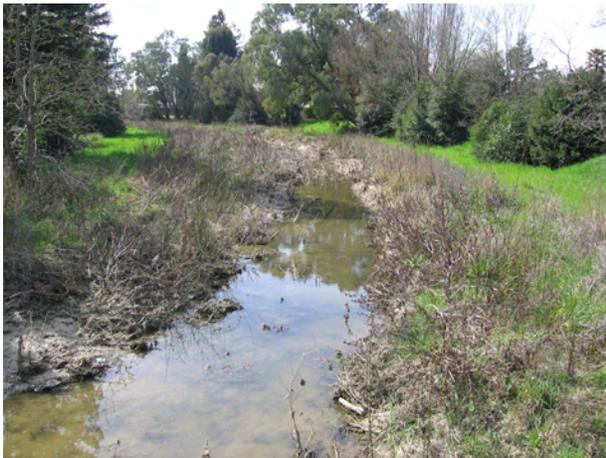
(b) looking downstream from Snyder Lane crossing; note broad/flat cross-section, shallow channel, dominated by fine sands, silts, mud; overbank flows overtop gentle bank slope; wide easement (March 6, 2007).

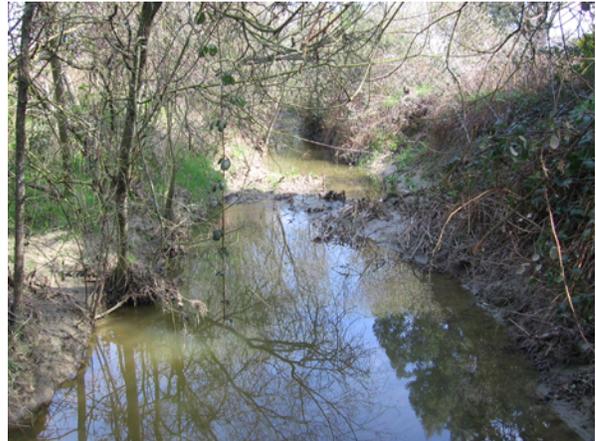
(a) looking upstream of Reach 1 from the Snyder Lane crossing; note high turbidity, fine sediments dominate bed and bank (March 6, 2007).

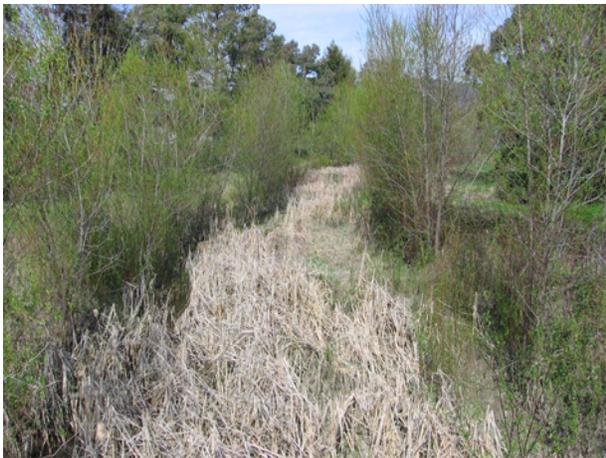
(c) mid-reach downstream from photo (b); willows grow along banks while cattails and other instream vegetation occupy south facing channel that has little shade (March 6, 2007).

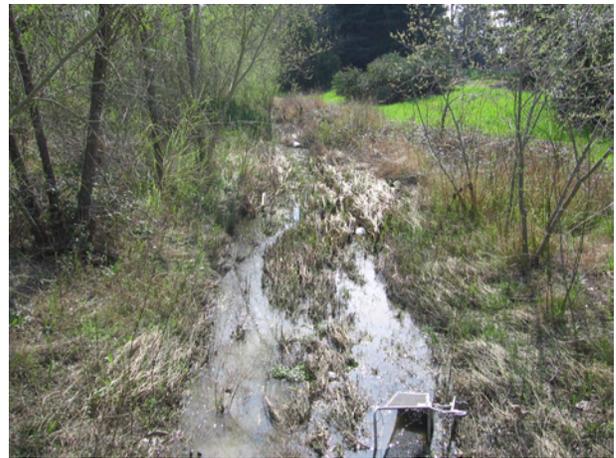
(d) looking downstream toward Crane Creek confluence; similar conditions as upstream, fine channel sediments, evidence of overbank flows depositing sediment on benches to either side of channel, instream cattails and other vegetation, some willows along banks (March 6, 2007).

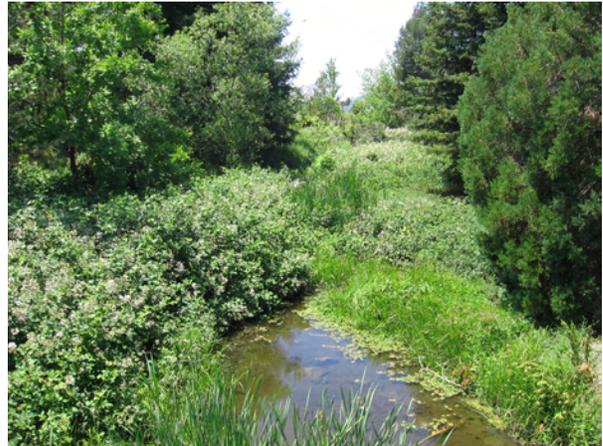
(a) Upper reach looking downstream from Redwood Dr.; mature willows on upper banks provide some limited shade but most of reach is sunny (May 29, 2007).

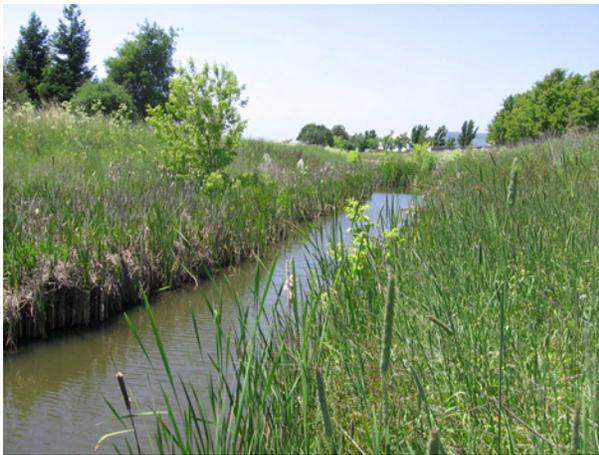
(c) Mid-reach looking downstream; well defined channel with deep pools (up to 3 ft deep under low flow conditions); grassy banks 1:1 to 2:1 sloped (May 29, 2007).

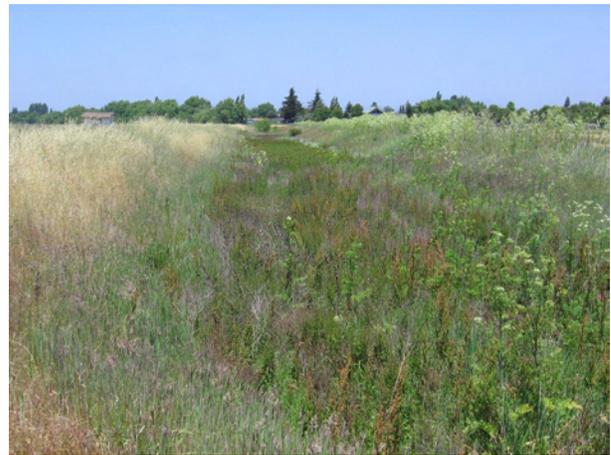
(e) Washoe Creek looking downstream toward confluence with Upper Laguna Reach 3; wide channel alignment, gentle sloped banks, wide flat central channel covered with emergent vegetation, no shade (May 29, 2007).

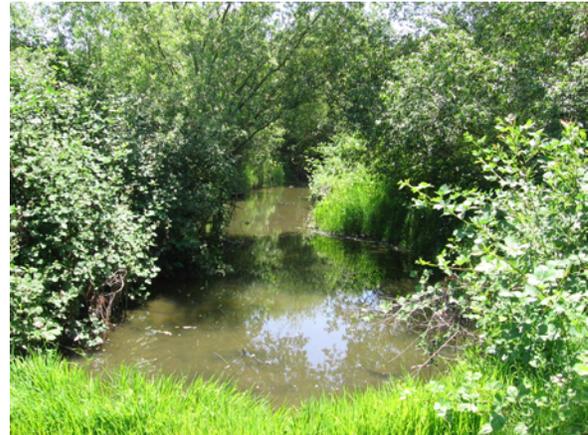
(a) Upper Reach 2 looking downstream; note wider channel than upstream reaches, mix of streambank vegetation, and developing canopy that provides shade to creek.

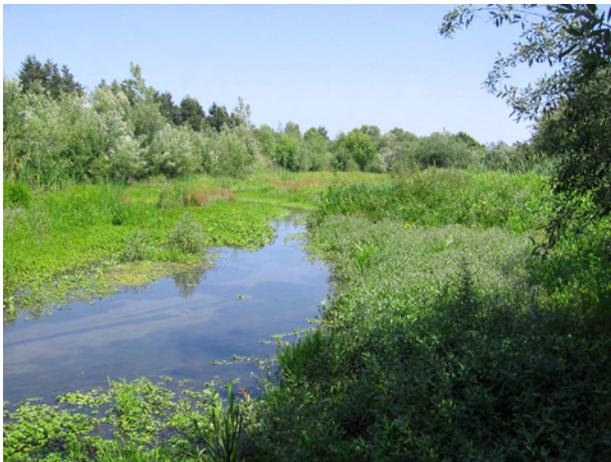
(c) Lower Reach 2 downstream of Gossage Creek confluence, looking upstream; very wide channel cross section compared to upstream; note Ludwigia growing in-channel (and continues up into Gossage Creek).

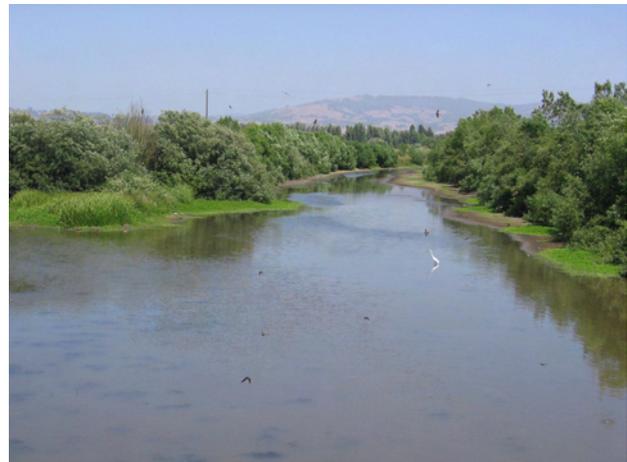
(d) Lower Reach 2 looking upstream from Stony Point Road crossing; confluence of Bellevue-Wilfred channel seen to far left; now in Laguna setting, wide channel with lower velocity flows that backwater up into system.

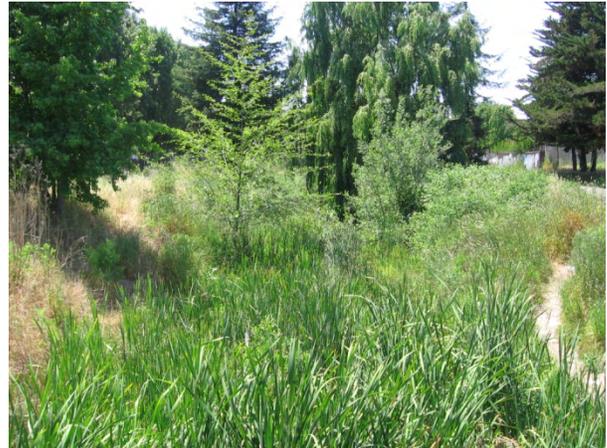
(a) Reach 1 looking downstream from Redwood Dr; cattails grow in non-shaded channel portion just downstream of the Hwy 101 crossing (May 29, 2007).

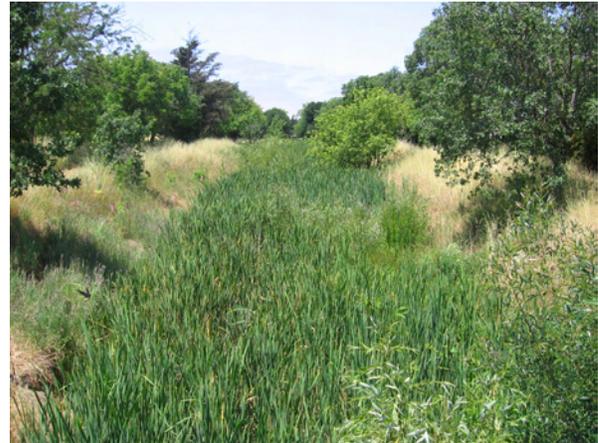
(a) Upper Reach 2 looking upstream; abundant cattails fill channel bed, flow occurs diffusely through micro channels between cattails; some trees recently planted along south bank (left) to provide shading; banks are mostly rock riprap (Mar 29, 2007).

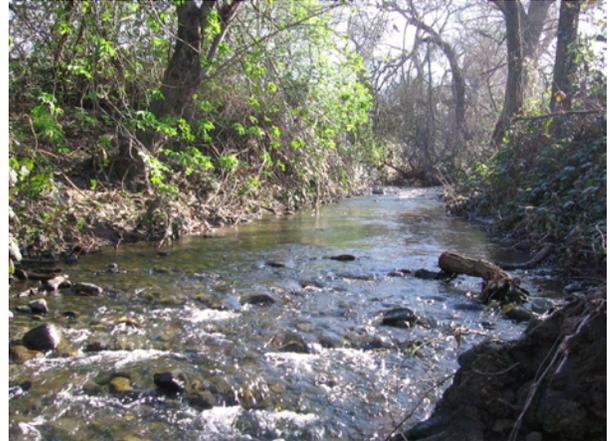
(a) Reach 5 looking upstream; note pool-riffle sequence with cobble bar in foreground and distance (March 6, 2007).

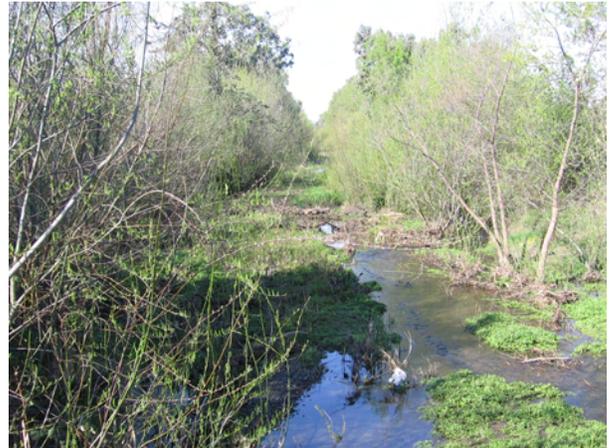
(a) Top of Reach 4 looking downstream from Snyder Ln; abundant deposition in multiple bars with finer sediments than Reach 5 (March 6, 2007).

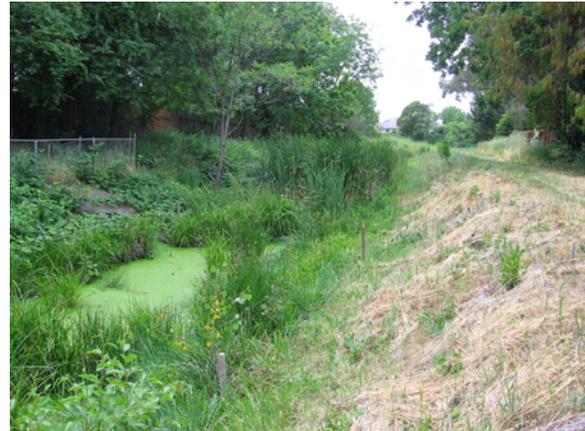
(a) Upper Reach 7 looking downstream near pipe outfall; cattails creating stagnant pond with algae; vegetation recently removed and trees planted on bank in near ground (May 29, 2007).

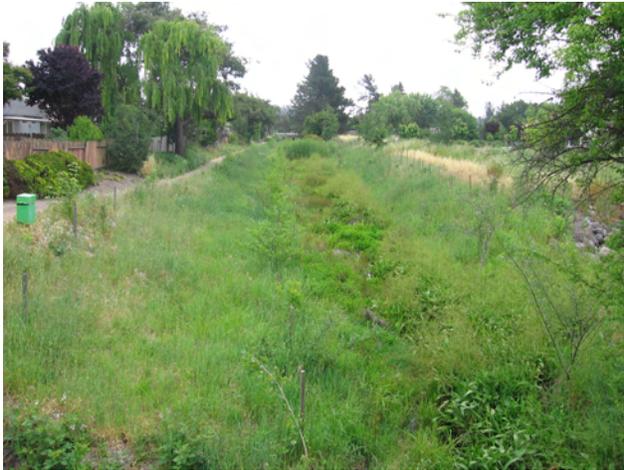
(b) Mid Reach 6 looking upstream near McGinnis Circle; wide and shallow channel with gentle gradient and banks (3:1), note recent tree planting along banks; reach is similar to Lower Reach 7 (May 29, 2007).

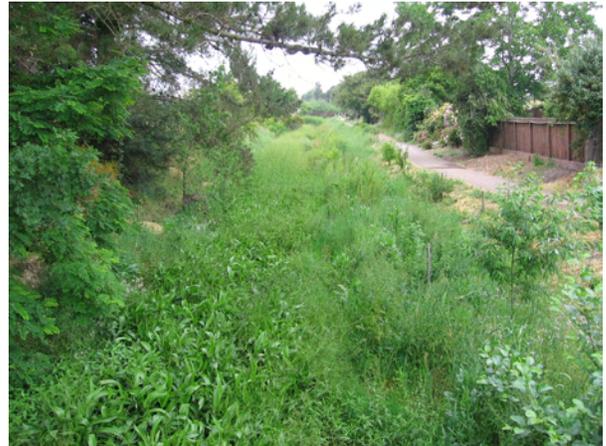
(a) Upper Reach 6 looking downstream from Benson Lane; reach has gentle gradient and banks (3:1); is depositional along most of its bed; and has recent tree planting along banks; reach is similar to Lower Reach 7 (May 29, 2007).

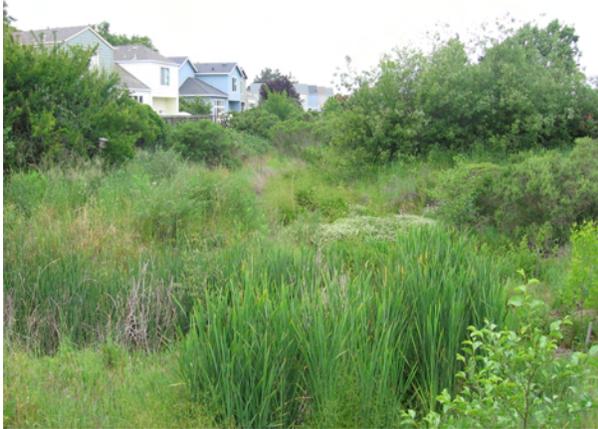
(c) Lower Reach 6 looking downstream near McGinnis Circle; culvert tributary enters from left; in-channel vegetation increasing compared to upstream section seen in photo b (May 29, 2007).

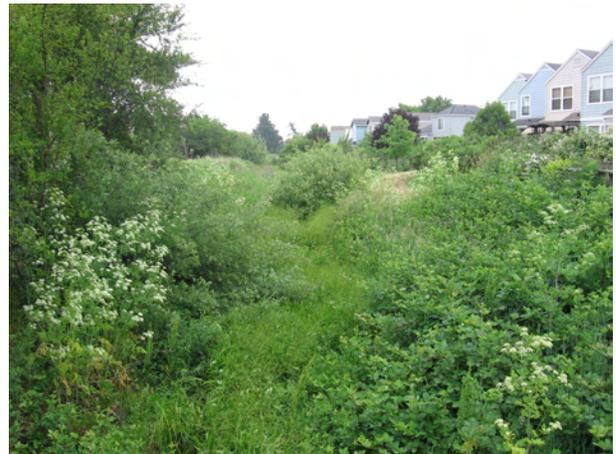
(d) Lower Reach 6 looking upstream from East Cotati Avenue; abundant shrub and grass vegetation both in the channel and along the banks throughout lower reach (May 29, 2007).

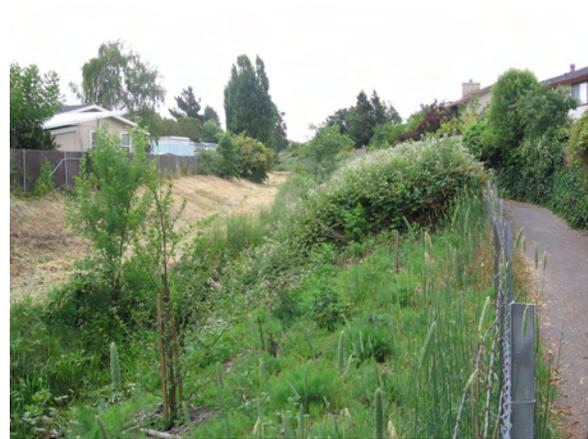
(b) Mid-Reach 5 looking upstream; far bank (left) recently cleared of vegetation; near ground (center) also recently cleared and trees planted; thick blackberry vegetation remains on right bank (center back) (May 29, 2007).

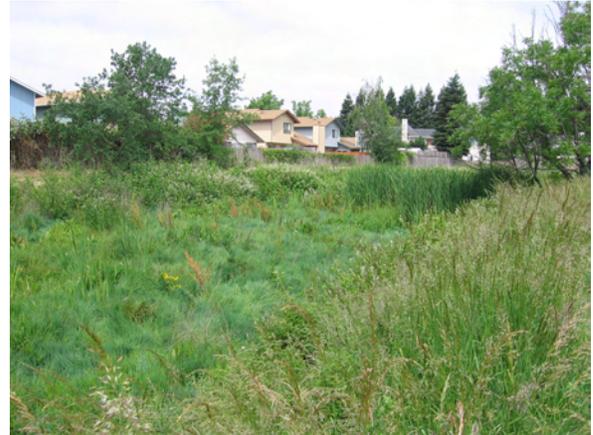
(a) Upper Reach looking downstream; thick in-channel vegetation of grasses, cattails, and willows create some stagnant pooling just upstream of photo (May 29, 2007).

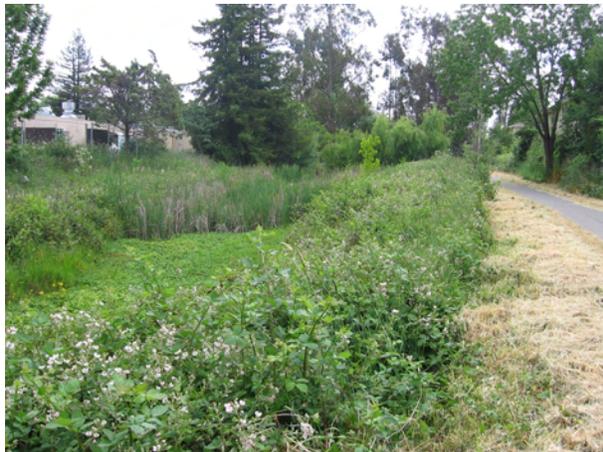
(c) Mid Reach looking upstream; mid reach sections alternate between shaded areas dominated by water plantain and non-shaded sections with cattails and other in-channel vegetation (May 29, 2007).

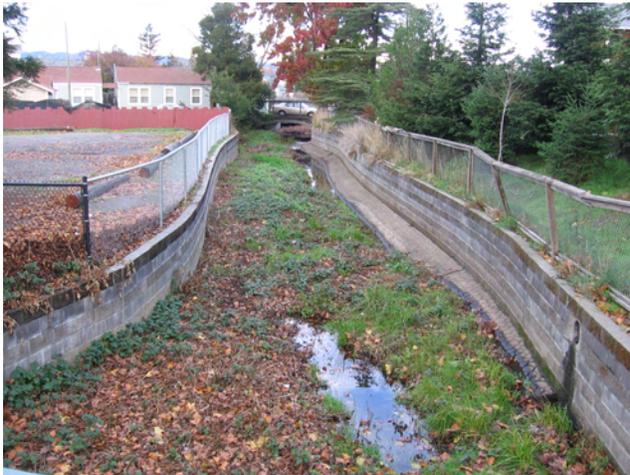
(b) Cotati Creek Reach 1 looking downstream from Old Redwood Hwy, concrete lined channel with paver block banks is filling uniformly with sediment across its bed (Dec. 16, 2008).

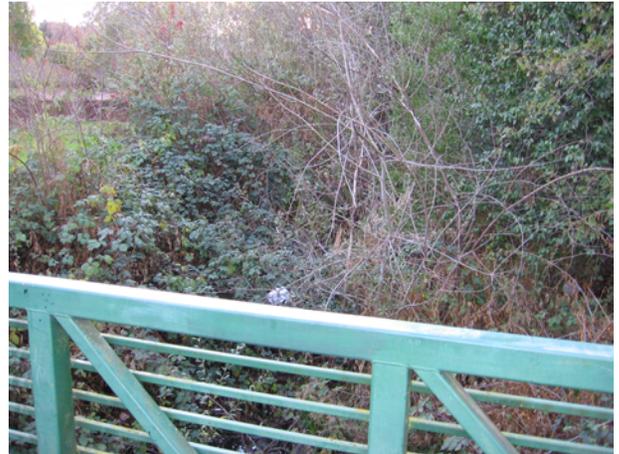
(a) Cotati Creek Reach 2 looking upstream from Delano Park crossing; abundant vegetation including blackberry shrubs and willows fill the channel; some larger trees > 3-4" diameter are growing in mid channel bed. (Dec. 16, 2008).
