Figure 4-1  
Windsor Subbasin

**FIGURE 4-2**  
**Reaches and Vegetation**  
**Windsor (1 of 4)**

# Windsor Creek – Reaches 4 & 3

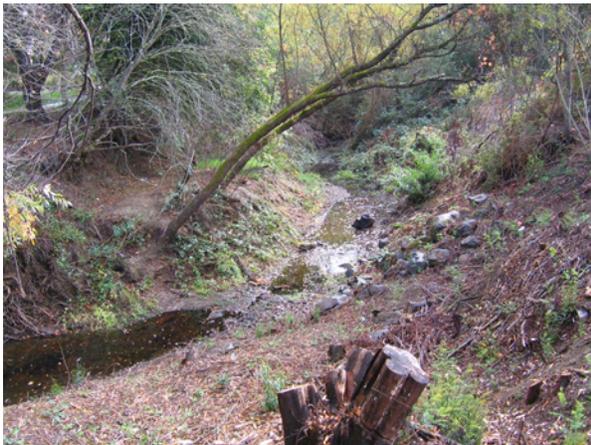
(b) Mid Reach 4, looking downstream. Note cut stump in foreground, this section of Reach 4 has experienced recent vegetation thinning and removal. Channel morphology includes pool and riffle sequences throughout Reaches 4 and 3 (Nov 2008).

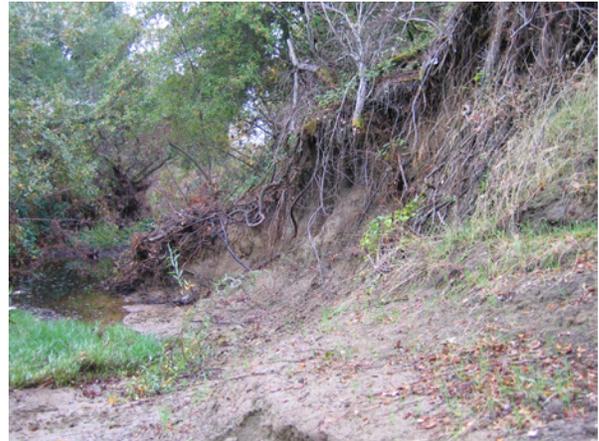
(a) Upper Reach 4 looking downstream, right bank shows widespread bank erosion with an area of failure approx. 50-75 ft long. The sands from this eroding bank appear to be the source of numerous bars forming in and along the channel downstream (Nov 2008).

**Bed sediments/texture:** bars are either exposed or underlain with gravel and cobbles; recent sandy deposits from eroding banks (photo a) transported downstream.

**Channel processes:** Windsor 4 channel is incising and causing additional bank erosion and bank failures (photo a); traveling downstream the channel changes from incising to aggrading and sediment fines. It appears that chronic bank failures upstream are contributing to bar and wedge formations downstream.

Management considerations for Reach 4 focus on addressing chronic bank failures, especially the large slip approximately 50 ft downstream from Brooks Rd. Management in Reach 4 should also address the large sediment wedges that have built-up upstream of the Natalie Dr. crossing. This series of bars and wedges extends at least 50 ft upstream from the crossing and is between 1-2 ft above the baseflow water surface elevation. There are also a number of localized sediment wedges in Reach 3 (generally behind rock features) that should be monitored. Based on existing channel capacity, planting to create a canopy in Reach 3 would benefit a wide array of wildlife species and possibly create conditions conducive to supporting steelhead.

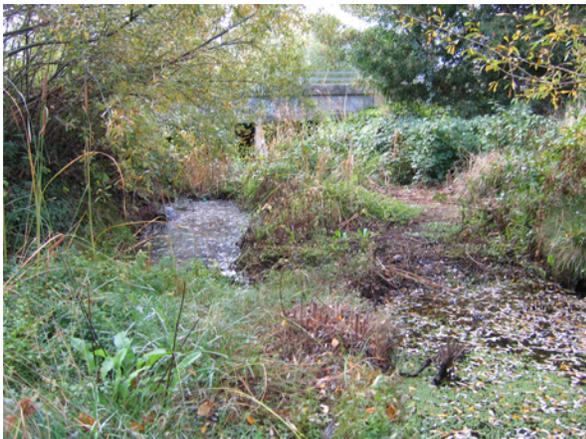
(c) Bottom of Reach 4, looking downstream to Natalie Dr. crossing. Note large bar in the foreground on the left and background on the right. Reach 4 is dominated by numerous areas of bank instability and increasing bar formations (Nov 2008).

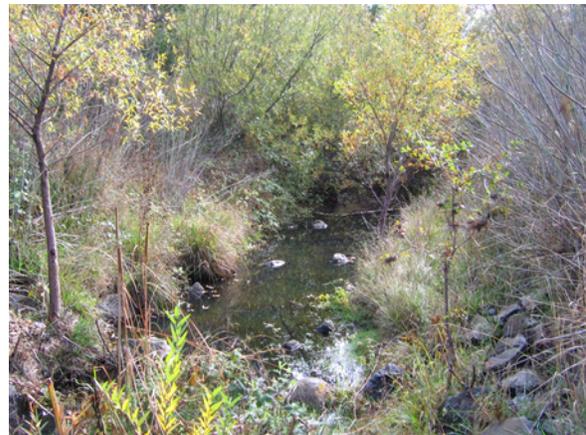
(d) Middle of Reach 3, looking downstream. Notice that the banks from the toe to the top are composed of large ungrouted rip-rap. This rip-rap is also found across the channel in many locations and appears to be functioning as grade control, and trapping and retaining sediments (Nov 2008).

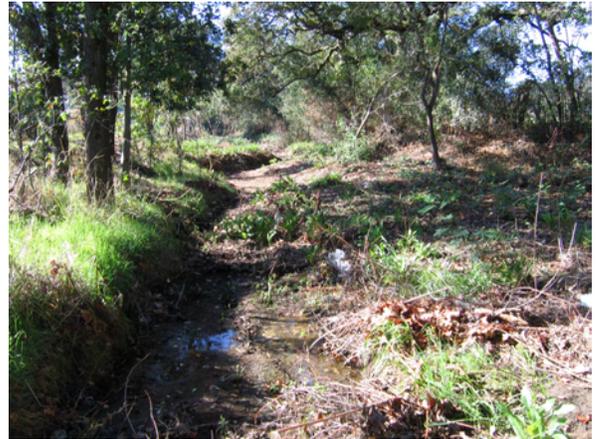
(a) Top of Reach 2, looking downstream. The upper section of this reach was mostly dry with a few small pools (foreground) and the margin bars in the active channel (right) are heavily vegetated with blackberry, ox-tongue, and annual grasses. Also, note the low flow channel is cutting through the bars and re-creating some sinuosity (Nov. 2008).

*Riparian corridor and canopy closure:* Upper Reach 2 supports a dense, but very narrow riparian corridor with canopy closure reaching 75% (photo a) and Reach 1 contains only sparse canopy with closure between 0%-10%. The corridor ranges from ~10- 30 ft wide on either side.

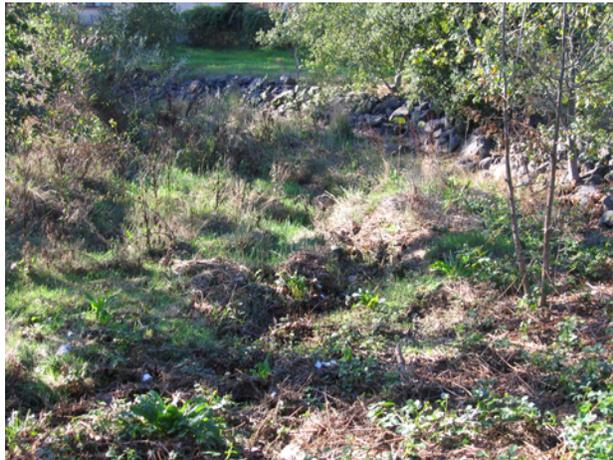
(b) Reach 1 looking downstream from Oak Park St. crossing. Note that the right bank is completely rocky, Starr 1 contains significant rip-rap at all bends and along most banks. Also notice that the low flow channel is barely visible through the sediment and vegetation (Nov. 2008).

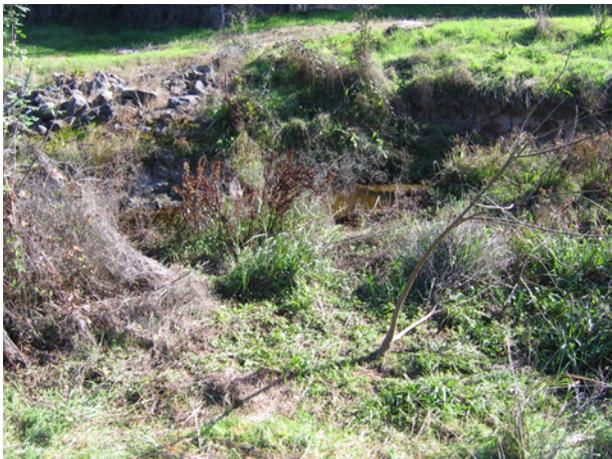
reach (photo c); large bypass in lower Reach 1 (photo d). Most of Starr 1 and 2 were either dry or had shallow barely flowing water in November 2008. A few isolated pools (2' max depth) were also observed.

(c) Middle of Starr 1, looking across the channel. Note the rocks on the left and the eroding bank just downstream on the right. This situation is common in Reach 1, where part of a bank had been repaired with rock and the adjacent, downstream bank is now unraveling (Nov 2008).

Assuming the flood bypass channel (photo d) functions as designed, management considerations for Reaches 2 and 1 should focus on ameliorating the bank erosion occurring along many of the non-rocked banks and regular vegetation maintenance to remove blackberries. Sediment accumulation should be monitored throughout the reach. If bypass channel is not working as designed, some sediment management activities may be necessary to increase the conveyance capacity of these channels and reduce the risk of overbank flows. If this is necessary, skimming of the existing bars and wedges should allow the current “notched” low flow channel to remain inset within the cross section. Lower Reach 2 and Reach 1 could also benefit from upper bank planting to increase canopy and retard growth of in-channel vegetation.

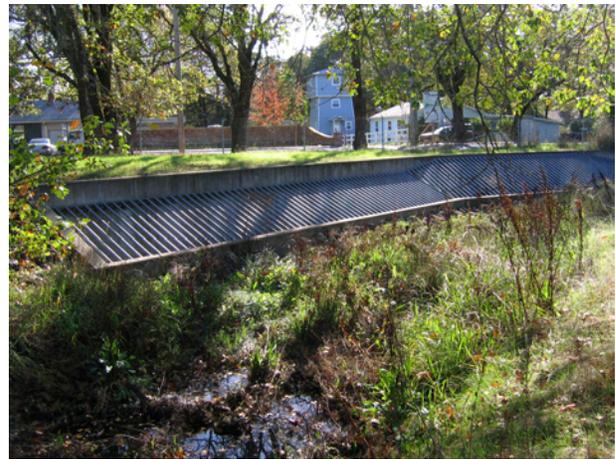
(d) Bottom of Reach 1 looking downstream at the inlet of a large bypass structure. This structure is located near the bottom of the reach at a big bend. Bypass inlet covers approximately 75 ft of bank conveying high flows into an underground culvert (Nov 2008).

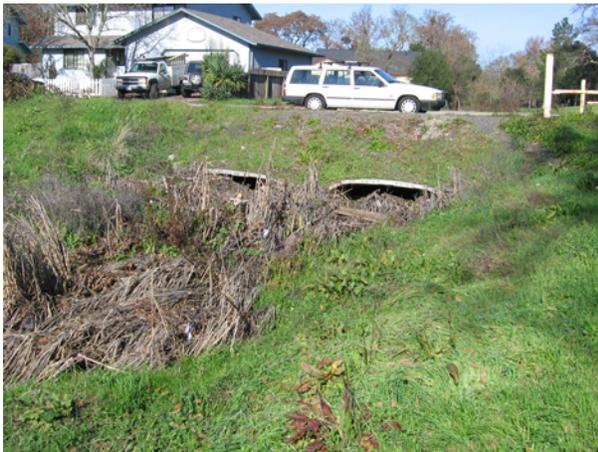
(b) Starr Cr. Tributary looking upstream to blocked culverts at Stellar Lane crossing. Two parallel corrugated pipe culverts are blocked with abundant deposition, both upstream and downstream of the crossing (Jan. 8, 2009).

Management opportunities at Starr Cr. Tributary focus on the removal of sediment at blocked culverts upstream and downstream of the Stellar Lane (photos b/c) and Buckingham Dr. (photo d) crossings. These lower sections of the reach should be evaluated for the potential excavation of a low flow channel, similar to what is observed in the upper reach (photo a), where channelized low-flows pass through a 3-5 ft. wide channel that maintains itself free of being overly depositional. Slopes and gradient in the lower reach may or may not facilitate development of a low flow channel, but the opportunity should be evaluated. Additionally, in the section upstream of Stellar Lane, bank plantings would greatly improve the riparian canopy cover.

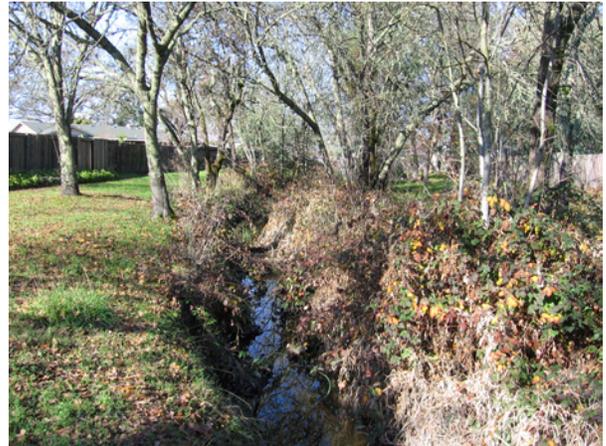
(a) Starr Cr. Tributary looking upstream, from above Colleen Dr.; channel 4-6 ft wide is inset 2-4 ft. below bench of riparian corridor with oaks, alders, and eucalyptus (Jan 8, 2009).

**Active channel:** in upper reach width ranges between 4-6 ft and 2-4 ft. deep with flow depth up to 2 ft. (photo a); in lower reach active channel widens to 10-15 ft wide at the base of broad trapezoidal channel form, with shallow diffuse flows across bed (photos c/d).

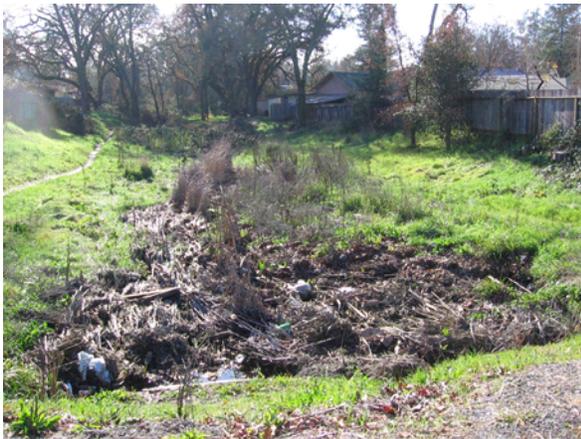
**Bed sediments/texture:** generally silts and sands in the upper reach, with finer sediments and mud collecting downstream of culverts in the lower reach (photos c/d).

(c) Starr Cr. Tributary looking downstream from Stellar Lane crossing. Presence of cattails, deposited sediment, and some trash and debris downstream of crossing. Riparian canopy of oaks develops further downstream (Jan 8, 2009).

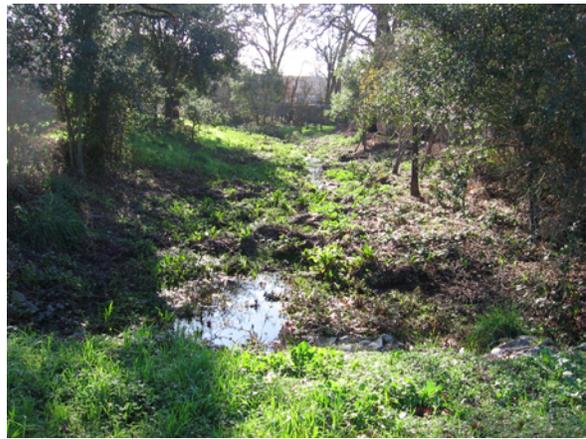
(d) Starr Cr. Tributary looking downstream from Buckingham Dr. crossing. Similar to Stellar Lane crossing, gentle and wide stream cross section collects sediment. Instream emergent marsh vegetation and shallow/diffuse flow conditions (Jan 8, 2009).

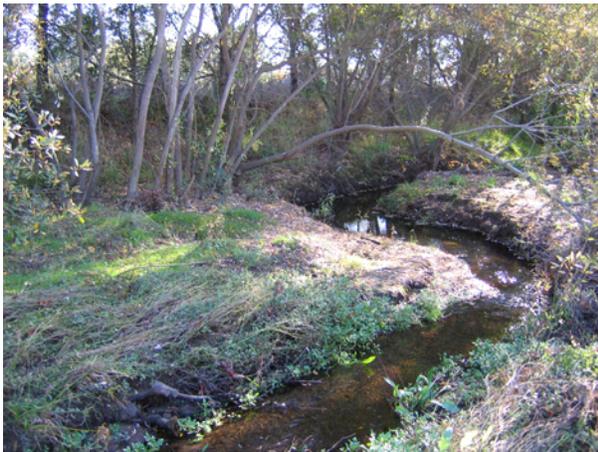
(b) Middle of Reach 1 looking downstream. This photo shows the progression of Windsor Creek regaining a natural meander through increasing high sediment deposits on both sides of the channel. Also notice the line of willow (background) along the toe of bank showing the historic channel configuration (Nov 2008).

**Channel processes:** Reach 1 appears to be a major depositional reach, with an array of coarse and fine sediments creating large in-channel bars throughout (photos a, b, and d). Although the active channel is a straightened trapezoid, sediment deposition and scour have re-created a sinuous low flow channel in most locations (photos a and b). Also, the shallow banks on the north side allow for connections between the channel and a small remnant bench-floodplain.

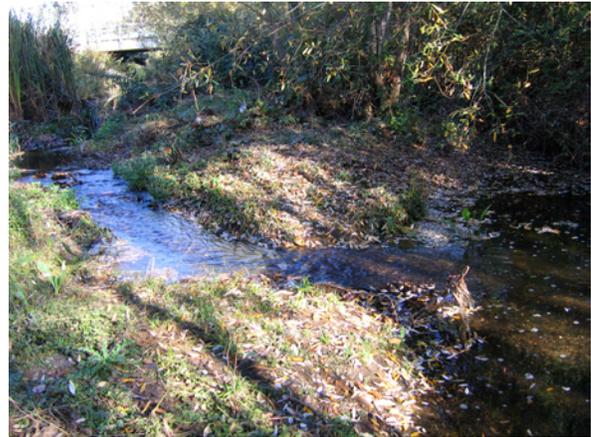
(a) Near top of reach looking upstream toward Windsor Rd. crossing. Low flow channel meandering through sediment bars of varying sizes on both side of the channel (Nov 2008).

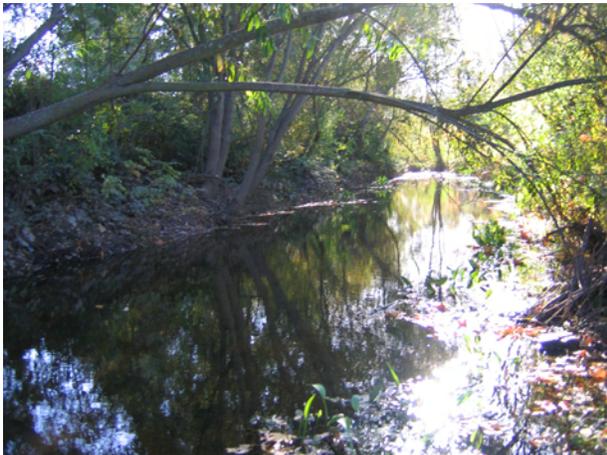
(c) Lower Reach 1, looking downstream at one of the wider channel sections. This section has no sediment wedges and instead of a meandering, confined low flow channel, in this section the channel is wide, shallow, and more ponded (Nov 2008).

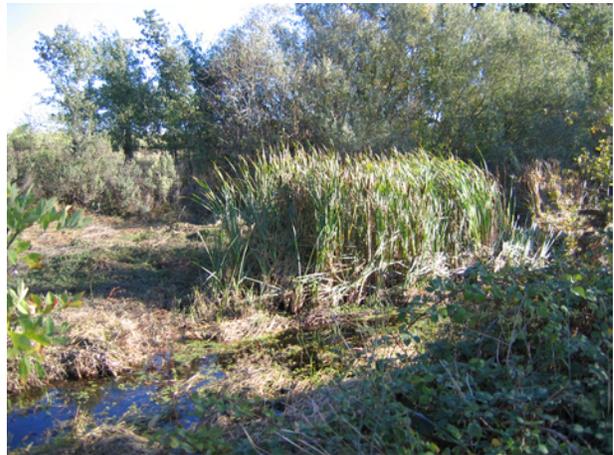
*Vegetation composition:* The reach supports dense stands of woody riparian vegetation along much of both banks with arroyo willow and alders at the margins of the active channel (photo b and c) and a mix of oaks, willows, alders, and other tree species along the low floodplain and banks. Understory is dominated by blackberry and grasses and is generally limited by significant shade. Emergent or margin vegetation is dominated by a variety of shade tolerant herbaceous plants including grasses and sedges. In areas with open canopy (generally lower sections of the reach), cattails form large clumps on shallow bars (photo d).

(d) Near the bottom of Reach 1, looking across channel. Note low flow channel in foreground and the large wide "floodplain" bench adjacent to the low flow channel. The bench shows signs of recent inundation (photo from November 2008) and supports an array of wetland vegetation including cattails, water plantain, etc. (Nov 2008).

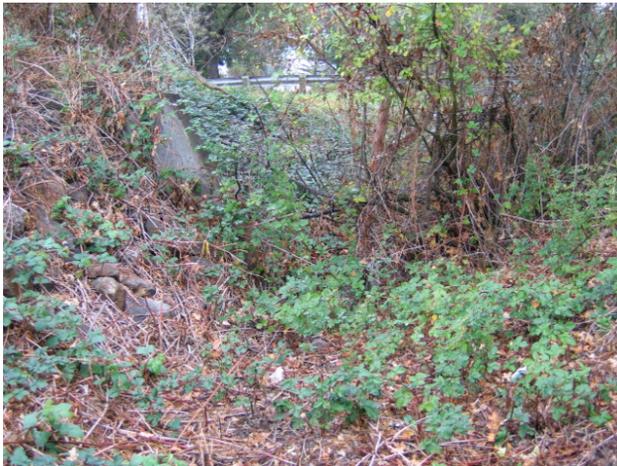
(b) Looking upstream toward Old Redwood Hwy. Key things to note in photo: (1) the sliver of concrete in upper left is concrete wing wall of bypass culvert (photo a); and (2) channel downstream of bypass culvert is completely dry and appears to be perched about 1.5 ft above the culvert inlet (shunting all flows into the bypass)(Nov. 2008).

The current bypass inlet at Faught Creek Reach 1 appears to be not only conveying high flows, but conveying all low flows. Management should focus on determining (via as-builts) whether the current condition reflects the intent of the design. If this design was intended to bypass high flows only, then the inlet area and adjacent channel may need to be reworked to re-perennialize the channel. There does appear to be a sediment wedge or earthen berm across the channel about 10 ft downstream of the inlet. This blockage might be responsible for diverting low flows into the inlet and may allow for a simple fix. Regardless of the original intent of the designs, re-routing low flows through the natural channel would result in creating better riparian and instream habitat for an array of species and does not appear to be problematic from a flood control perspective.

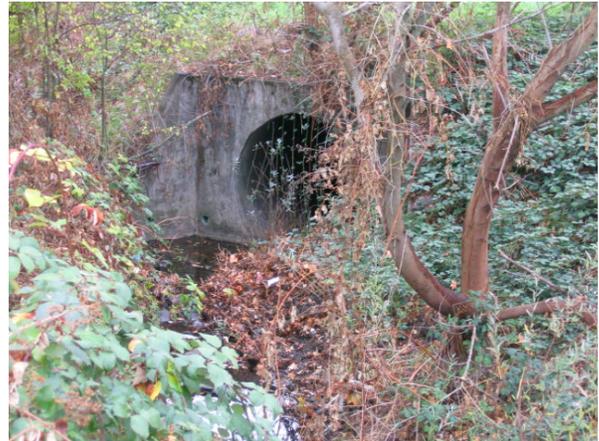
(a) Faught Creek from Old Redwood Highway looking downstream into the concrete bypass conduit. Water is flowing in the uppermost section of this reach between the bridge and bypass culvert (photo taken Nov. 2008). This culvert carries flows to its outlet downstream of Reach 1, below Amie Dr.

**Reach setting:** Faught Cr., located on the alluvial plain below the Mayacamas Mnts, is a small creek draining upstream fields and some small hillside drainages. Aerial photo analysis suggests that Faught Cr might have been an abandoned arm of Pool Cr., a larger system directly to the north. This reach is unique because the majority of all flows bypass (photo a) the channel and flow through an underground conduit,

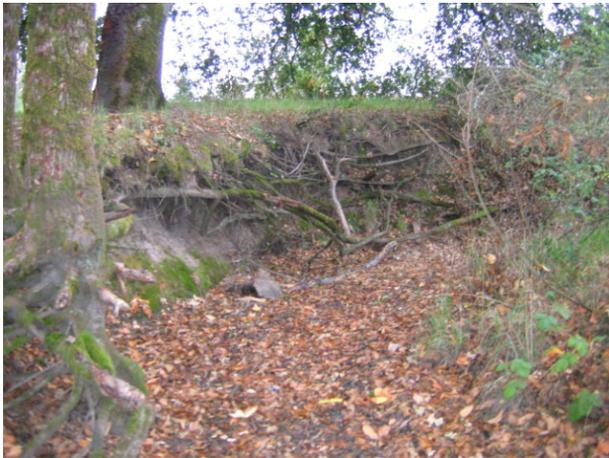
(c) Middle of Faught Creek Reach 1 looking downstream, channel bottom is covered with leaves with no apparent surface flow. The outside bank at this bend appears to be eroding and portions of the channel are aggrading and other portions are incising (Nov 2008).

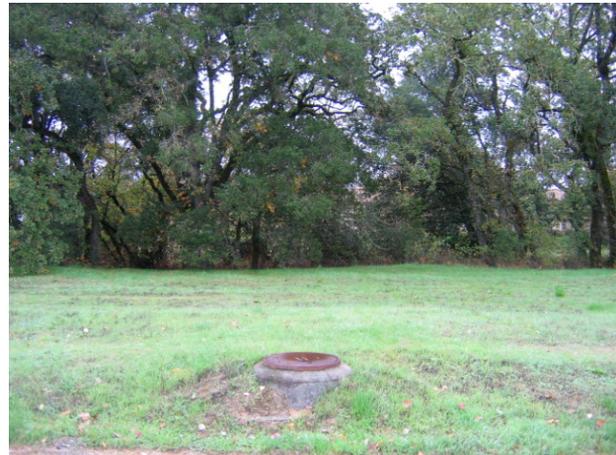
(d) Middle of Reach 1, cross-section showing both the manhole for the bypass conduit and the narrow, but dense valley oak riparian corridor along the stream channel (Nov 2008).

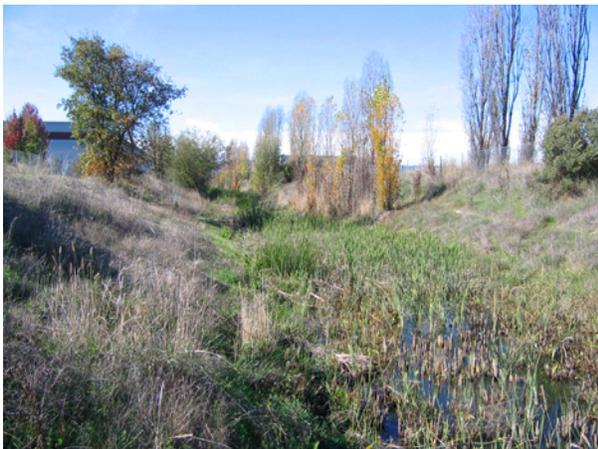
(b) Near the top of the reach looking downstream. Notice the engineered trapezoidal channel configuration and abundance of cattails growing across the flat channel bottom. Although this reach has very little riparian growth, plant poplars and oaks as well as willows appear to be thriving along a small section of creek (see photo c) (May 13, 2008).

Management considerations for Airport Creek Reaches 1 and 2 focus on vegetation removal throughout the reach and sediment removal near the Skylane Blvd culvert crossing. Due to lack of sinuosity, complexity, and shade, a number of treatments could be used to improve habitat conditions and reduce in-channel emergent vegetation growth. Aggressive planting with riparian species to provide shade and habitat would help control cattail growth and increase the value of these reaches as a migration corridor.

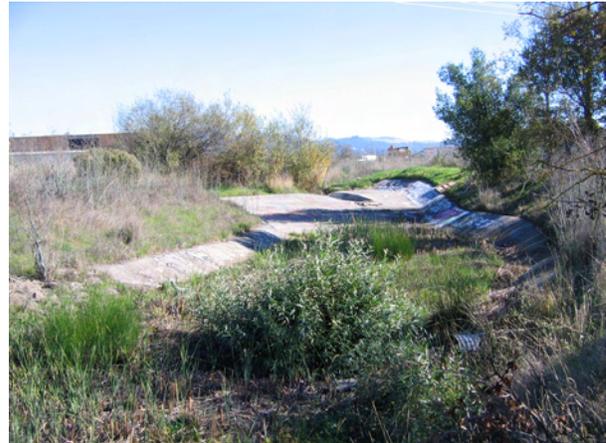
(a) Upper Reach 2 looking upstream to concrete apron that marks the beginning of SCWA's easement. Area upstream of apron channel appears more like a shallow swale across the lower plain. Broad and wide channel. Note recently cut cattails in the channel re-growing and entering culvert in the lower right (May 13, 2008).

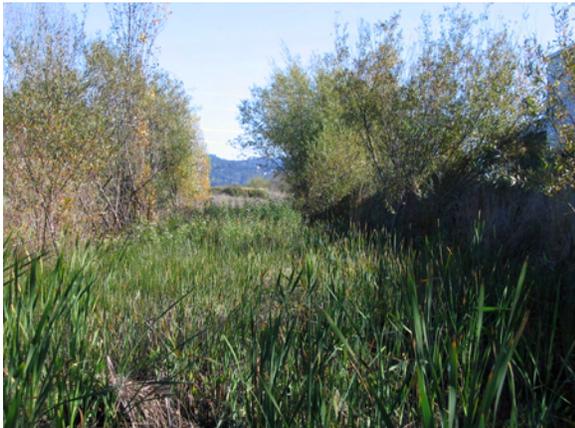
(c) Middle of the reach, looking upstream. Although woody riparian species are limited throughout much of this reach, a 200+ft section in the middle of Reach 2 contains a dense patch of willows near the toe of slope and planted oaks and poplars at top of bank (May 13, 2008).

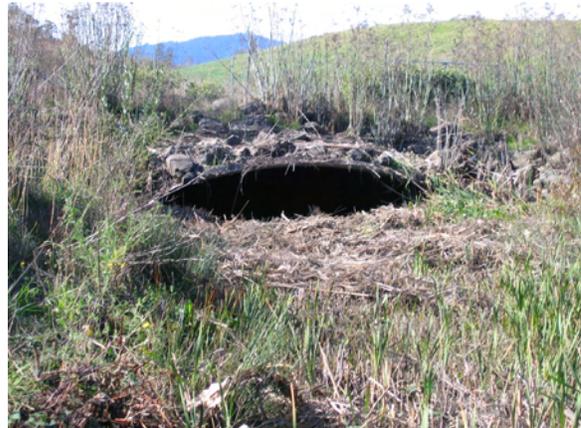
(d) Looking downstream at the culvert under Skylane Blvd. This aluminum arch is heavily impacted (as of 11/07) by sediment and cattail growth. It looks as though the culvert has lost at least ¾ of its capacity and the road bed is within a few feet of the top of the culvert. There is also a large sediment wedge on the downstream side of the culvert (May 13, 2008).
