## Integrated Maintenance Approach at a Reach Scale

**Sonoma County Water Agency  
 Stream Maintenance Program  
 Conceptual Planting Diagram**

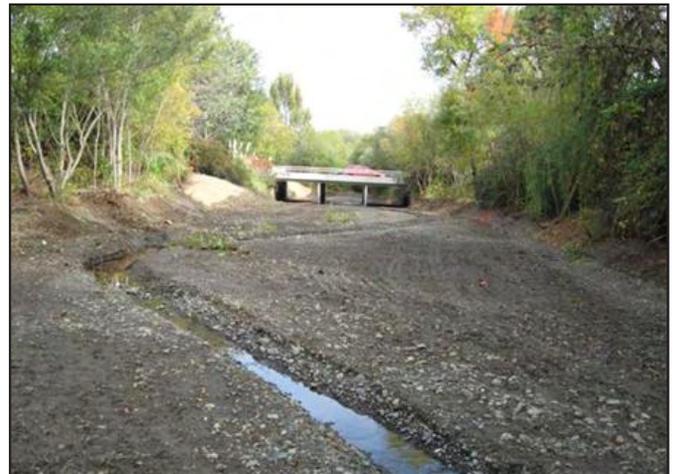
Photo d. Copeland Creek at Snyder Lane crossing, October 2008, following sediment removal activities and construction of low-flow channel.

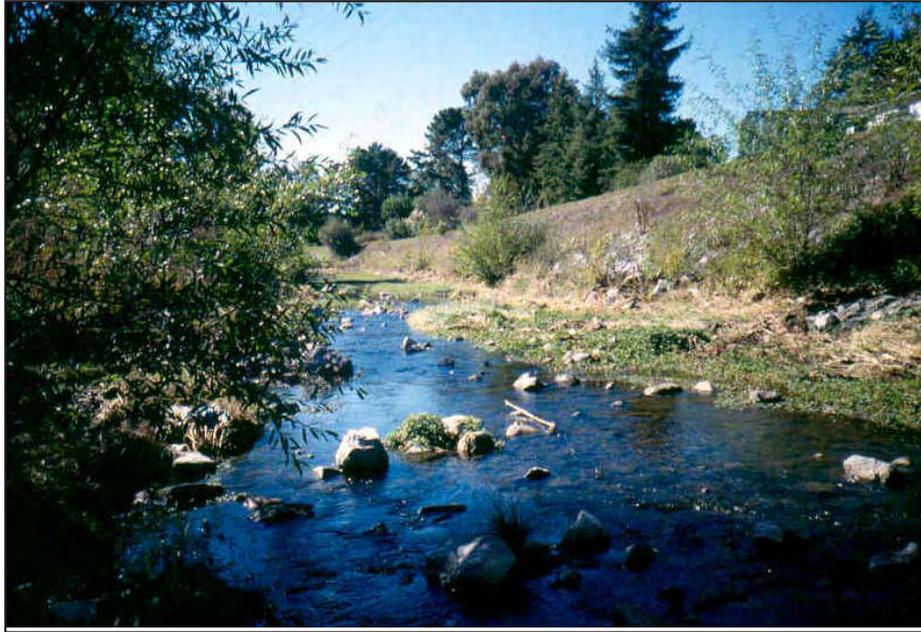
Photo a. Santa Rosa Creek, 1997, looking downstream near Pierson Street Crossing.

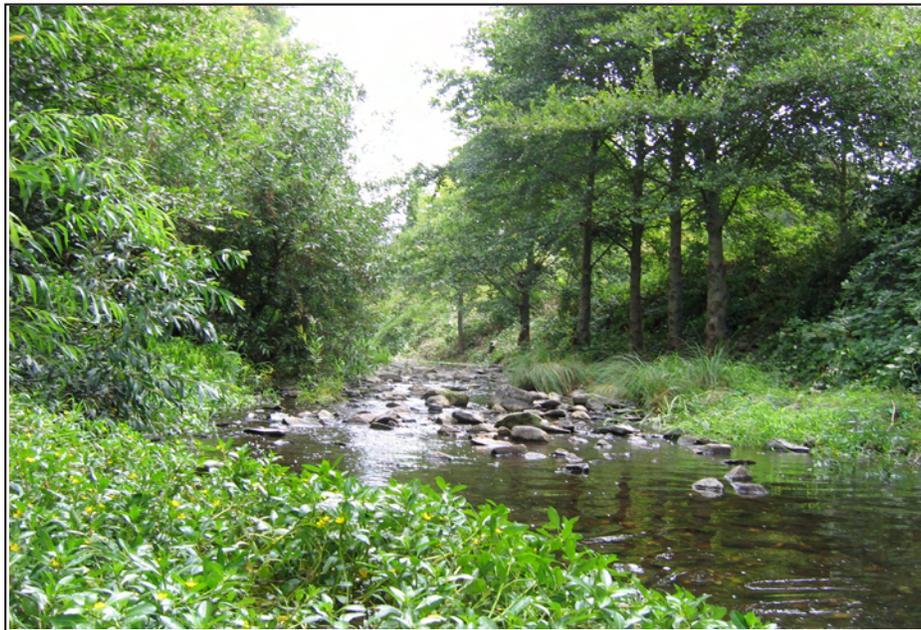
Photo b. Santa Rosa Creek, 2007, looking downstream near Pierson Street Crossing.

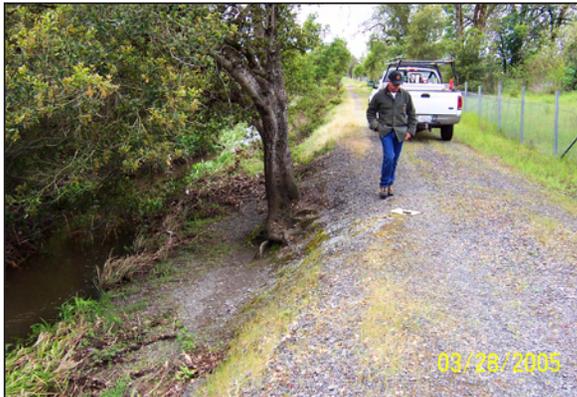
Photo a. Bank failure on Peterson Creek (Zone 1A).

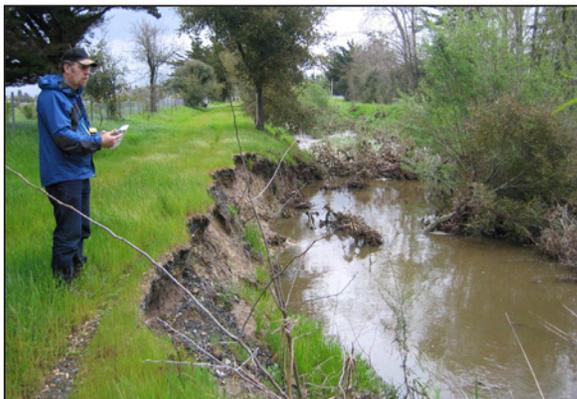
Photo a. Bank failure on Gossage Creek (Zone 1A).

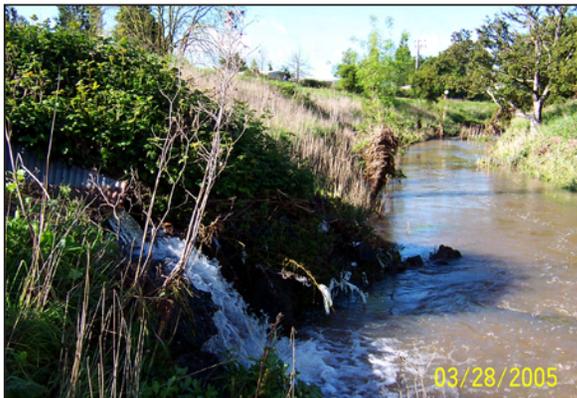
Photo a. Culvert failure on Piner Creek (Zone 1A).

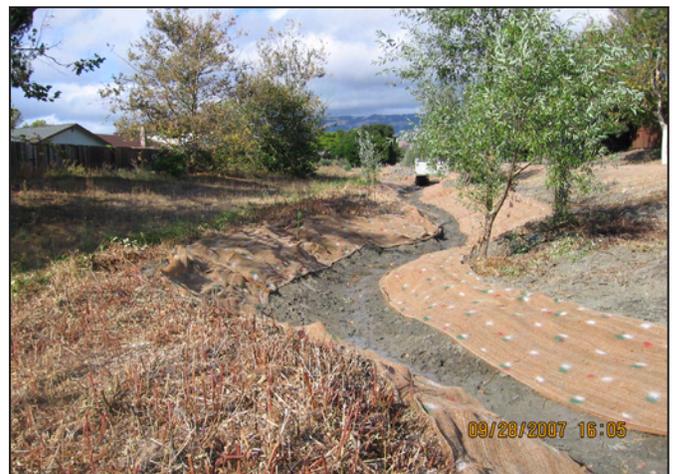
Photo f. East Washington Creek, looking upstream at Garfield Drive, after sediment removal project.

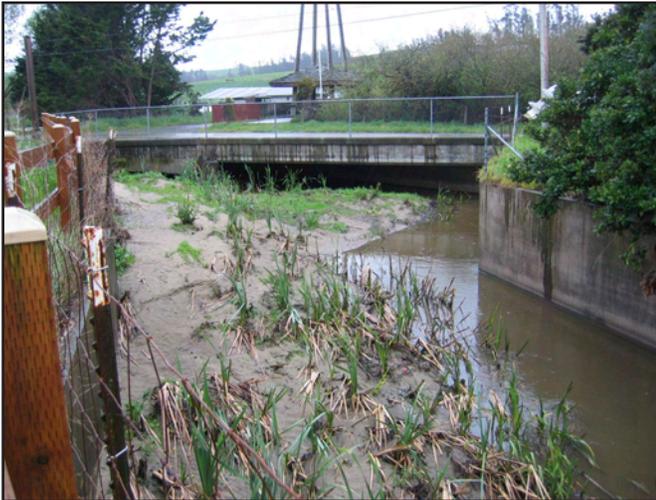
Photo a. Looking upstream at Bloomfield Channel (Zone 8A) filled with sediment.

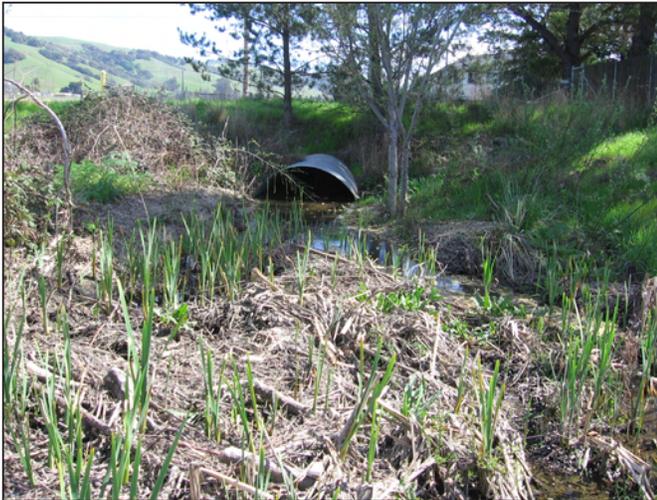
Photo a. Wilfred Creek at Snyder Lane crossing (March 2007) - culvert severely blocked by chronic deposition, good site for targeted sediment removal.

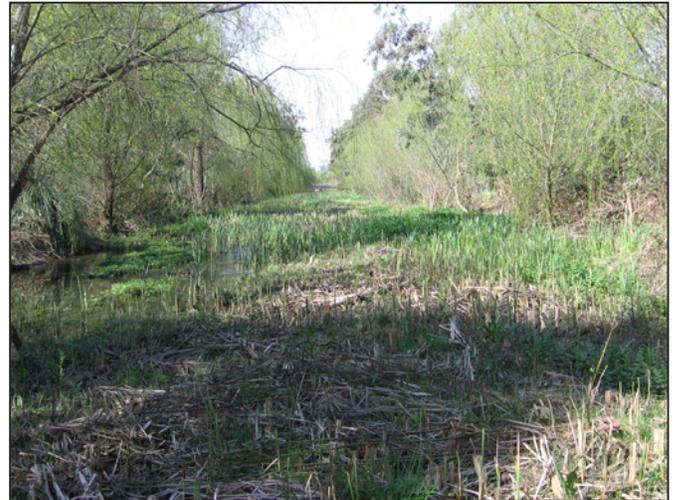
Photo b. Copeland Creek at Snyder Lane crossing (March 2007) - similar to Photo (a), a chronic depositional area, see Figure 5-3 to view 2008 maintenance activities at this site.

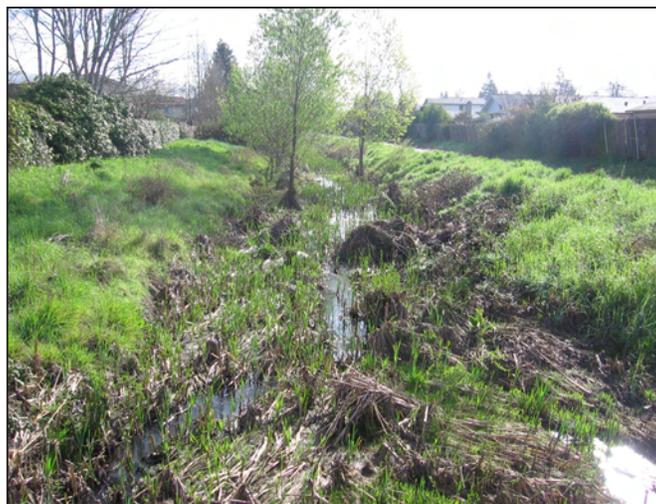
Photo c. Coleman Creek at Hillview Drive (March 2007) - chronic depositional area that is a good site for targeted sediment removal.

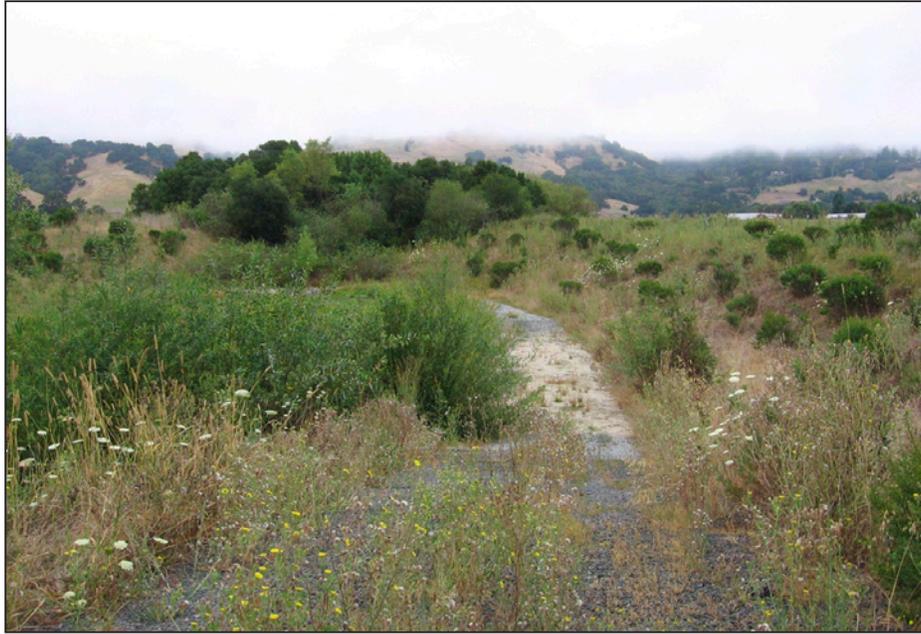
Photo a. Cook Creek Sediment Basin (Zone 1A) before being cleared of sediment.

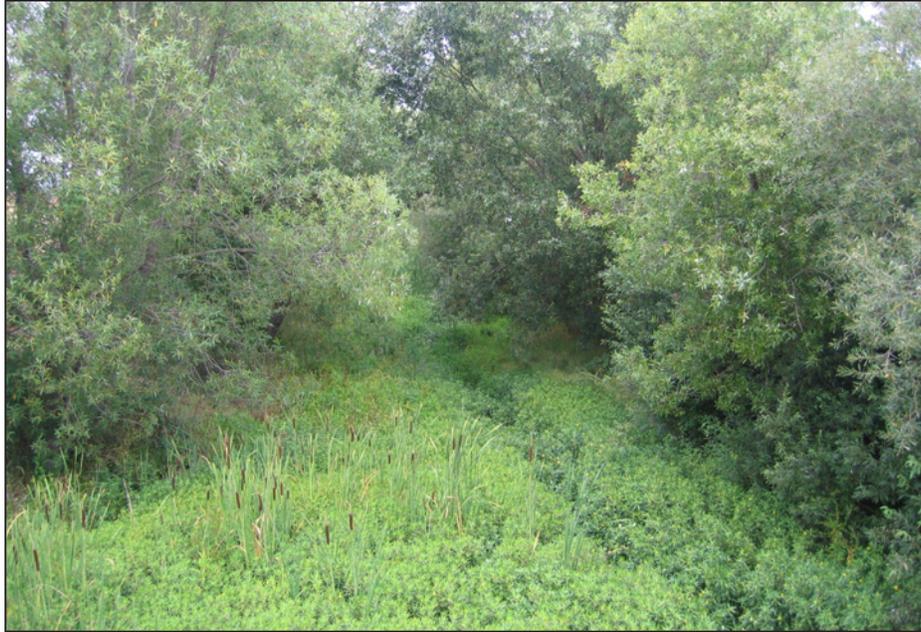
Photo a. Ludwigia filling the channel. Hinebaugh Creek, looking upstream from Rohnert Park Expressway (Zone 1A).

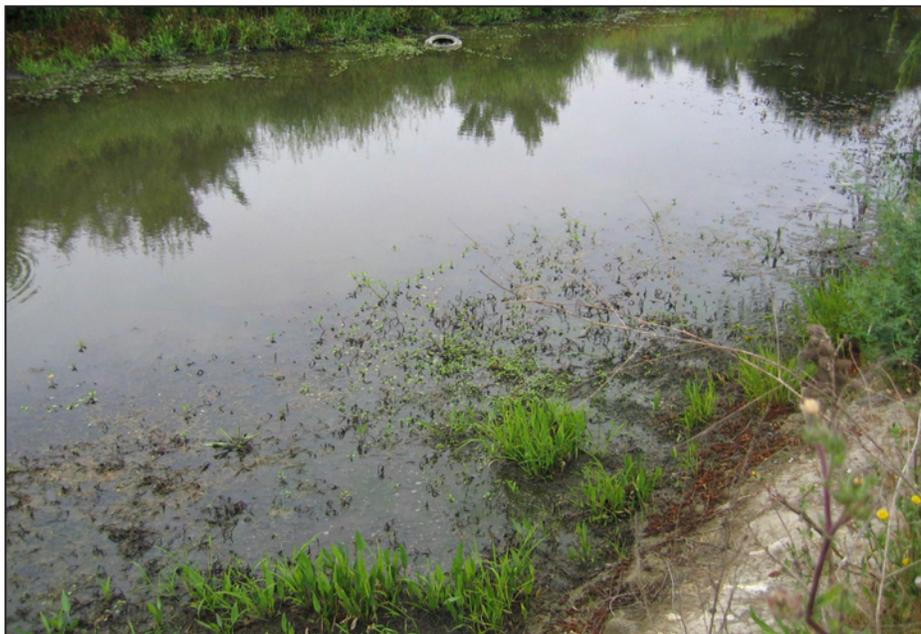
Photo b. Ludwigia reestablishing along edge of channel after recent removal project. Laguna de Santa Rosa, looking downstream, immediately downstream of confluence with Hinebaugh Creek and approximately 200 feet downstream of Photo (a) (Zone 1A).

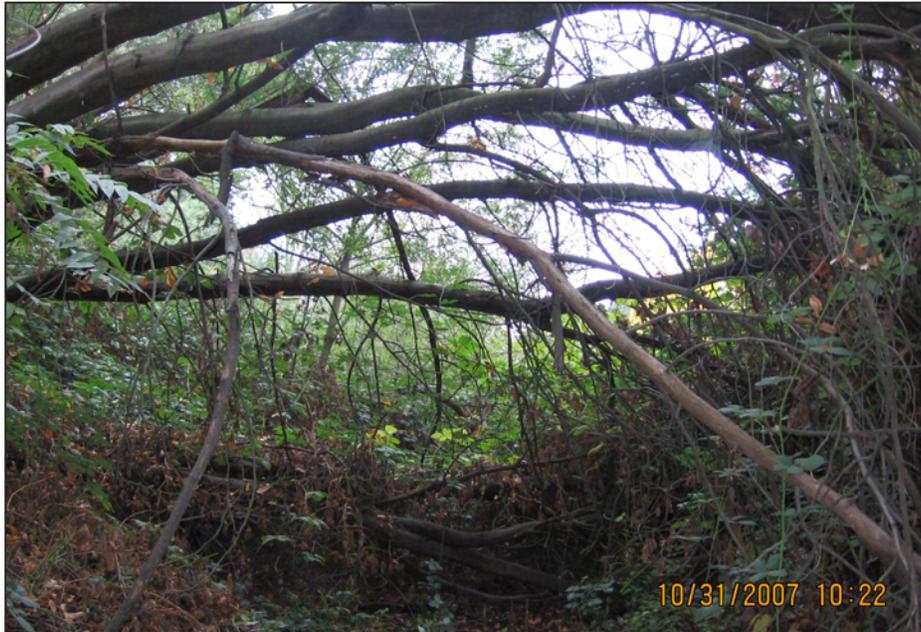
Photo a. Nathanson Creek (modified channel) before vegetation management (Zone 3A).

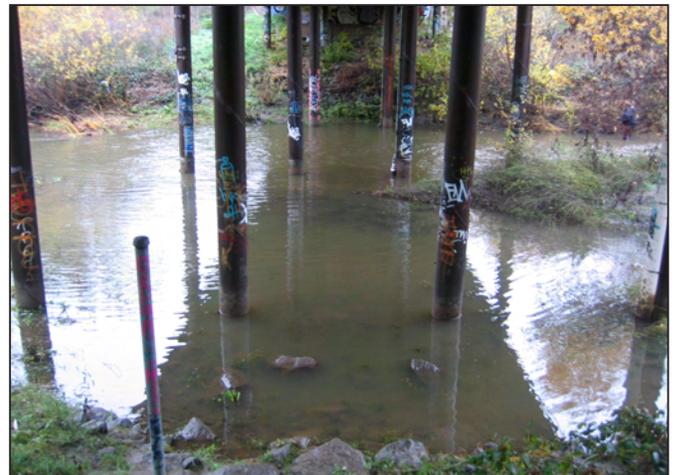
Photo d. Graffiti on bridge piling on Santa Rosa Creek at Willowside (Zone 1A).

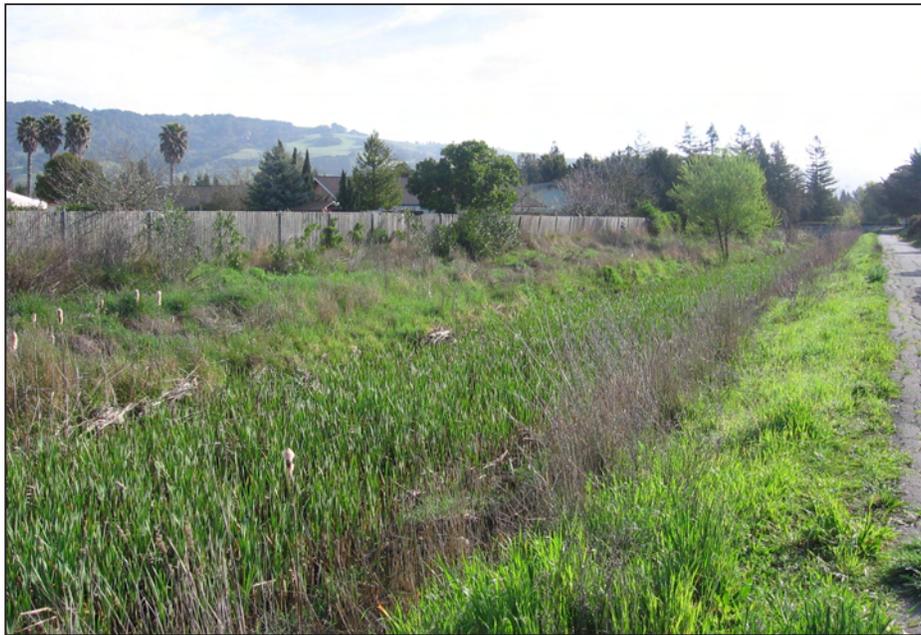
Photo a. Coleman Creek upstream of Hillview Drive (March 2007).  
No shade along channels due to lack of riparian canopy and taller bank vegetation, cattails flourish in sunny conditions without shading.
