Sonoma County Water Agency
Stream Maintenance Program (SMP)
**Annual Notification for
2015 Maintenance Projects**

Prepared for:
The SMP Inter-Agency Working Group

April 30, 2015

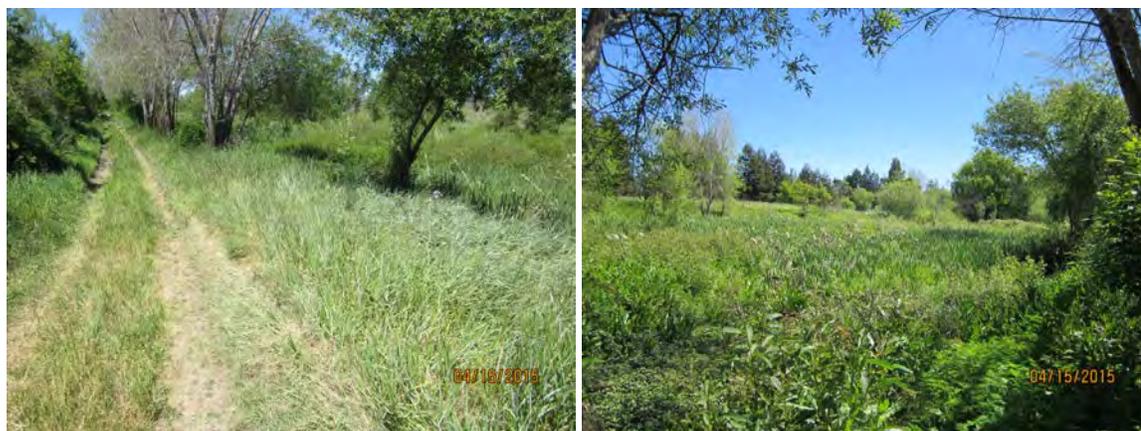
Photo 5 (above, left). Ruderal vegetation typical of the access roads paralleling both sides of Laguna 2. **Photo 6** (above, right). Perennial emergent wetland habitat at Laguna 2 project site,

The project on Laguna 2 involves the localized removal of sediment just below the confluence with Gossage and Hinebaugh Creeks. This work will be accomplished in willow scrub and perennial emergent wetland habitat. Dominant species occurring within the project area are cattail (*Typha* sp.) and water primrose (*Ludwigia* sp.). Other species include willow weed (*Polygonum* sp) curly dock (*Rumex crispus*), ditch carrot (*Oenanthe sarmentosa*) and various willows (*Salix laevigata/lasiolepis/lucida lasiandra*). The emergent wetland habitat precludes the presence of vernal pool species associated with intermittent wetland, and no special-status plant species were observed in or adjacent to the project footprint, or throughout the entire reach. Photos 5 and 6 below illustrate site conditions at the Laguna 2 project location.

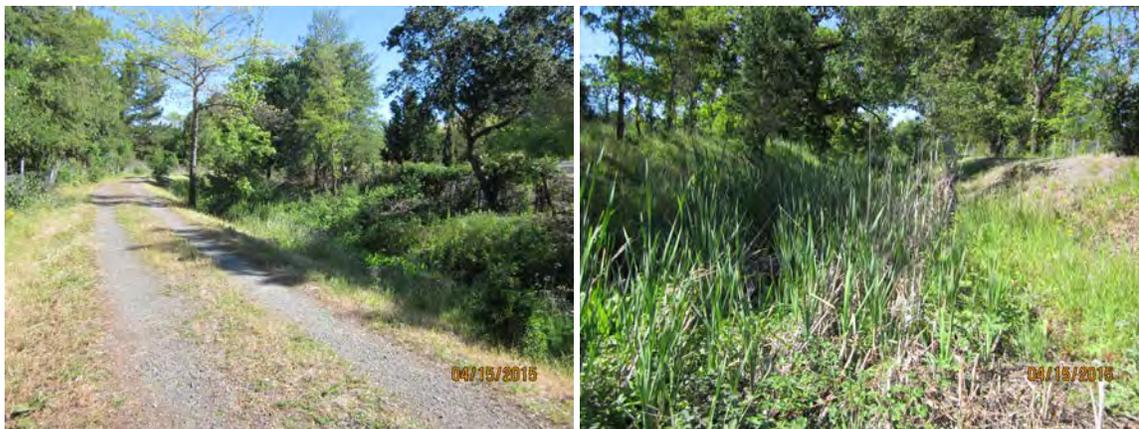
Photo 7 (above, left). Non-native grass and v-ditch habitat along Peterson 2 access road (where equipment will be staged). **Photo 8** (above, right). In-stream habitat conditions at Peterson 2, looking downstream from upper portion of reach. Both photos taken April 15, 2015.

As mentioned above, the Peterson 2 project will remove sediment deposits below the OHWM throughout the reach. The in-stream habitat that will be impacted by these activities is predominately wetland emergent species including tule (*Scirpus sp.*), cattails, water plantain (*Alisma sp*), curly doc, and Himalayan blackberry (*Rubus armeniacus*). Though Peterson 2 channel supports intermittent wetland, the dominance of these species impedes the presence of vernal pool obligates and none were observed throughout the reach. Photos 7 and 8 below illustrate the habitat within the project footprint.

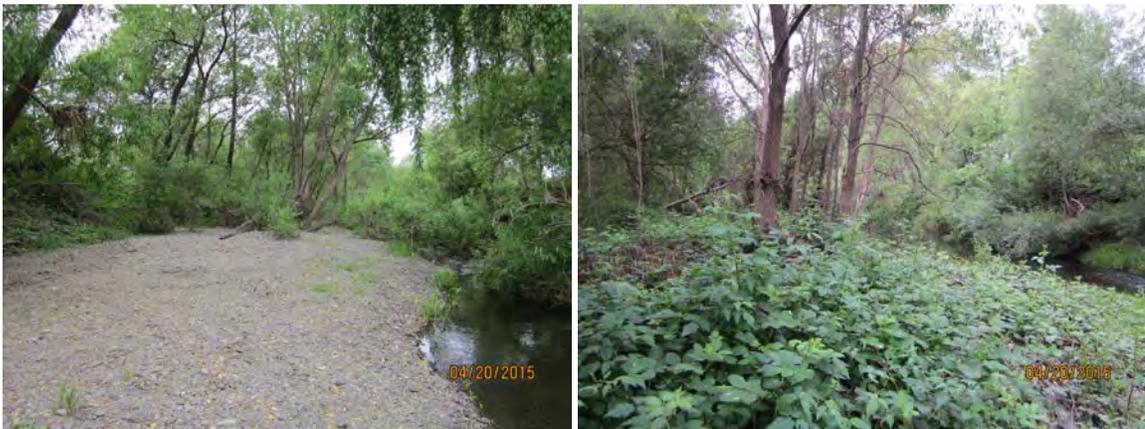
Photo 9 (above, left). Non-vegetated gravel deposit and in-stream conditions typical of purposed basin sites. **Photo 10** (above, right). Woody riparian and dense understory habitat typical of the purposed sediment basin sites. Both photos taken April 20, 2015.

Specifically, the Santa Rosa 1 project will establish nine sediment basins ranging in size from 150 to 390 linear feet. Construction will be focused in-channel and will only impact areas below the OHWM. The 2015 survey revealed that vernal pool/vernal swale habitat is not present within the project footprint area. Rather, the project area supports dense woody riparian vegetation along the banks and down to the toe, with a dense understory dominated by Himalayan blackberry, poison hemlock (*Conium maculatum*), and various riparian tree saplings/willow scrub. The active channel within the purposed project area largely lacks emergent growth and holds large deposits of un-vegetated gravel. Special-status plant species surveys of Santa Rosa 1 were also conducted in 2011 and 2012, and to date no target species have been observed. Photos 9 and 10, below, depict representative site conditions within the project area.

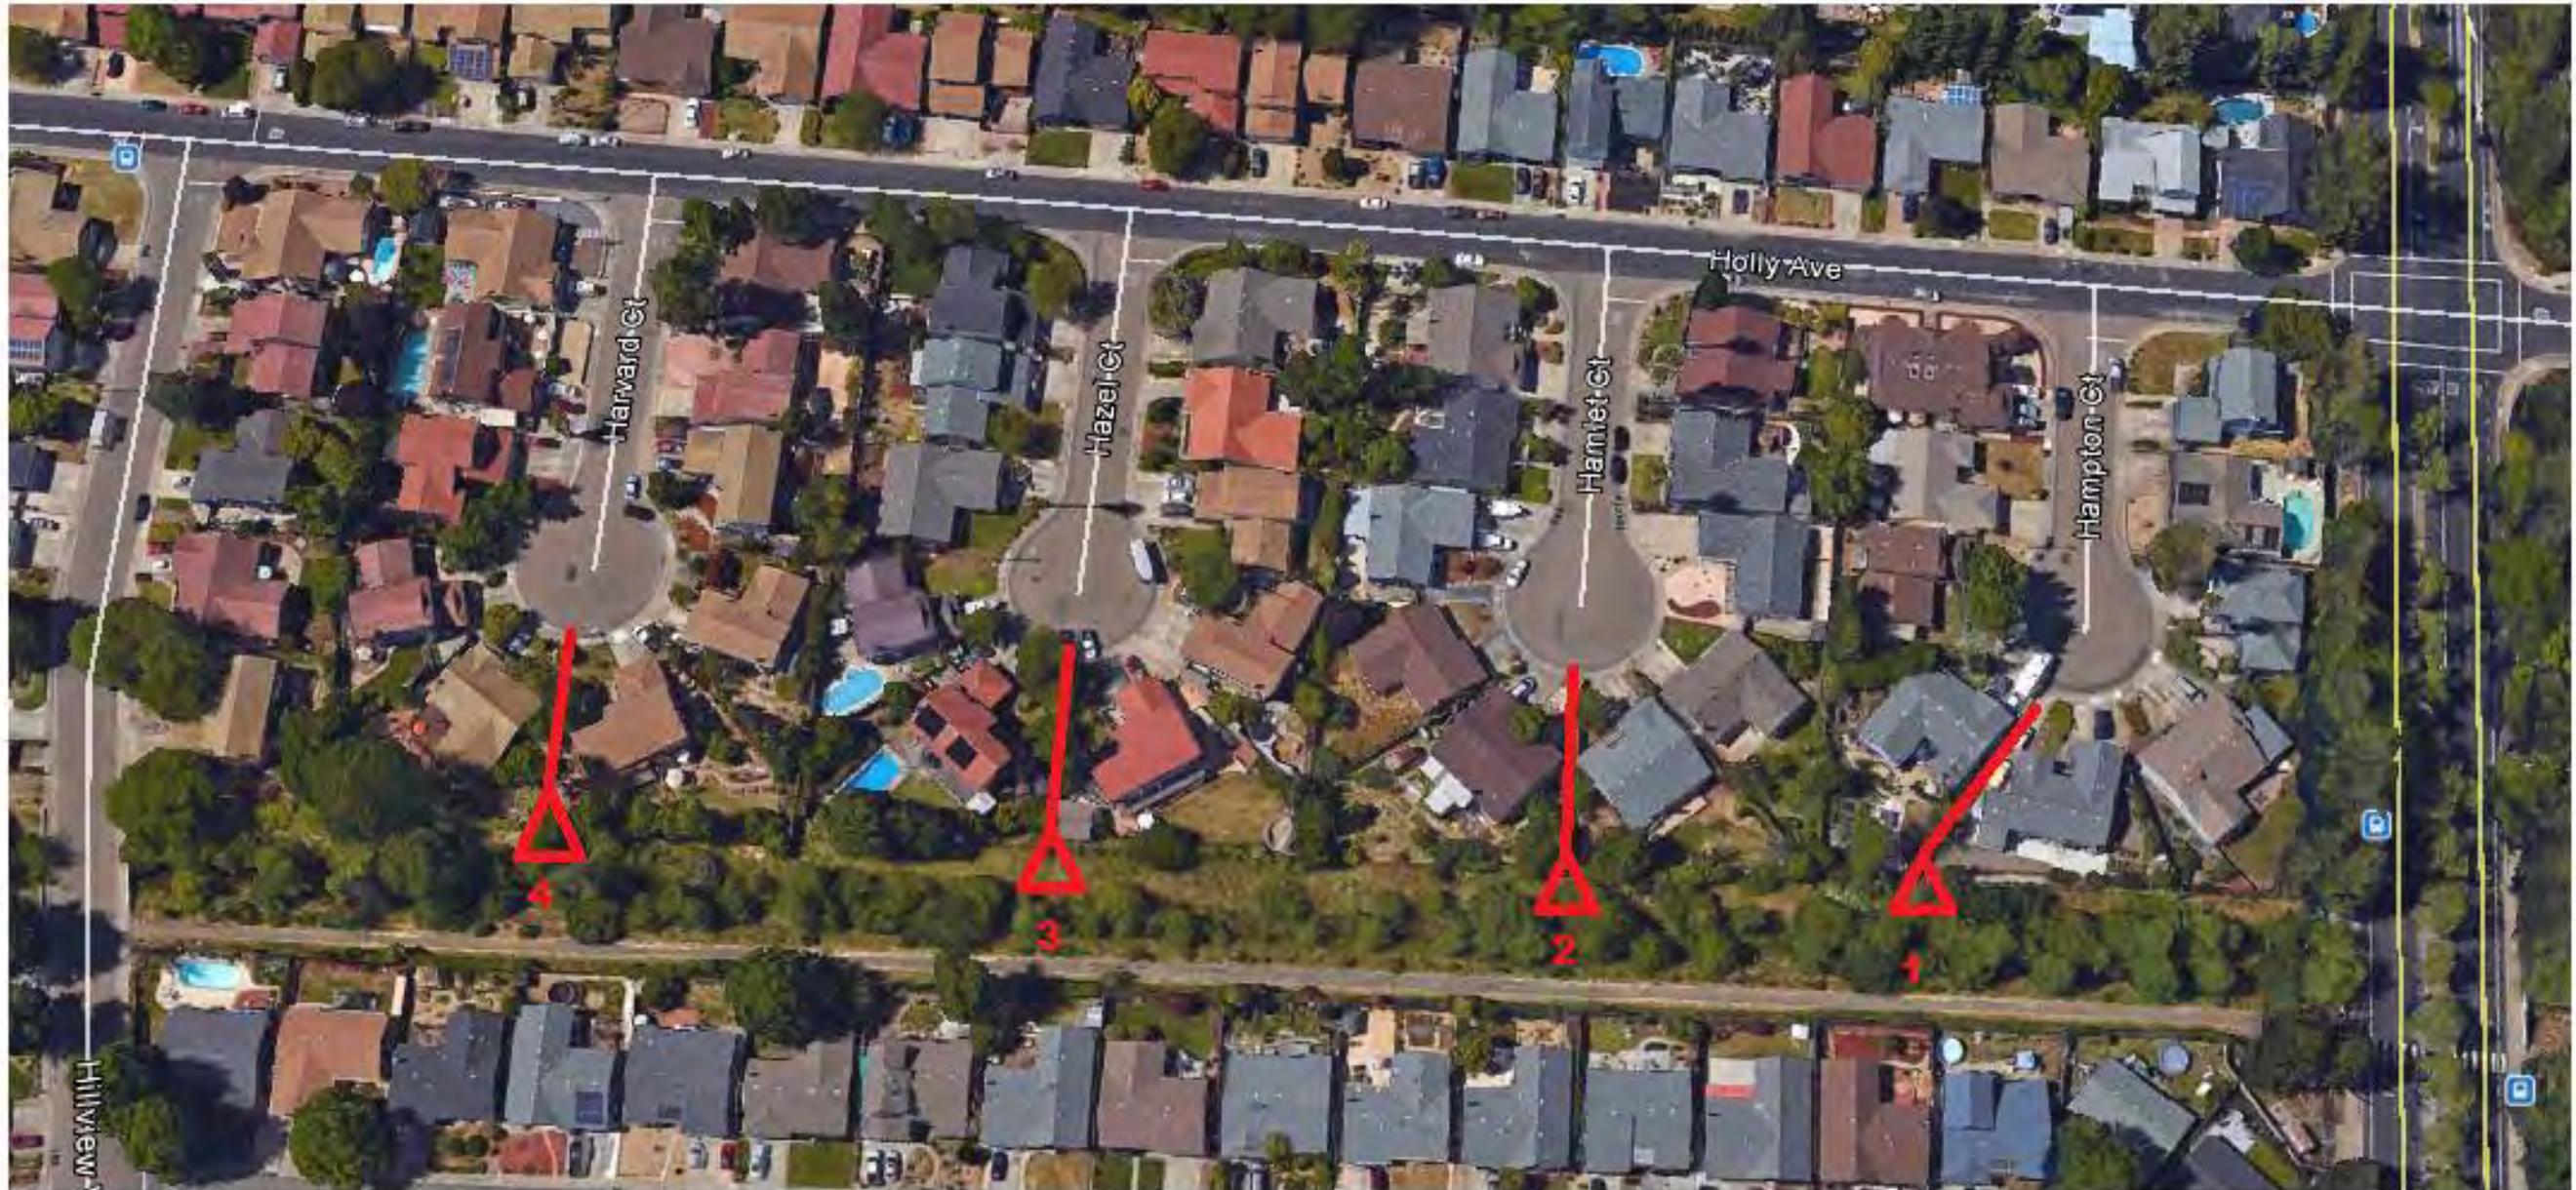
2015 COLEMAN 2 LOCALIZED SCALE CULVERT CLEARING

Total Length: 64 linear feet
Total Area: 140 square feet
 Total Above OHWM: 50 square feet
 Total Disturbed Below OHWM: 90 square feet
Total Sediment To Remove: 300 cubic yards

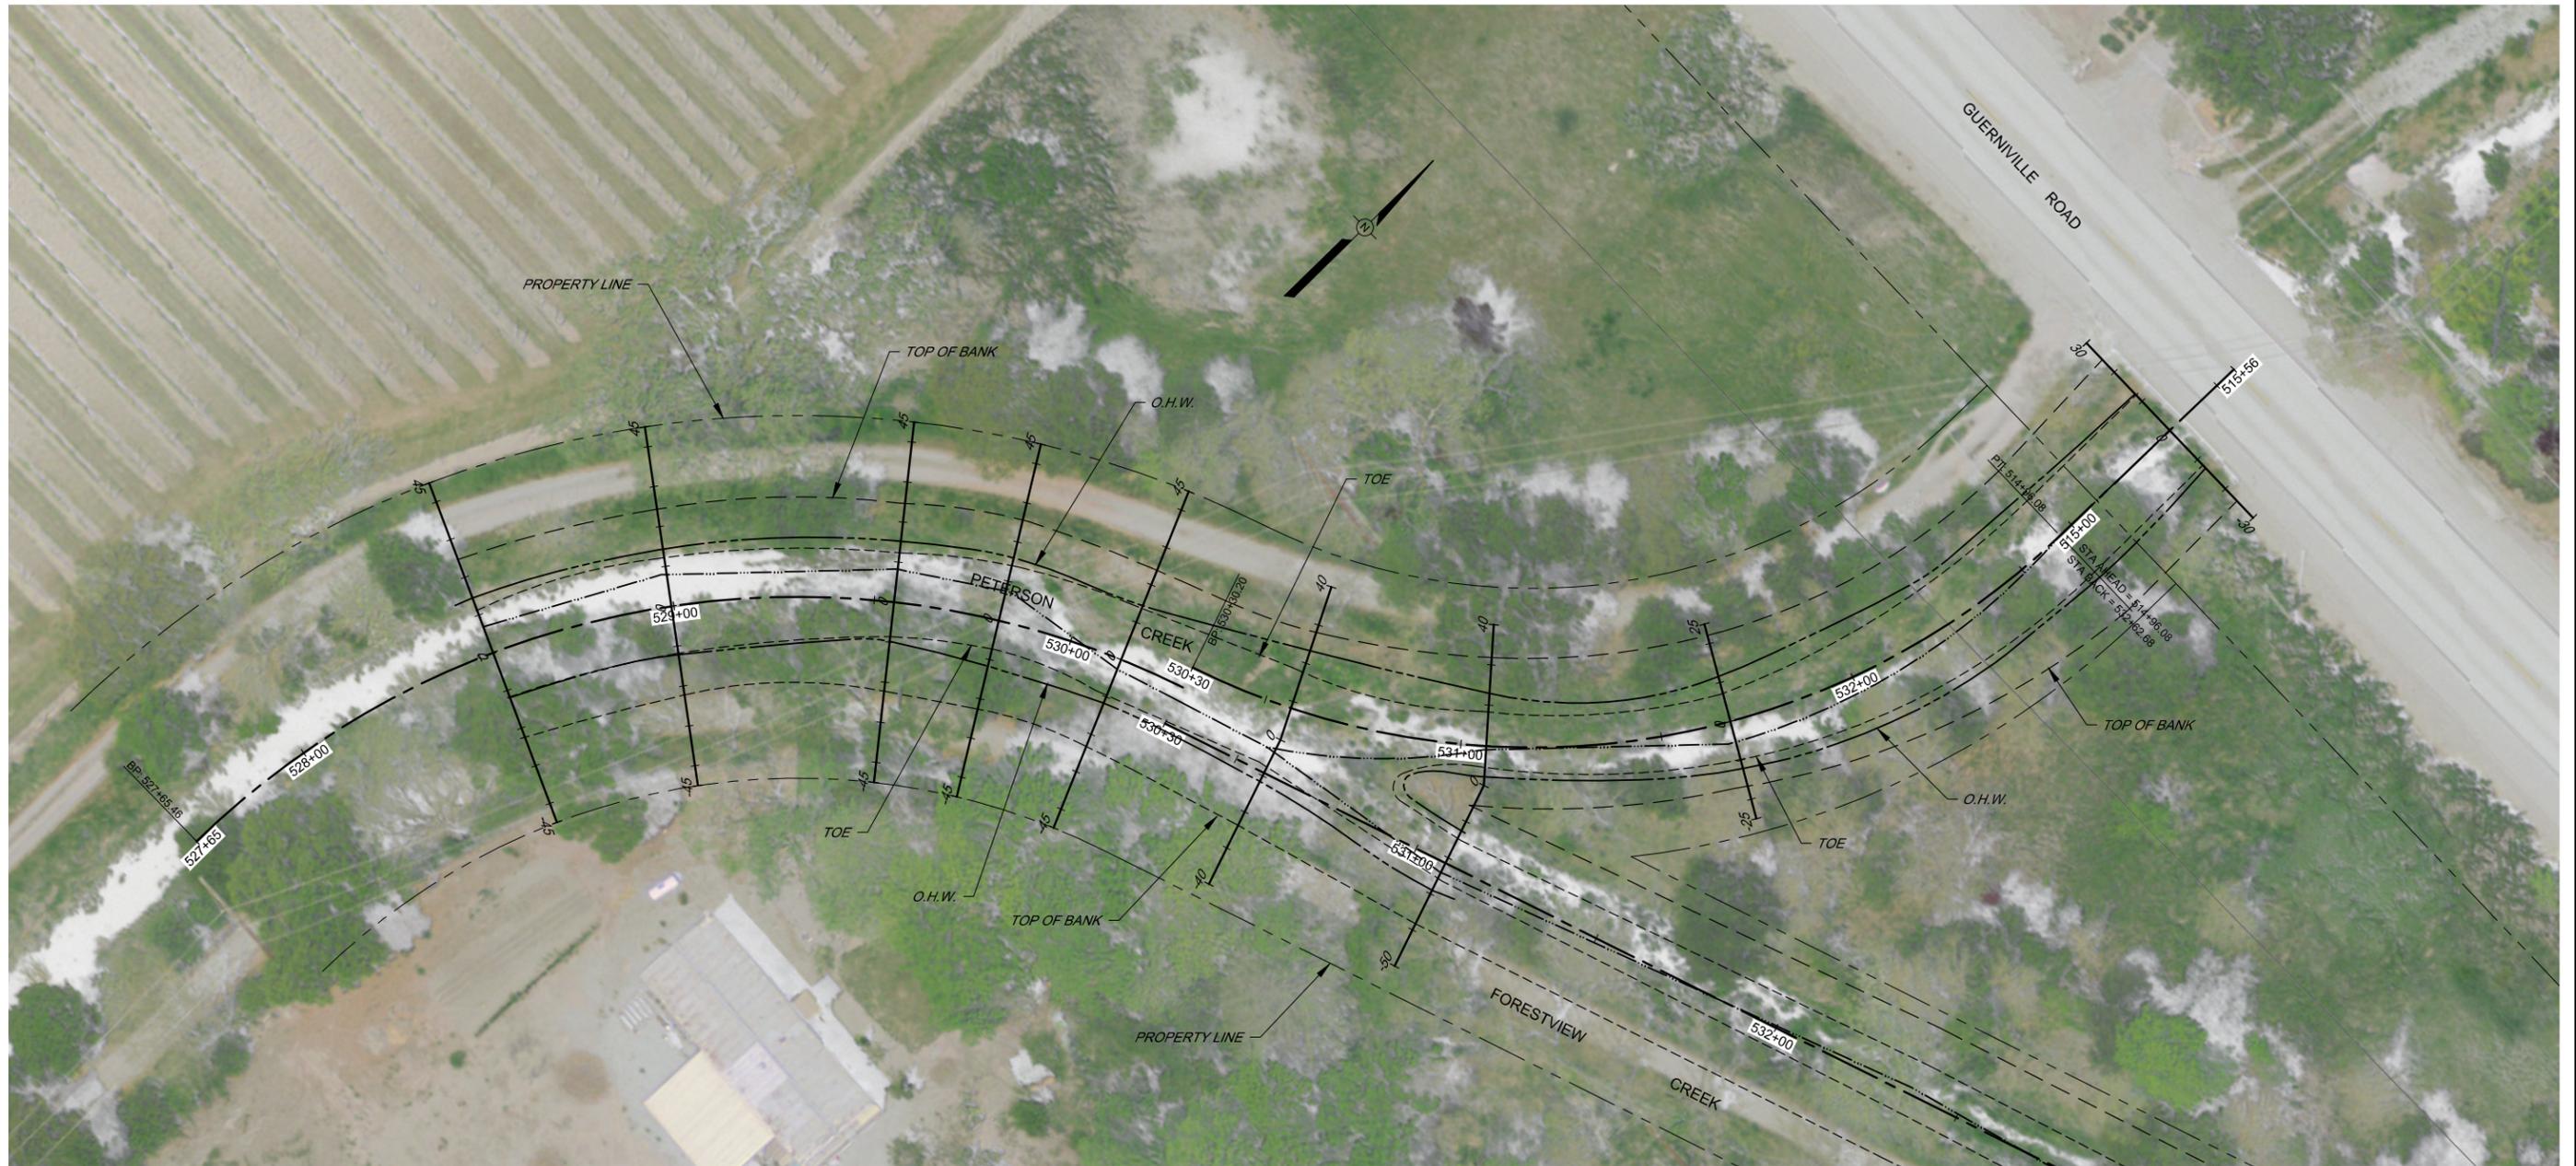
PLAN
SCALE 1" = 40'

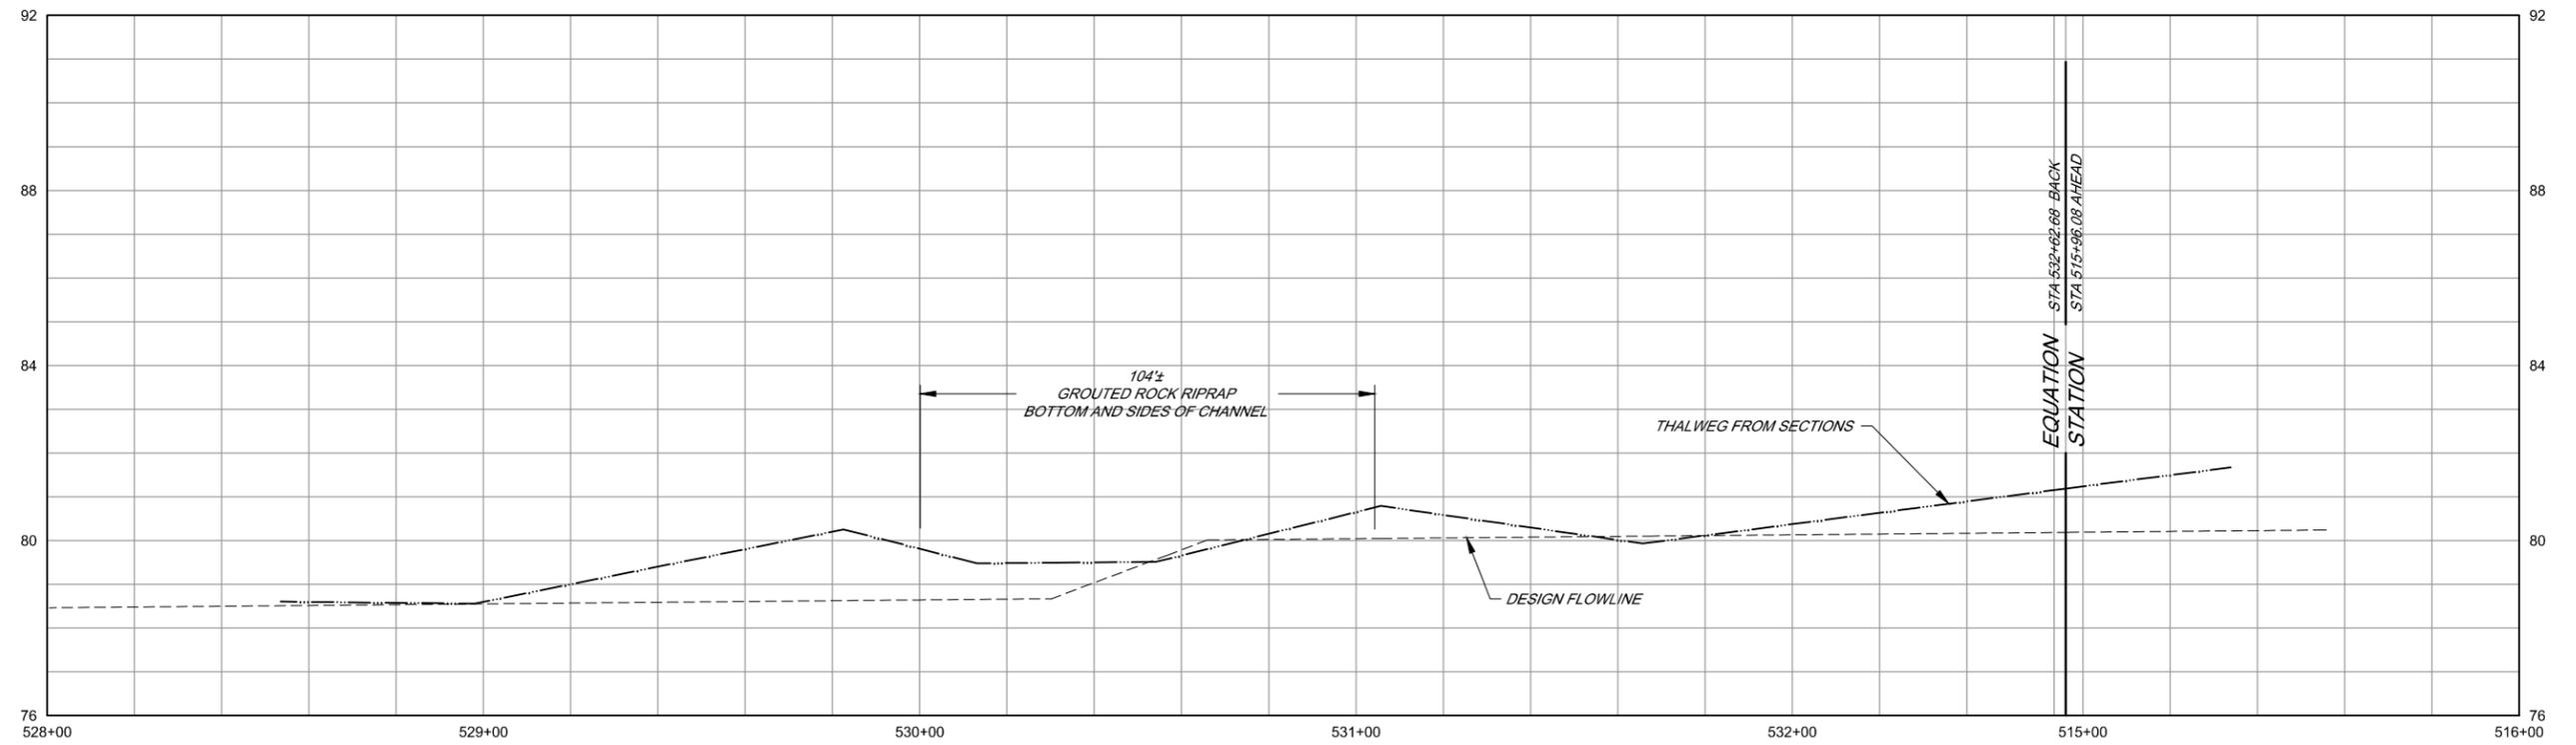
PROFILE - PETERSON CREEK
 SCALE HORIZ 1" = 20'
 VERT 1" = 2'

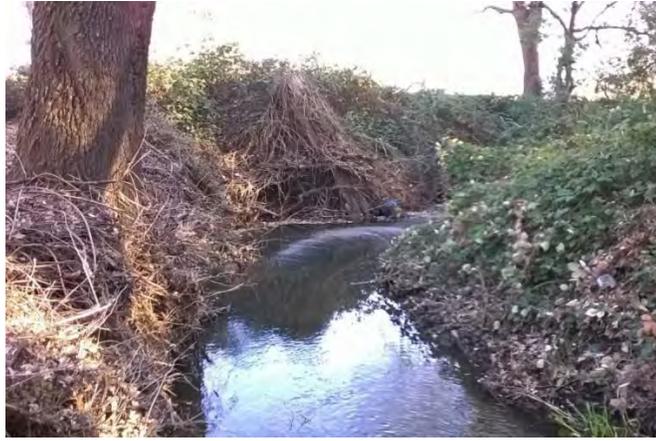
Photo 1: Himalayan blackberry, toe erosion
