Goat Rock State Beach Jetty Study

Chris Delaney
Senior Engineer
cdelaney@scwa.ca.gov

What is the Goat Rock State Beach Jetty?

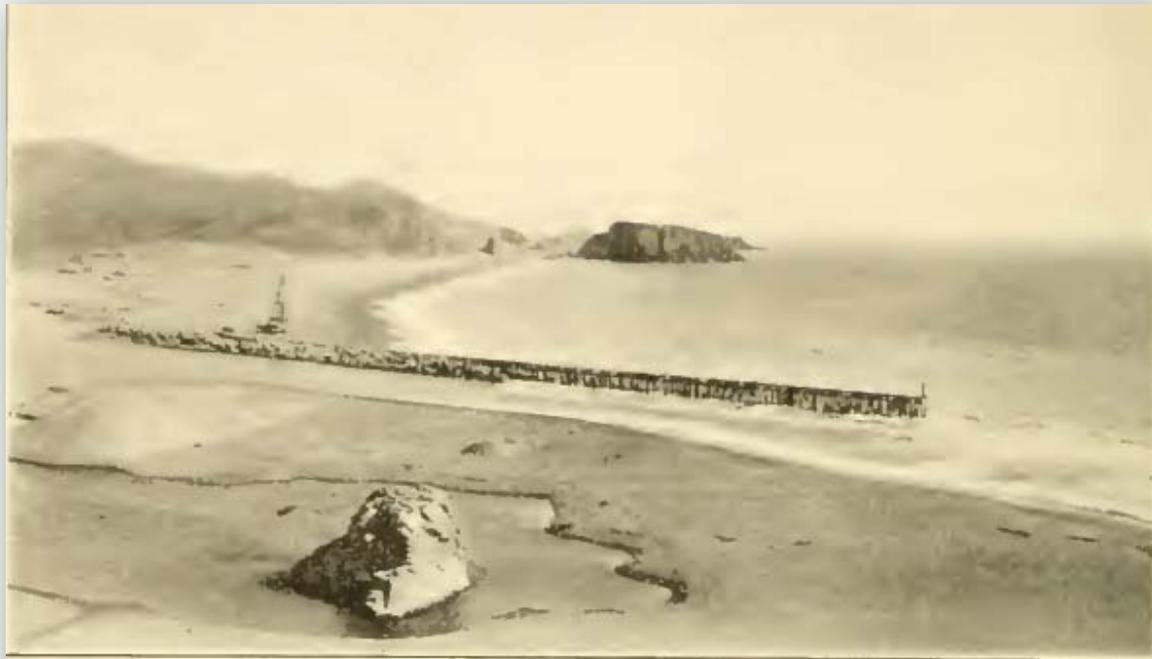
Russian river jetty—August 9, 1930. Looking south from county road, showing entire jetty, railroad and quarry.

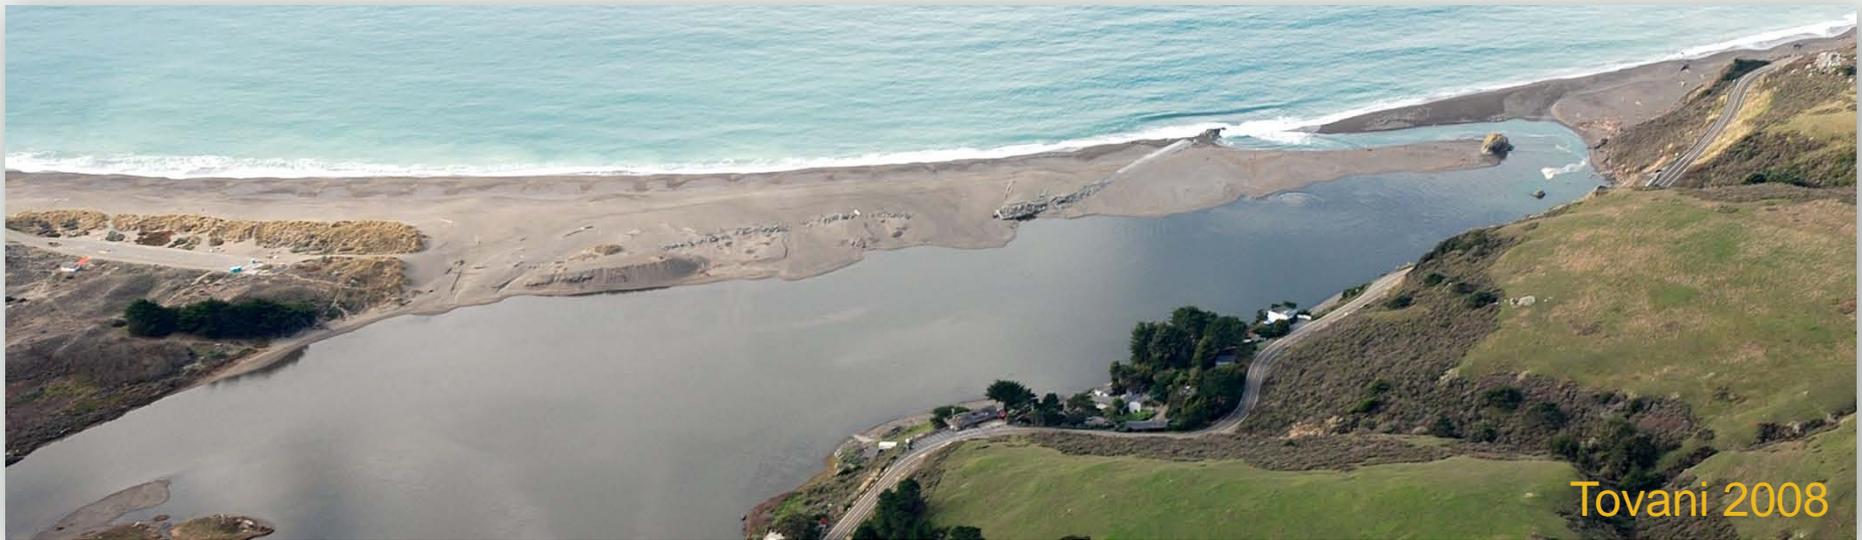
- Constructed 1924-1948
- Maintain open passageway into estuary
 - Facilitate transport of mined gravel
- 1,600 lineal feet

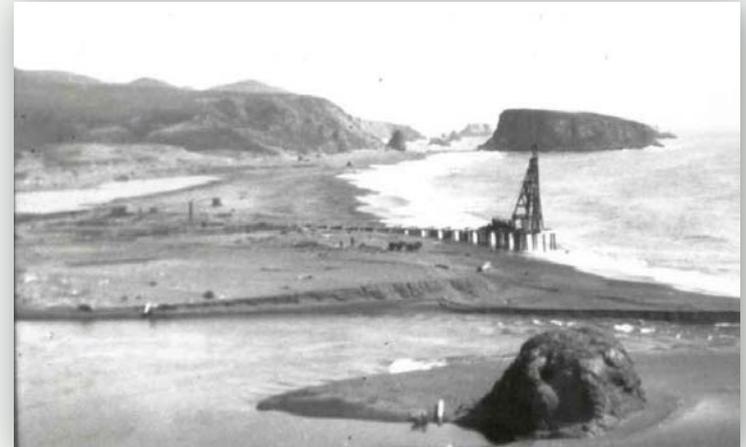
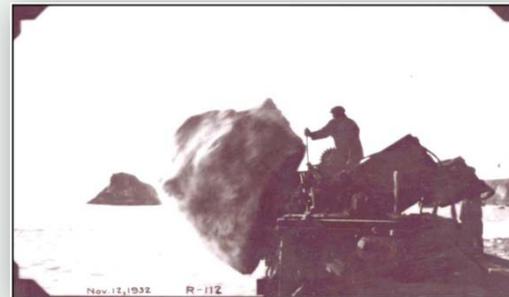
- Limited information on composition
 - Reports
 - Plans
 - Photographs and Aerials
- Two phases of construction
 - 1st Phase: 1924 to 1934
 - 2nd Phase: 1938 to 1948

- **1924-1929:** Quarry, railway constructed. Rock fence constructed to protect railway
- **1930:** Groin constructed
- **1930-1934:** Groin repairs

- **1938-1939:** Seawall and rock fence constructed
- **1940-1941:** Concrete cap placed on groin
- **1948:** Stone armoring added to groin

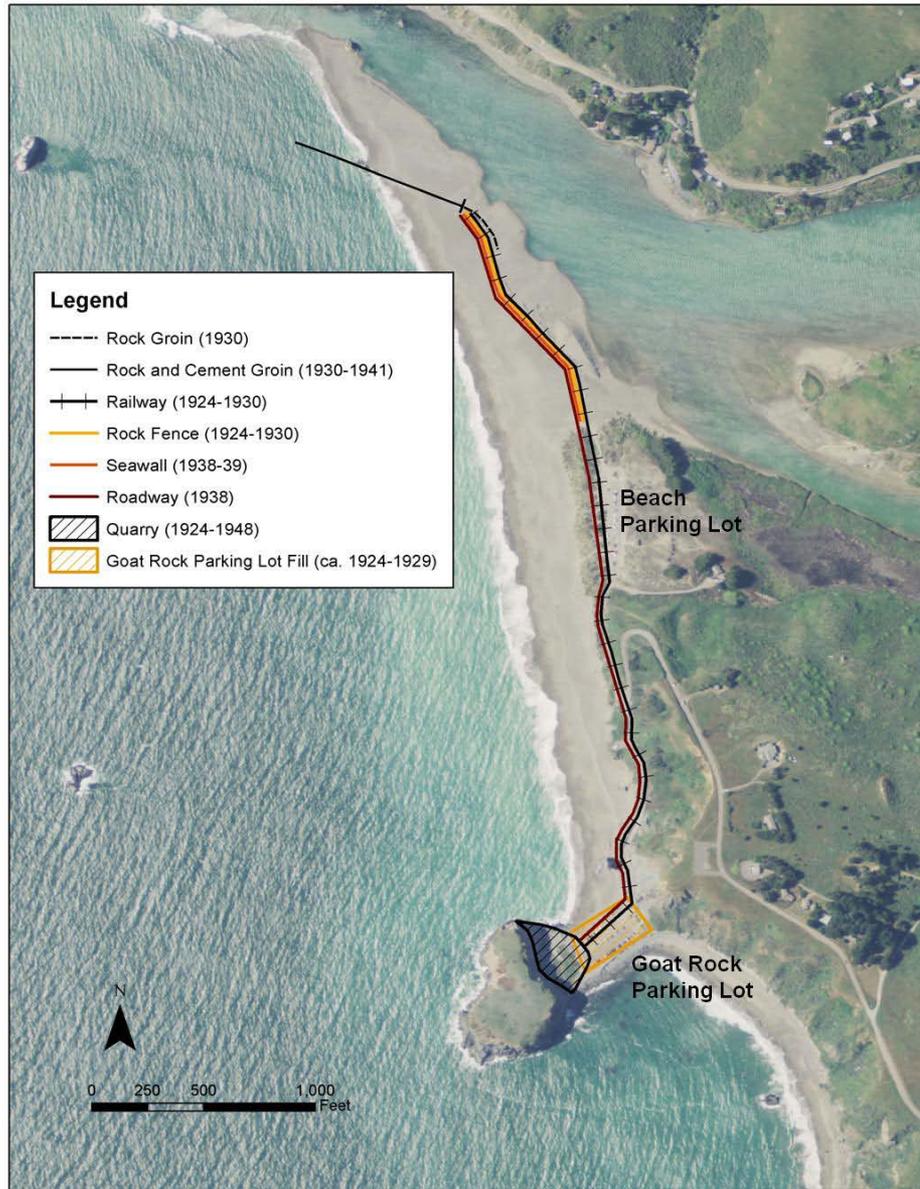
First Phase of Construction

Second Phase of Construction

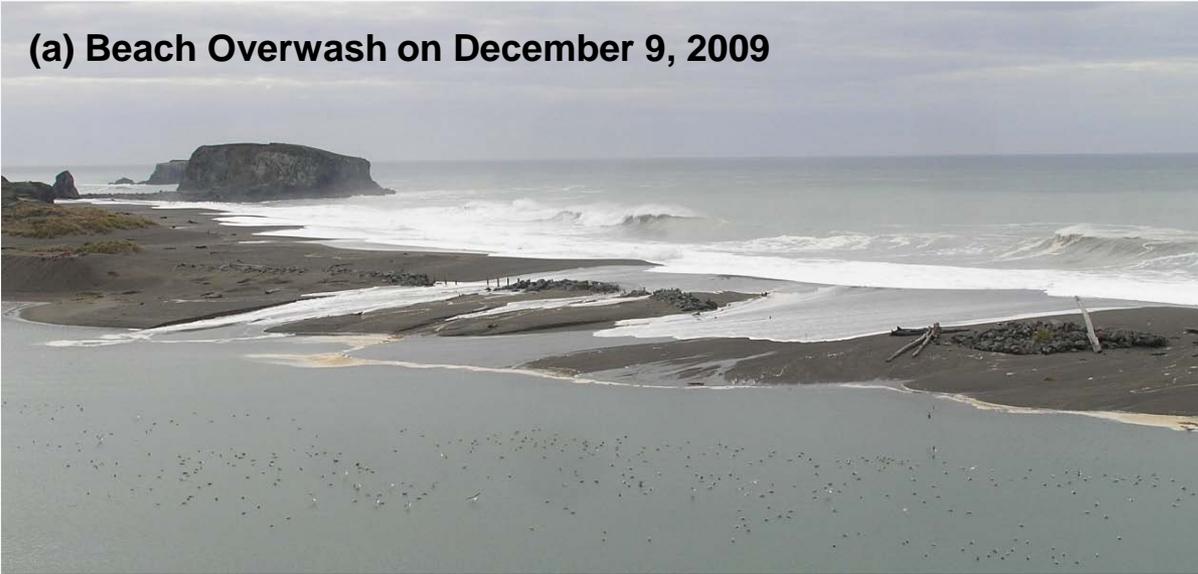
(a) Beach Overwash on December 9, 2009

- How waves affect lagoon conditions
 - Wave overwash = saltwater increase
- Comparison to estuary beaches w/o jetty
 - Gualala River Estuary
 - Navarro River Estuary
- Increase in overwash
 - May to October
 - Steelhead rearing season

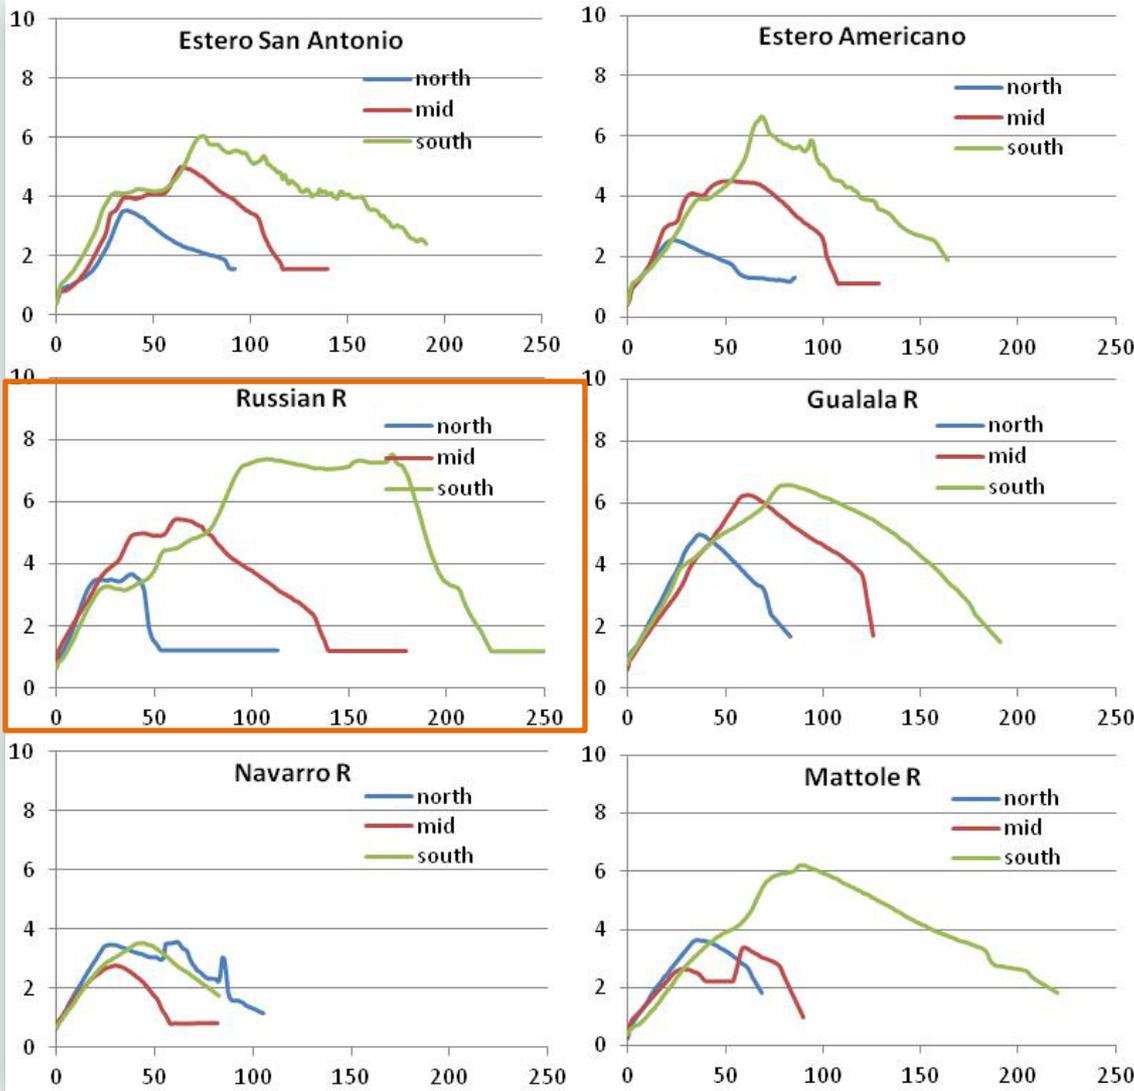
- Findings
 - South of groin, beach is wider and higher than other beaches in area
- Possible Implications
 - Decreased groundwater flow south of groin
 - Reduced wave overtopping south of groin

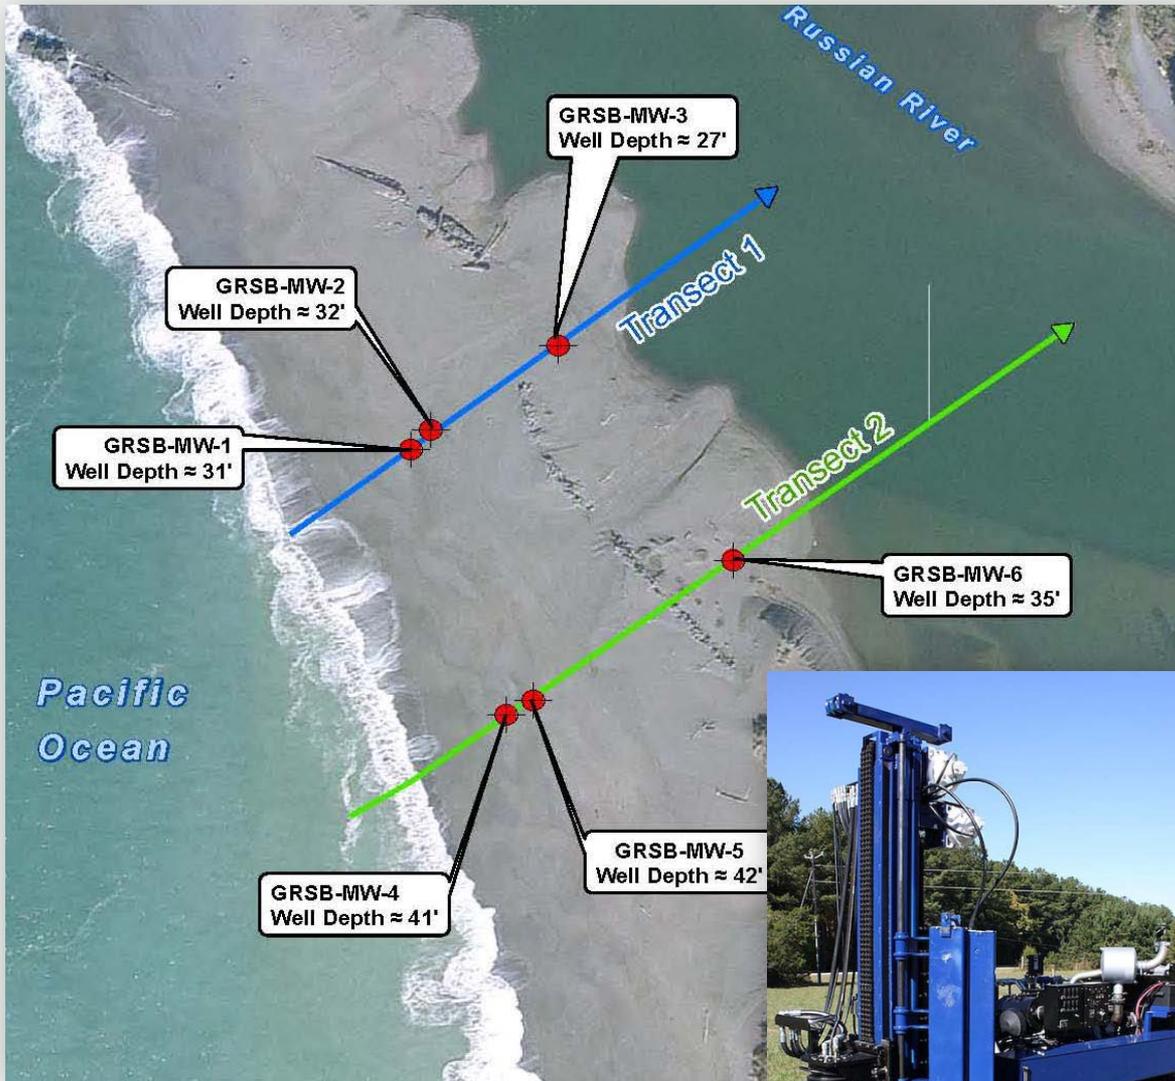
- Why?: Better understand groundwater flow through beach
- How?:
 - Up to 6 monitoring wells
 - 2" well casing
 - Top of well buried in sand
 - Wells to be instrumented
 - Monitored/maintained once per month
 - Public will have access to beach during construction
 - Restricted access in immediate vicinity of well construction
 - 2 to 4 days

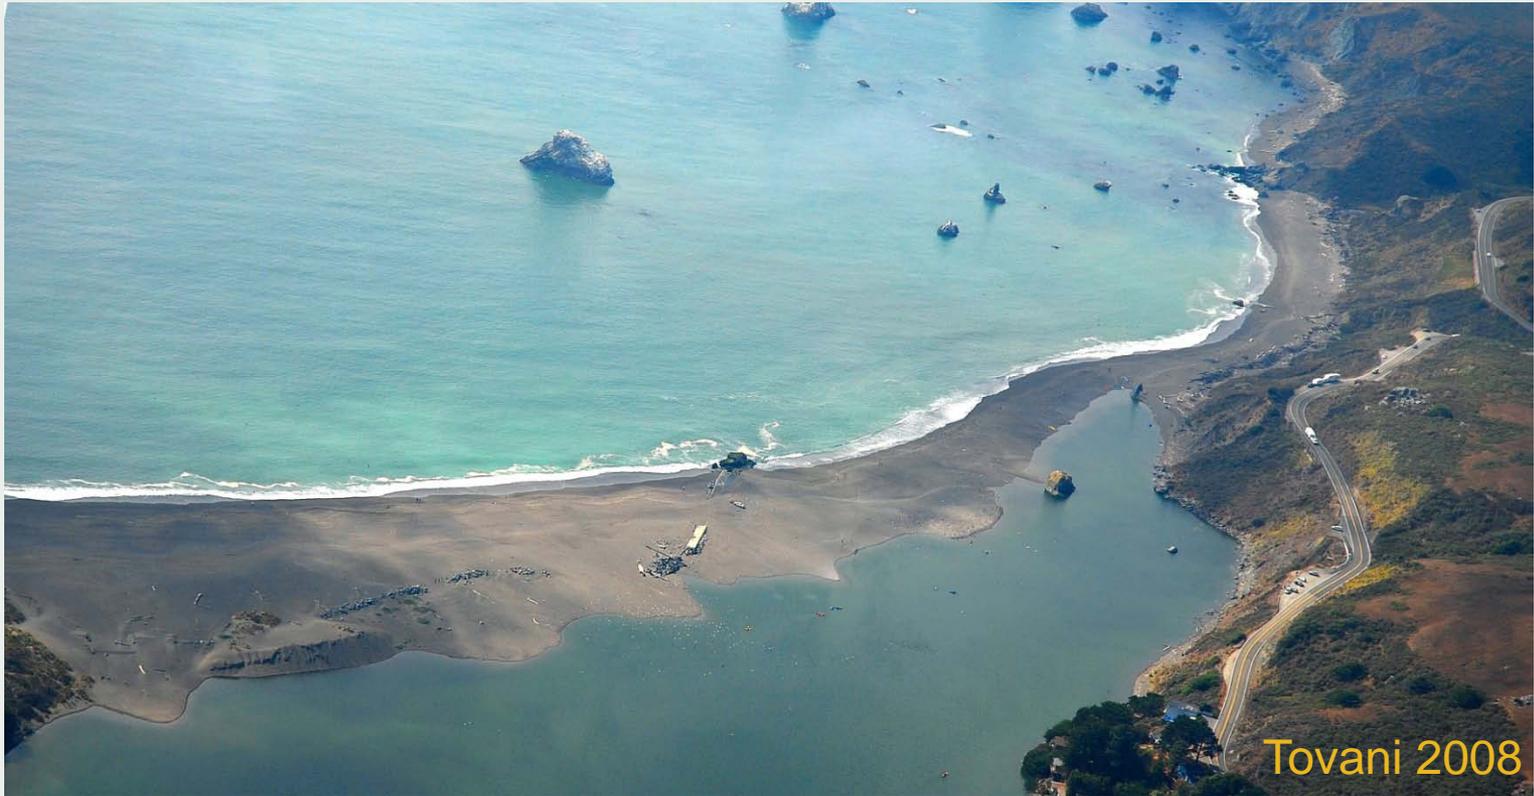
- Why?:
 - Geometry and composition of buried rock jetty
 - Thickness of sand and bedrock
 - Groundwater flow through beach berm

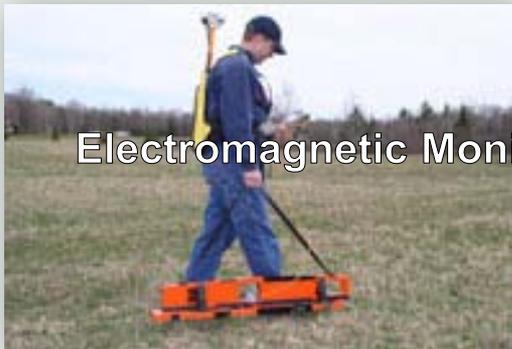
- Seismic Refraction – up to twice
- Electrical Resistance Tomography - once
- Ground Penetrating Radar - once
- Electromagnetic Monitoring – up to 10
- No permanent installation of equipment
- Public will have access to beach
- Restricted access in immediate vicinity of survey activity
- 1 to 2 days per survey
- Researchers:
 - Lawrence Berkeley National Lab
 - NorCal Geophysical

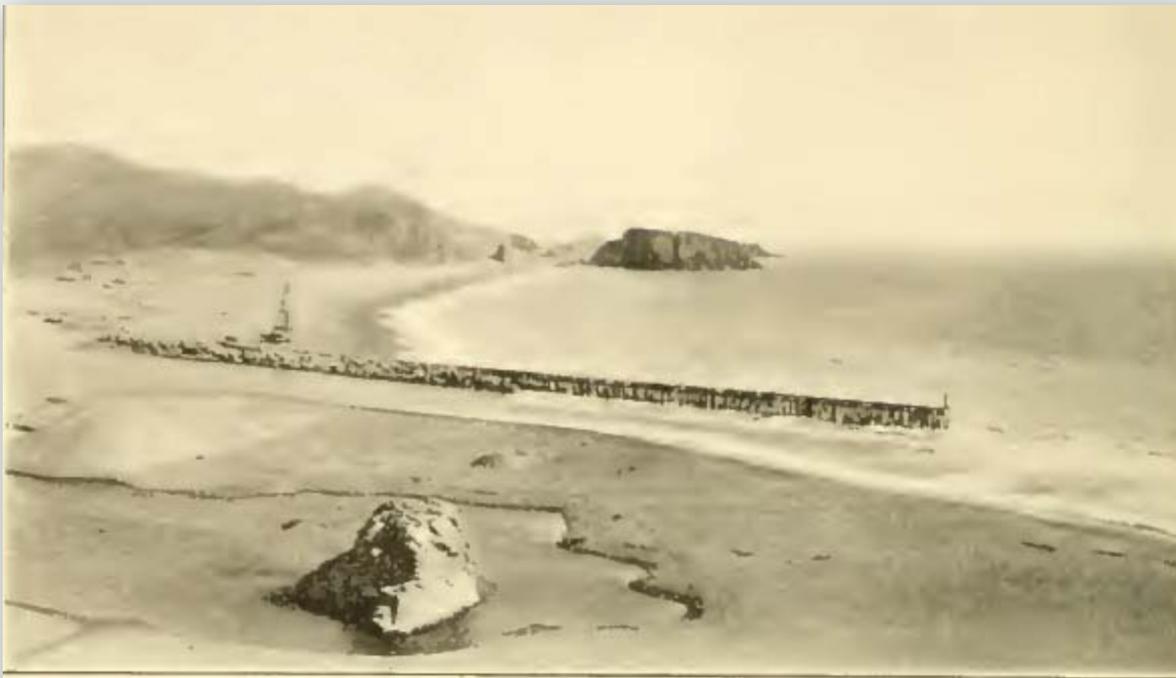
Russian river jetty—August 9, 1930. Looking south from county road, showing entire jetty, railroad and quarry.
