RESULTS OF THE FISHERIES MONITORING PLAN TO MEET STATE WATER RESOURCES CONTROL BOARD ORDER WR 2009 – 0034 EXEC

December 9, 2009

Sonoma County Water Agency
P. O. Box 11628
Santa Rosa, CA 95406

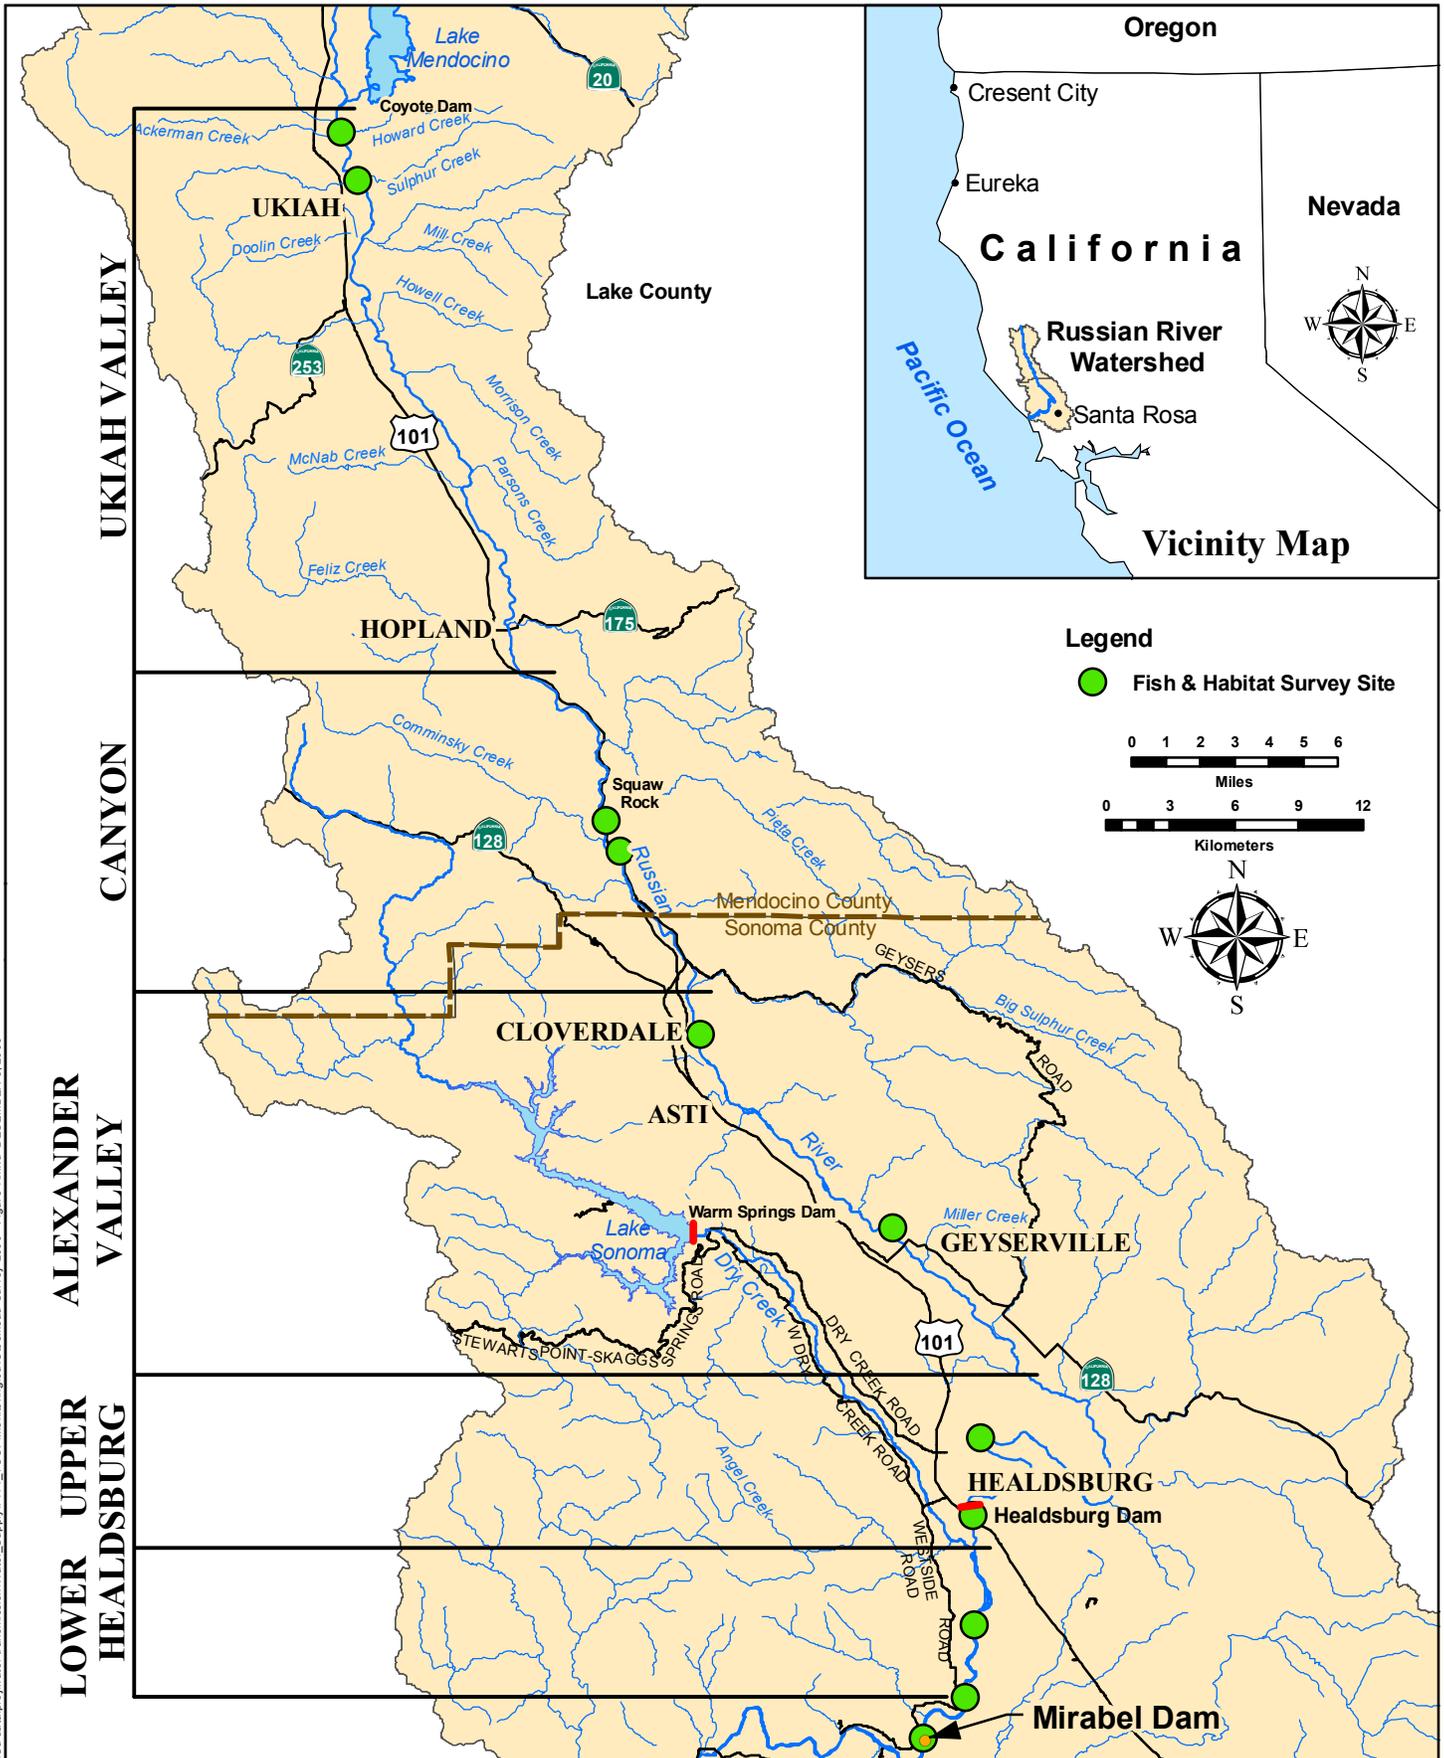
Figure 1

Fish and Habitat Monitoring Locations

Species of concern during the period of reduced flow include rearing juvenile steelhead in the upper Russian River (primarily above Cloverdale), and native species such as Sacramento sucker, Sacramento pikeminnow, and Russian River tule perch. Juvenile salmonids emigrate to the ocean from approximately March through June (primarily mid-April through mid-May). Adult Chinook salmon are the earliest returning salmonids, migrating from approximately September through December, and may also have been affected by the reduction in flow. Reduced summer flows may impact fish through altering physical habitat. Reduced flows were anticipated to result in a reduction in stream width, depth, cross sectional area, and velocity. We sought to document changes to physical habitat and fish habitat use in five reaches of the mainstem Russian River between Ukiah and the upstream end of the Wohler Pool. Habitat sampling locations overlapped spatially with fish monitoring sites (Figure 1).

Physical measurements were collected in seven reaches along the Russian River between the City of Ukiah and the Wohler Pool (Figure 1). At these seven reaches, a total of 63 habitat units were measured, including 204 transects (82 pools, 59 riffles, and 63 flatwaters). Although each transect was marked with flagging and GPS coordinates were recorded for each transect, in some cases individual transects could not be relocated exactly (or the channel configuration had changed substantially between surveys). As a conservative approach, we excluded transects where the Pre and Post flow reduction contour data did not follow the same general pattern. In all, we excluded 25 transects. The analysis used for this report includes data for 179 individual transects (73 pools, 49 riffles, and 57 flatwaters habitats). Graphs of cross sectional areas for each transect analyzed are presented in Appendices A-G. Measured widths, depths, and cross sectional areas for each transect are presented in Appendix H. Appendix I lists transects excluded from the analysis (however, graphs of all transects are included in the appropriate appendices). Photographs were taken at all transect stations during Pre- and Post flow reduction surveys and are available on CD.

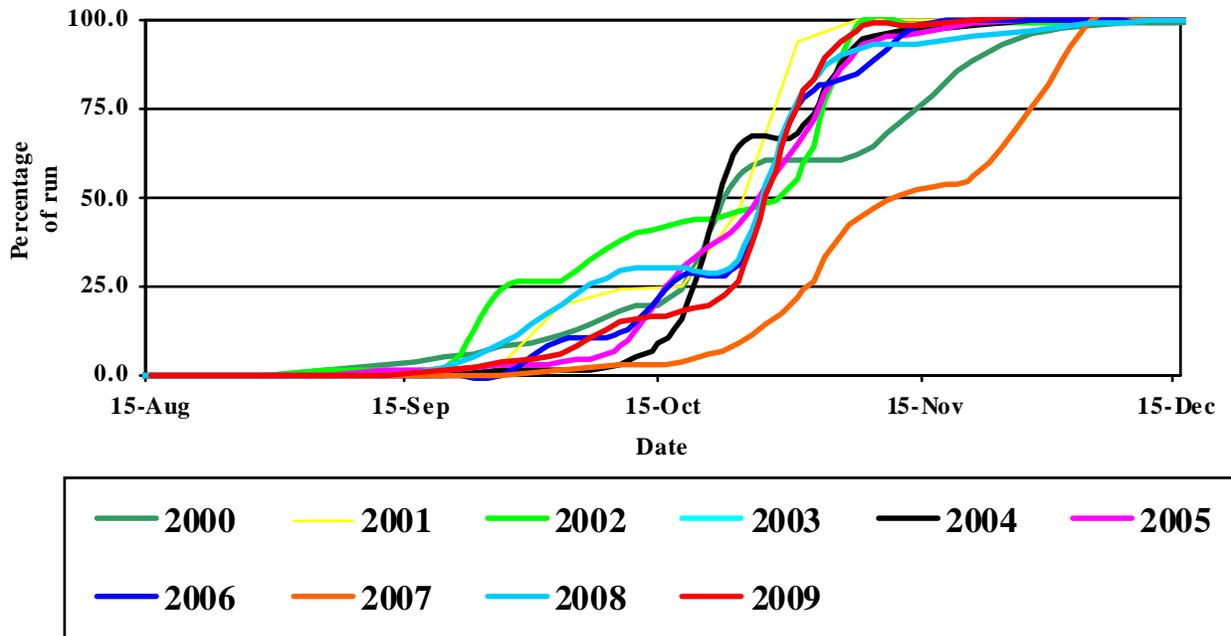
Figure 2. Cumulative proportion of Chinook salmon that passed Mirabel Inflatable Dam from 2000 to 2009.

Figure 2. Cumulative proportion of Chinook salmon that passed Mirabel Inflatable Dam from 2000 to 2009.....19

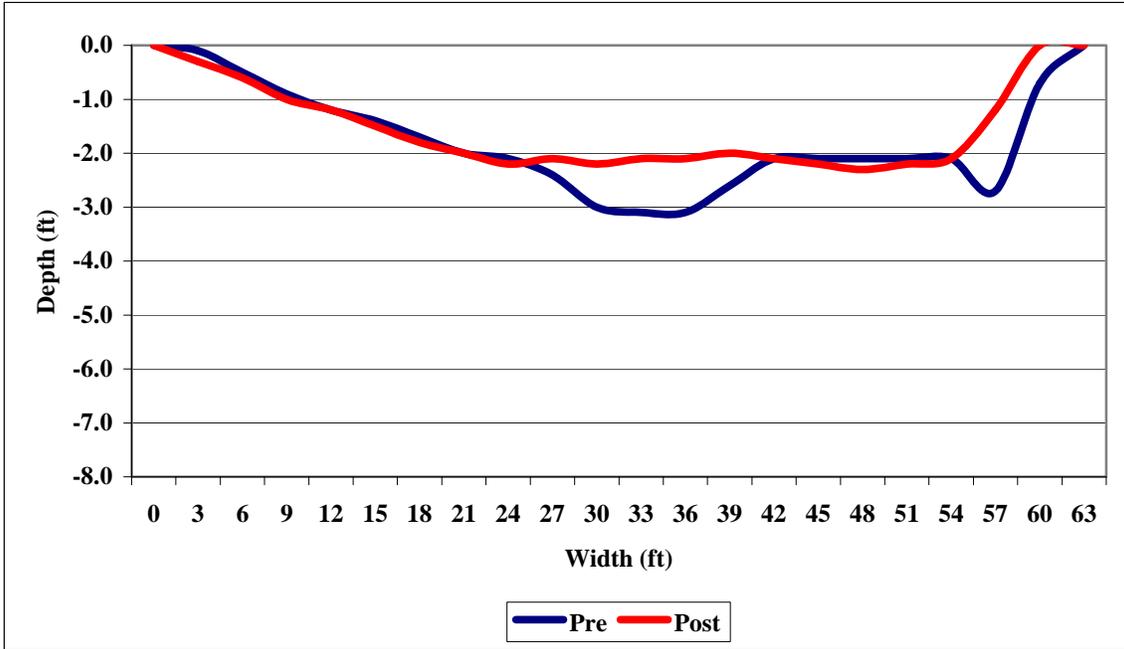
Appendix A-1. Pre and Post cross sections at Pool 1 Transect 1 – Ukiah Reach

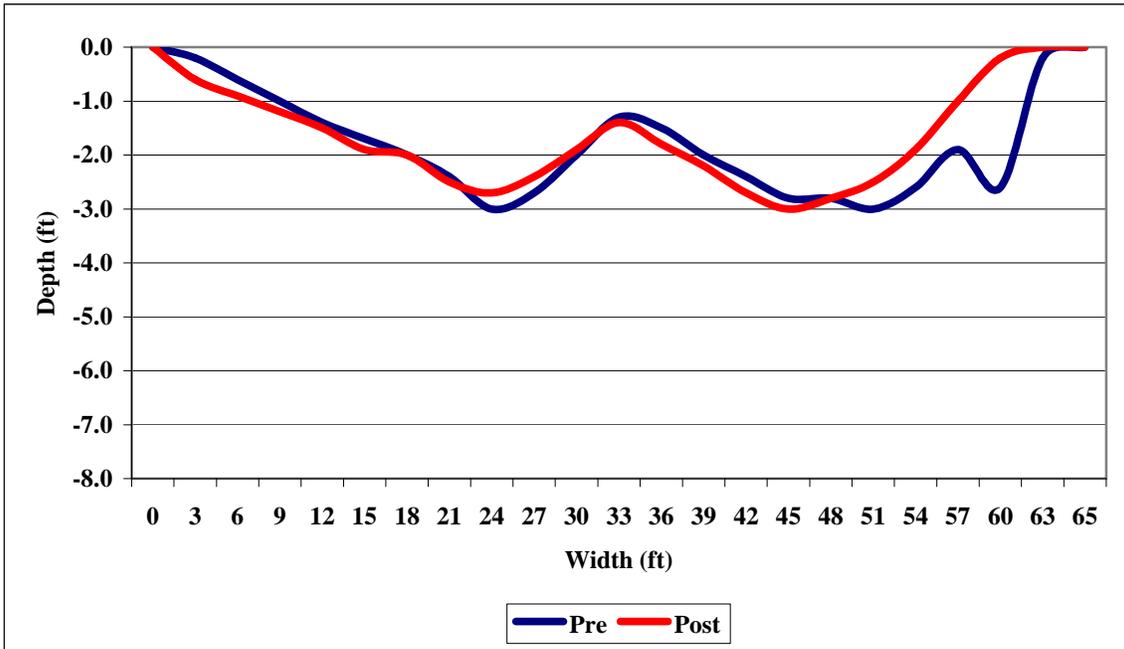
Appendix A-2. Pre and Post cross sections at Pool 1 Transect 2 – Ukiah Reach

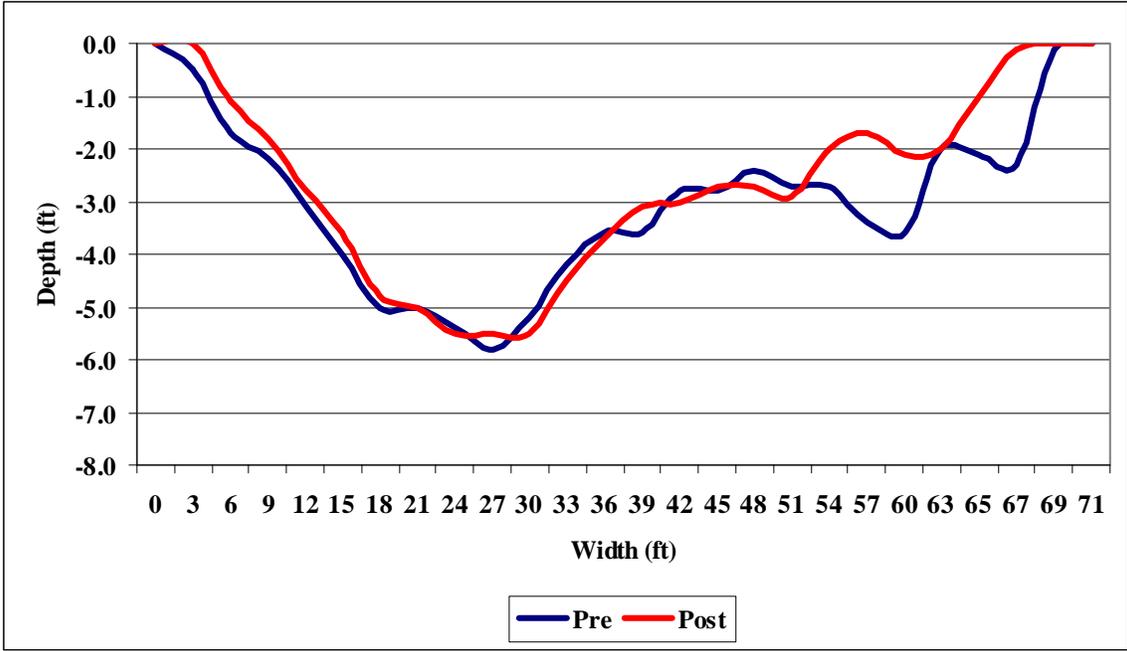
Appendix A-3. Pre and Post cross sections at Pool 1 Transect 3 – Ukiah Reach

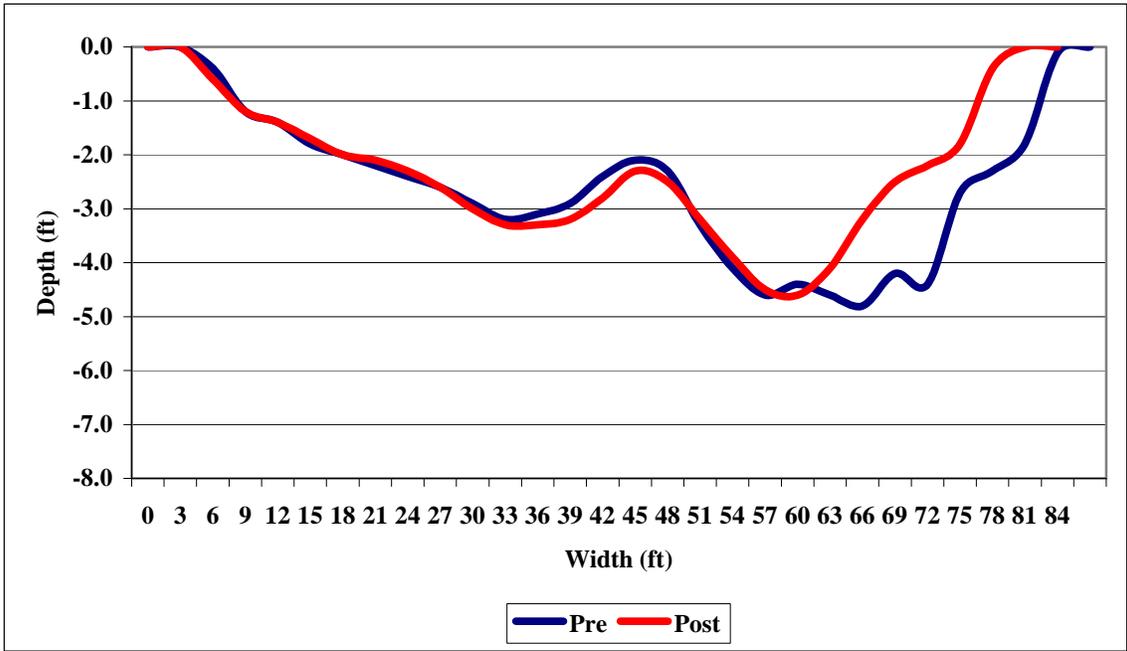
Appendix A-4. Pre and Post cross sections at Pool 1 Transect 4 – Ukiah Reach

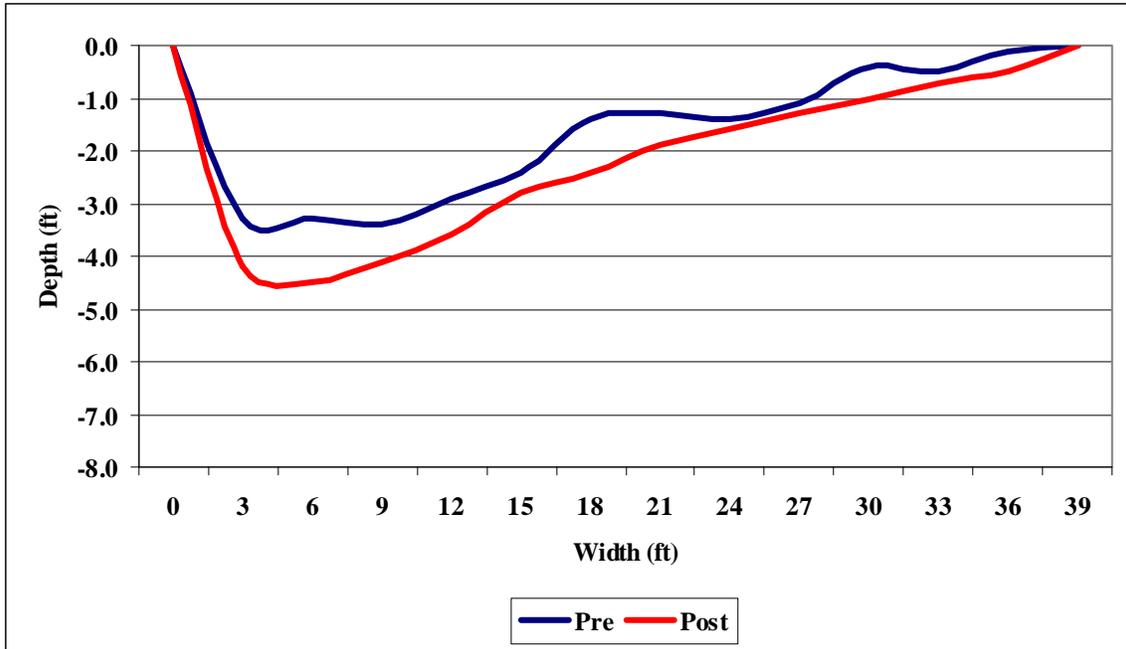
Appendix A-5. Pre and Post cross sections at Pool 2 Transect 1 – Ukiah Reach

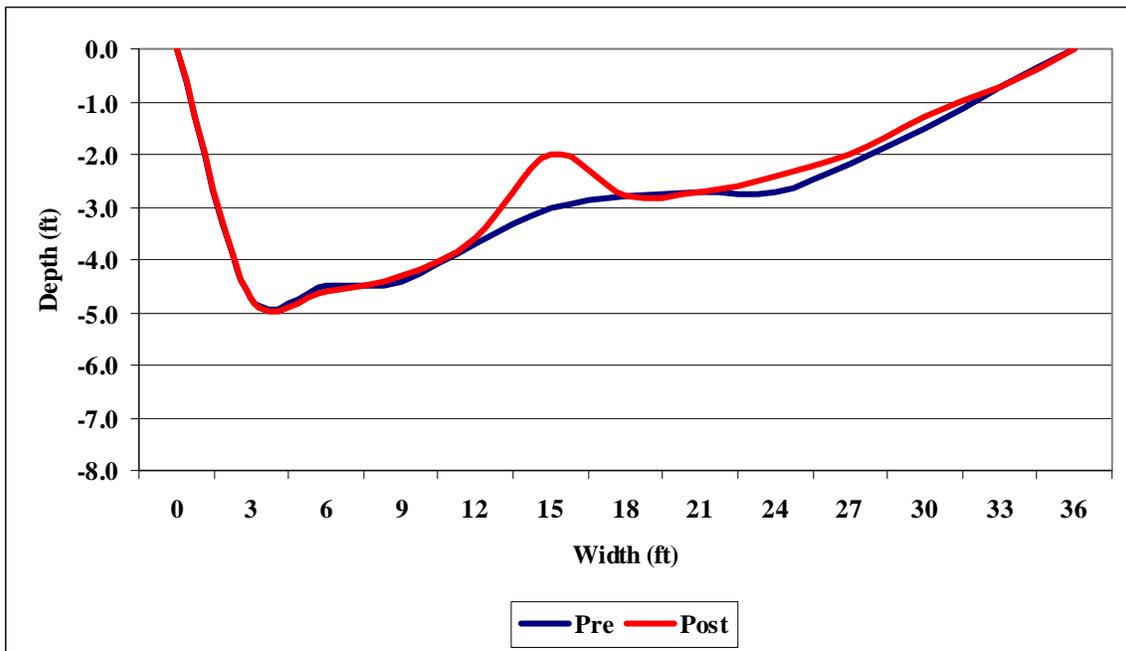
Appendix A-6. Pre and Post cross sections at Pool 2 Transect 2 – Ukiah Reach

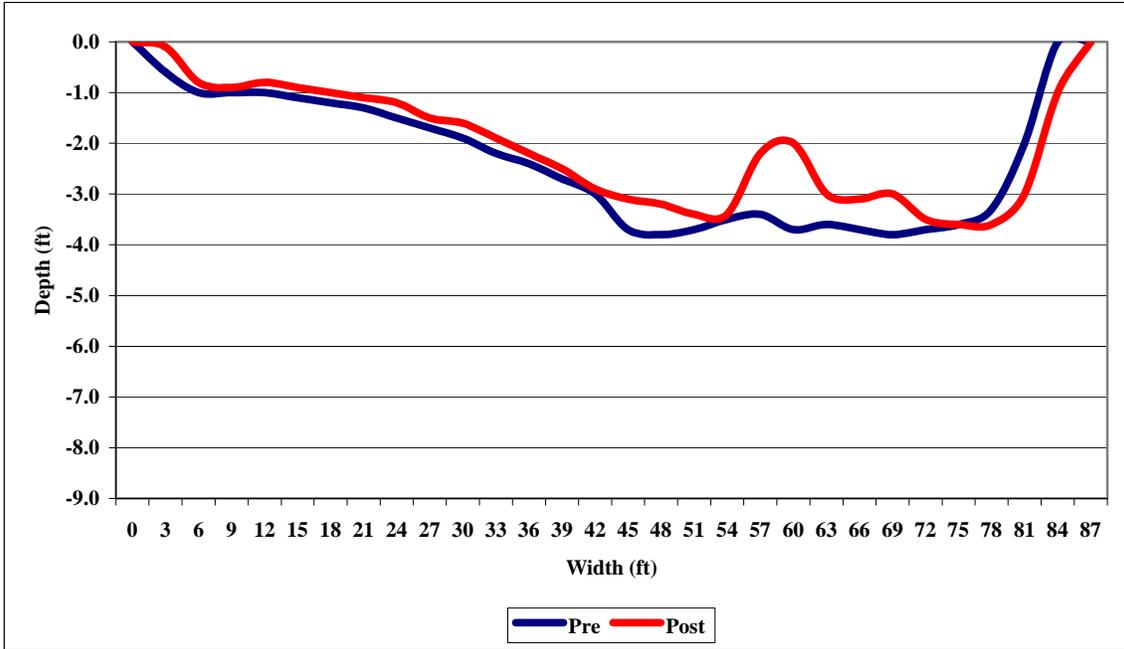
Appendix B-1. Pre and Post cross sections at Pool 1 Transect 1 – Comminsky Station Reach

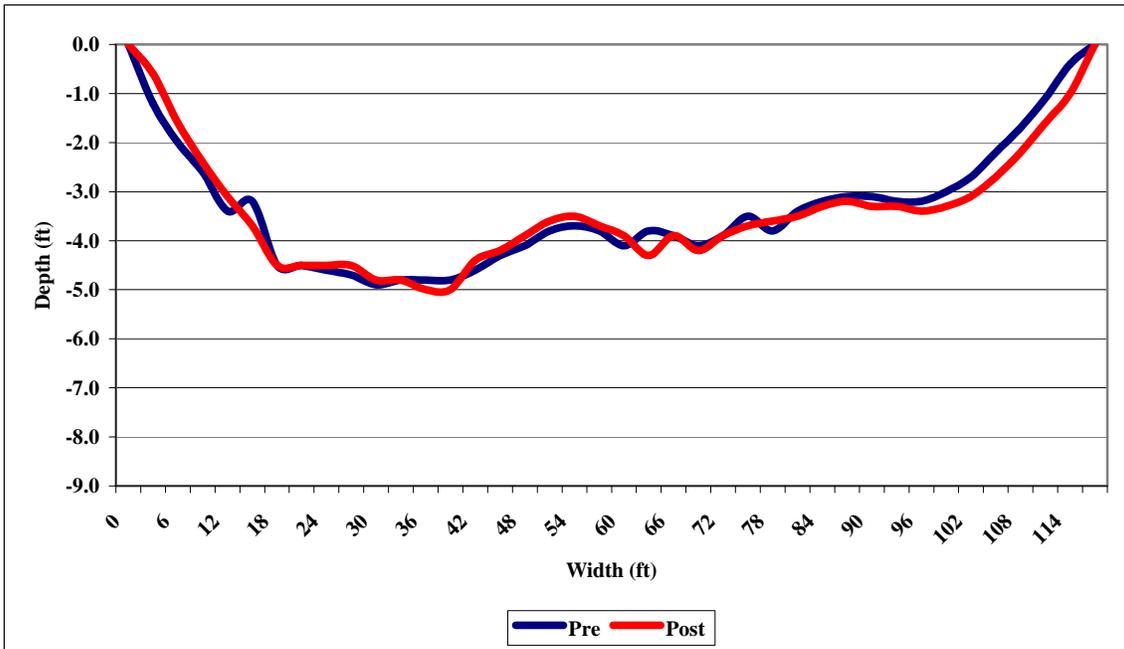
Appendix B2. Pre and Post cross sections at Pool 1 Transect 2 – Comminsky Station Reach

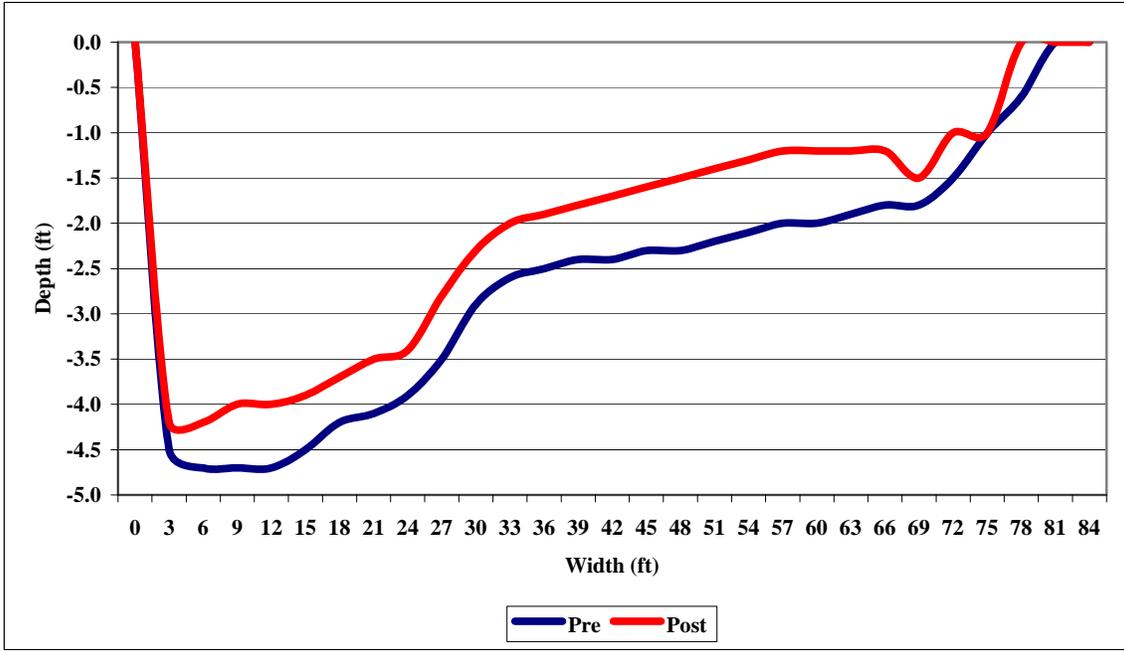
Appendix F-1. Pre and Post cross sections at Pool 1 Transect 1 – Healdsburg Reach

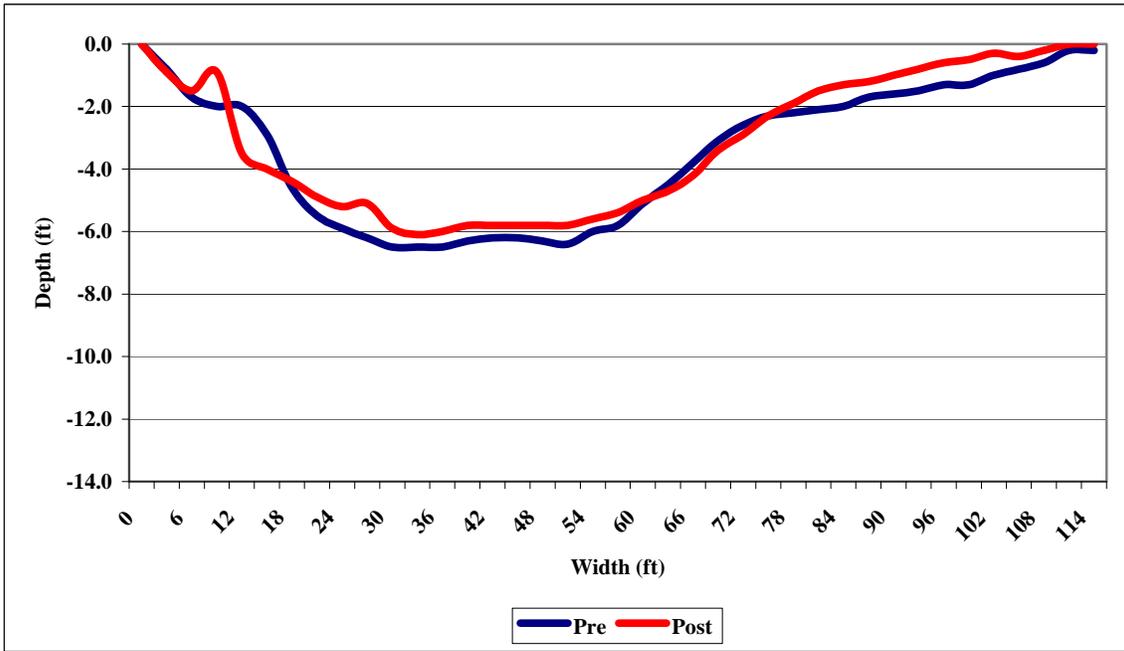
Appendix F-2. Pre and Post cross sections at Pool 1 Transect 2 – Healdsburg Reach

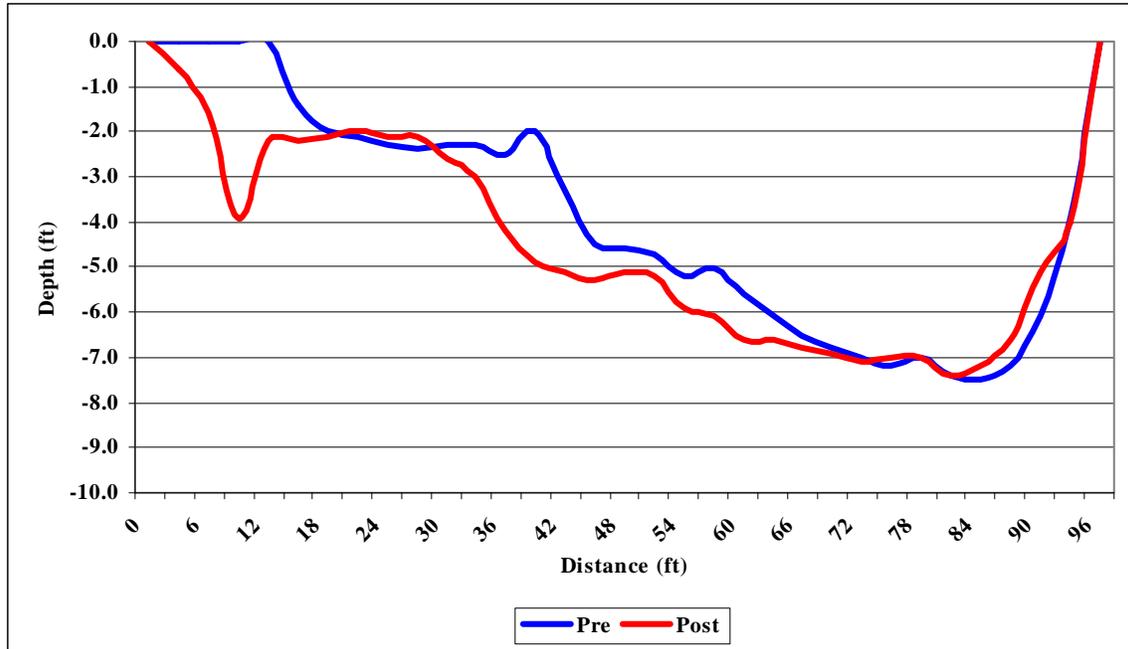
Appendix G-9. Pre and Post cross sections at Pool 3 Transect 2 – Below Dry Creek Reach

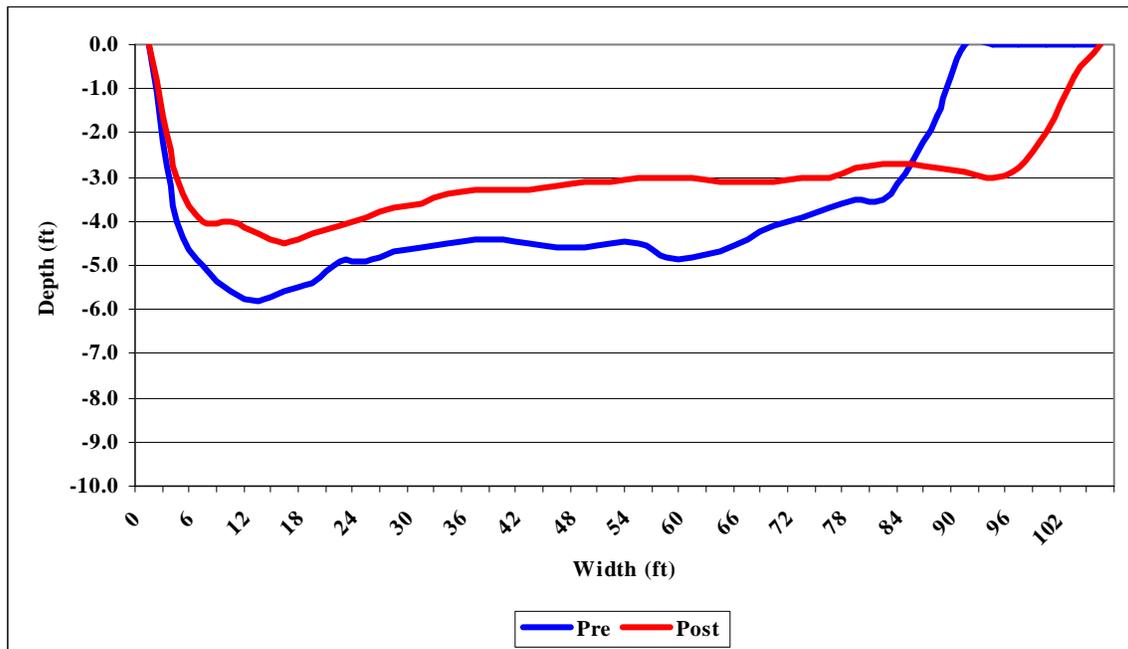
Appendix G-10. Pre and Post cross sections at Pool 3 Transect 3 – Below Dry Creek Reach
