Sonoma County Water Agency
Stream Maintenance Program (SMP)
**Annual Notification for
2010 Maintenance Projects**

Prepared for:
The SMP Inter-Agency Working Group

April 28, 2010

Sonoma County Water Agency Stream Maintenance Program 2010 Projects

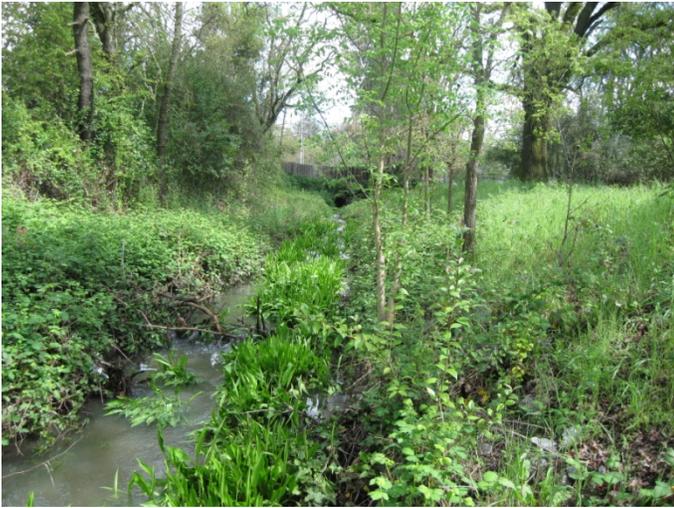
Photo 1: Ducker 2
Sediment removal near Middle Rincon Road
Taken April 22, 2010

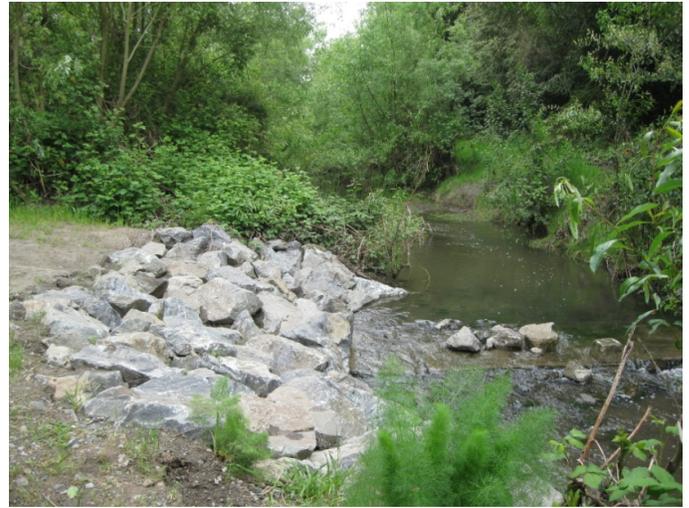
Photo 2: Hinebaugh Creek
Sediment removal near Dawn Court
Taken April 22, 2010

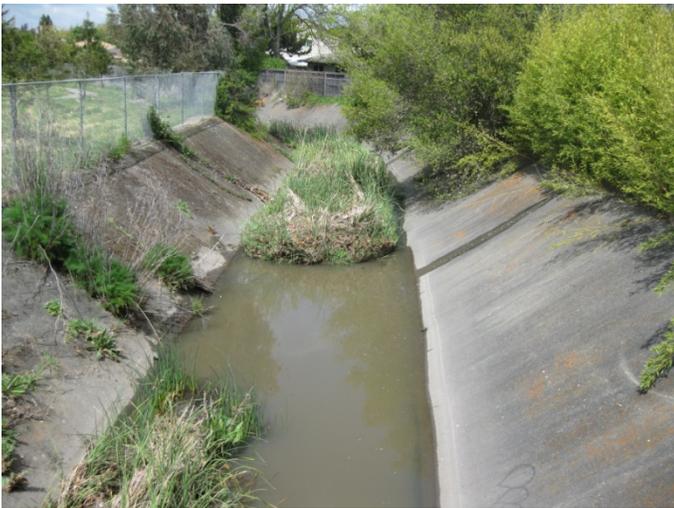
Photo 3: Lorna Dell Creek
Reach-scale sediment removal and vegetation clearing in concrete-lined channel upstream of Tacheva Drive (photo looking downstream of pedestrian bridge)
Taken April 22, 2010

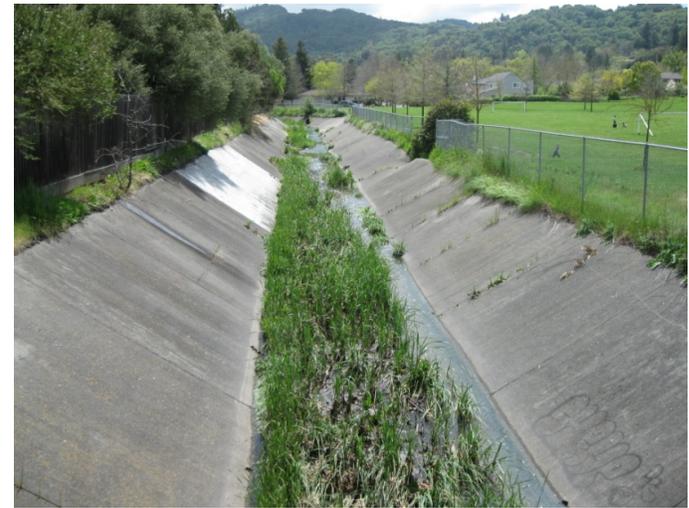
Photo 4: Lorna Dell Creek
Reach-scale sediment removal and vegetation clearing in concrete lined channel - looking upstream of pedestrian bridge
Taken April 22, 2010

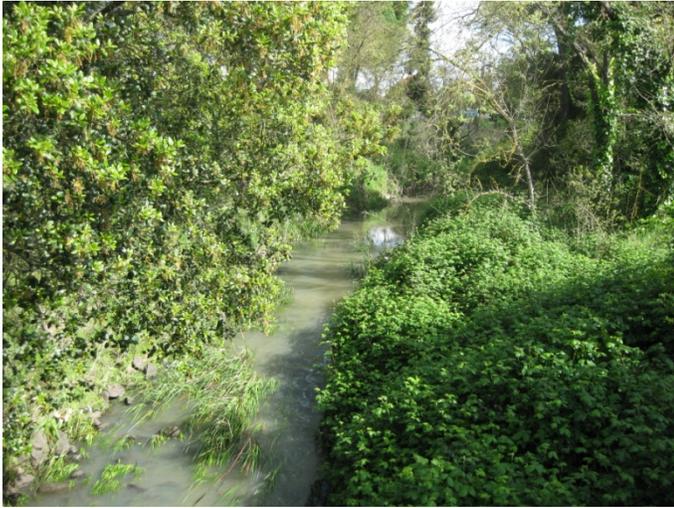
Photo 5: Paulin Creek Reach 2
Sediment removal at West Steele Lane crossing (photo looking upstream)
Taken April 22, 2010

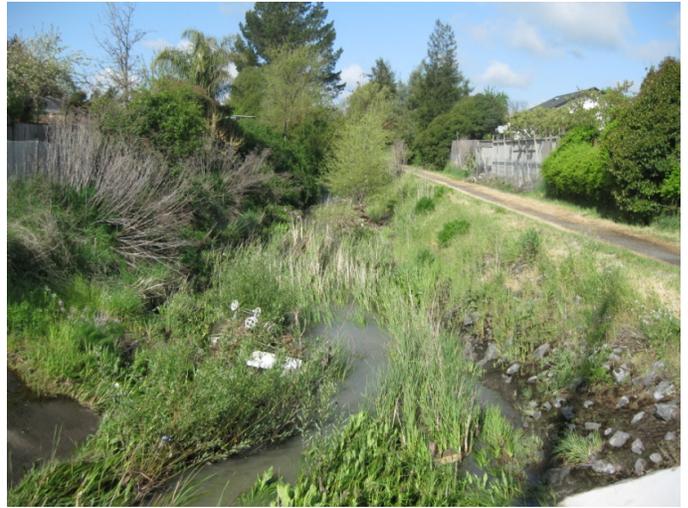
Photo 6: Paulin Creek Reach 3
Sediment and debris removal at Apache Street crossing (photo looking downstream)
Taken April 22, 2010

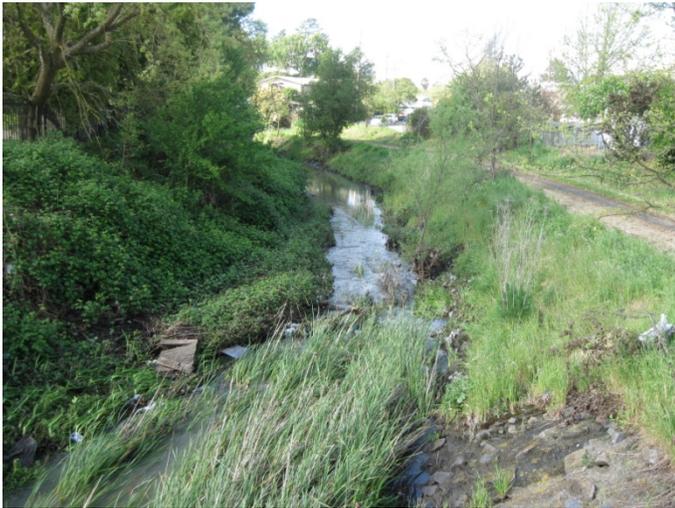
Photo 7: Paulin Creek Reach 4
Sediment and debris removal and vegetation clearing upstream of Mohawk Drive
Taken April 22, 2010

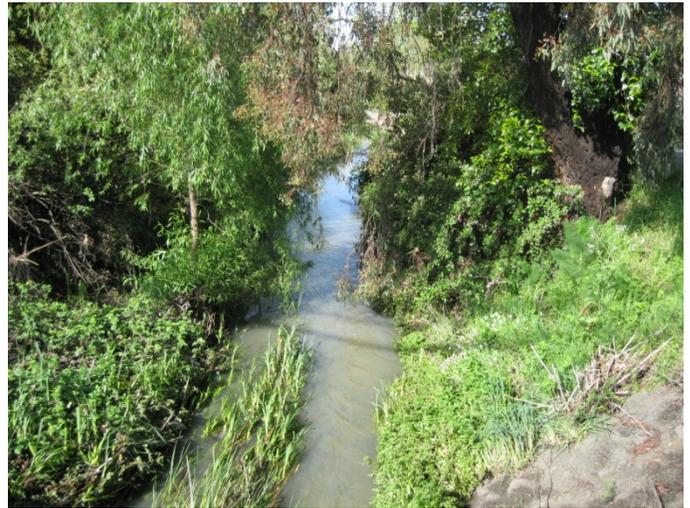
Photo 8: Paulin Creek Reach 4
Sediment removal at Coffey Lane crossing (photo looking downstream)
Taken April 22, 2010

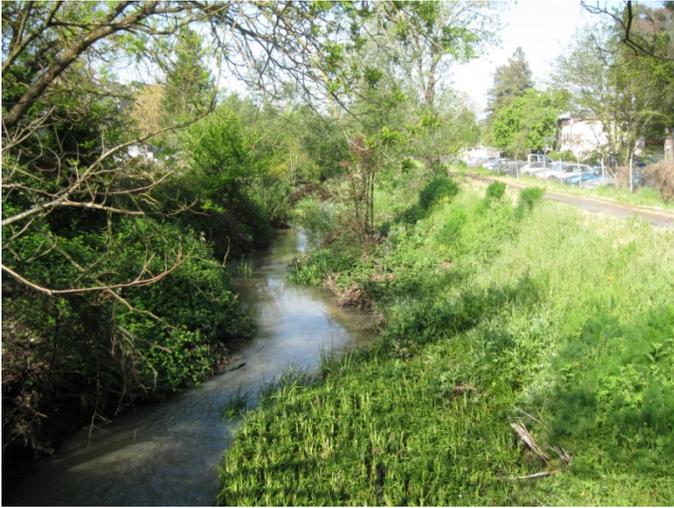
Photo 9: Paulin Creek Reach 6
Sediment removal and vegetation clearing at Range Avenue crossing (photo looking downstream)
Taken April 22, 2010

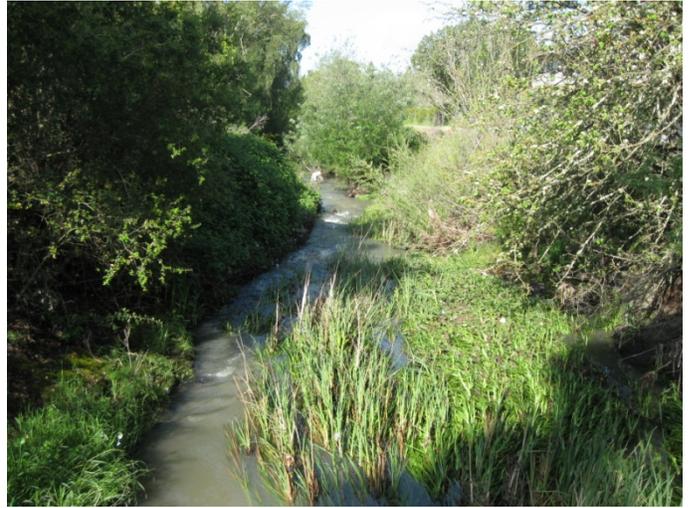
Photo 10: Paulin Creek Reach 6
Sediment removal and vegetation clearing at McBride Lane crossing (photo looking downstream)
Taken April 22, 2010

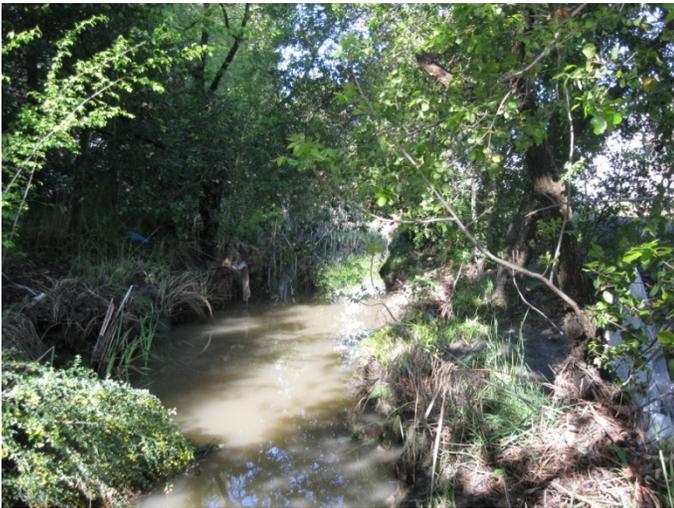
Photo 11: Russell Creek Reach 1
Sediment removal downstream of Range Avenue crossing
Taken April 22, 2010

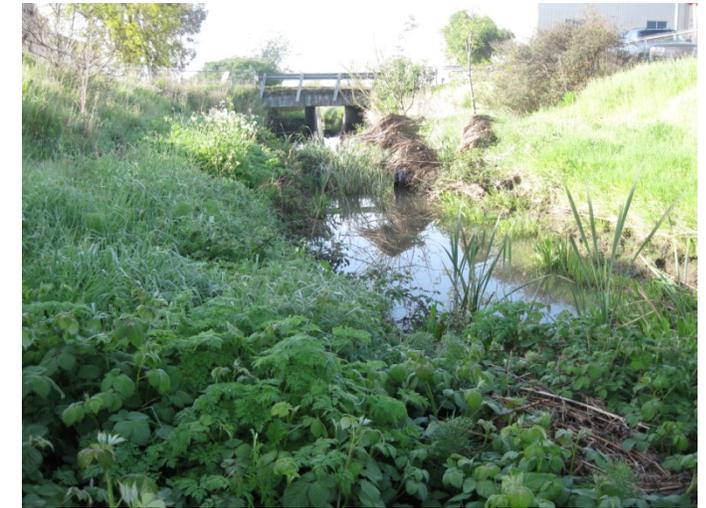
Photo 12: Todd Creek Reach 4
Sediment removal at East Todd Road crossing (photo looking downstream at crossing)
Taken April 22, 2010

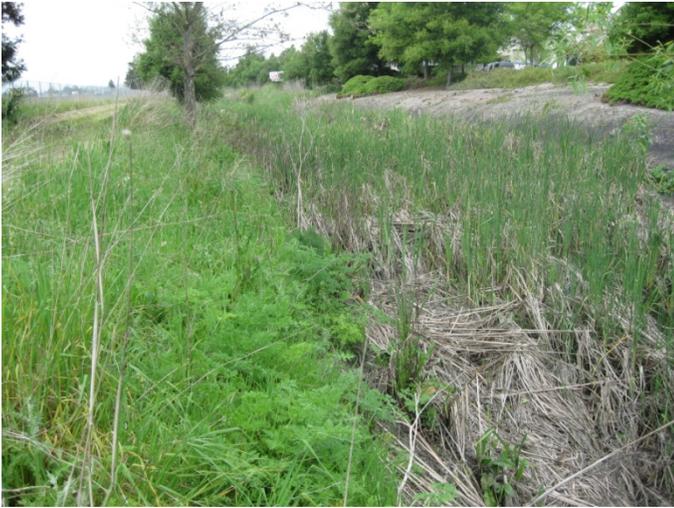
Photo 13: Corona Creek Reach 1
Reach-scale vegetation clearing and sediment removal –
photo looking upstream from mid-reach.
Taken April 22, 2010

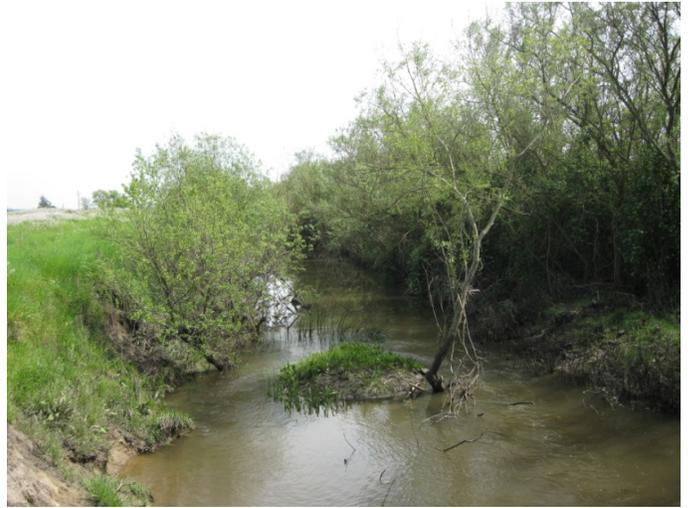
Photo 14: Laguna de Santa Rosa Reach 1
Reach scale sediment removal and vegetation clearing:
looking upstream near eastern edge of project area.
Taken April 22, 2010

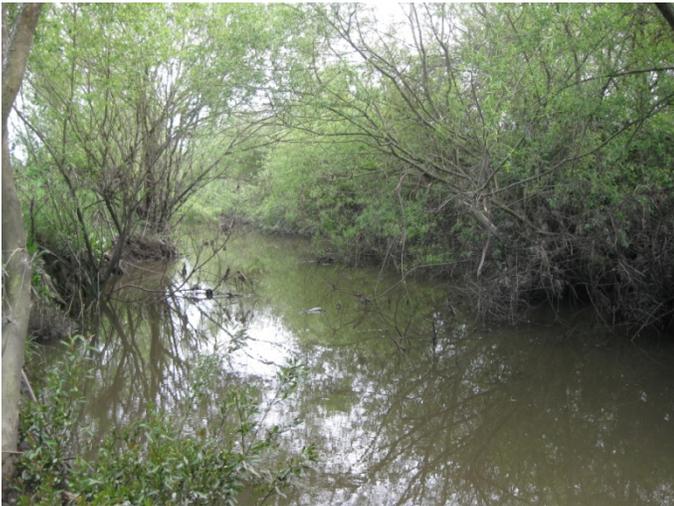
Photo 15: Laguna de Santa Rosa Reach 1
Reach scale: looking downstream from mid-project area.
Taken April 22, 2010

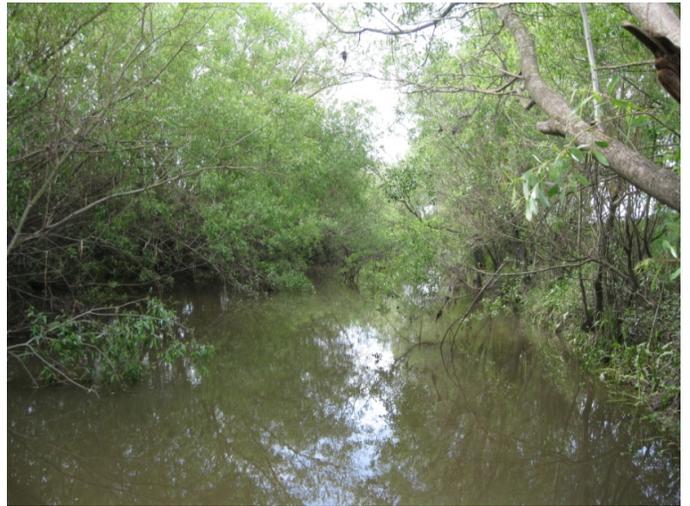
Photo 16: Laguna de Santa Rosa Reach 1
Reach scale- looking downstream from mid-project area
Taken April 22, 2010

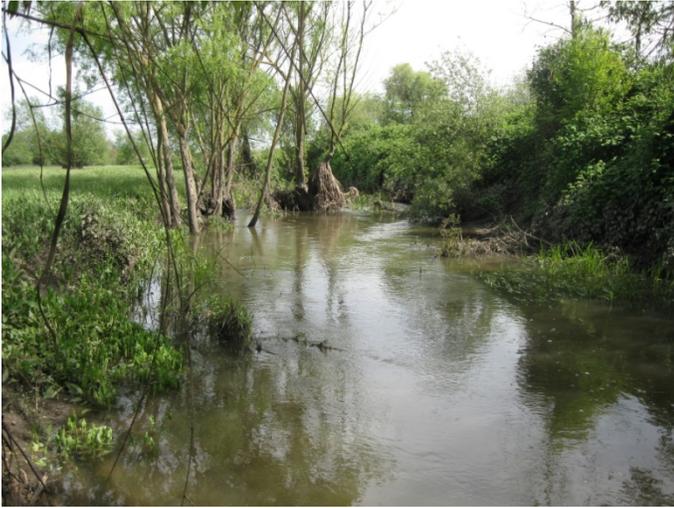
Photo 17: Laguna de Santa Rosa Reach 1
Reach scale- looking upstream from western edge of
project area
Taken April 22, 2010

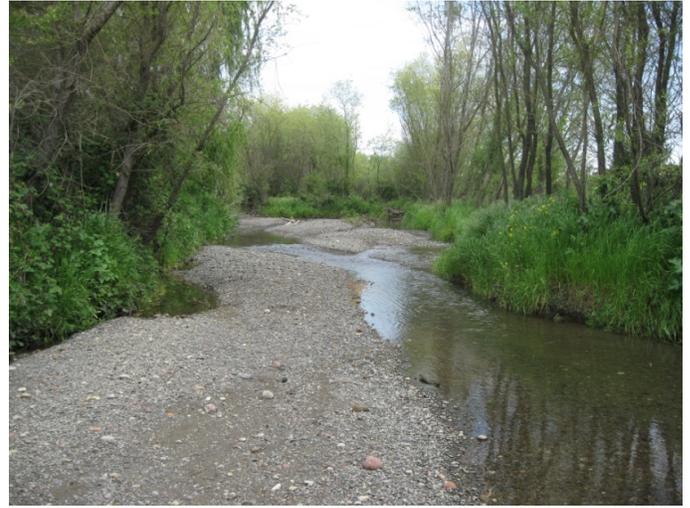
Photo 18: Adobe Creek Reach 2
In-stream sediment basin clearing (photo looking upstream
of S. McDowell Blvd)
Taken April 22, 2010

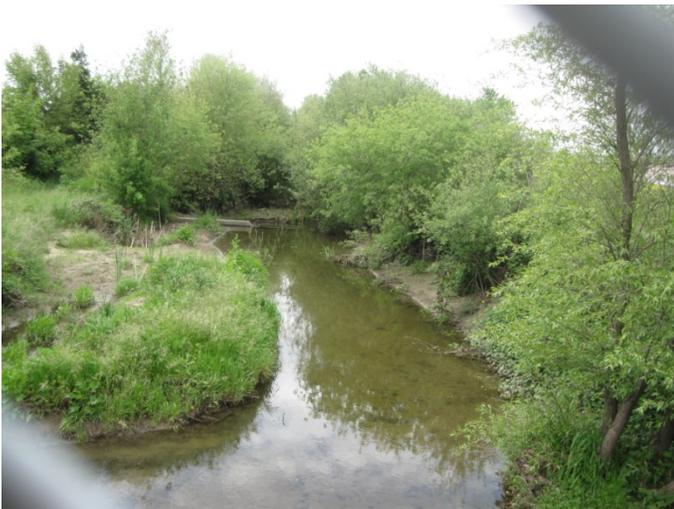
Photo 19: Adobe Creek Reach 2
In-stream sediment basin clearing (photo looking
downstream of S. McDowell Blvd)
Taken April 22, 2010

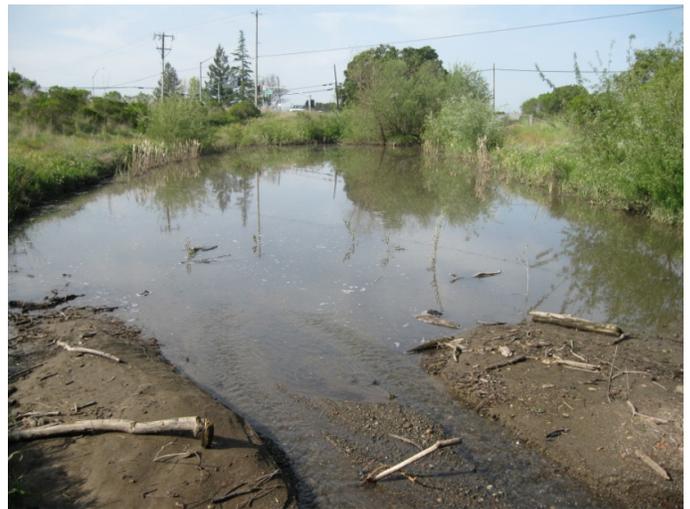
Photo 20: Cook Creek Reach 2
Sediment basin clearing upstream of Petaluma Hill Road.
Taken April 22, 2010

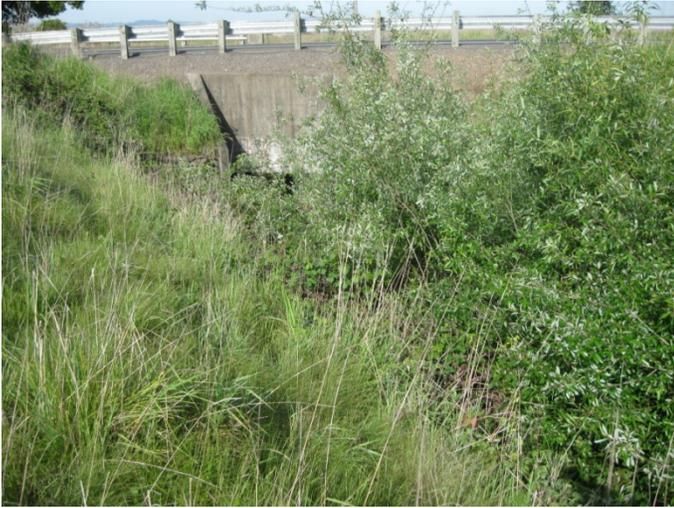
Photo 21: Cook Creek Reach 2
Sediment basin clearing upstream of Petaluma Hill Road:
looking at culvert.
Taken April 22, 2010

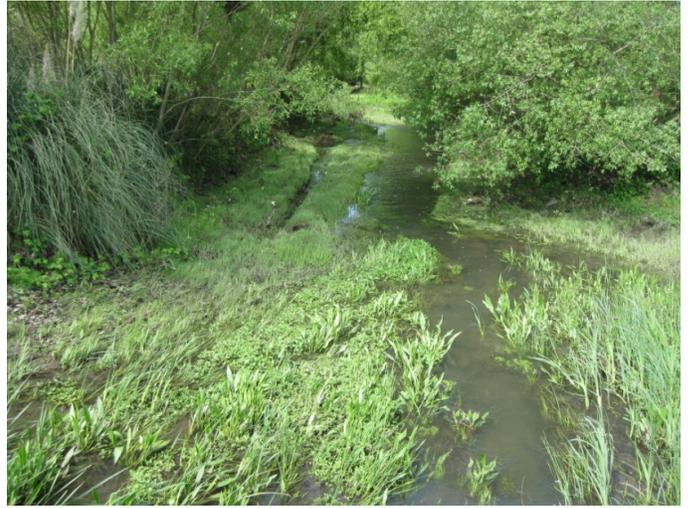
Photo 22: Copeland Creek at Country Club
In-stream sediment basin clearing at road crossing: looking
downstream
Taken April 22, 2010

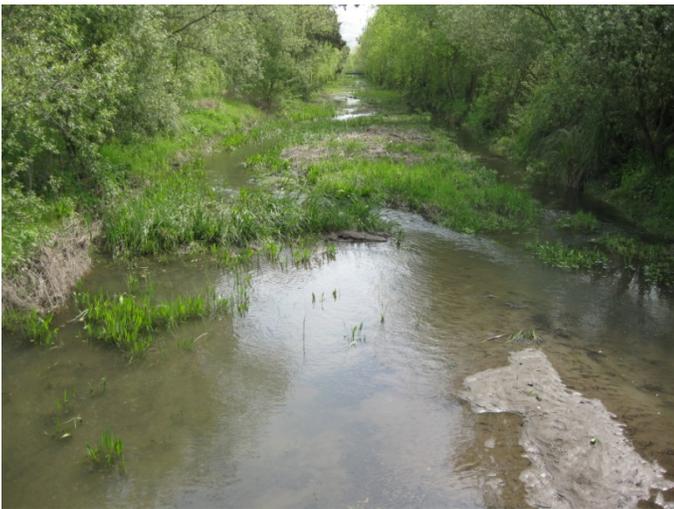
Photo 23: Copeland Creek at Country Club
In-stream sediment basin clearing at road crossing:
looking downstream
Taken April 22, 2010

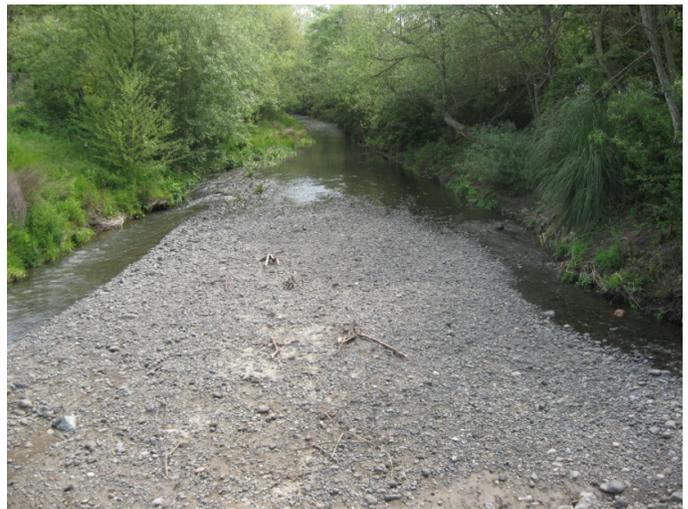
Photo 24: Copeland Creek at Snyder Lane
In-stream sediment basin clearing at road crossing: looking
upstream
Taken April 22, 2010

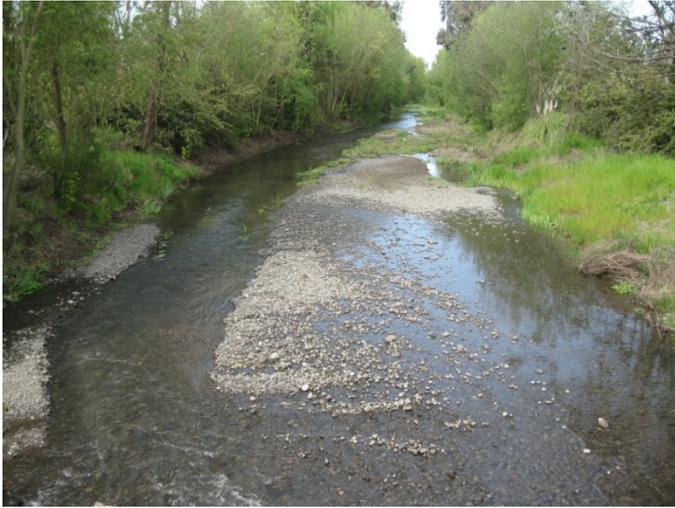
Photo 25: Copeland Creek at Snyder Lane
In-stream sediment basin clearing at road crossing:
looking downstream
Taken April 22, 2010

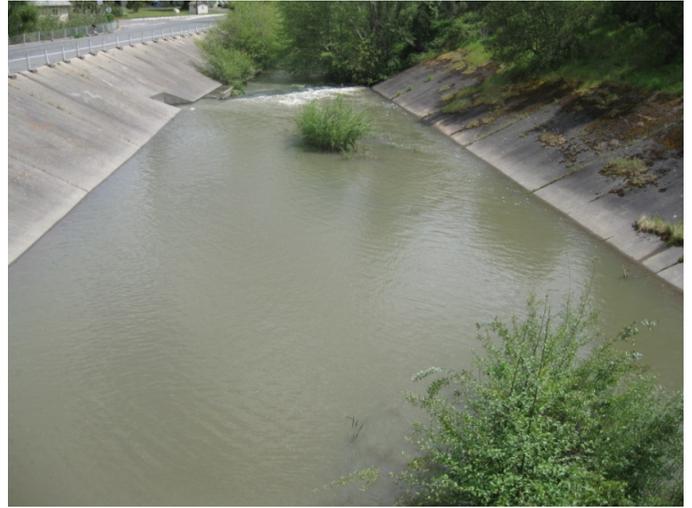
Photo 26: Santa Rosa Creek Diversion Structure
Sediment basin clearing and vegetation removal
Taken April 22, 2010

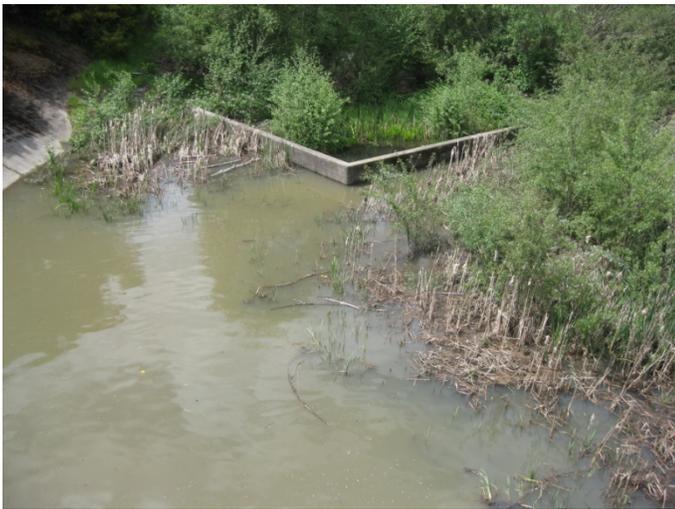
Photo 27: Santa Rosa Creek Diversion Structure
Sediment basin clearing and vegetation removal
Taken April 22, 2010

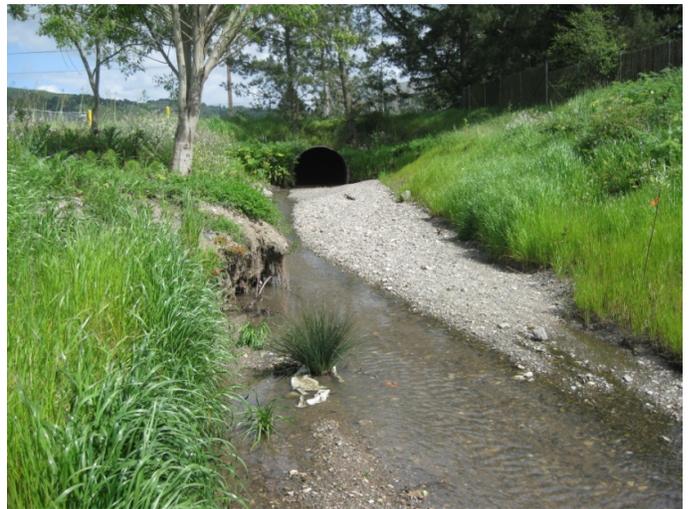
Photo 28: Wilfred Creek at Snyder Lane
In-stream sediment basin clearing at road crossing: note
sediment accumulation at culvert
Taken April 22, 2010

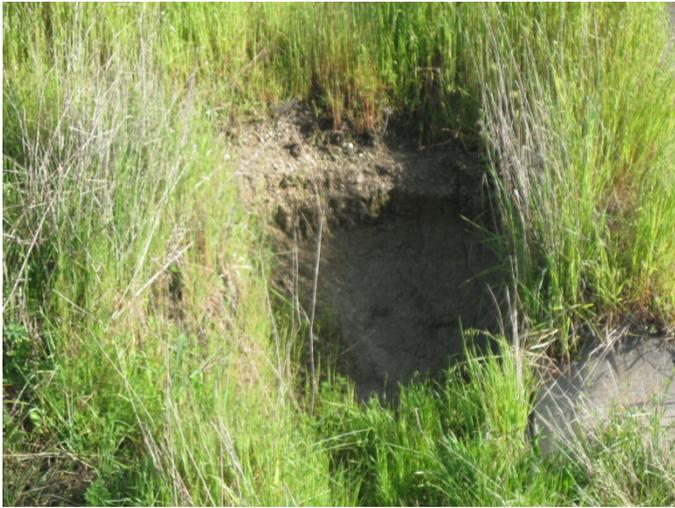
Photo 29: Hunter Creek Reach 2 bank stabilization
(14 ft long repair on northern bank)
Taken April 22, 2010

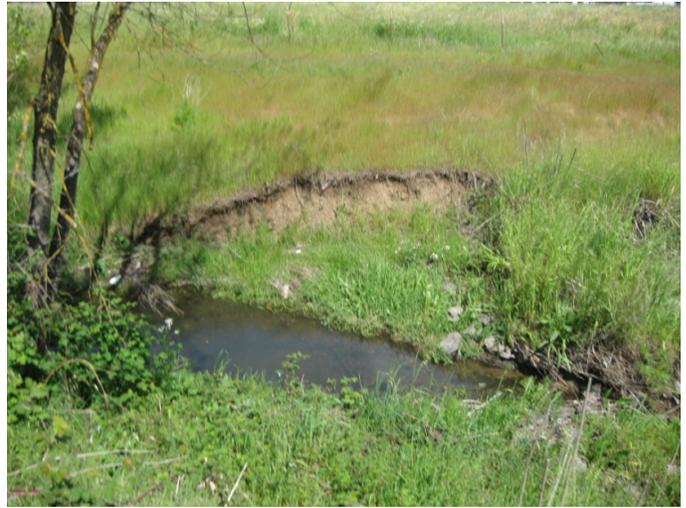
Photo 30: Moorland Creek Reach 1 bank stabilization
Two small bank repairs near Todd Channel
Taken April 22, 2010

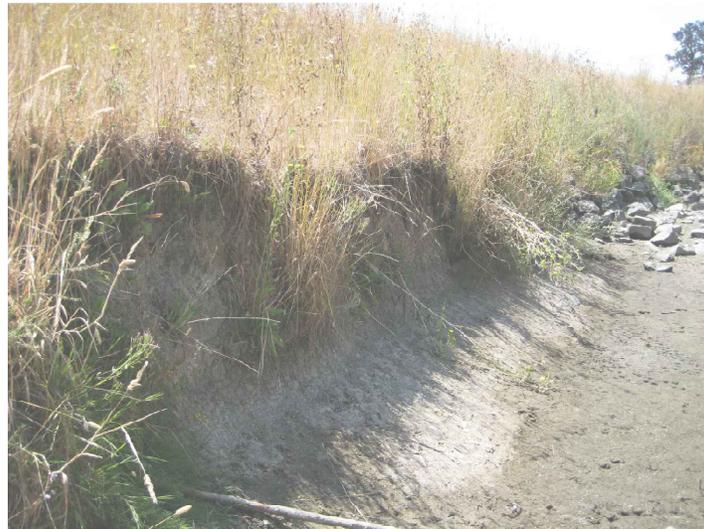
Photo 31: Todd Creek Reach 4 bank stabilization
73 ft long repair on eastern bank
Taken February 23, 2010

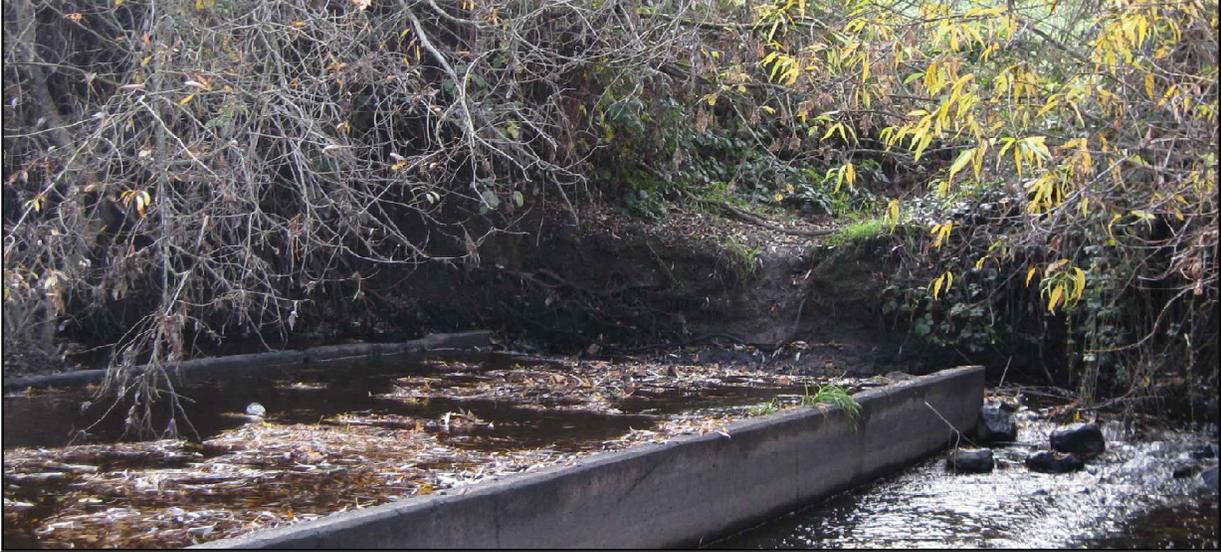
Photo 32: Santa Rosa Creek Reach 1 bank stabilization
30 ft long repair on south bank and removal of sediment and existing wooden bridge
Taken February 23, 2010

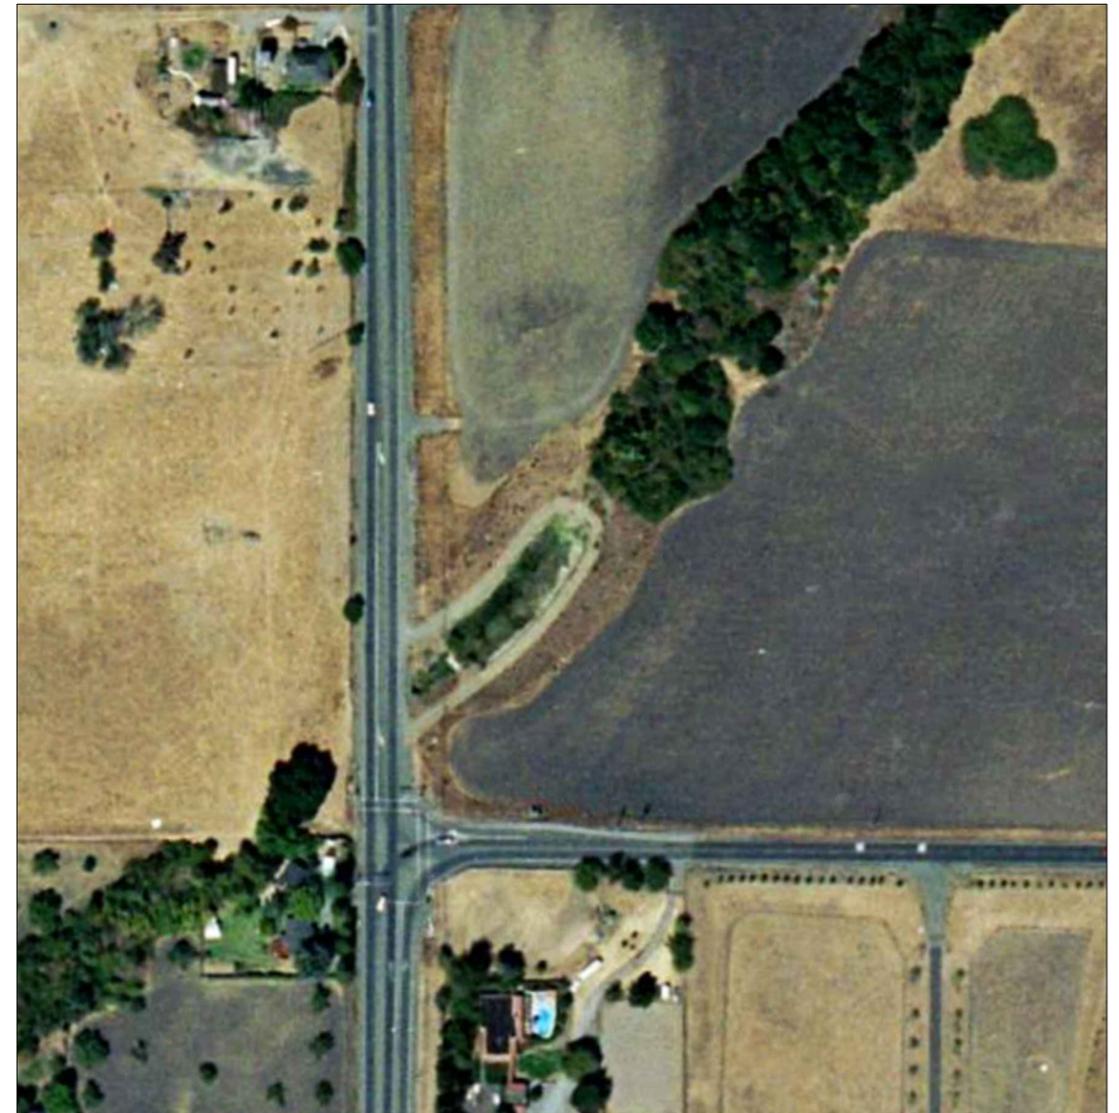
AERIAL

COOK CREEK SEDIMENT BASIN SEDIMENT REMOVAL

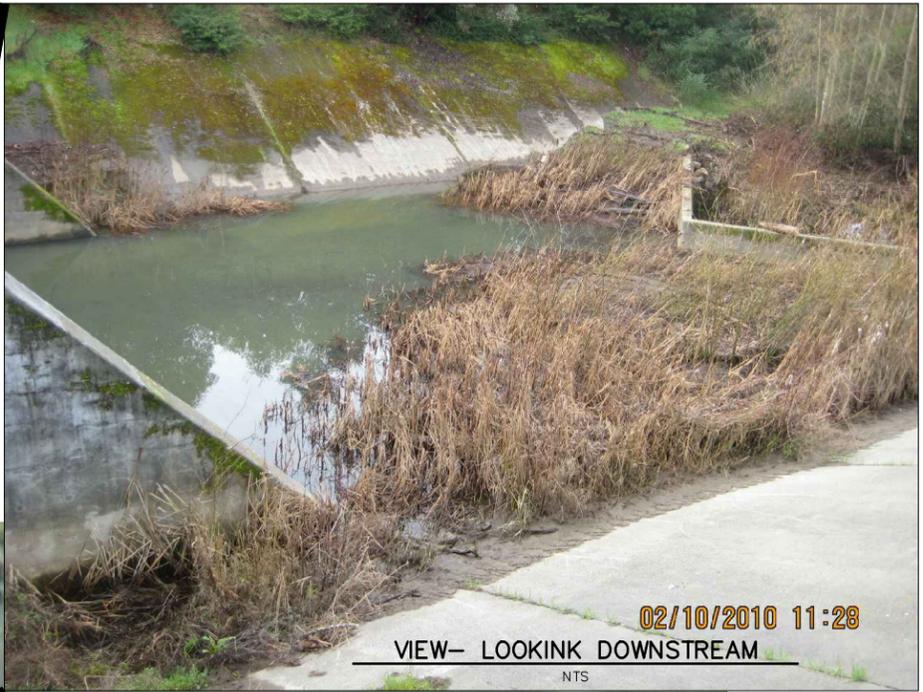
VIEW- LOOKING DOWNSTREAM
NTS

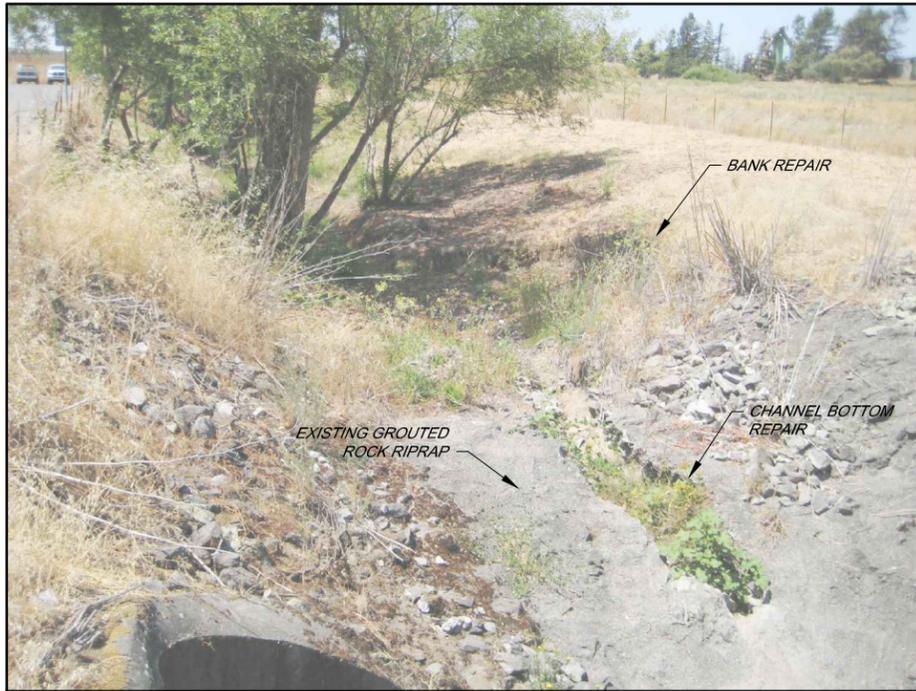
VIEW – BANK AND BOTTOM REPAIR AREAS

(LOOKING UP STREAM)
NOT TO SCALE

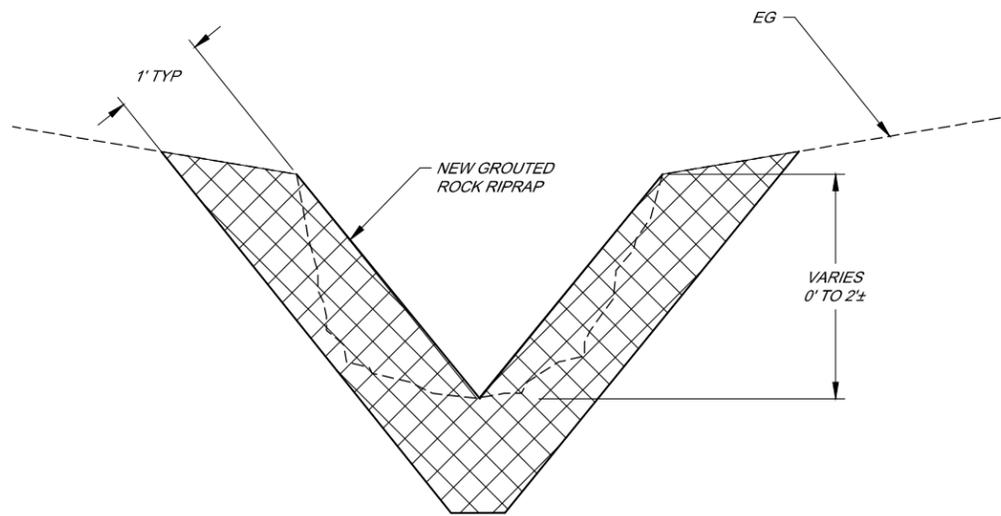
TYPICAL BOTTOM REPAIR SECTION

FIGURE 5-6 TYPICAL SECTION OF SMP MANUAL FOR BANK STABILIZATION DESIGN WILL BE USED FOR BANK REPAIRS.

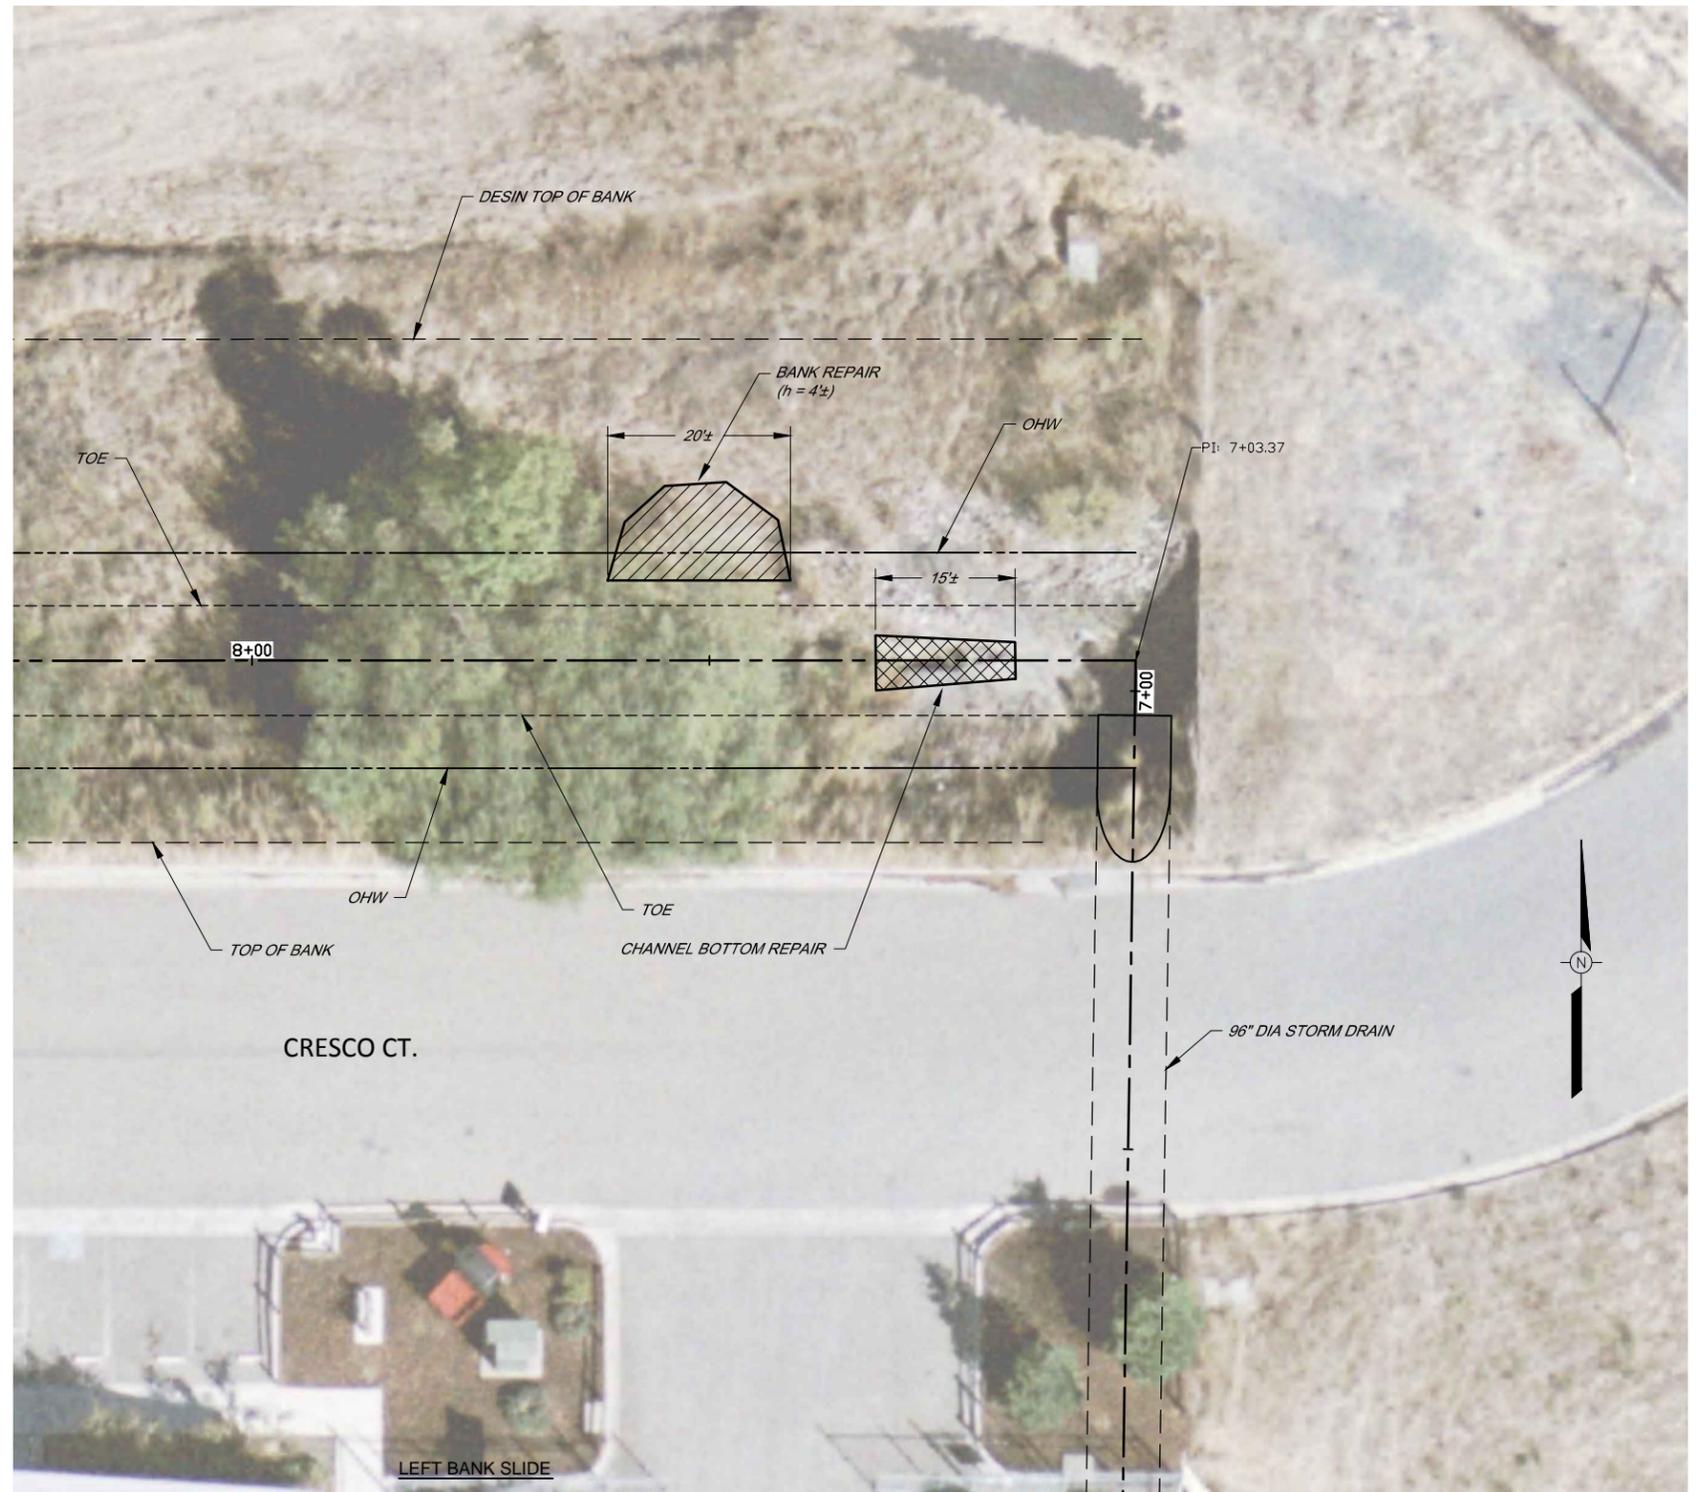
NOT TO SCALE

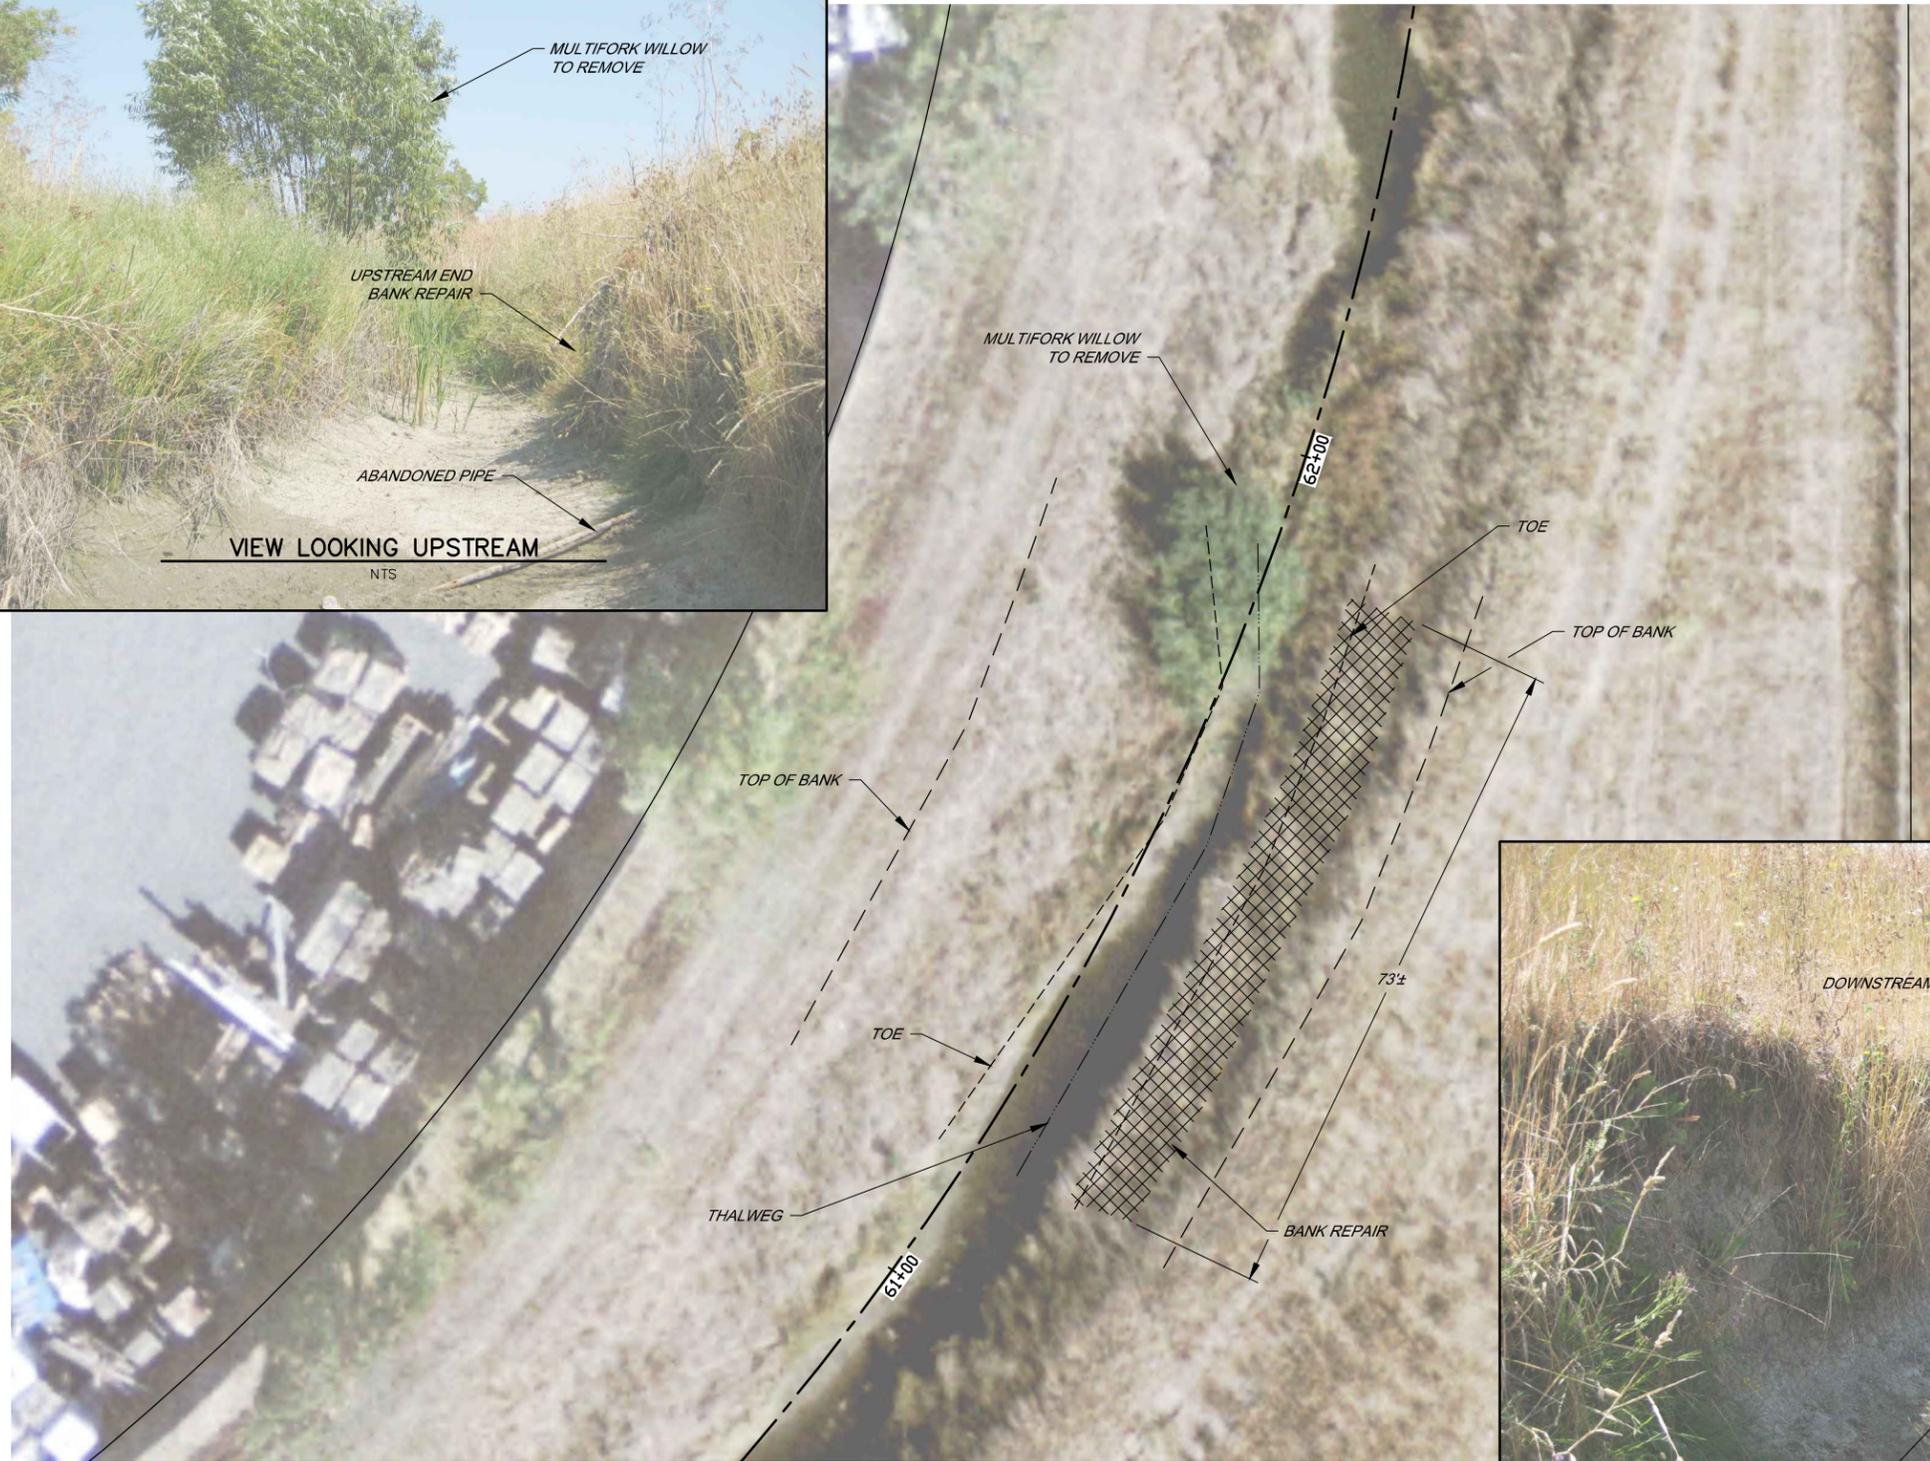
PLAN

BANK REPAIR
FILL BELOW OHWM
 ROCK RIPRAP
 438 sq. ft.
 32 cu. yds.

GENERAL NOTE:
 FIGURE 5-6 TYPICAL SECTION OF SMP MANUAL FOR BANK STABILIZATION DESIGN WILL BE USED FOR BANK REPAIRS.

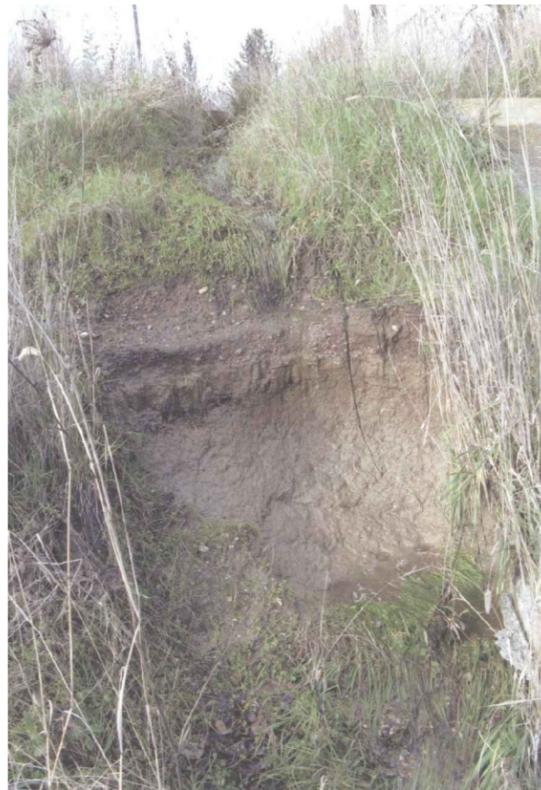
VIEW — WASHOUT

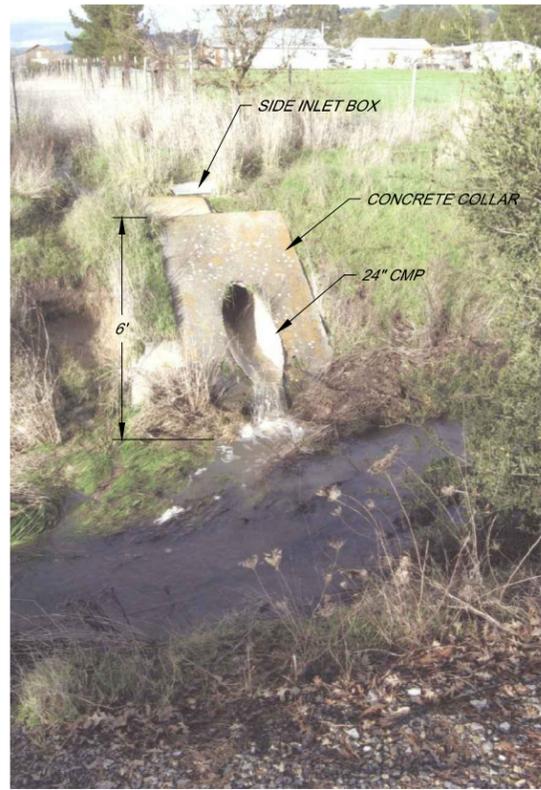
VIEW — SIDE INLET
