Sonoma County Water Agency
Stream Maintenance Program (SMP)
**Annual Notification for
2010 Maintenance Projects**

Prepared for:
The SMP Inter-Agency Working Group

April 28, 2010

Sonoma County Water Agency Stream Maintenance Program 2010 Projects

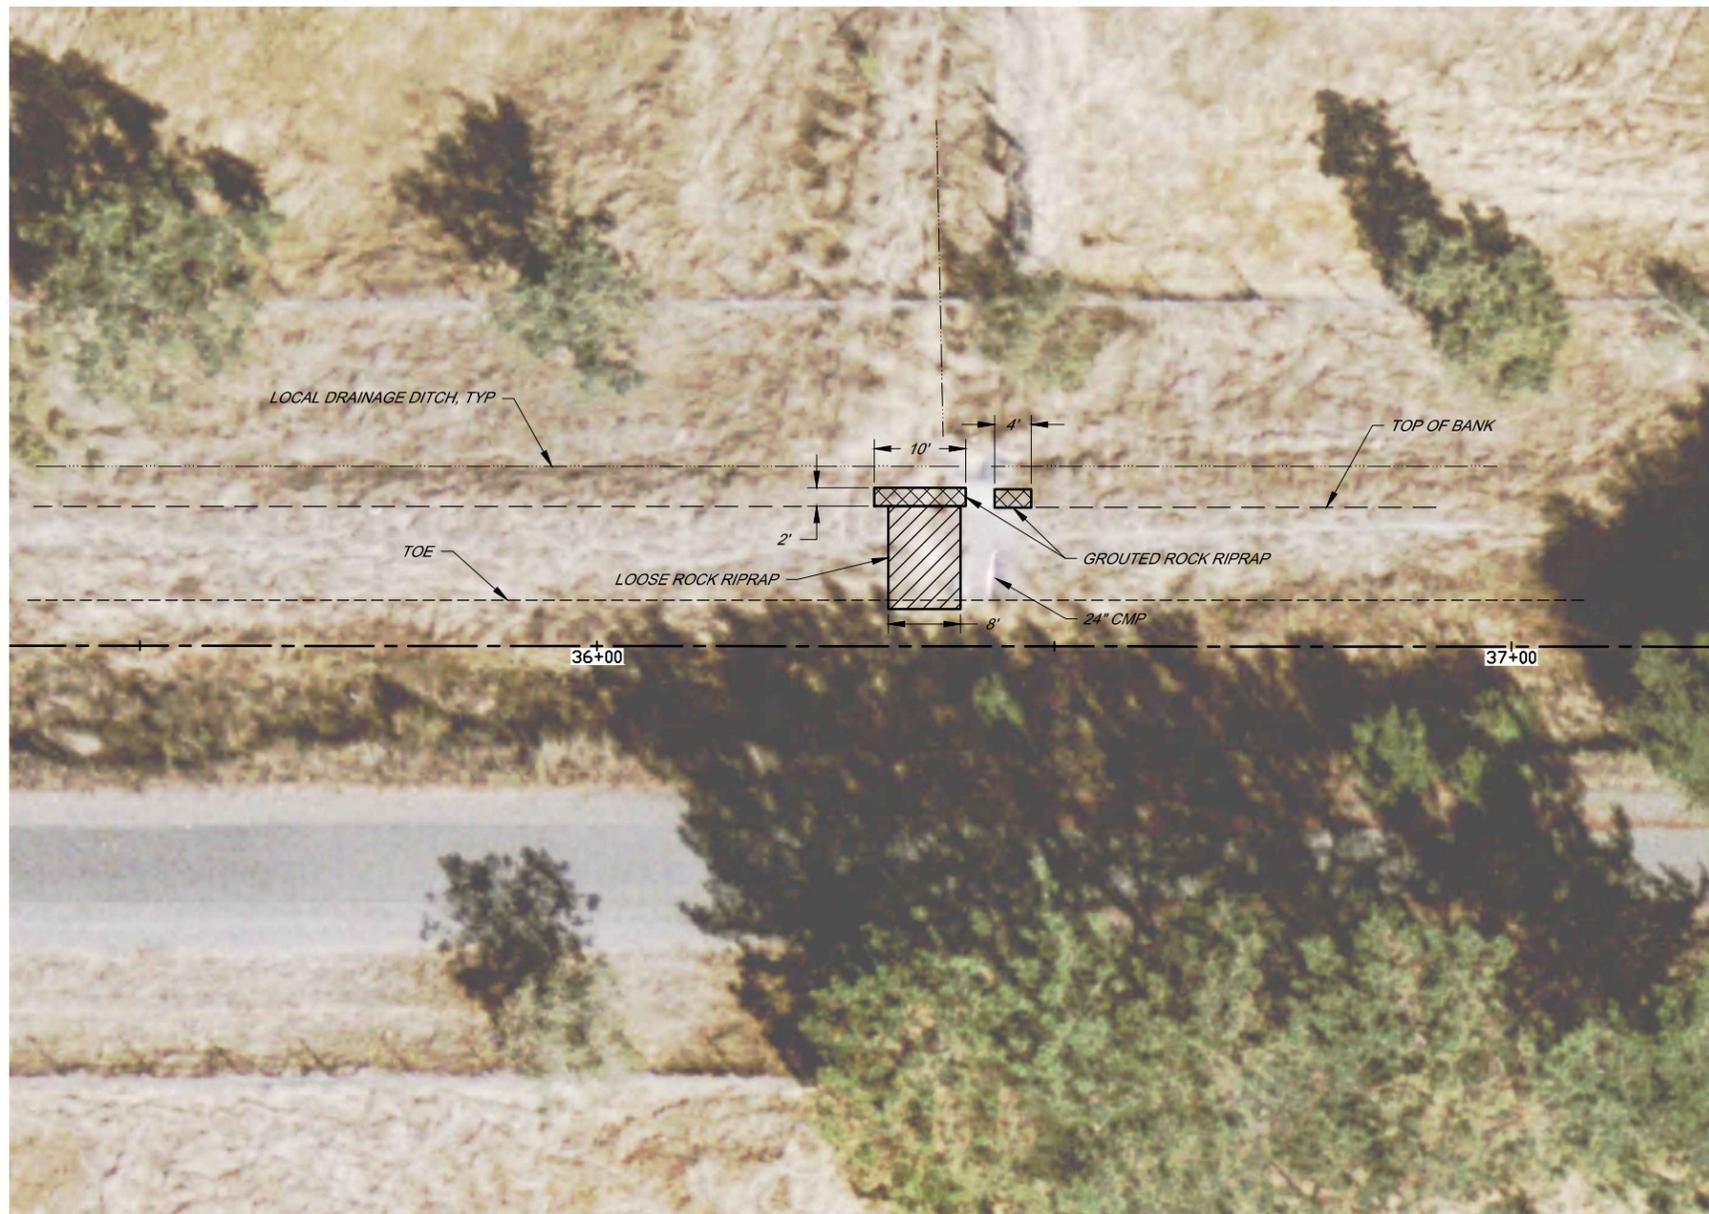
PLAN

75 sq. ft.
LOOSE ROCK RIPRAP
6 cu. yds.

49 sq. ft.
GROUTED ROCK RIPRAP
2 cu. yds.
LOOSE ROCK RIPRAP
2 cu. yds.

GENERAL NOTE:
FIGURE 5-6 TYPICAL SECTION OF SMP MANUAL FOR BANK STABILIZATION DESIGN WILL BE USED FOR BANK REPAIRS.

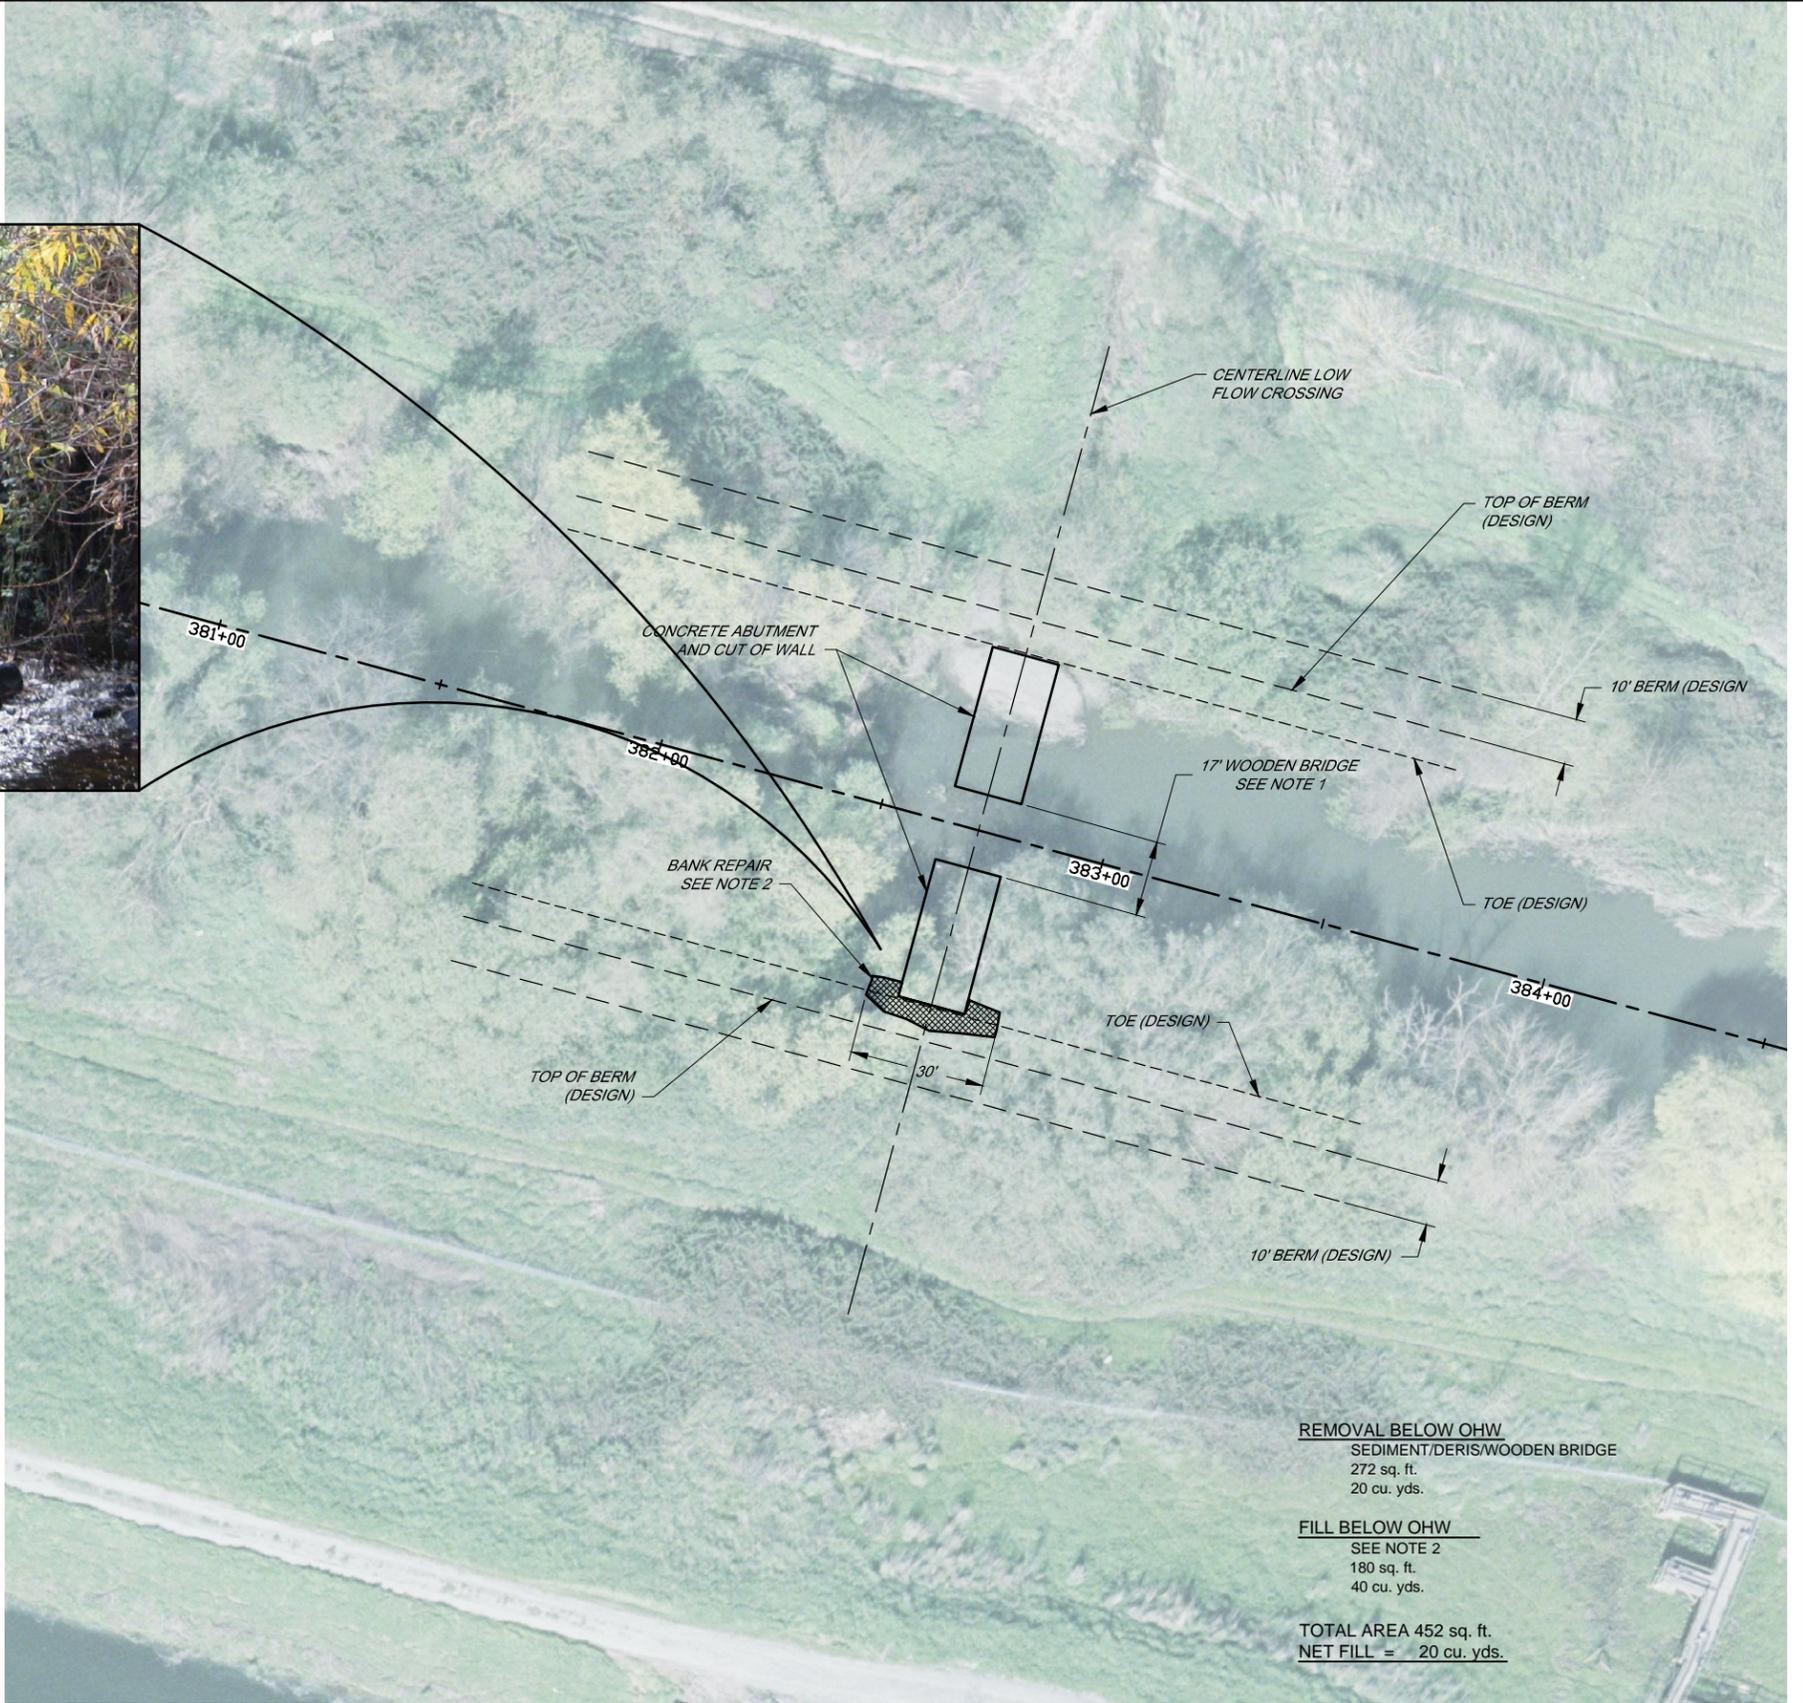
- NOTES:**
- WOODEN BRIDGE SECTION AND DEBRIS/SEDIMENT TO BE REMOVED TWO FEET BELOW TOP OF CONCRETE ABUTMENT AT CROSSING ONLY.
 - FIGURE 5-5 TYPICAL SECTION OF SMP MANUAL FOR BANK STABILIZATION DESIGN WILL BE USED FOR BANK REPAIR.

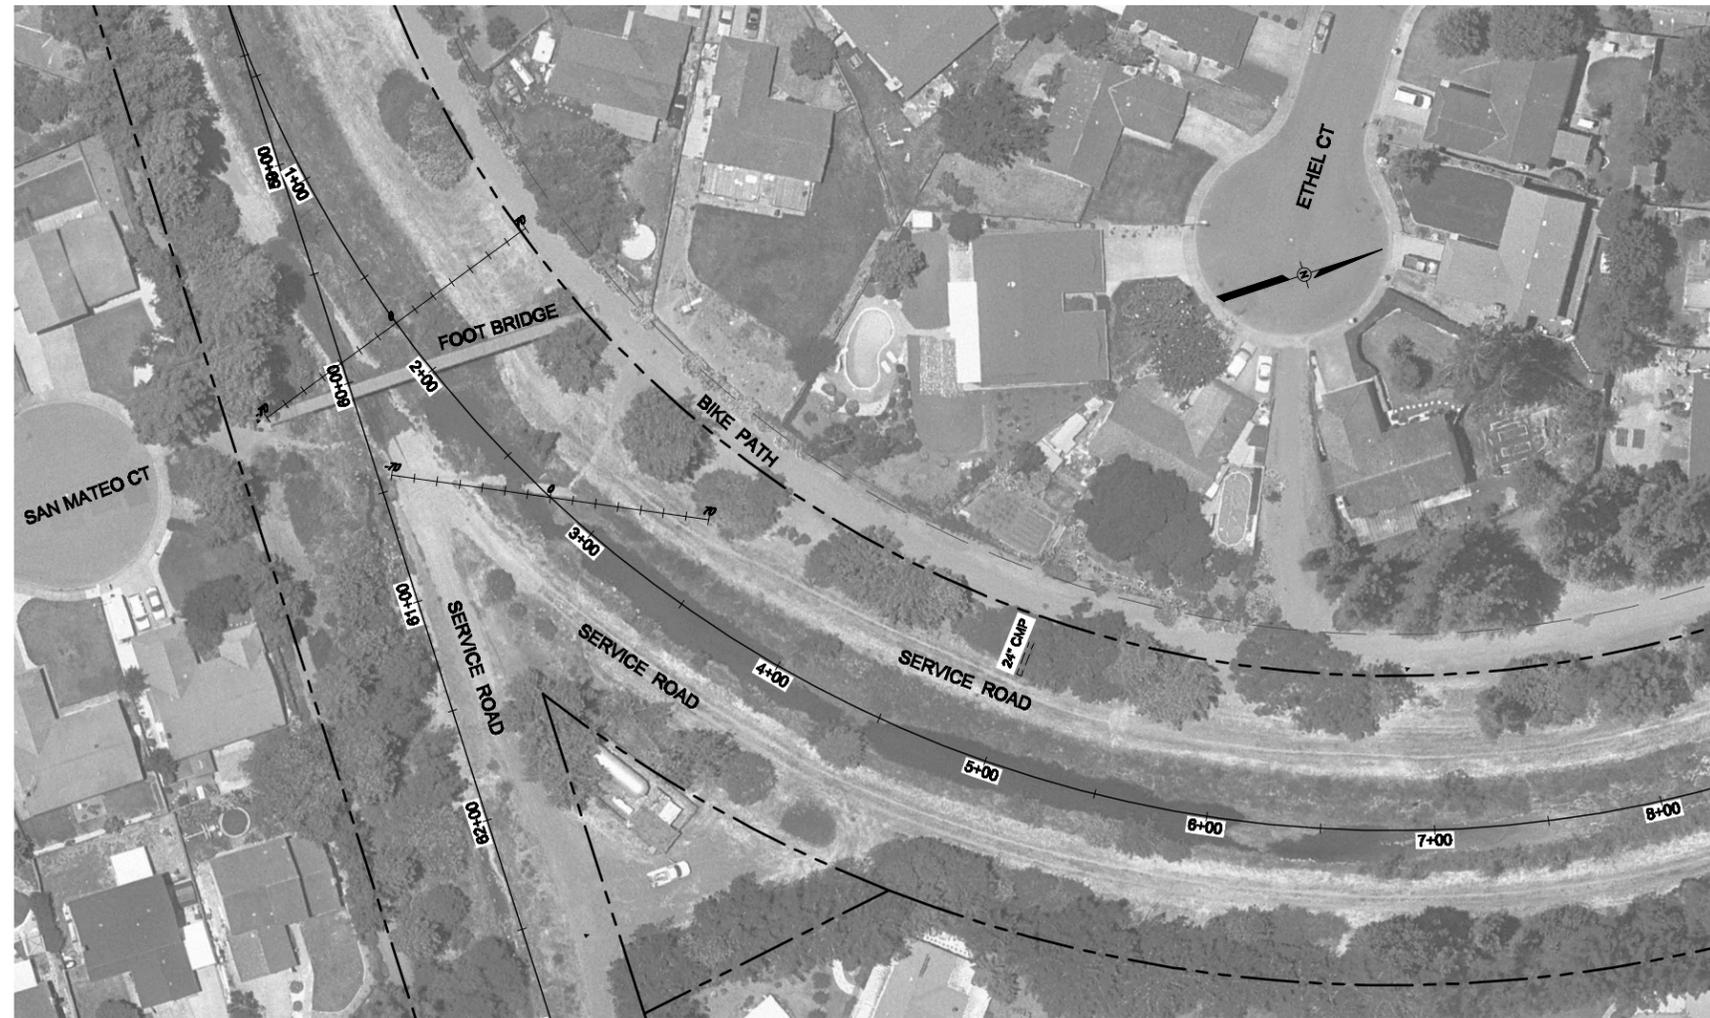
PLAN
SCALE: 1" = 40'

<p>PRELIMINARY SUBJECT TO REVISION</p>		<p>SONOMA COUNTY WATER AGENCY</p>	SCALE: AS SHOWN	<p>LAGUNA - MARK WEST ZONE 1A SANTA ROSA CREEK BANK REPAIR</p>
			DATE: 12/2/09	
NO.	DATE	REVISION	BY	<p>FILE NAME: 10-02-03_S_R_CRK.dwg CONTRACT NUMBER:</p>
			DRAWN: ADF	DRAWING NUMBER: C-4
			REVIEWED:	SHEET 5 OF 5

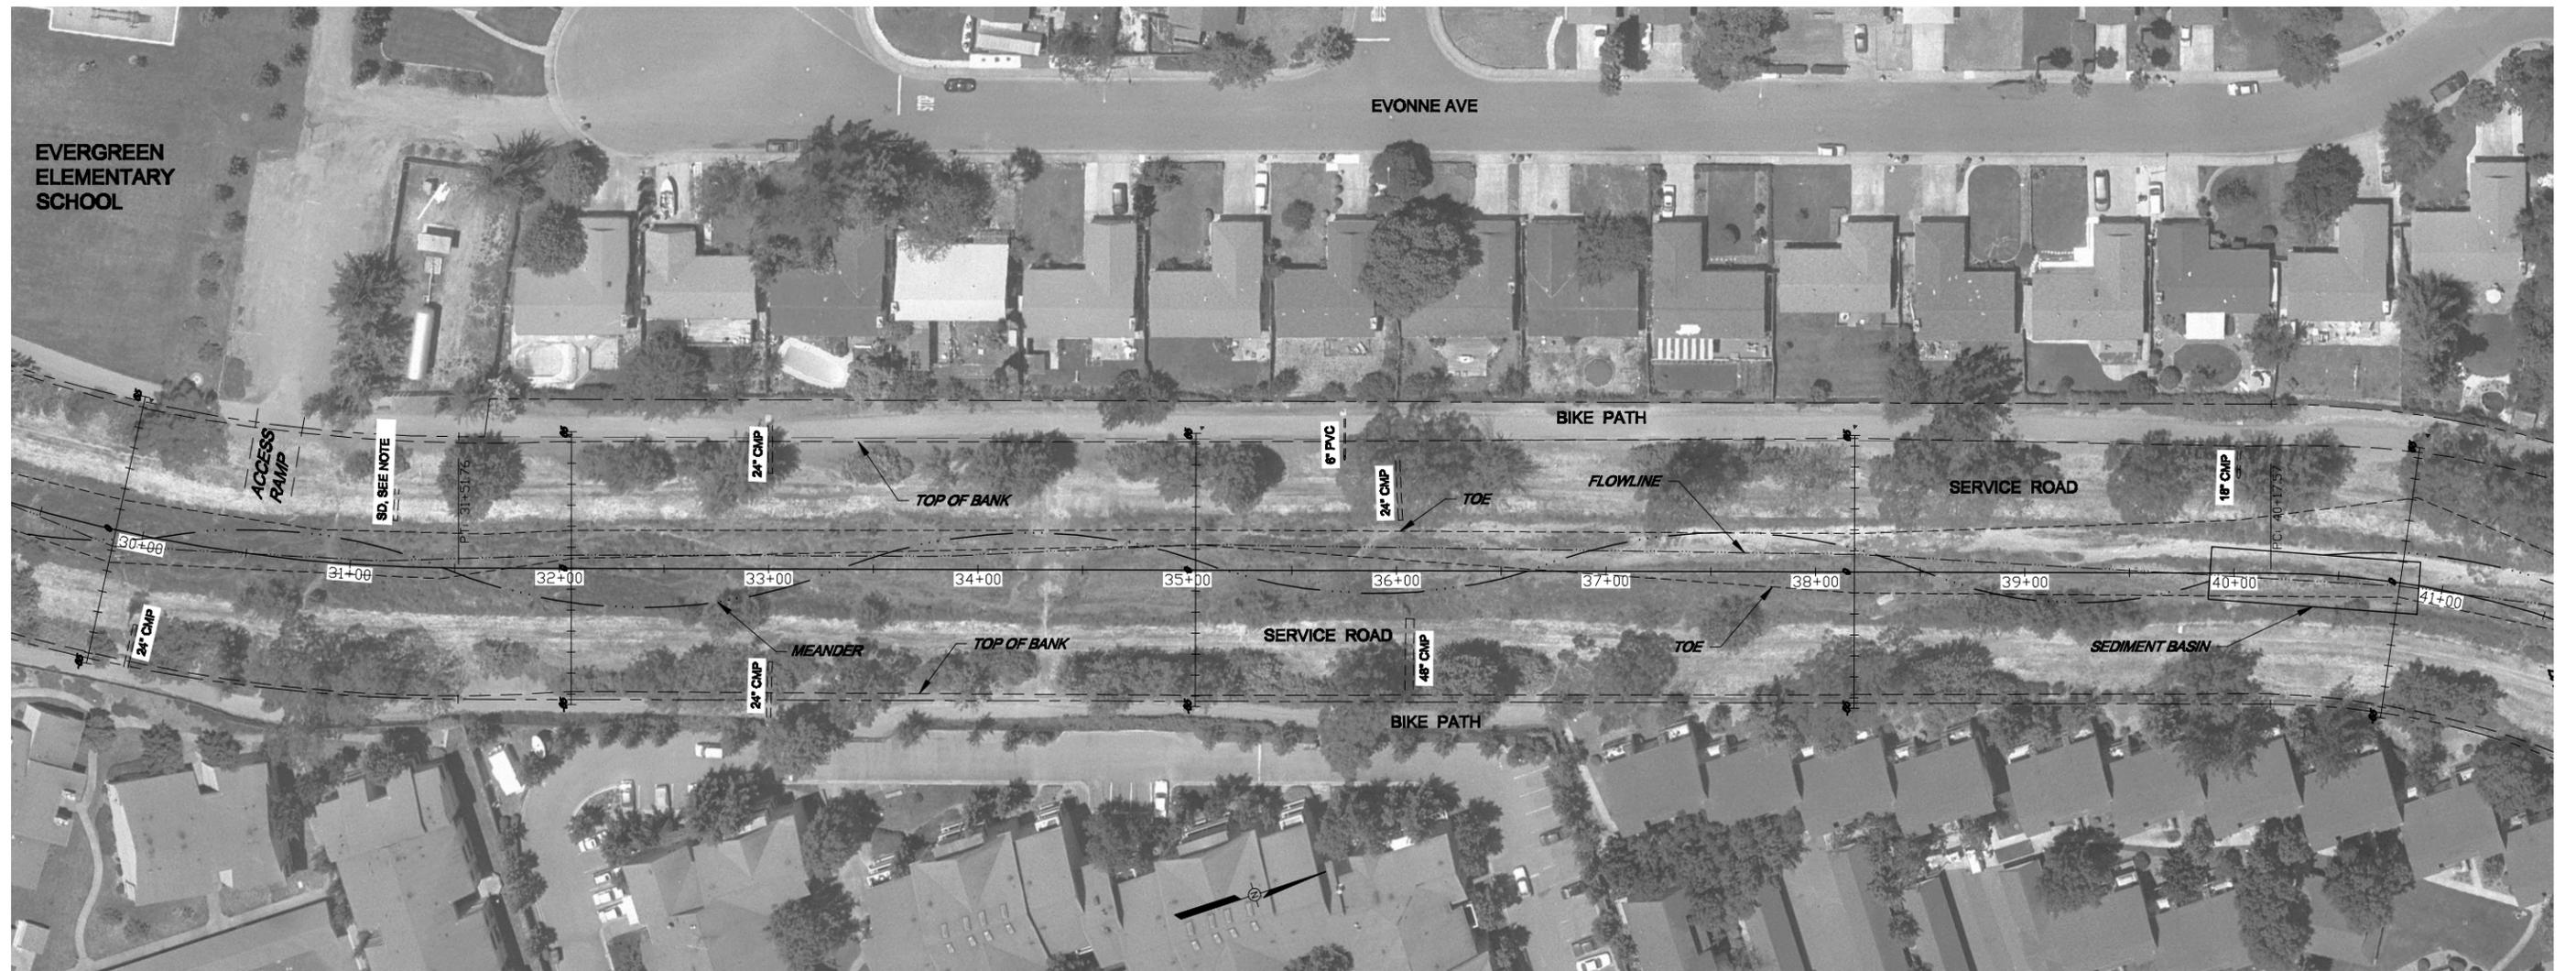
NOTE:
AT STA 31+21±, 21'± RIGHT, CITY PAINT LOCATION MARK
SIDE DRAIN, DEPTH AND SIZE UNKNOWN.
FLOW OBSERVED FROM UNDER VEGETATION.

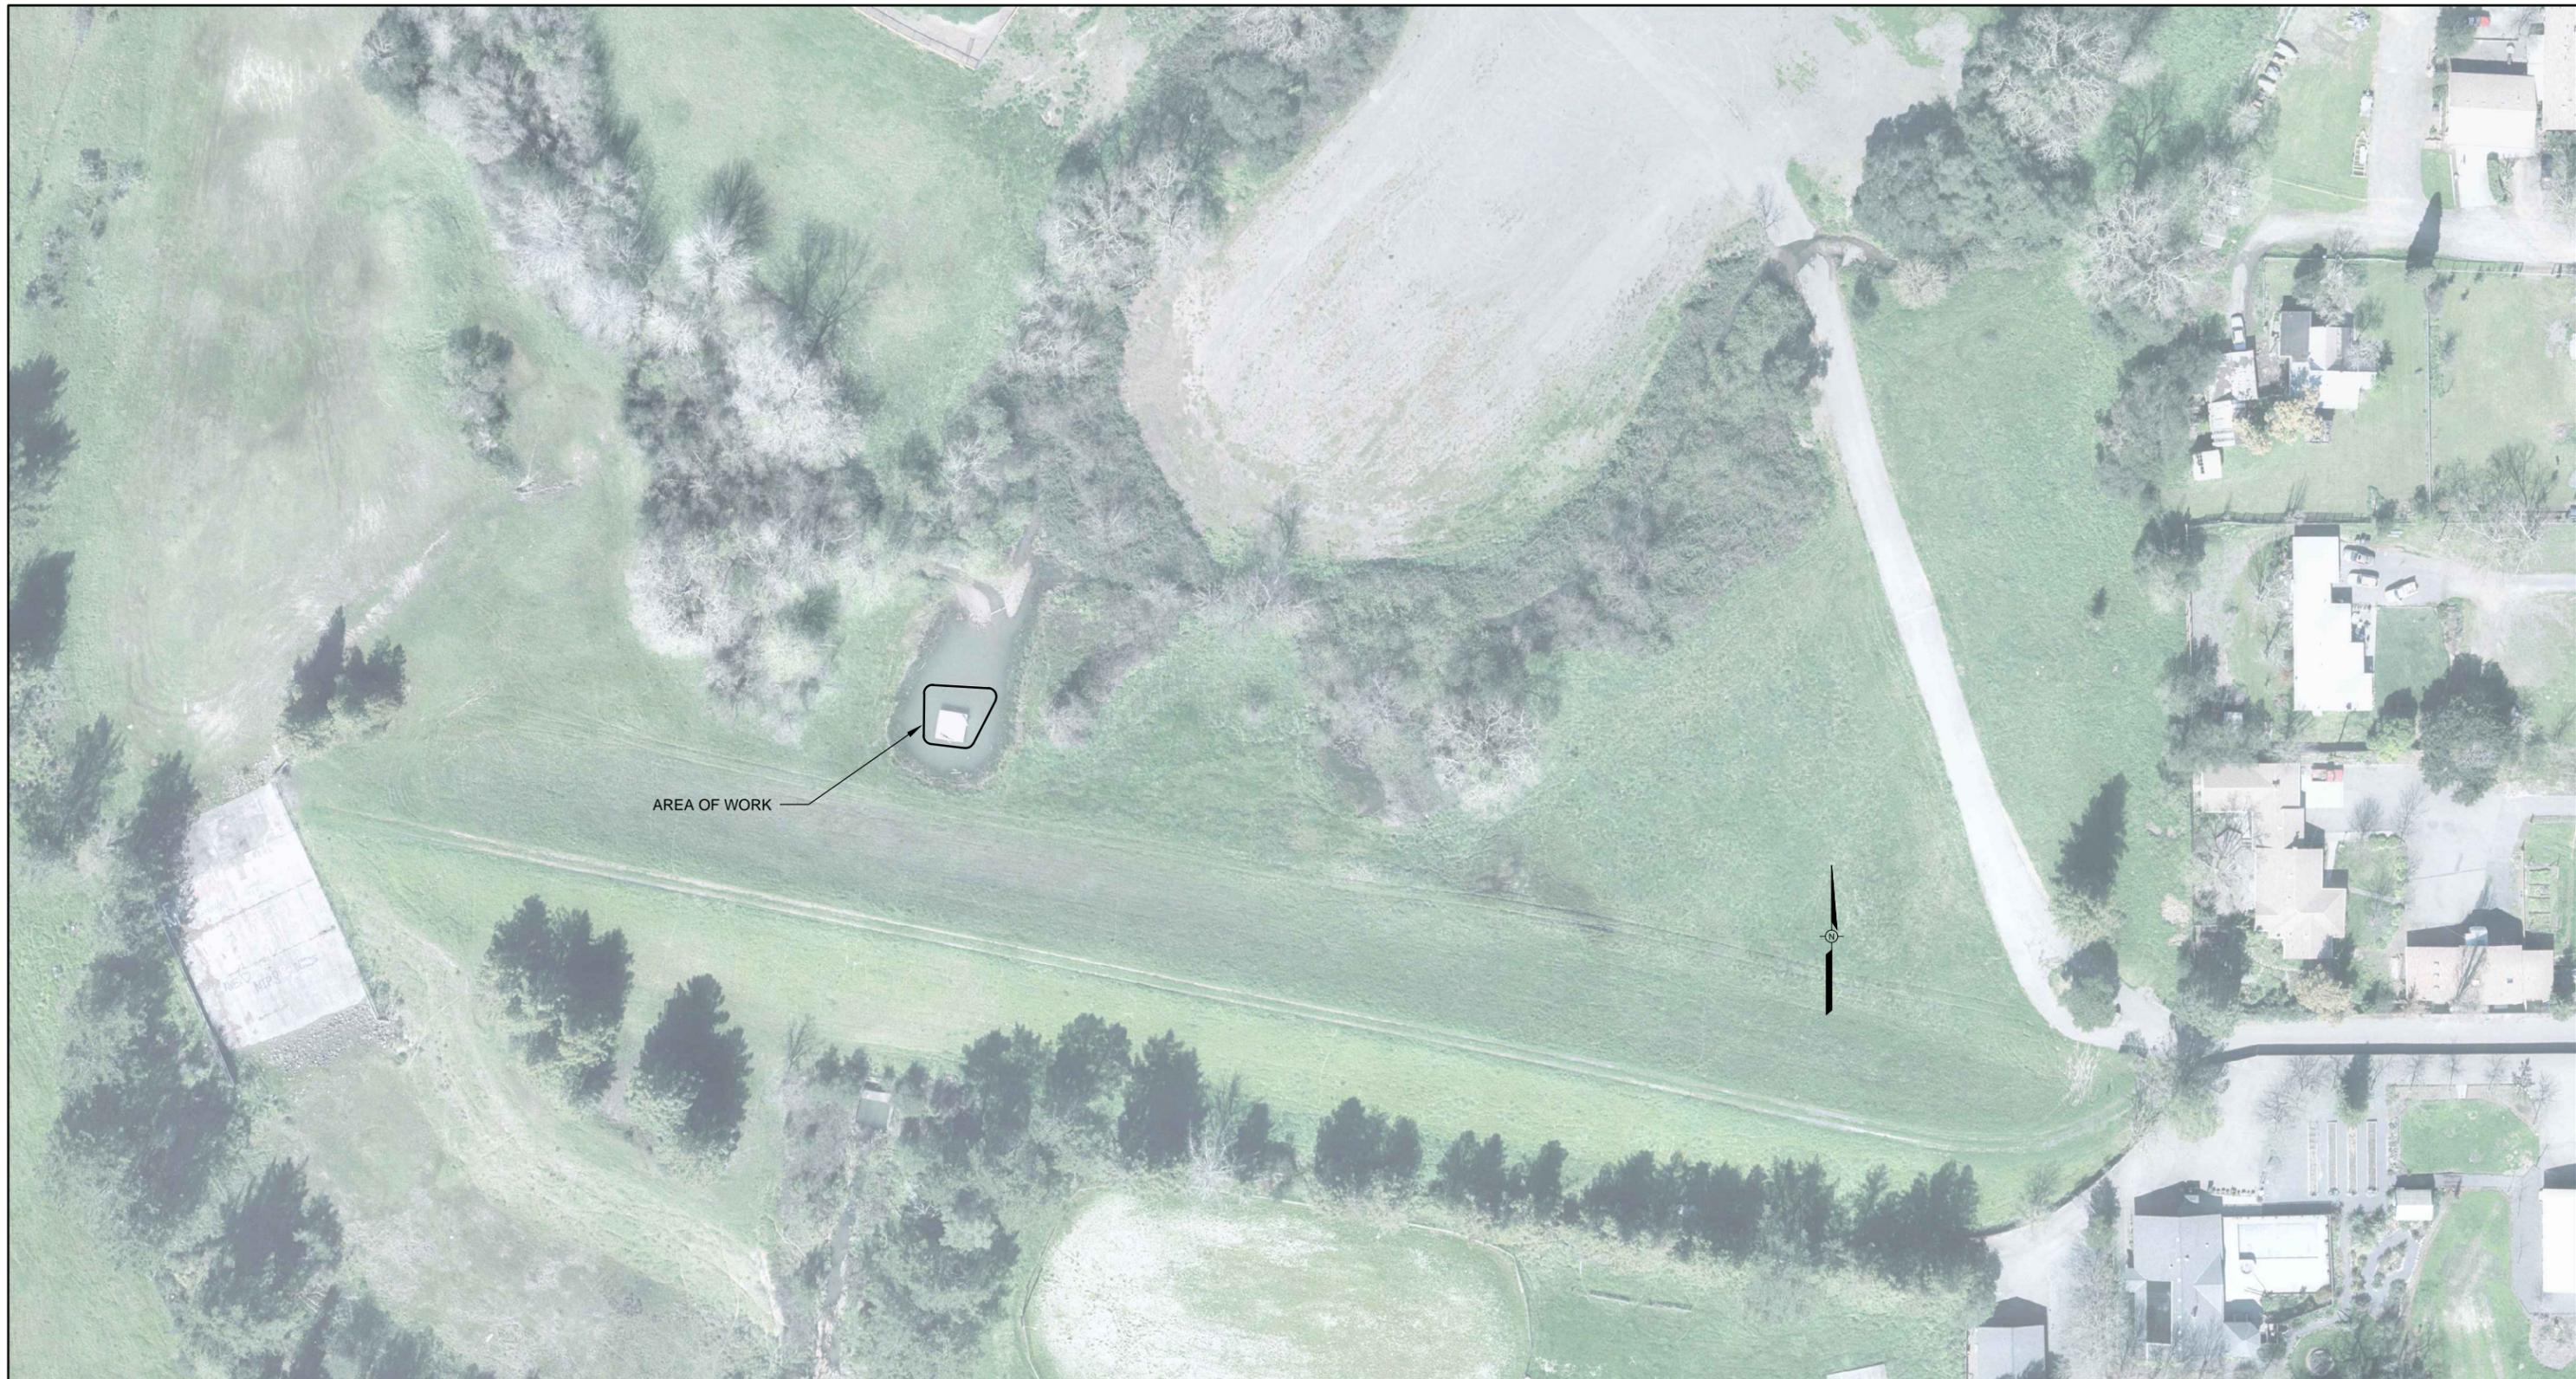
PLAN

AREA OF WORK

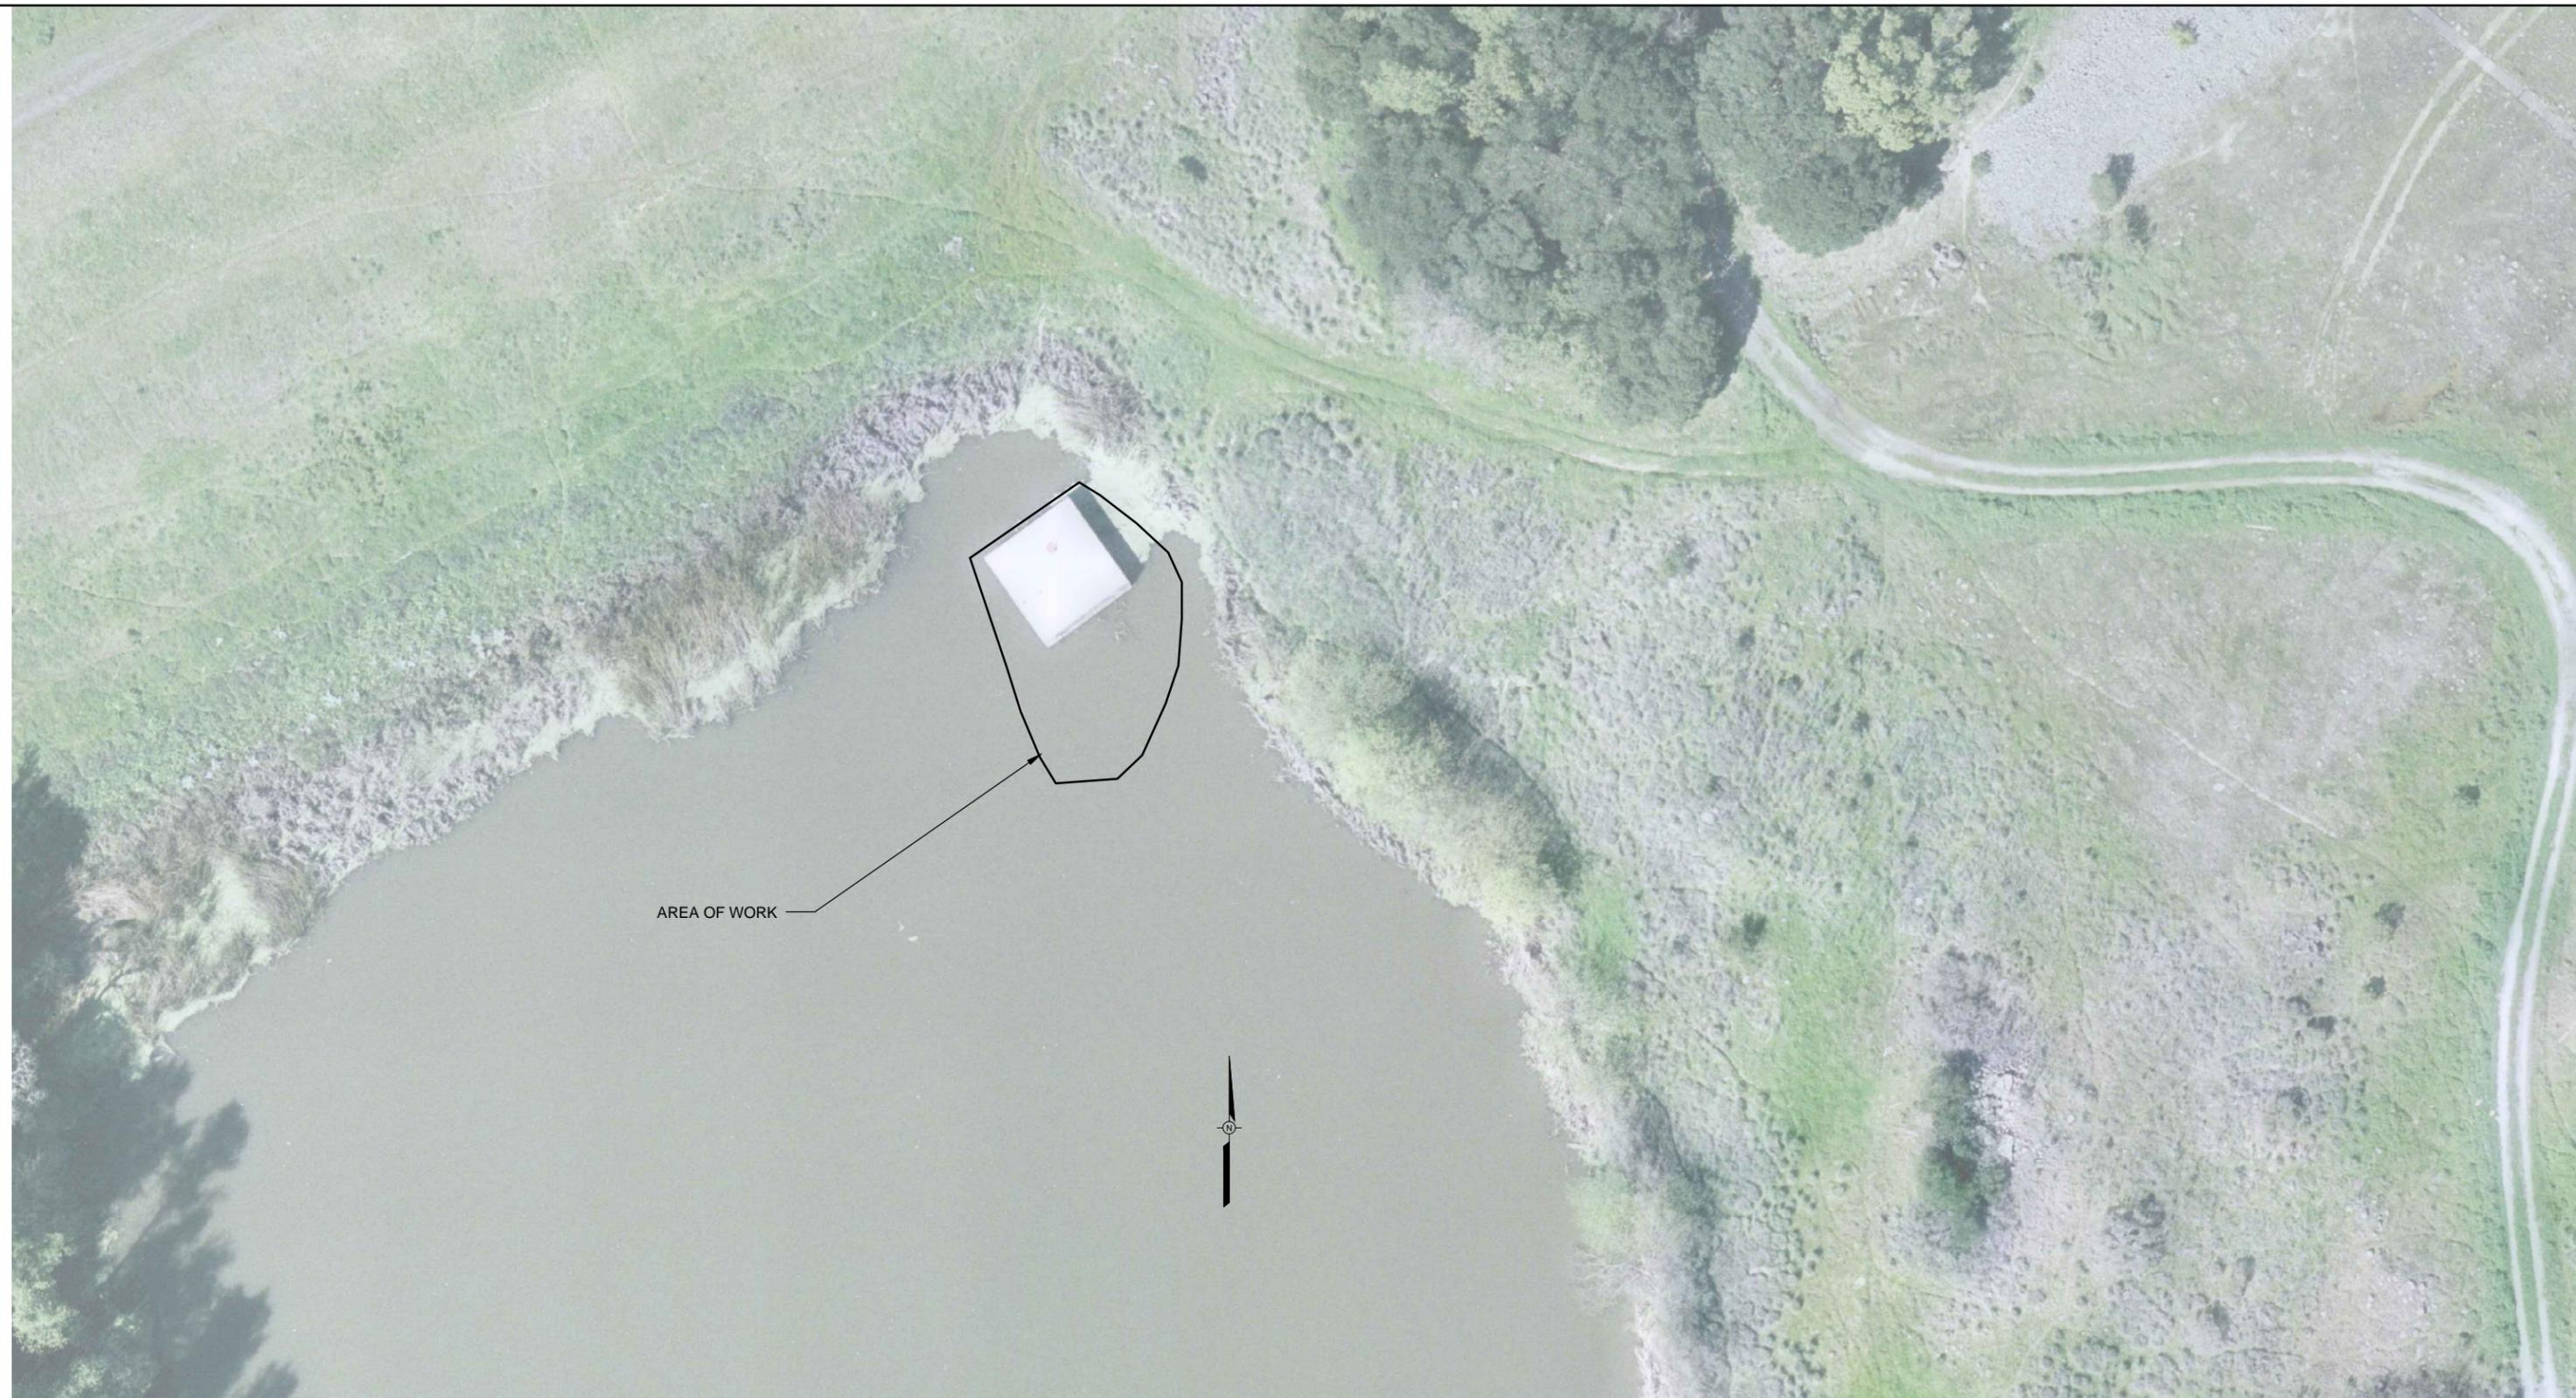
LAGUNA - MARK WEST ZONE 1A PINER CREEK RESERVOIR PLAN - OUTLET	
FILE NAME: c-2_AERIAL.dwg CONTRACT NUMBER:	DRAWING NUMBER: C-2 SHEET 4 OF 9

AREA OF WORK

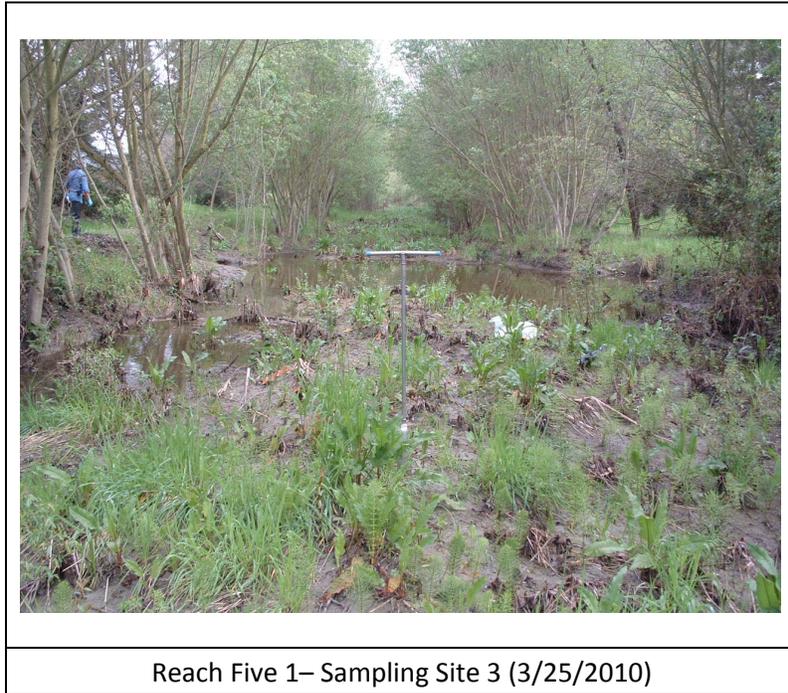
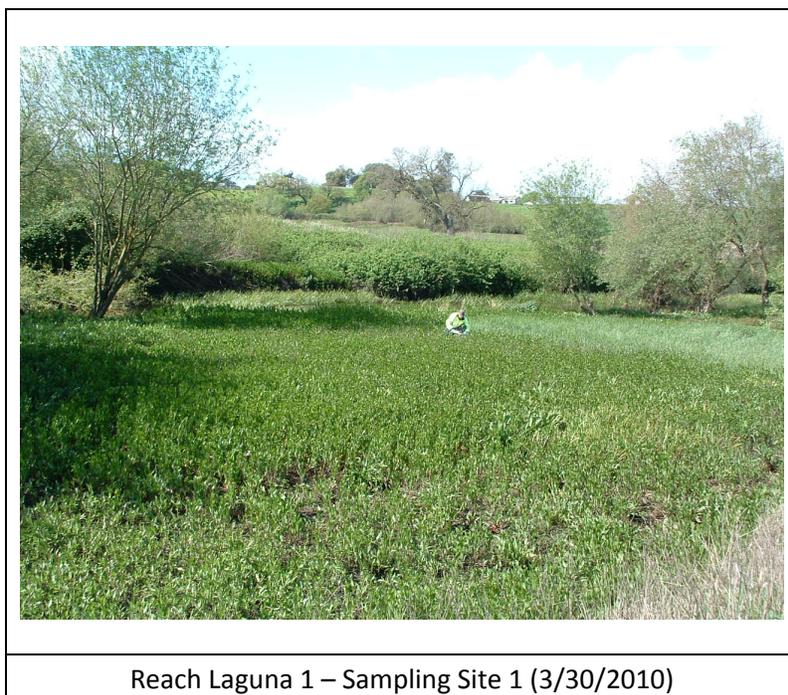
Representative Sampling Photos

The exact locations of all the sediment sampling sites will be provided in a matrix along with the sample results. Below are two photos taken during sediment sampling events conducted in March 2010.

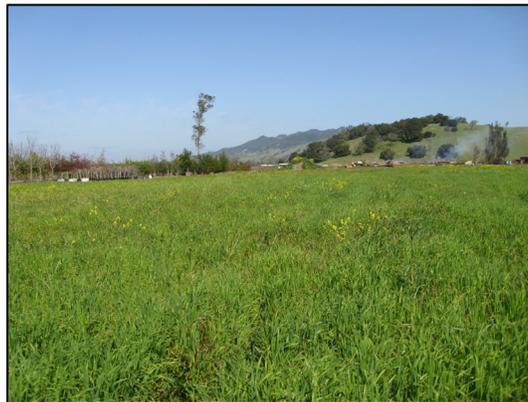
Looking north from southeast corner of Grossi property to area where sediment will be placed for sorting and reuse (3/24/2010)

This Grossi site has the potential capacity to receive the entirety of sediment excavated from the 2010 maintenance sites. The majority of sediment excavated from the Rohnert Park and Cotati areas would be taken to Grossi's property to reduce transportation costs. SMP sediment will not be used for agricultural purposes, such as growing row crops or feed grasses. At the Grossi site, the sediment will not be used for any agricultural purpose to prevent any potential bio-accumulation issues. The sediment will be sorted into size classes and sold as grading material or used as potting soil for nursery planters.

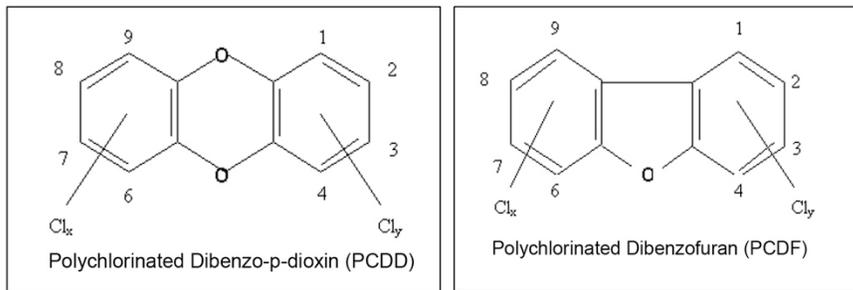
Figure 1. Generic structures of dibenzo dioxin and furan.
