**RUSSIAN RIVER ESTUARY OUTLET CHANNEL
ADAPTIVE MANAGEMENT PLAN
2014**

Sonoma County Water Agency

ESA PWA

May 15, 2014

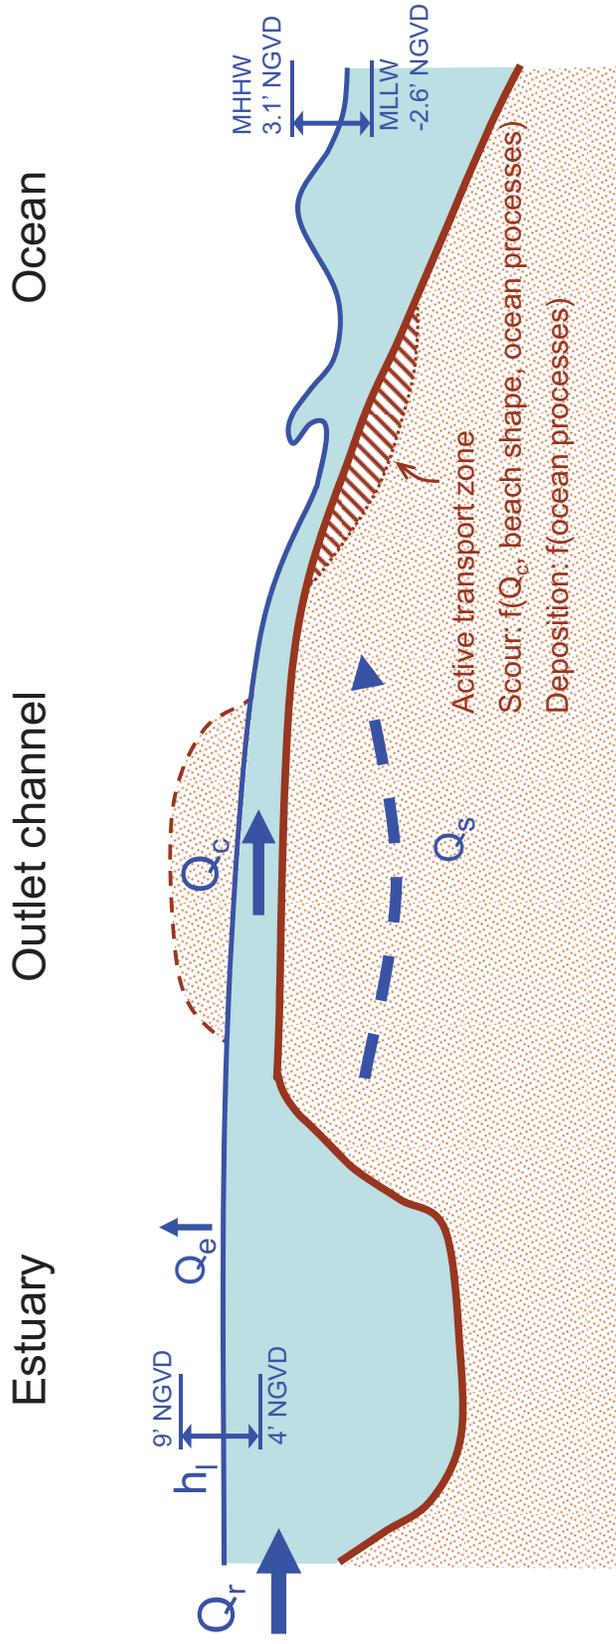
Parameters

h_l = lagoon water level

The conceptual model for target outlet conditions is shown in Figure 2. Ideally, the outlet channel conveys water from the estuary to the ocean so that estuary can be maintained in a non-tidal state during the management period. A key performance criterion of this non-tidal state is that the water levels in the estuary (h_1) fall within the range of 4 to 9 ft NGVD, with elevations above 7 ft NGVD preferred. The estuary water level will not be managed directly, e.g. by pumping. Instead, it will be managed indirectly by management actions dictated by the BO, the operation and maintenance of the outlet channel and the reduction of instream flow requirement.

Although sediment transport will be minimal within the outlet channel under target conditions, the channel's mouth will perpetually be an active transport zone. This portion of the channel, at its interface with the ocean, will be an active transport zone for two reasons. First, it lies within the surf zone and breaking waves move up and down its face in response to the tides and variations in wave

direction, magnitude, and period. Second, this wave action creates a slope on the order of 10:1, which is sufficiently steep that flows of nearly any magnitude from the outlet channel will accelerate to above the scour velocity threshold. In order for the outlet channel to persist with this active transport zone at its mouth, this zone will have to experience minimal net sediment transport. In other words, tidal fluctuations in water level and variability in wave intensity will cause the locations of scour and deposition to shift at hourly timescales, but averaging across several tidal cycles, any sand lost by scour will be balanced by an equivalent amount of deposition. This active transport zone also plays a significant role in lateral migration of the existing channel mouth. This process is discussed in Section 4.4 on planform alignment.

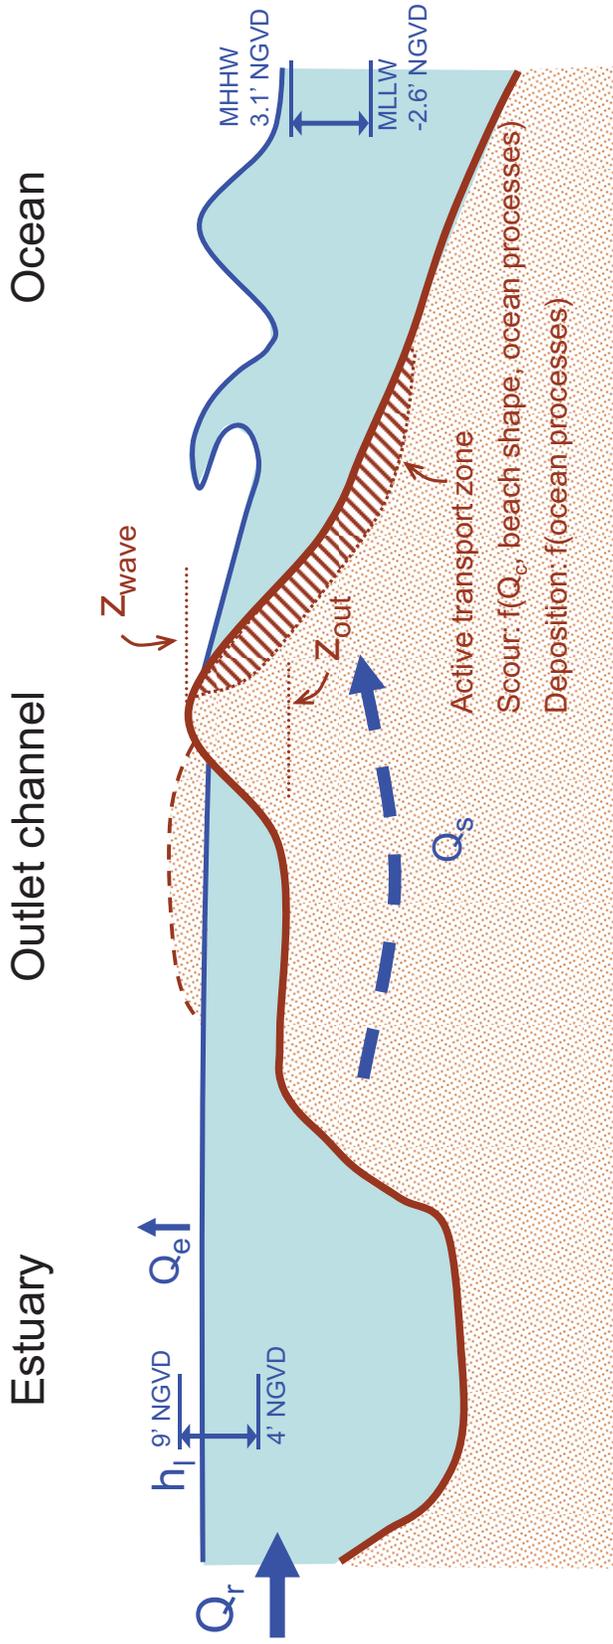
<i>Figure 3</i>	
<i>Russian River Estuary Outlet Channel Management Plan</i>	
Conceptual model – Closure	
PWA Ref# 1958.01

Parameters

- Z_{out} = target channel bed elevation
- Z_{wave} = wave runup elevation; $f(\text{wave conditions, ocean water level, channel location})$

- $Z_{wave} \geq Z_{out}$
- wave-induced sediment transport closes outlet channel
- $Q_c \rightarrow 0$
- h_l increasing

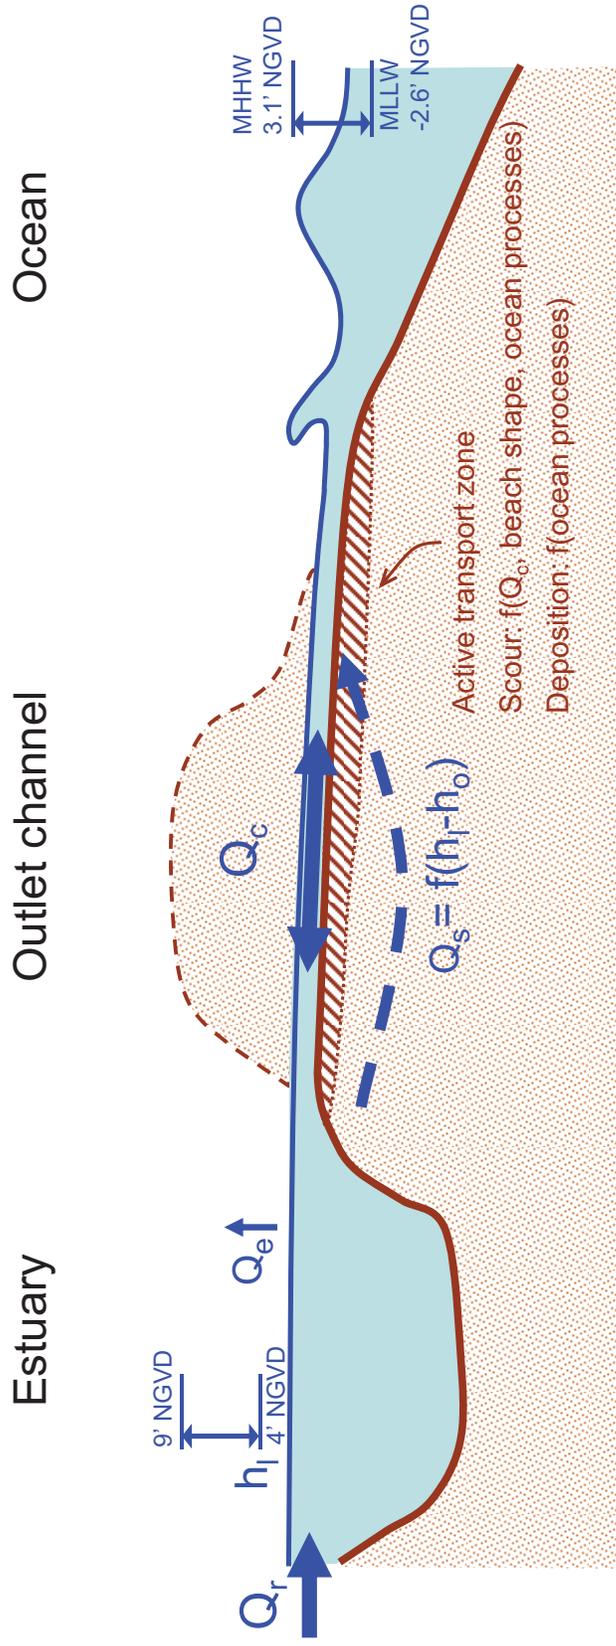
<p>Figure 4 Russian River Estuary Outlet Channel Management Plan</p>	
<p>Conceptual model – Breaching</p>	
	<p>PWA Ref# 1958.01</p>

Parameters

- $u_c = f(\text{channel slope, length, and width}; Q_r; \text{ocean water level})$
(can be managed to greater or lesser degree)
- u_{crit} is $f(\text{grain size})$

The breach failure considered as part of the conceptual model and shown in Figure 4 is breaching that occurs when the outlet channel is operating according to the target conditions described above. Breaching is likely to result from two processes, high discharge which scours the channel bed or seepage-induced bed mobilization. Self or artificial breaching after a closure event are not discussed in this section because it is assumed that management actions would be enacted to return the outlet channel to target conditions prior to either of these breach mechanisms occurring. Additionally, breaching by wave overtopping or strong river discharge are not considered because these processes are associated with winter storm events, which are rare during the management period.

Because the outlet channel is an unconsolidated bed composed of relatively small particles, it is susceptible to scour by the discharge flowing through the outlet channel. Sand scoured from the channel will be lost to the ocean and there is not a significant upstream source to replace scoured sand. Extensive scour will enlarge the channel to the point of breaching and tidal inflows. To prevent scour, flow conditions within the outlet channel (u_c) must be below the threshold for scouring sand (u_{crit}). This threshold is a function of the sand grain size, which has been observed to be coarse sand, narrowly distributed around 1 mm at the Russian River mouth (EDS, 2009a). Further north on the beach, large rocks imbedded in the beach berm may provide grade control and limit scour. Whether the flow velocity is below the threshold depends on the type of bed material and hydraulic conveyance through the management parameters of the outlet channel's width, length, and bed slope.

As noted in the description of target channel conditions, the beach face slope is set by wave action in the surf zone and is sufficiently steep that flow velocity exceeds threshold for sand movement for all expected discharge rates. Under target conditions, the sand scoured by this process will be replaced by wave action on high tides, yielding no net change in the channel mouth morphology. However, if the scour is larger than deposition on the beach face, the active scour zone may move landward, into the outlet channel. This upstream movement is similar to nick point migration or head-cutting observed in streams and rivers. It is also the process observed by the Agency's maintenance staff when the beach berm is artificially breached under current practice. The breaching typically happens very quickly, before wave-induced sand transport can close off the breach in subsequent higher tides.

A second possible mechanism of breaching is seepage-induced sand mobilization, represented in Figure 4 as an arrow associated with Q_s . If seepage rates are sufficiently large, the movement of water through the sand can mobilize sand particles where the seepage flow daylight at the ground surface. Piping of groundwater along preferred pathways, which may exist within or adjacent to the jetty, might encourage this process by increasing flow rates through portions of the beach. Although seepage failure has not been observed at the Russian River estuary, it has been observed at other estuaries including Crissy Field (Battalio et al 2006) and others (Kraus et al 2002). Seepage failure may simultaneously accompany other breach mechanisms and hence be difficult to identify on its

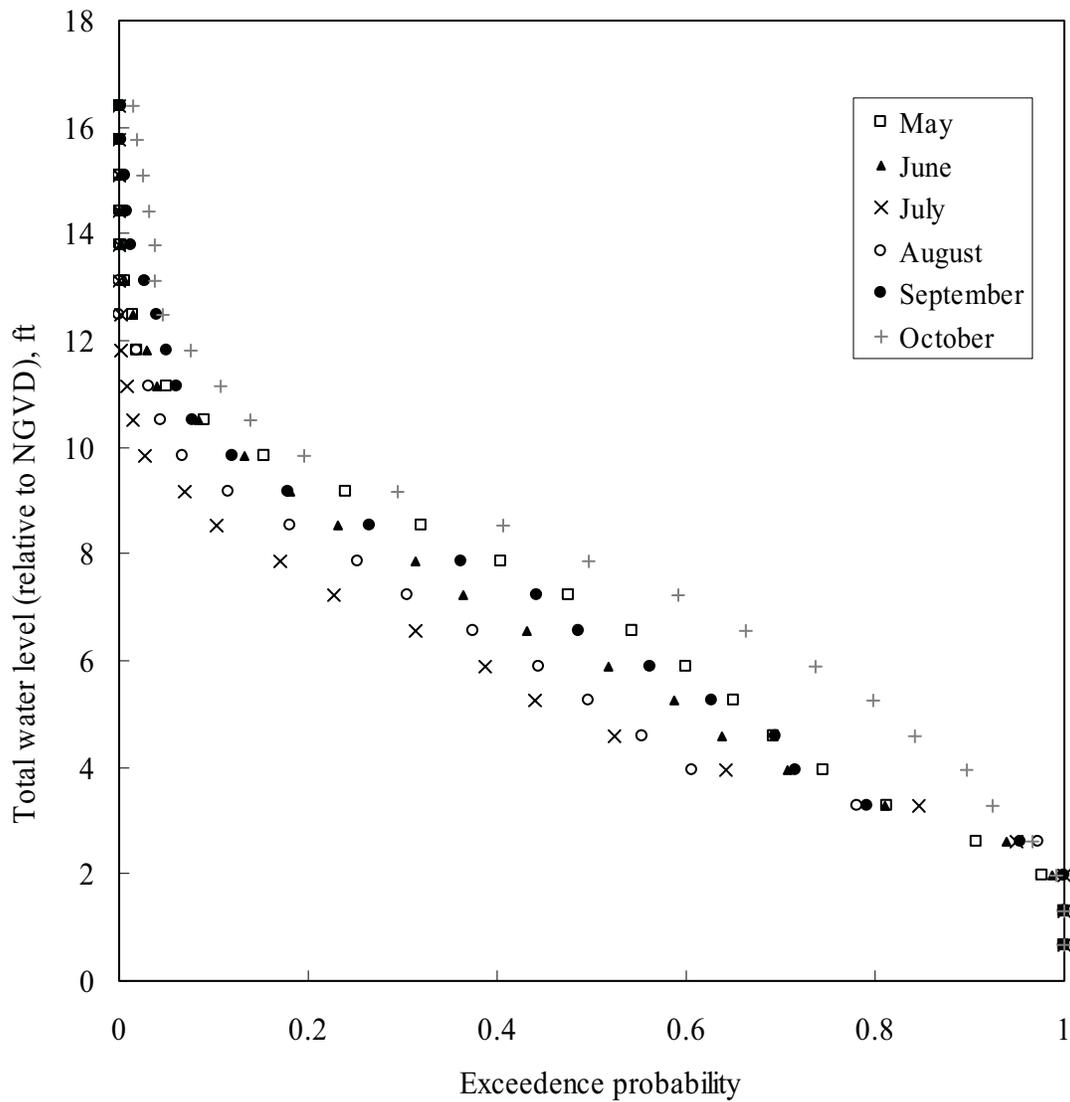
figure 5
 Russian River Outlet Channel Management Plan

Source: D. Behrens (unpublished). Wave data from CDIP Point Reyes buoy.
 Note: Total water level calculated as sum of daily higher high tide and wave runup elevation. Wave runup calculated from Stockdon et al (2006) using estimated de-shoaled deepwater equivalent wave heights.

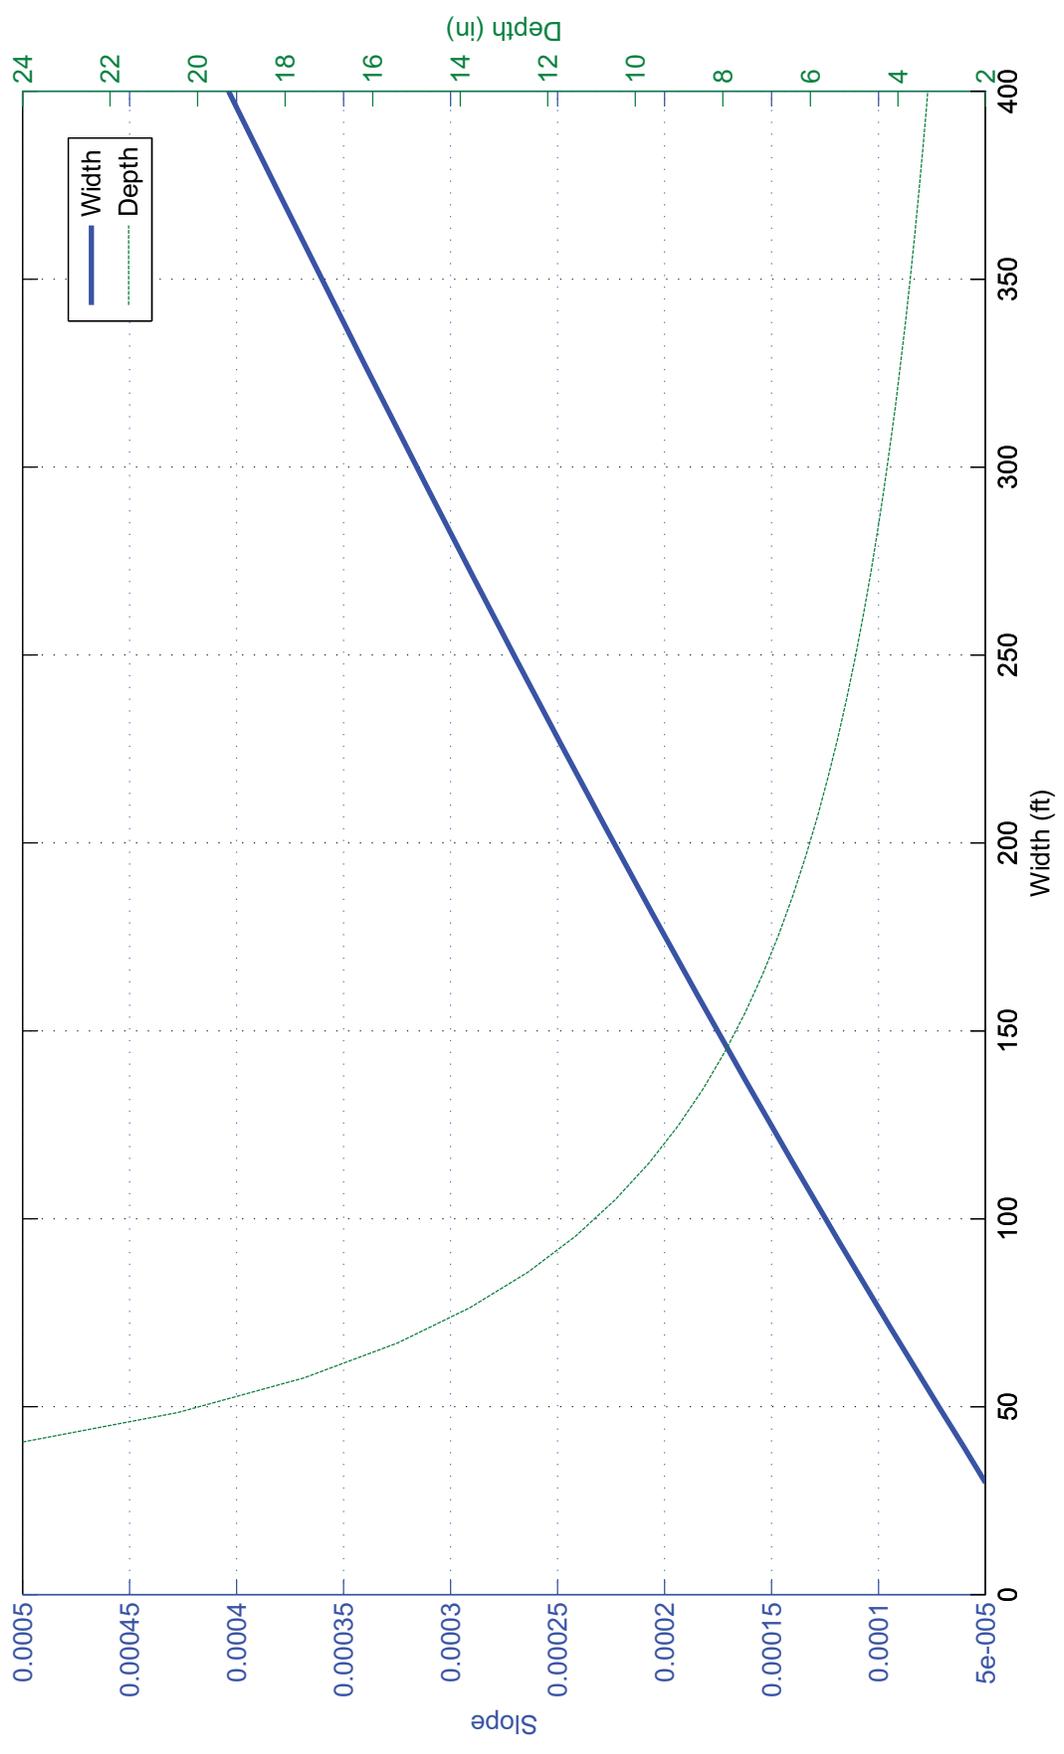
Figure 6
Russian River Estuary Outlet Channel Management Plan

Source: Stability curve for local bed shear stress of 0.5 Pa, flowrate of 70 cfs, and Manning's roughness of 0.02.

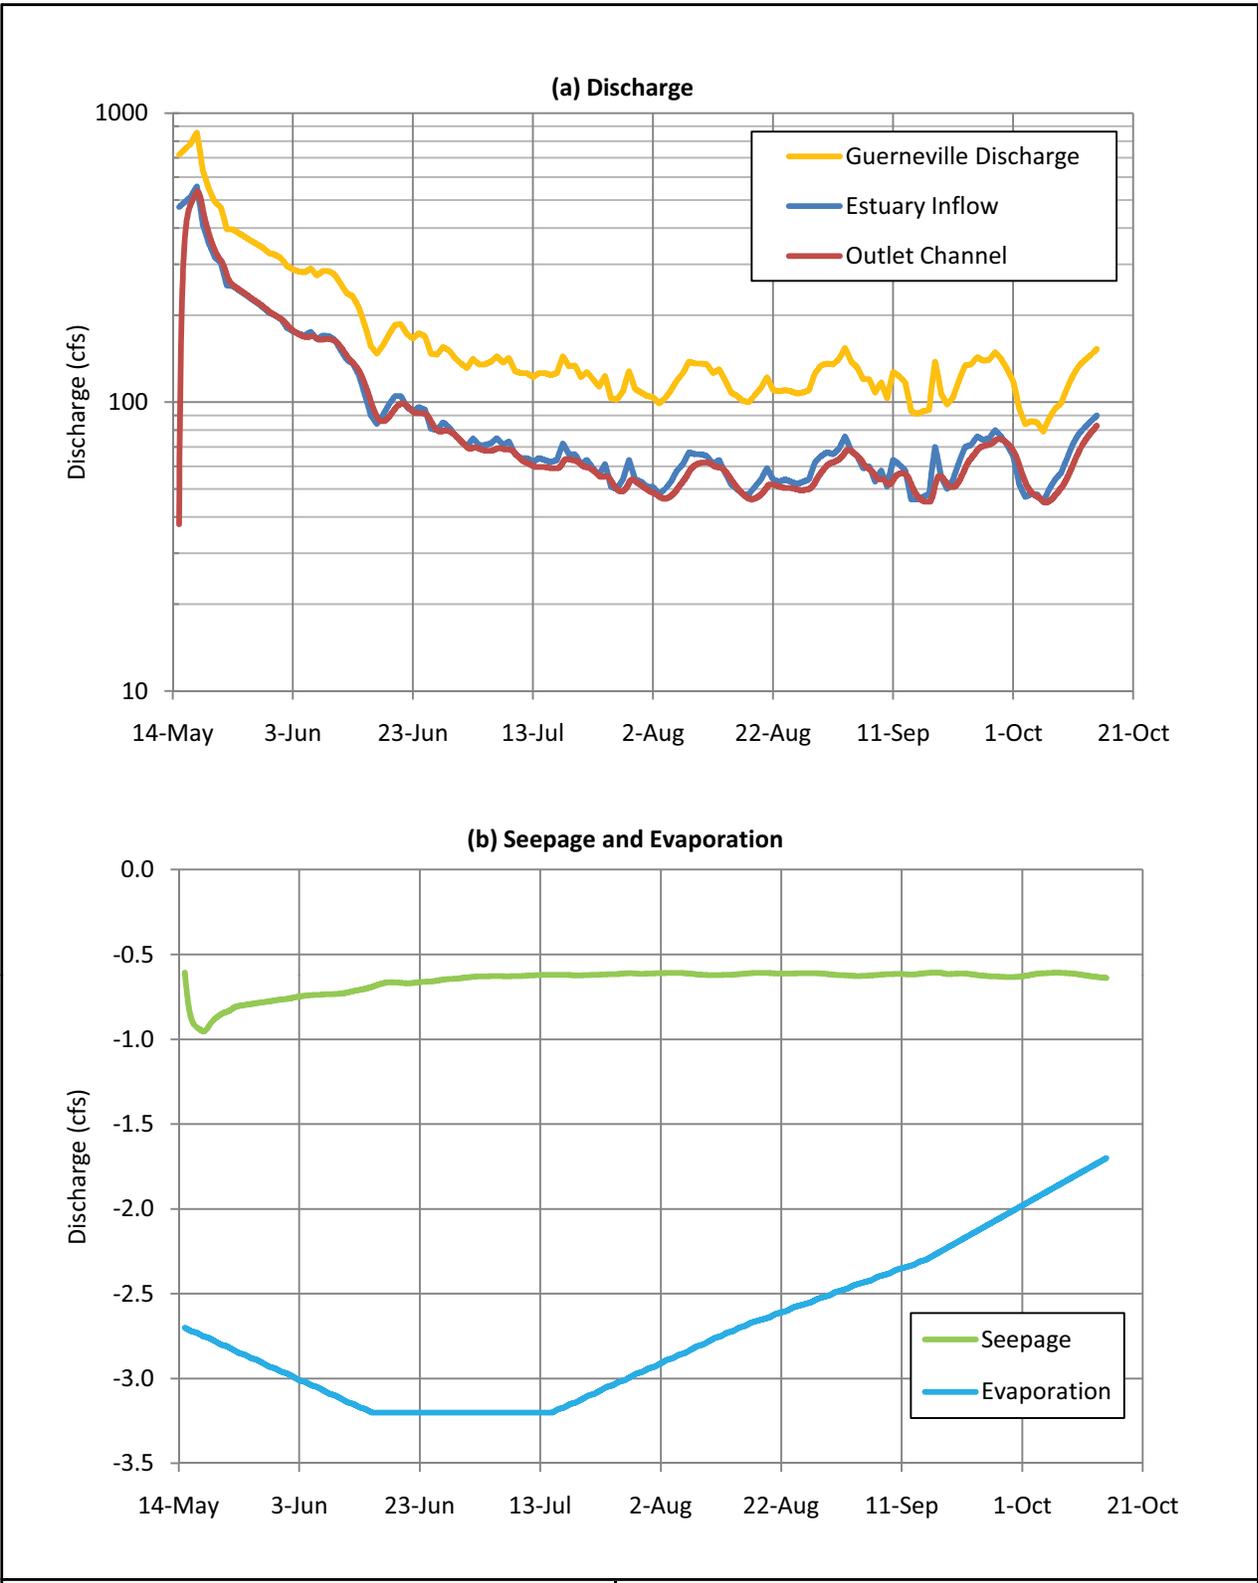
figure 7

Source: 2010 anticipated discharge at Guerneville and into lagoon calculated by scaling observed 2000 discharge at USGS gage #11467000 (Russian River near Guerneville, CA). Evaporation rates calculated from monthly climatological rates for CIMIS evapotranspiration zone 1 (California coast).

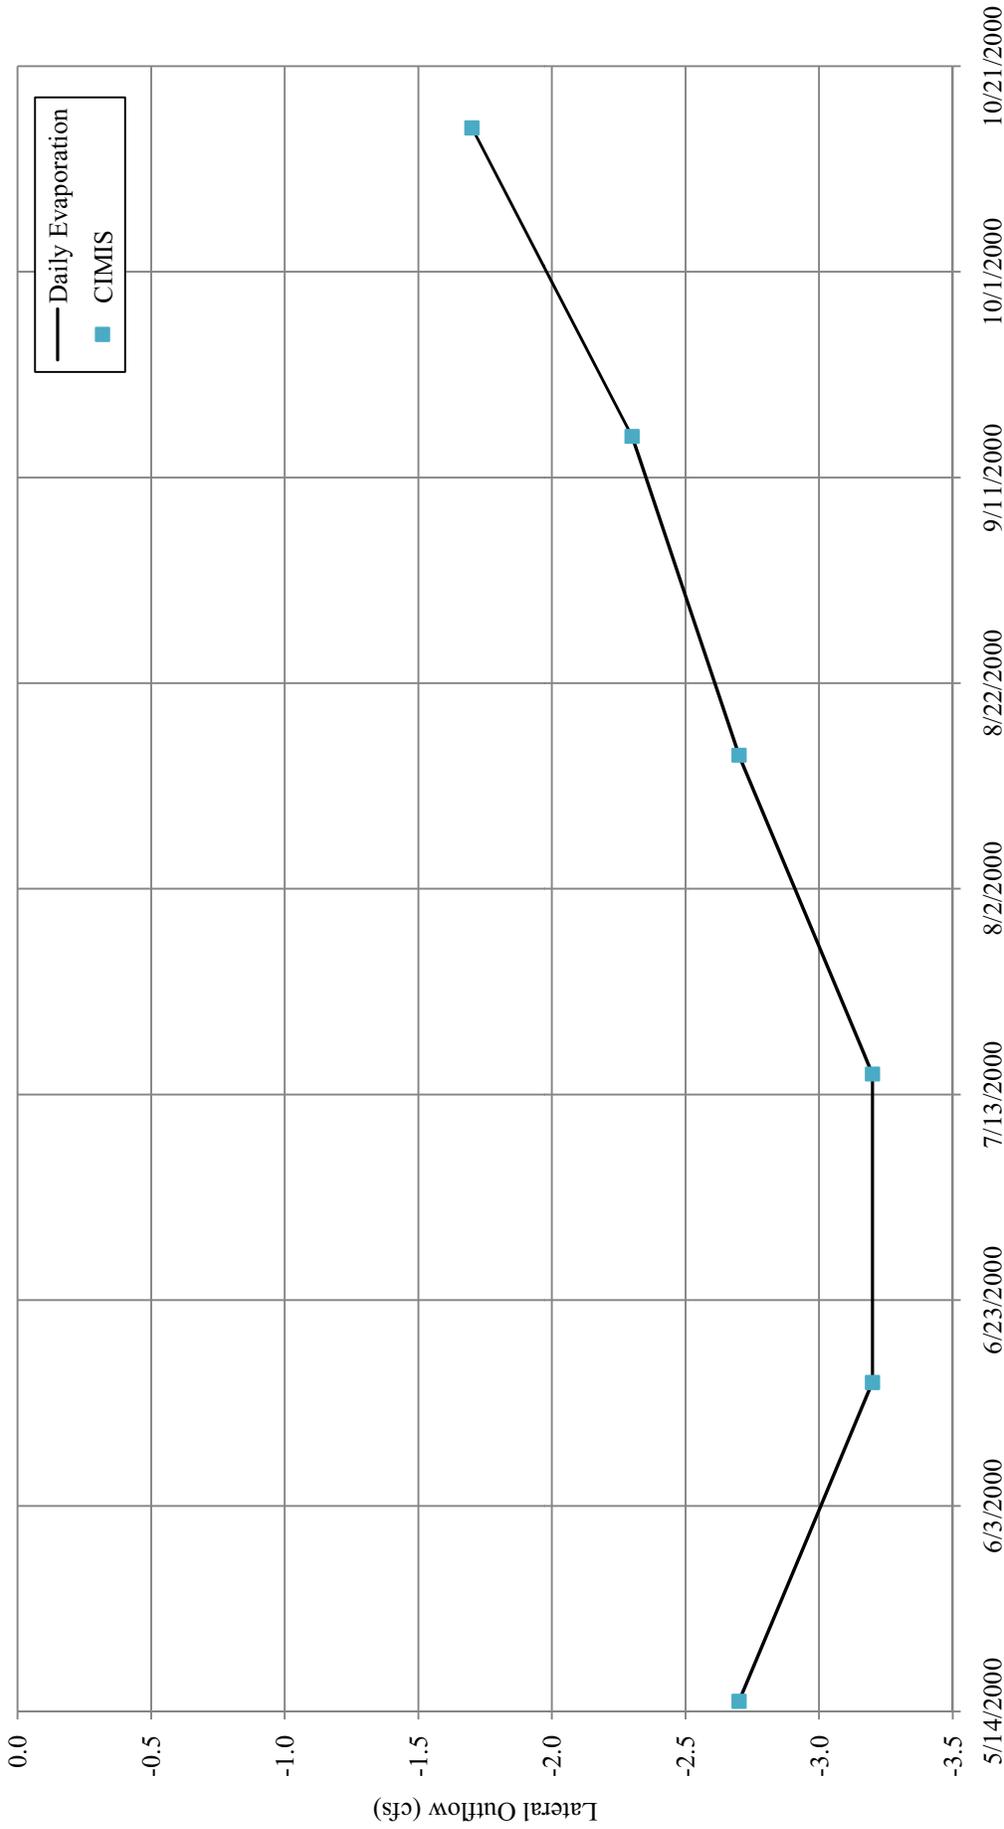
Appendix A-3
Russian River Estuary Outlet Channel Management Plan

Notes: Daily evaporation rates for Russian River lagoon interpolated from CIMIS average monthly evapotranspiration statistics for Zone 1 (Coastal plains and heavy fog). Calculations assume lagoon surface area of 500 acres.

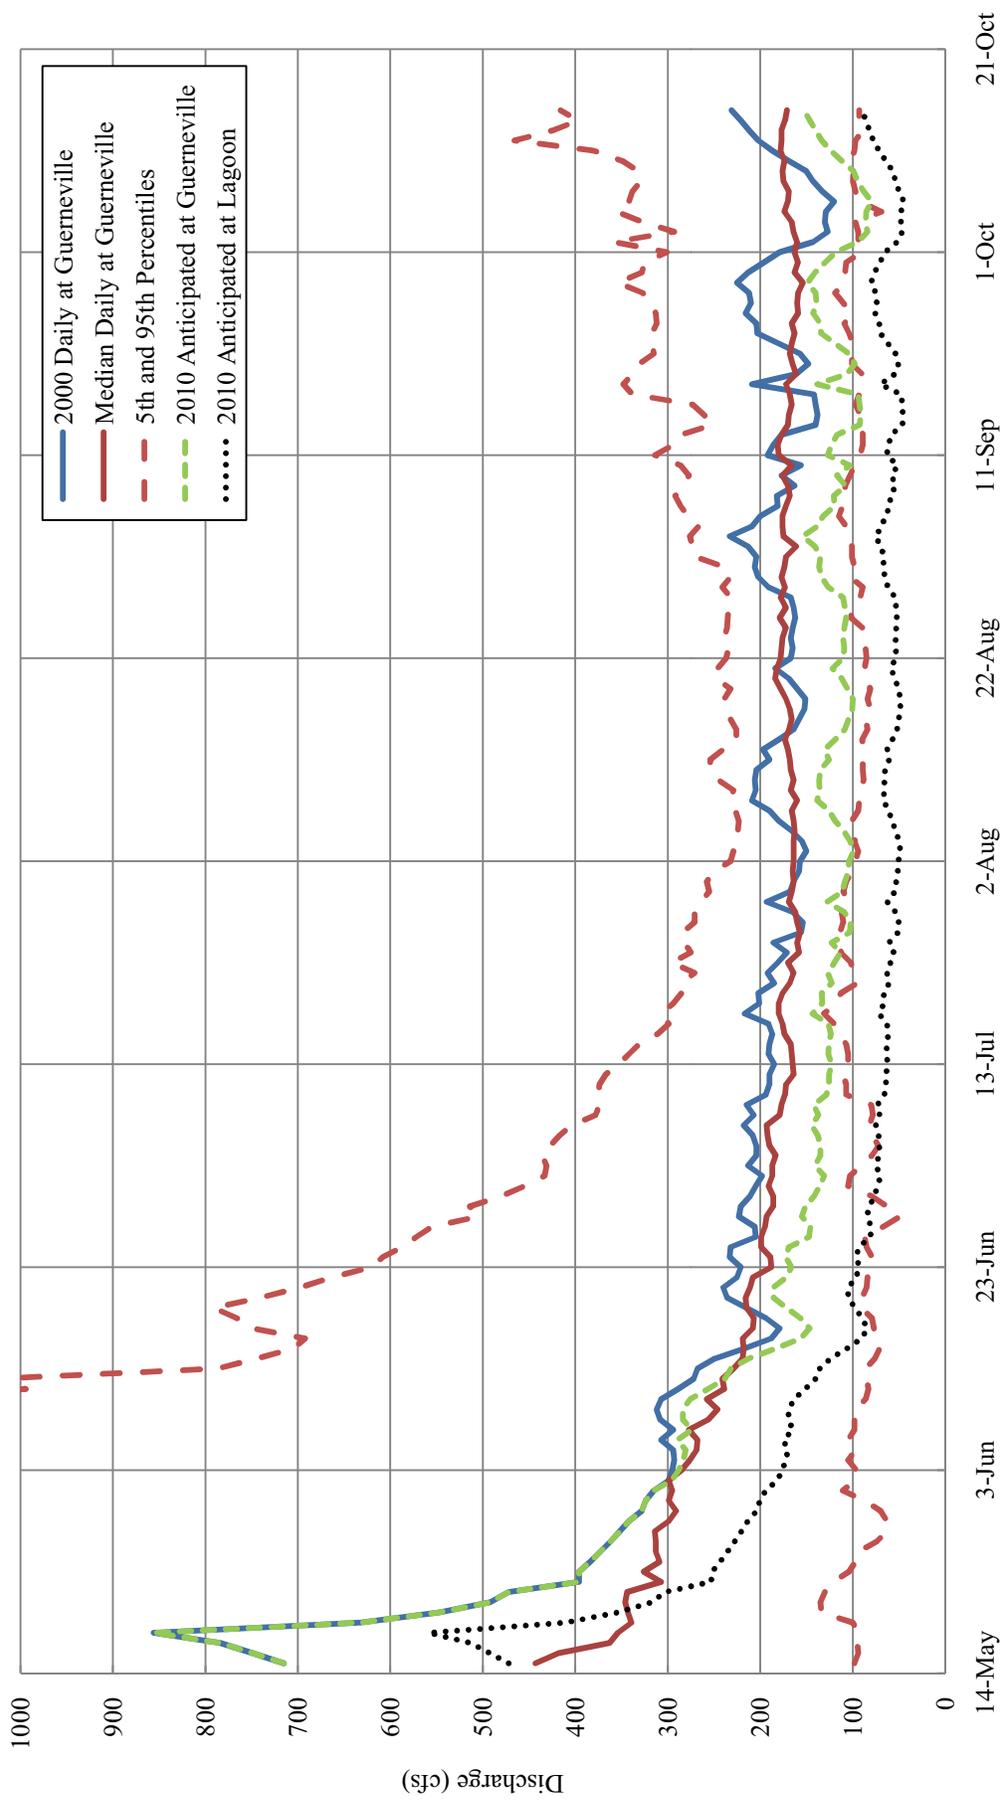
Appendix A-6
 Russian River Estuary Outlet Channel Management Plan

Notes: Median daily discharge calculated from 1970-2008.
 Source: USGS gage 11467000 (Russian River near Guerneville, CA). 2010 anticipated discharge at Guerneville calculated from 2000 discharge by scaling factor to obtain typical summertime flowrates of 120 cfs. 2010 anticipated lagoon inflow calculated based on calibrated seasonal losses from Guerneville to lagoon.

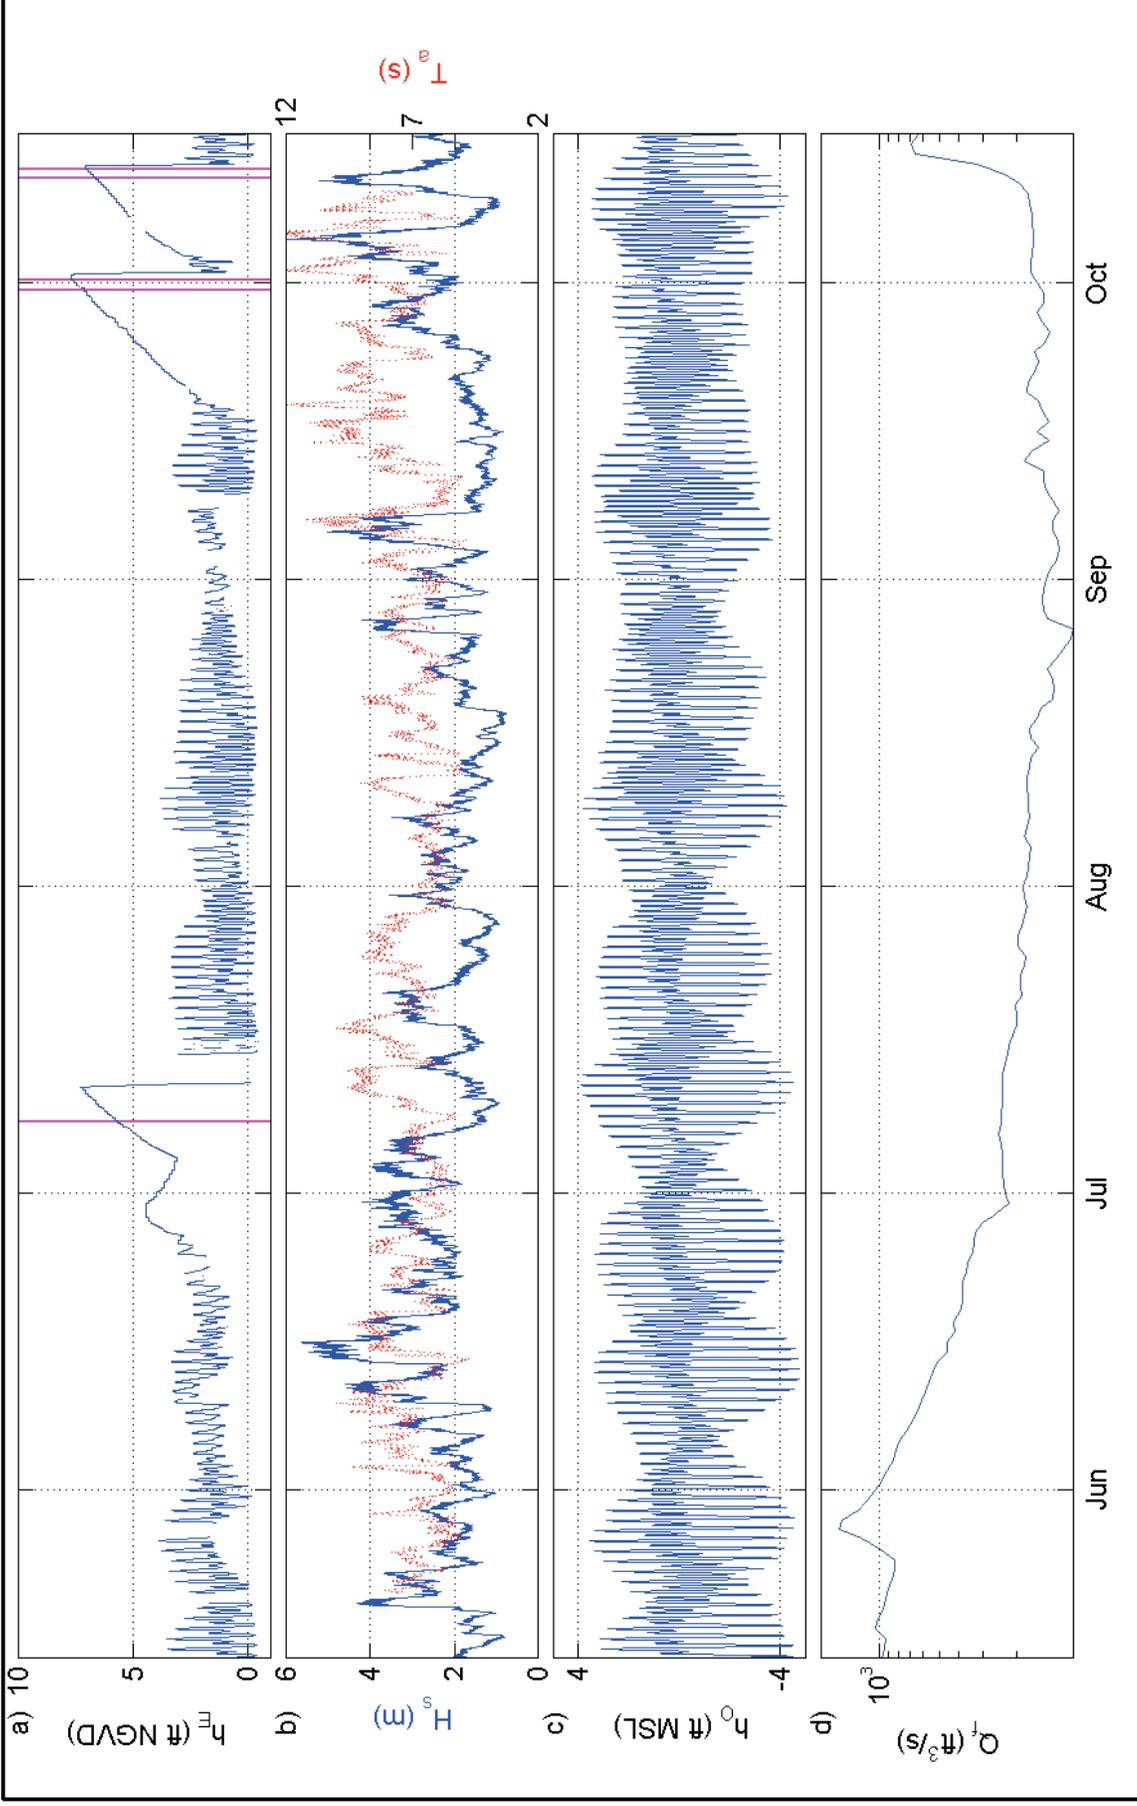
Figure 1
 Russian River Estuary Outlet Channel Management Plan
 Estuary and Ocean Conditions, May 15 - October 15 2010

Sources:
 a) h_e = estuary water level (SCWA); pink bar = mmgt action
 b) H_s = sig. wave height; T_s = avg. wave period (CDIP, Pt. Reyes, #029)
 c) h_o = ocean water level (NOAA, Pt. Reyes #9415020)
 d) Q_r = river discharge (USGS, Guerneville #11467000)

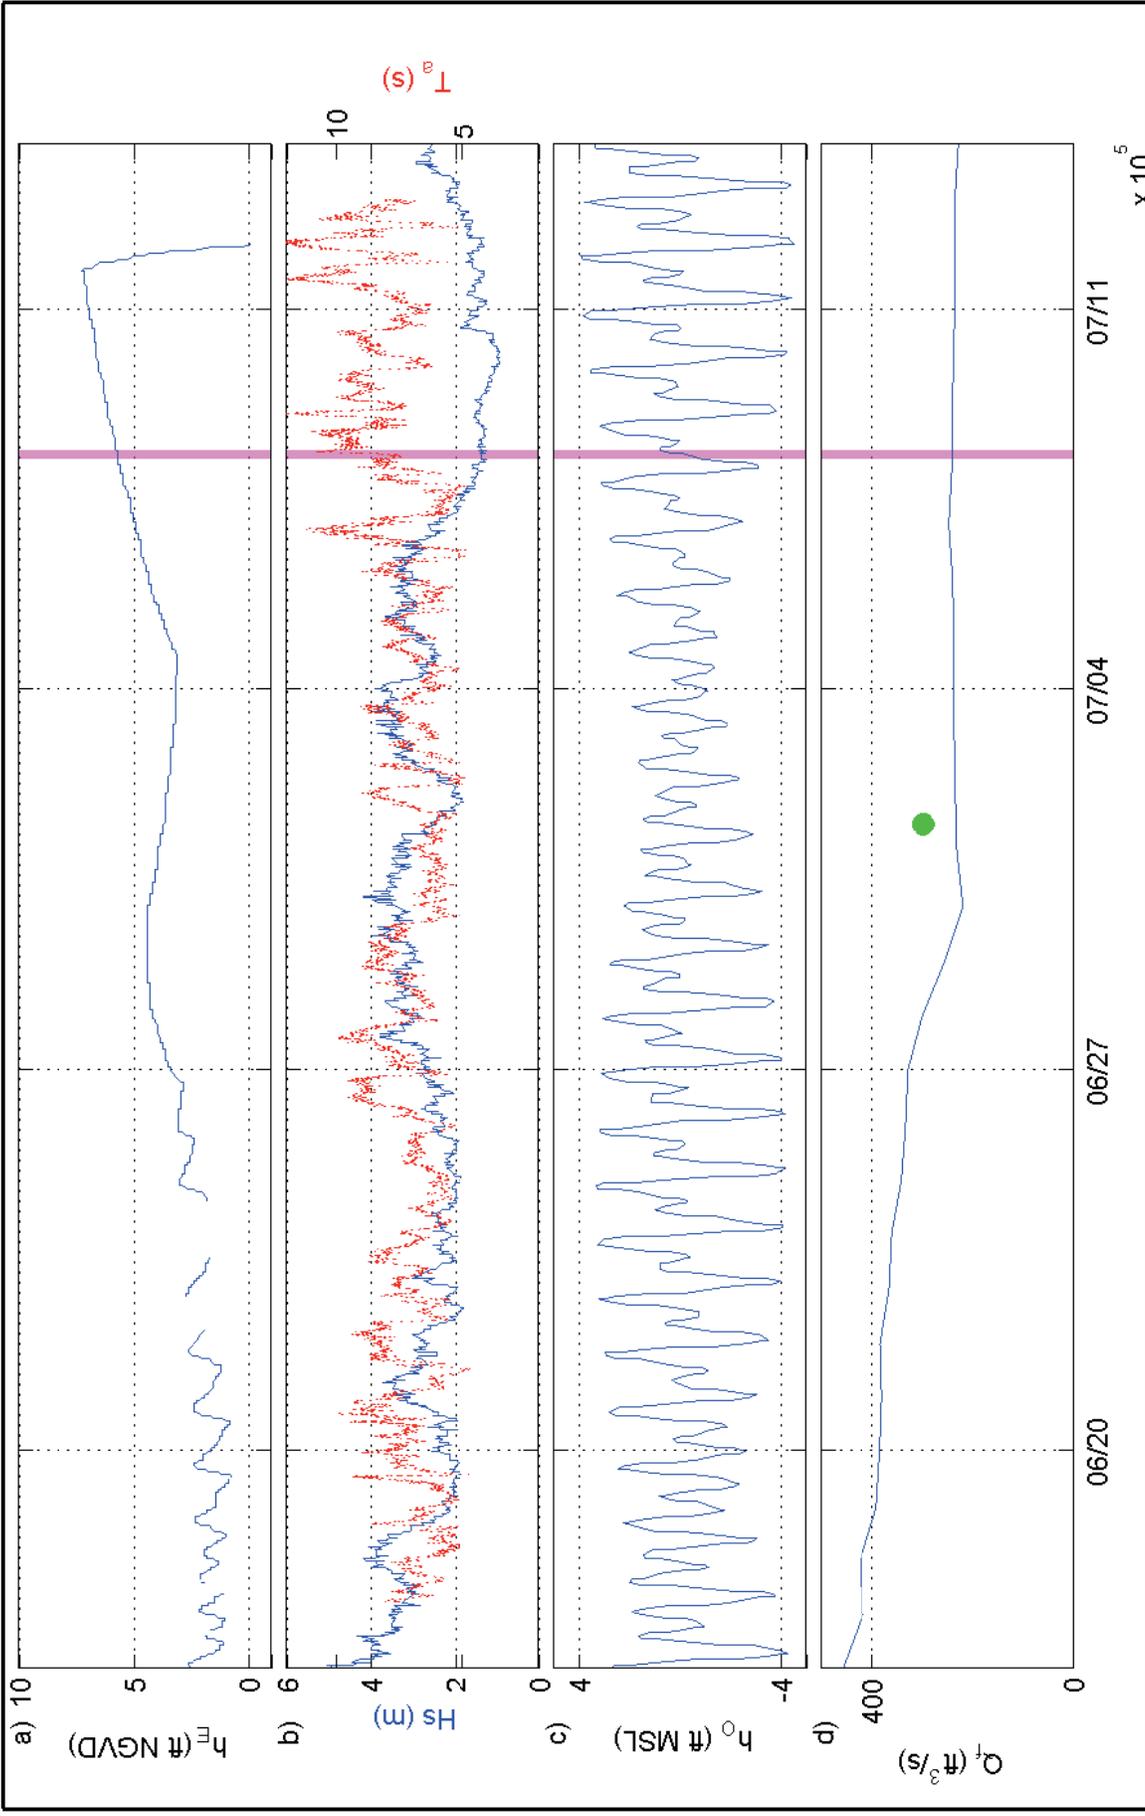
Figure 2
Russian River Estuary Outlet Channel Management Plan

Estuary and Ocean Conditions, June - July 2010

- Sources:
- a) h^E = estuary water level (SCWA); pink bar = mnngt action
 - b) H_s = sig. wave height; T_s = avg. wave period (CDIP, Pt. Reyes, #029)
 - c) h^o = ocean water level (NOAA, Pt. Reyes #9415020)
 - d) Q_r = river discharge (USGS, Guerneville #11467000)

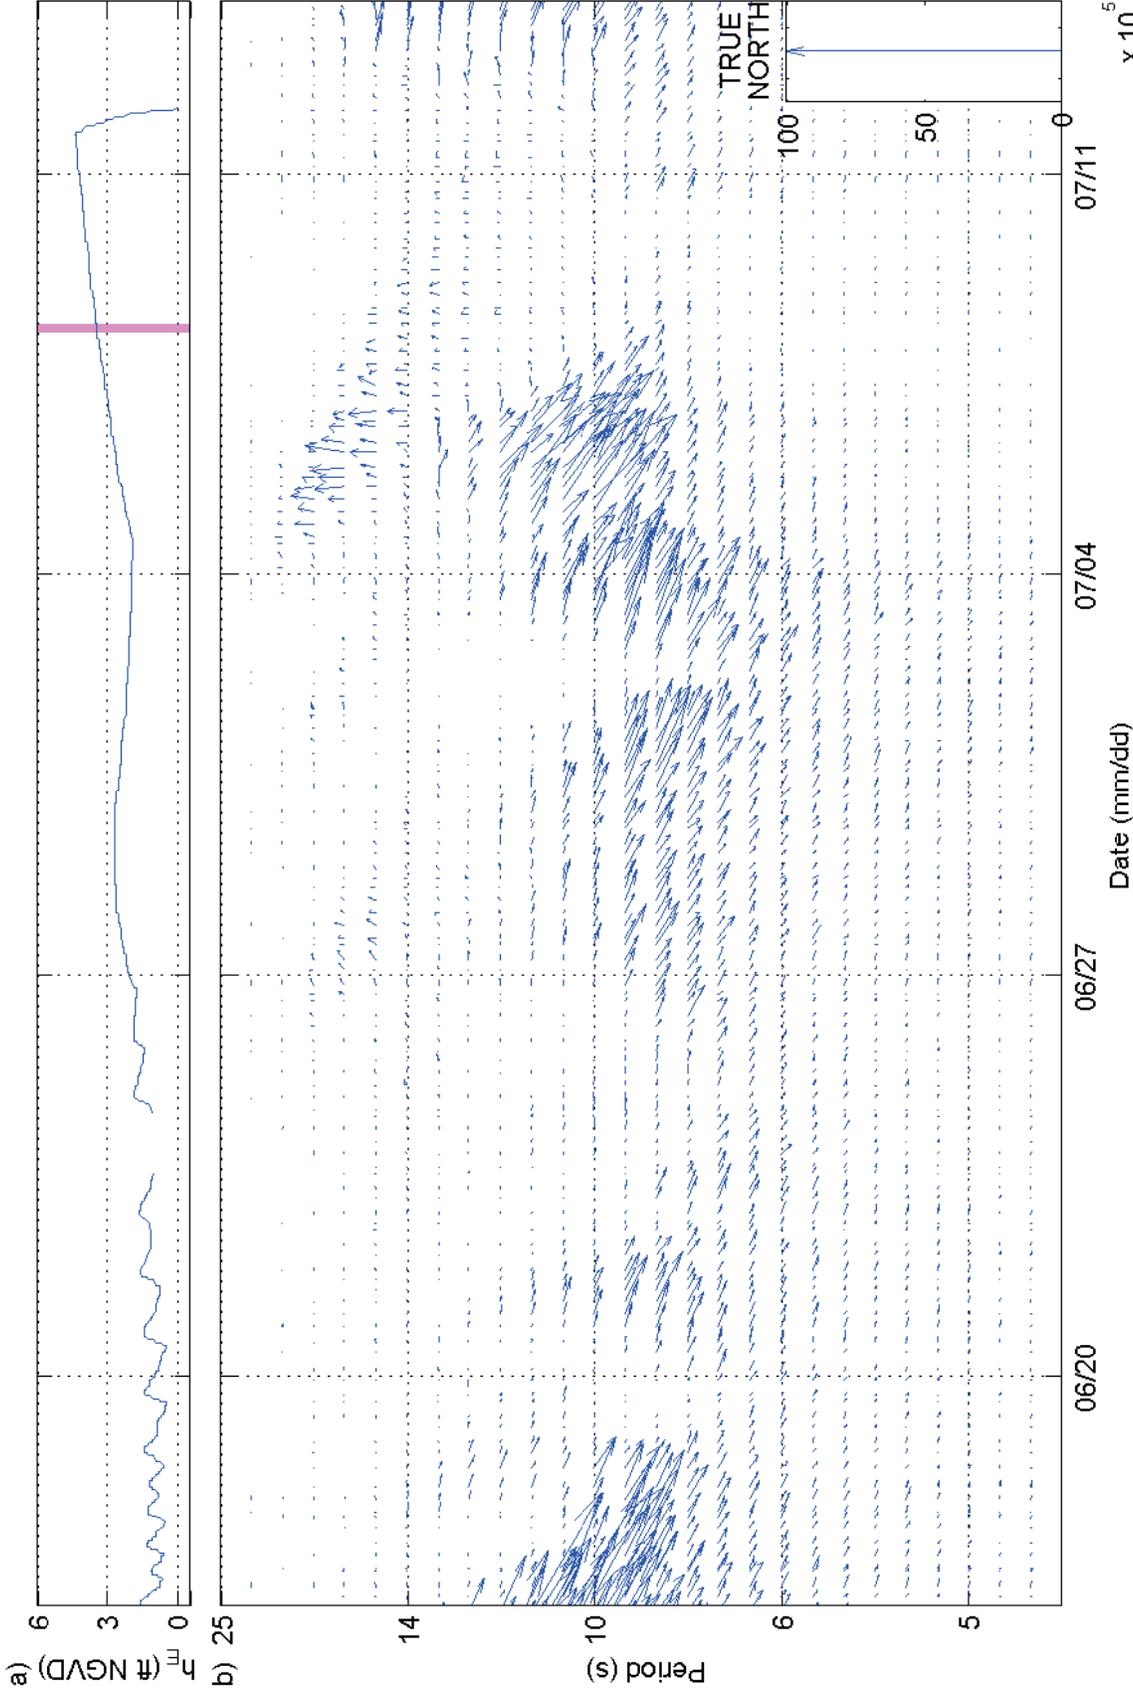
Figure 3
 Russian River Estuary Outlet Channel Management Plan
 Estuary Water Level and Wave Energy/Direction Spectrum
 JUNE-JULY 2010

Sources:
 a) h_E = estuary water level (SCWA); pink bar = mnngt action
 b) Wave magnitude and direction (CDIP, Pt. Reyes, #029)

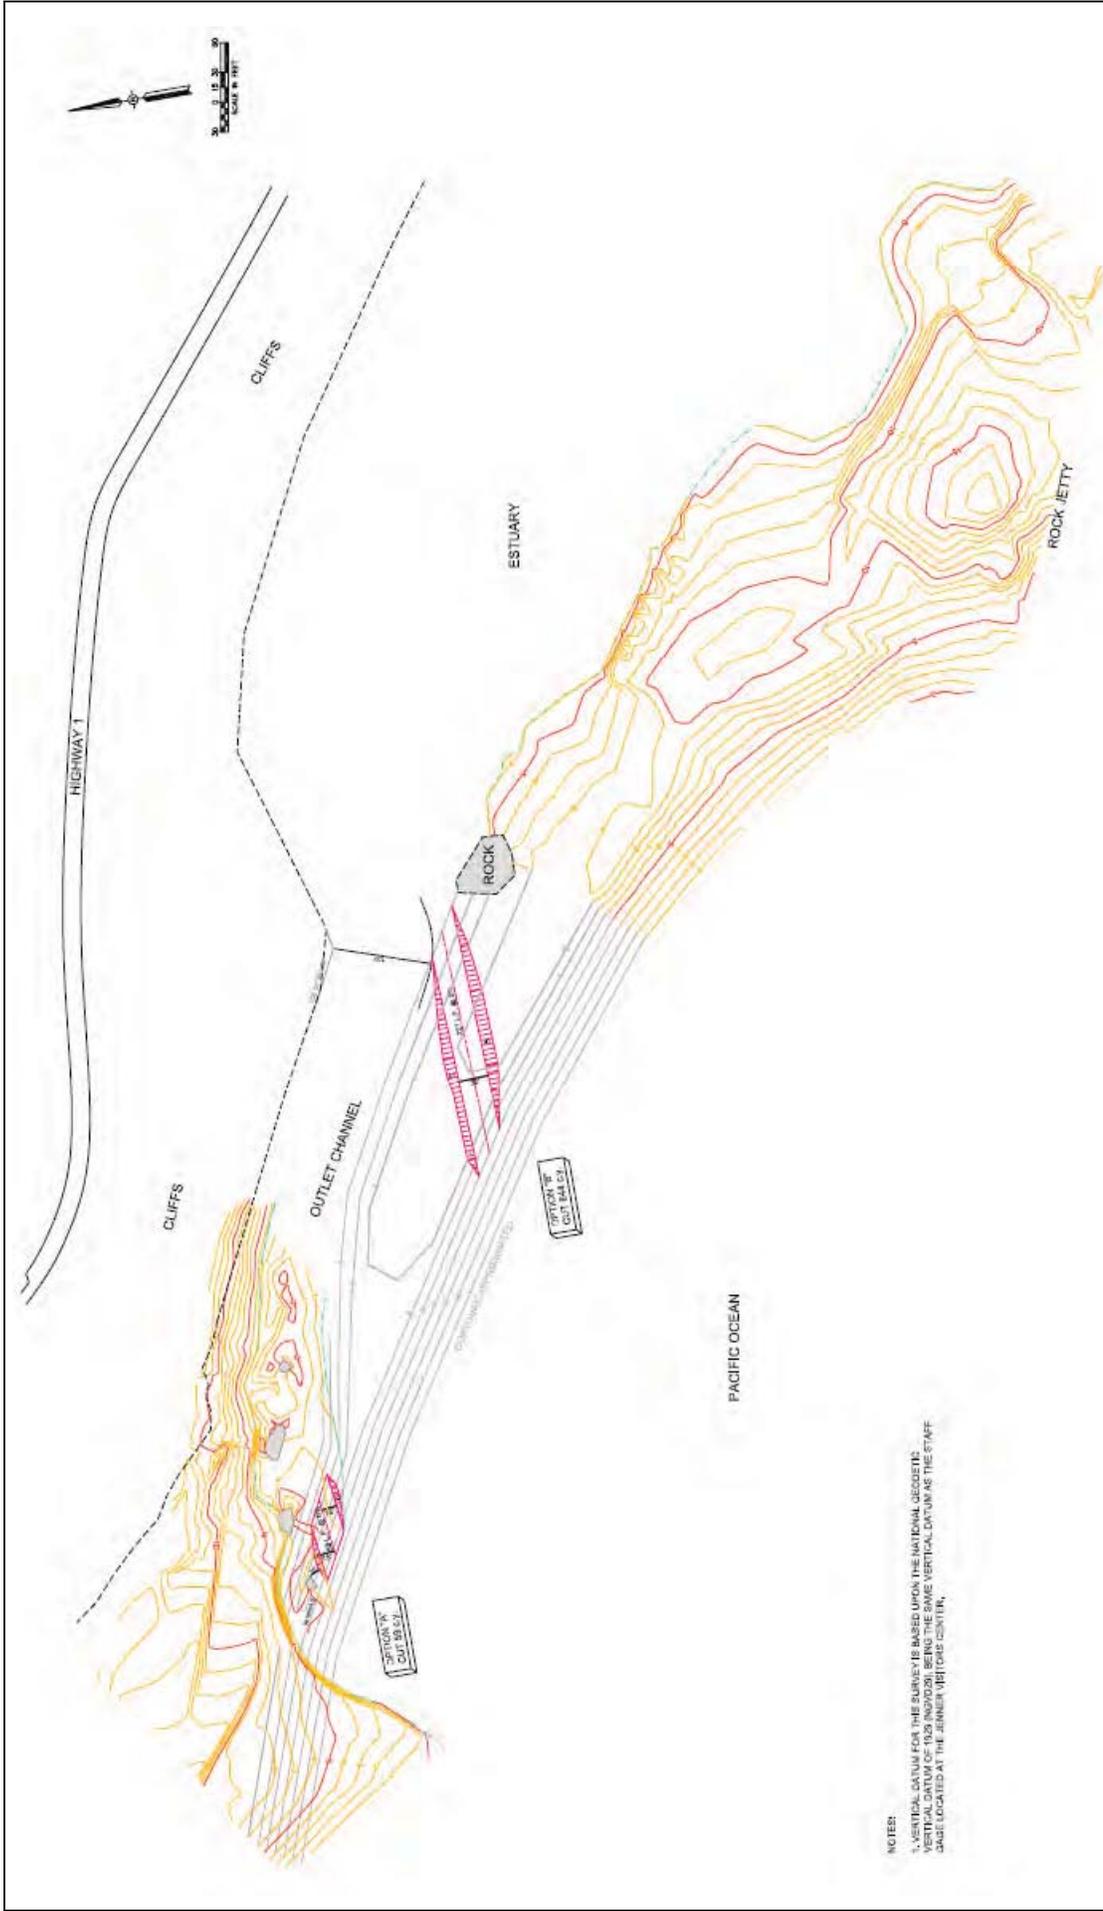
figure 4
Russian River Outlet Channel Adaptive Management Plan
 Beach Topography and Management Options, June 2010

Source: SCWA
