**RUSSIAN RIVER ESTUARY OUTLET CHANNEL
ADAPTIVE MANAGEMENT PLAN
2014**

Sonoma County Water Agency

ESA PWA

May 15, 2014

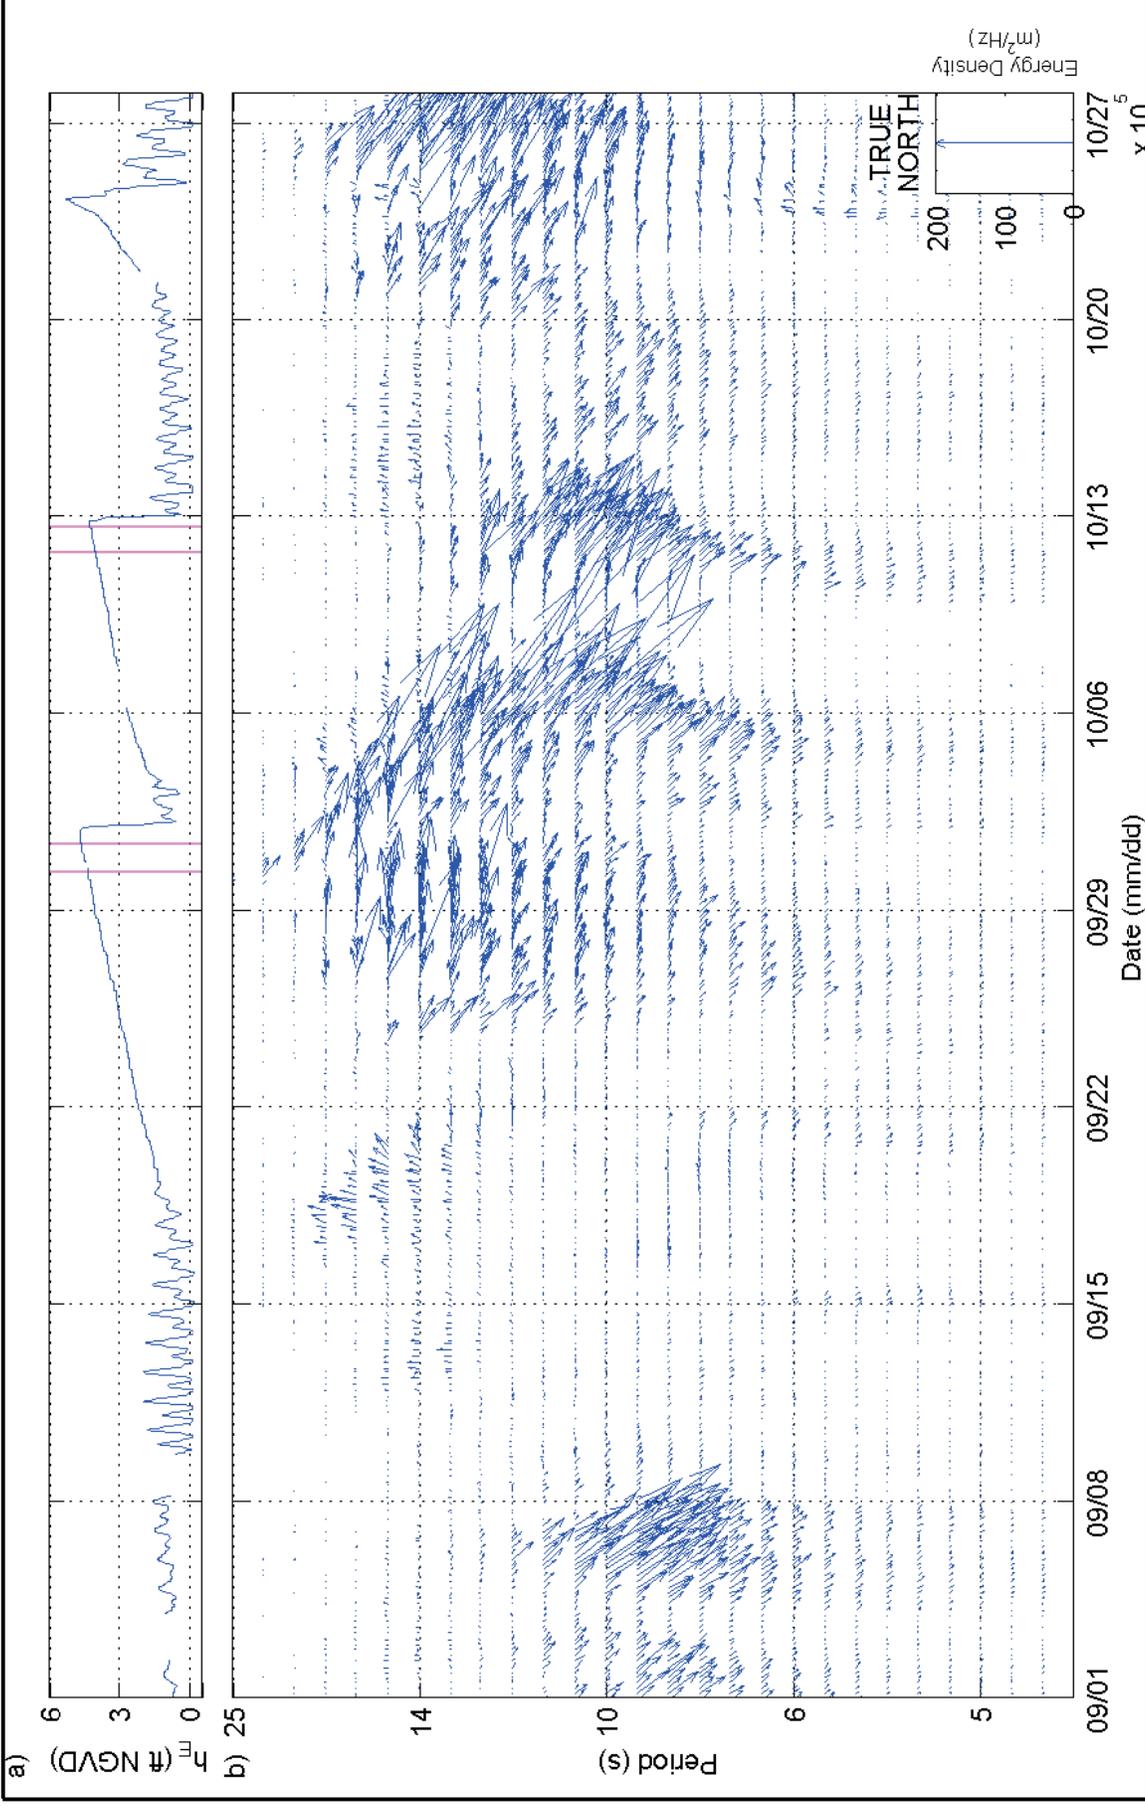
Figure 7
 Russian River Estuary Outlet Channel Management Plan
 Estuary Water Level and Wave Energy/Direction Spectrum
 September-October 2010

Sources:
 a) h_e = estuary water level (SCWA); pink bar = mnngt action
 b) Wave magnitude and direction (CDIP, Pt. Reyes, #029)

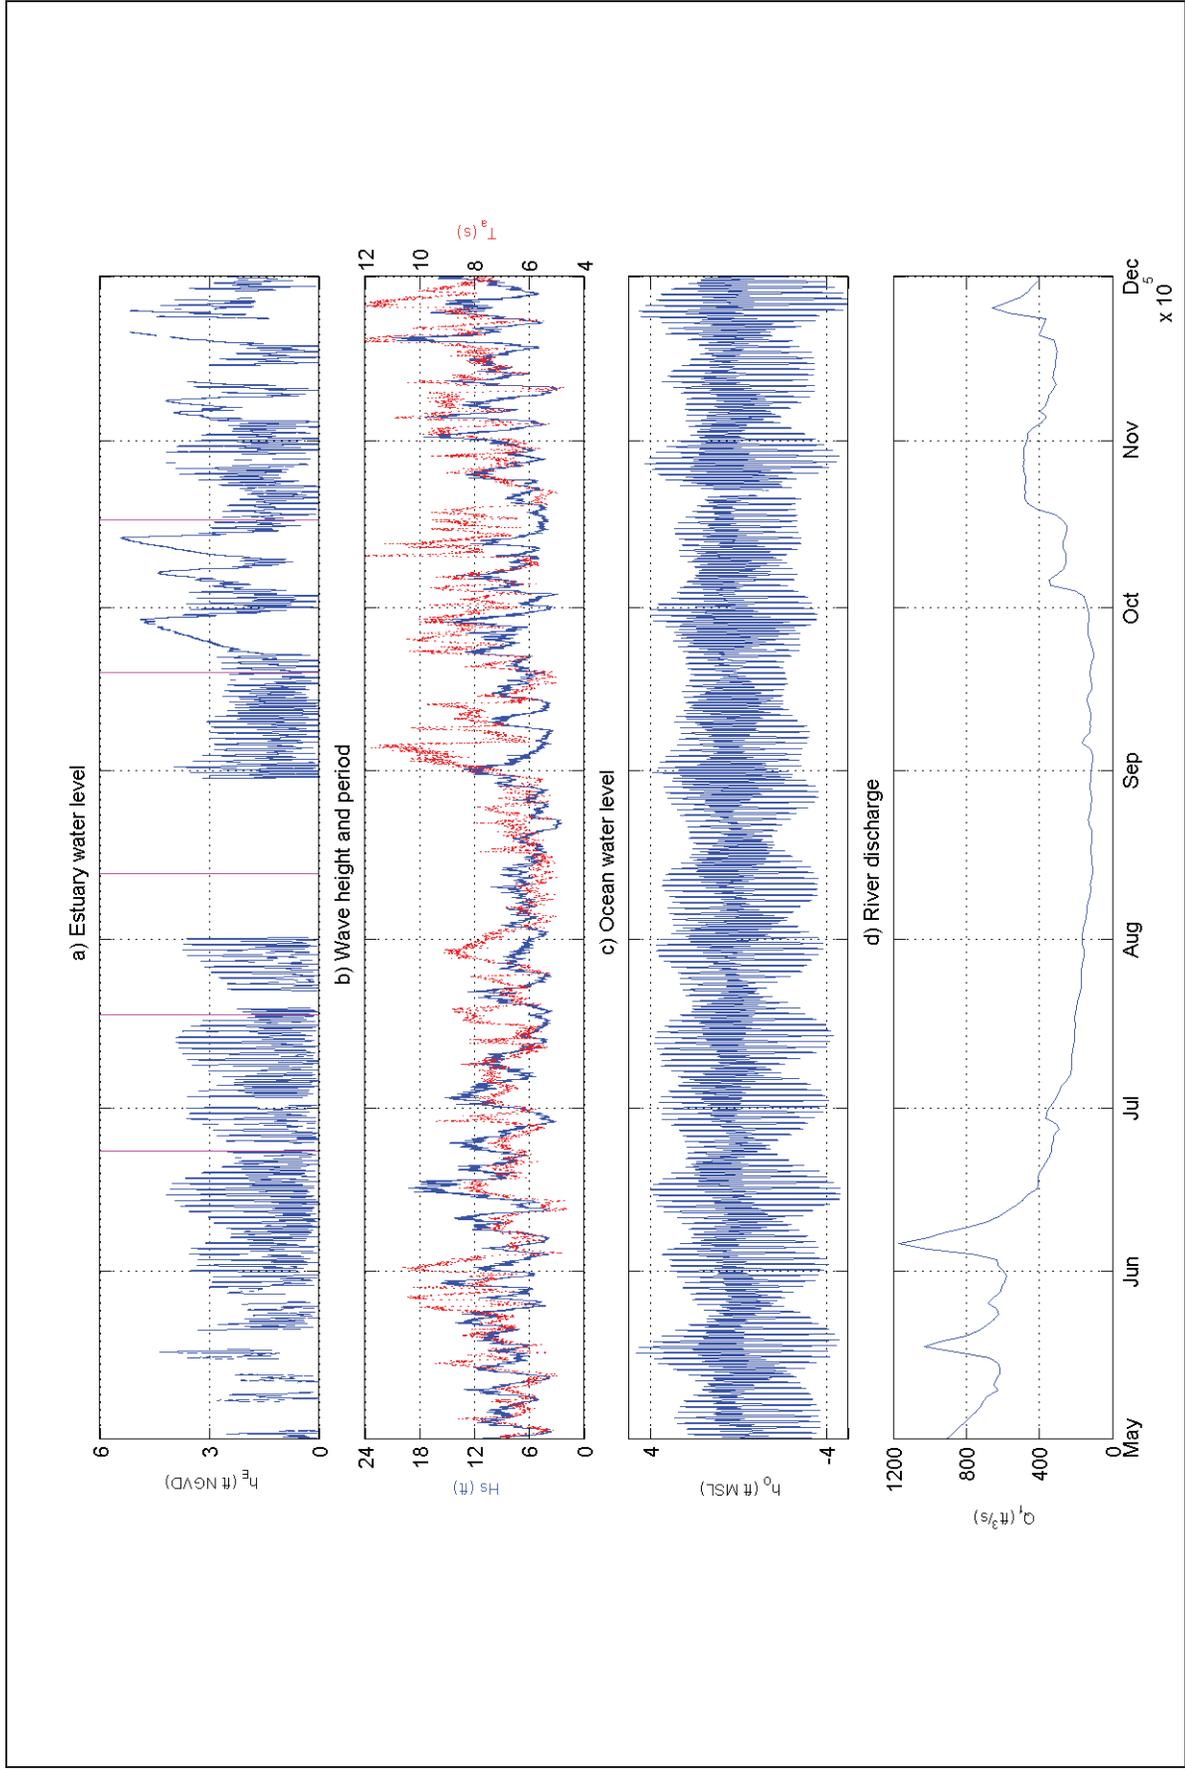
Figure 1
Estuary, Ocean, and River Conditions
May - November 2011

a) h_E =estuary water level (SCWA); pink bar = beach survey
 b) H_s =sig. wave height; T_a =avg. wave period (CDIP, Pt. Reyes, #029)
 c) h_o =ocean water level (NOAA, Pt. Reyes #9415020)
 d) Q_r =river discharge (USGS, Guerneville #11467000)

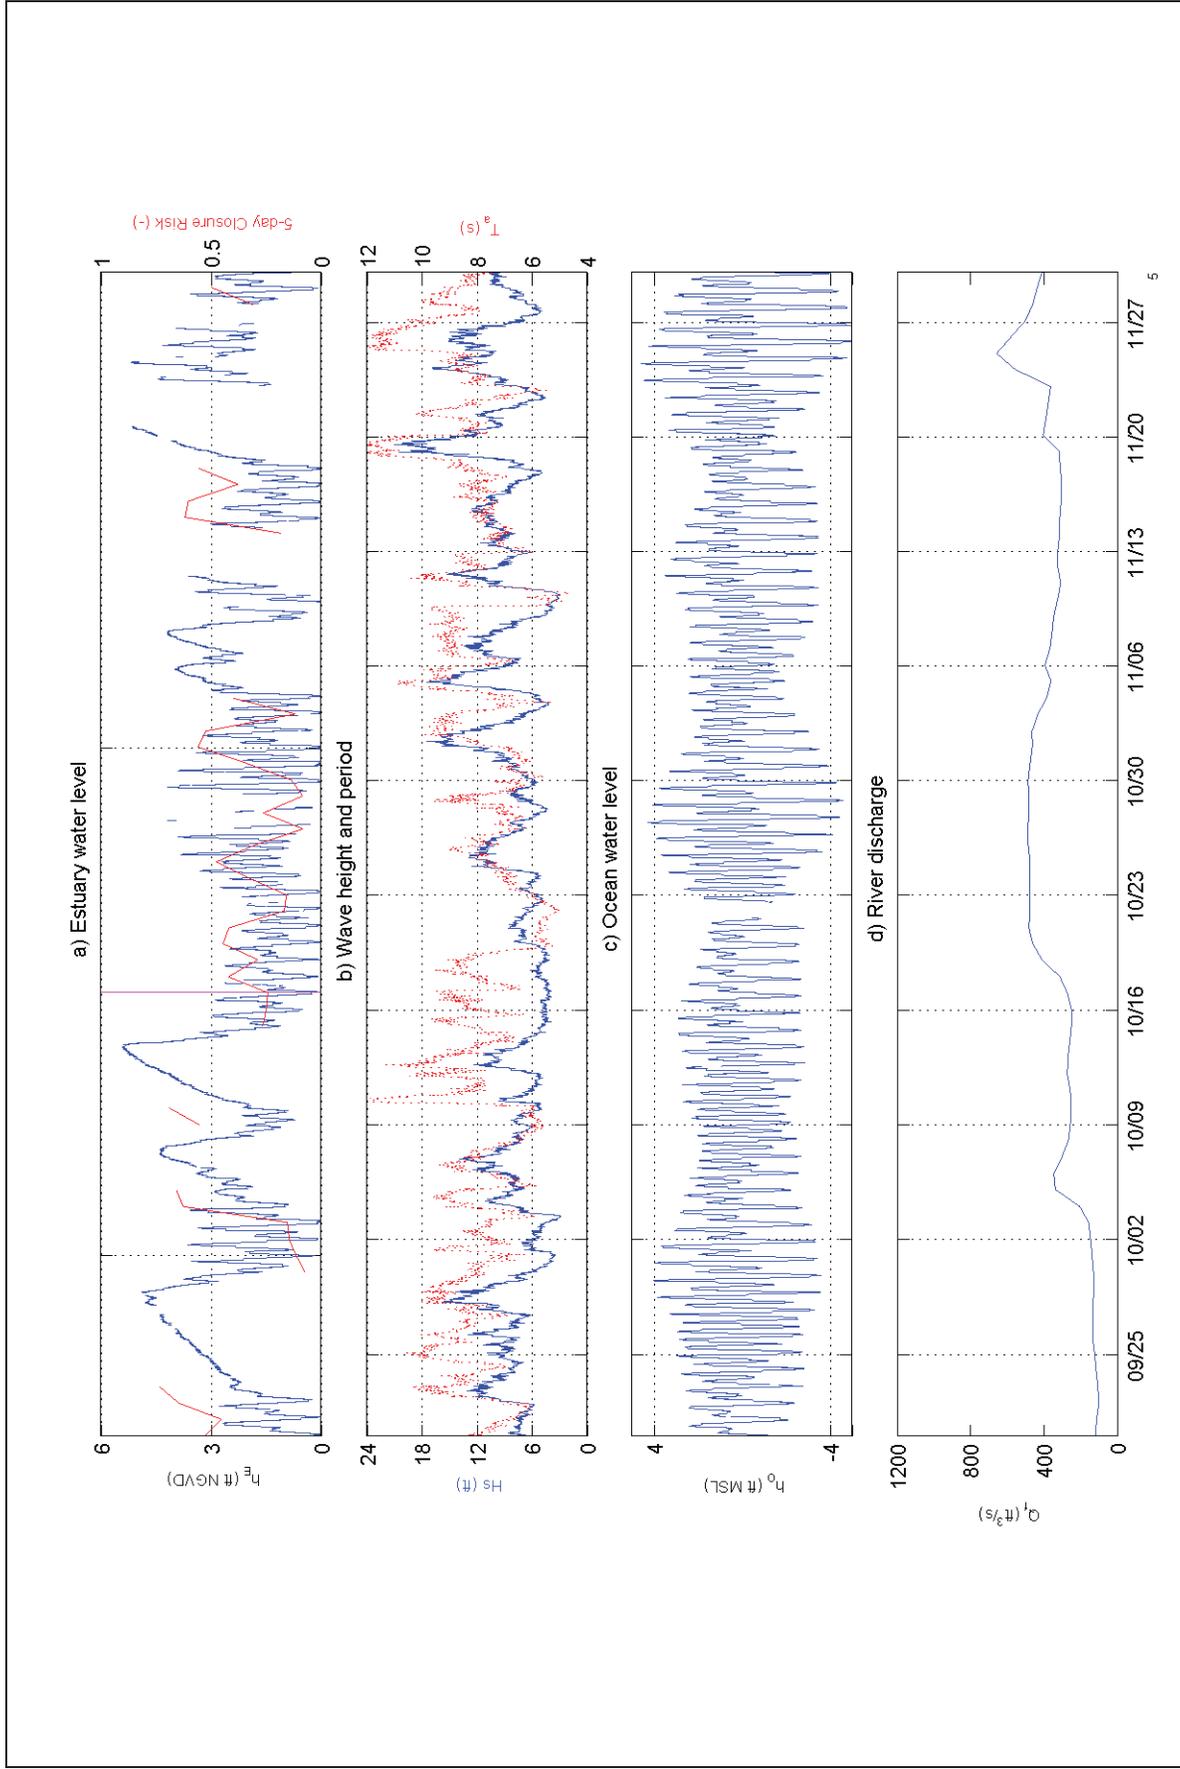
Figure 2
Estuary, Ocean, and River Conditions
September - November 2011

a) h_E =estuary water level (SCWA); pink bar = beach survey
 b) H_s =sig. wave height; T_a =avg. wave period (CDIP, Pt. Reyes, #029)
 c) h_o =ocean water level (NOAA, Pt. Reyes #9415020)
 d) Q_r =river discharge (USGS, Guerneville #11467000)

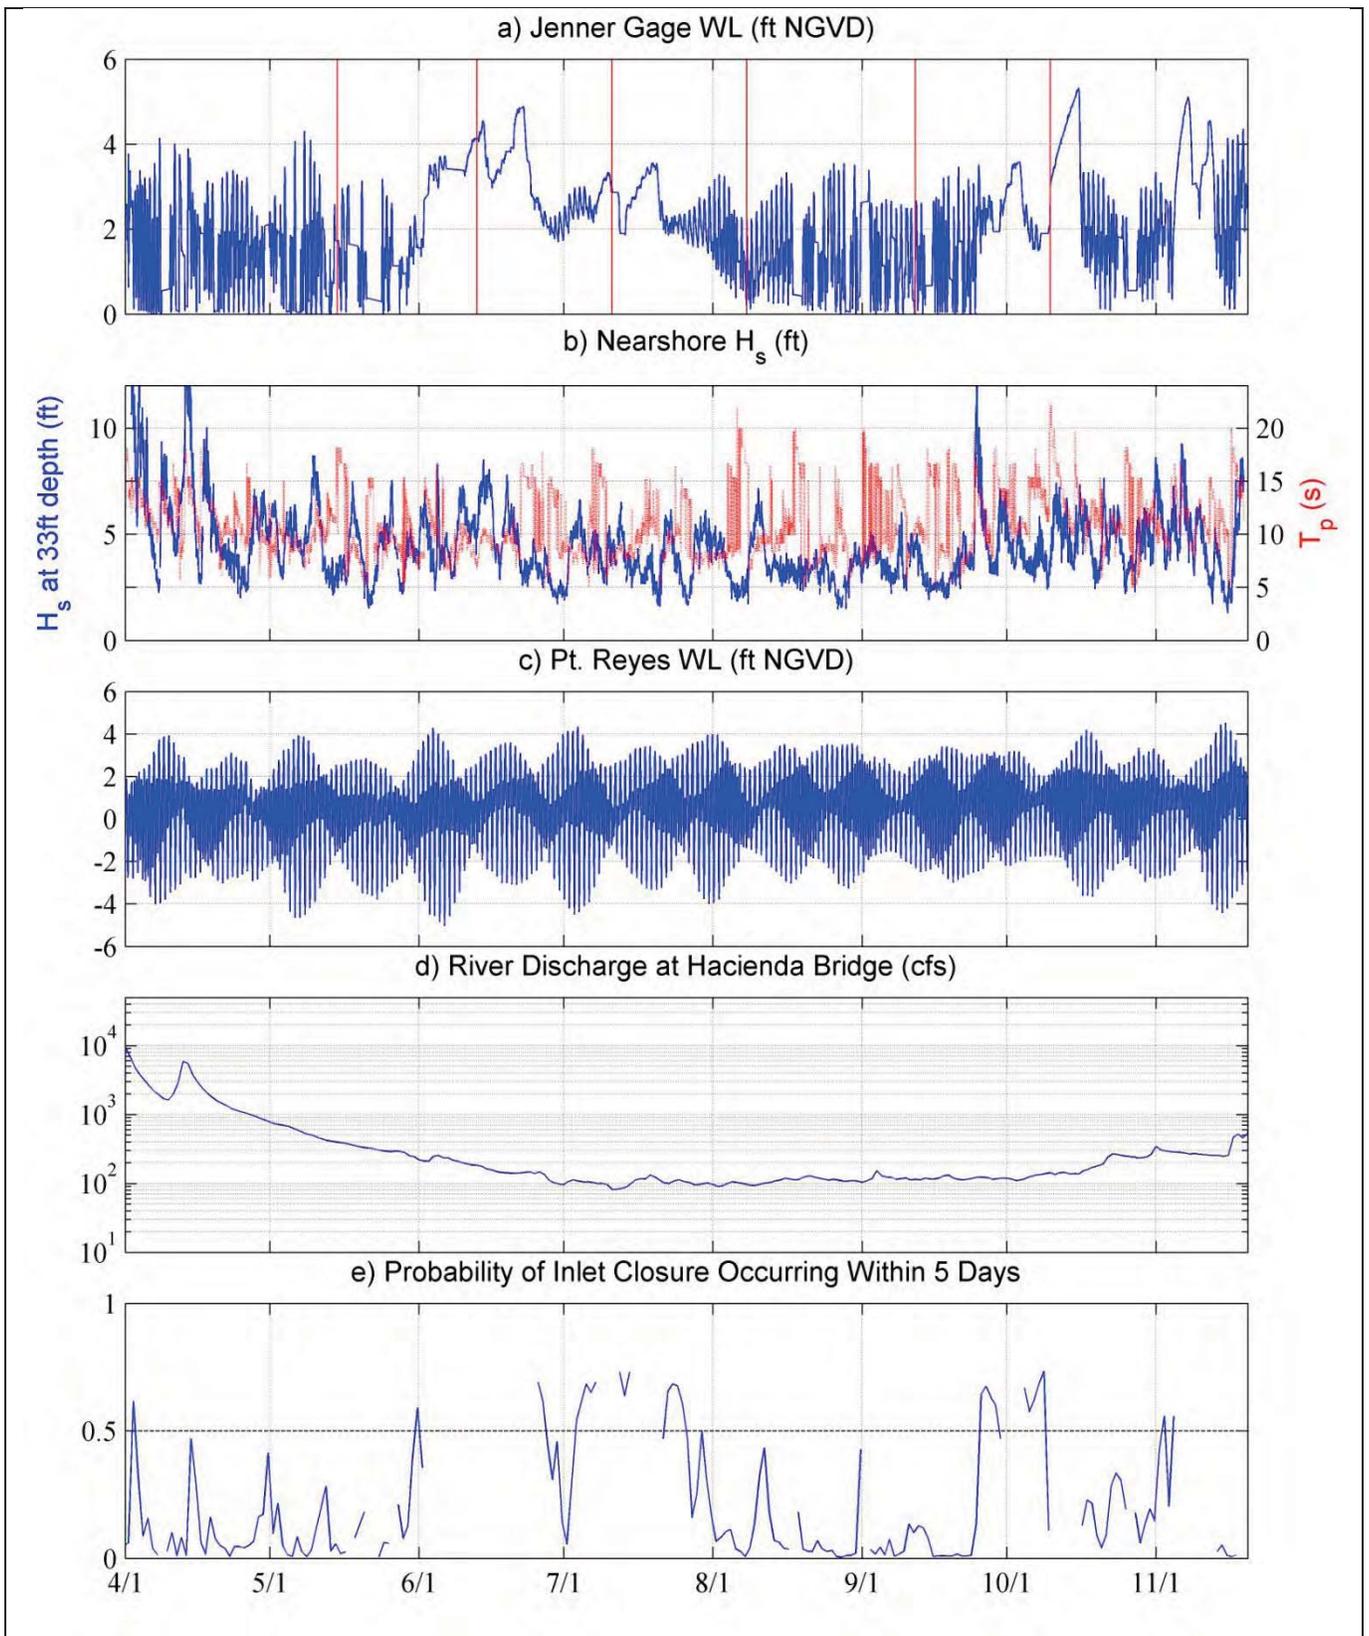
Figure 1
 Estuary, Ocean, and River Conditions Compared
 with Closure Probability:
 September – November 2012

- a) Jenner gage water level provided by SCWA; red bar = beach survey
- b) H_s = sig. wave height; T_p =peak wave period (CDIP, Pt. Reyes, #029)
- c) Ocean water level provided by NOAA (Pt. Reyes #9415020)
- d) River discharge provided by USGS (Guerneville #11467000)
- e) Five-day closure probability provided after Behrens et al. (2013)

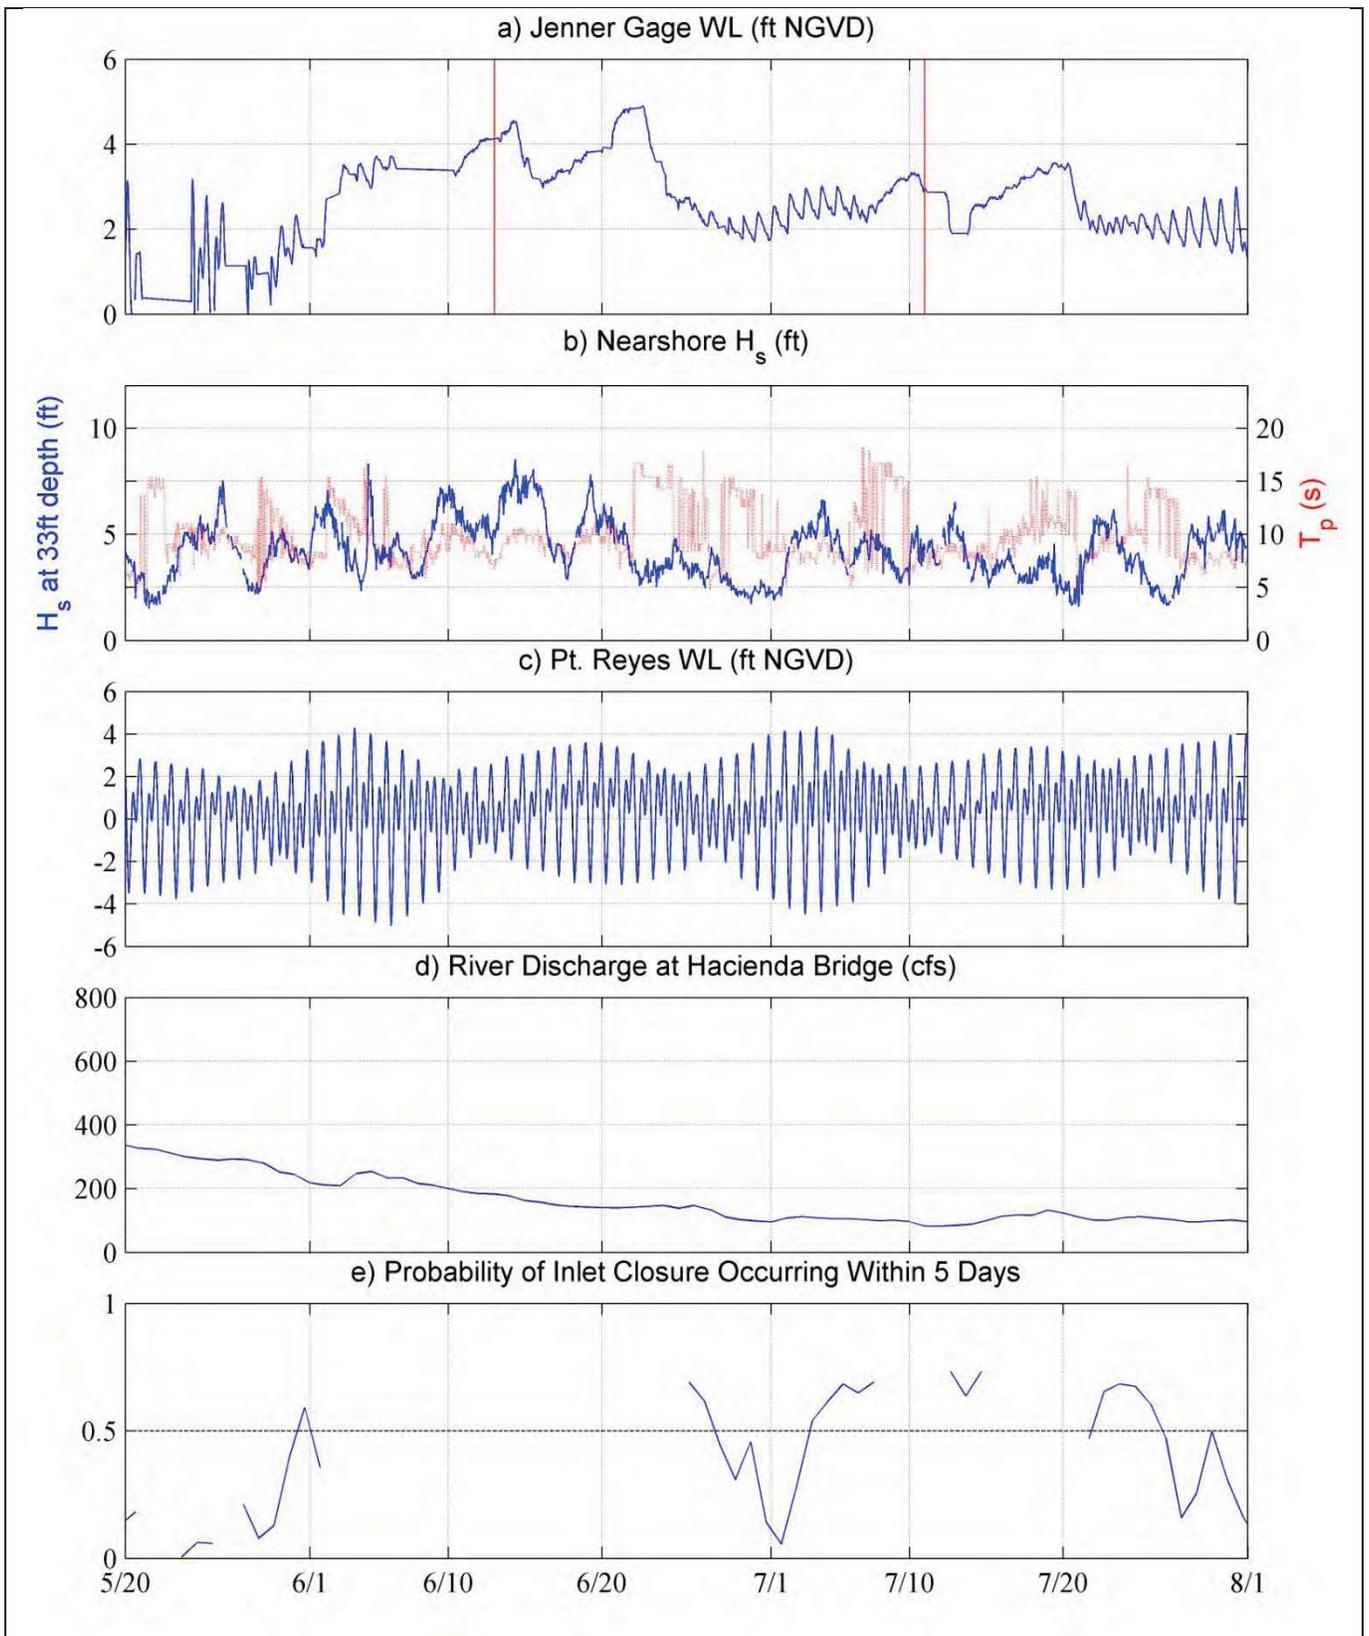
Figure 2
 Estuary, Ocean, and River Conditions Compared
 with Closure Probability:
 May 20 – August 1, 2012

- a) Jenner gage water level provided by SCWA; red bar = beach survey
- b) H_s = sig. wave height; T_p = peak wave period (CDIP, Pt. Reyes, #029)
- c) Ocean water level provided by NOAA (Pt. Reyes #9415020)
- d) River discharge provided by USGS (Guerneville #11467000)
- e) Five-day closure probability provided after Behrens et al. (2013)

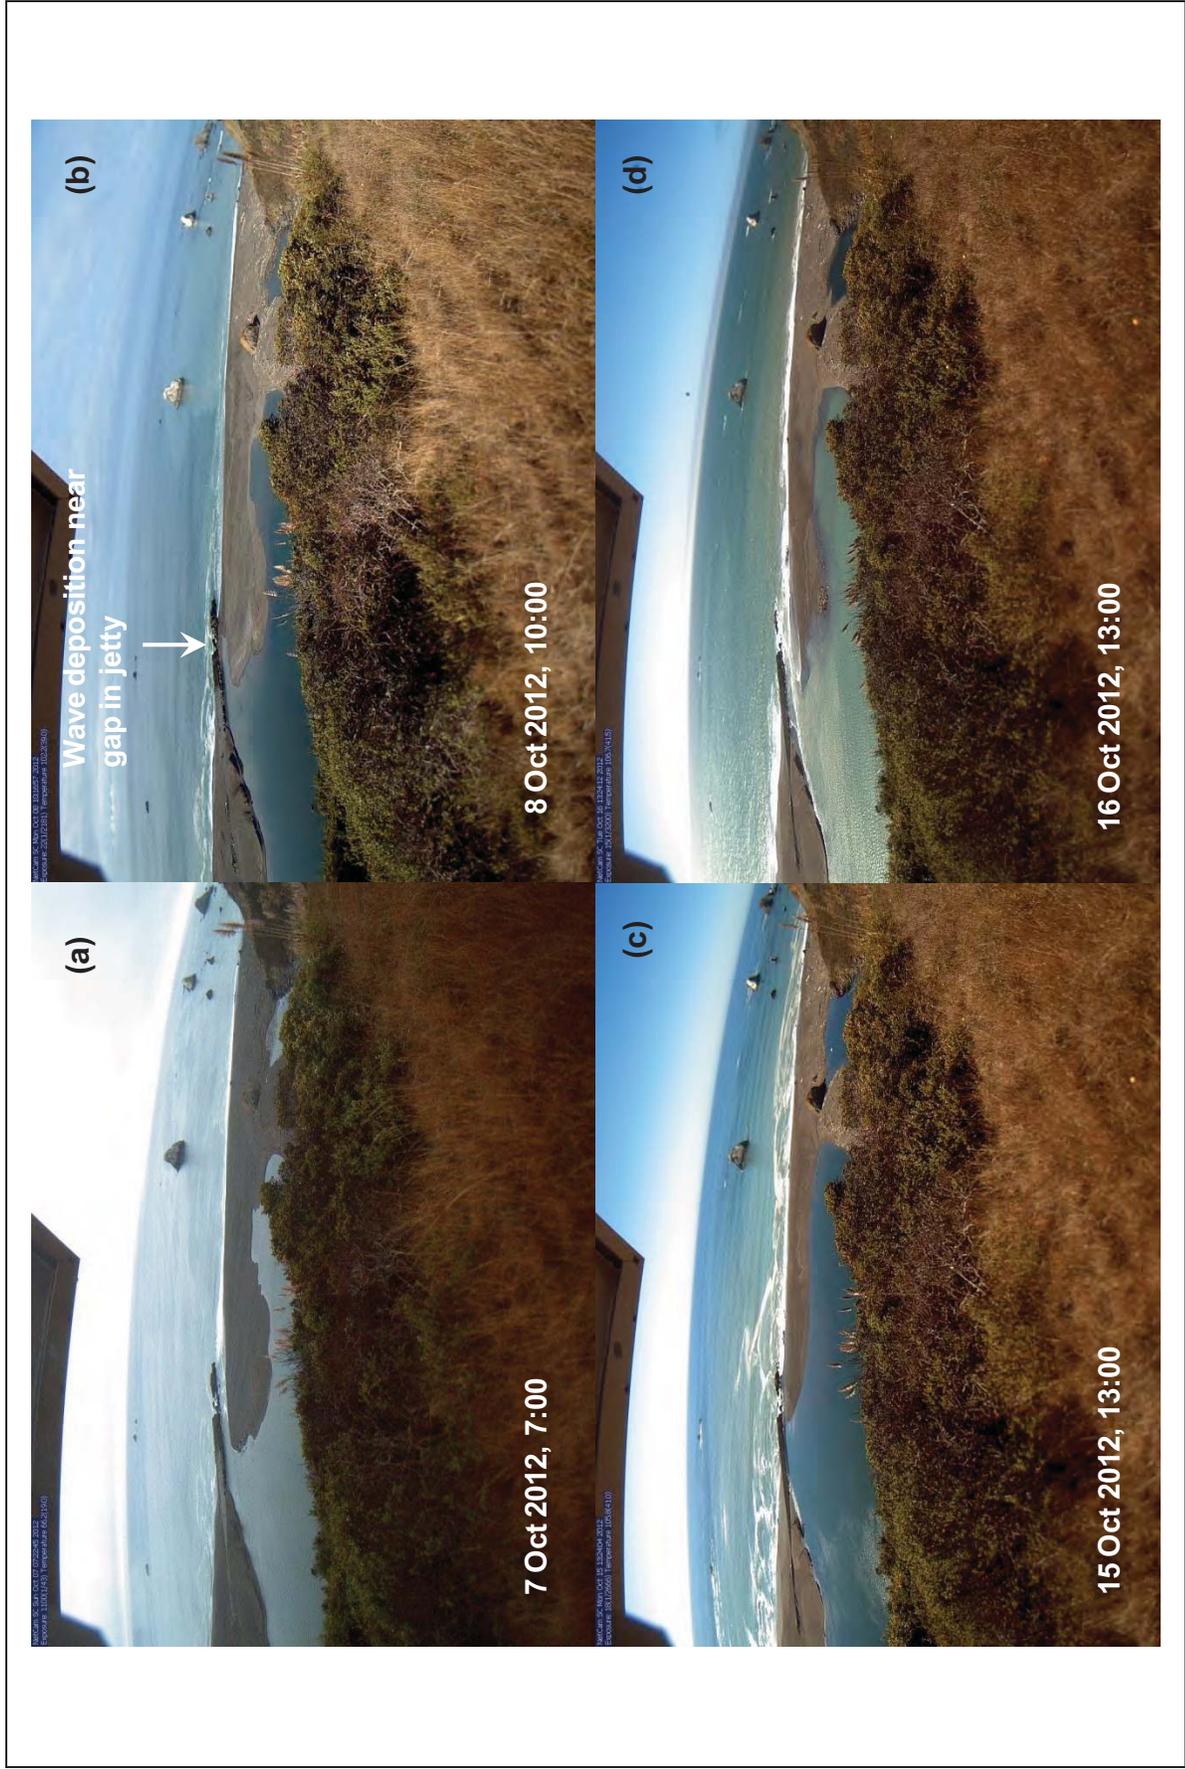
Russian River Estuary Outlet Channel Management Plan . DW01958
Figure 4
 Inlet Closure and Self-Breach in October 2012

SOURCE: Russian River stationary observation camera (BML)

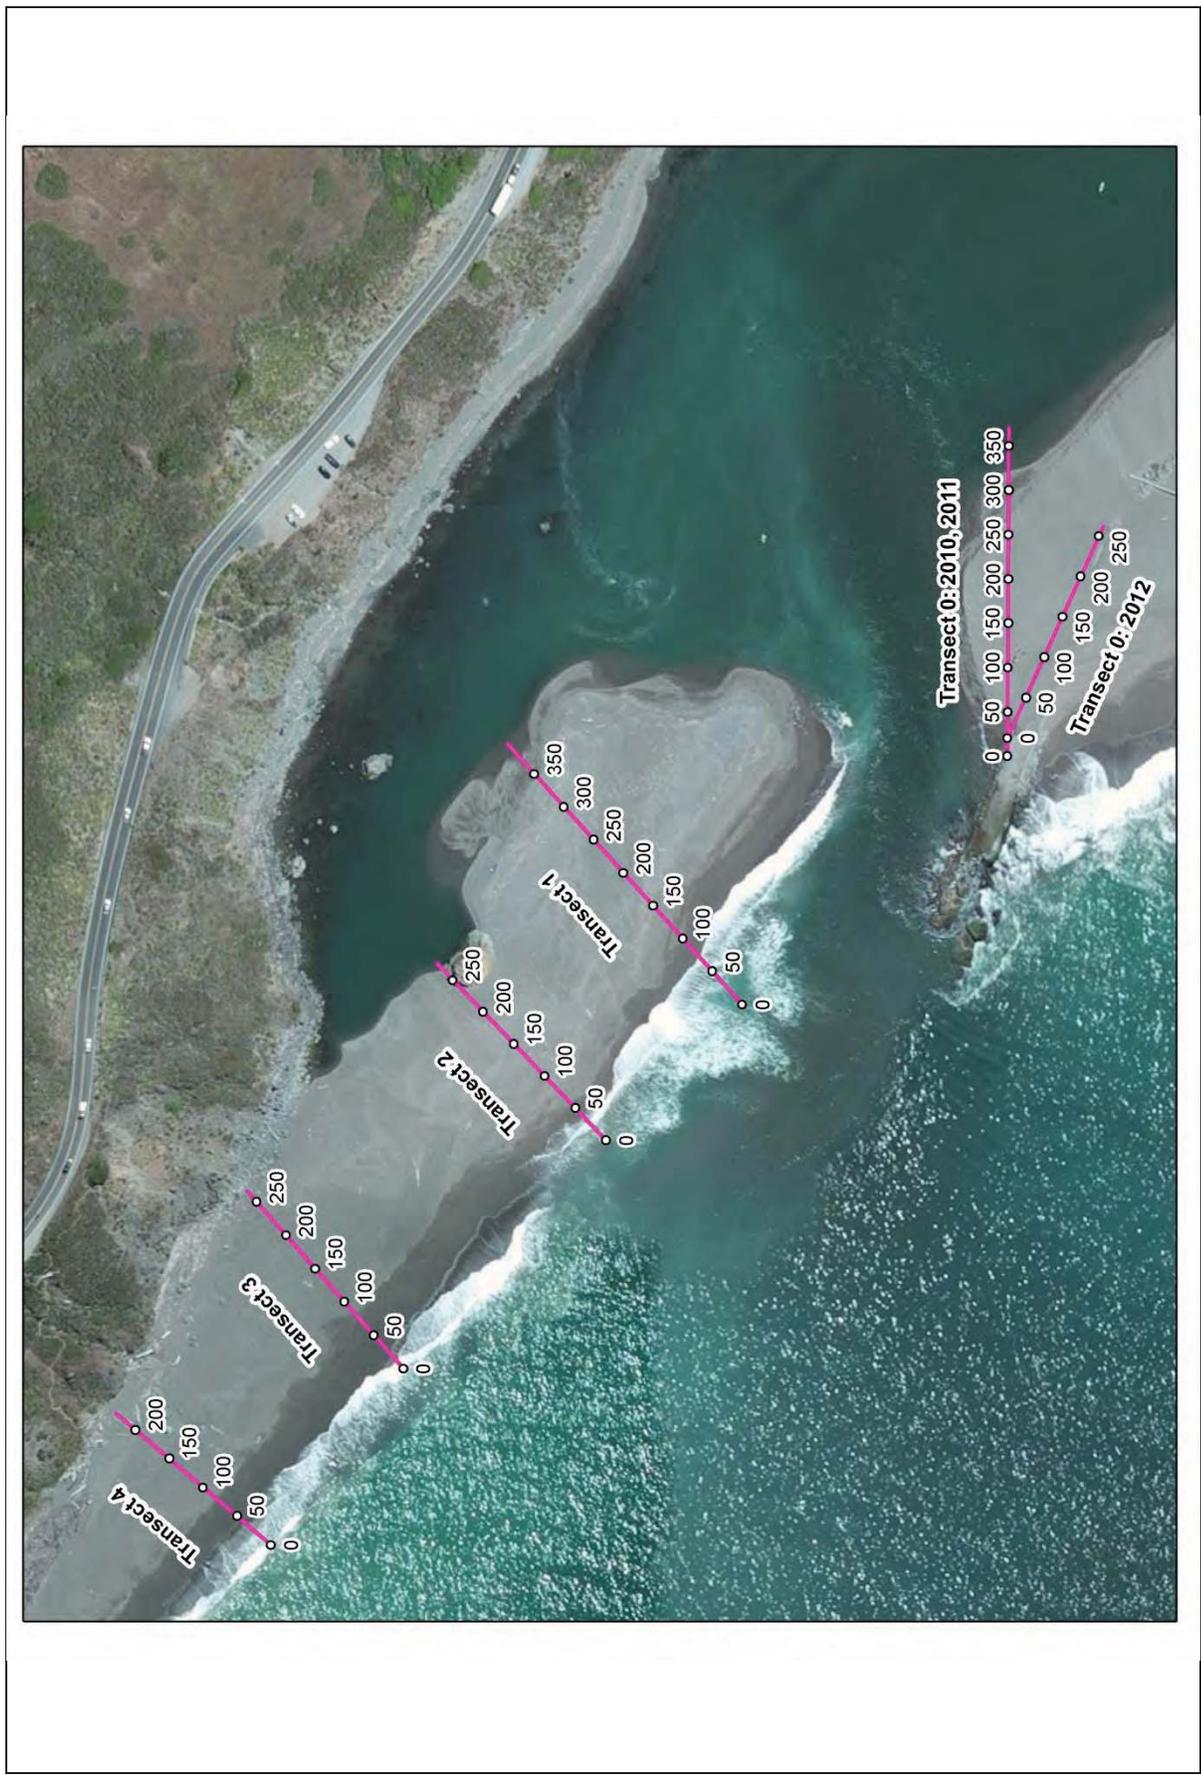
Russian River Estuary Outlet Channel Management Plan . DW01958
Figure 6
 Beach Transect Locations

SOURCE: image from USDA NAIP

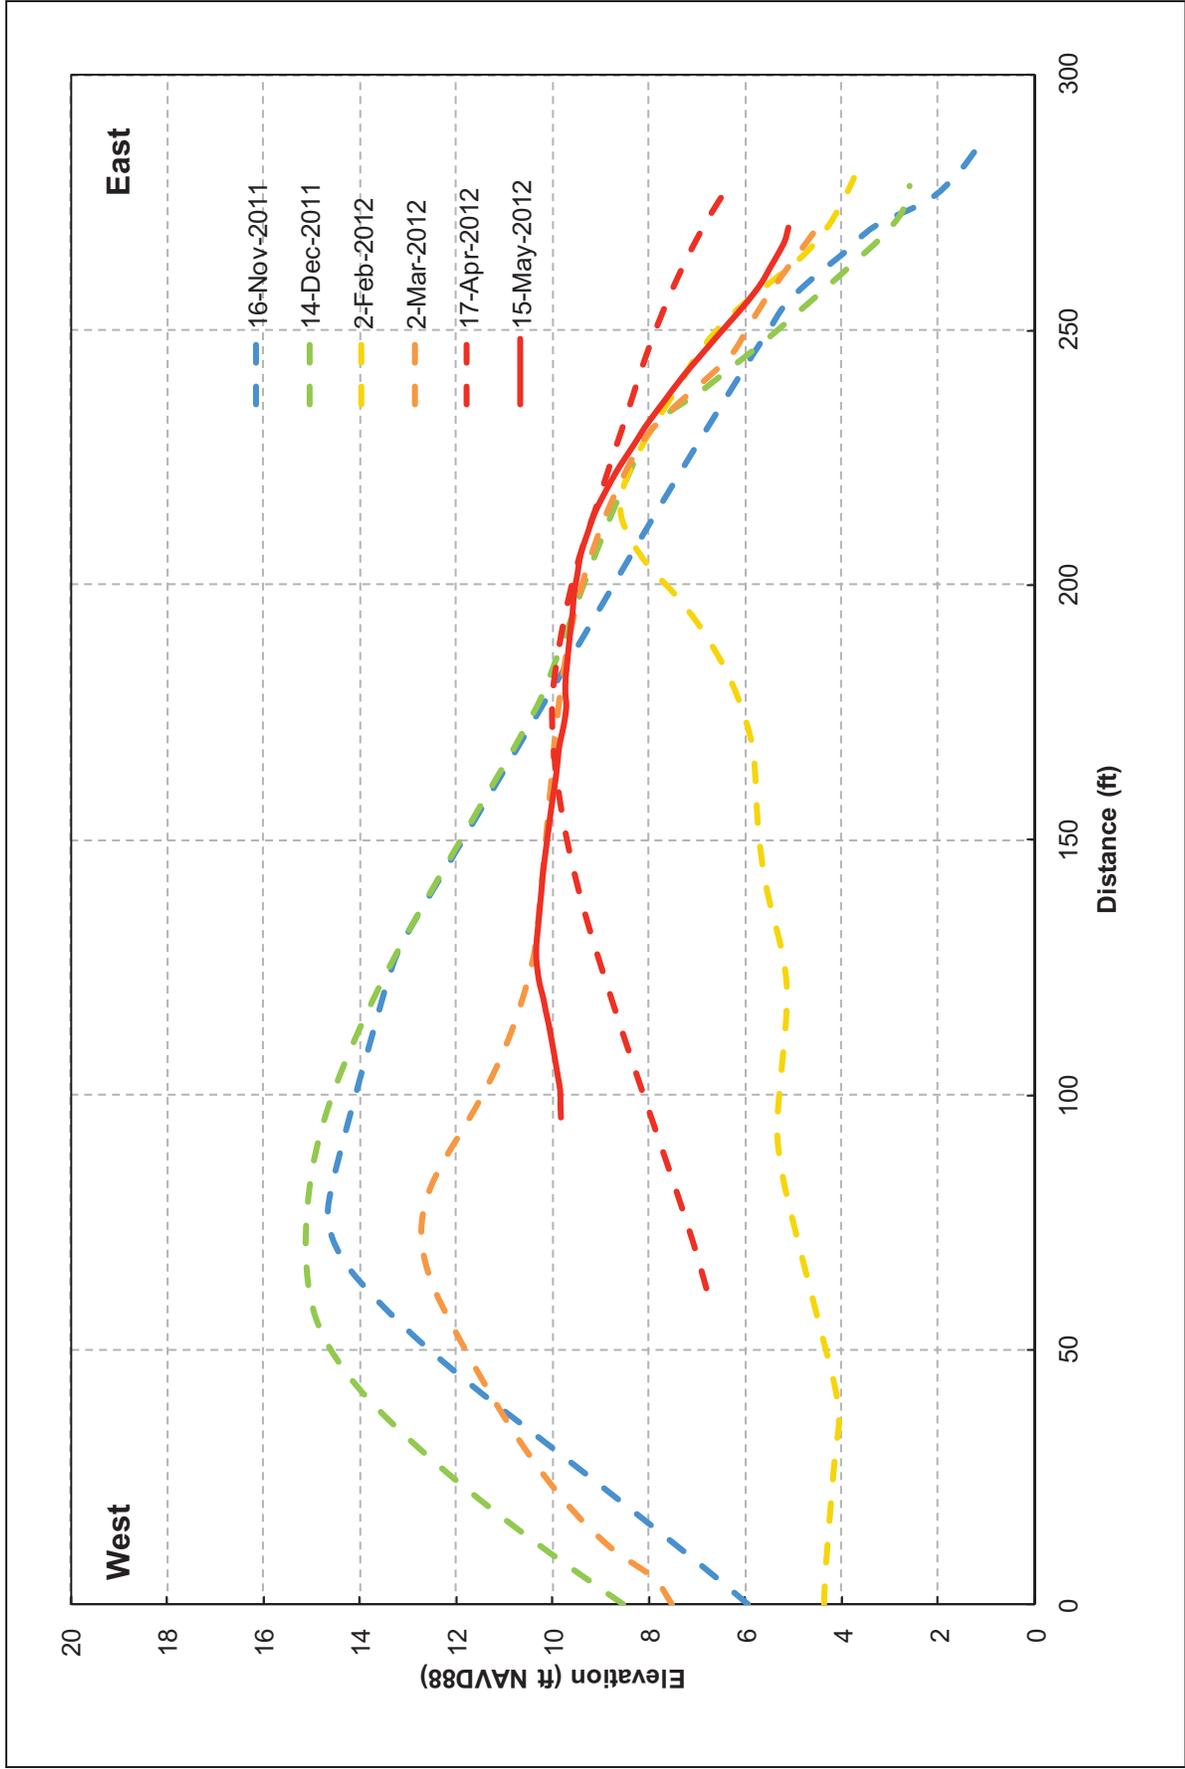
Figure 11
Nov 2011 to May 2012 topographic change at Beach Transect 2

SOURCE: SCWA survey data

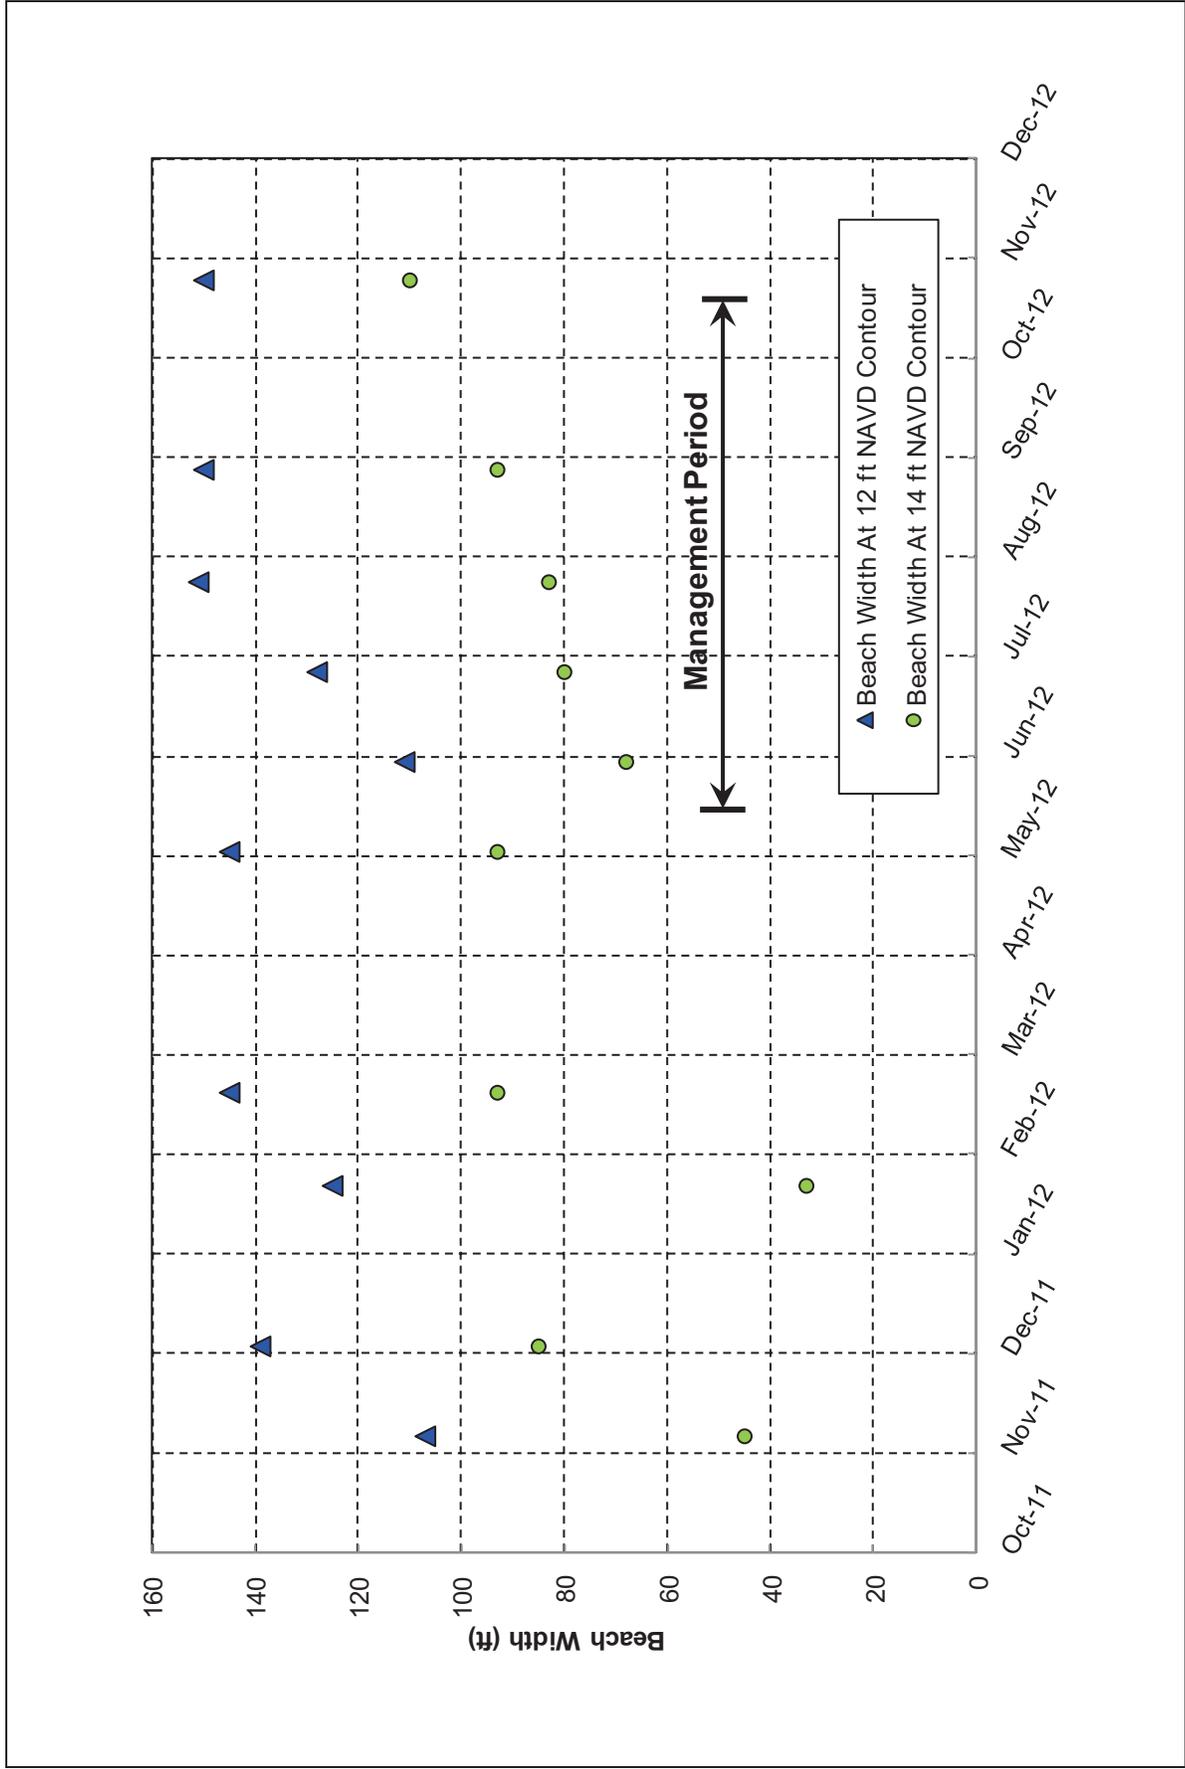
Russian River Estuary Outlet Channel Management Plan . D120709.00
Figure 13
 Beach Width at Beach Transect 3.

SOURCE: SCWA survey data

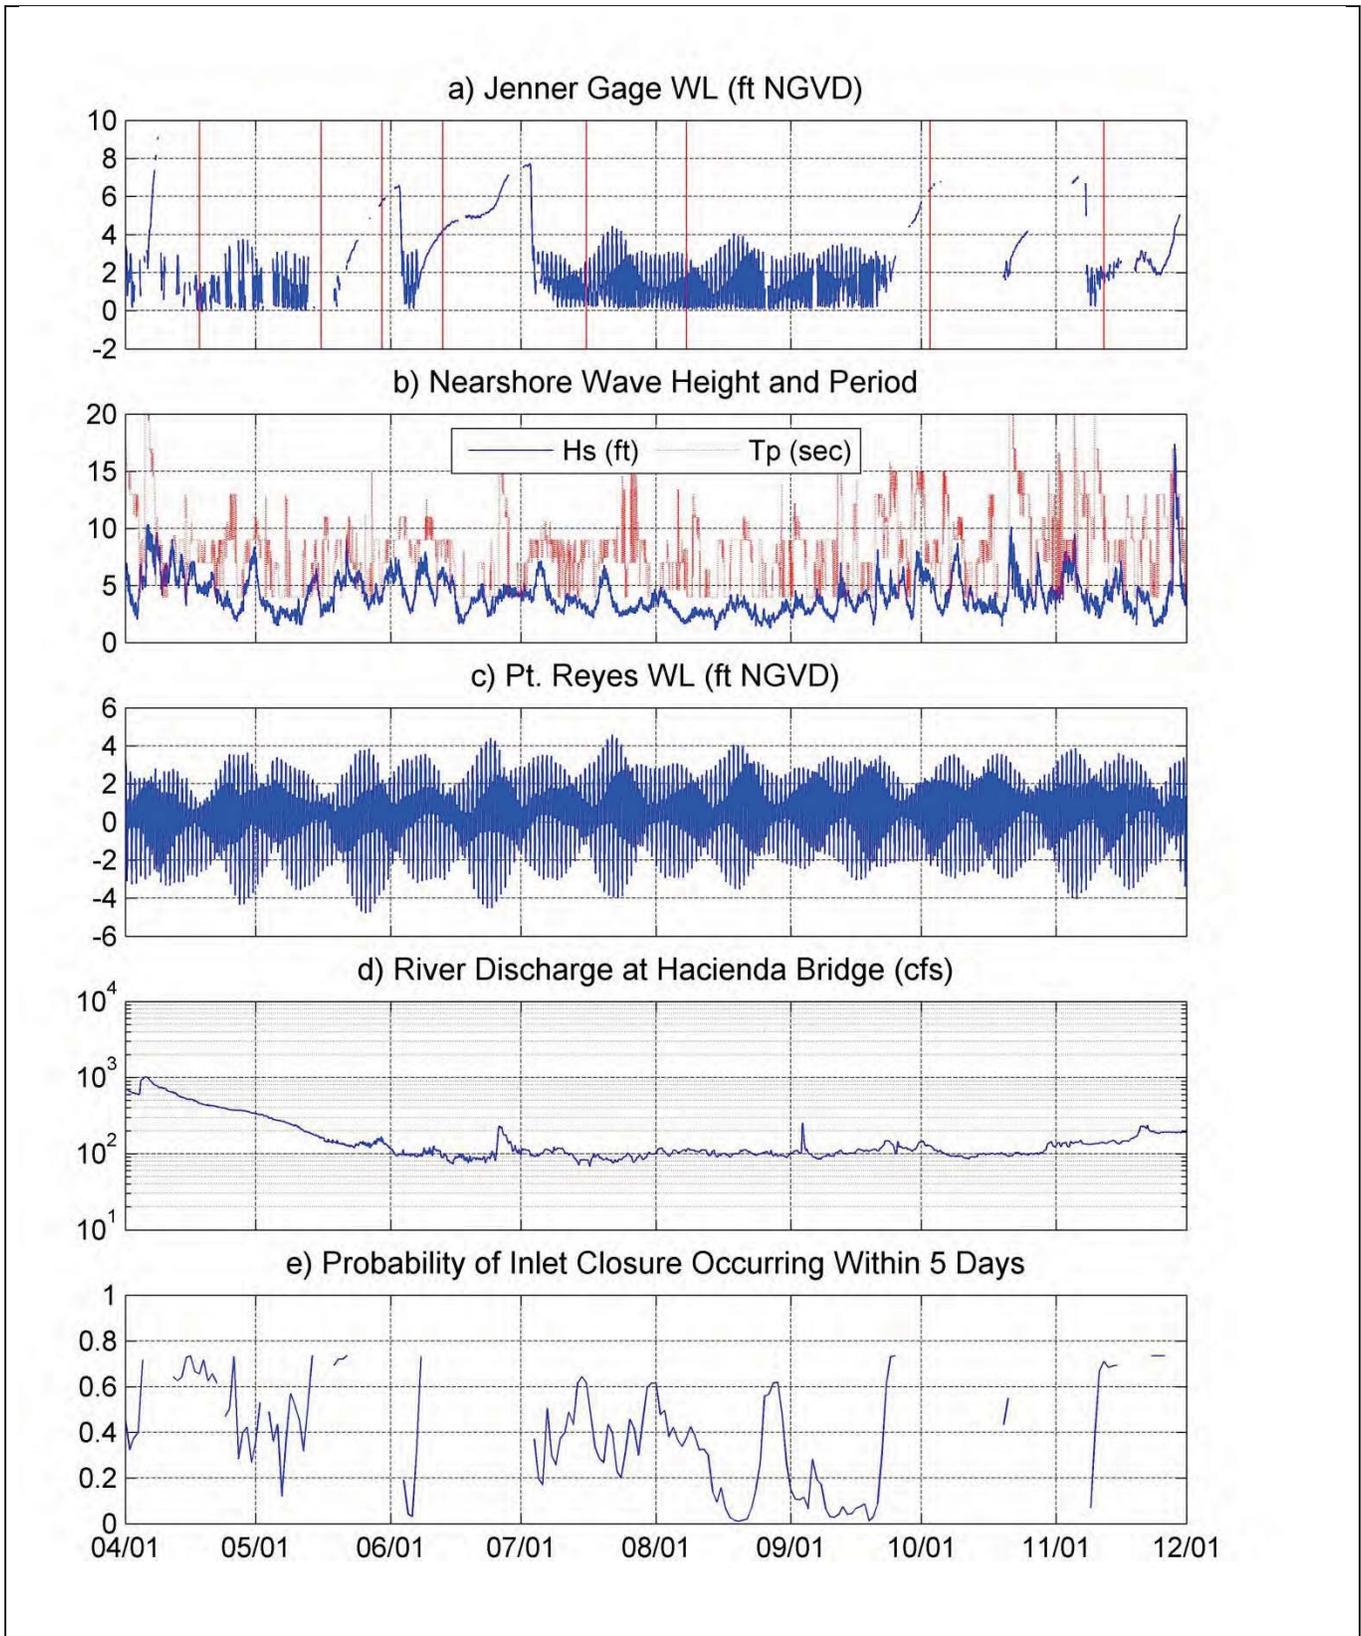
Figure 1
 Estuary, Ocean, and River Conditions Compared
 with Closure Probability:
 April – November 2013

- a) Jenner gage water level provided by SCWA; red bar = beach survey
- b) H_s = sig. wave height; T_p = peak wave period (CDIP, Pt. Reyes, #029)
- c) Ocean water level provided by NOAA (Pt. Reyes #9415020)
- d) River discharge provided by USGS (Guerneville #11467000)
- e) Five-day closure probability provided after Behrens et al. (2013)
