**RUSSIAN RIVER ESTUARY OUTLET CHANNEL
ADAPTIVE MANAGEMENT PLAN
2014**

Sonoma County Water Agency

ESA PWA

May 15, 2014

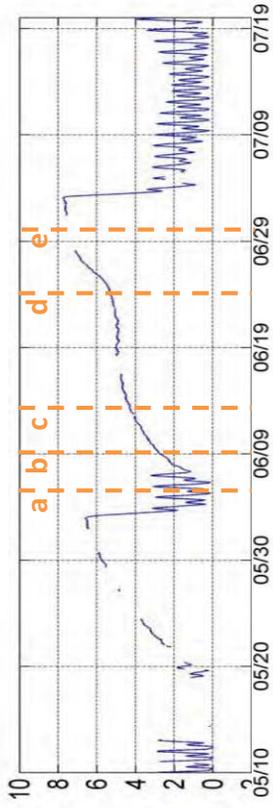
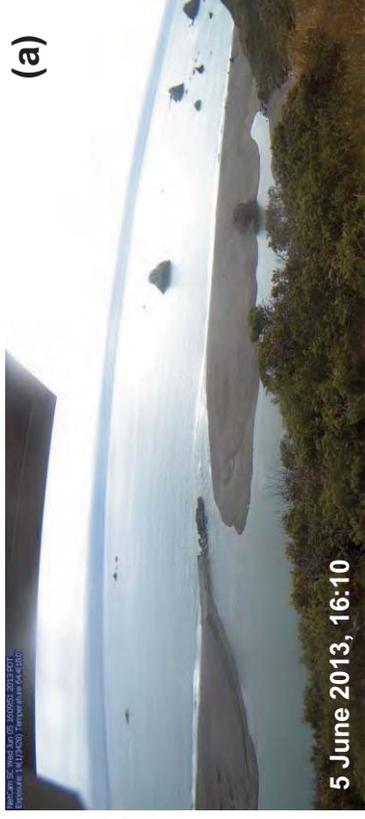
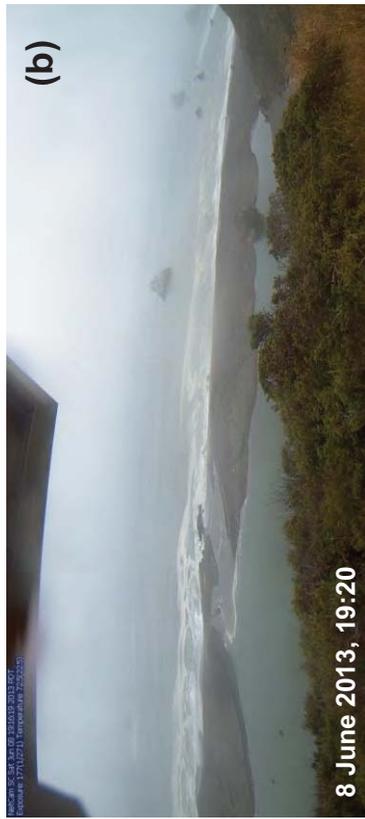
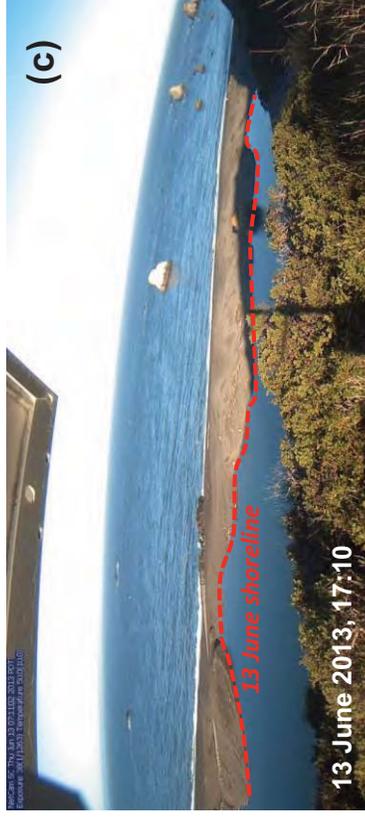
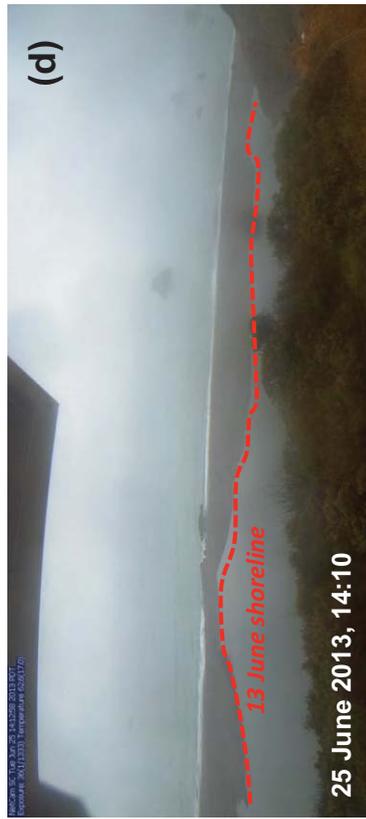
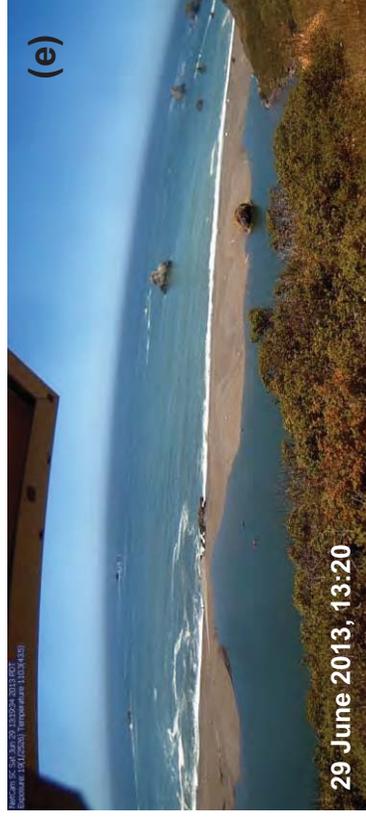
Russian River Estuary Outlet Channel Management Plan . DW01958
Figure 4
 Inlet Closure Event in June-July 2013

SOURCE: Russian River stationary observation camera (BML)

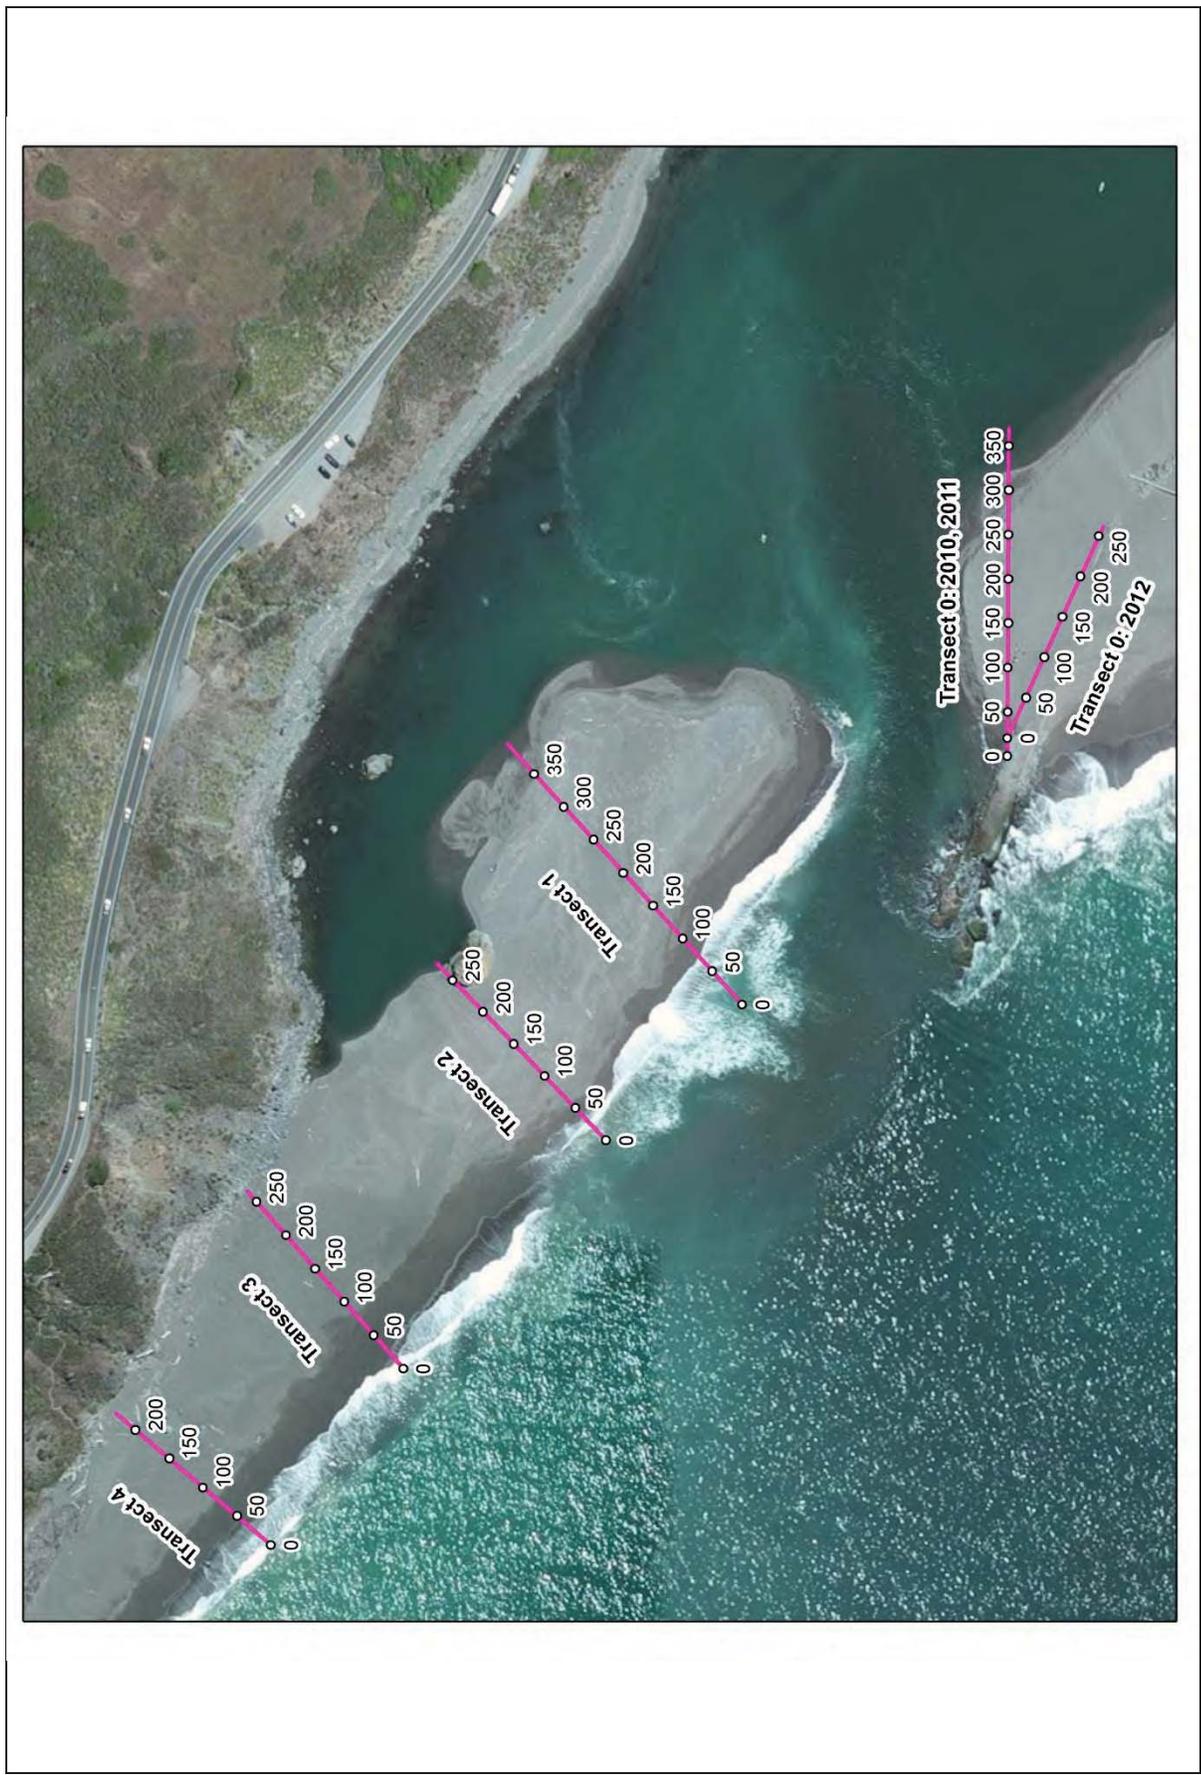
Russian River Estuary Outlet Channel Management Plan . DW01958
Figure 5
 Beach Transect Locations

SOURCE: image from USDA NAIP

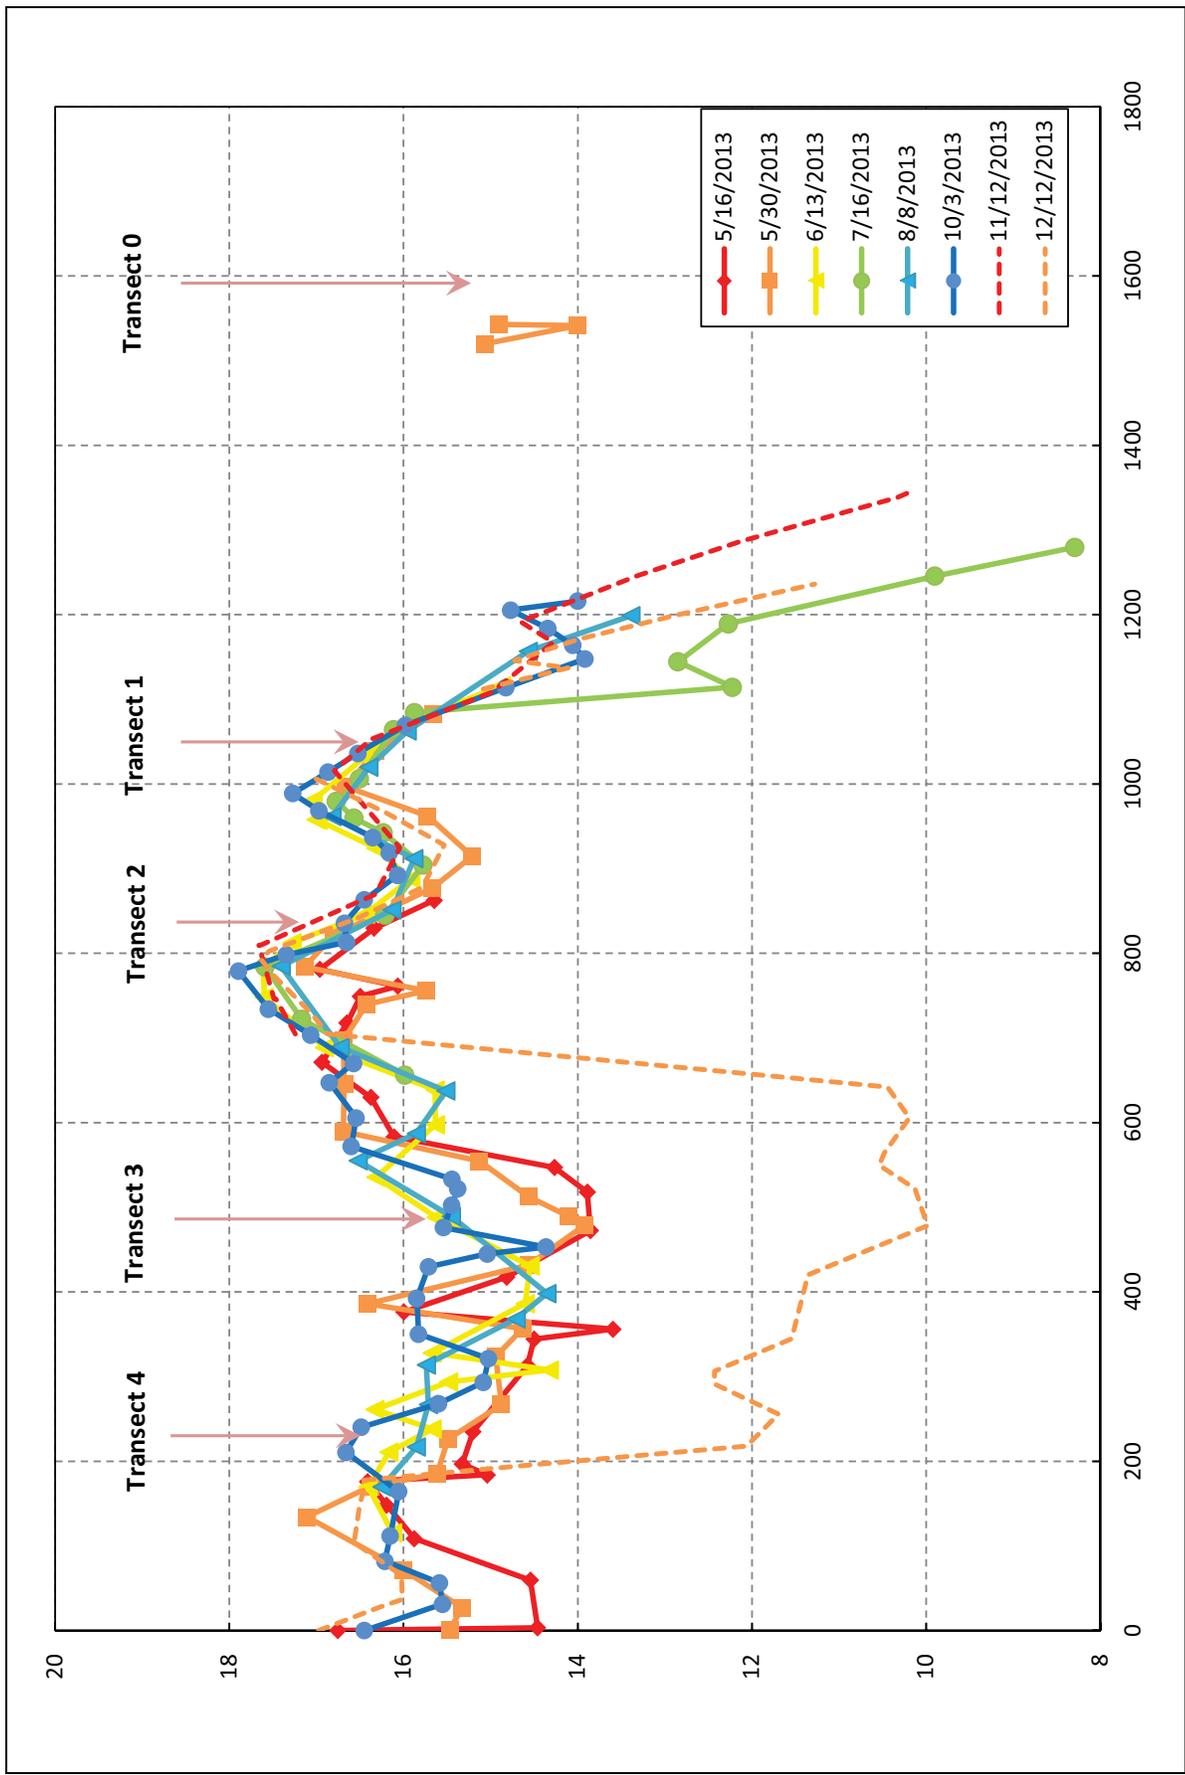
Russian River Estuary Outlet Channel Management Plan . DW01958
Figure 11
 Beach Crest Profiles During the 2013 Management Period.

SOURCE: SCWA survey data

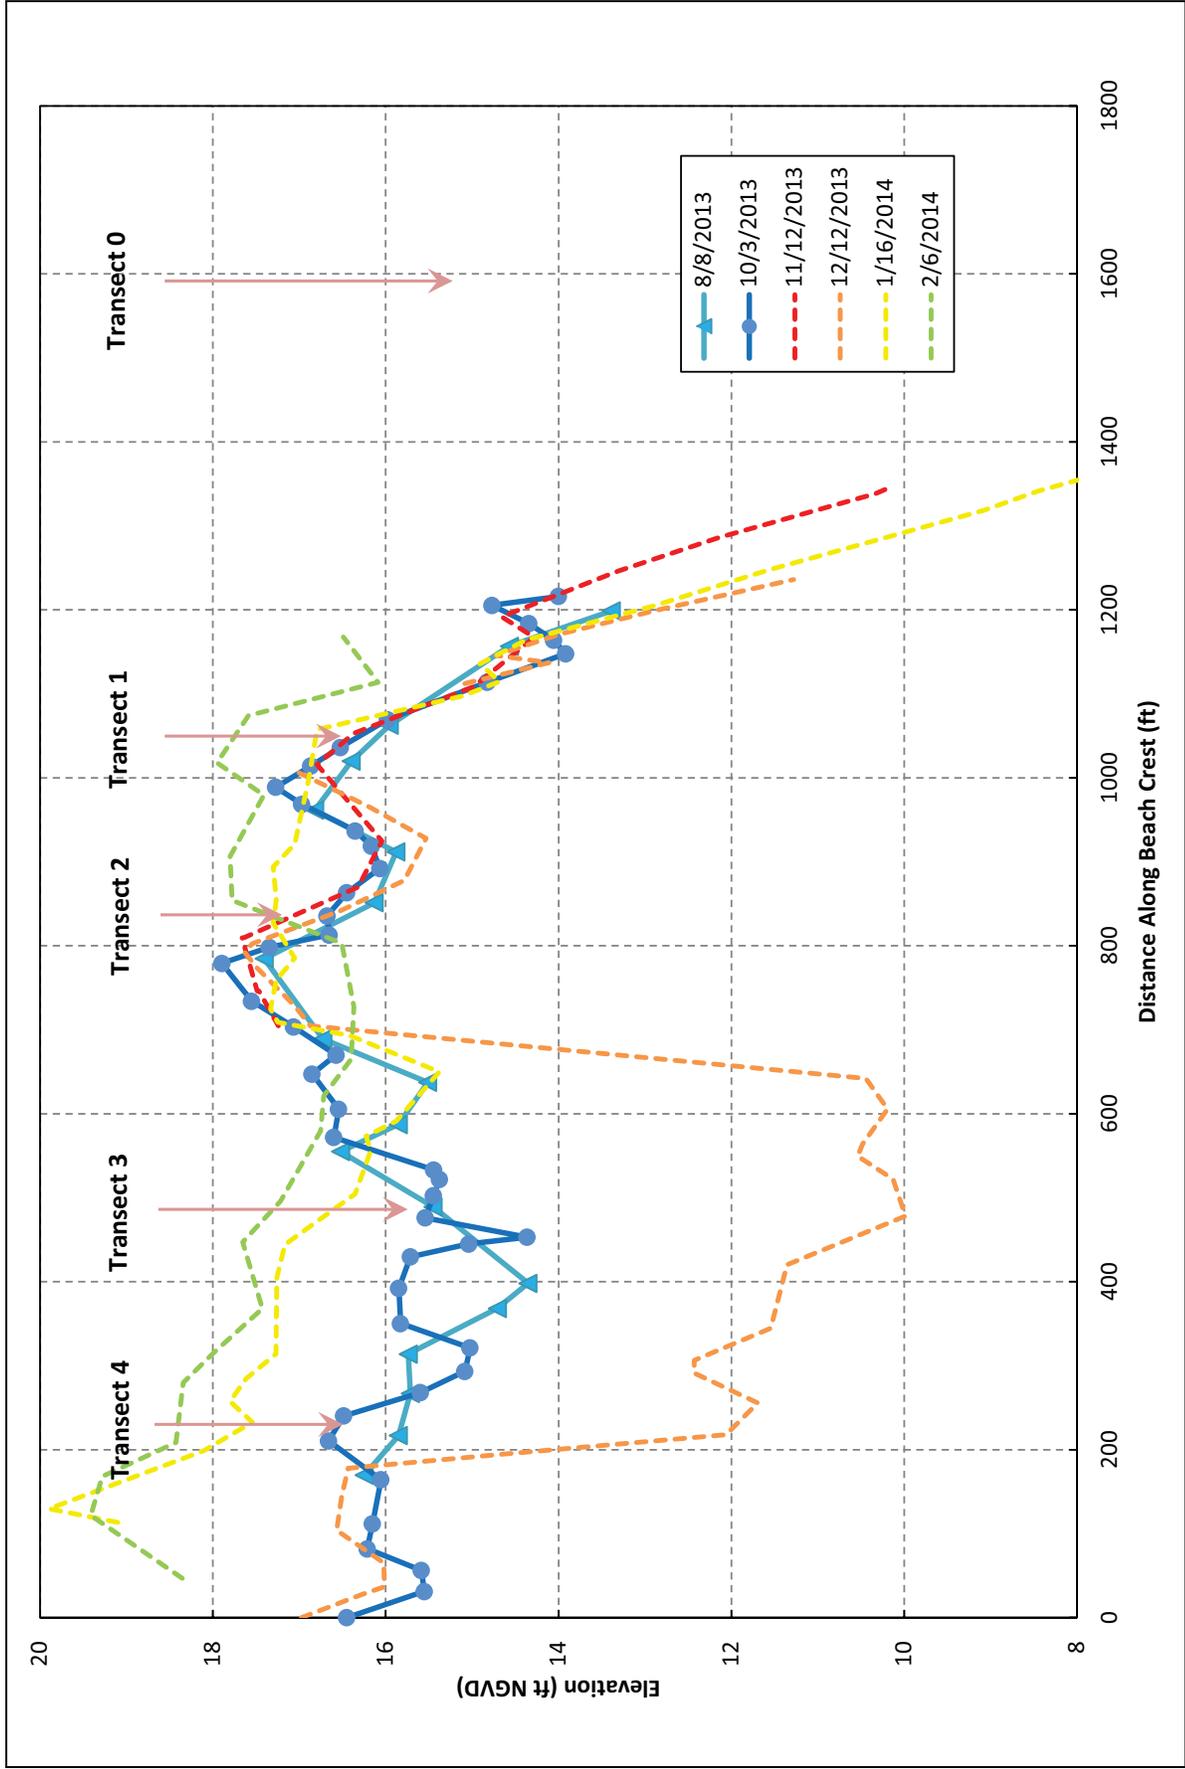
Russian River Estuary Outlet Channel Management Plan . DW01958
Figure 12
 Beach Crest Profiles From August 2013 to February 2014.

SOURCE: SCWA survey data
