**RUSSIAN RIVER ESTUARY OUTLET CHANNEL
ADAPTIVE MANAGEMENT PLAN
2015**

Sonoma County Water Agency

ESA

May 15, 2015

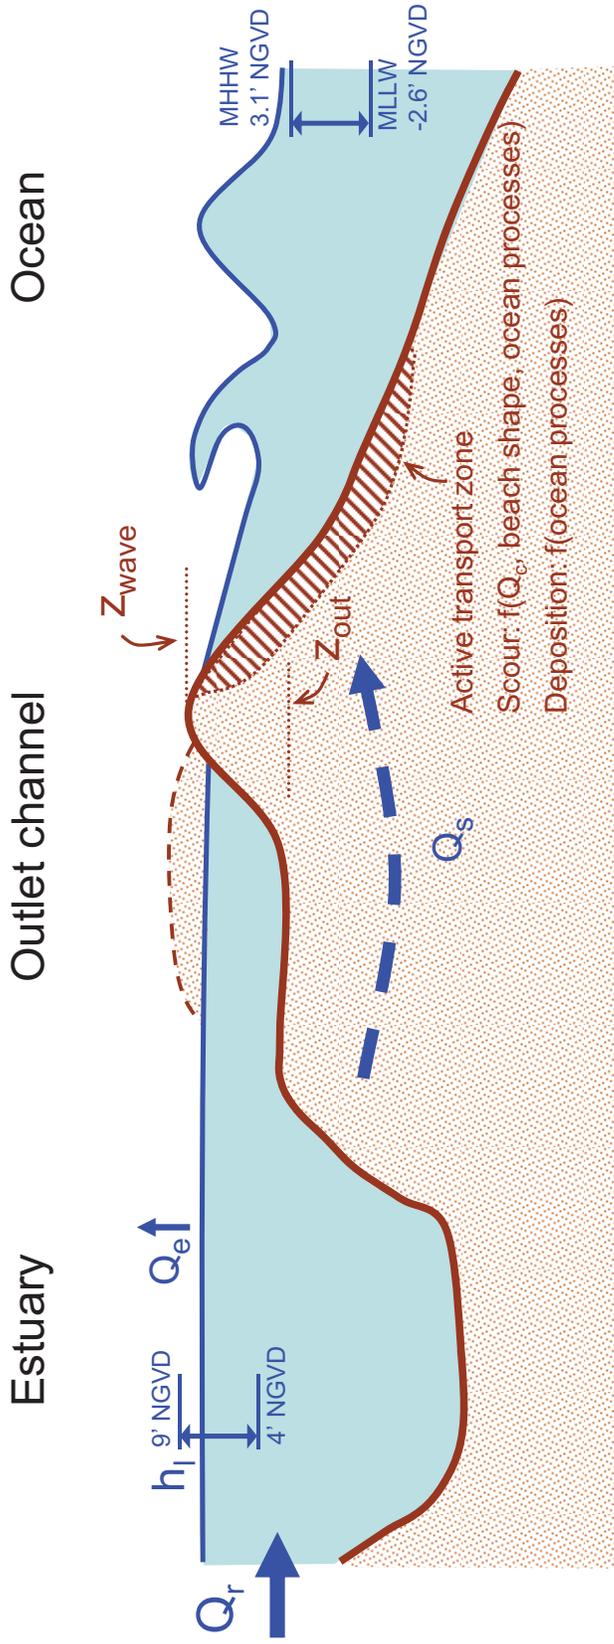
Parameters

- Z_{out} = target channel bed elevation
- Z_{wave} = wave runup elevation; $f(\text{wave conditions, ocean water level, channel location})$

The conceptual model for target outlet conditions is shown in Figure 2. Ideally, the outlet channel conveys water from the estuary to the ocean so that estuary can be maintained in a non-tidal state during the management period. A key performance criterion of this non-tidal state is that the water levels in the estuary (h_1) fall within the range of 4 to 9 ft NGVD, with elevations above 7 ft NGVD preferred. The estuary water level will not be managed directly, e.g. by pumping. Instead, it will be managed indirectly by management actions dictated by the BO, the operation and maintenance of the outlet channel and the reduction of instream flow requirement.

Although sediment transport will be minimal within the outlet channel under target conditions, the channel's mouth will perpetually be an active transport zone. This portion of the channel, at its interface with the ocean, will be an active transport zone for two reasons. First, it lies within the surf zone and breaking waves move up and down its face in response to the tides and variations in wave

direction, magnitude, and period. Second, this wave action creates a slope on the order of 10:1, which is sufficiently steep that flows of nearly any magnitude from the outlet channel will accelerate to above the scour velocity threshold. In order for the outlet channel to persist with this active transport zone at its mouth, this zone will have to experience minimal net sediment transport. In other words, tidal fluctuations in water level and variability in wave intensity will cause the locations of scour and deposition to shift at hourly timescales, but averaging across several tidal cycles, any sand lost by scour will be balanced by an equivalent amount of deposition. This active transport zone also plays a significant role in lateral migration of the existing channel mouth. This process is discussed in Section 4.4 on planform alignment.

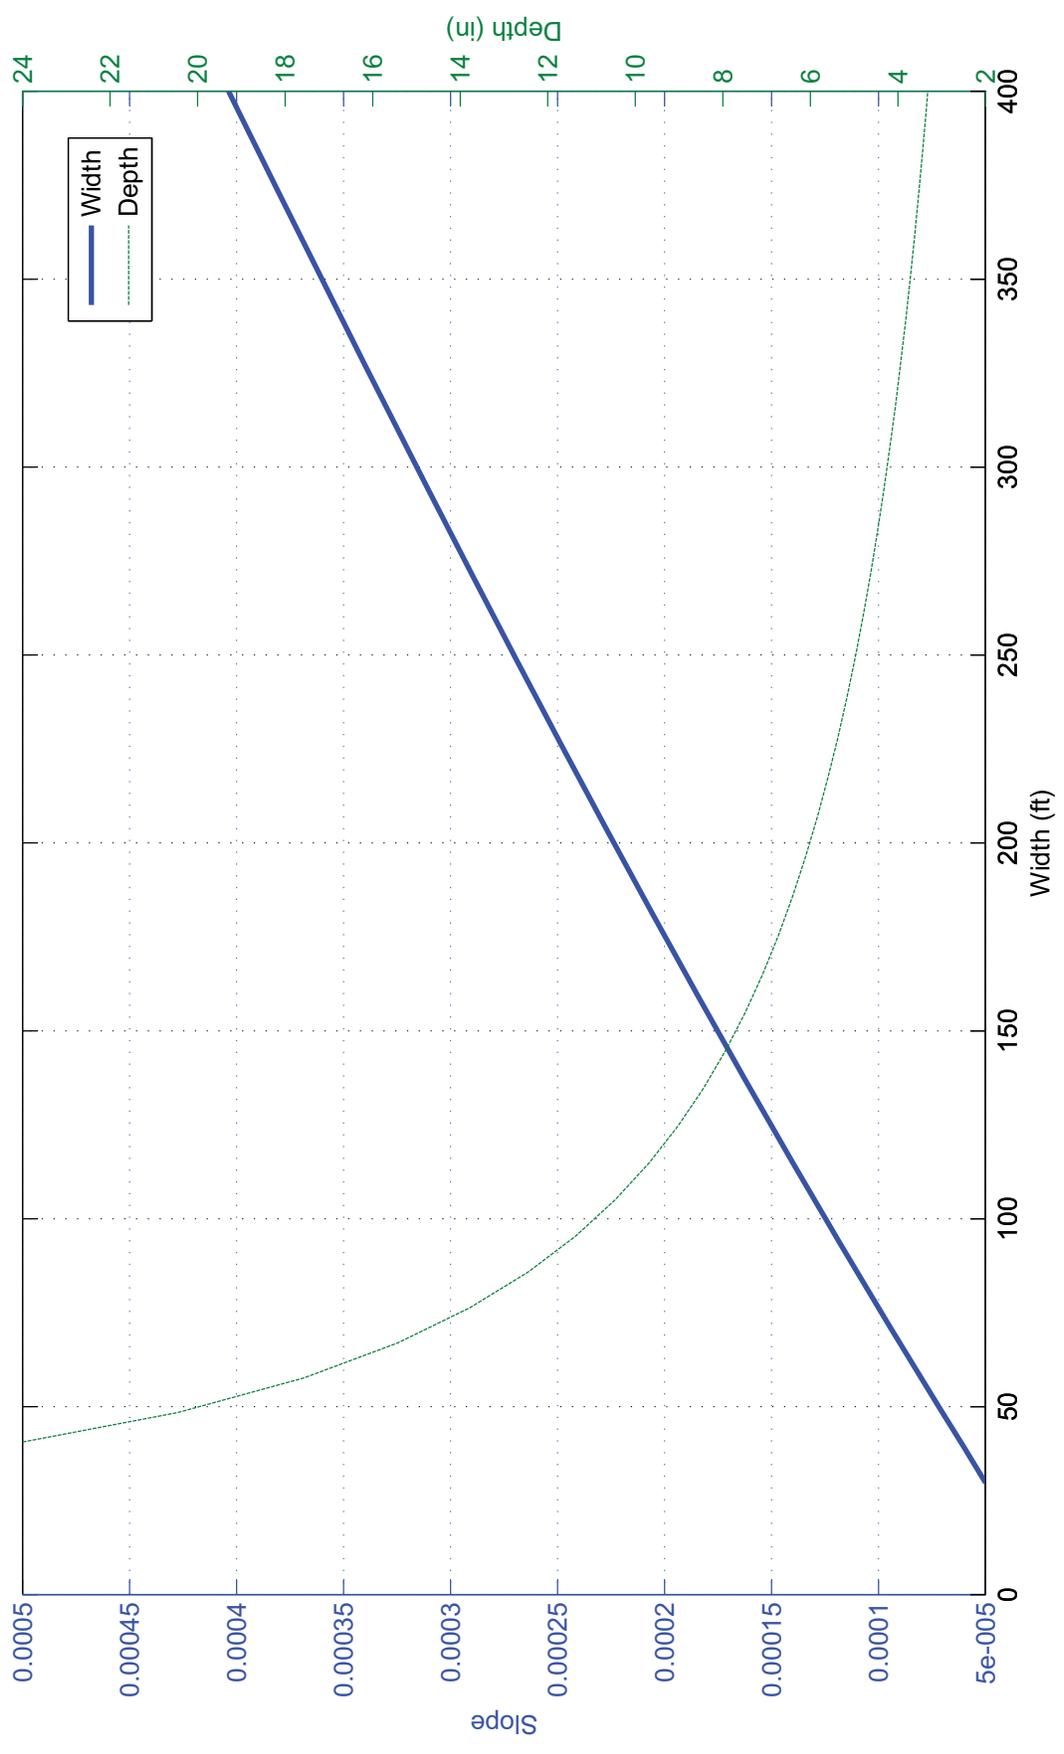
Figure 6
Russian River Estuary Outlet Channel Management Plan

Source: Stability curve for local bed shear stress of 0.5 Pa, flowrate of 70 cfs, and Manning's roughness of 0.02.

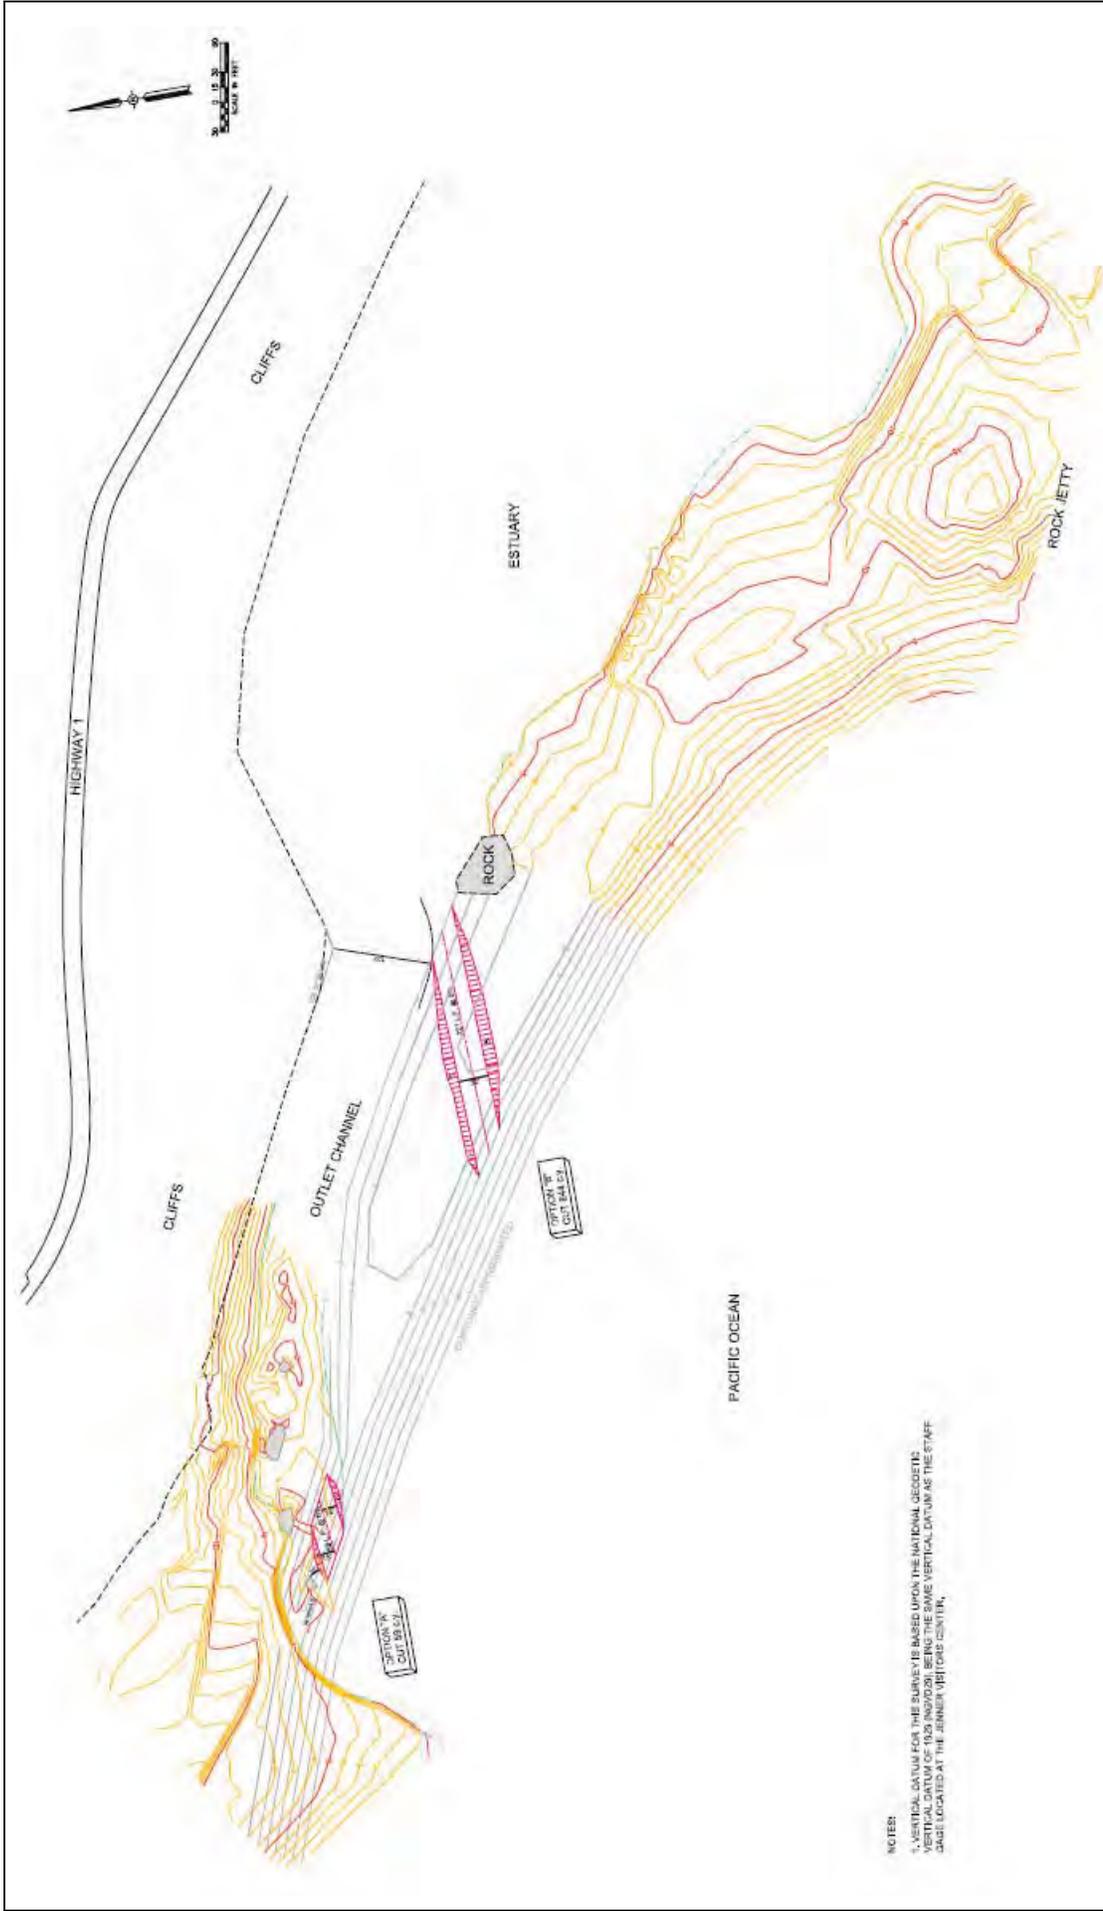
figure 4
 Russian River Outlet Channel Adaptive Management Plan
 Beach Topography and Management Options, June 2010

Source: SCWA

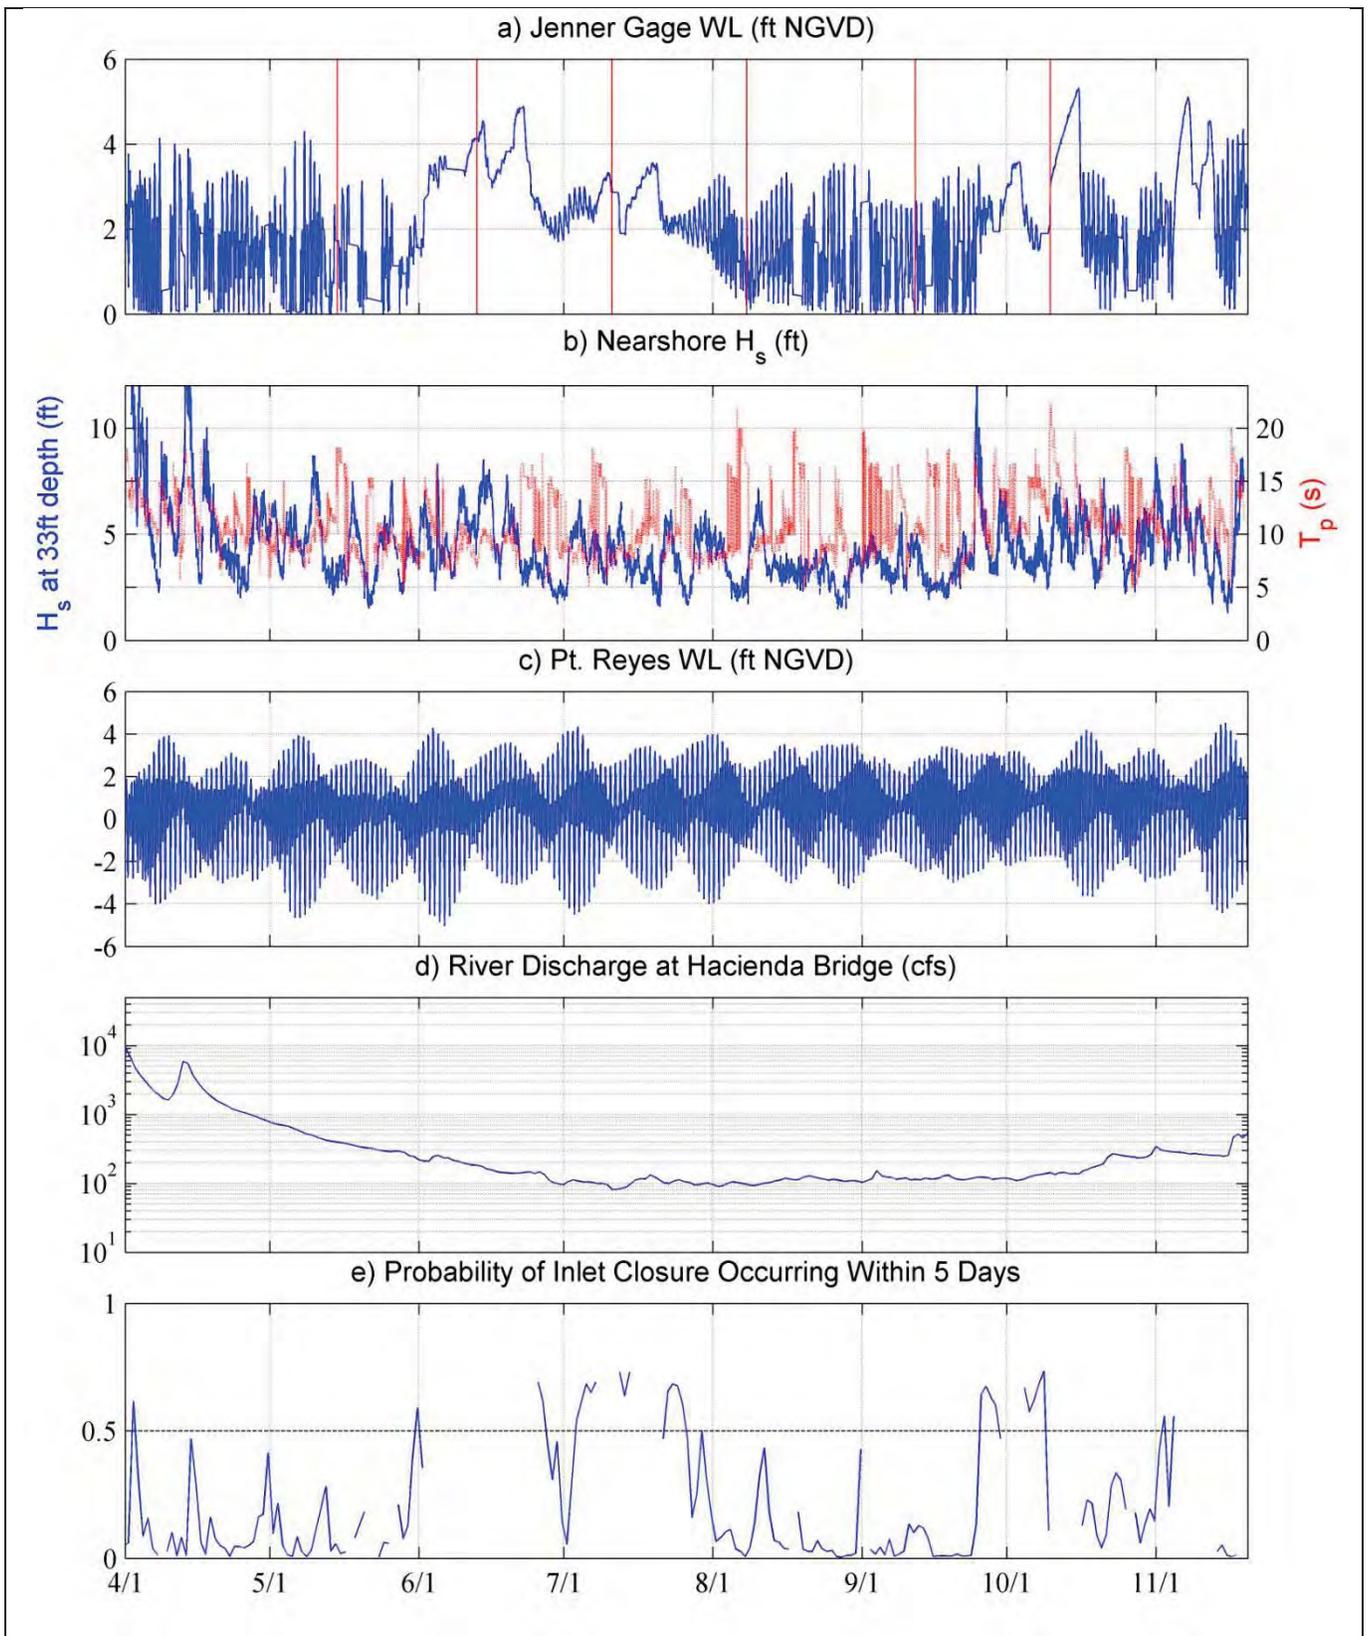
Figure 1
 Estuary, Ocean, and River Conditions Compared
 with Closure Probability:
 September – November 2012

- a) Jenner gage water level provided by SCWA; red bar = beach survey
- b) H_s = sig. wave height; T_p =peak wave period (CDIP, Pt. Reyes, #029)
- c) Ocean water level provided by NOAA (Pt. Reyes #9415020)
- d) River discharge provided by USGS (Guerneville #11467000)
- e) Five-day closure probability provided after Behrens et al. (2013)

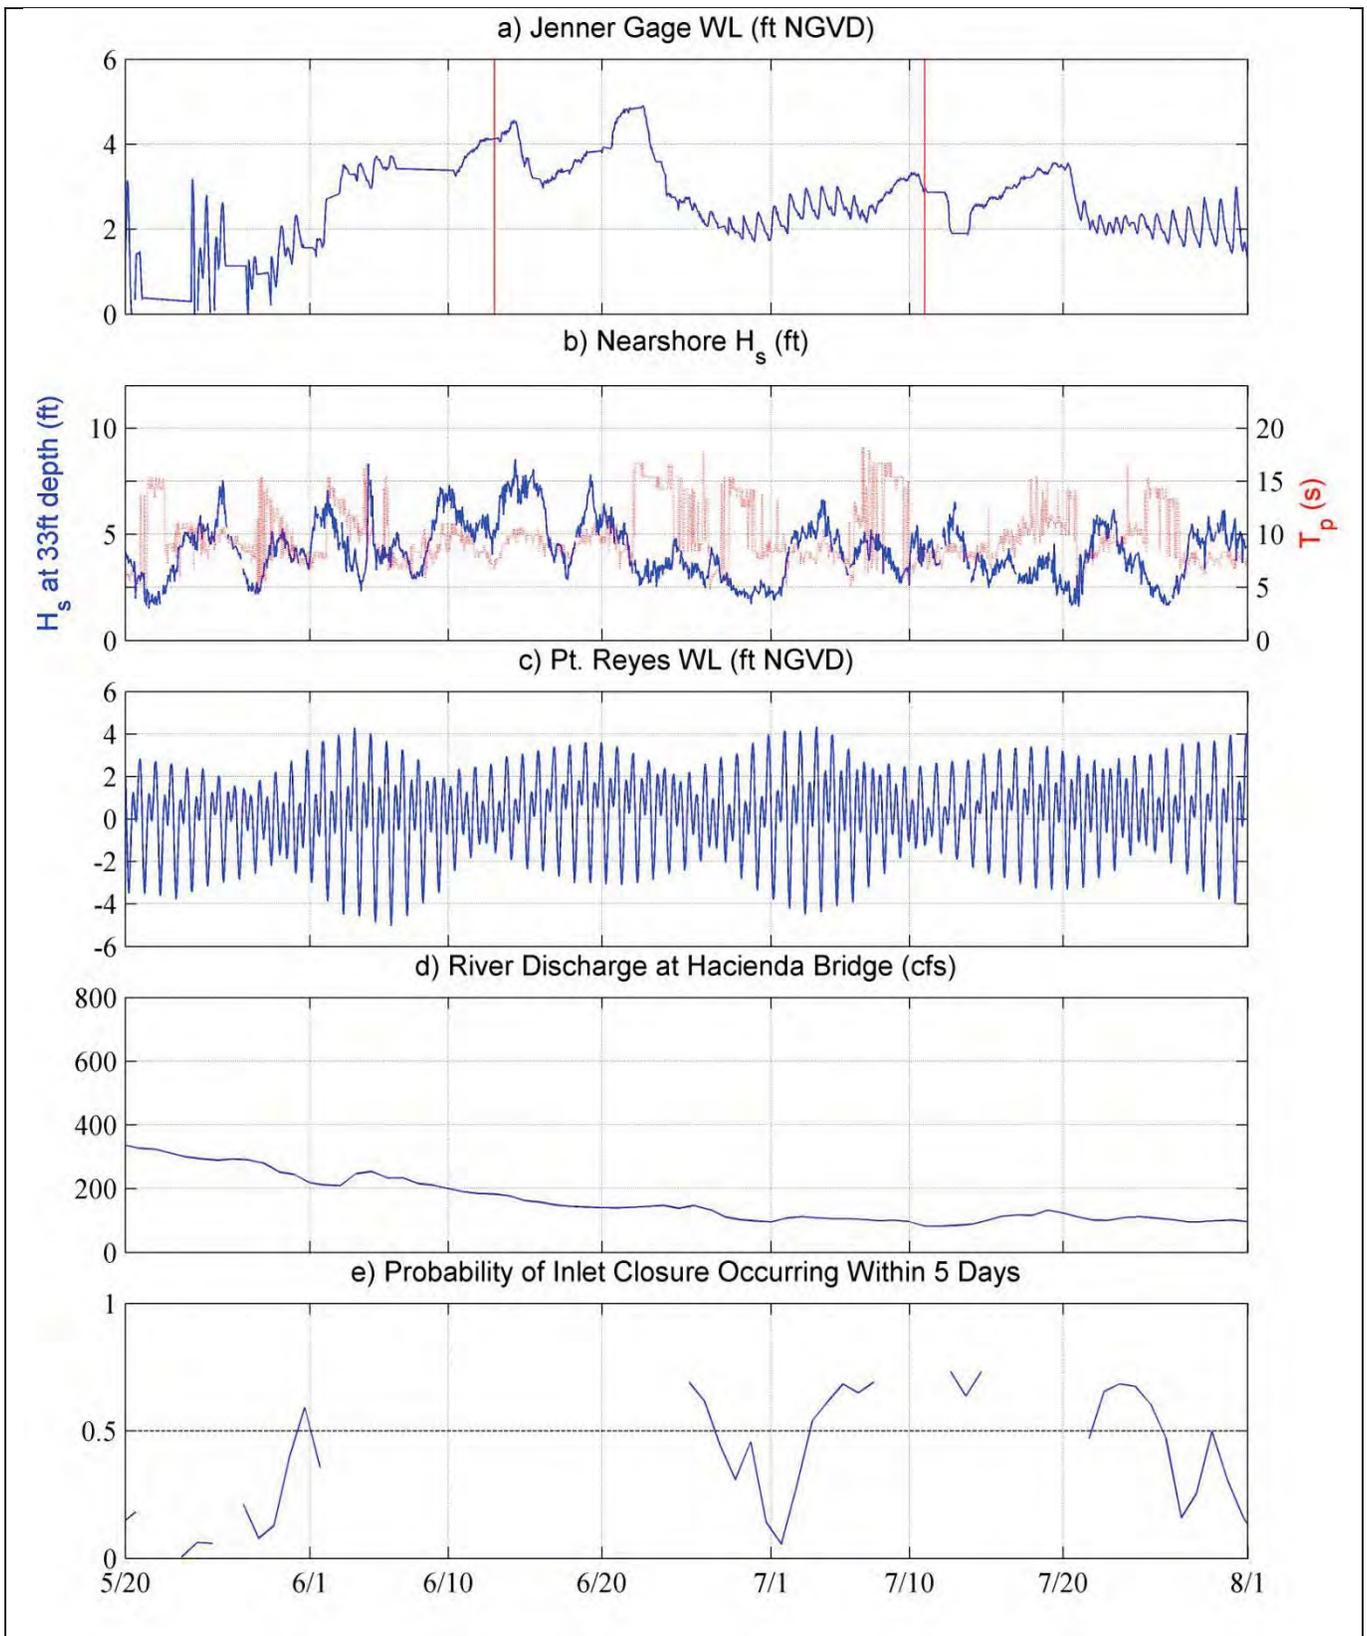
Figure 2
 Estuary, Ocean, and River Conditions Compared
 with Closure Probability:
 May 20 – August 1, 2012

- a) Jenner gage water level provided by SCWA; red bar = beach survey
- b) H_s = sig. wave height; T_p = peak wave period (CDIP, Pt. Reyes, #029)
- c) Ocean water level provided by NOAA (Pt. Reyes #9415020)
- d) River discharge provided by USGS (Guerneville #11467000)
- e) Five-day closure probability provided after Behrens et al. (2013)

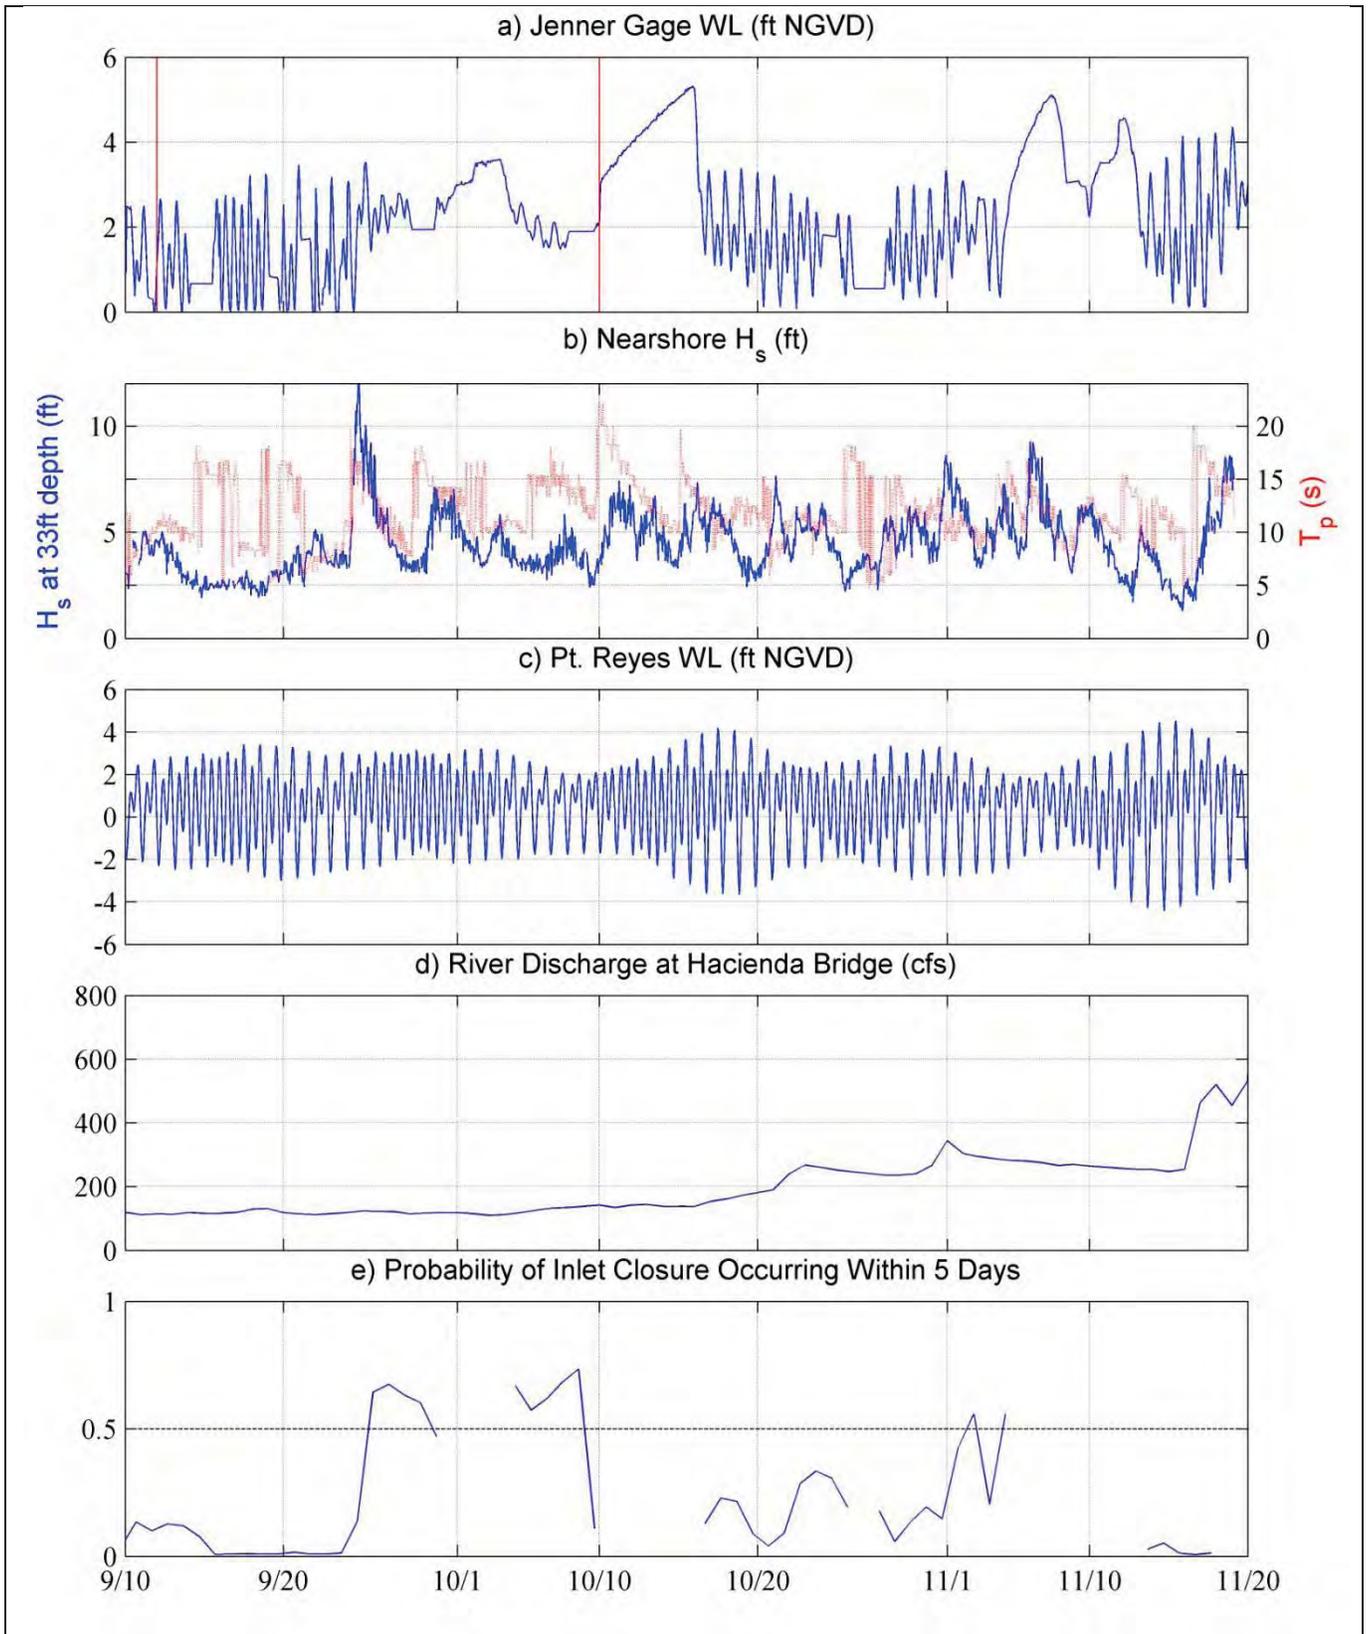
Figure 3
 Estuary, Ocean, and River Conditions Compared
 with Closure Probability:
 September 10 – November 20, 2012

- a) Jenner gage water level provided by SCWA; red bar = beach survey
- b) H_s = sig. wave height; T_p = peak wave period (CDIP, Pt. Reyes, #029)
- c) Ocean water level provided by NOAA (Pt. Reyes #9415020)
- d) River discharge provided by USGS (Guerneville #11467000)
- e) Five-day closure probability provided after Behrens et al. (2013)

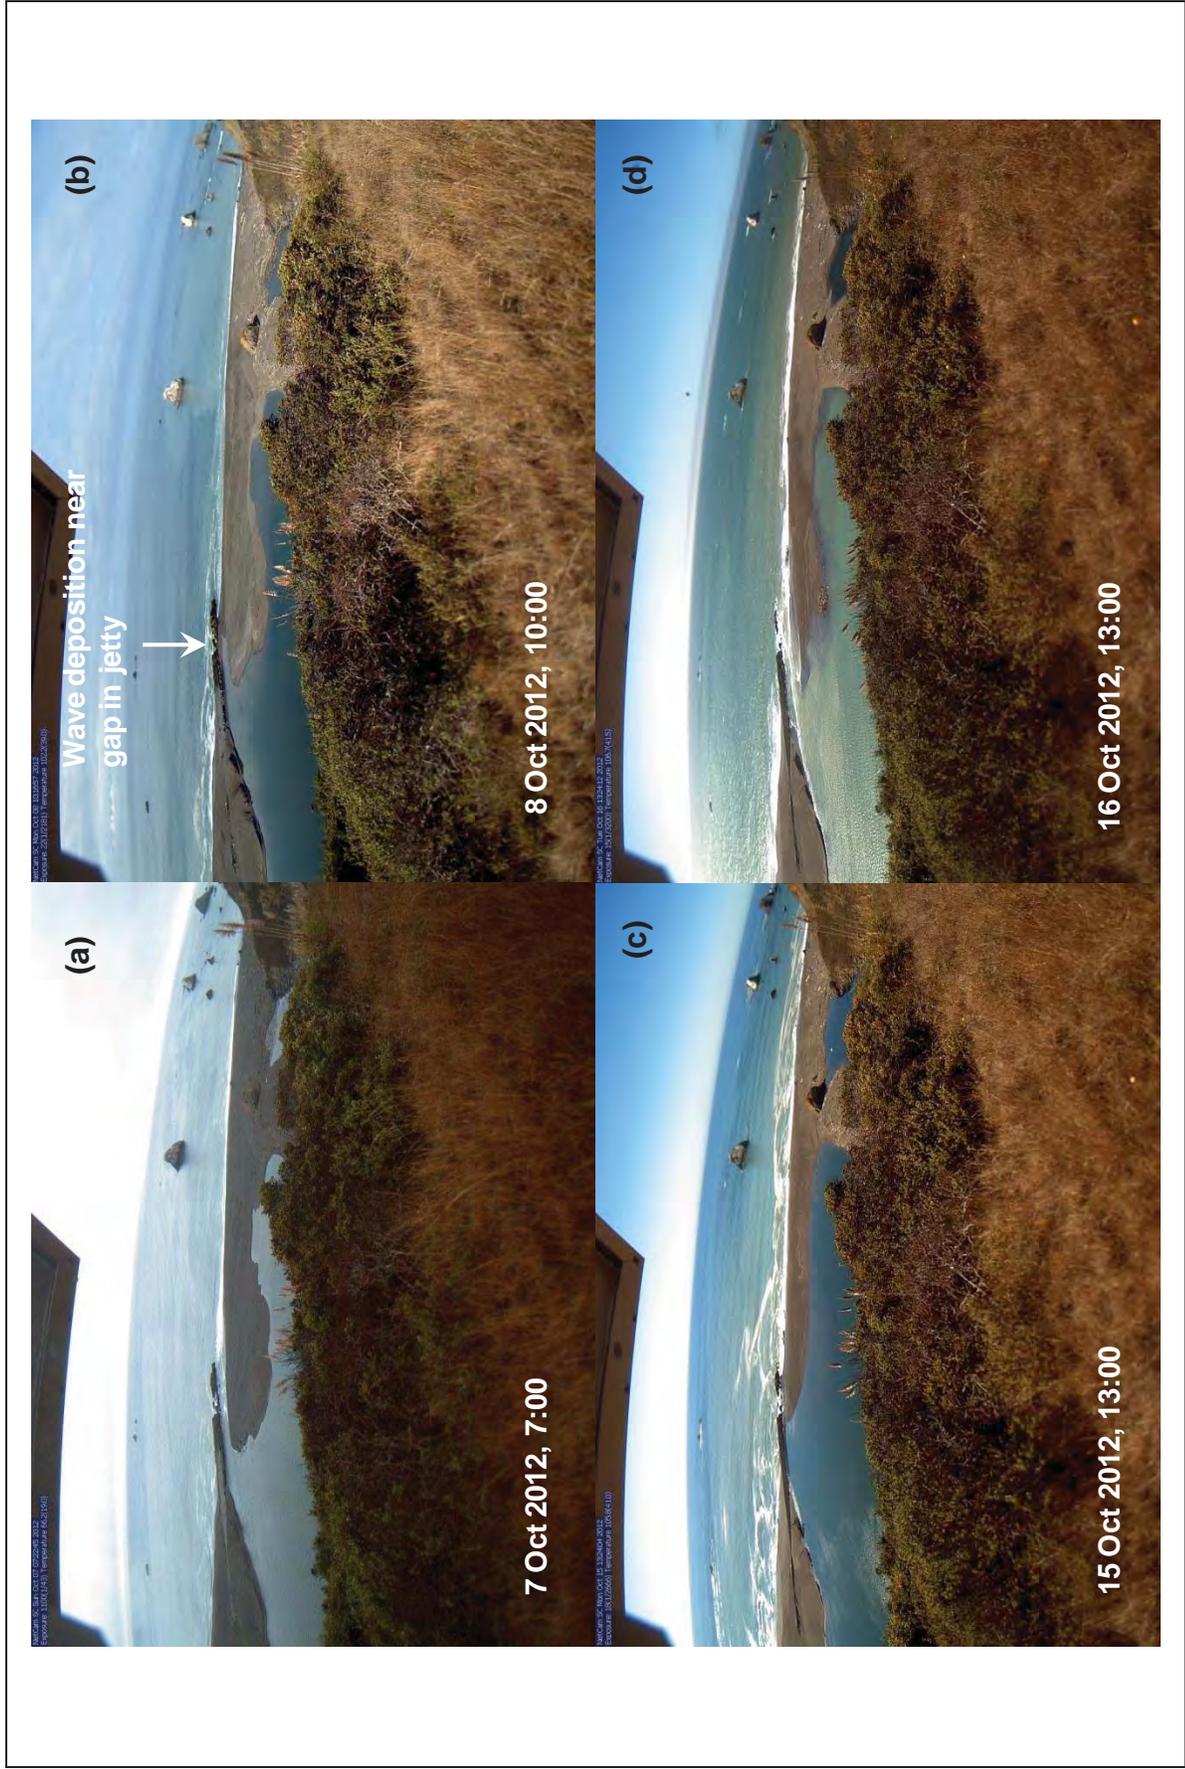
Russian River Estuary Outlet Channel Management Plan . DW01958
Figure 4
 Inlet Closure and Self-Breach in October 2012

SOURCE: Russian River stationary observation camera (BML)

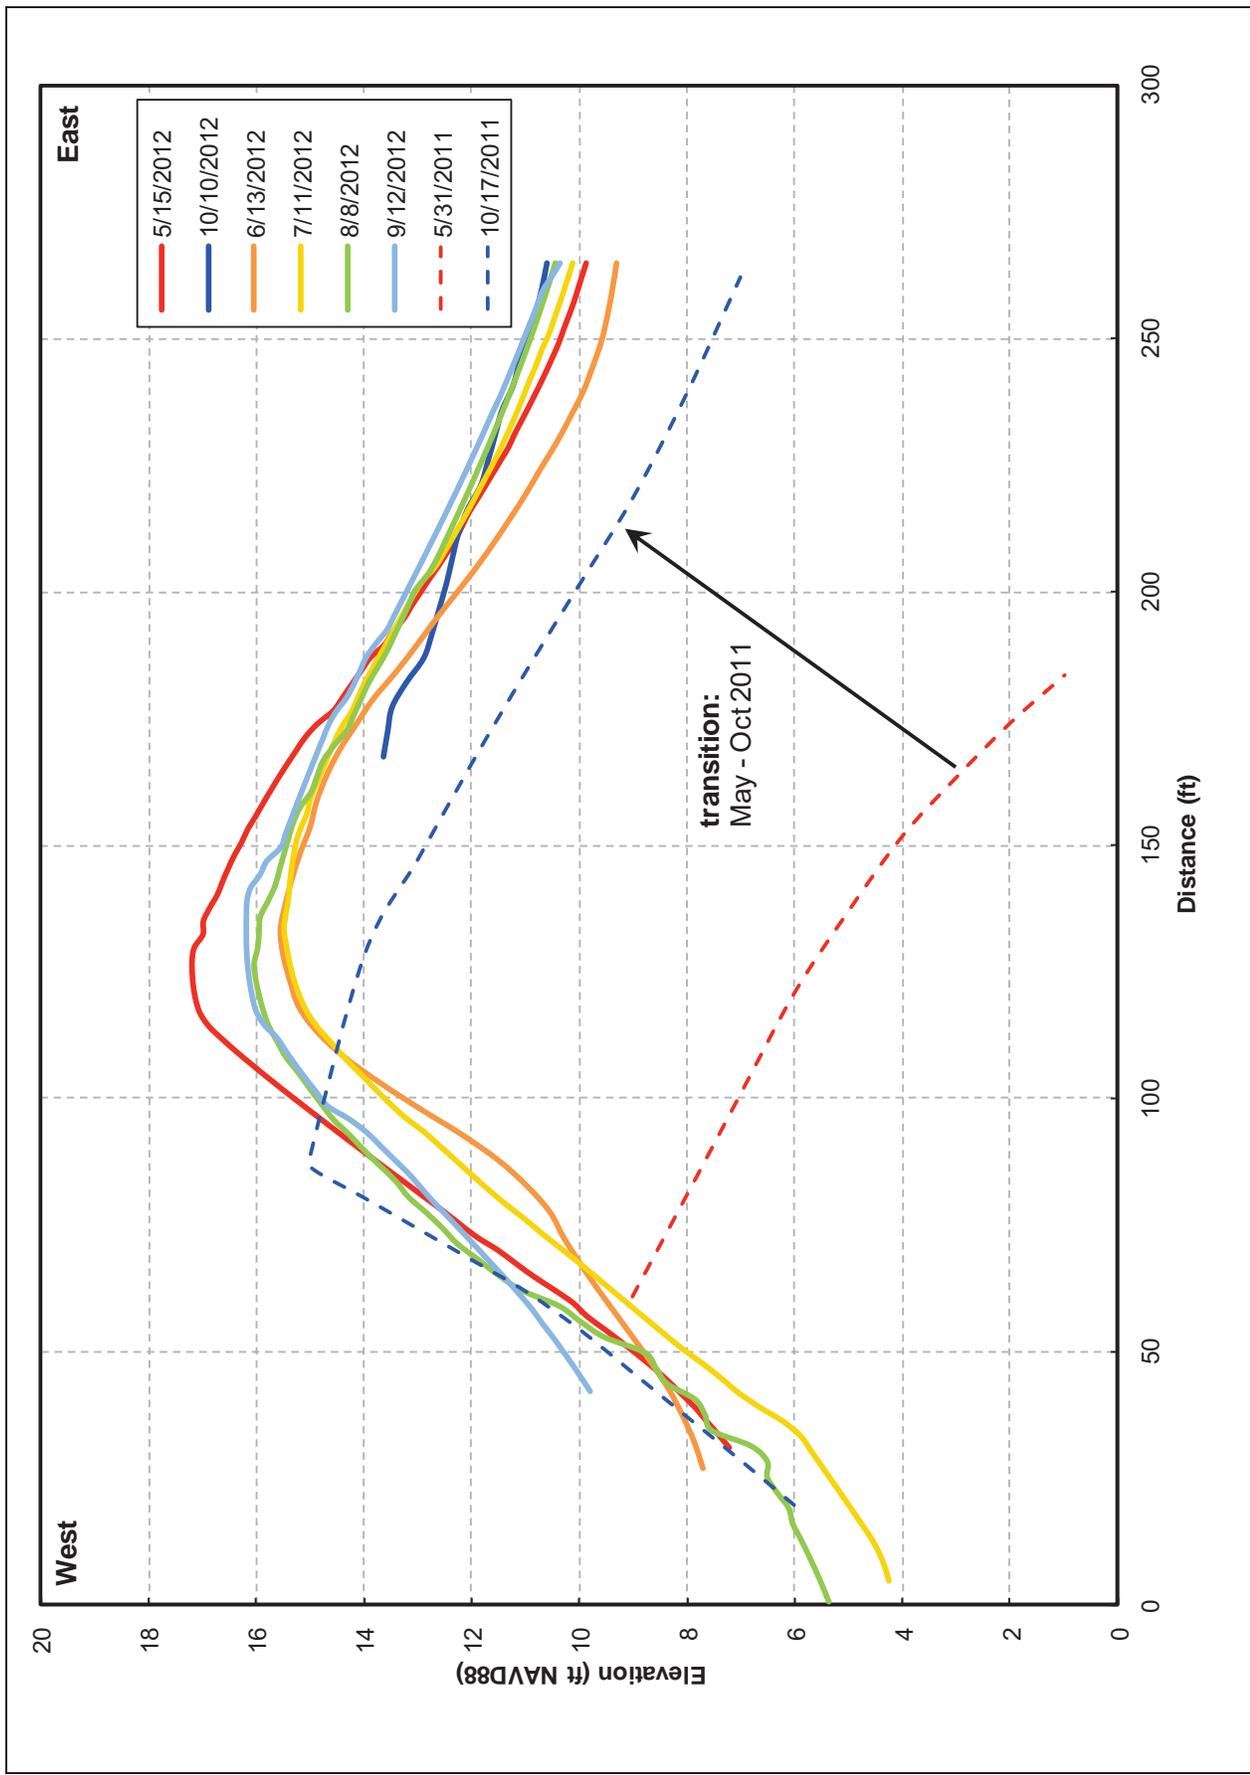
Figure 8
Beach Transect 3

SOURCE: SCWA survey data

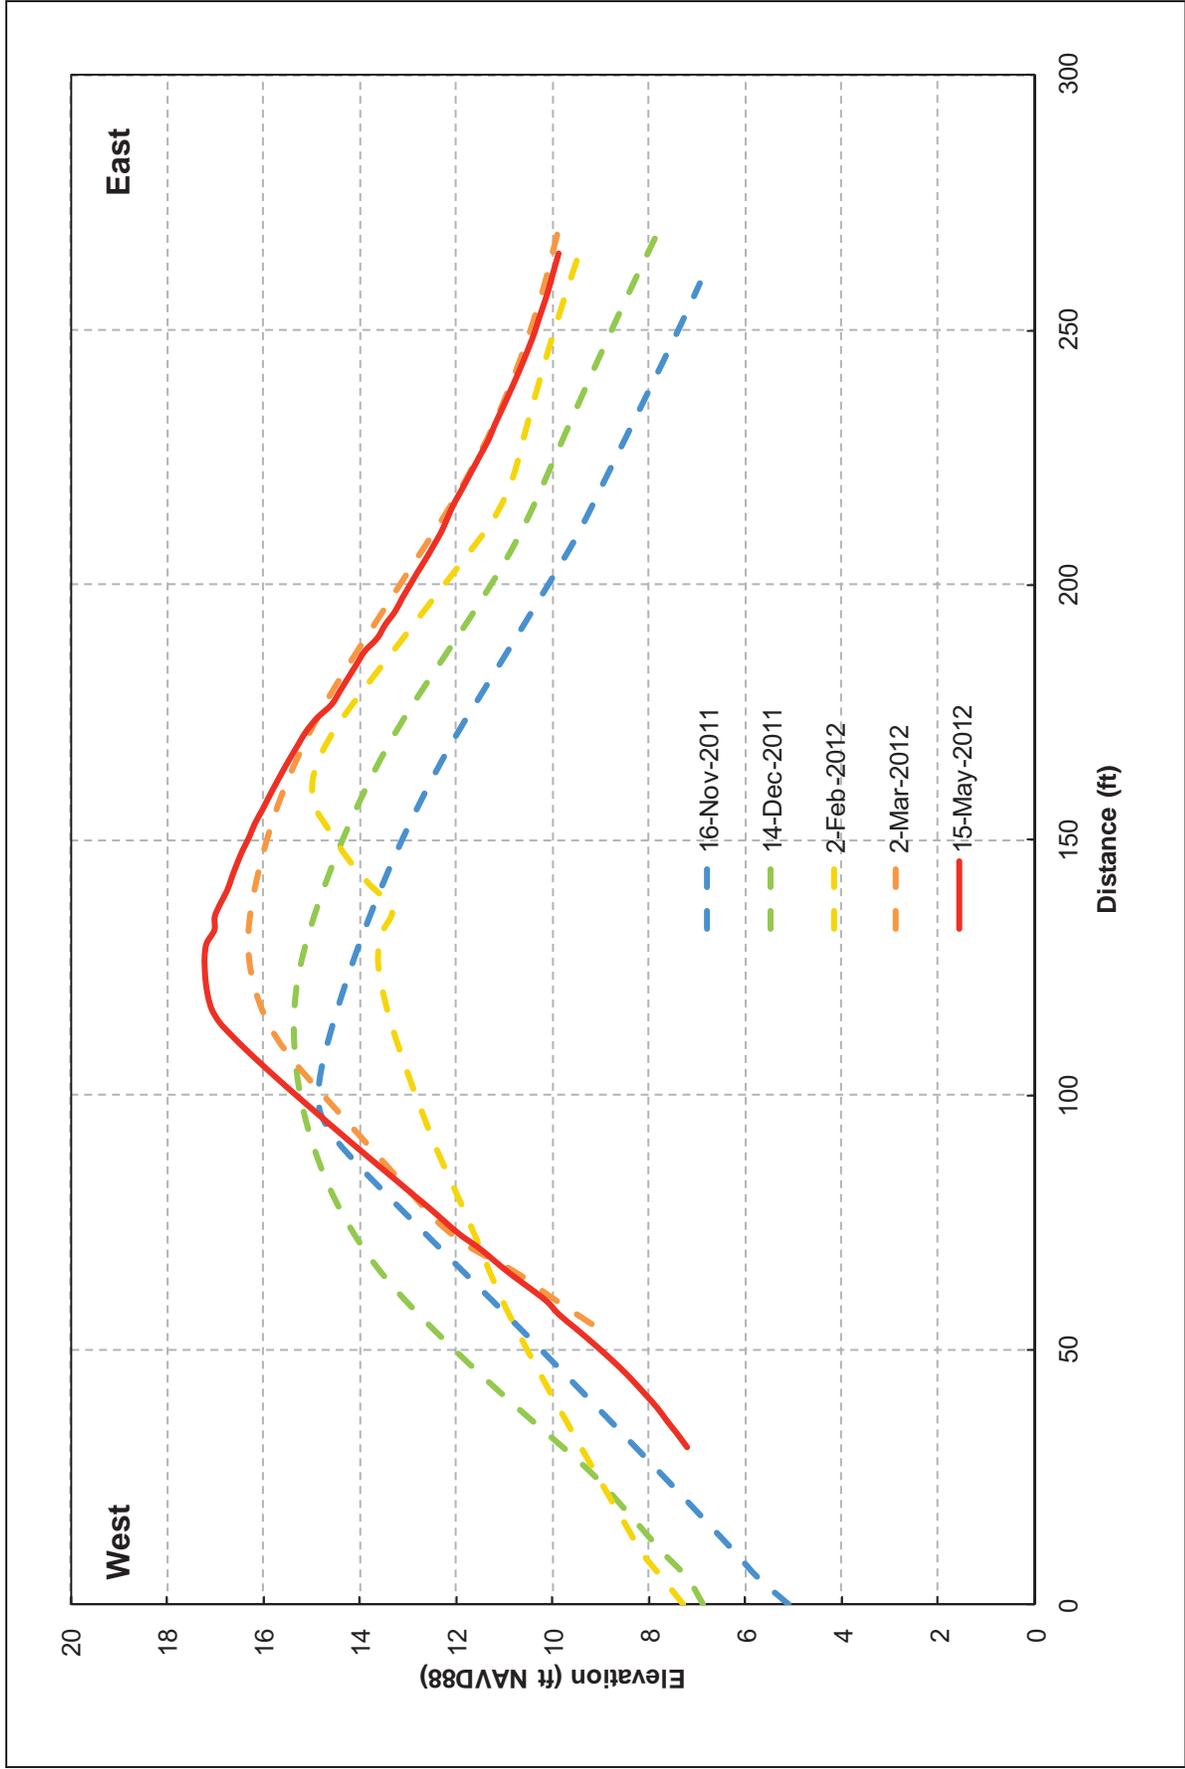
Figure 12
Nov 2011 to May 2012 topographic change at Beach Transect 3

SOURCE: SCWA survey data

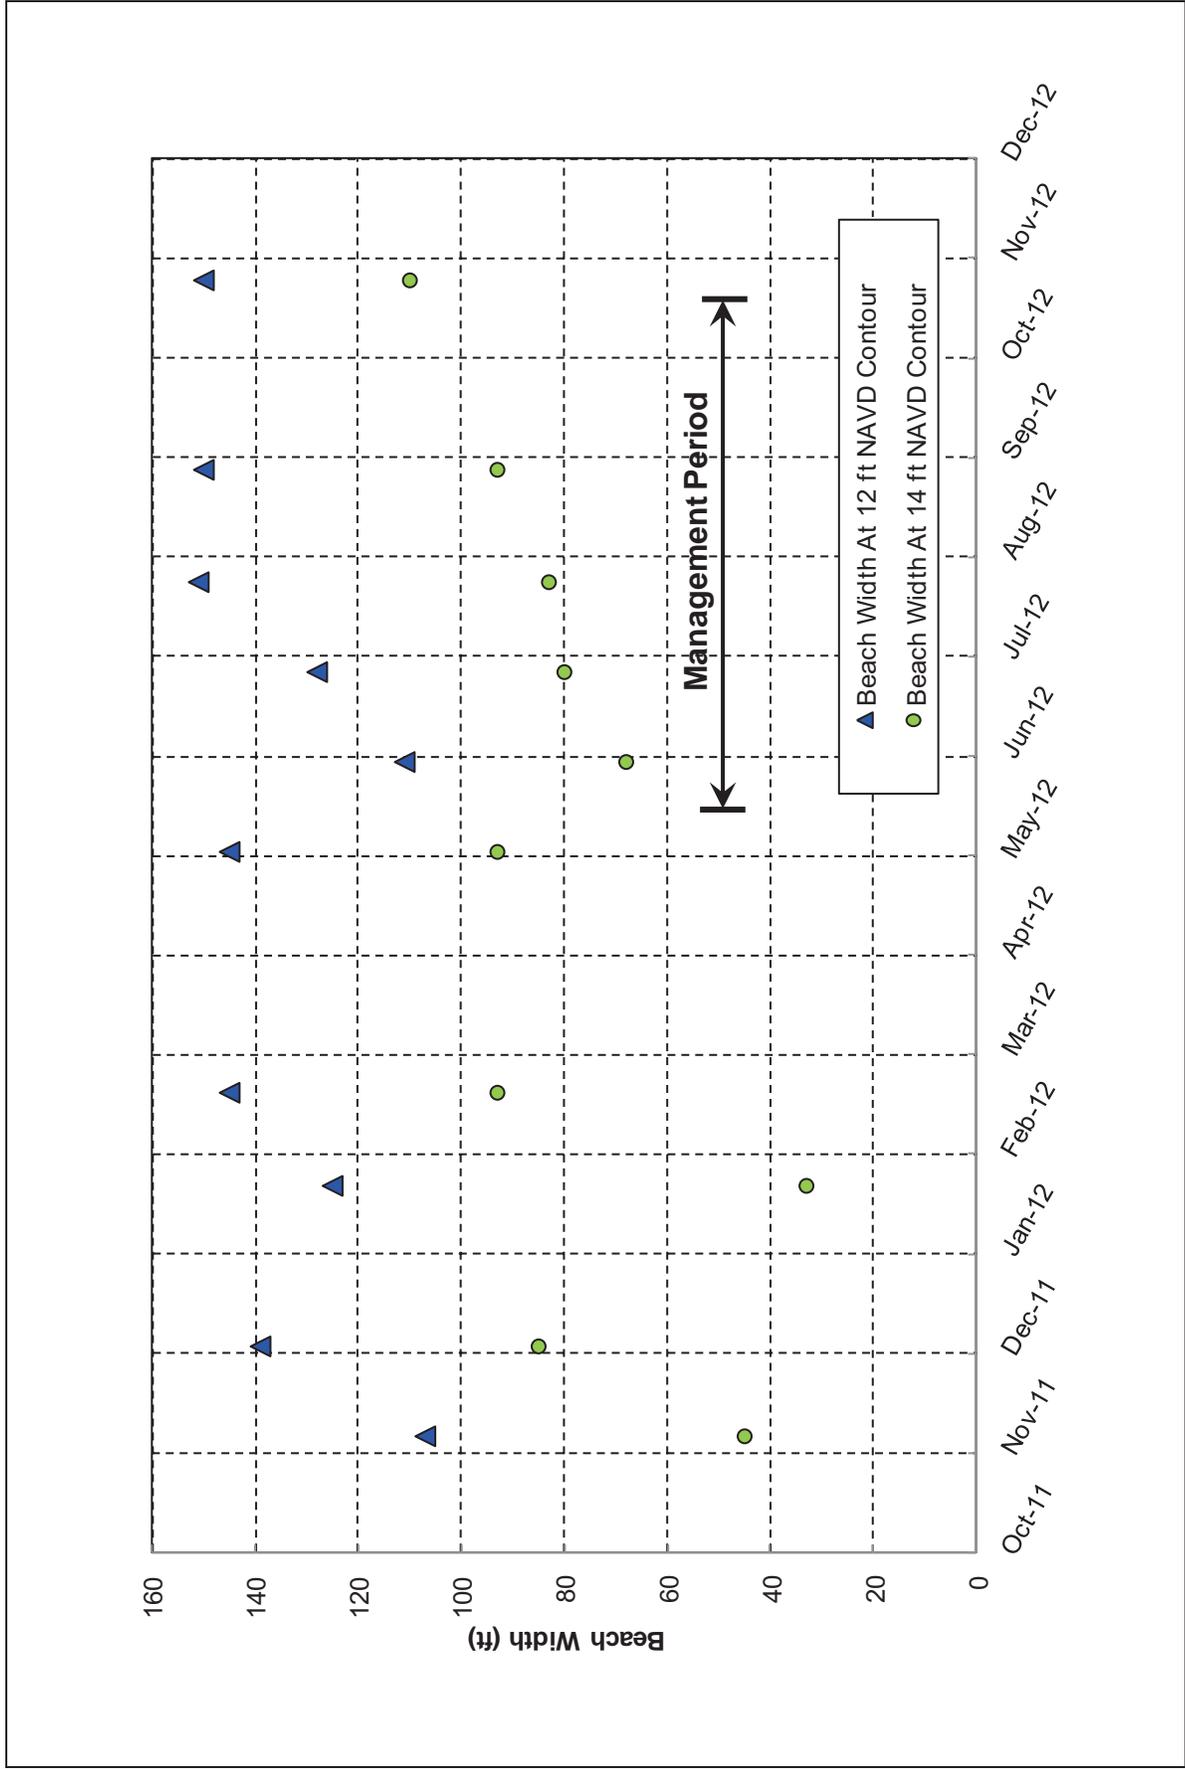
Russian River Estuary Outlet Channel Management Plan . D120709.00
Figure 13
 Beach Width at Beach Transect 3.

SOURCE: SCWA survey data
