**RUSSIAN RIVER ESTUARY OUTLET CHANNEL
ADAPTIVE MANAGEMENT PLAN
2015**

Sonoma County Water Agency

ESA

May 15, 2015

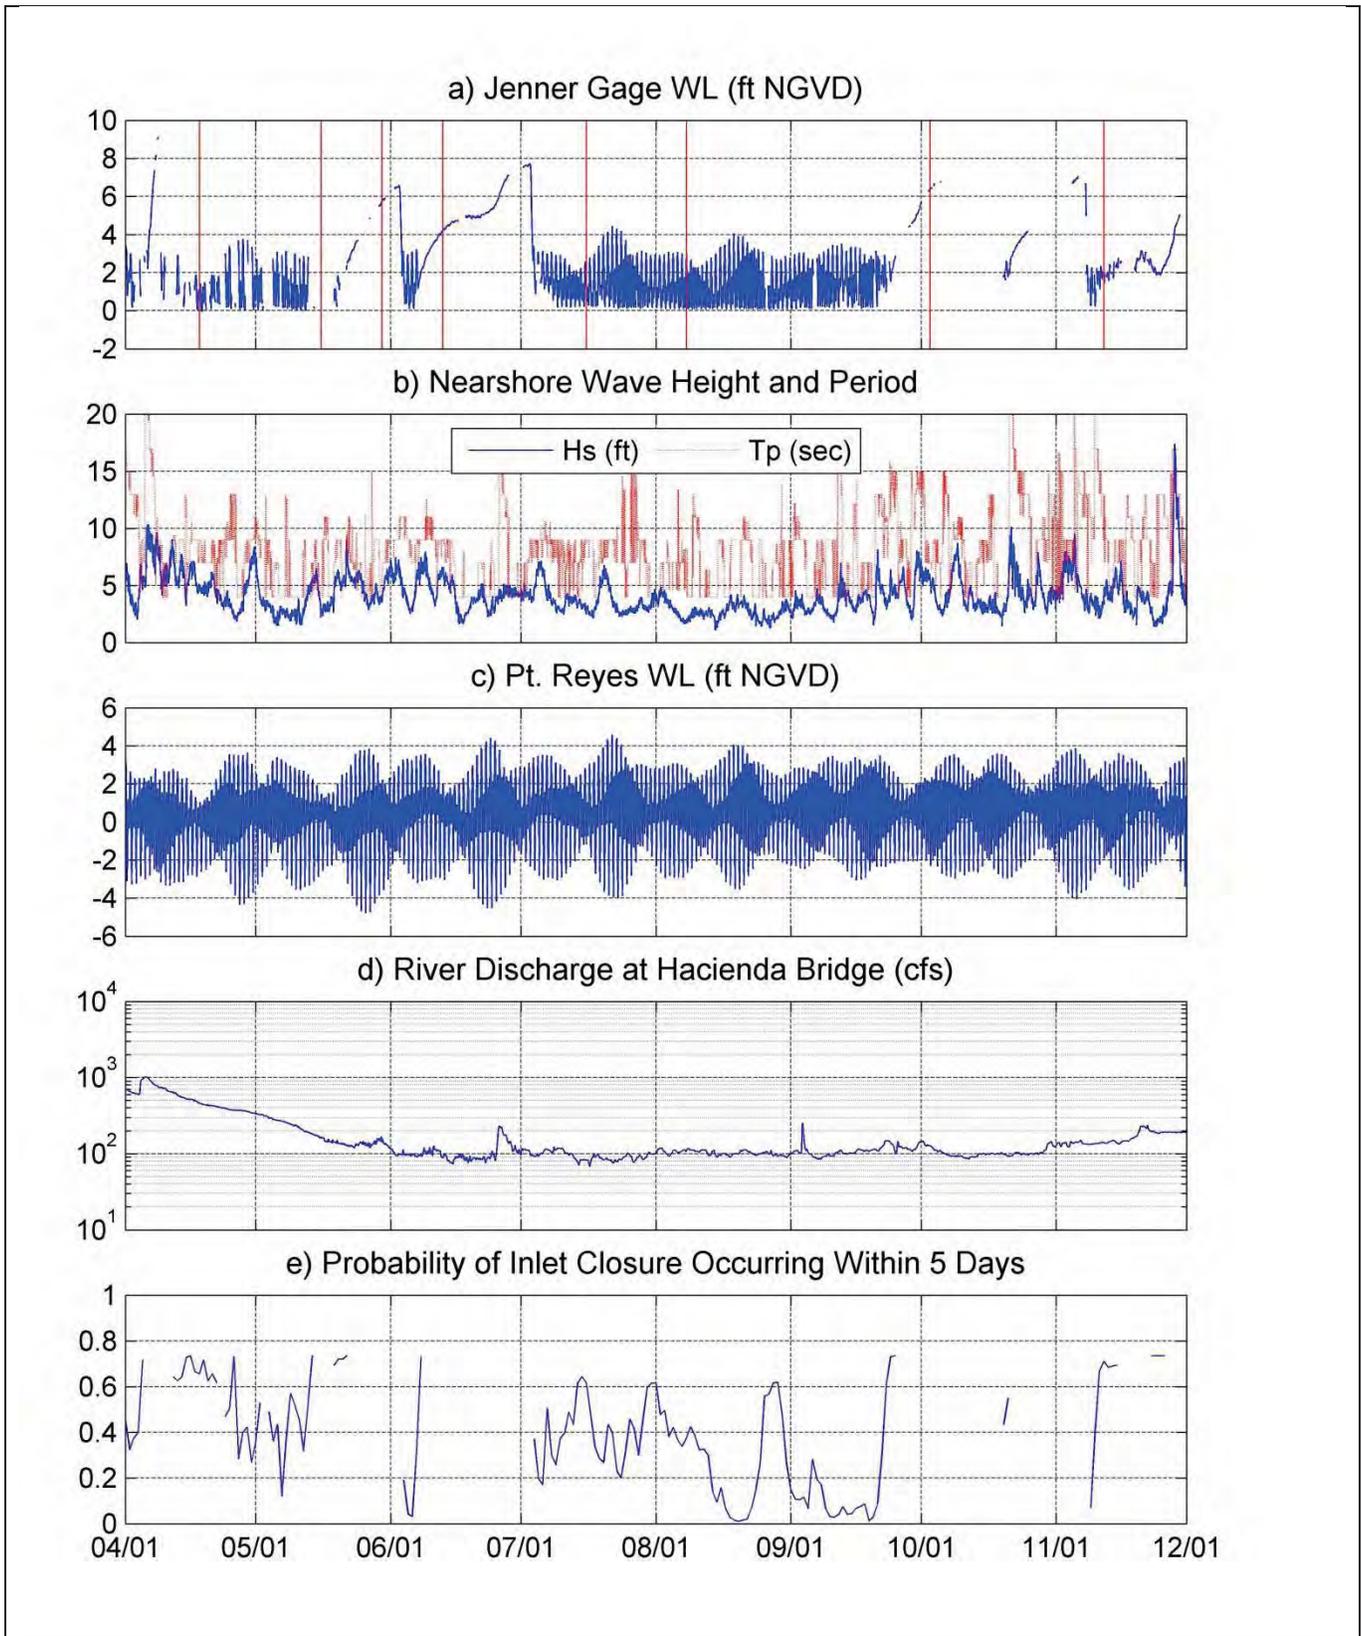
Figure 1
 Estuary, Ocean, and River Conditions Compared
 with Closure Probability:
 April – November 2013

- a) Jenner gage water level provided by SCWA; red bar = beach survey
- b) H_s = sig. wave height; T_p =peak wave period (CDIP, Pt. Reyes, #029)
- c) Ocean water level provided by NOAA (Pt. Reyes #9415020)
- d) River discharge provided by USGS (Guerneville #11467000)
- e) Five-day closure probability provided after Behrens et al. (2013)

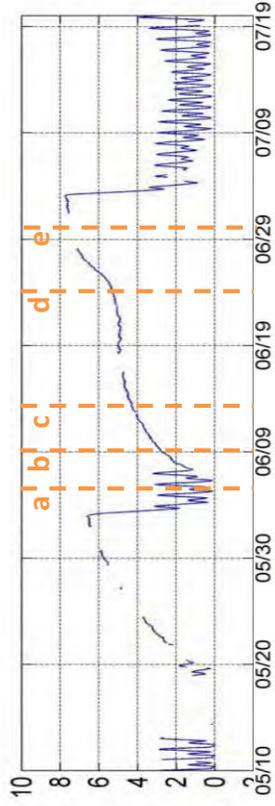
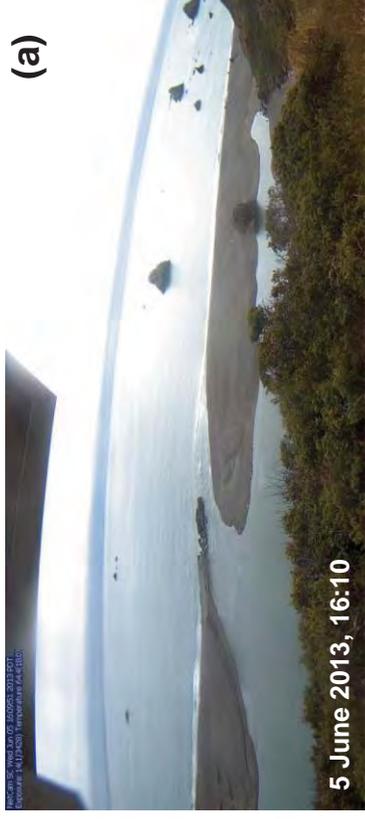
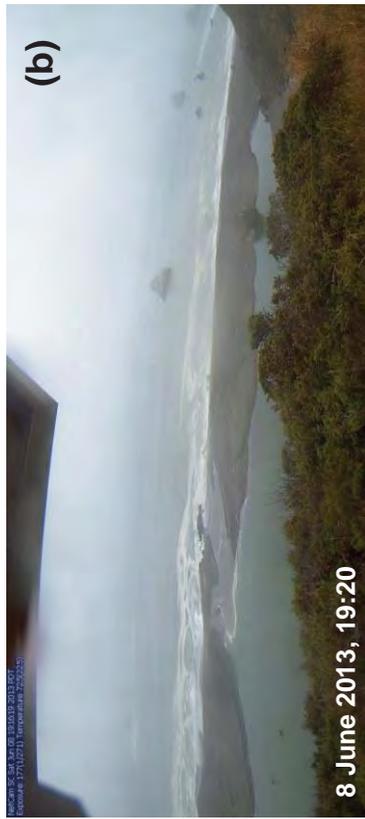
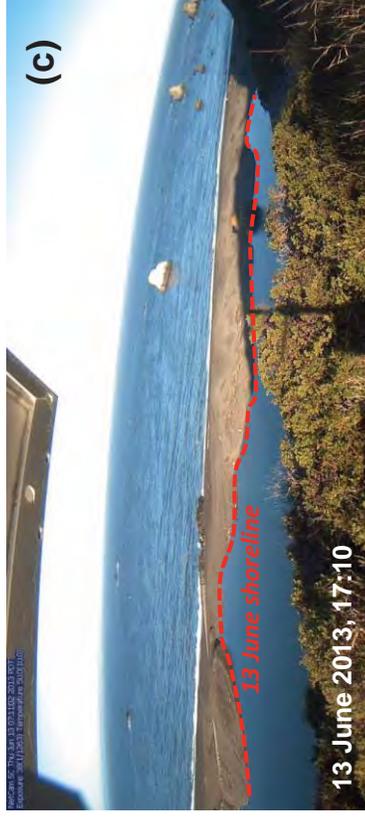
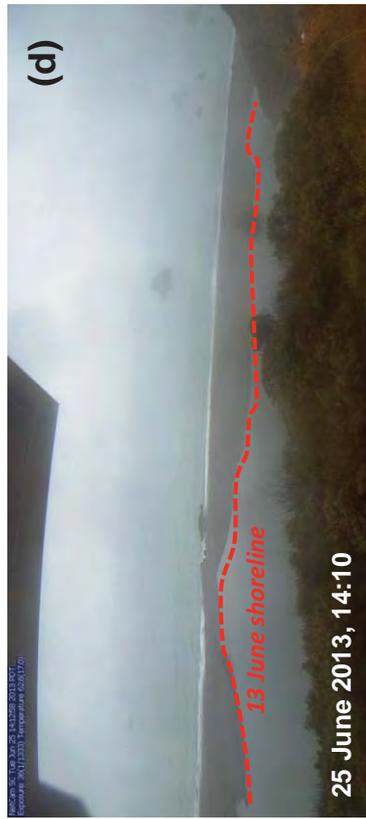
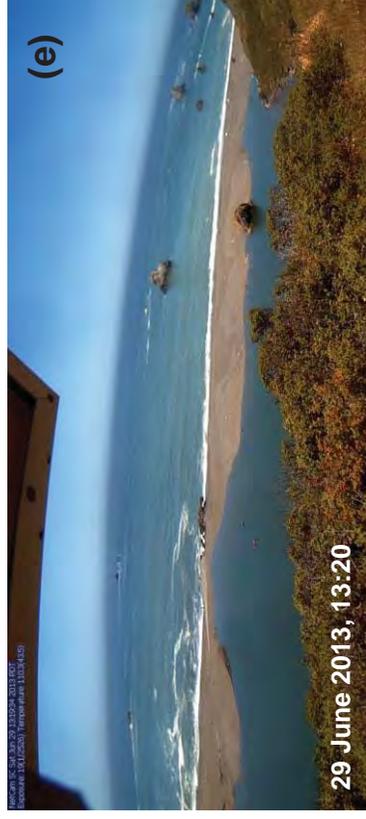
Russian River Estuary Outlet Channel Management Plan . DW01958
Figure 4
 Inlet Closure Event in June-July 2013

SOURCE: Russian River stationary observation camera (BML)

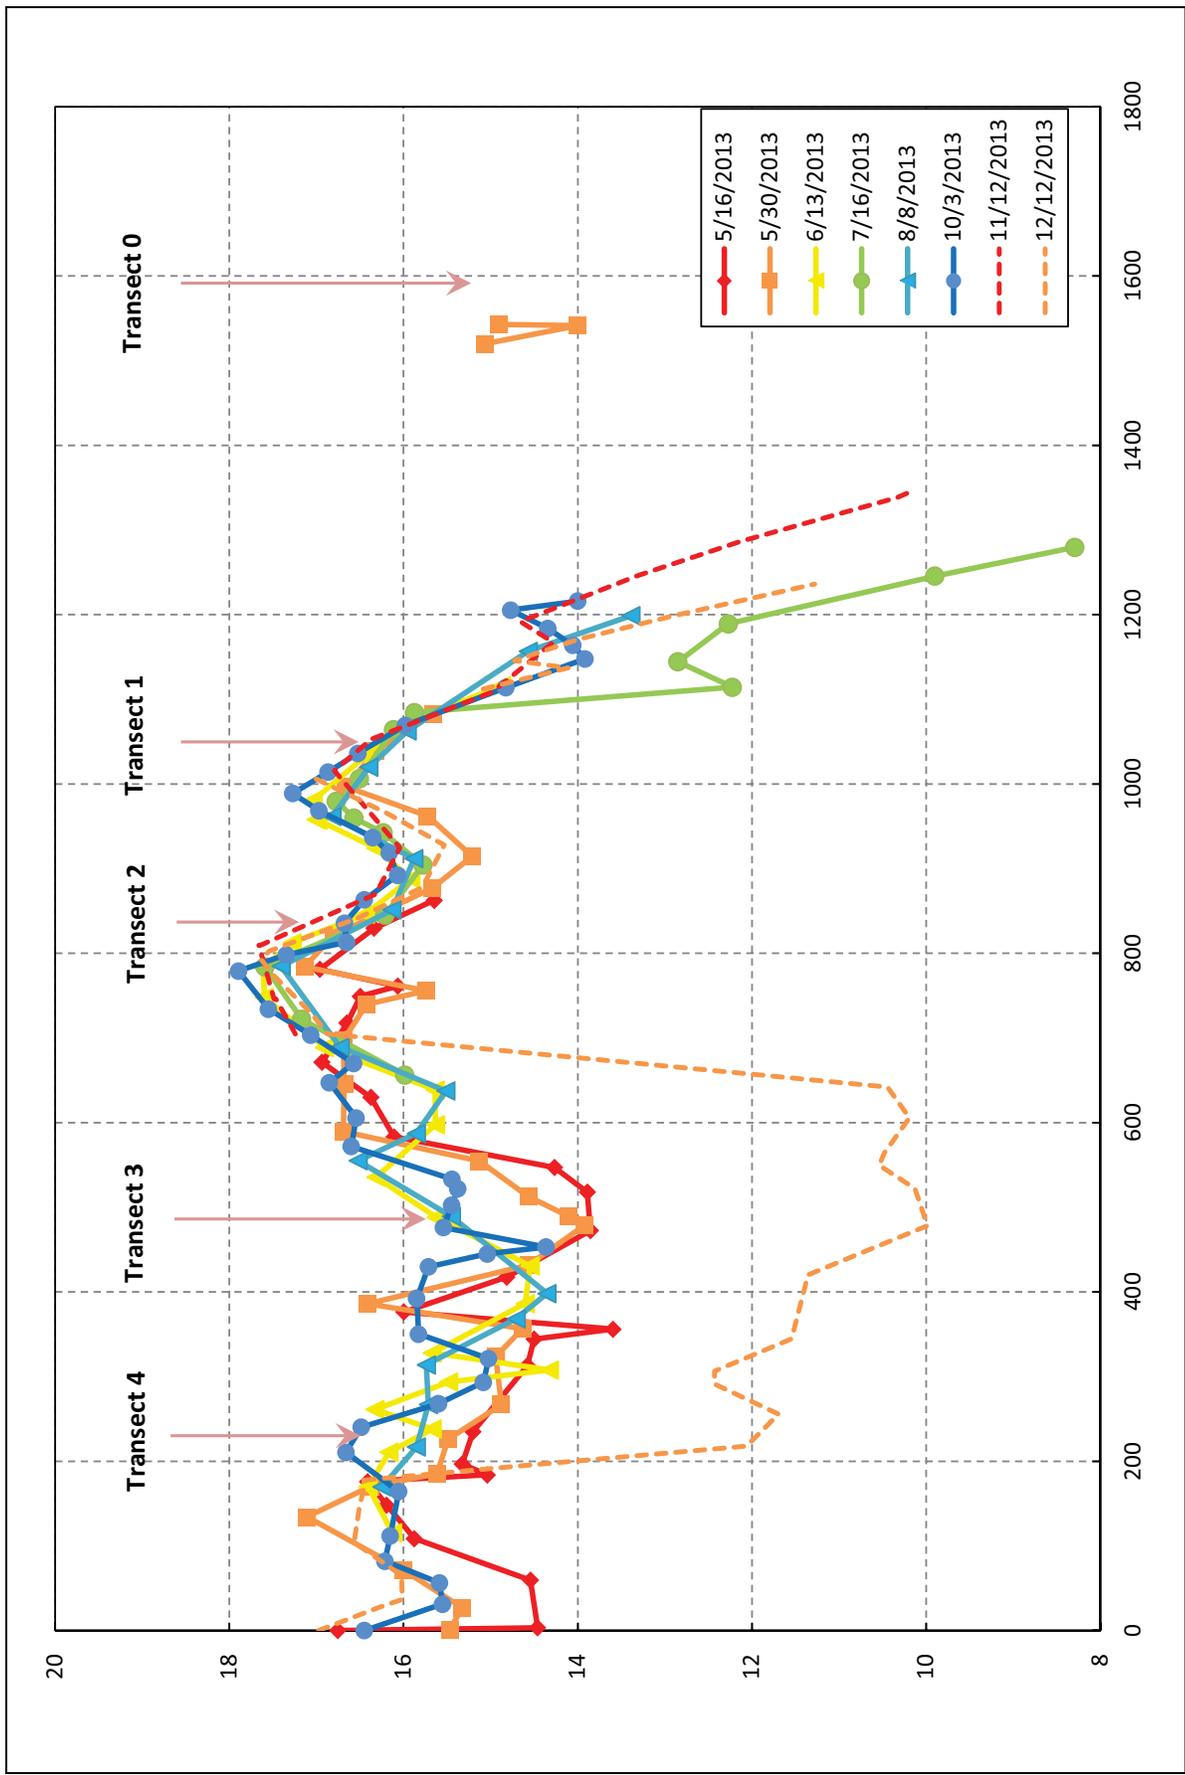
Figure 11
Beach Crest Profiles During the 2013 Management Period.

SOURCE: SCWA survey data

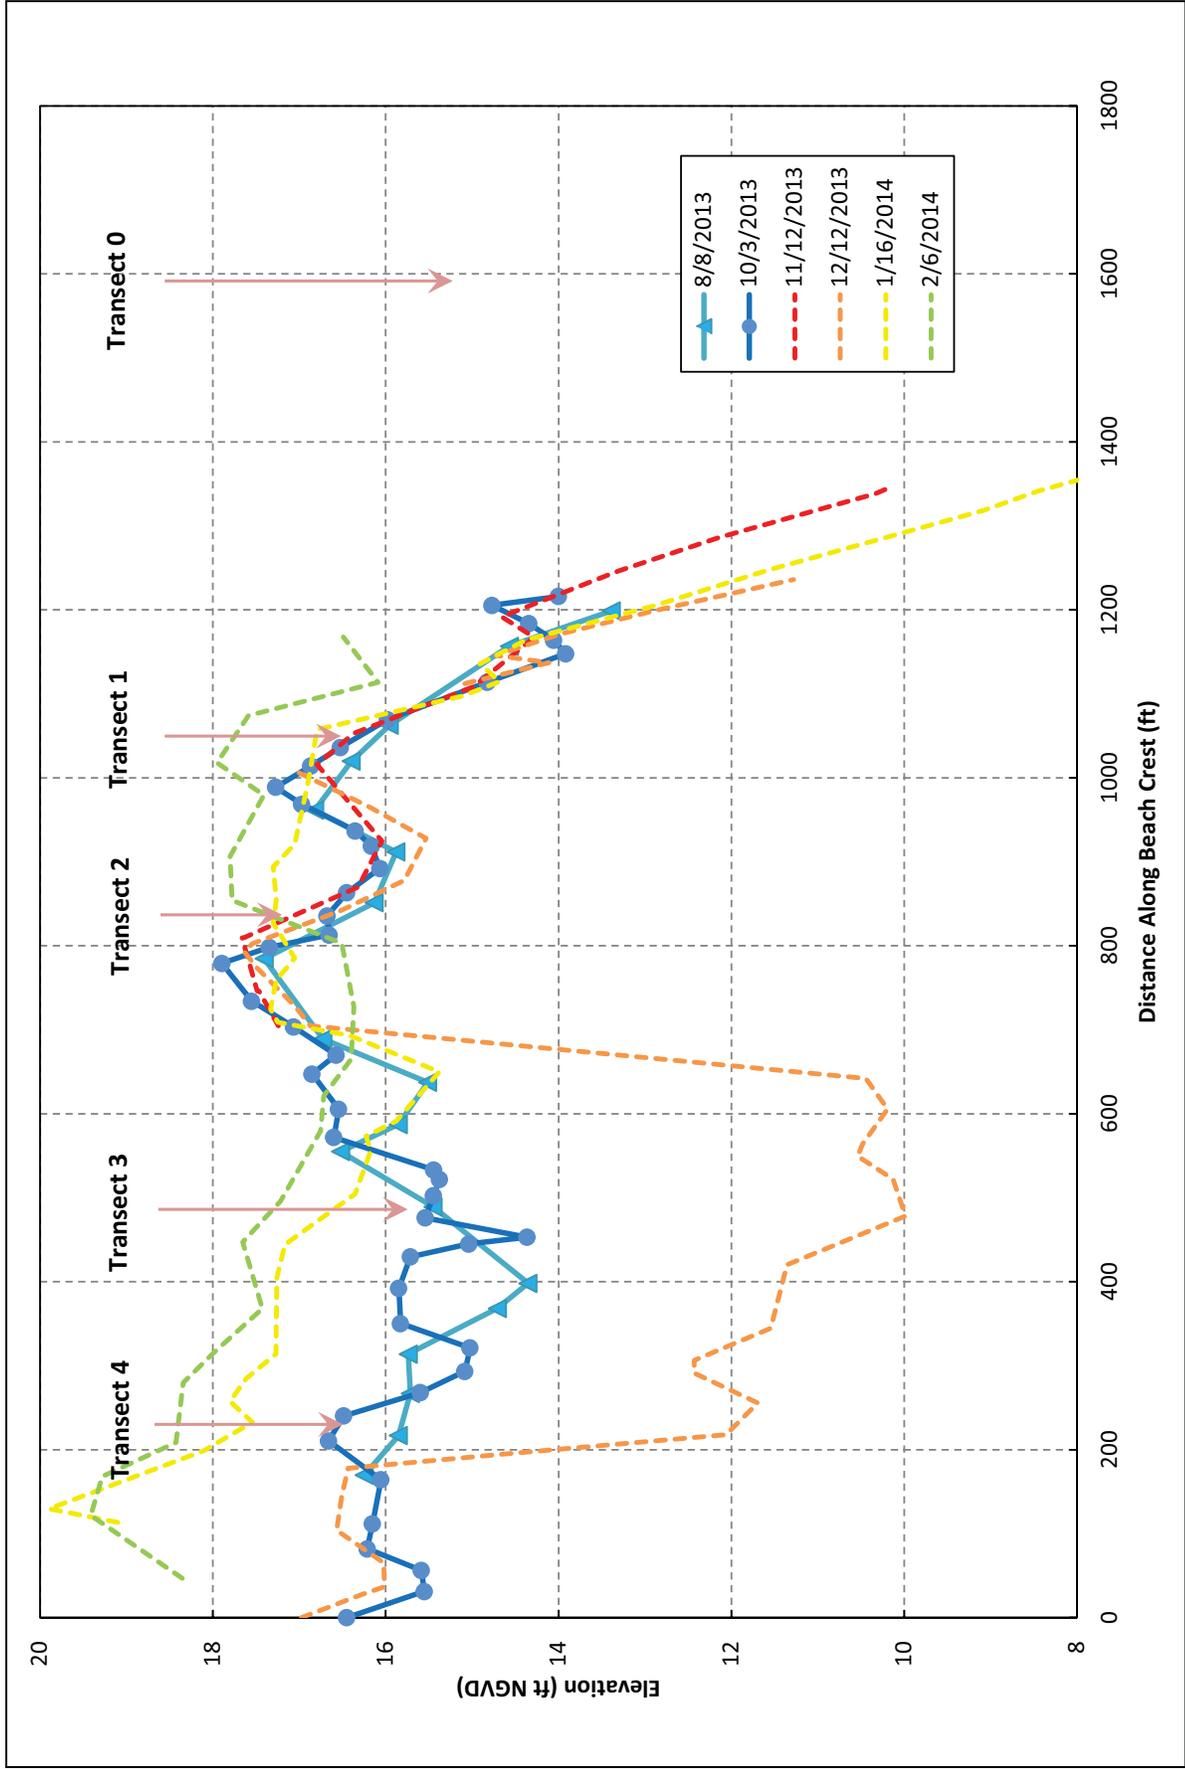
Russian River Estuary Outlet Channel Management Plan . DW01958
Figure 12
 Beach Crest Profiles From August 2013 to February 2014.

SOURCE: SCWA survey data

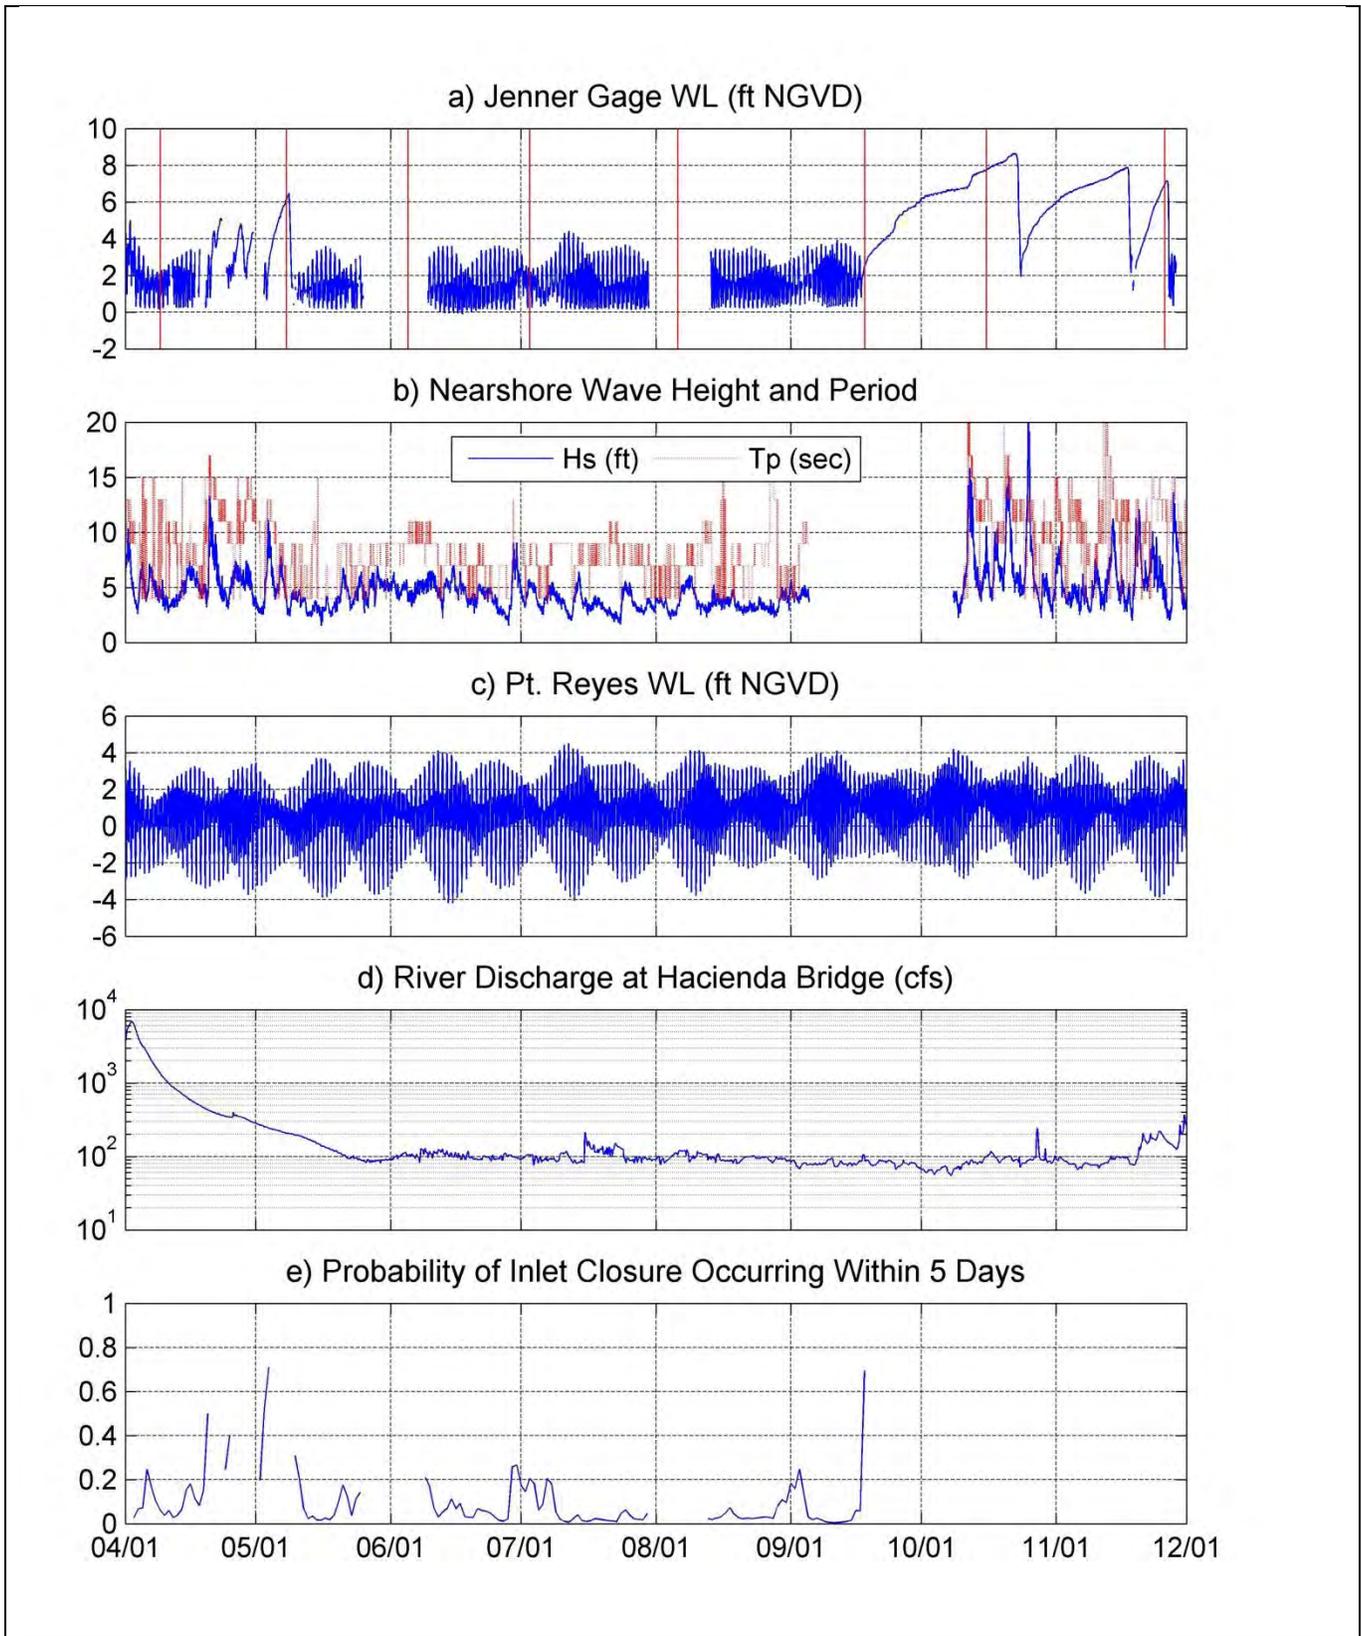
Figure 1
 Estuary, Ocean, and River Conditions Compared
 with Closure Probability:
 April – November 2014

- a) Jenner gage water level provided by SCWA; red bar = beach survey
- b) H_s = sig. wave height; T_p = peak wave period (CDIP, Pt. Reyes, #029)
- c) Ocean water level provided by NOAA (Pt. Reyes #9415020)
- d) River discharge provided by USGS (Guerneville #11467000)
- e) Five-day closure probability provided after Behrens et al. (2013)

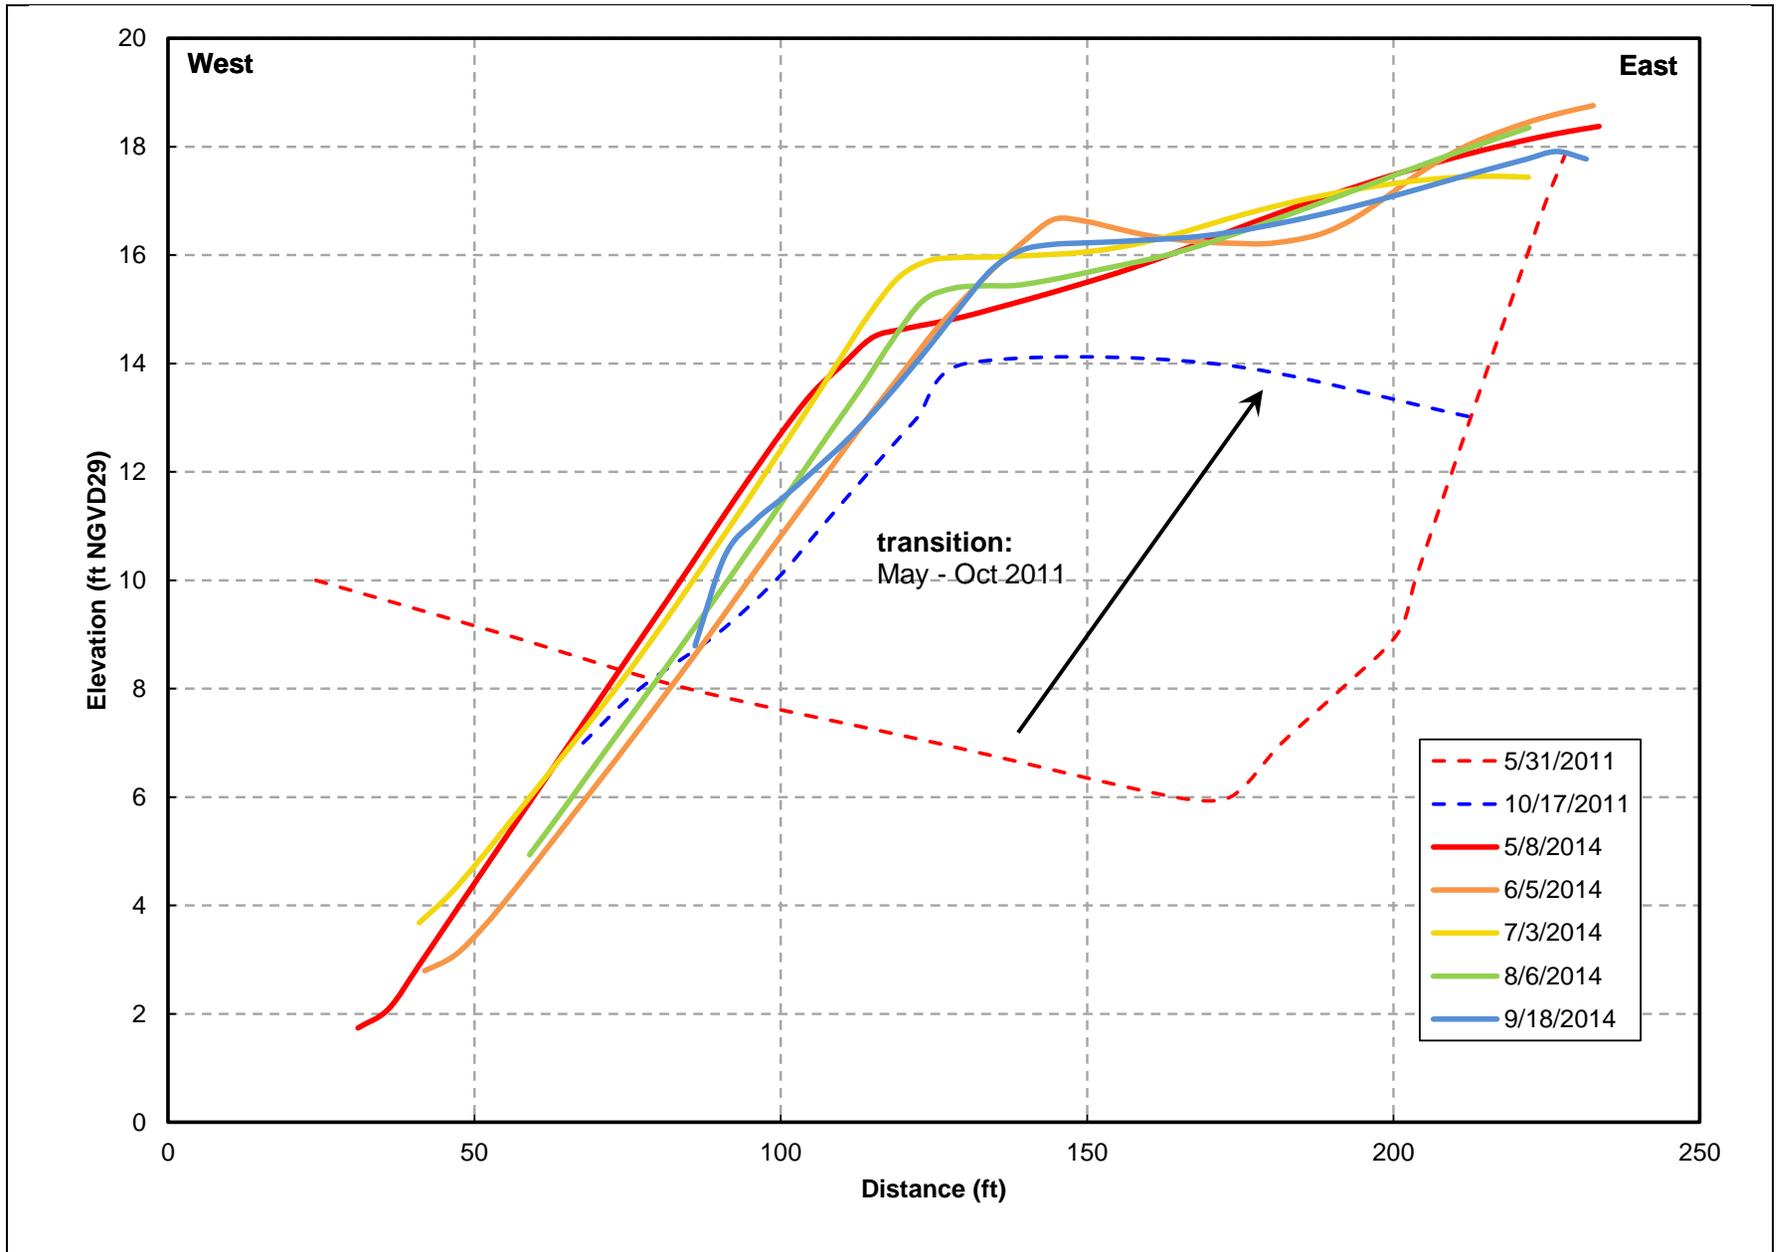
Figure 5
Beach Transect #4

SOURCE: SCWA survey data

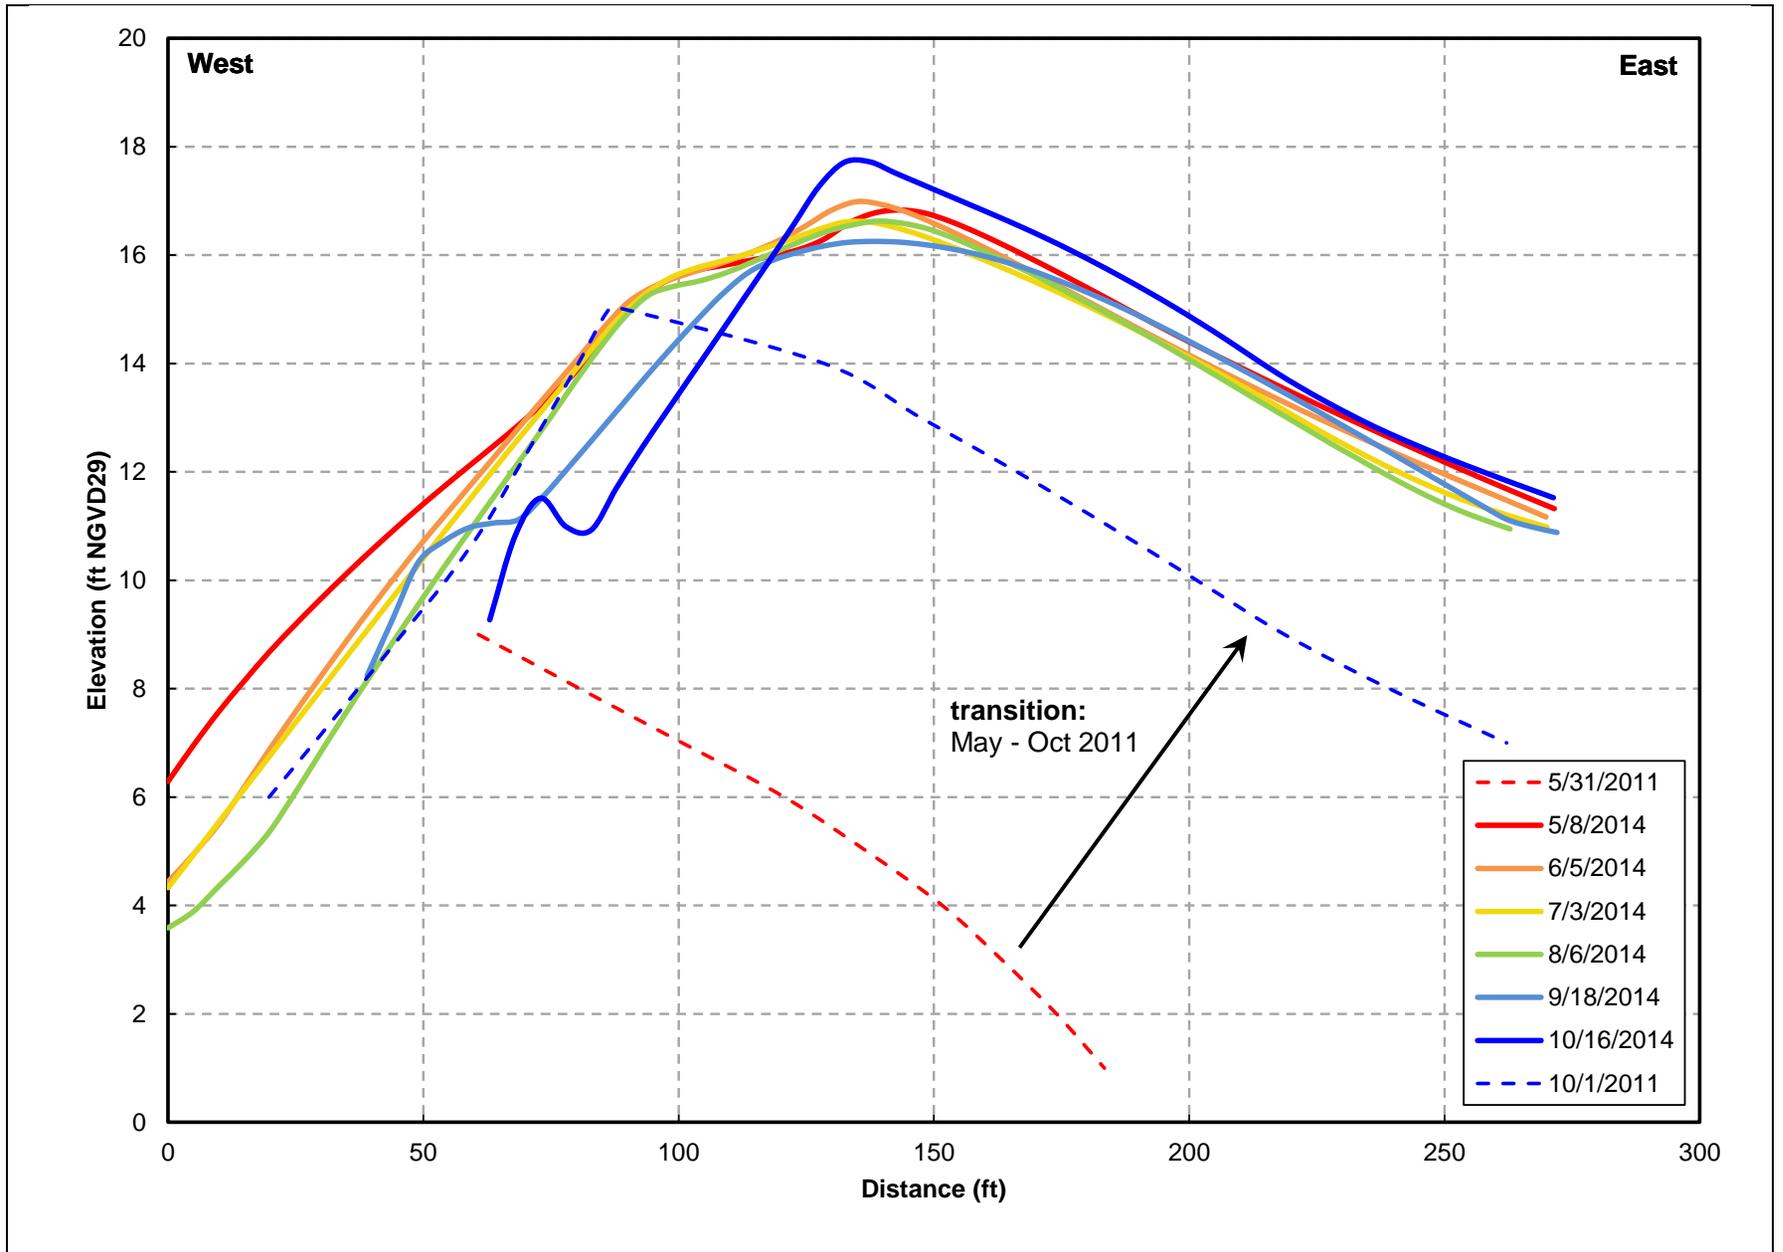
Figure 6
Beach Transect #3

SOURCE: SCWA survey data

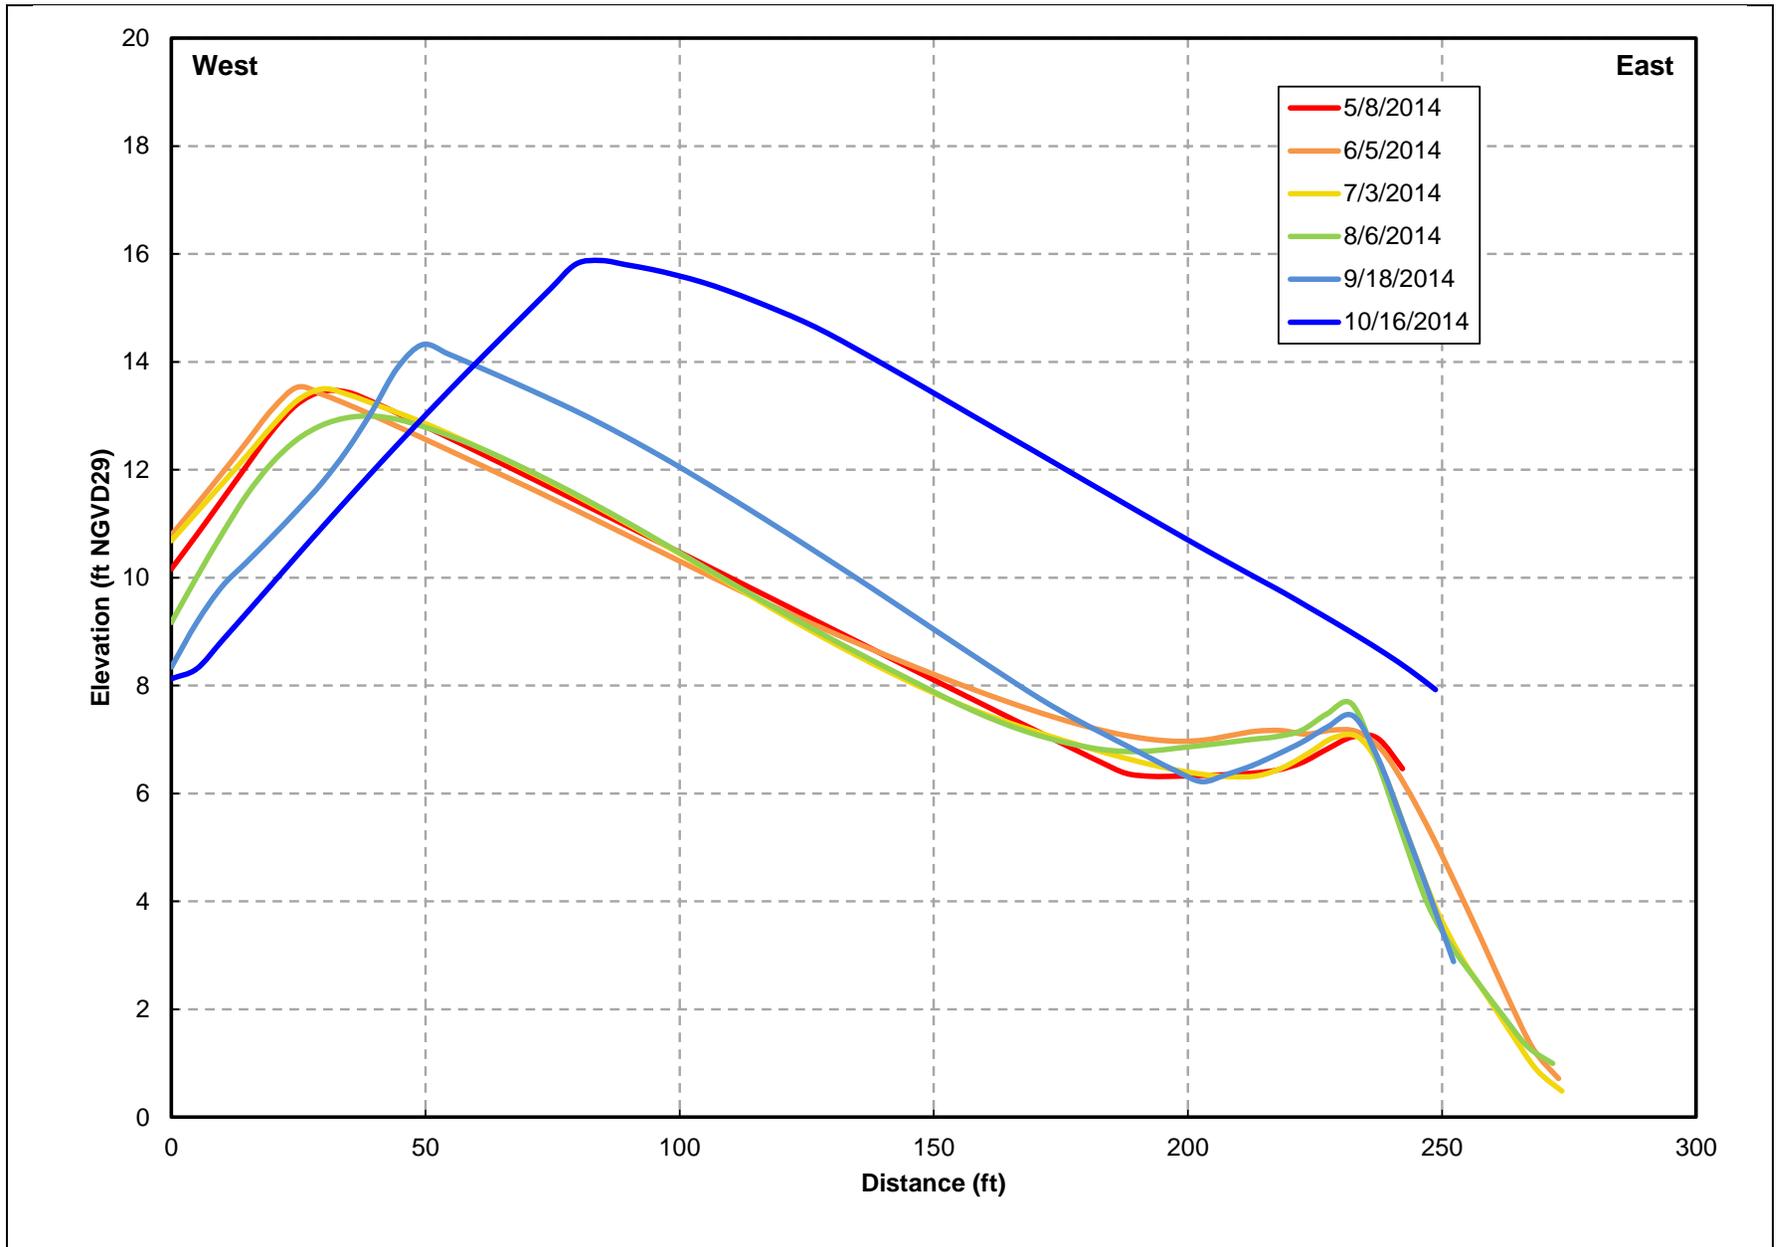
Figure 7
Beach Transect #2

SOURCE: SCWA survey data

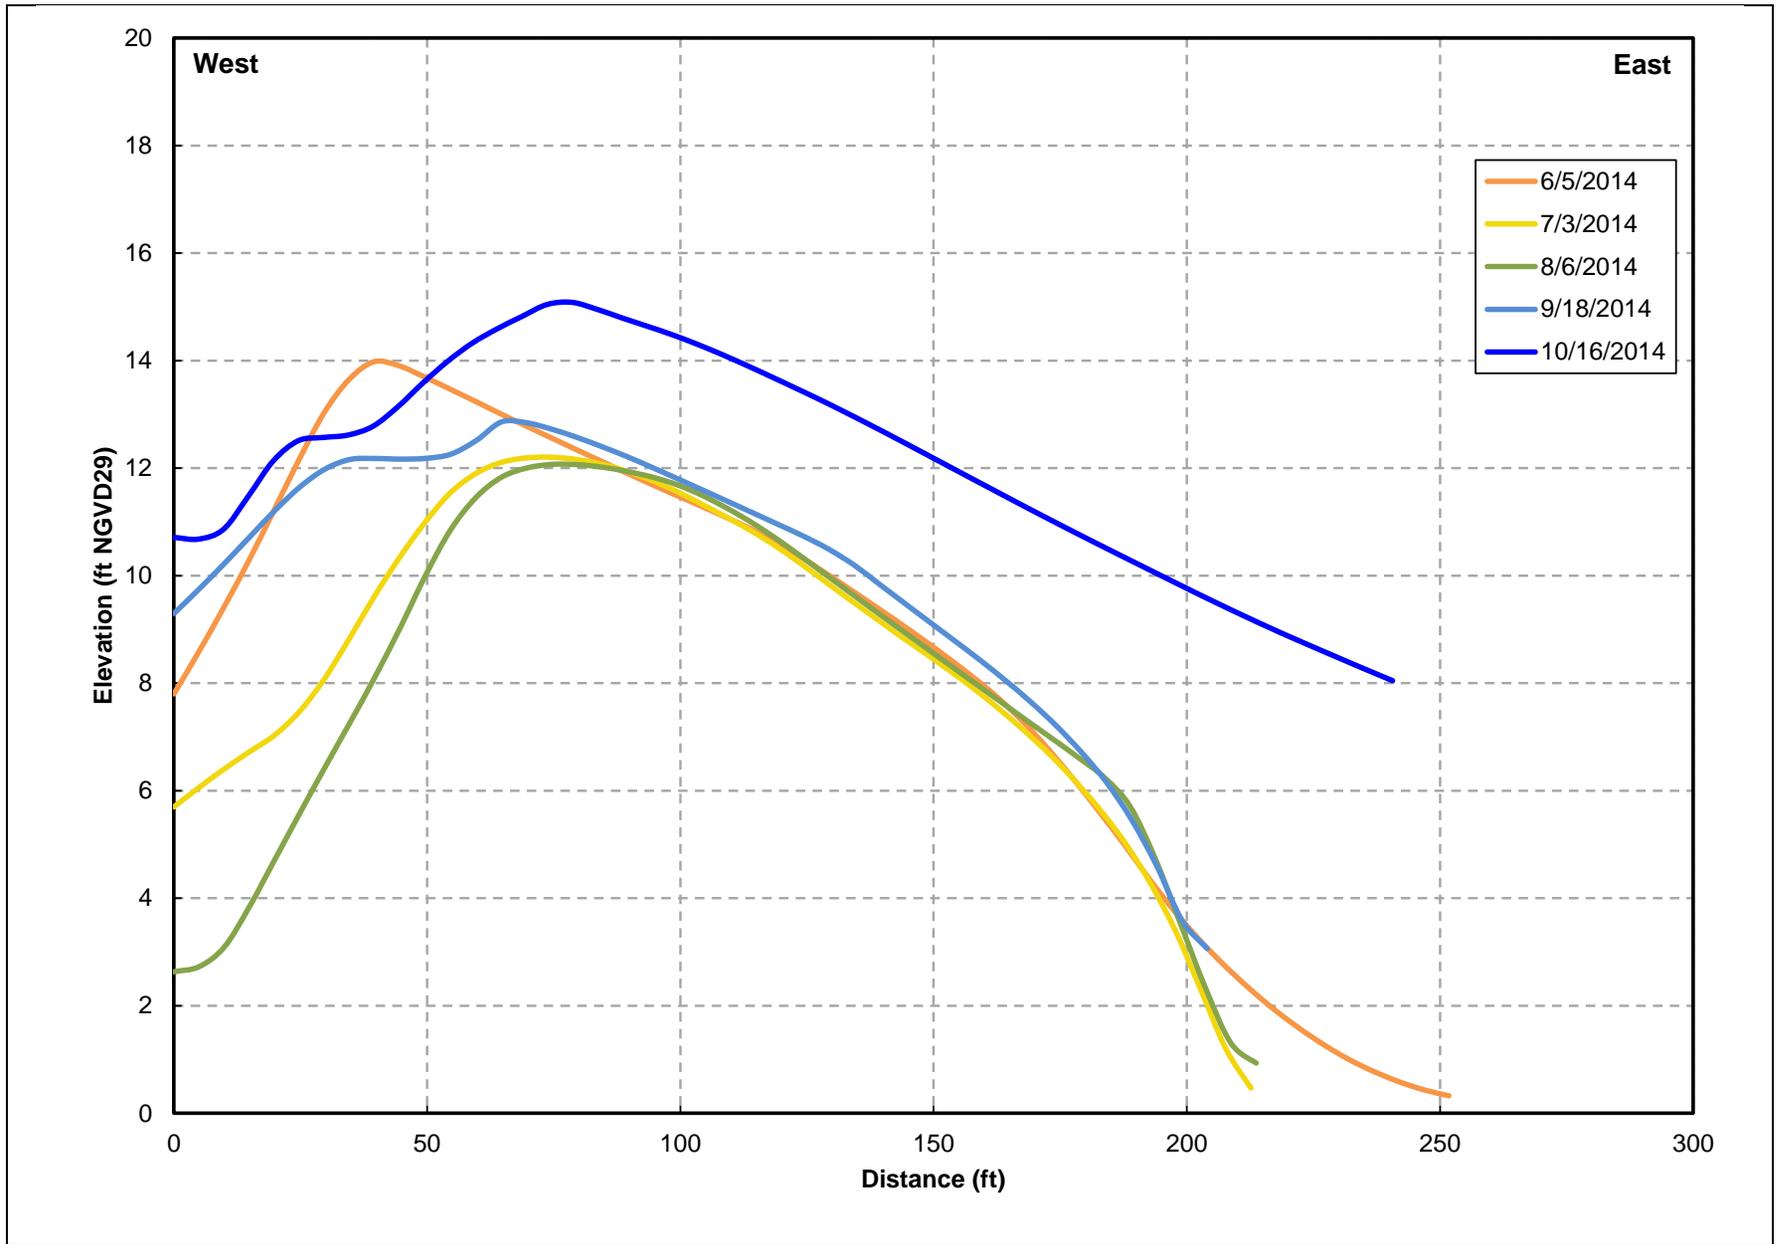
Figure 8
Beach Transect #1

SOURCE: SCWA survey data

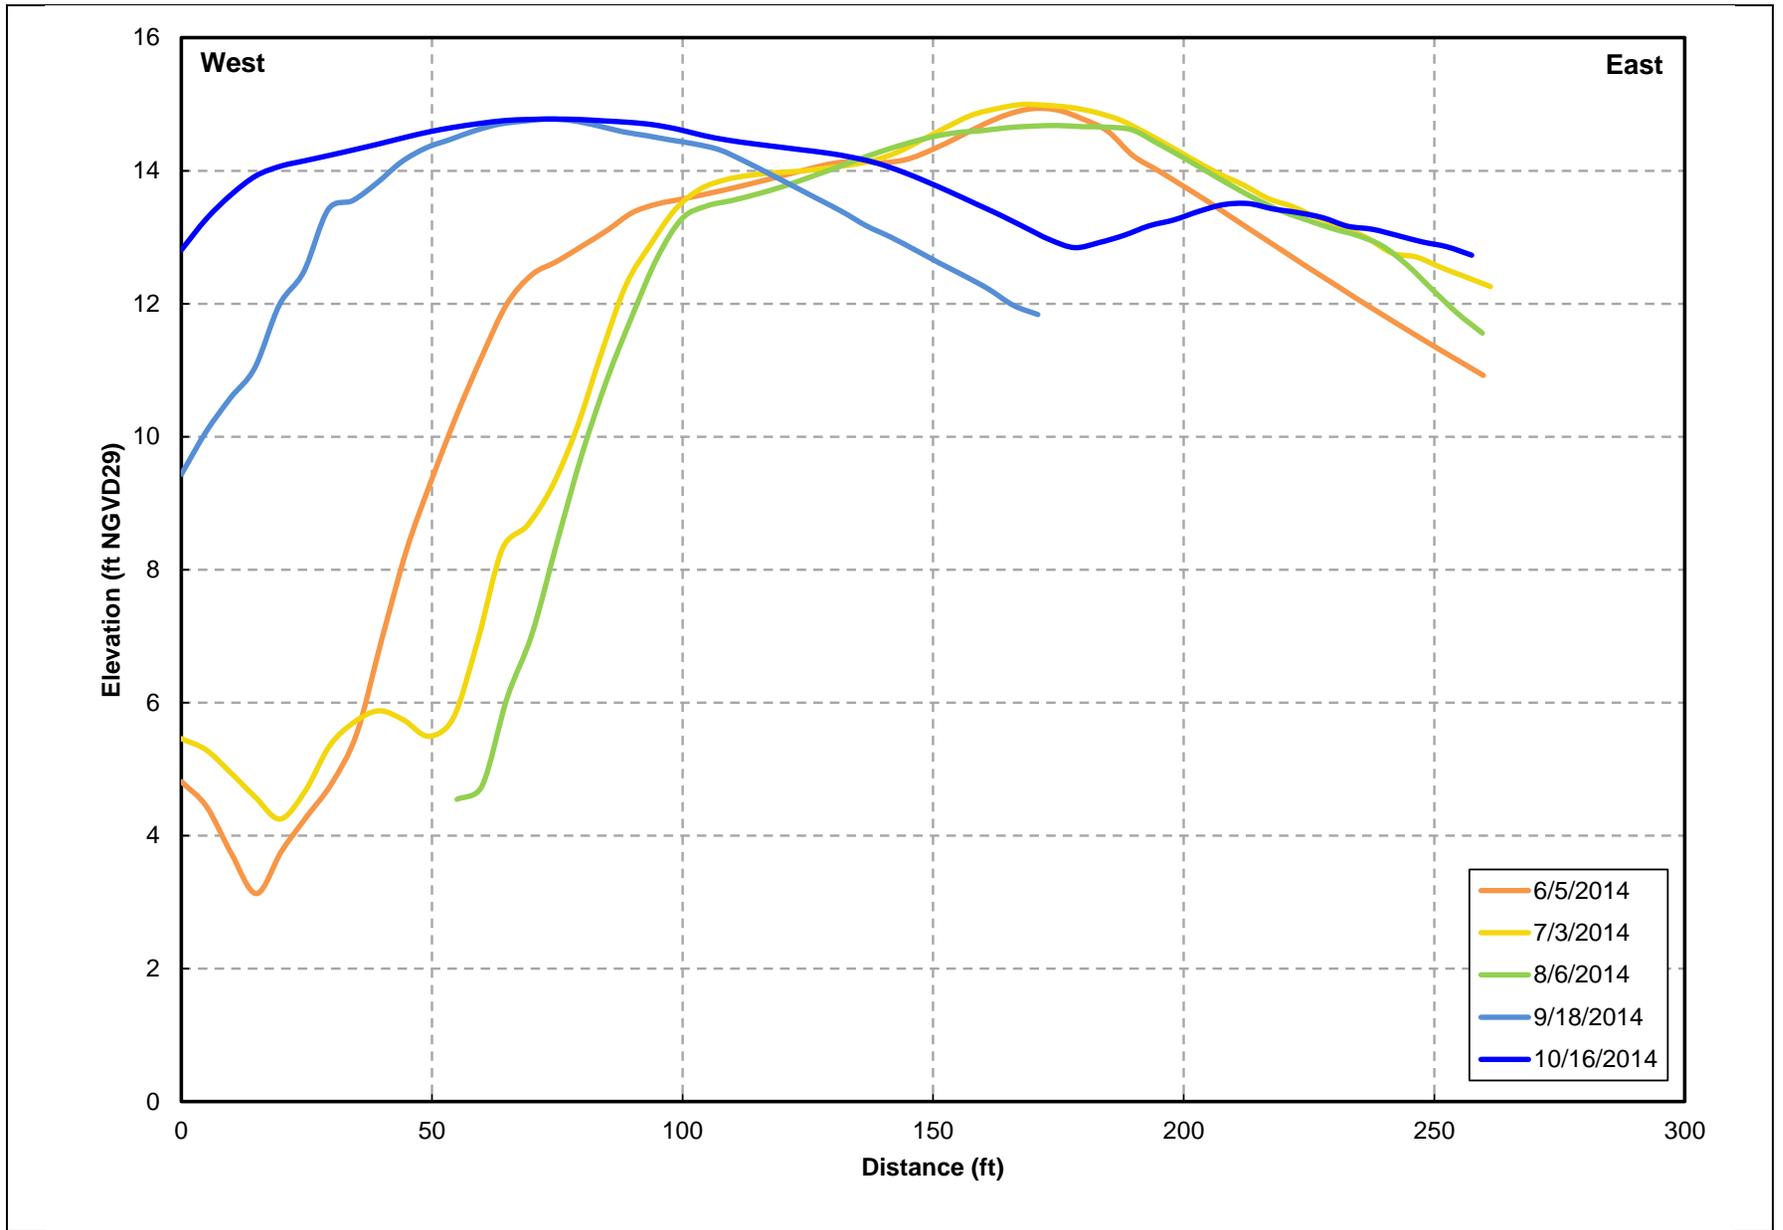
Russian River Estuary Outlet Channel Management Plan . DW01958
Figure 9
 Beach Transect #0 from 2014 management period.

SOURCE: SCWA survey data
