**RUSSIAN RIVER ESTUARY OUTLET CHANNEL
ADAPTIVE MANAGEMENT PLAN
2015**

Sonoma County Water Agency

ESA

May 15, 2015

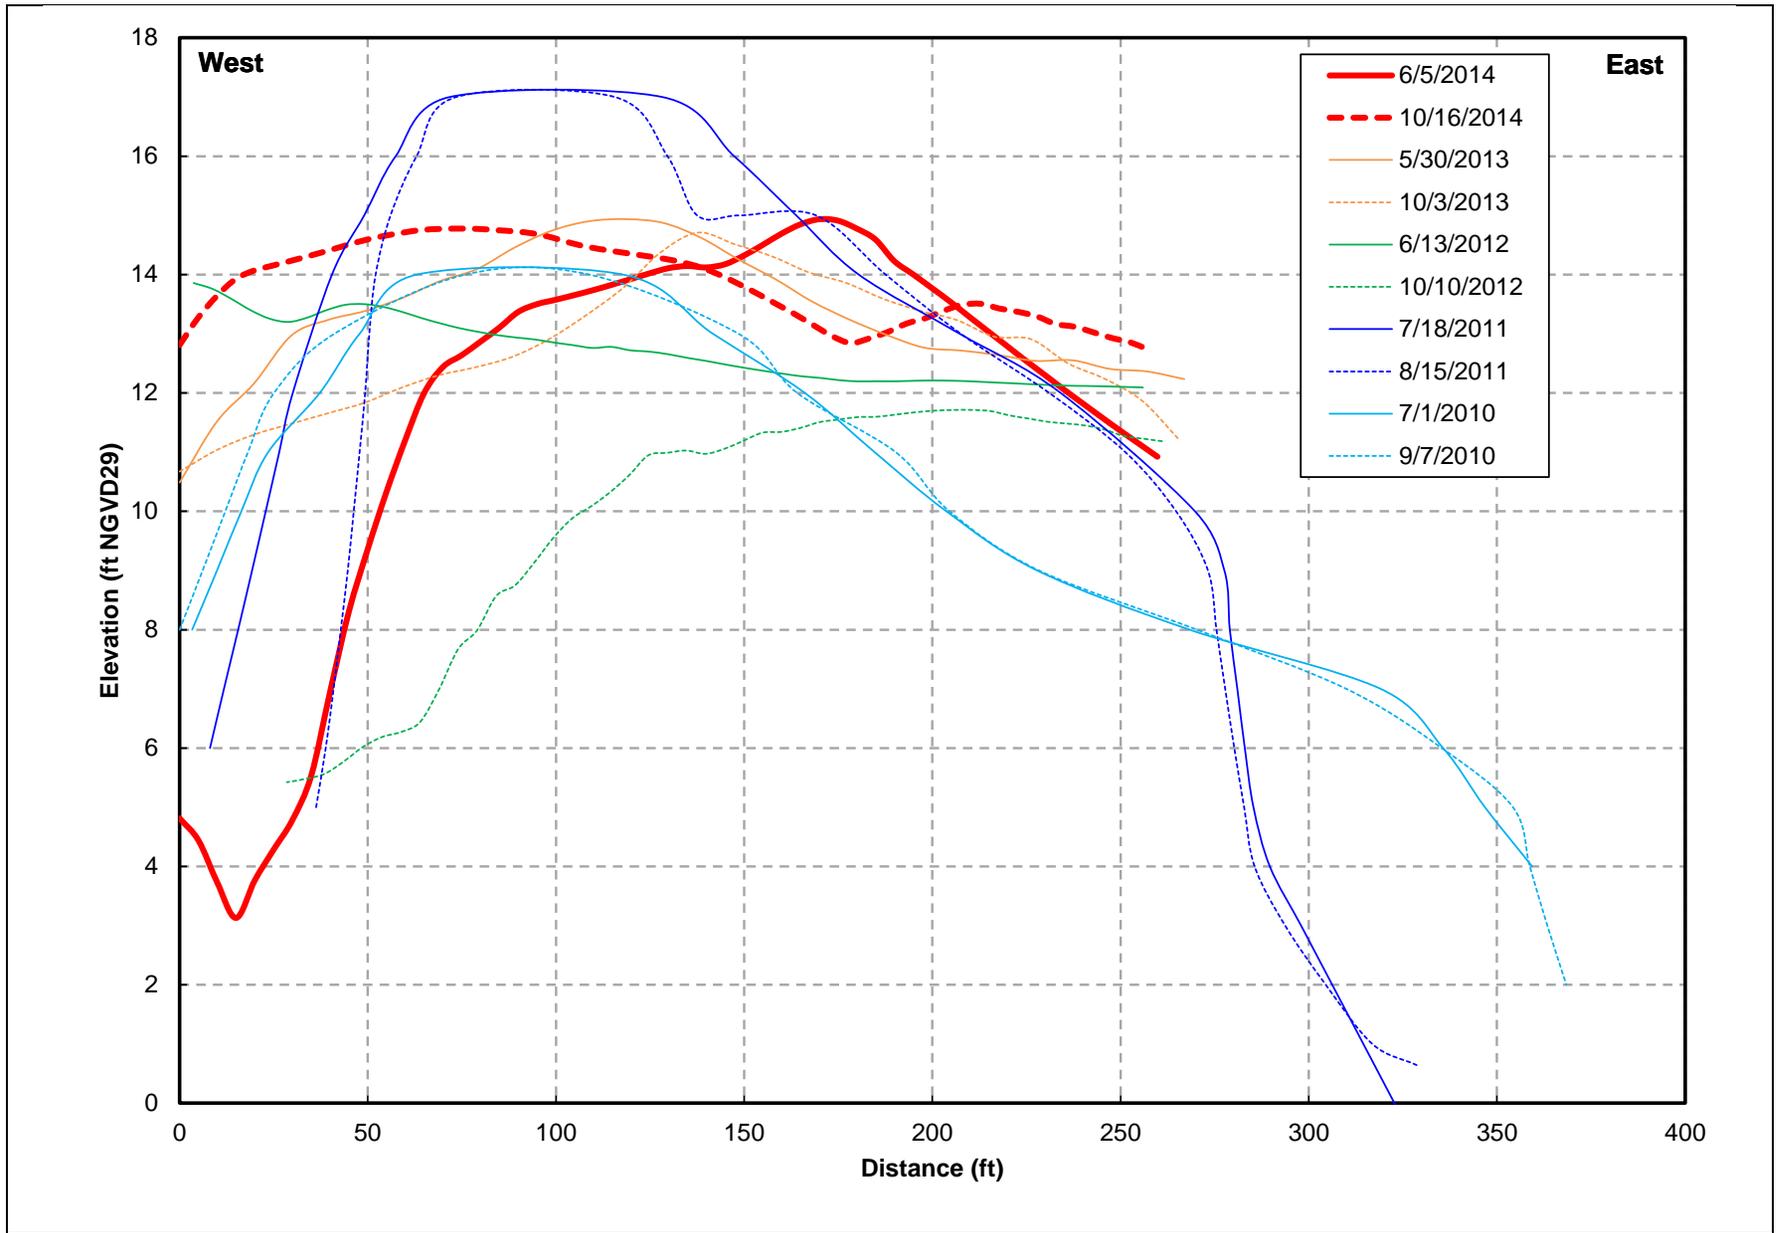
Figure 10
Beach Transect #0 from 2010-2014 management periods.

SOURCE: SCWA survey data

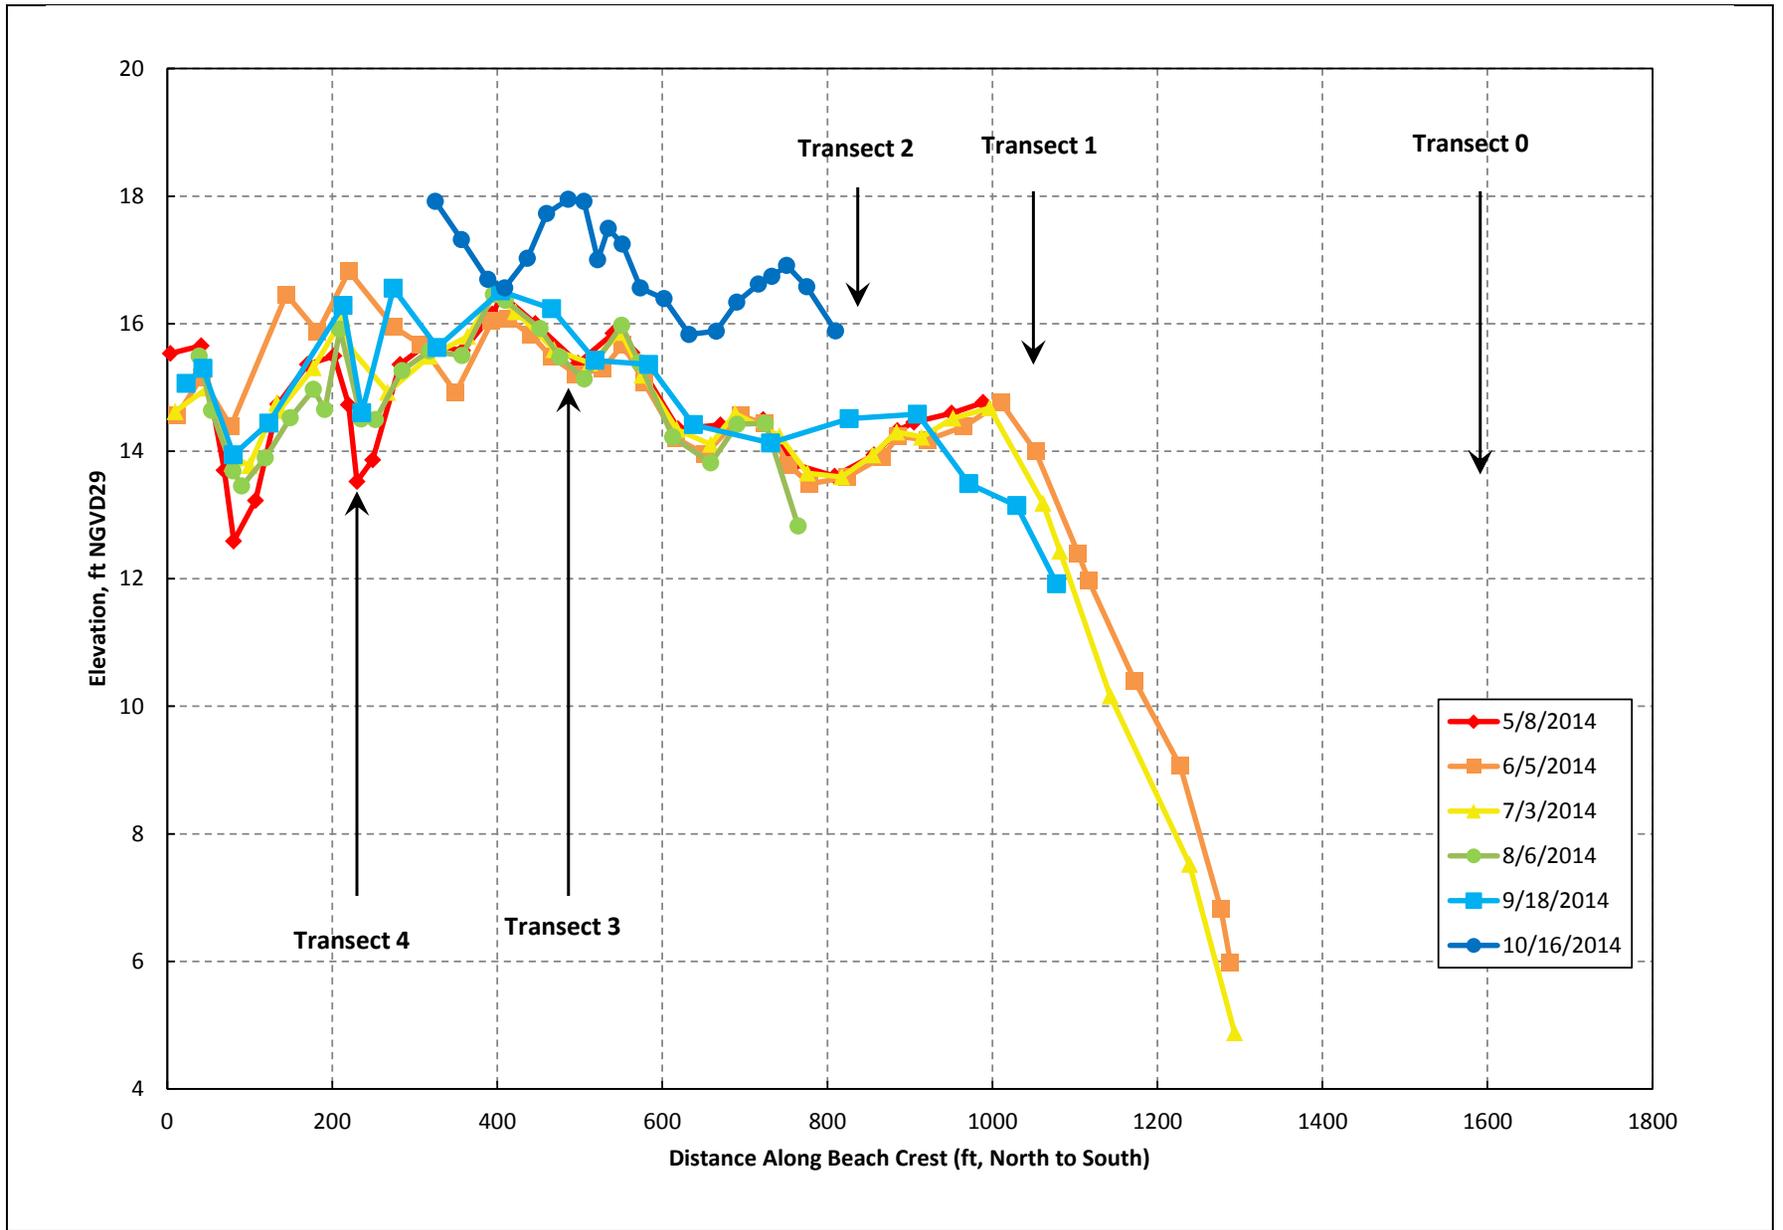
Figure 11
Beach Crest Profiles During the 2014 Management Period.

SOURCE: SCWA survey data

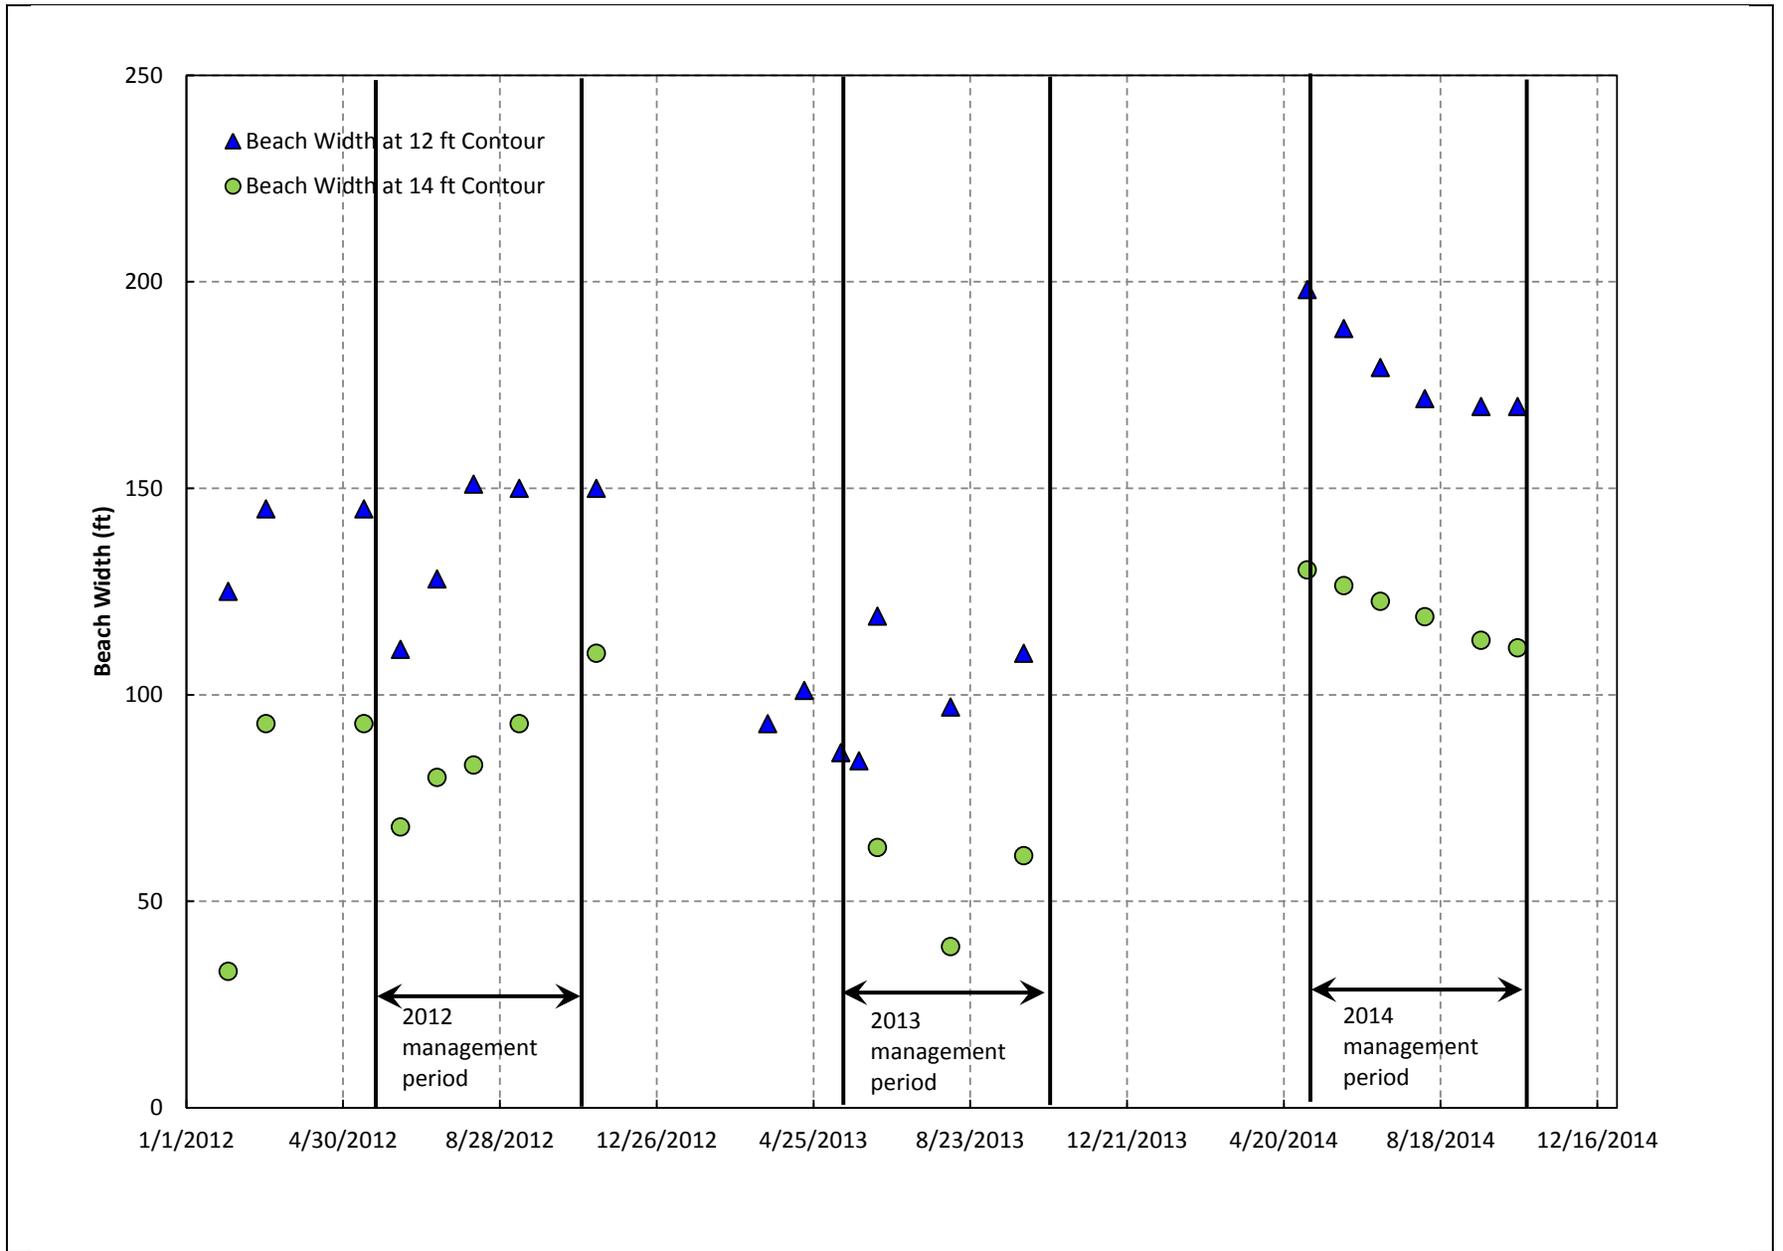
Figure 12
Beach Width During 2012-2014 Management Periods.

SOURCE: SCWA survey data
