## Geotechnical Study for Pond 6-7-8, Napa Plant Site Restoration

**Project: Napa Salt Marsh Restoration , Ponds 6-7-8**

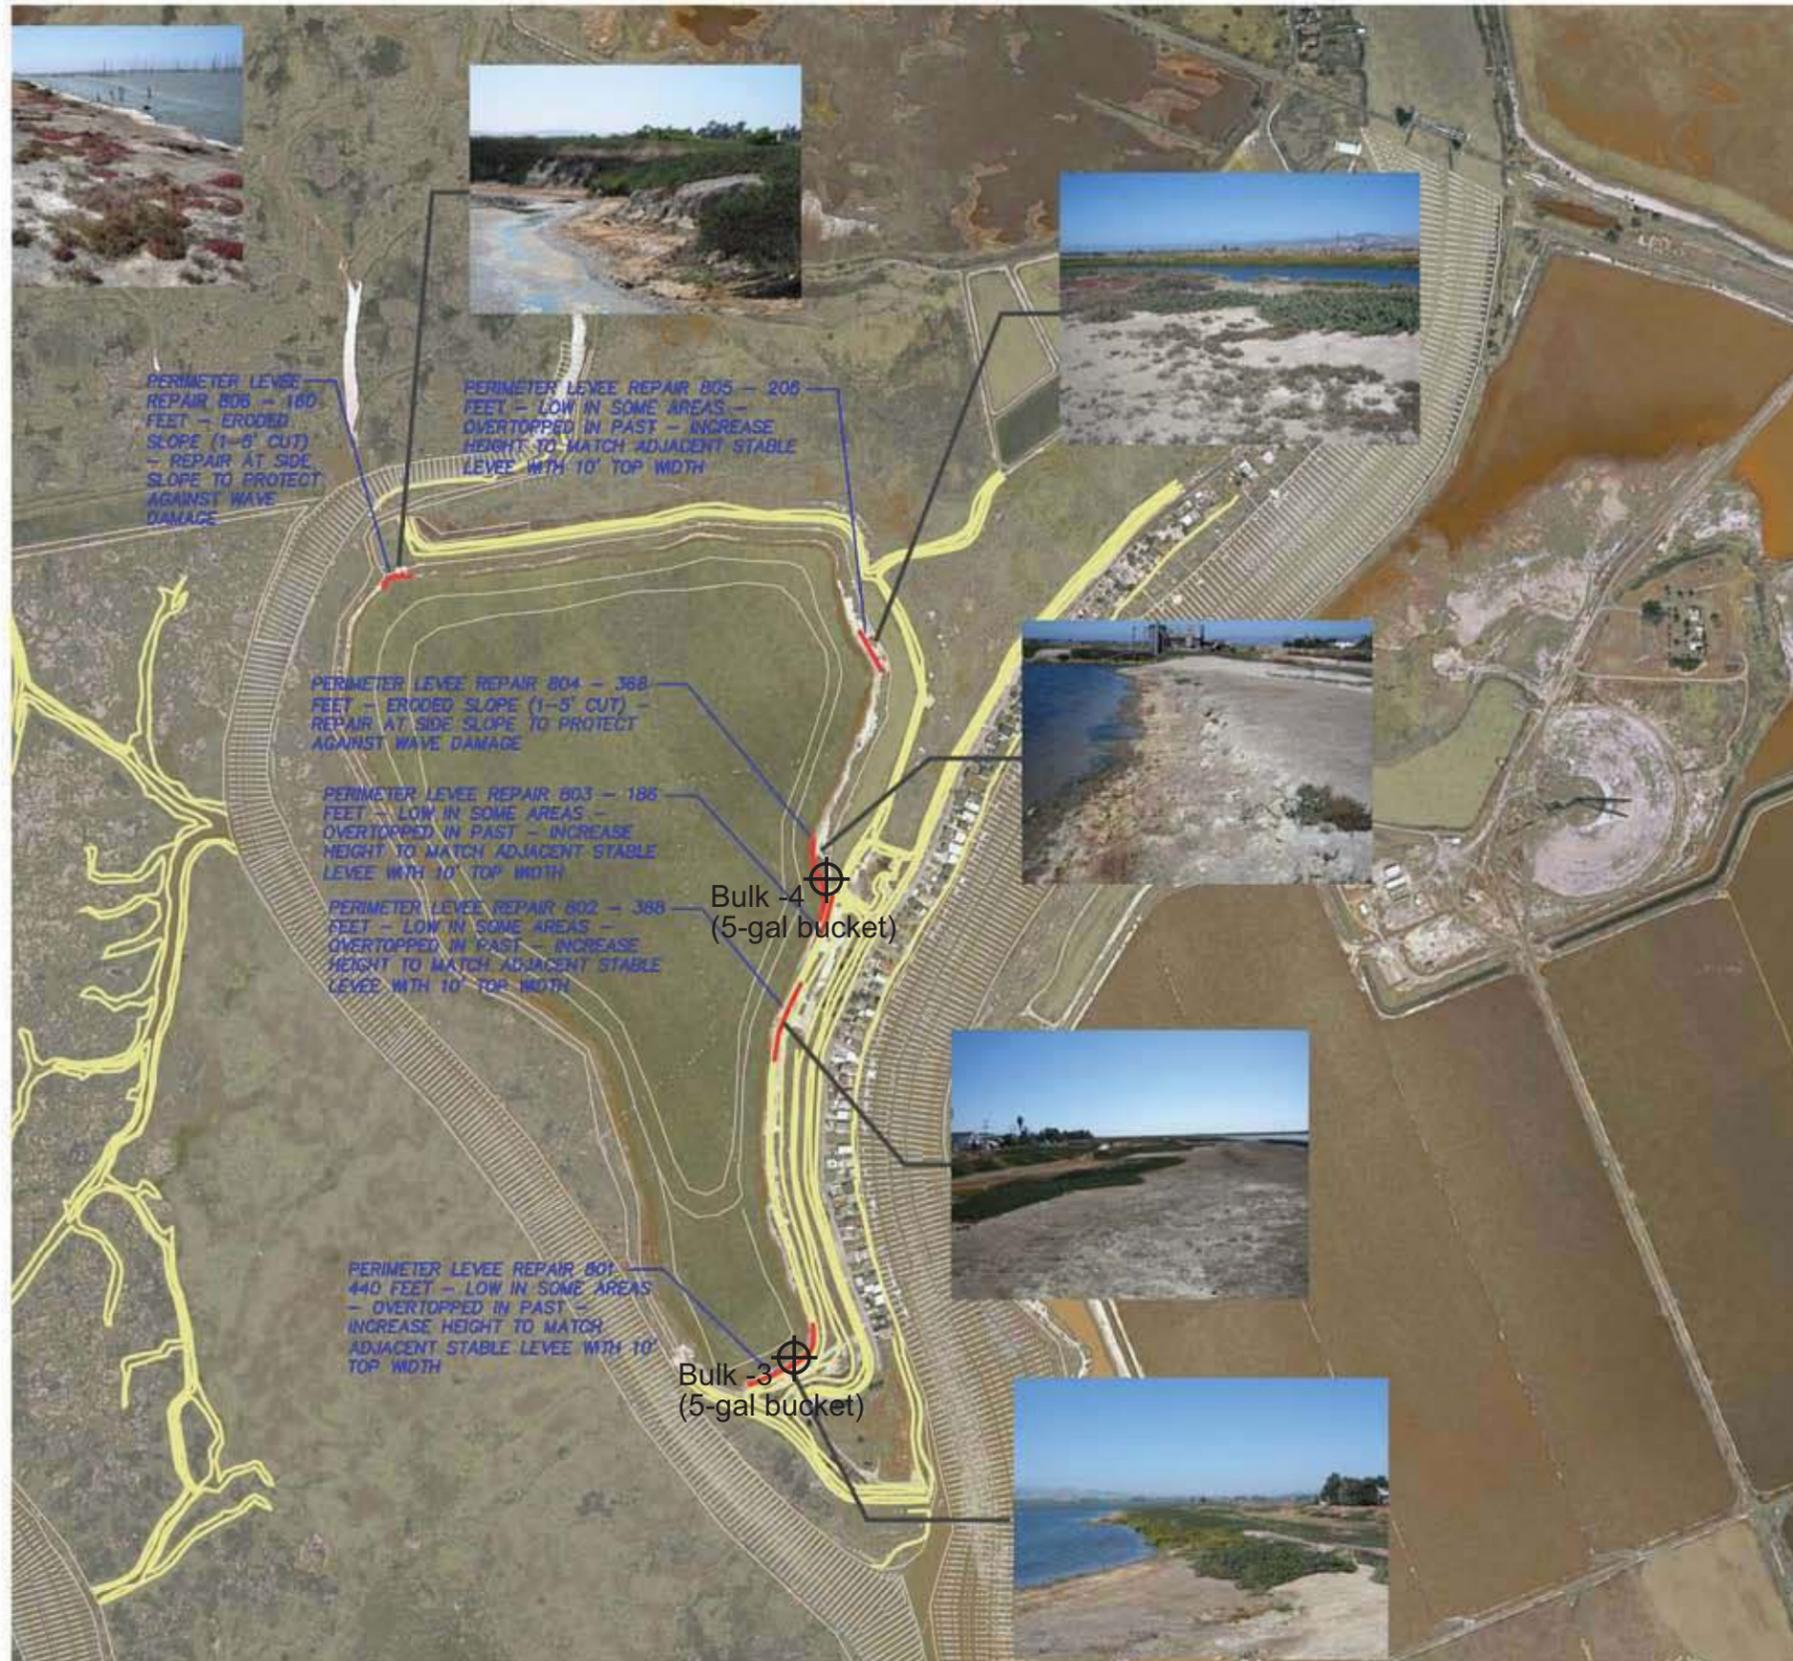
- Levee Improvement Area
- Bulk Samples

As part of the geotechnical studies, one exploratory boring (B-1) was drilled near the east end of the interior levee between Ponds 7 and 7A on November 16, 2006. Two additional exploratory borings (B-3 and B-4) were drilled near Milton Road along the eastern boundary of Pond 8 on June 18, 2007. The locations of the soil borings are shown on Figures B-1 through B-3, Site Plan and Boring Location Plan. Note that boring designation B-2 was not used. URS obtained the soil boring permits from the Napa County Department of Environmental Management (NCDEM). Underground Services Alert was notified at least 48 hours prior to the scheduled drilling dates to clear the underground utility lines. The site is clear of any underground or above-ground utility lines.

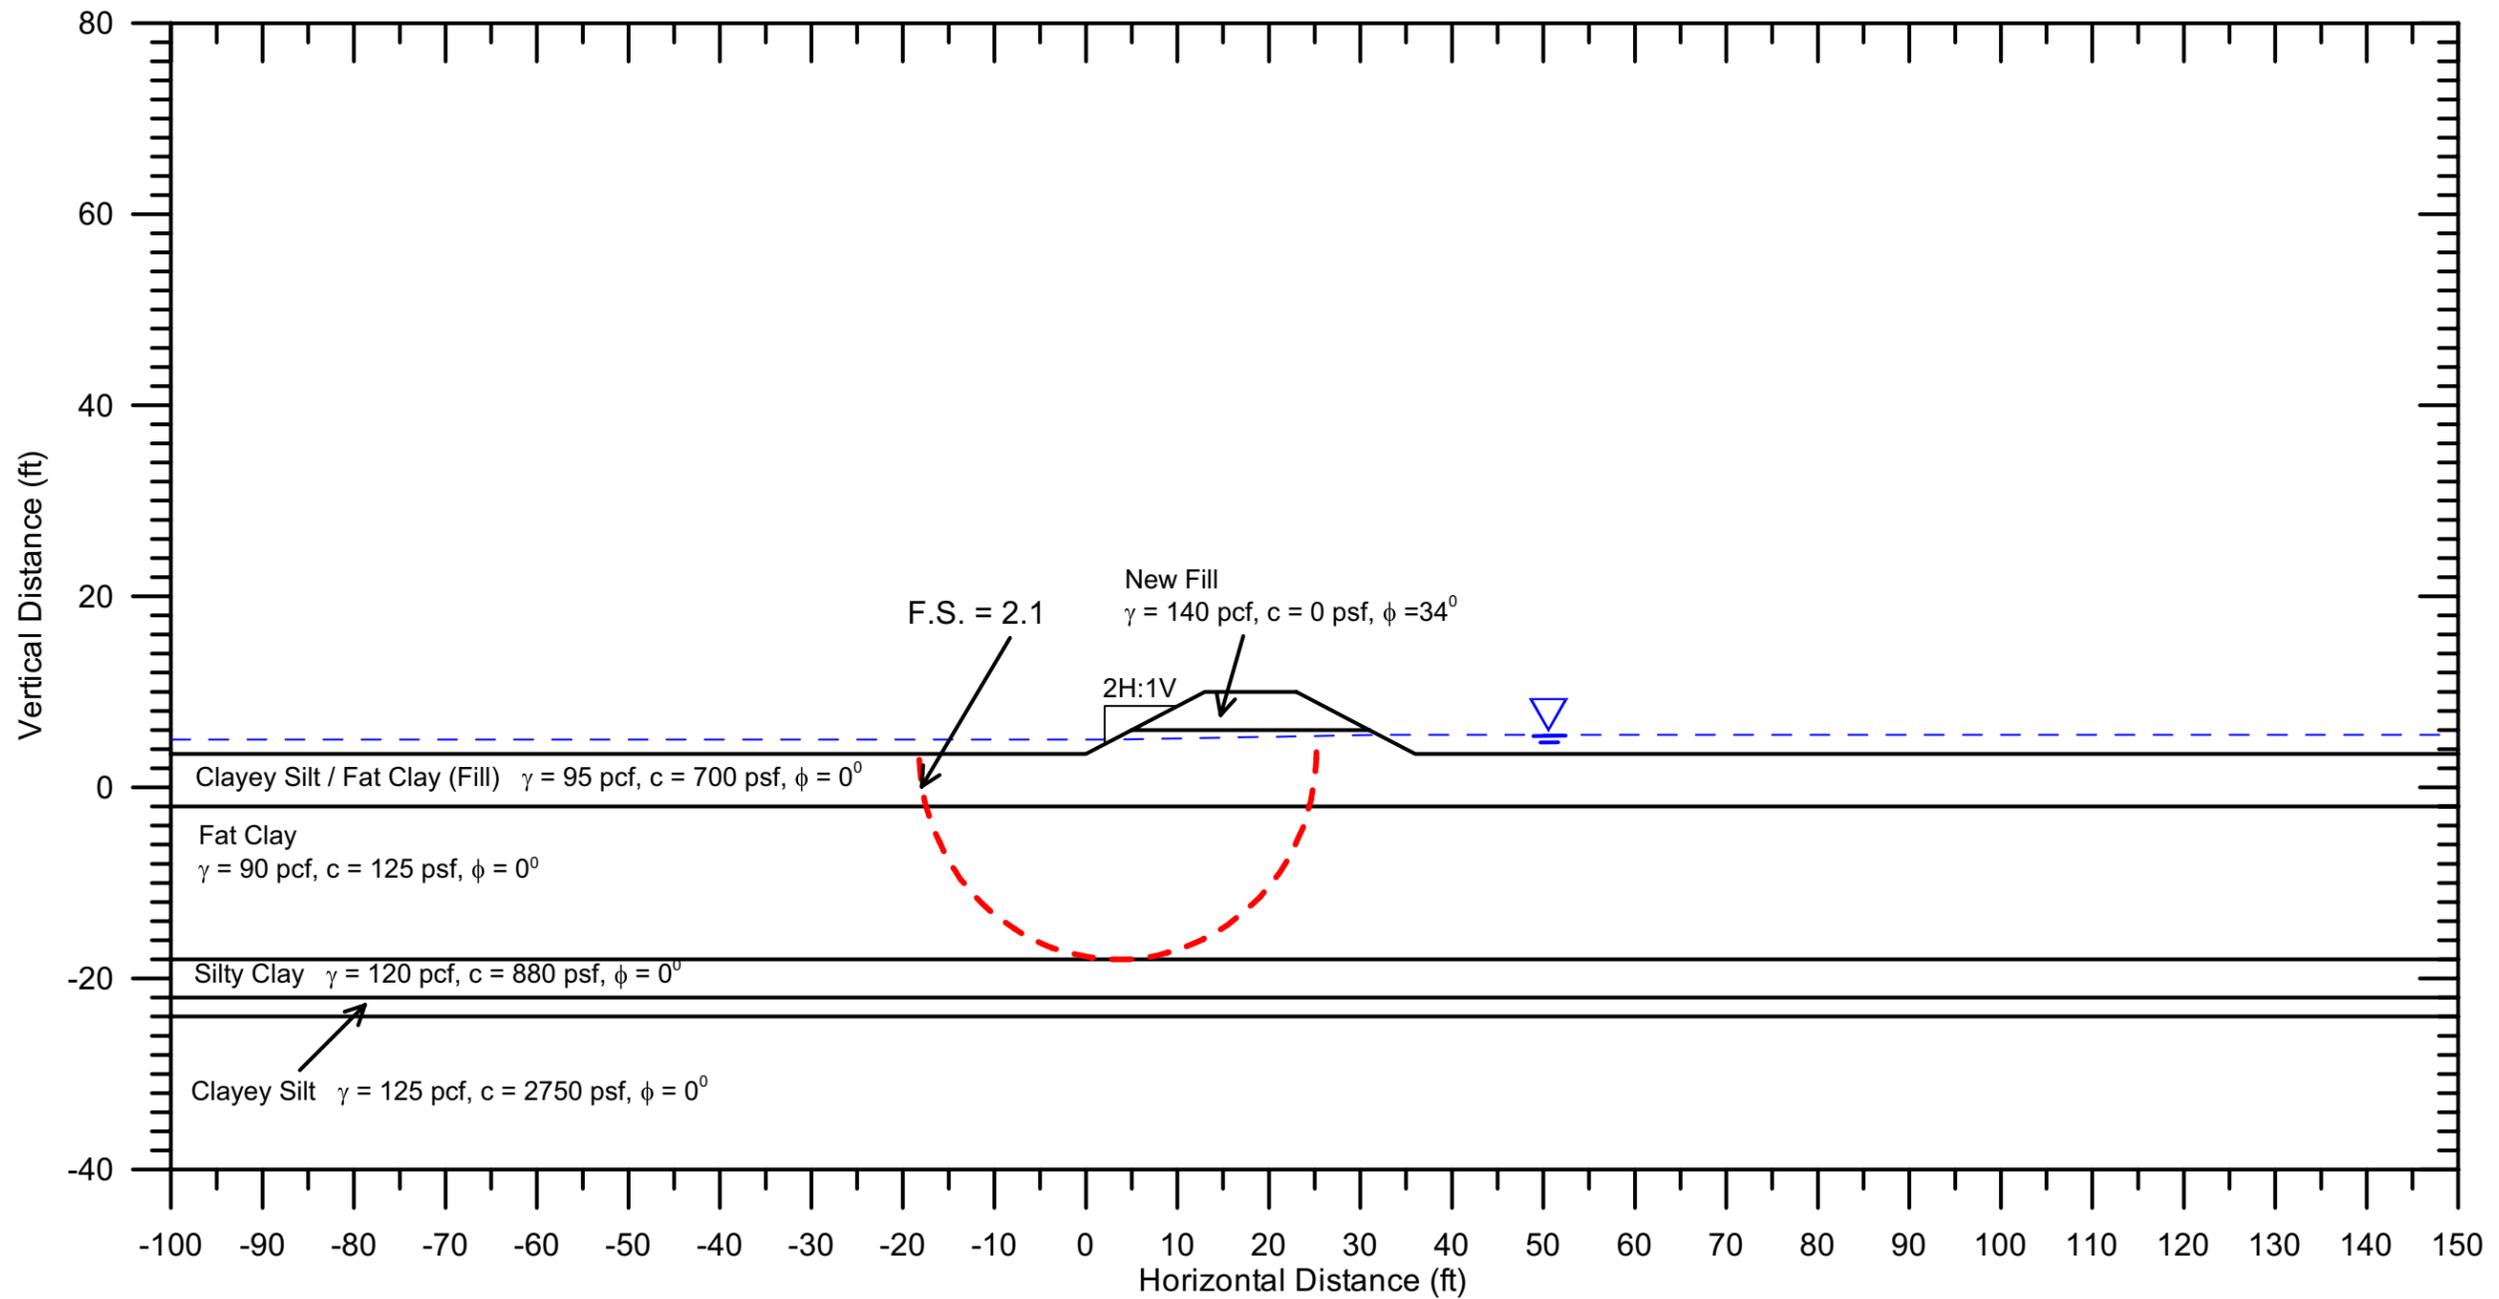
Figure  
 B-4

SLOPE STABILITY RESULTS  
 NAPA PLANT SITE PONDS 6 & 7  
 CROSS SECTION 7-03 LEVEE

The results of the slope stability analyses for the above four cases for Ponds 6/6A and 7/7A are summarized in Table 3. The potential failure planes are presented on Figures B-4 through B-7. Based on the results of the slope stability analyses, Case 2 results in F.S. less than 1.3. URS re-evaluated the levee slope stability of Case 2 with 2 feet of fill, shown as Case 3 on Table 3. The resulting minimum F.S. for Case 3 is higher than the minimum required F.S. of 1.3 for the end-of-construction condition. Therefore, URS recommends limiting the total height of new fill to 2 feet or less. Case 4 also satisfies the minimum F.S. criterion. Therefore, it is URS' opinion that slope stability failure is not a major concern for Ponds 6/6A and 7/7A side slopes, provided the height of additional fill is limited to 2 feet.

<b>Case No.</b>	<b>Thickness of Fill (feet)</b>	<b>Finished Levee Elevation (feet)</b>	<b>Failure Surface</b>	<b>F.S.</b>
1	4	10	Circular	2.1
2	4	10	Wedge-shaped	1.1
3	2	8	Wedge-shaped	1.4
4	2	8	Wedge-shaped	1.3

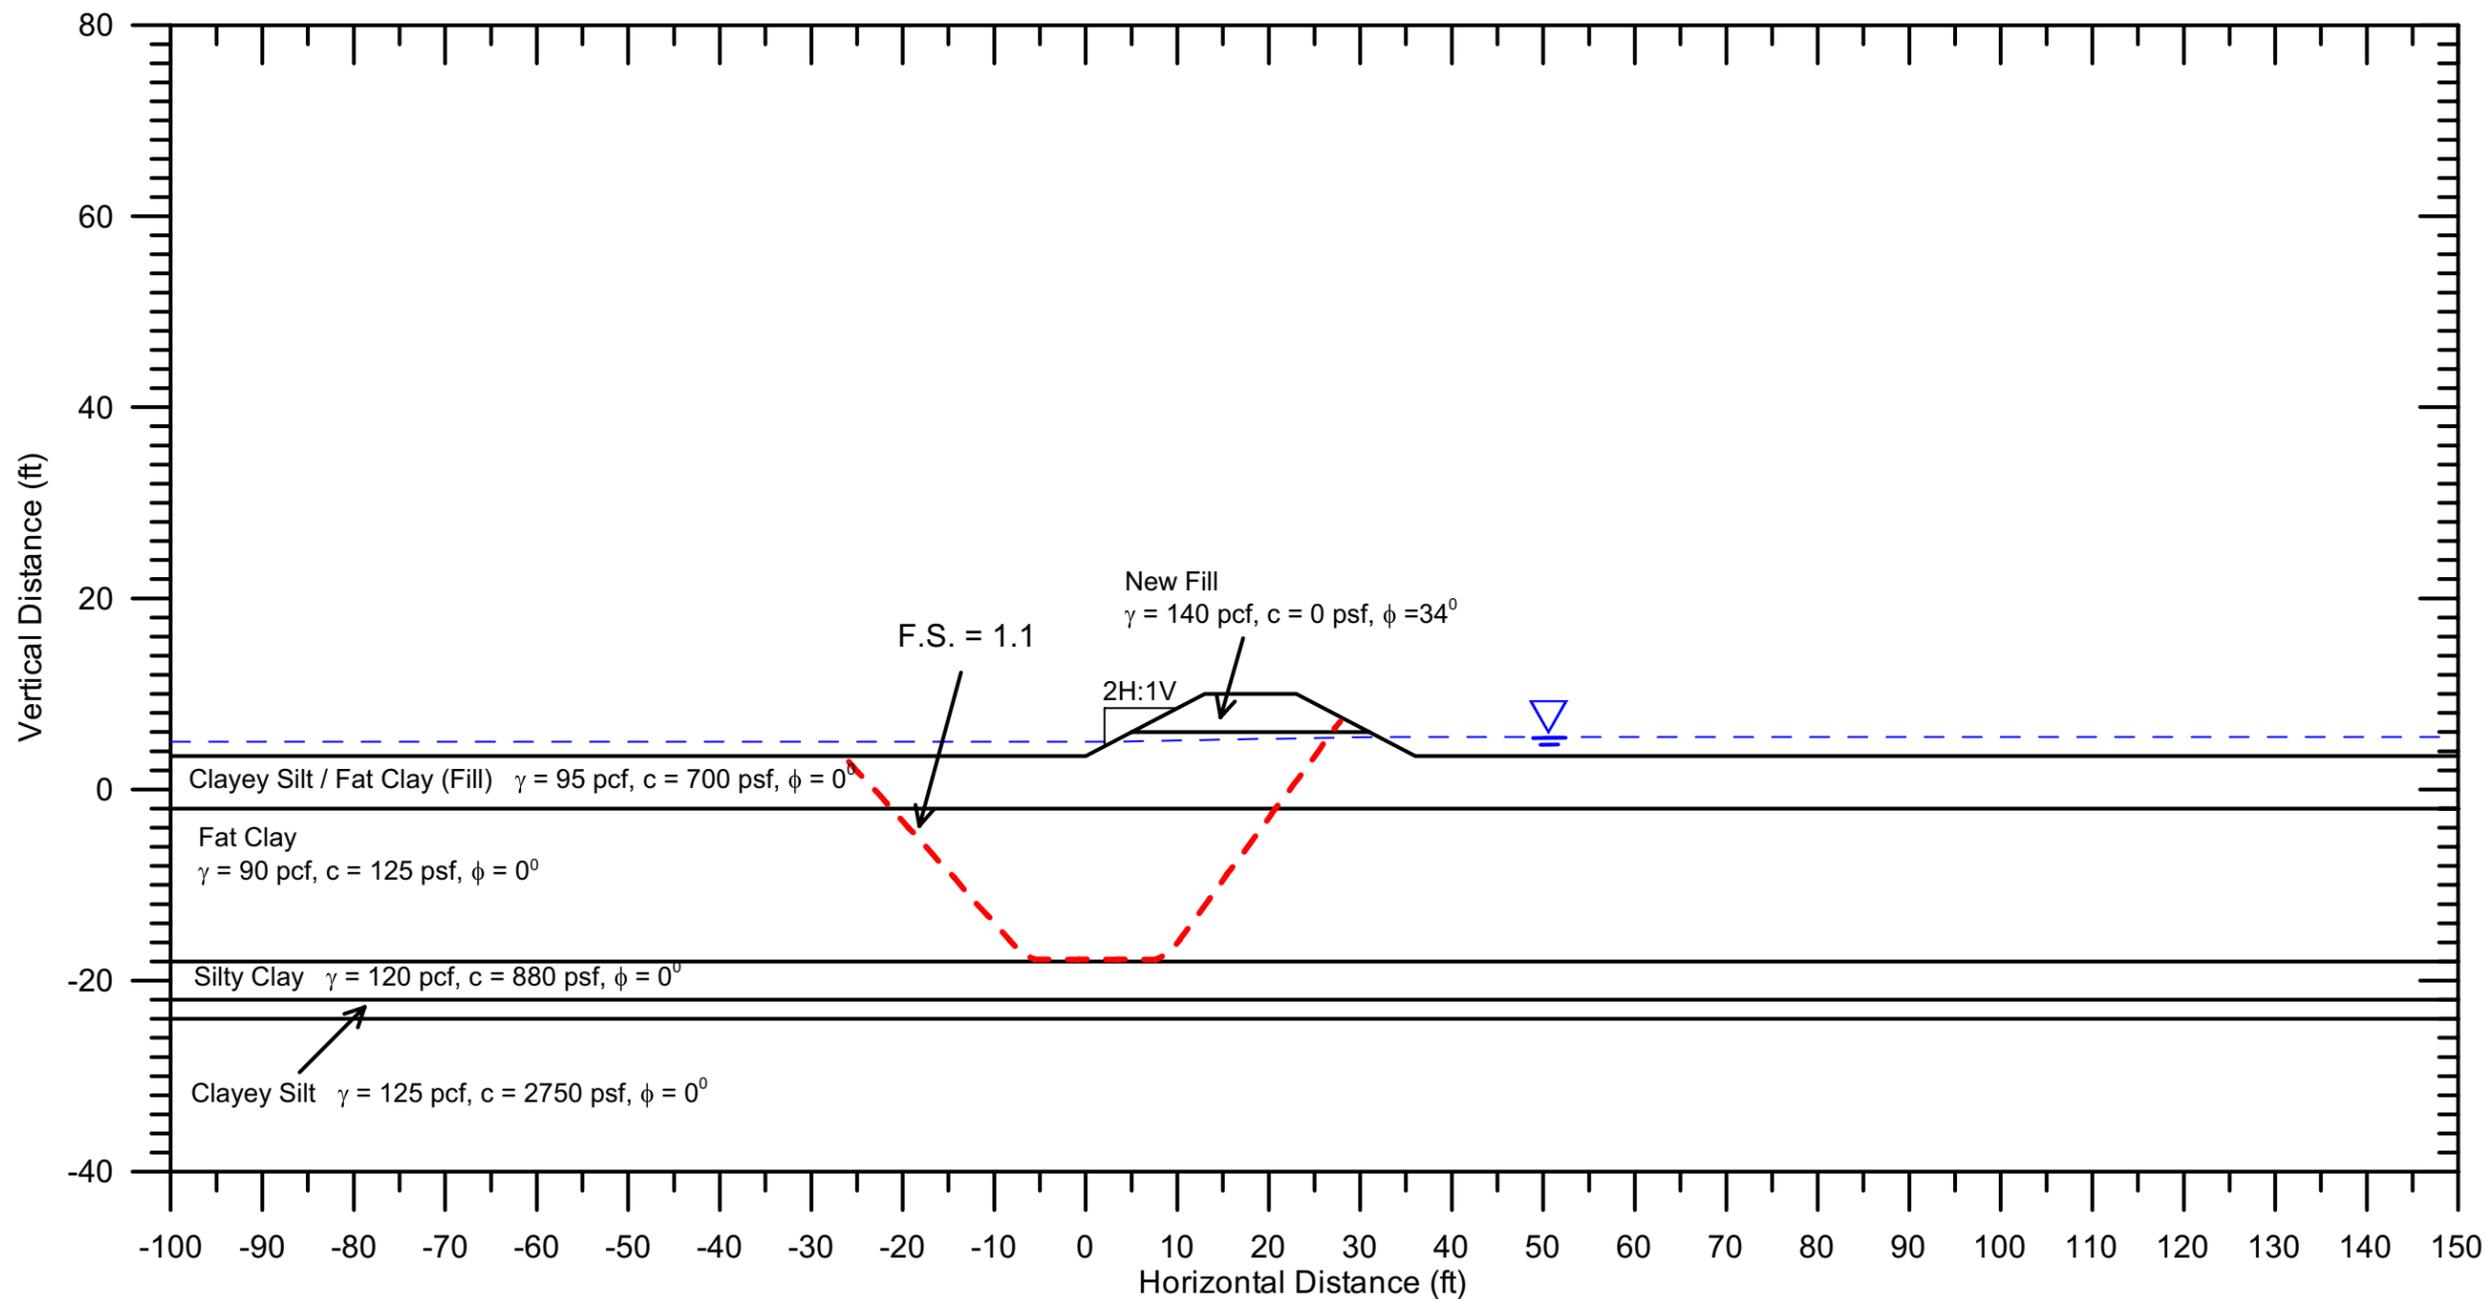
Figure  
 B-5

SLOPE STABILITY RESULTS  
 NAPA PLANT SITE PONDS 6 & 7  
 CROSS SECTION 7-03 LEVEE

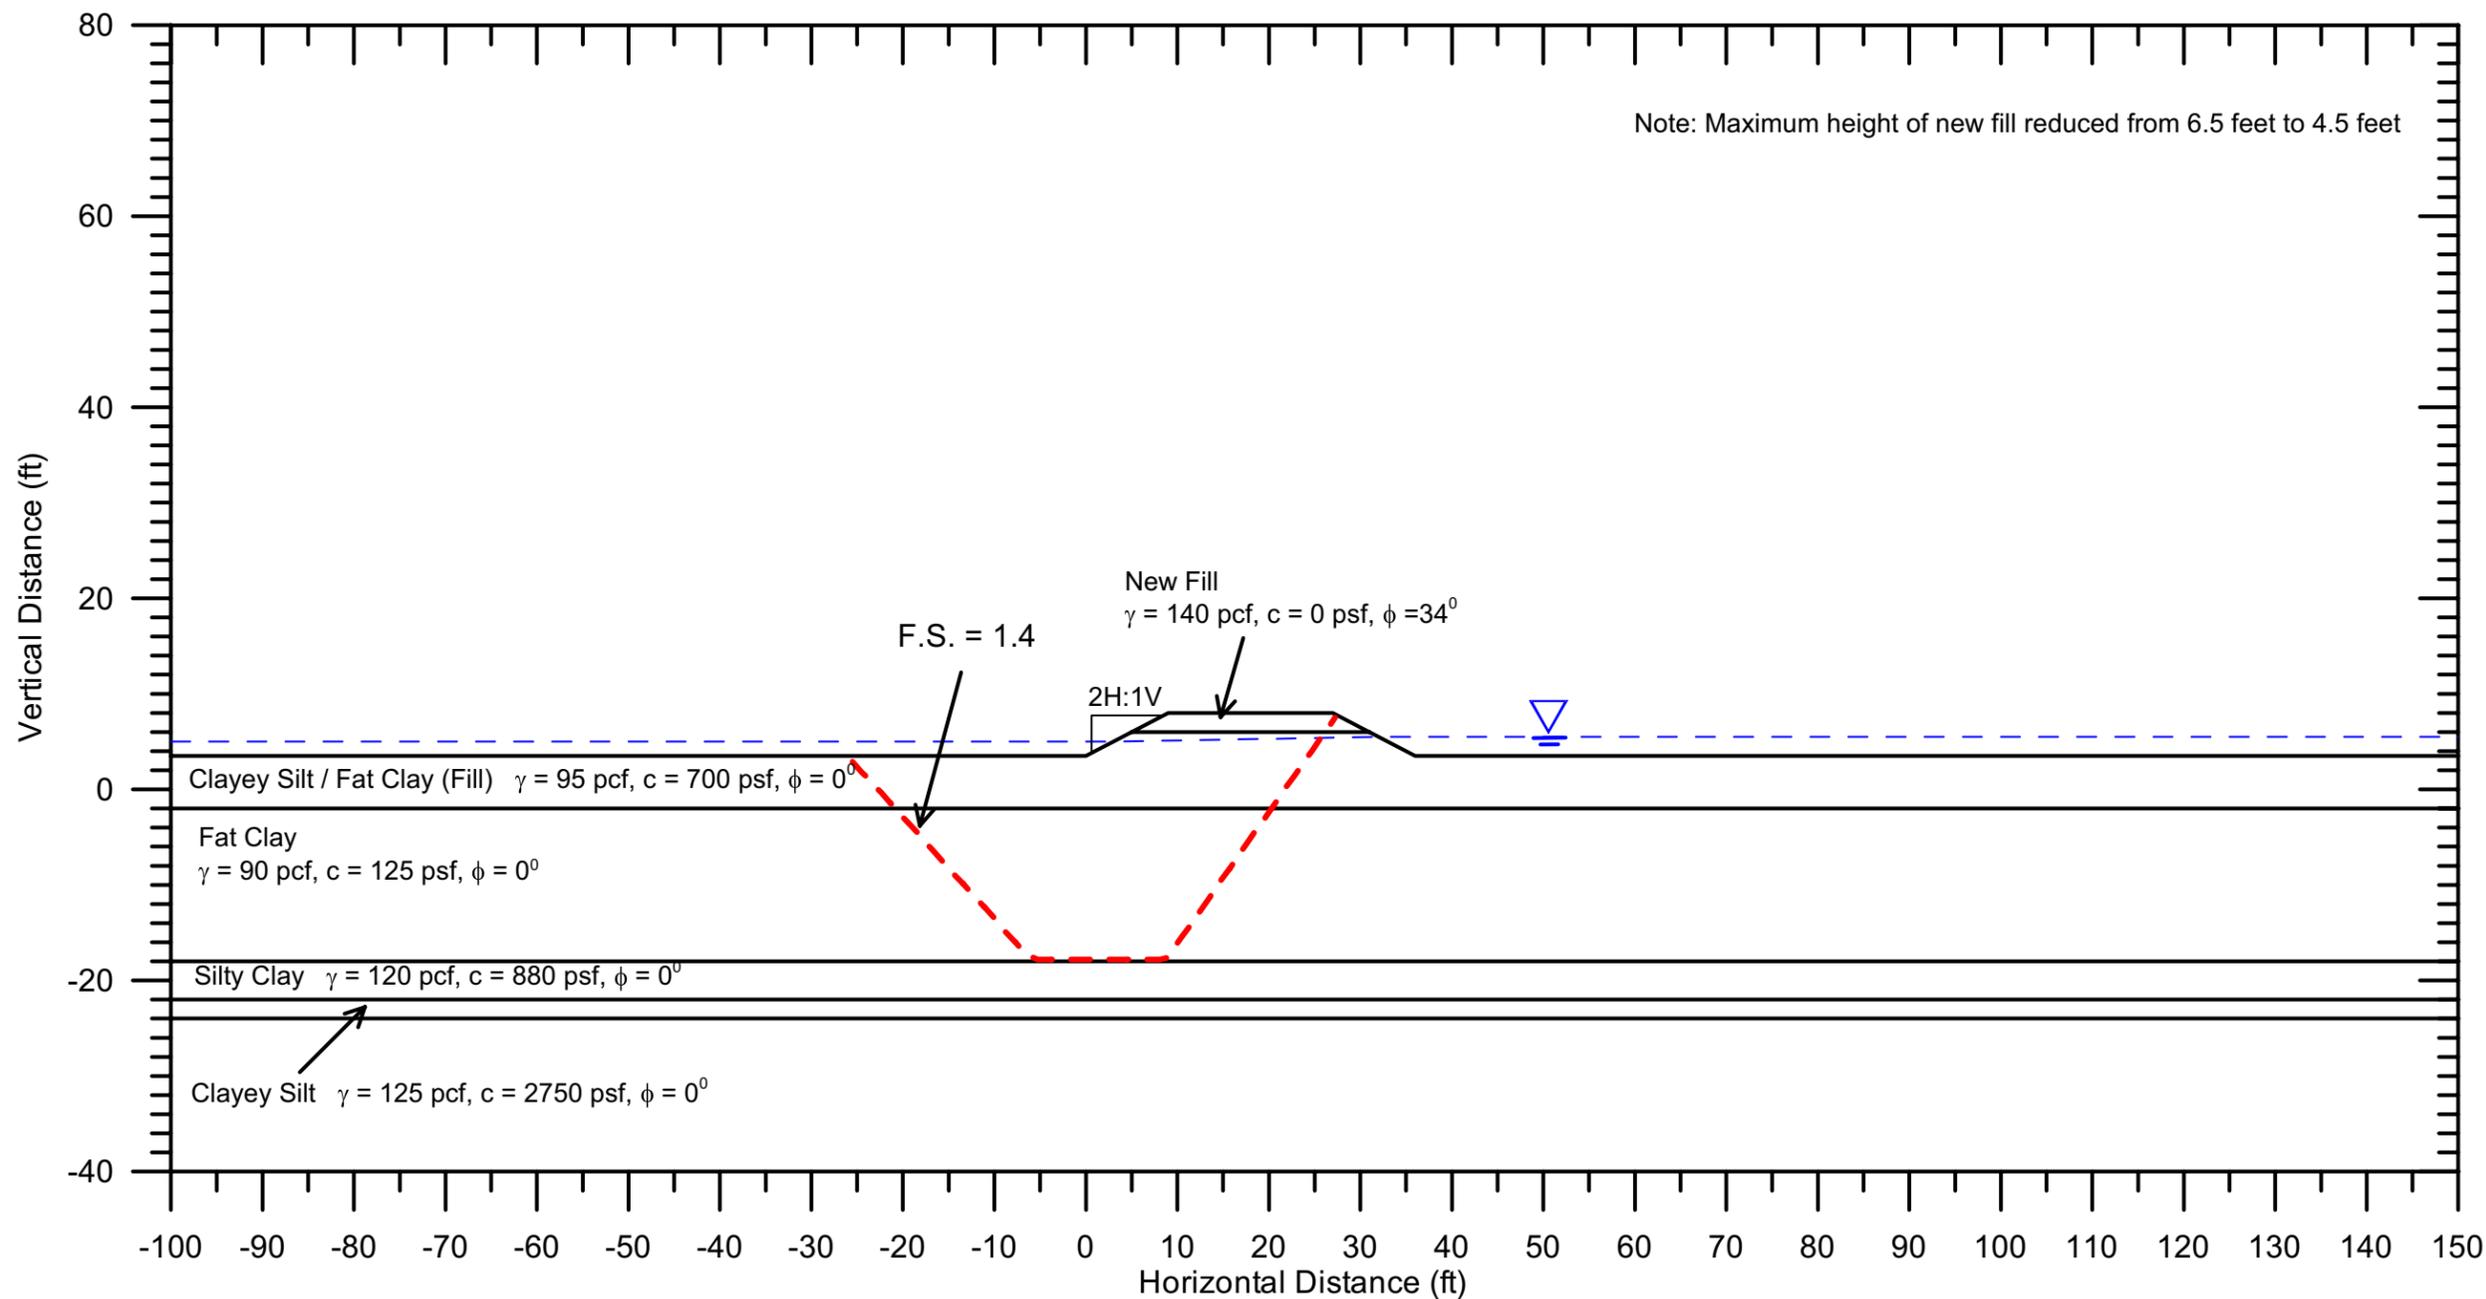
Figure  
 B-6

SLOPE STABILITY RESULTS  
 NAPA PLANT SITE PONDS 6 & 7  
 CROSS SECTION 7-03 LEVEE

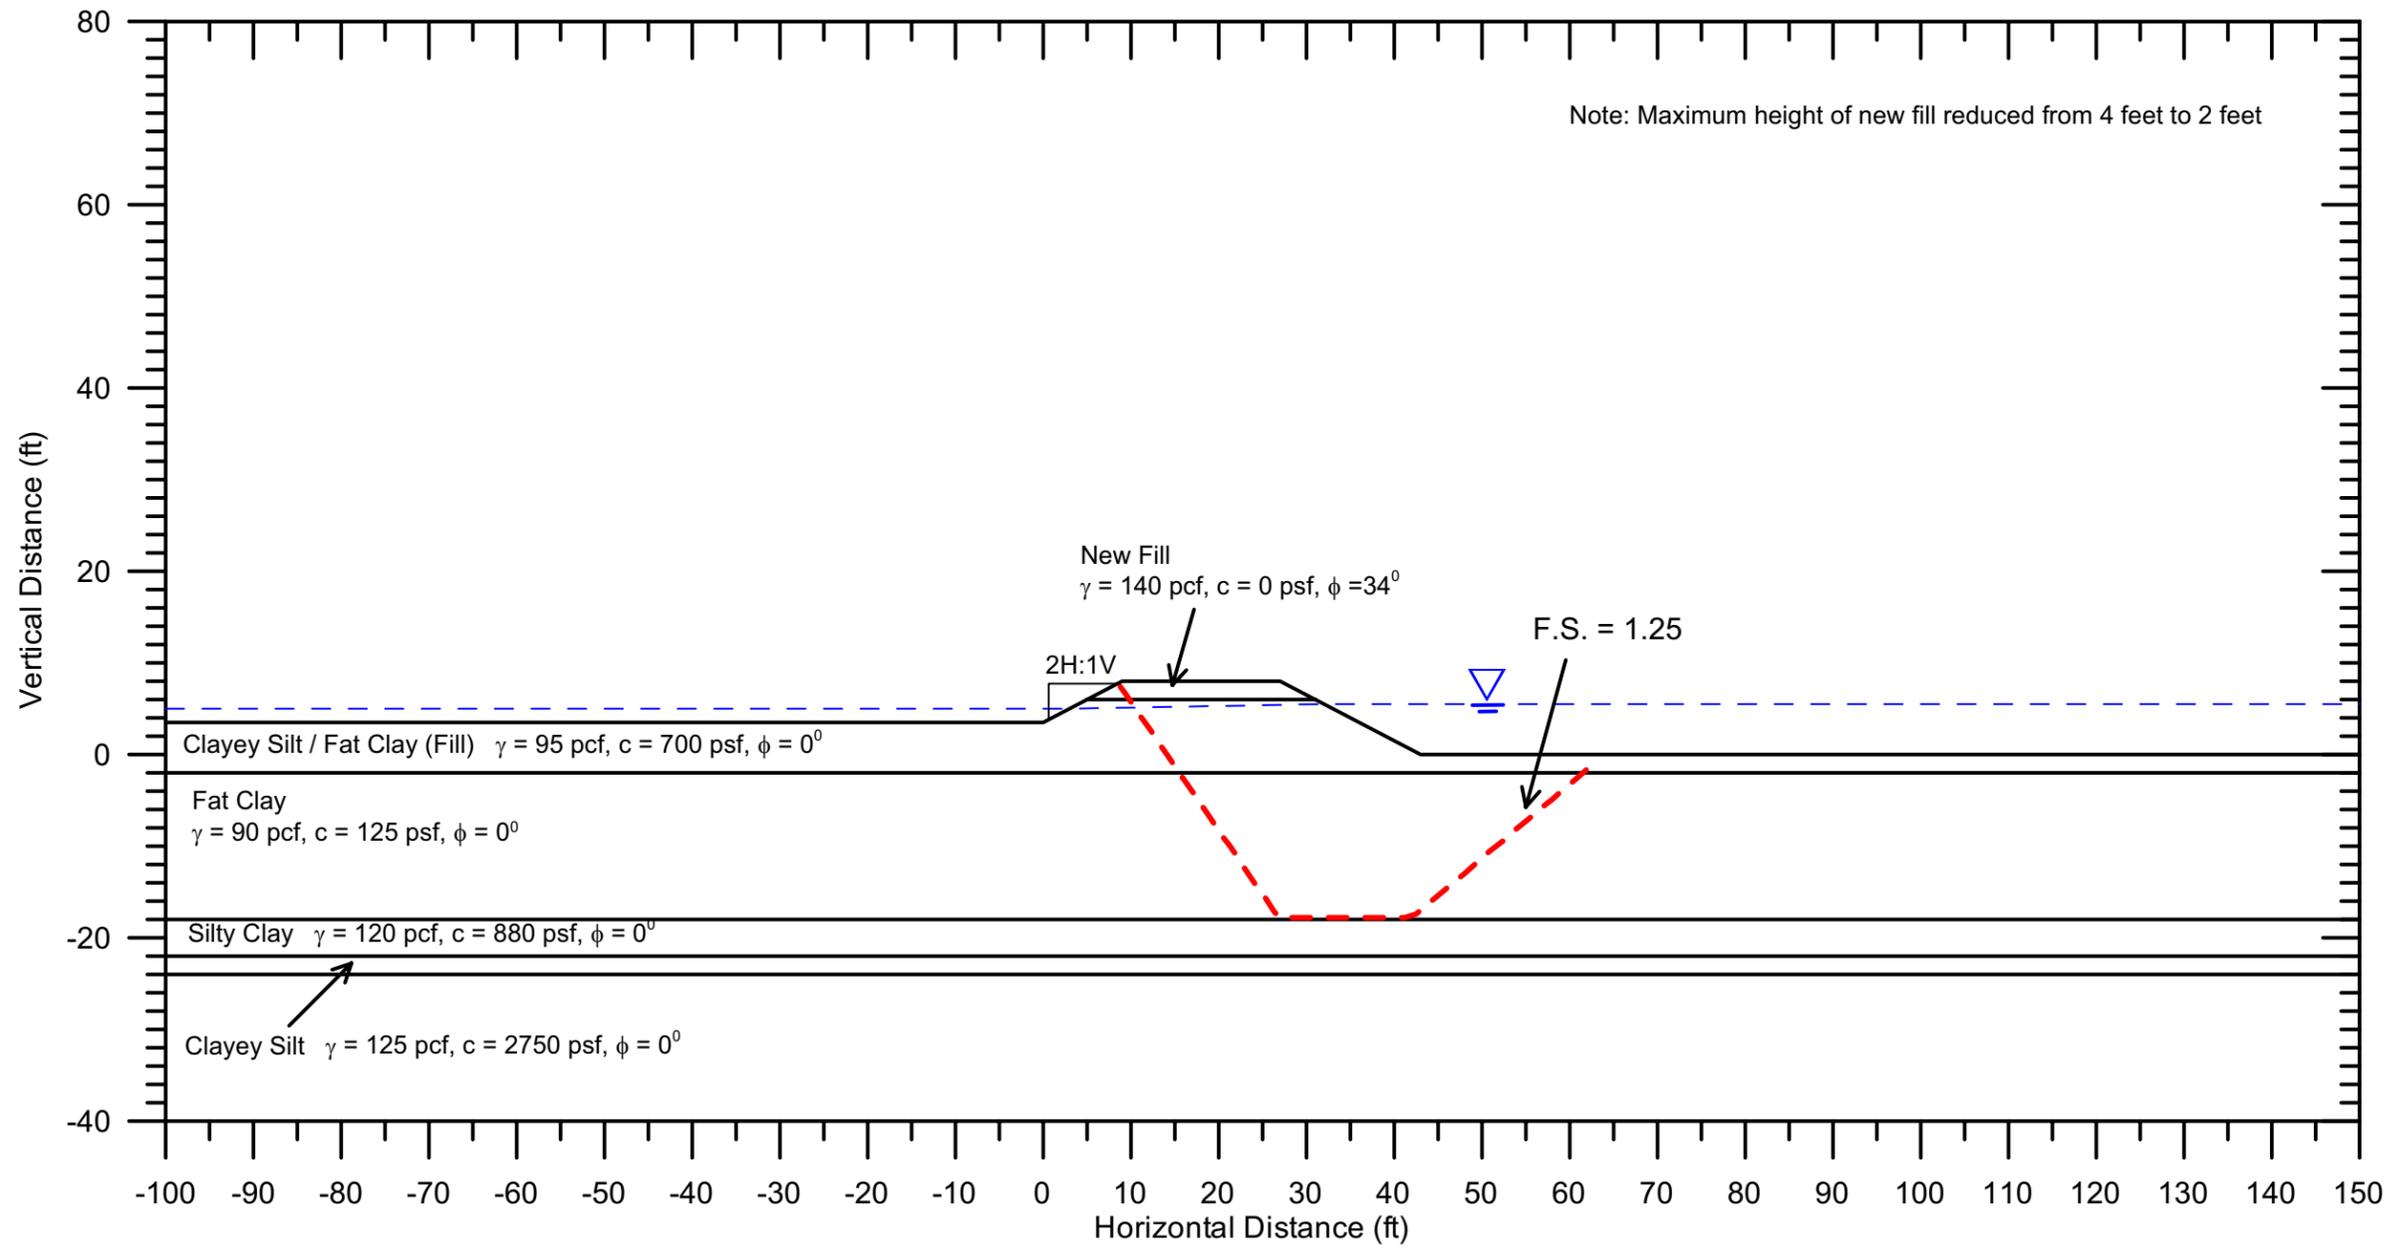
Figure  
 B-7

SLOPE STABILITY RESULTS  
 NAPA PLANT SITE PONDS 6 & 7  
 CROSS SECTION 7-03 LEVEE

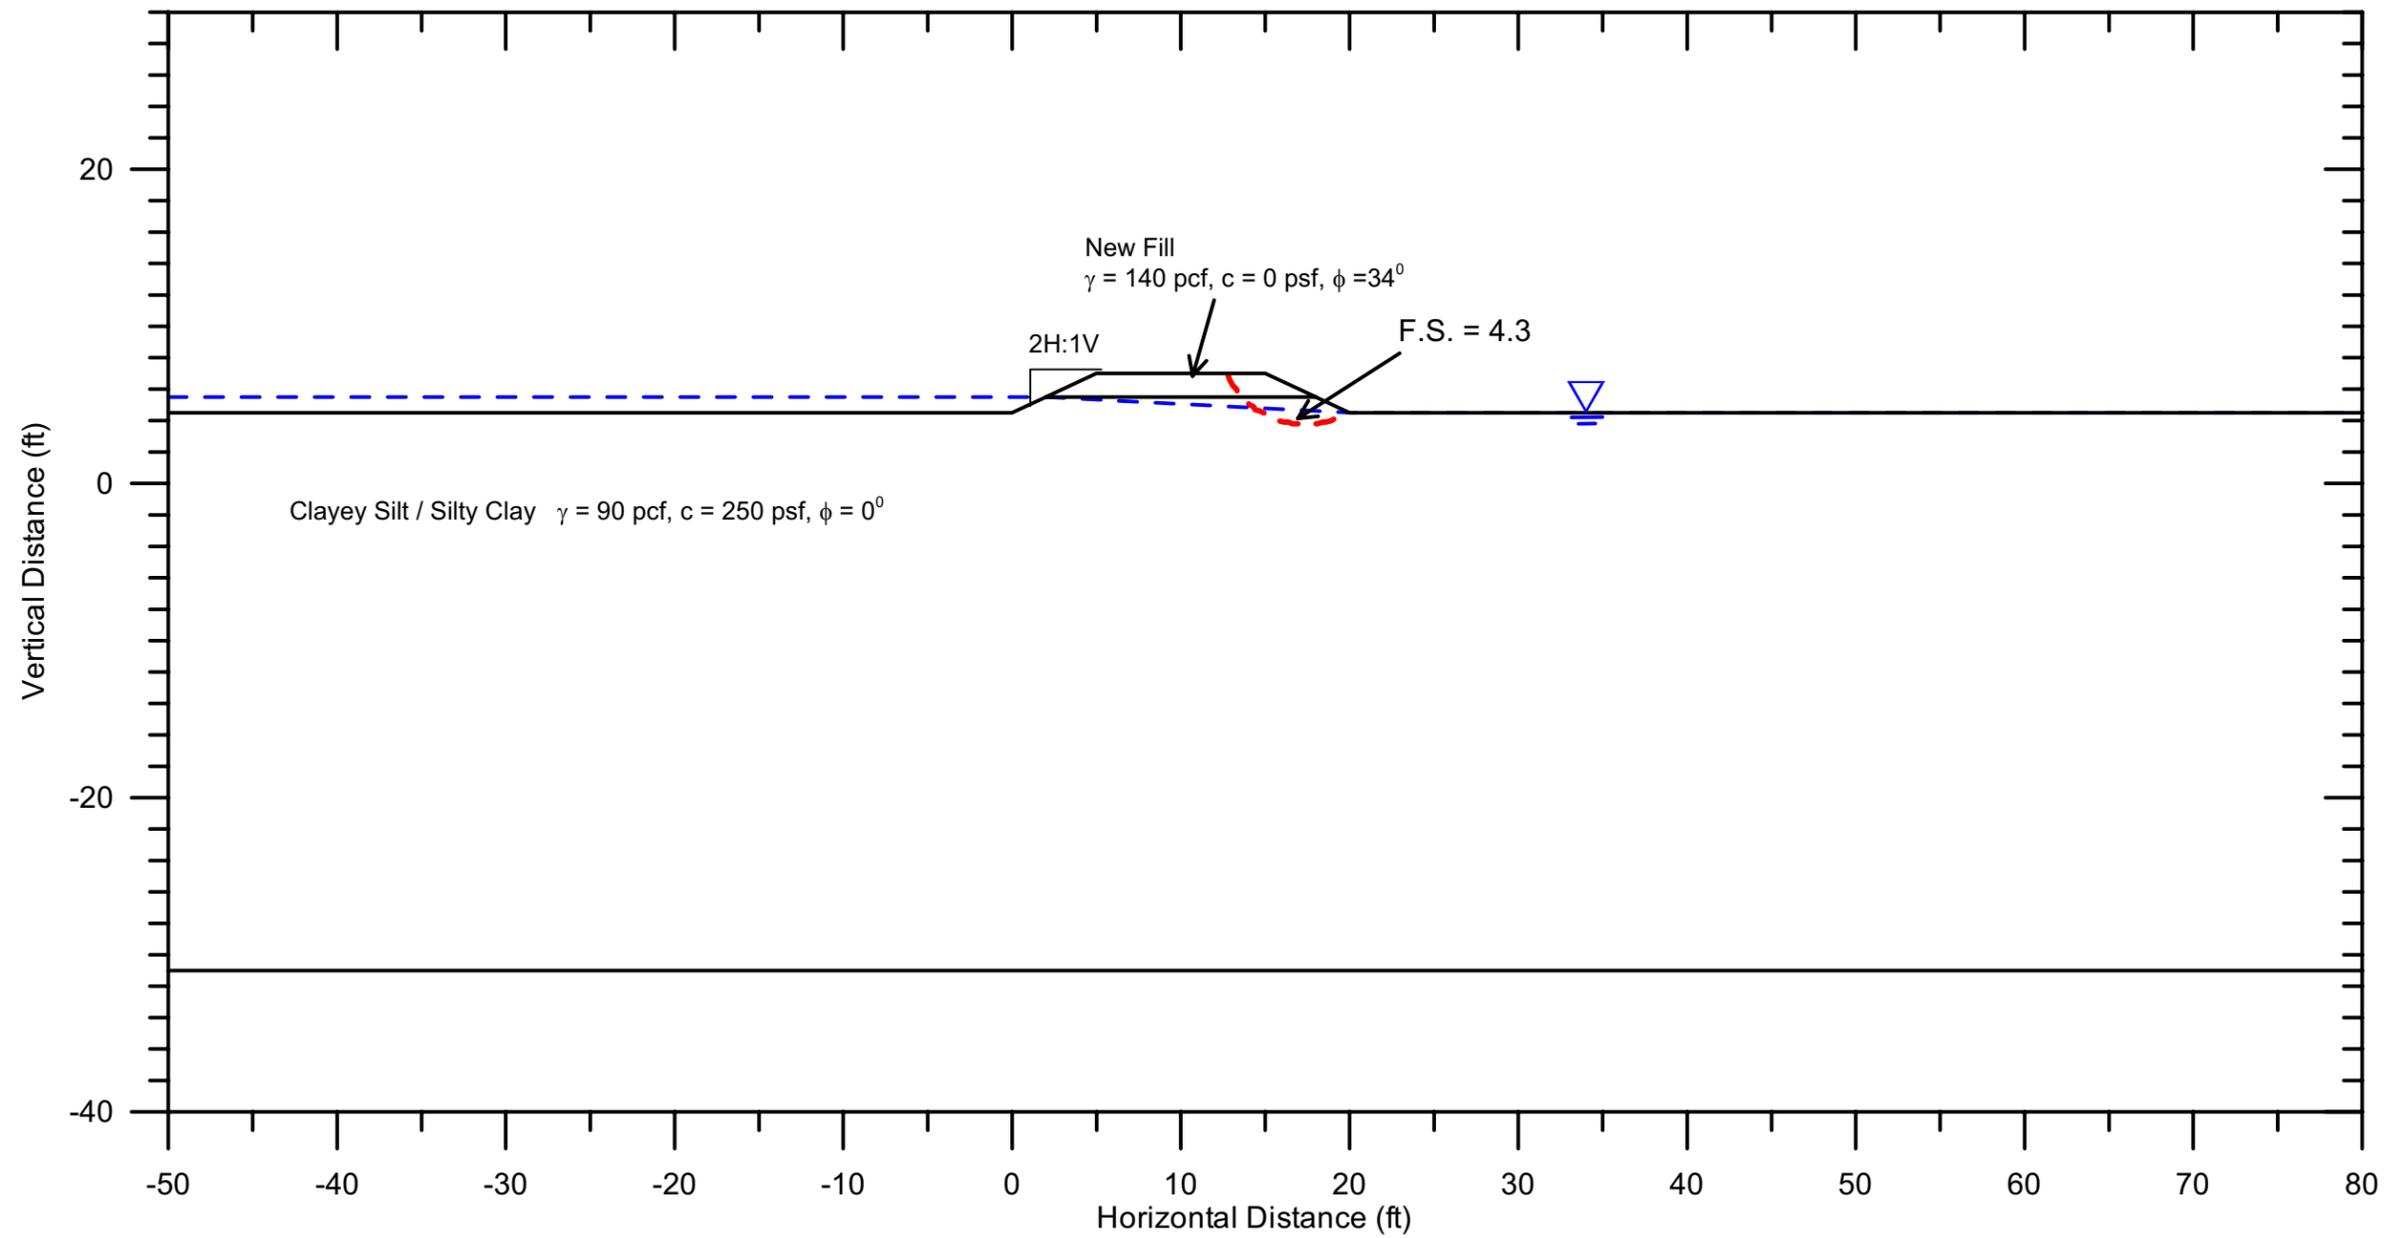
Figure  
 B-8

SLOPE STABILITY RESULTS  
 NAPA PLANT SITE POND 8  
 CROSS SECTION 8-07 LEVEE  
 (CREST ELEVATION: 7 FT)

The results of the slope stability analyses for Pond 8 are summarized in Table 4 and shown on Figures B-8 through B-11. Since the resulting minimum F.S. for the cases analyzed are higher than the minimum required F.S. of 1.3 for the end-of-construction condition, it is URS' opinion that slope stability failure is not a major concern for Pond 8 side slopes.

<b>Case No.</b>	<b>Thickness of New Fill</b>	<b>Finished Levee Elevation (feet)</b>	<b>Failure Surface</b>	<b>F.S.</b>
1	1.5	7	Circular	4.3
2	2.5	8	Circular	2.9
3	4.5	10	Circular	1.9
4	4.5	10	Wedge-Shaped	1.8

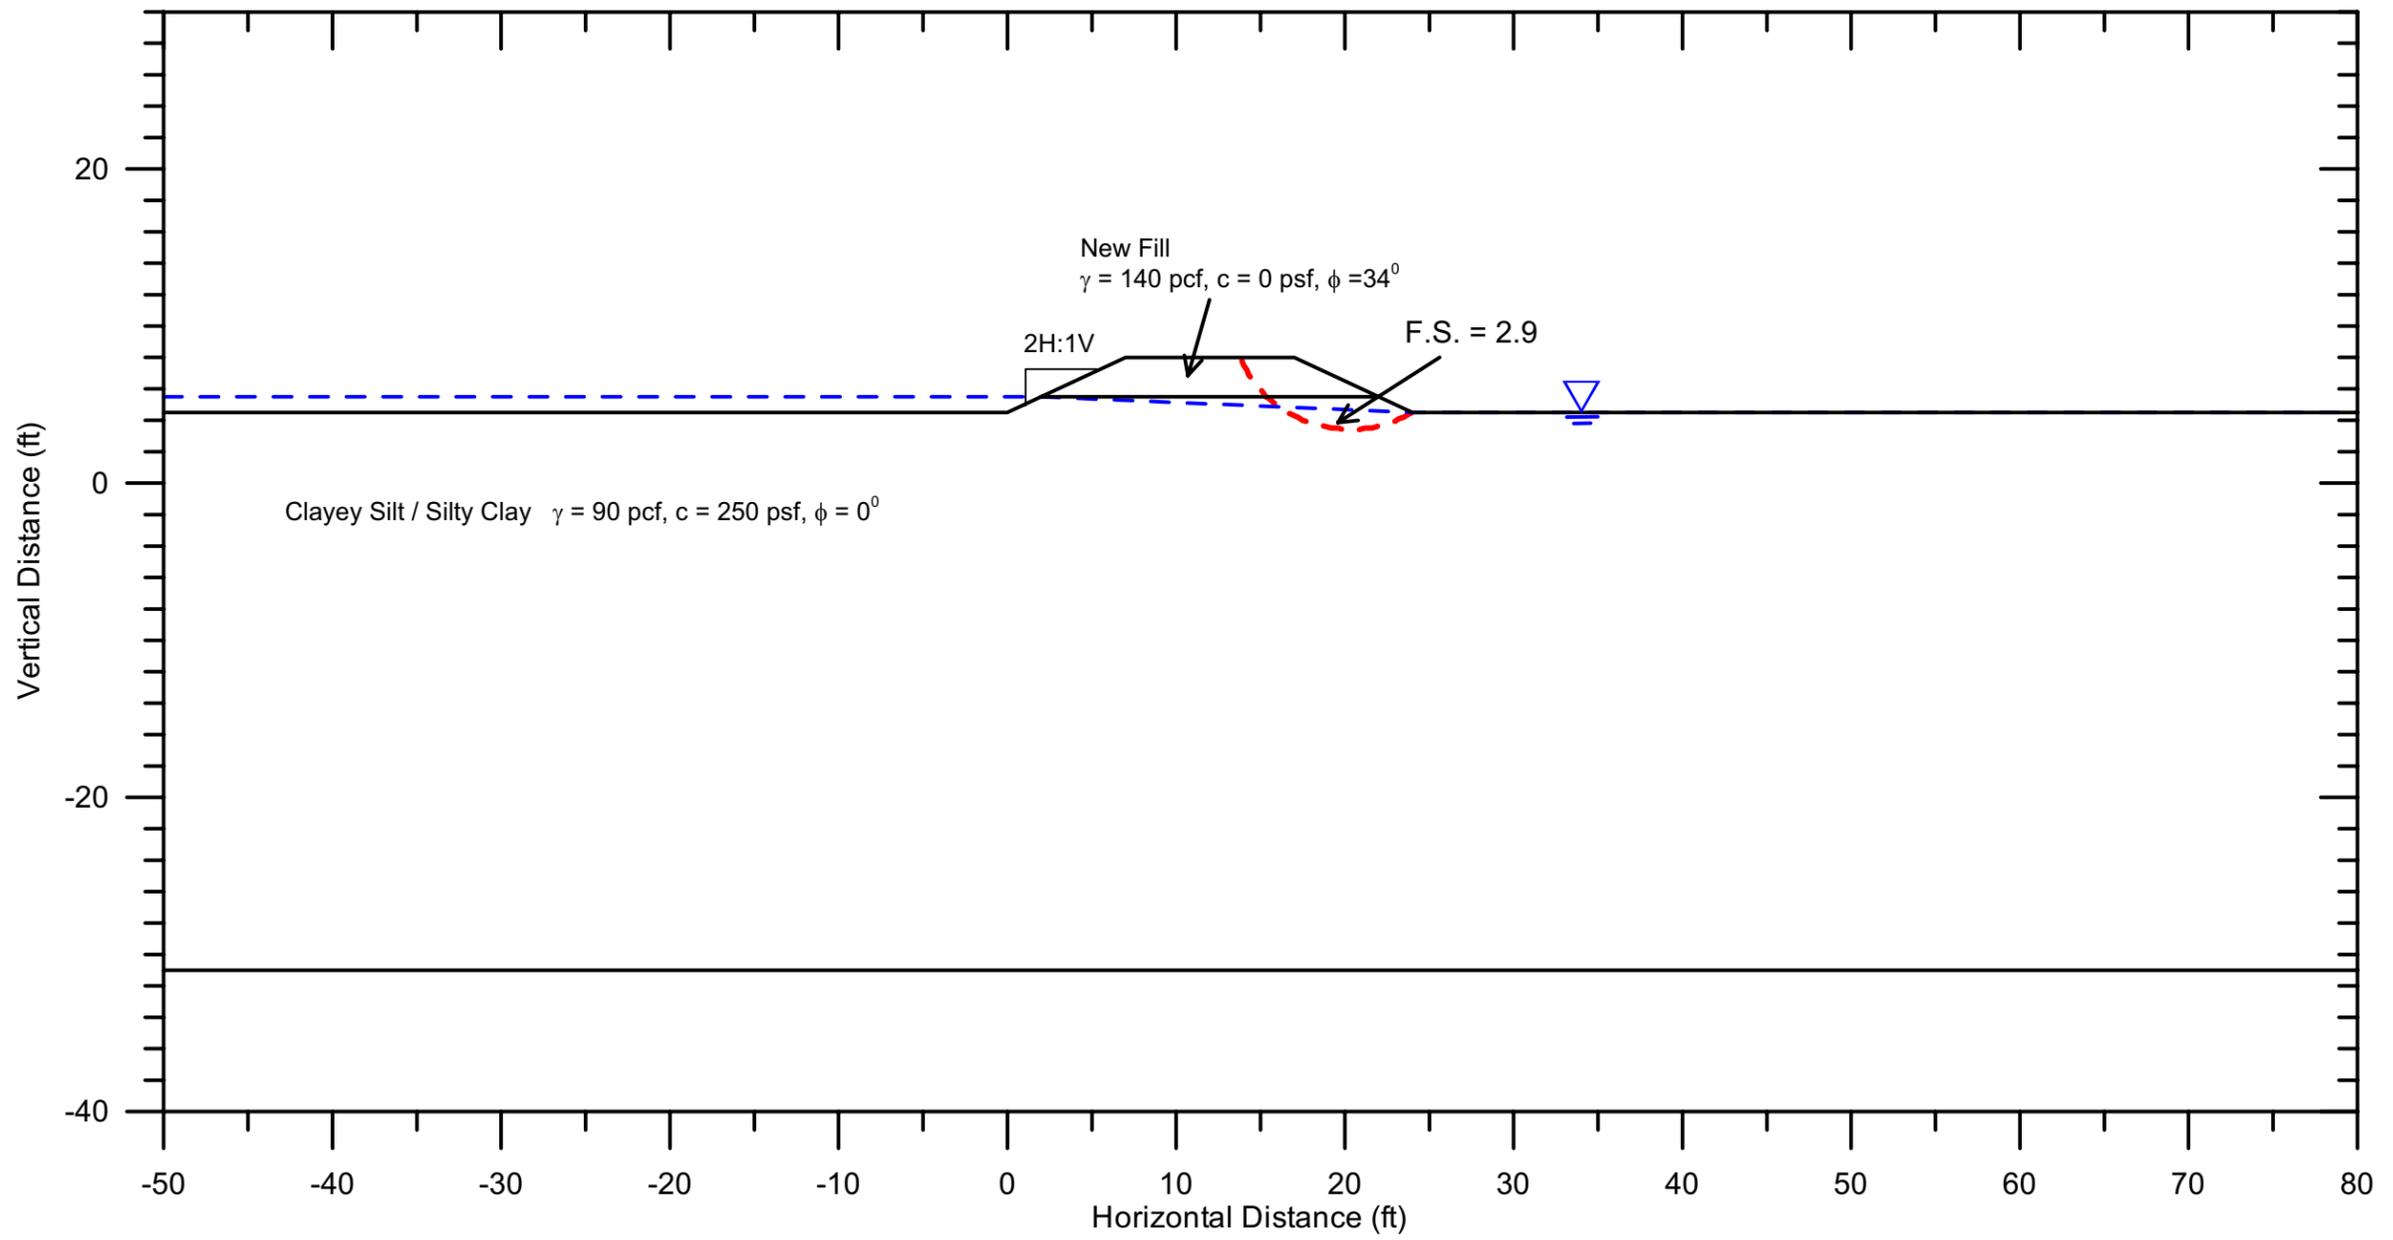
Figure  
 B-9

SLOPE STABILITY RESULTS  
 NAPA PLANT SITE POND 8  
 CROSS SECTION 8-07 LEVEE  
 (CREST ELEVATION: 8 FT)
