## Geotechnical Study for Pond 6-7-8, Napa Plant Site Restoration

**Project: Napa Salt Marsh Restoration , Ponds 6-7-8**

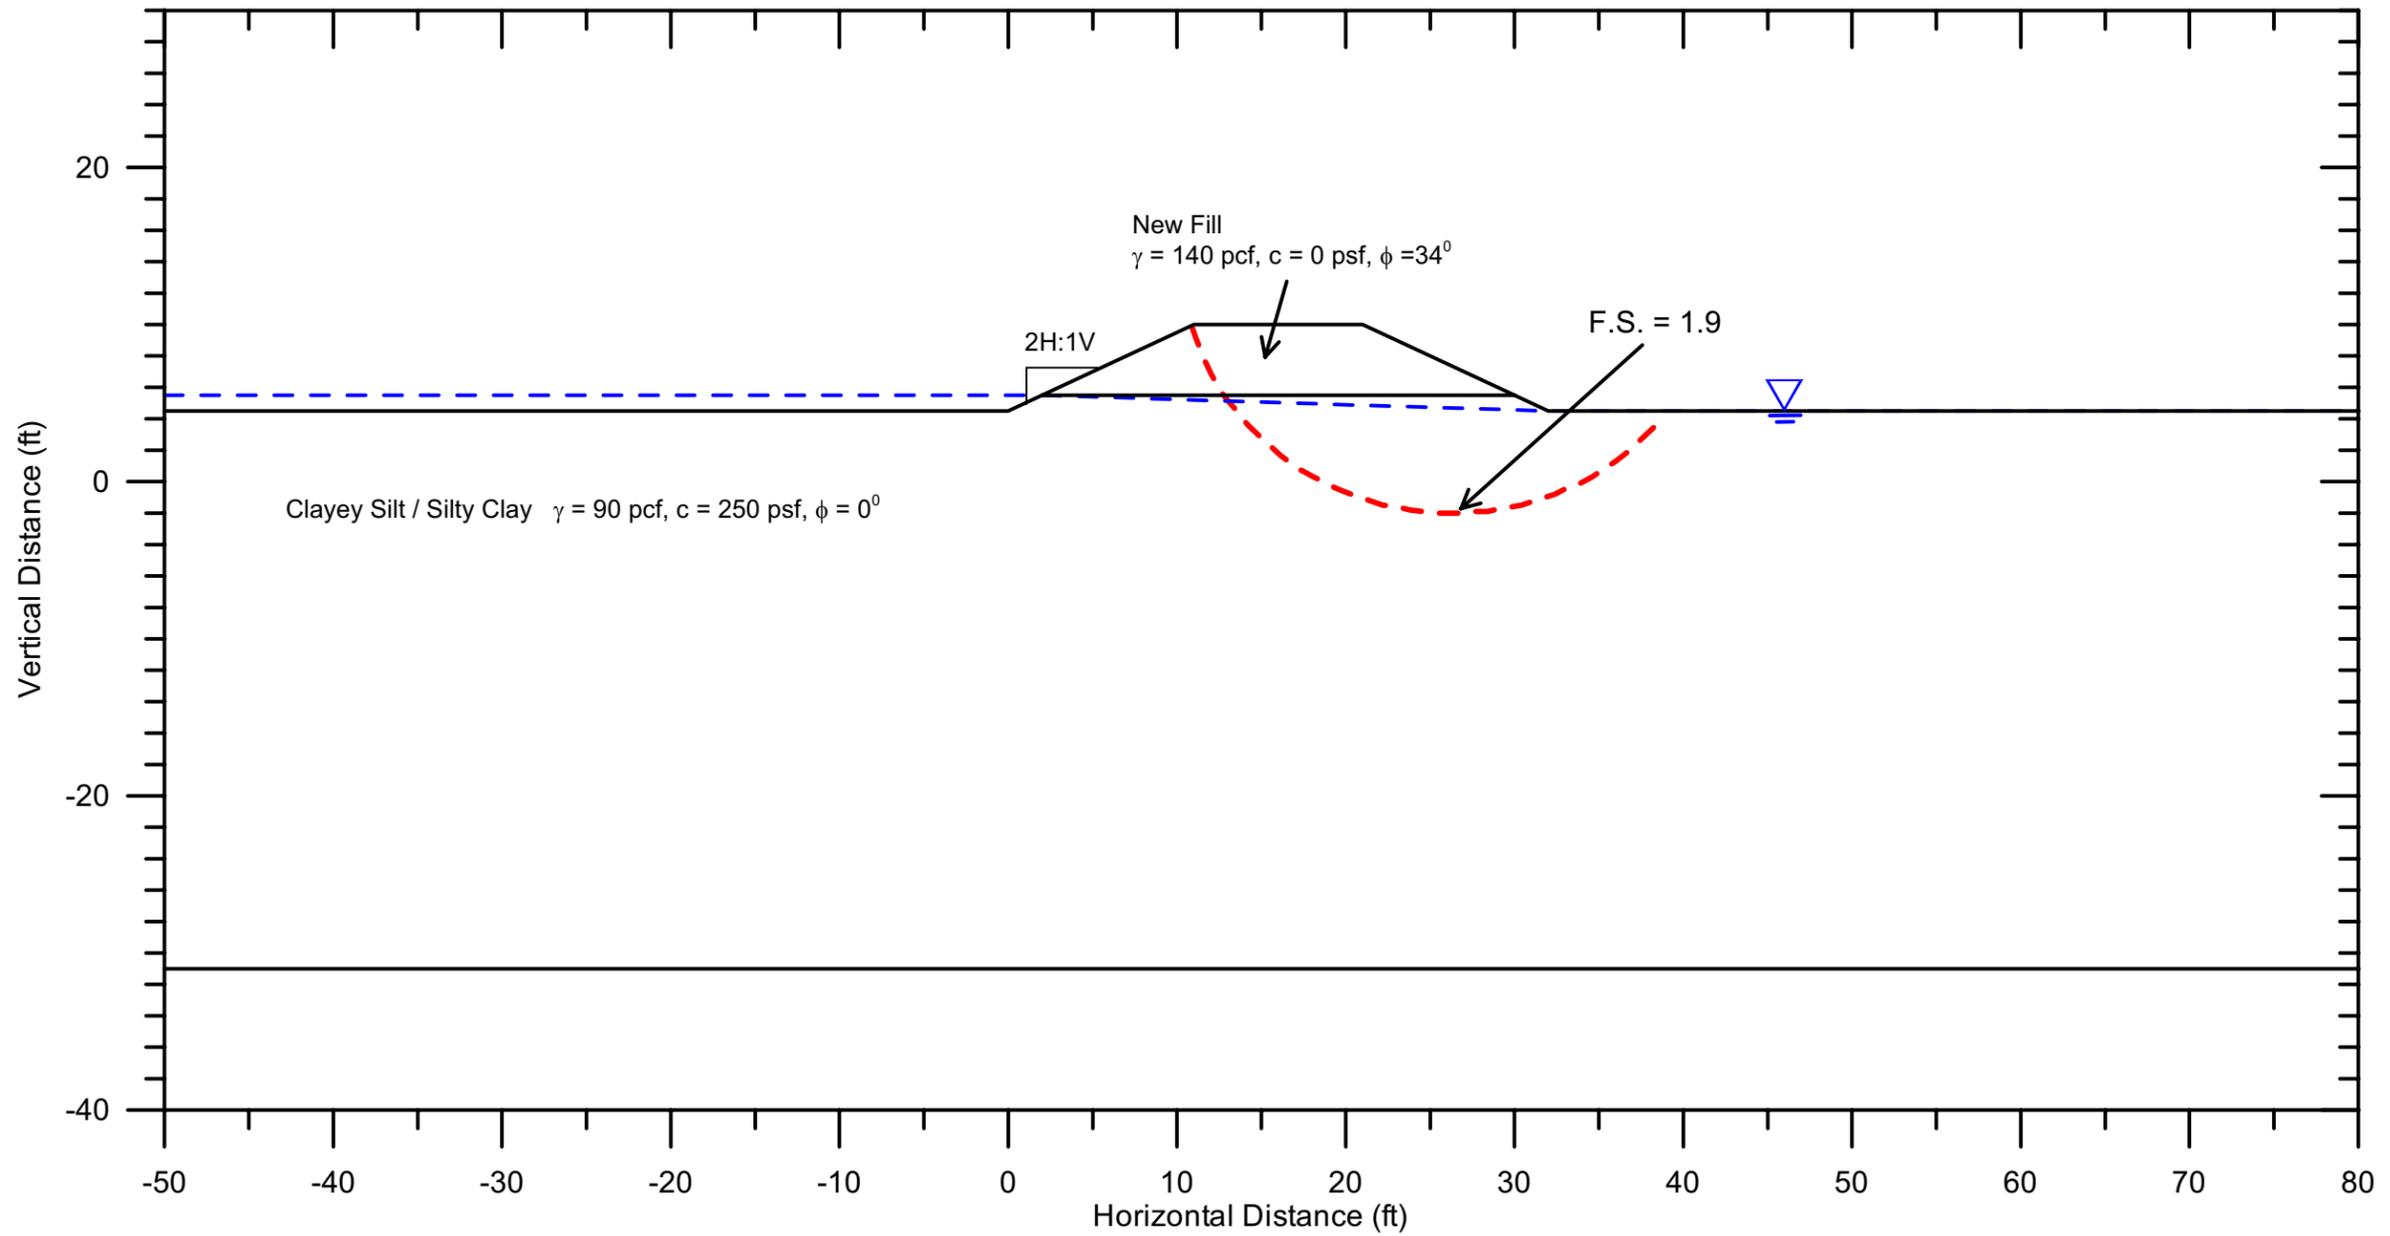
Figure  
B-10

SLOPE STABILITY RESULTS  
NAPA PLANT SITE POND 8  
CROSS SECTION 8-07 LEVEE  
(CREST ELEVATION: 10 FT)

The results of the slope stability analyses for Pond 8 are summarized in Table 4 and shown on Figures B-8 through B-11. Since the resulting minimum F.S. for the cases analyzed are higher than the minimum required F.S. of 1.3 for the end-of-construction condition, it is URS' opinion that slope stability failure is not a major concern for Pond 8 side slopes.

<b>Case No.</b>	<b>Thickness of New Fill</b>	<b>Finished Levee Elevation (feet)</b>	<b>Failure Surface</b>	<b>F.S.</b>
1	1.5	7	Circular	4.3
2	2.5	8	Circular	2.9
3	4.5	10	Circular	1.9
4	4.5	10	Wedge-Shaped	1.8

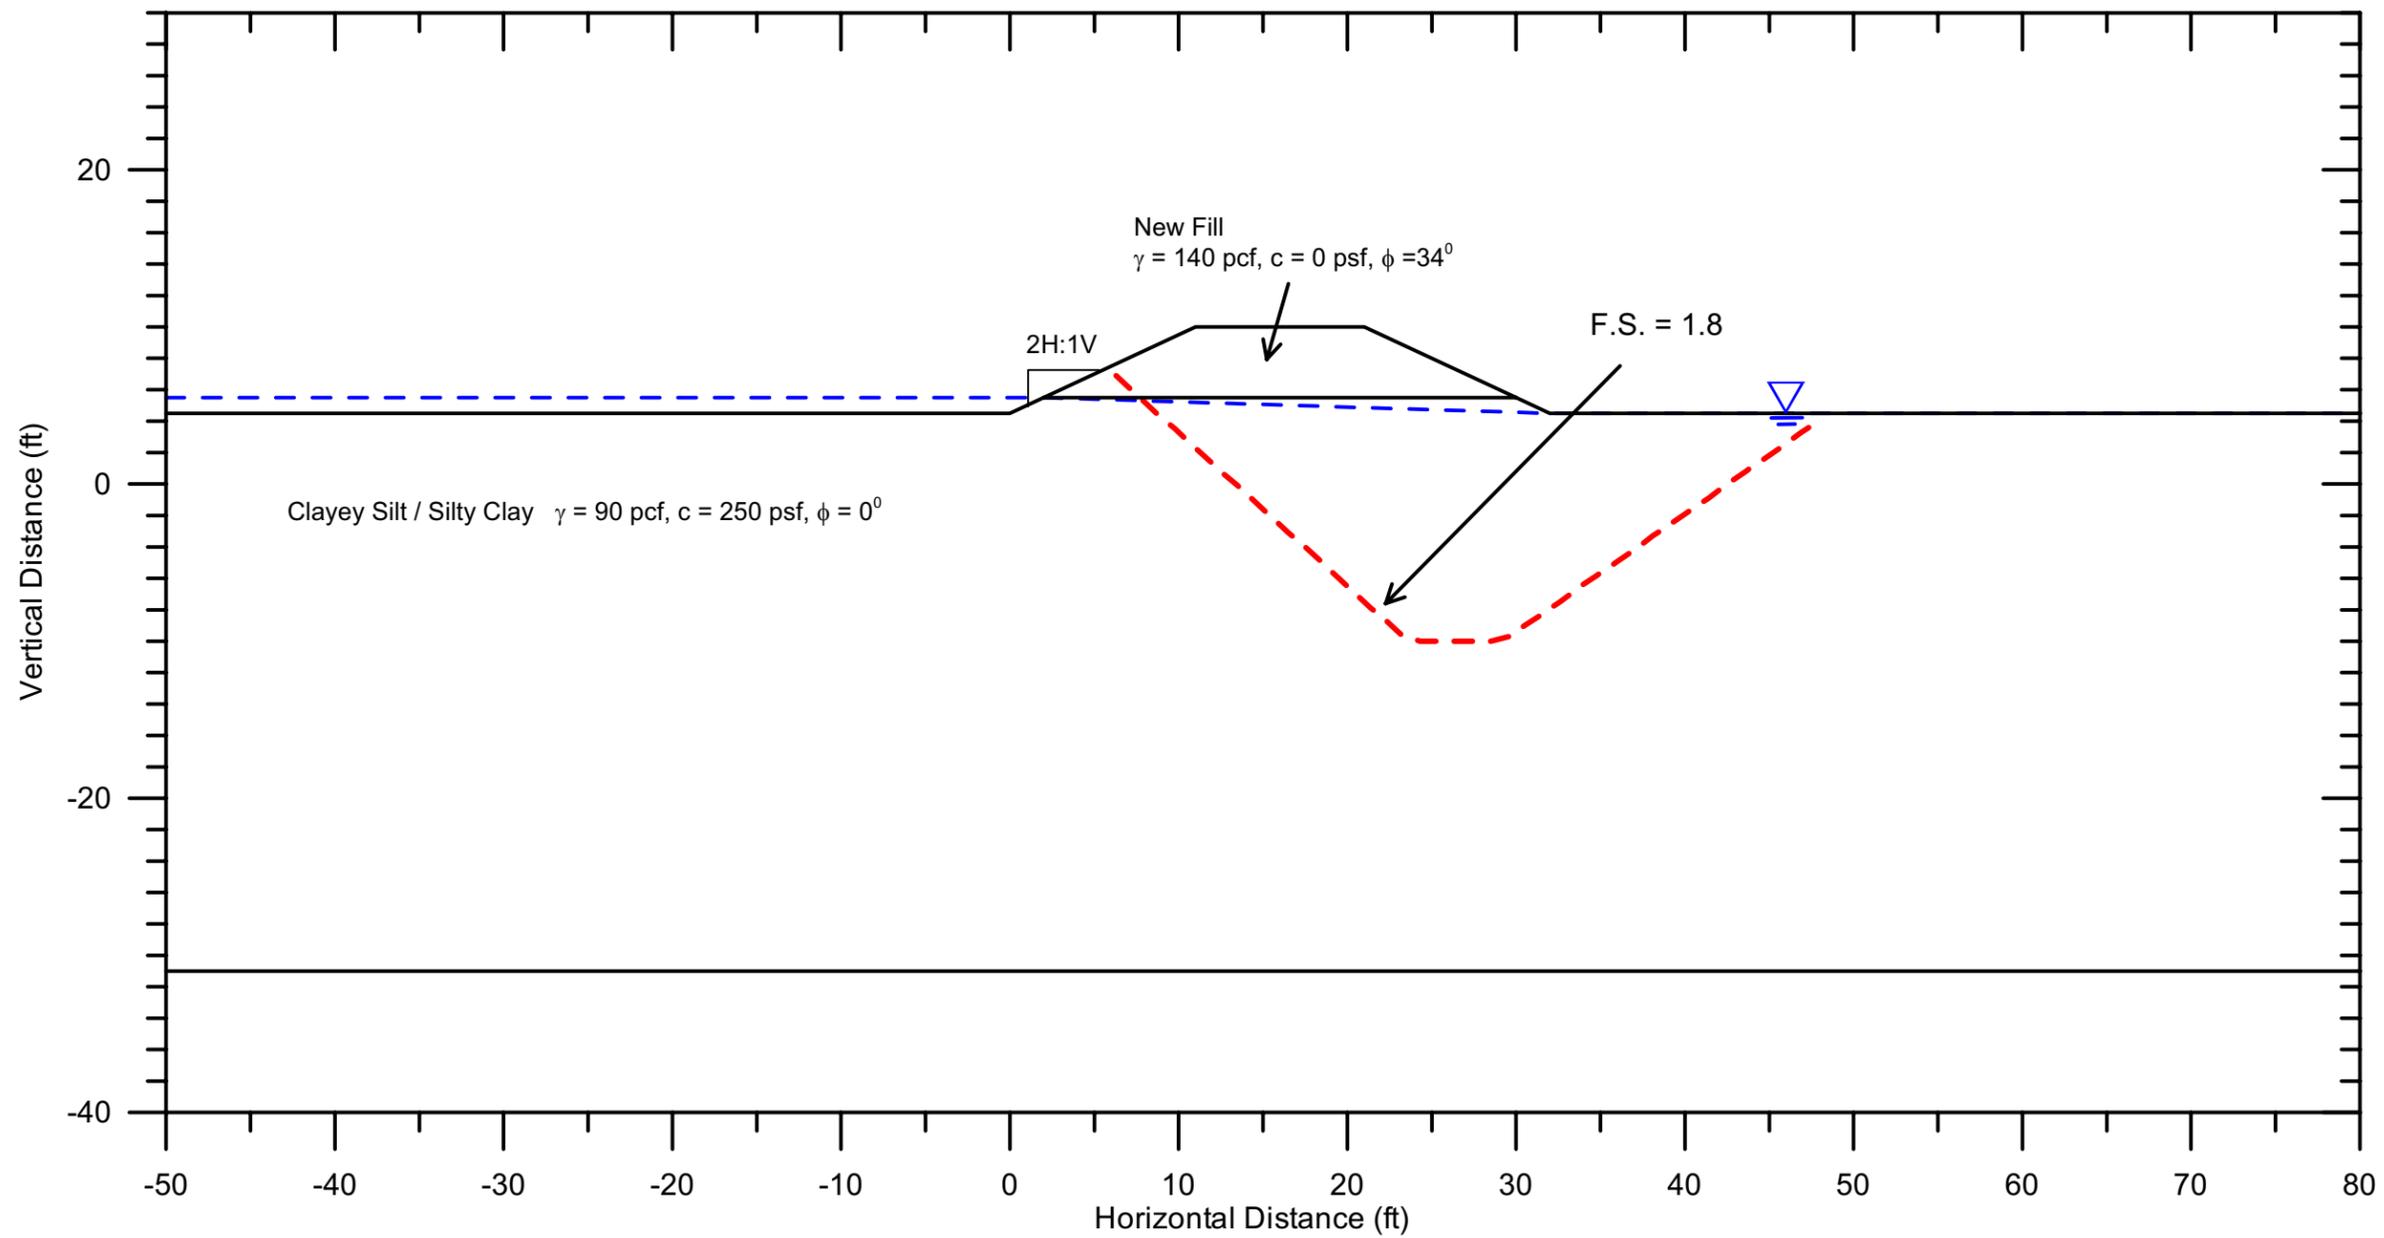
<b>URS</b>	Napa Plant Site American Canyon, CA	SLOPE STABILITY RESULTS NAPA PLANT SITE POND 8 CROSS SECTION 8-07 LEVEE (CREST ELEVATION: 10 FT)	Figure B-11
	Project No. 26815678

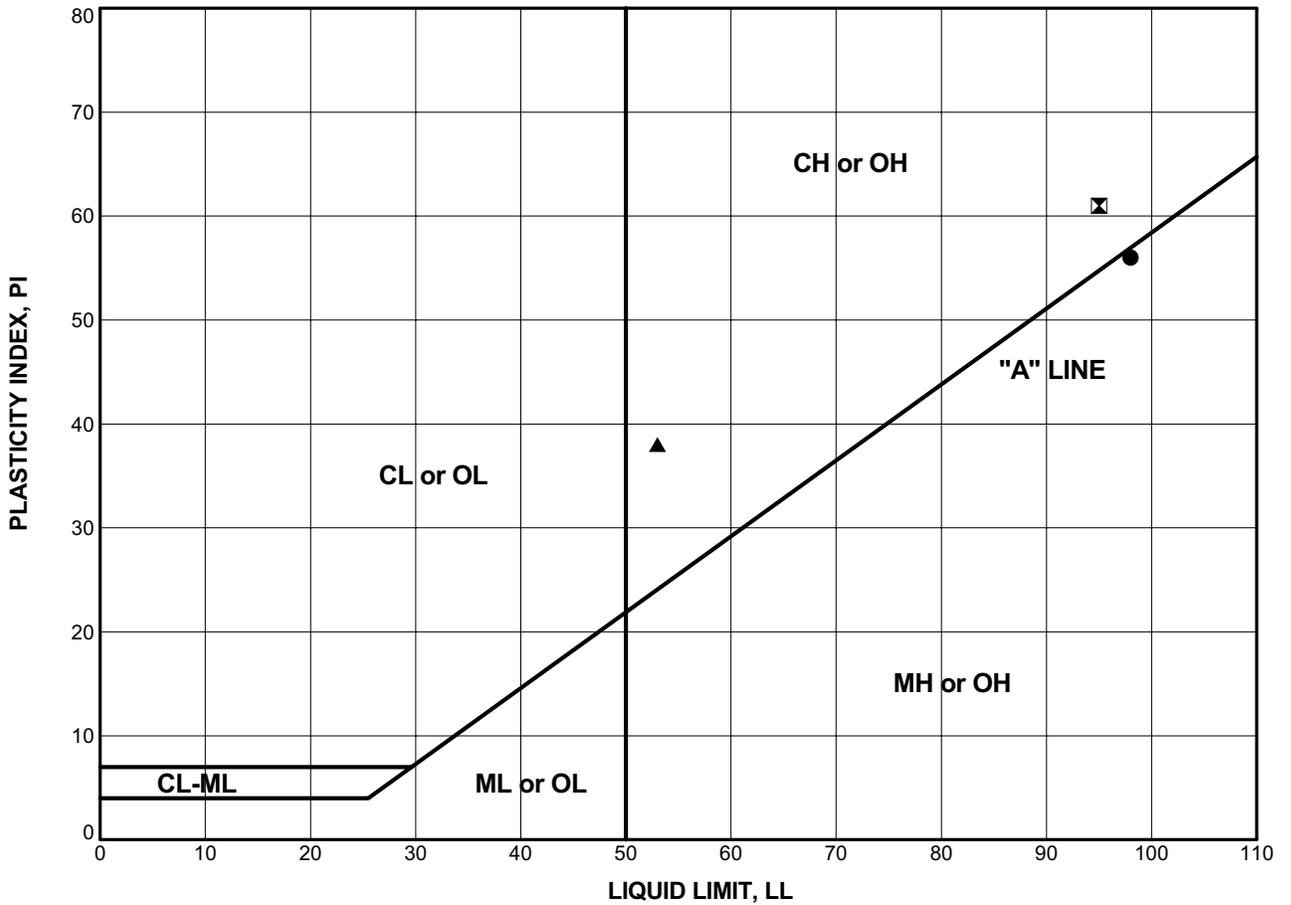
Boring Number	Sample Number	Depth (feet)	Test Symbol	Water Content (%)	LL	PL	PI	Classification
B-1	1-2	2.5-3	●		98	42	56	Clayey Silt (MH)
B-1	4-2	15.5-16	⊠		95	34	61	Fat Clay (CH)
B-1	6-2	25.5-26	▲		53	15	38	Silty Clay (CH)

Ponds 6-7-8  
**PLASTICITY CHART**

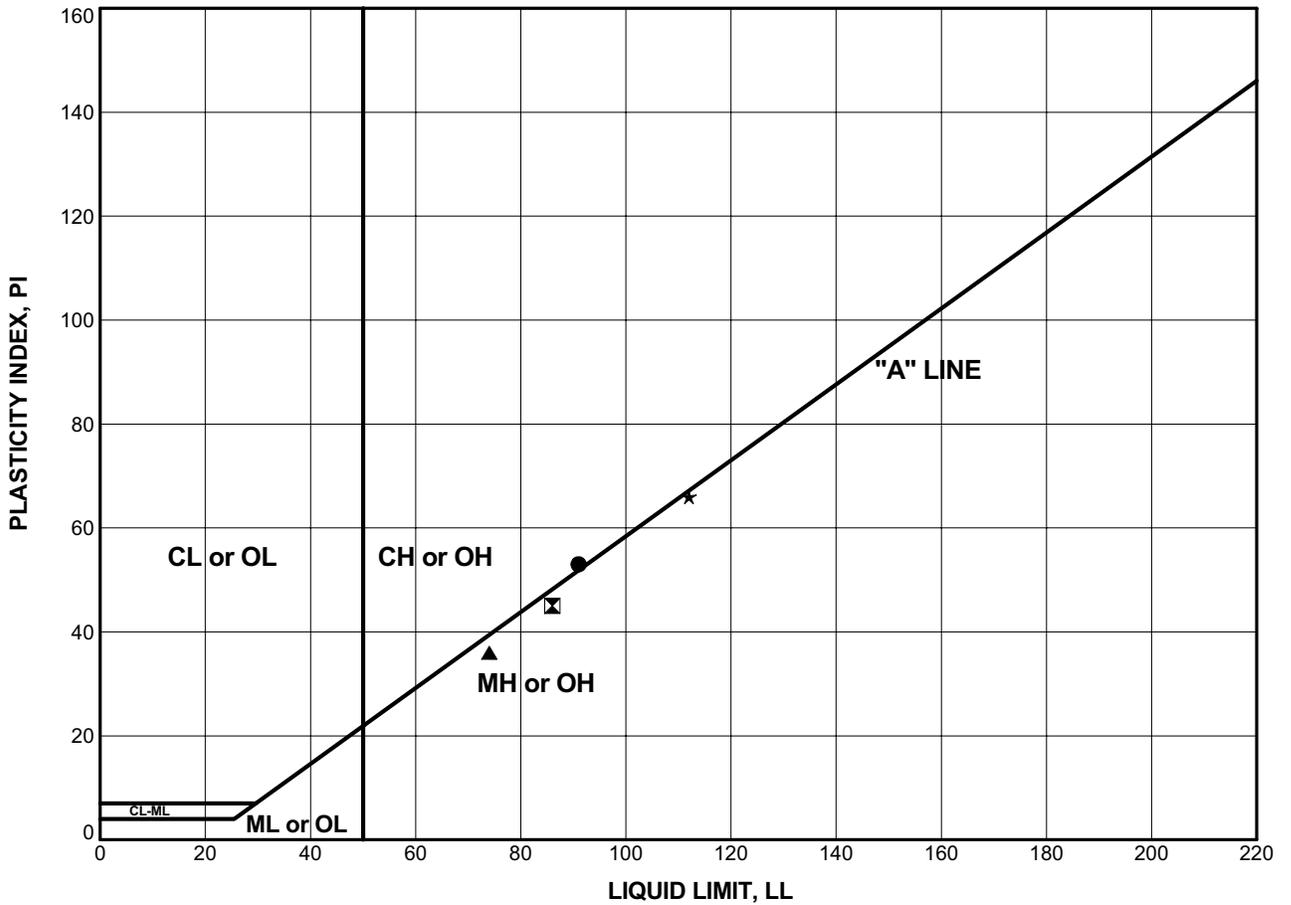
Boring Number	Sample Number	Depth (feet)	Test Symbol	Water Content (%)	LL	PL	PI	Classification
B-3	3-1	2-2.5	●		91	38	53	Silty Clay (CH)
B-3	3-10	20.5-21	⊠		86	41	45	Clayey Silt (MH)
B-4	4-1	5-5.5	▲		74	38	36	Clayey Silt (MH)
B-4	4-5	15-17	★	229.5	112	46	66	Clayey Silt (MH)

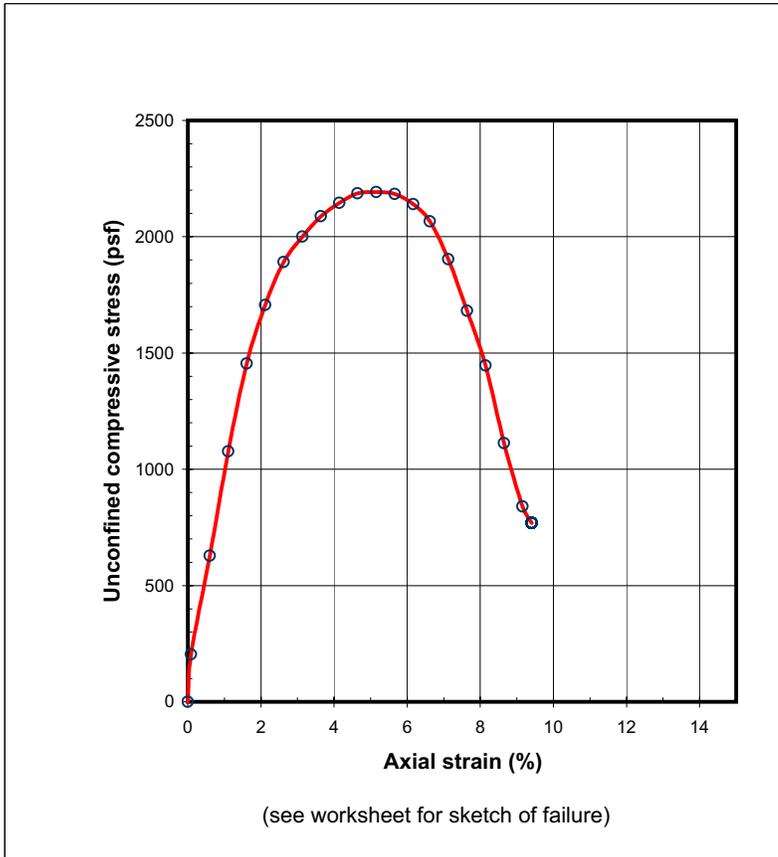
Test Report: Void ratio = 1.794  
 Ht/Dia ratio = 2.48  
 Moisture = 60.5 %  
 Total density = 96.8 pcf  
 Dry density = 60.3 pcf  
 Saturation = 91.1 %  
 Unconfined compressive strength = 2191 psf  
 Shear strength = 1096 psf  
 Strain @ failure = 5.15 %

**UNCONFINED COMPRESSION TEST - U<sub>c</sub>**  
**ASTM D-2166**

Client : URS  
 Project : Napa Salt Marsh Restoration Project  
 Job No. : 26815678.00100  
 Boring # : B-1-2  
 Sample # : 3  
 Depth (ft) : 6-6.5  
 Date tested : 12/03/06  
 Soil (Visual Description) : Undisturbed brown clay

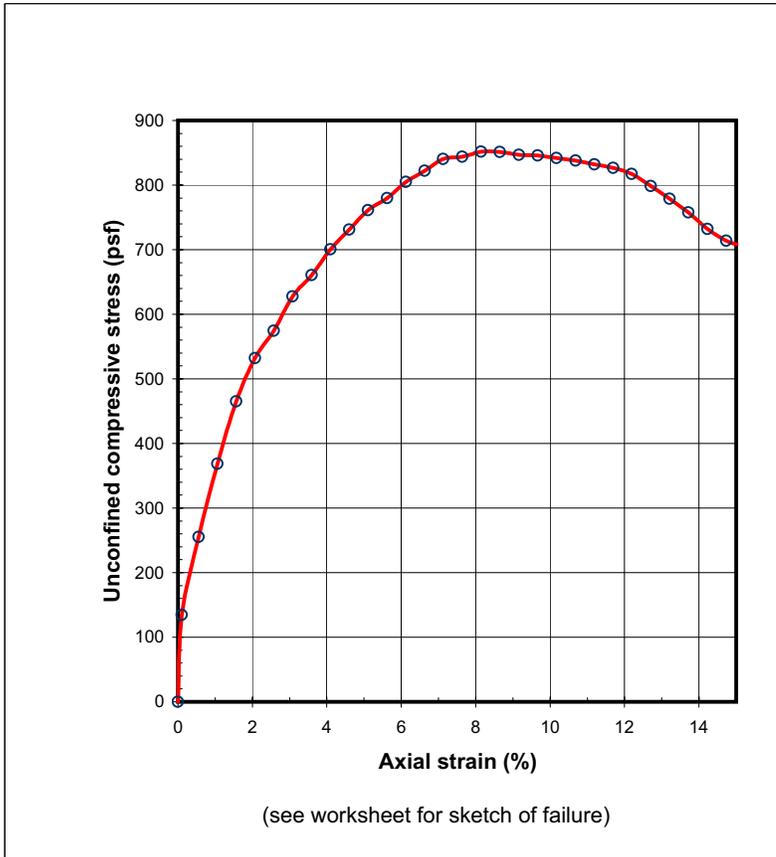
Test Report: Void ratio = 1.986  
 Ht/Dia ratio = 2.45  
 Moisture = 68.8 %  
 Total density = 95.3 pcf  
 Dry density = 56.4 pcf  
 Saturation = 93.6 %  
 Unconfined compressive strength = 852 psf  
 Shear strength = 426 psf  
 Strain @ failure = 8.15 %

**UNCONFINED COMPRESSION TEST - U<sub>c</sub>**  
**ASTM D-2166**

Client : URS  
 Project : Napa Salt Marsh Restoration Project  
 Job No. : 26815678.00100  
 Boring # : B-1-3  
 Sample # : 3  
 Depth (ft) : 11-11.5  
 Date tested : 12/03/06

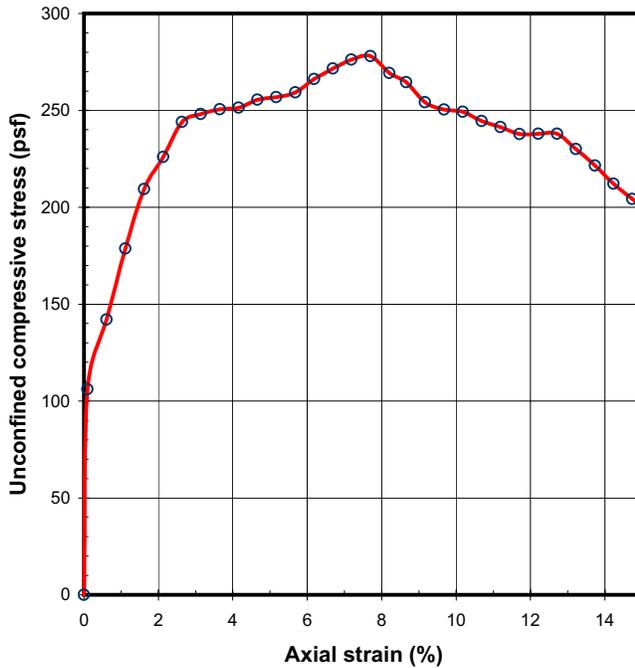
Test Report: Void ratio = 2.452  
 Ht/Dia ratio = 2.49  
 Moisture = 85.6 %  
 Total density = 90.6 pcf  
 Dry density = 48.8 pcf  
 Saturation = 94.3 %  
 Unconfined compressive strength = 278 psf  
 Shear strength = 139 psf  
 Strain @ failure = 7.70 %

(see worksheet for sketch of failure)

**UNCONFINED COMPRESSION TEST - U<sub>c</sub>**  
**ASTM D-2166**

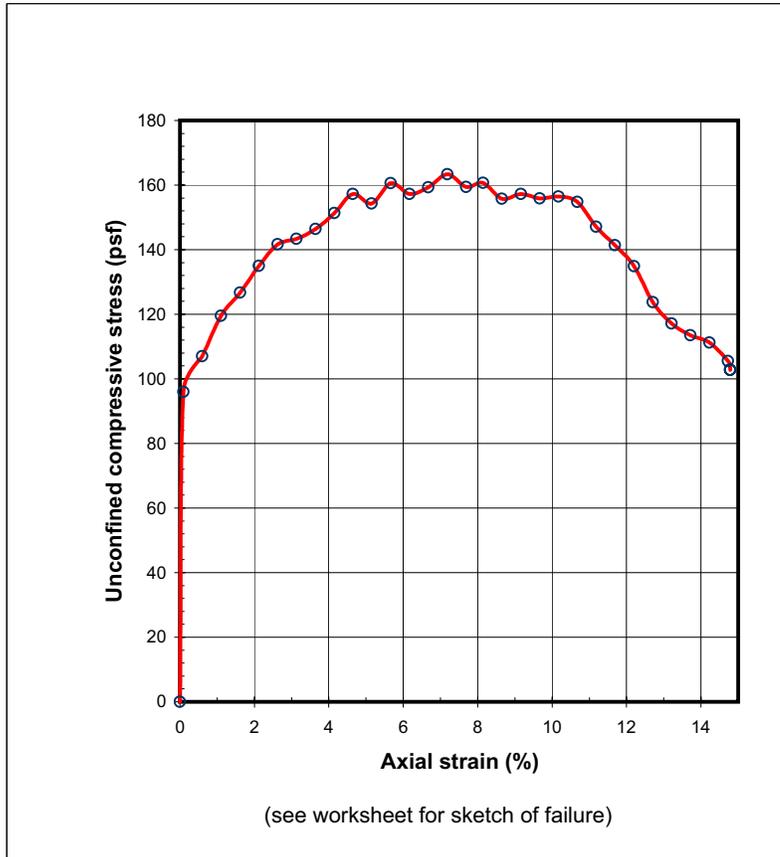
Test Report: Void ratio = 2.874  
 Ht/Dia ratio = 2.37  
 Moisture = 105.5 %  
 Total density = 89.4 pcf  
 Dry density = 43.5 pcf  
 Saturation = 99.1 %  
 Unconfined compressive strength = 163 psf  
 Shear strength = 82 psf  
 Strain @ failure = 7.18 %

**UNCONFINED COMPRESSION TEST - U<sub>c</sub>**  
**ASTM D-2166**

Client : URS  
 Project : Napa Salt Marsh Restoration Project  
 Job No. : 26815678.00100  
 Boring # : B-1-5  
 Sample # : 3  
 Depth (ft) : 21-21.5  
 Date tested : 12/03/06  
 Soil (Visual Description) : Undisturbed dark olive gray clay

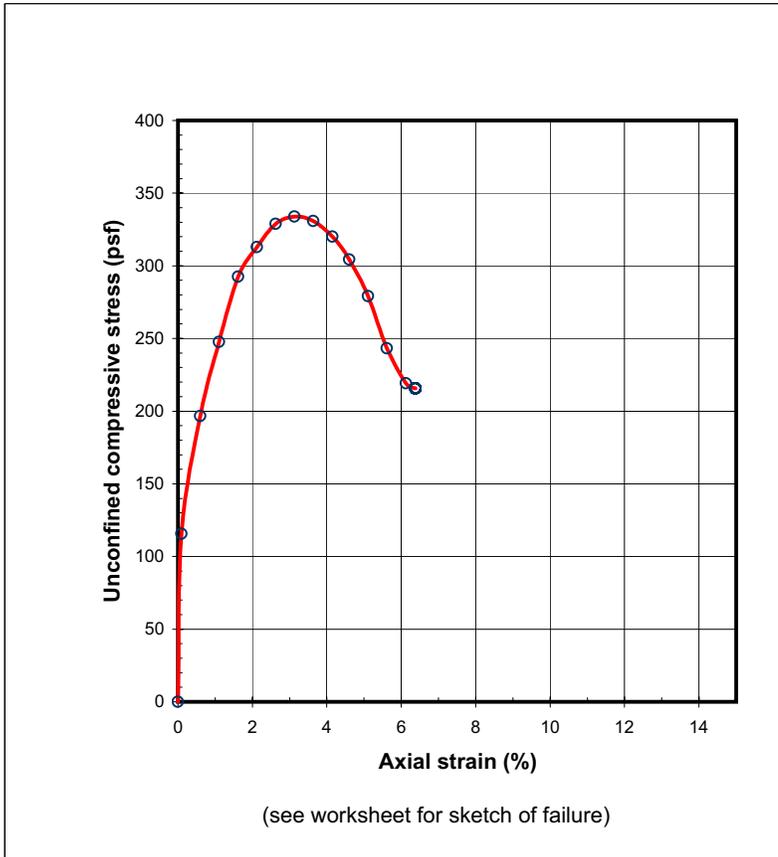
Test Report: Void ratio = 3.177  
 Ht/Dia ratio = 2.47  
 Moisture = 115.2 %  
 Total density = 86.8 pcf  
 Dry density = 40.3 pcf  
 Saturation = 97.9 %  
 Unconfined compressive strength = 334 psf  
 Shear strength = 167 psf  
 Strain @ failure = 3.13 %

**UNCONFINED COMPRESSION TEST - U<sub>c</sub>**  
**ASTM D-2166**

Client : URS  
 Project : Napa Salt Marsh Restoration Project  
 Job No. : 26815678.00100  
 Boring # : B-1-6  
 Sample # : 3  
 Depth (ft) : 26-26.5  
 Date tested : 12/03/06

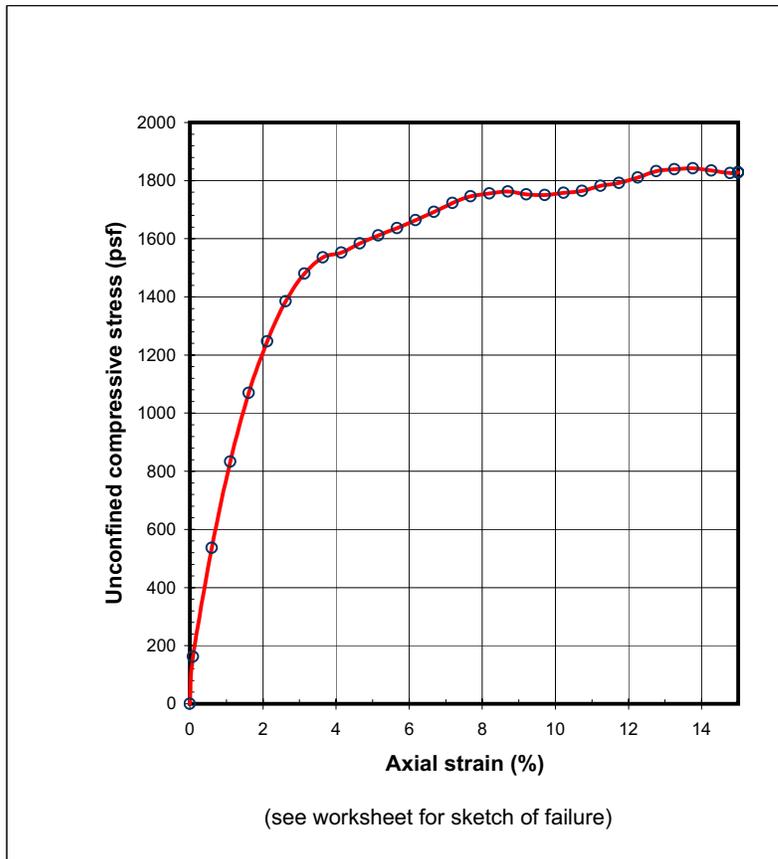
Test Report: Void ratio = 0.752  
 Ht/Dia ratio = 2.50  
 Moisture = 27.6 %  
 Total density = 122.7 pcf  
 Dry density = 96.2 pcf  
 Saturation = 99.1 %  
 Unconfined compressive strength = 1755 psf  
 Shear strength = 878 psf  
 Strain @ failure = 10.00 %

**UNCONFINED COMPRESSION TEST - U<sub>c</sub>**  
**ASTM D-2166**

Client : URS  
 Project : Napa Salt Marsh Restoration Project  
 Job No. : 26815678.00100  
 Boring # : B-1-7  
 Sample # : 3  
 Depth (ft) : 29.5-30  
 Date tested : 12/03/06  
 Soil (Visual Description) : Undisturbed brown clay

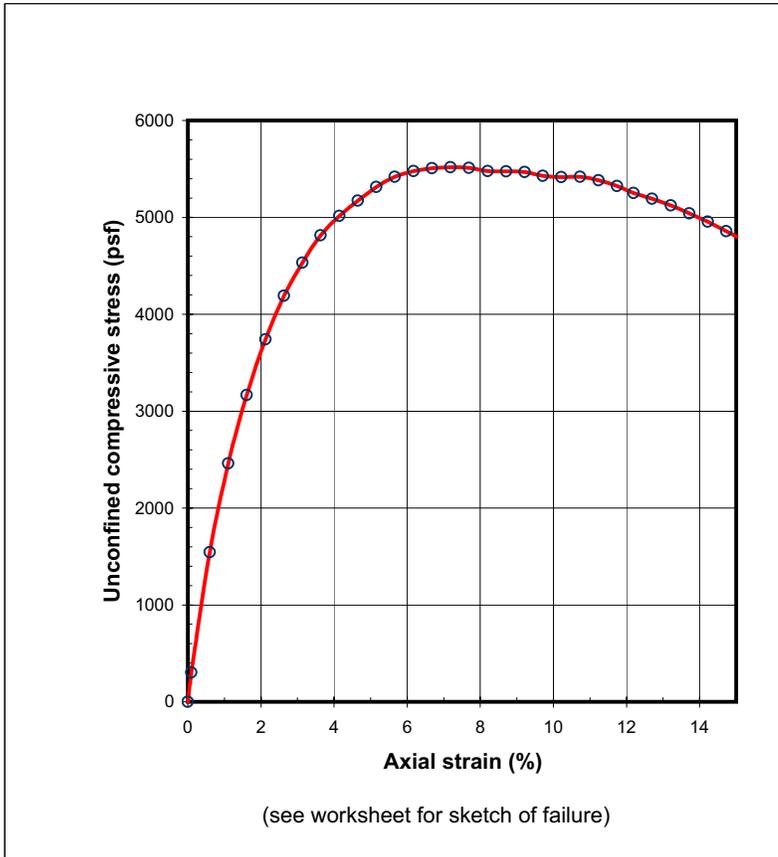
Test Report: Void ratio = 0.683  
 Ht/Dia ratio = 2.45  
 Moisture = 24.6 %  
 Total density = 124.7 pcf  
 Dry density = 100.1 pcf  
 Saturation = 97.0 %  
 Unconfined compressive strength = 5516 psf  
 Shear strength = 2758 psf  
 Strain @ failure = 7.19 %

**UNCONFINED COMPRESSION TEST - U<sub>c</sub>**  
**ASTM D-2166**

Client : URS  
 Project : Napa Salt Marsh Restoration Project  
 Job No. : 26815678.00100  
 Boring # : B-3  
 Sample # : 2  
 Depth (ft) : 2.5-3  
 Date tested : 07/07/07

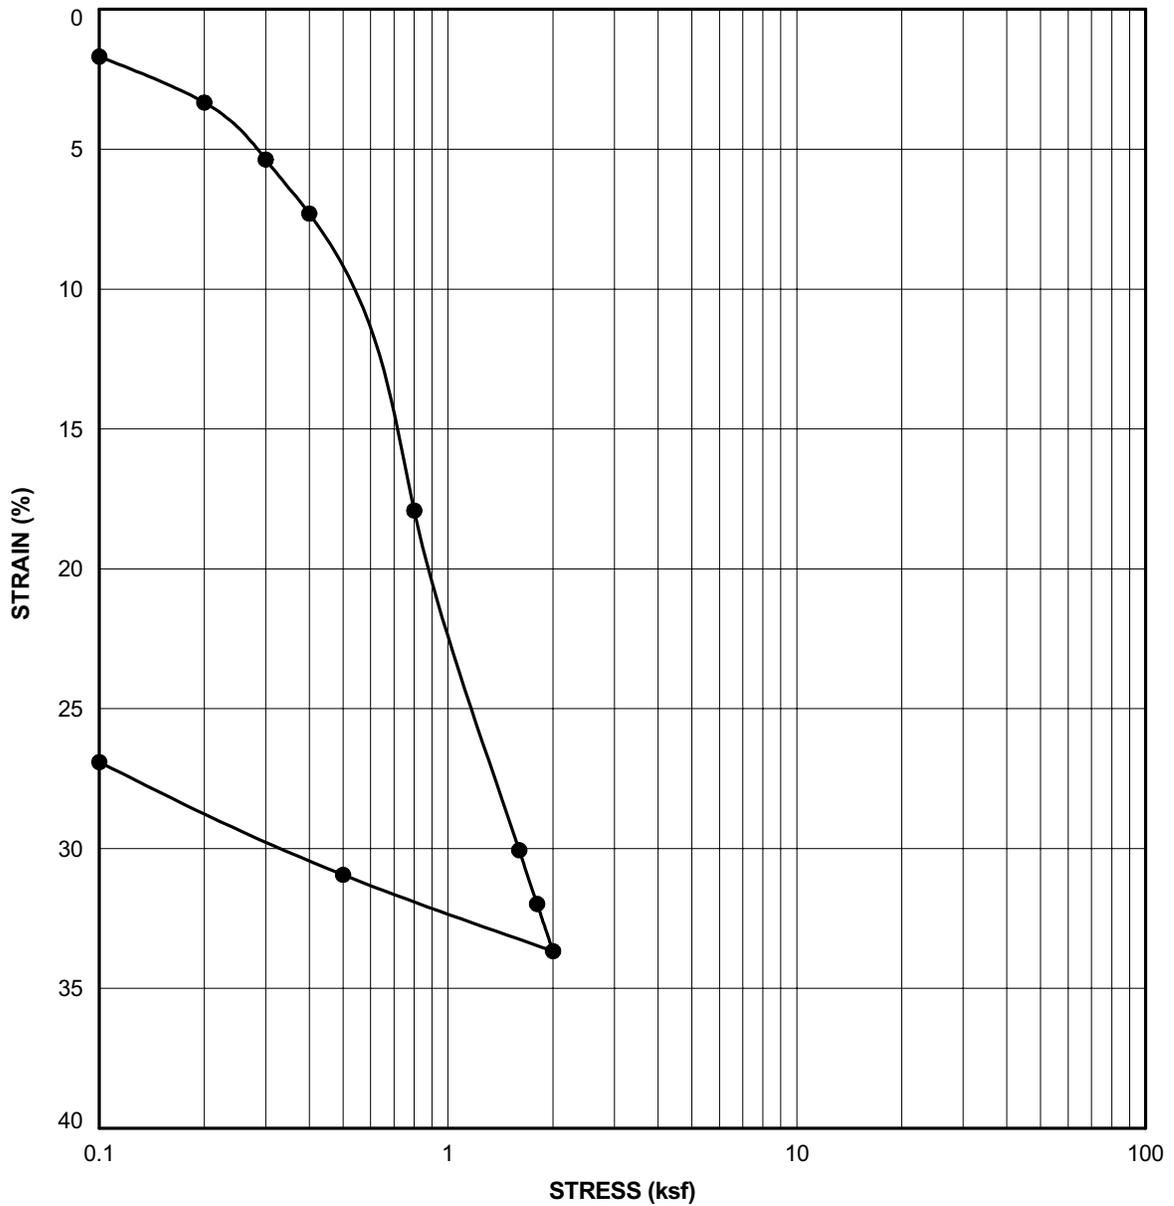
**Boring B-4 Sample No. 4-5 15-17 ft**

Description	Liquid Limit	Plasticity Index	Specific Gravity	Diameter (inches)
Clayey Silt (MH)	112	66	2.70 *	2.420

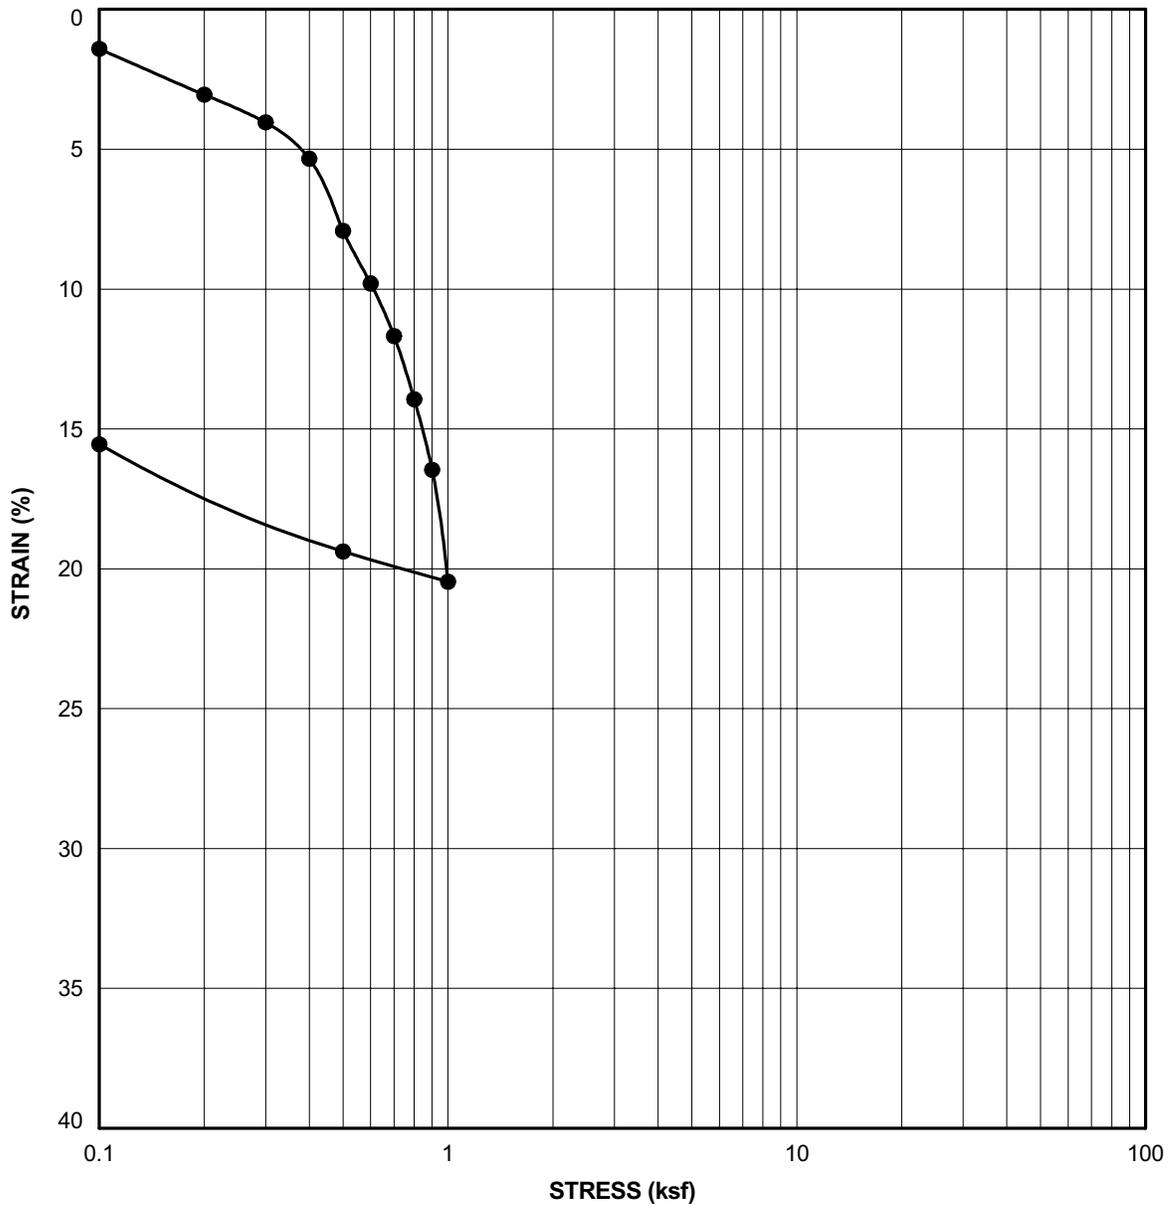
**Boring B-4 Sample No. 4-5 15-17 ft**

Description	Liquid Limit	Plasticity Index	Specific Gravity	Diameter (inches)
Clayey Silt (MH)			2.70 *	2.420
