**RUSSIAN RIVER ESTUARY OUTLET CHANNEL
ADAPTIVE MANAGEMENT PLAN
2013**

Sonoma County Water Agency

ESA PWA

May 14, 2013

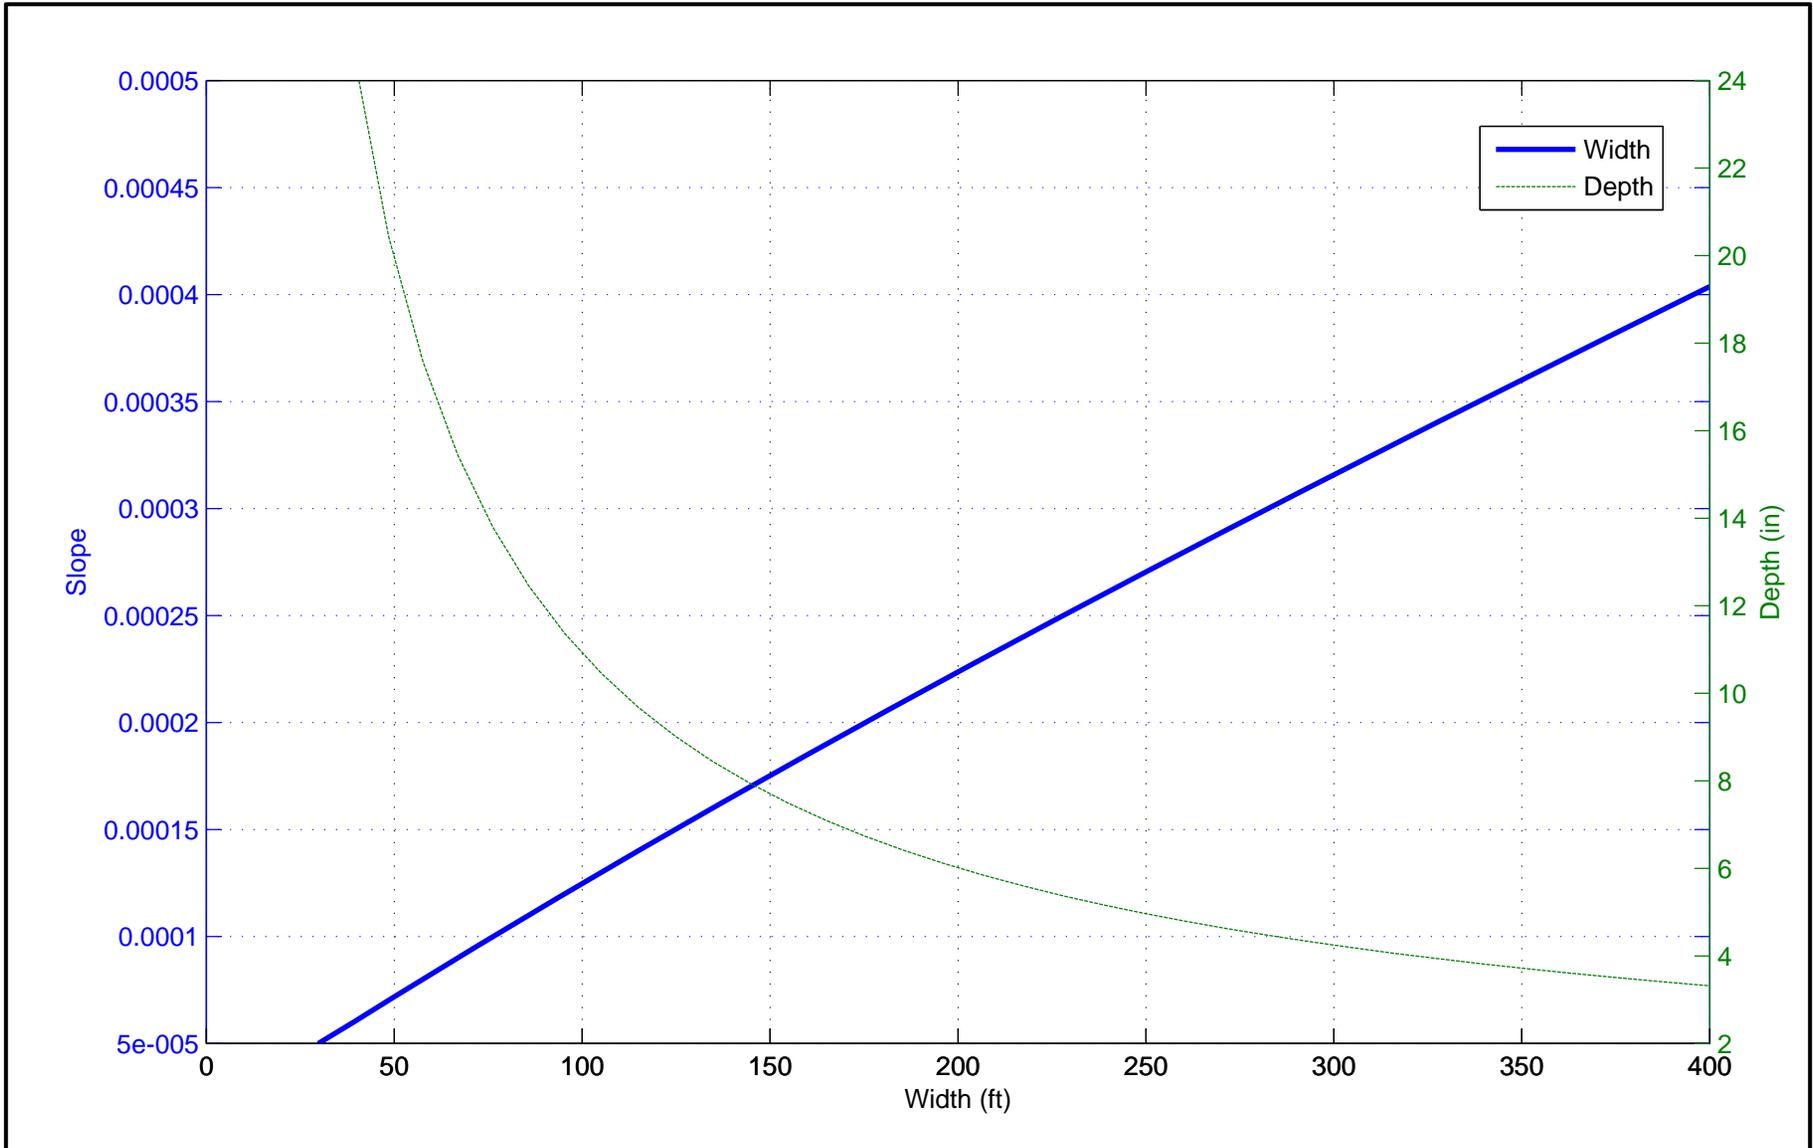
Figure 6
Russian River Estuary Outlet Channel Management Plan

Source: Stability curve for local bed shear stress of 0.5 Pa, flowrate of 70 cfs, and Manning's roughness of 0.02.

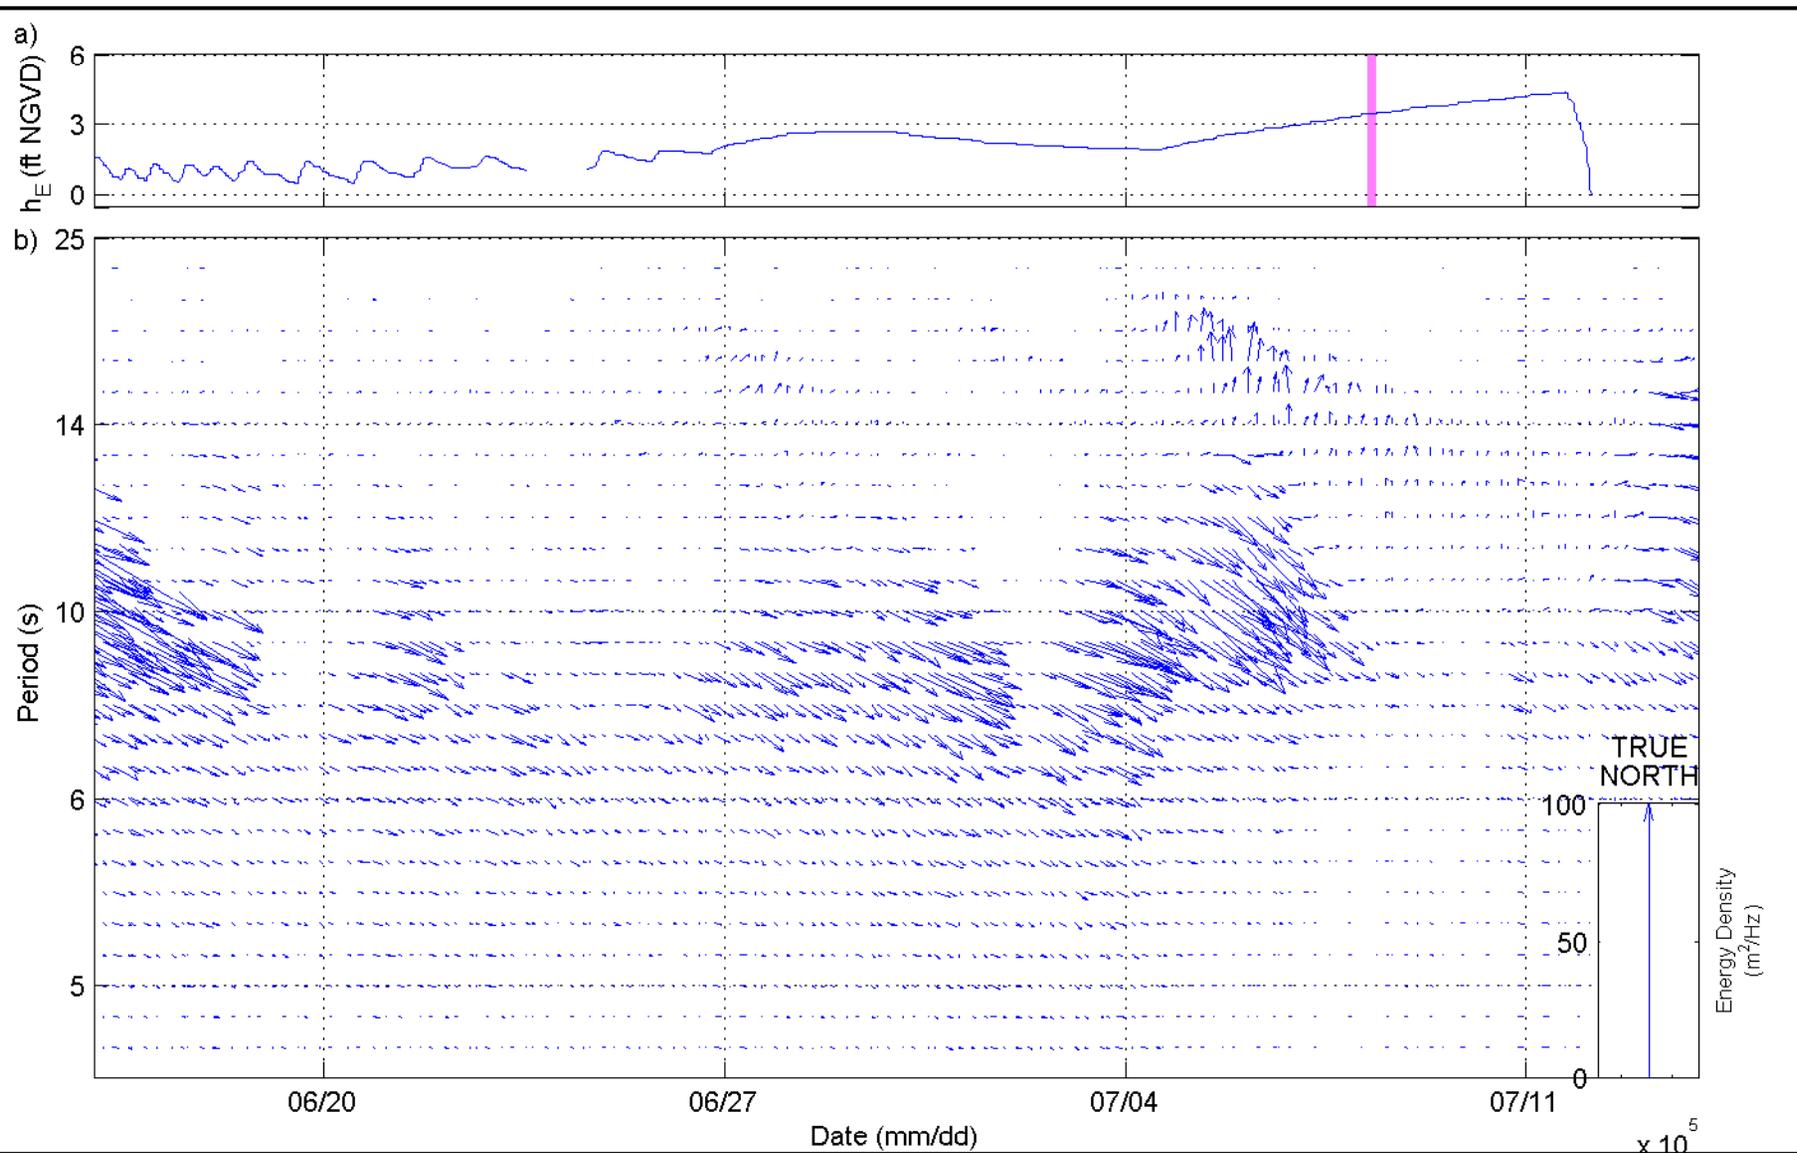
Sources:
 a) h_E = estuary water level (SCWA); pink bar = mmgt action
 b) Wave magnitude and direction (CDIP, Pt. Reyes, #029)

Figure 3
 Russian River Estuary Outlet Channel Management Plan
 Estuary Water Level and Wave Energy/Direction Spectrum
 JUNE-JULY 2010

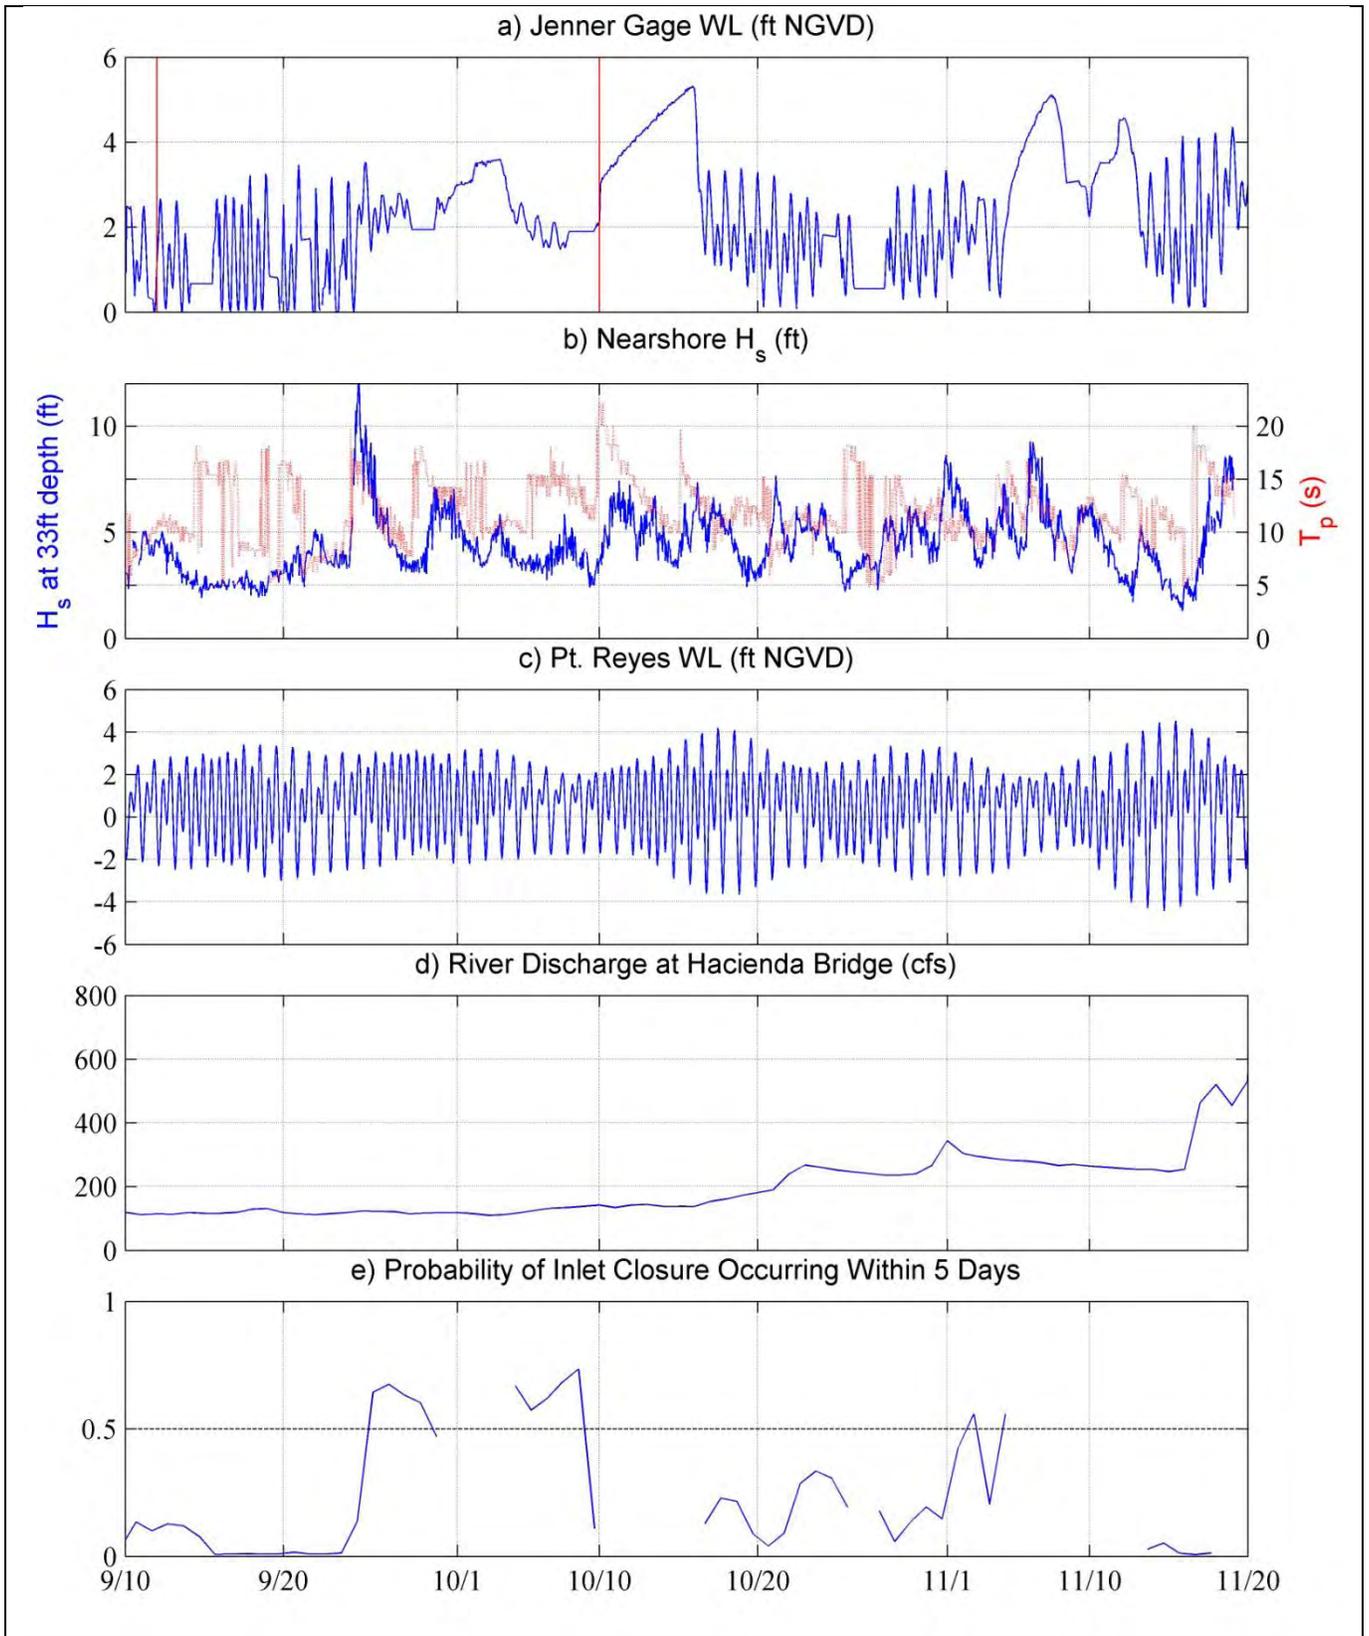
Figure 3
 Estuary, Ocean, and River Conditions Compared
 with Closure Probability:
 September 10 – November 20, 2012

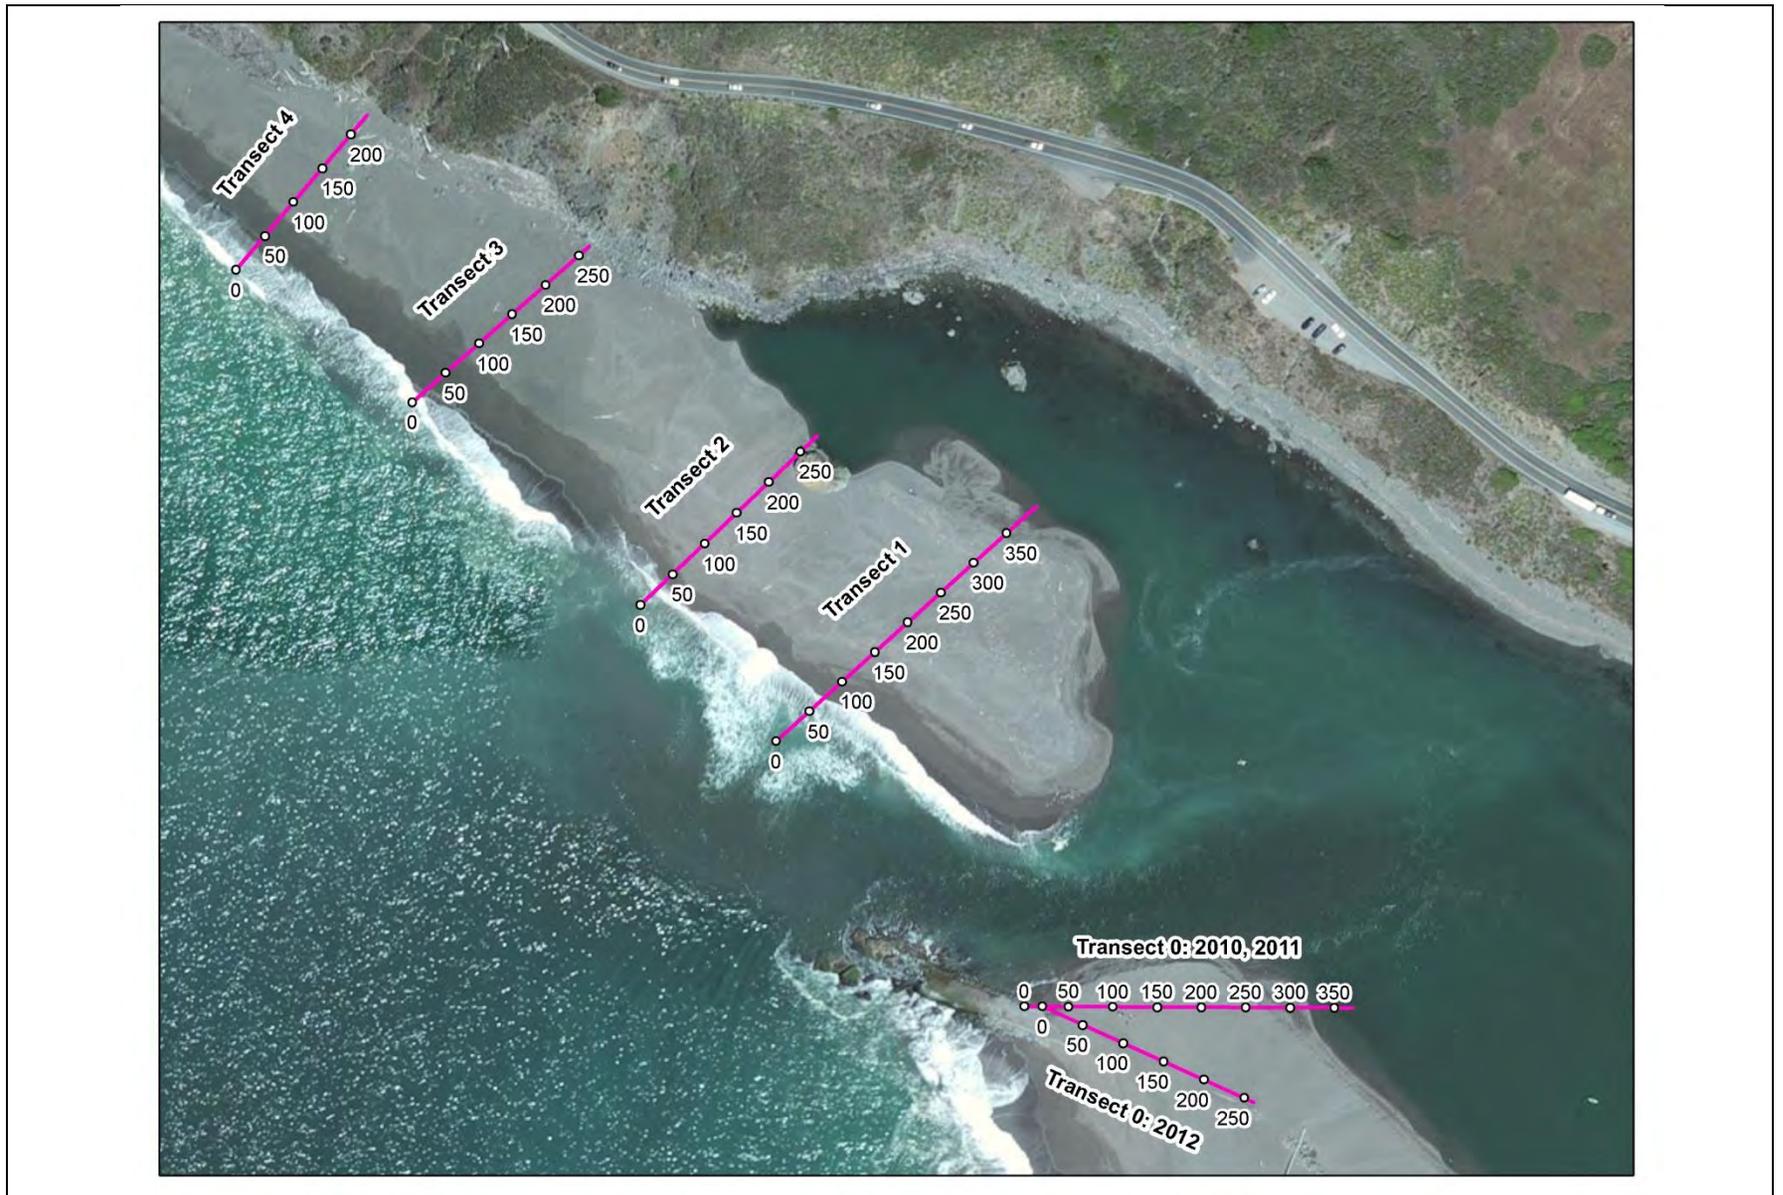
Figure 6
Beach Transect Locations

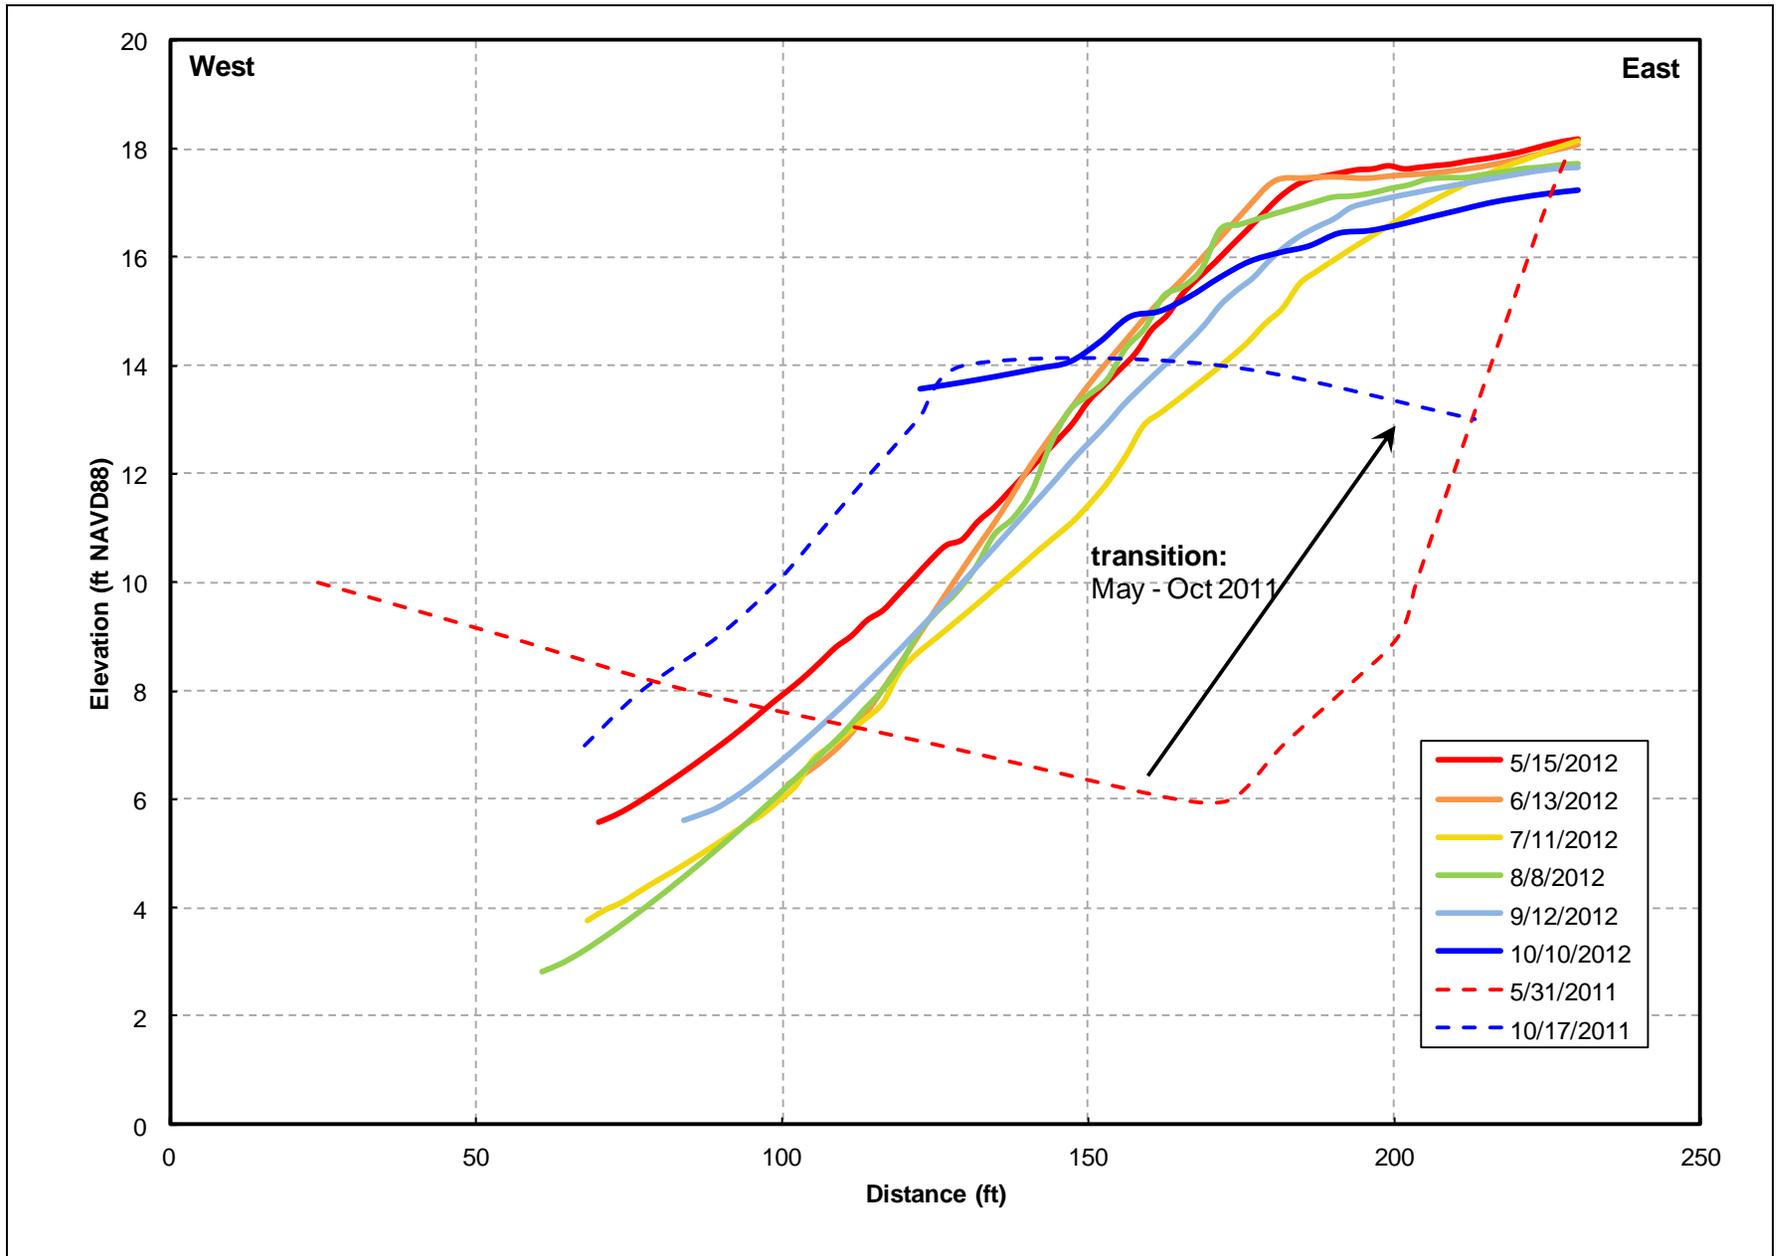
Figure 7
Beach Transect 4

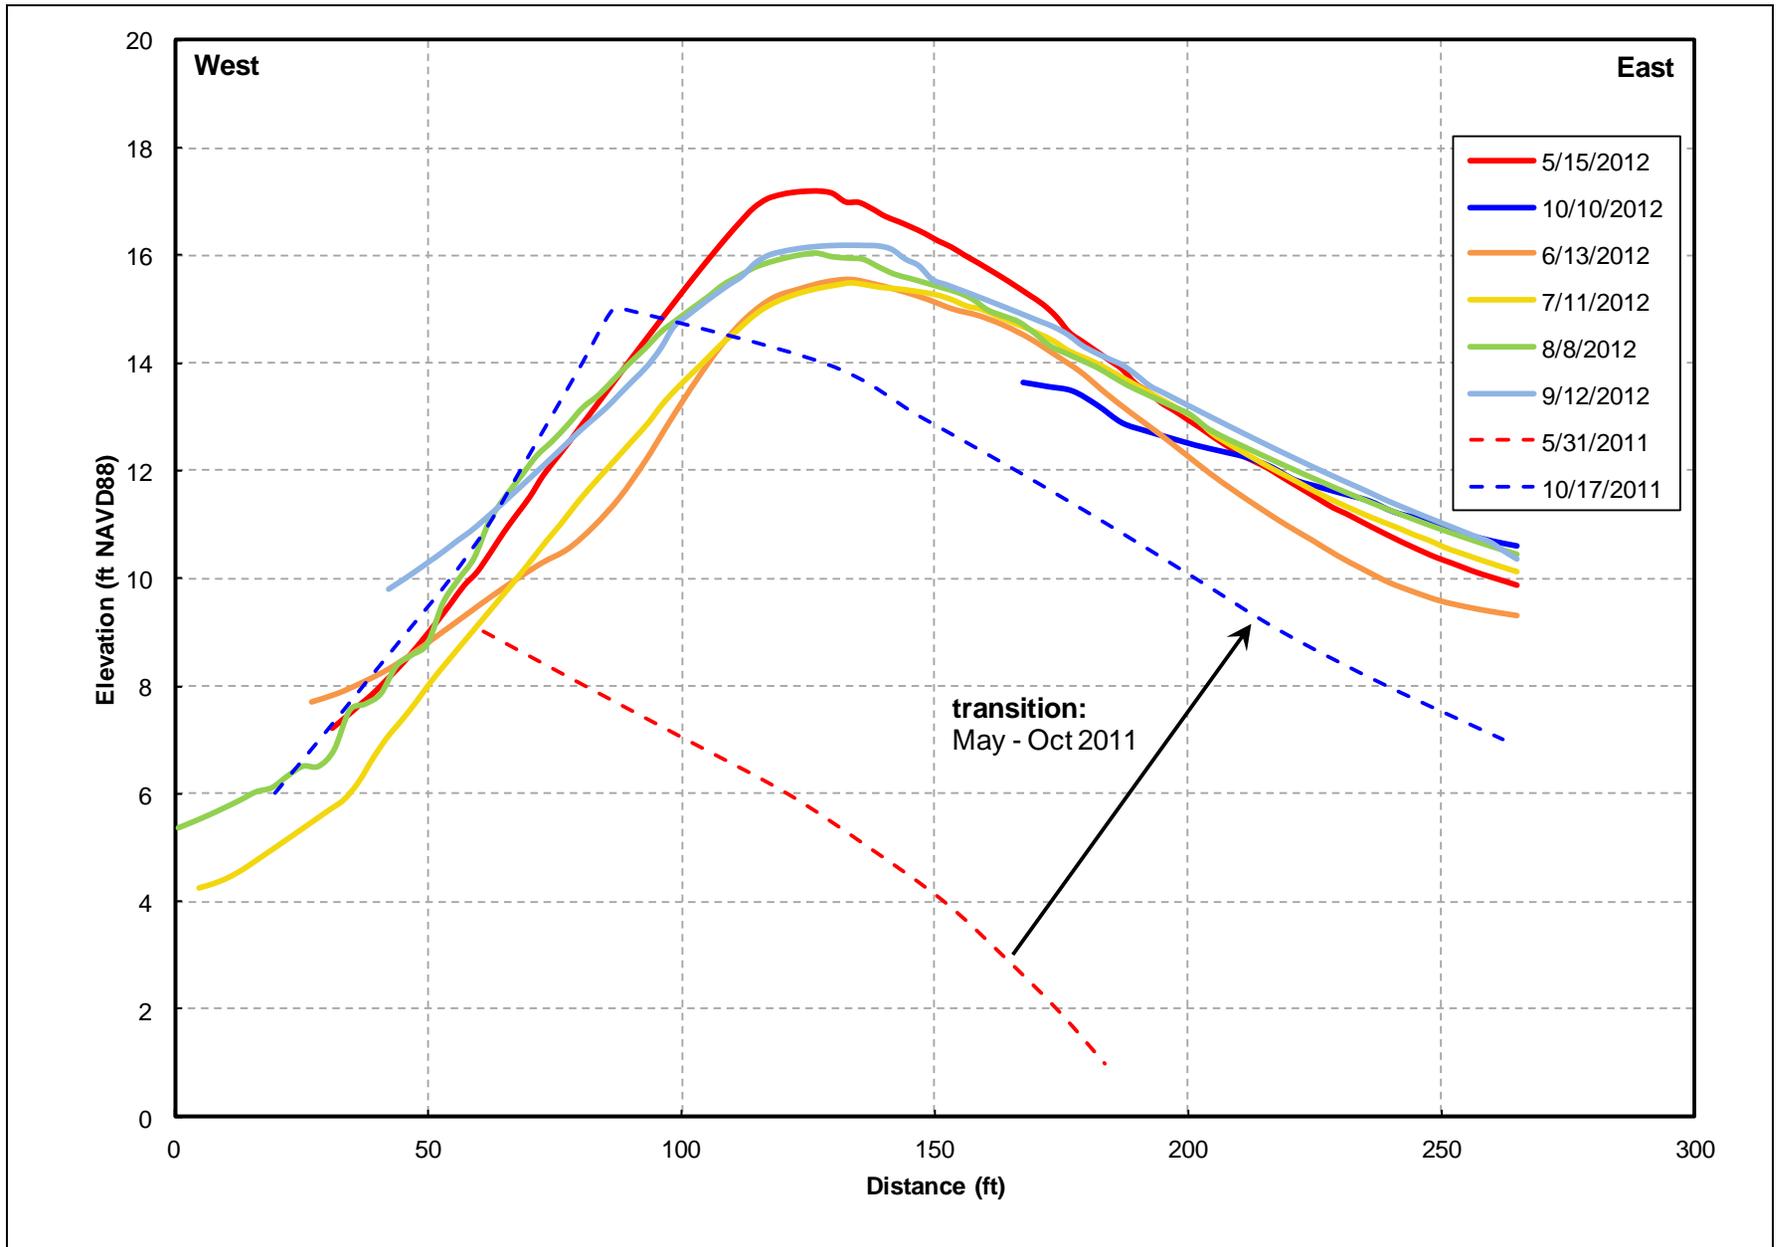
Figure 8
Beach Transect 3

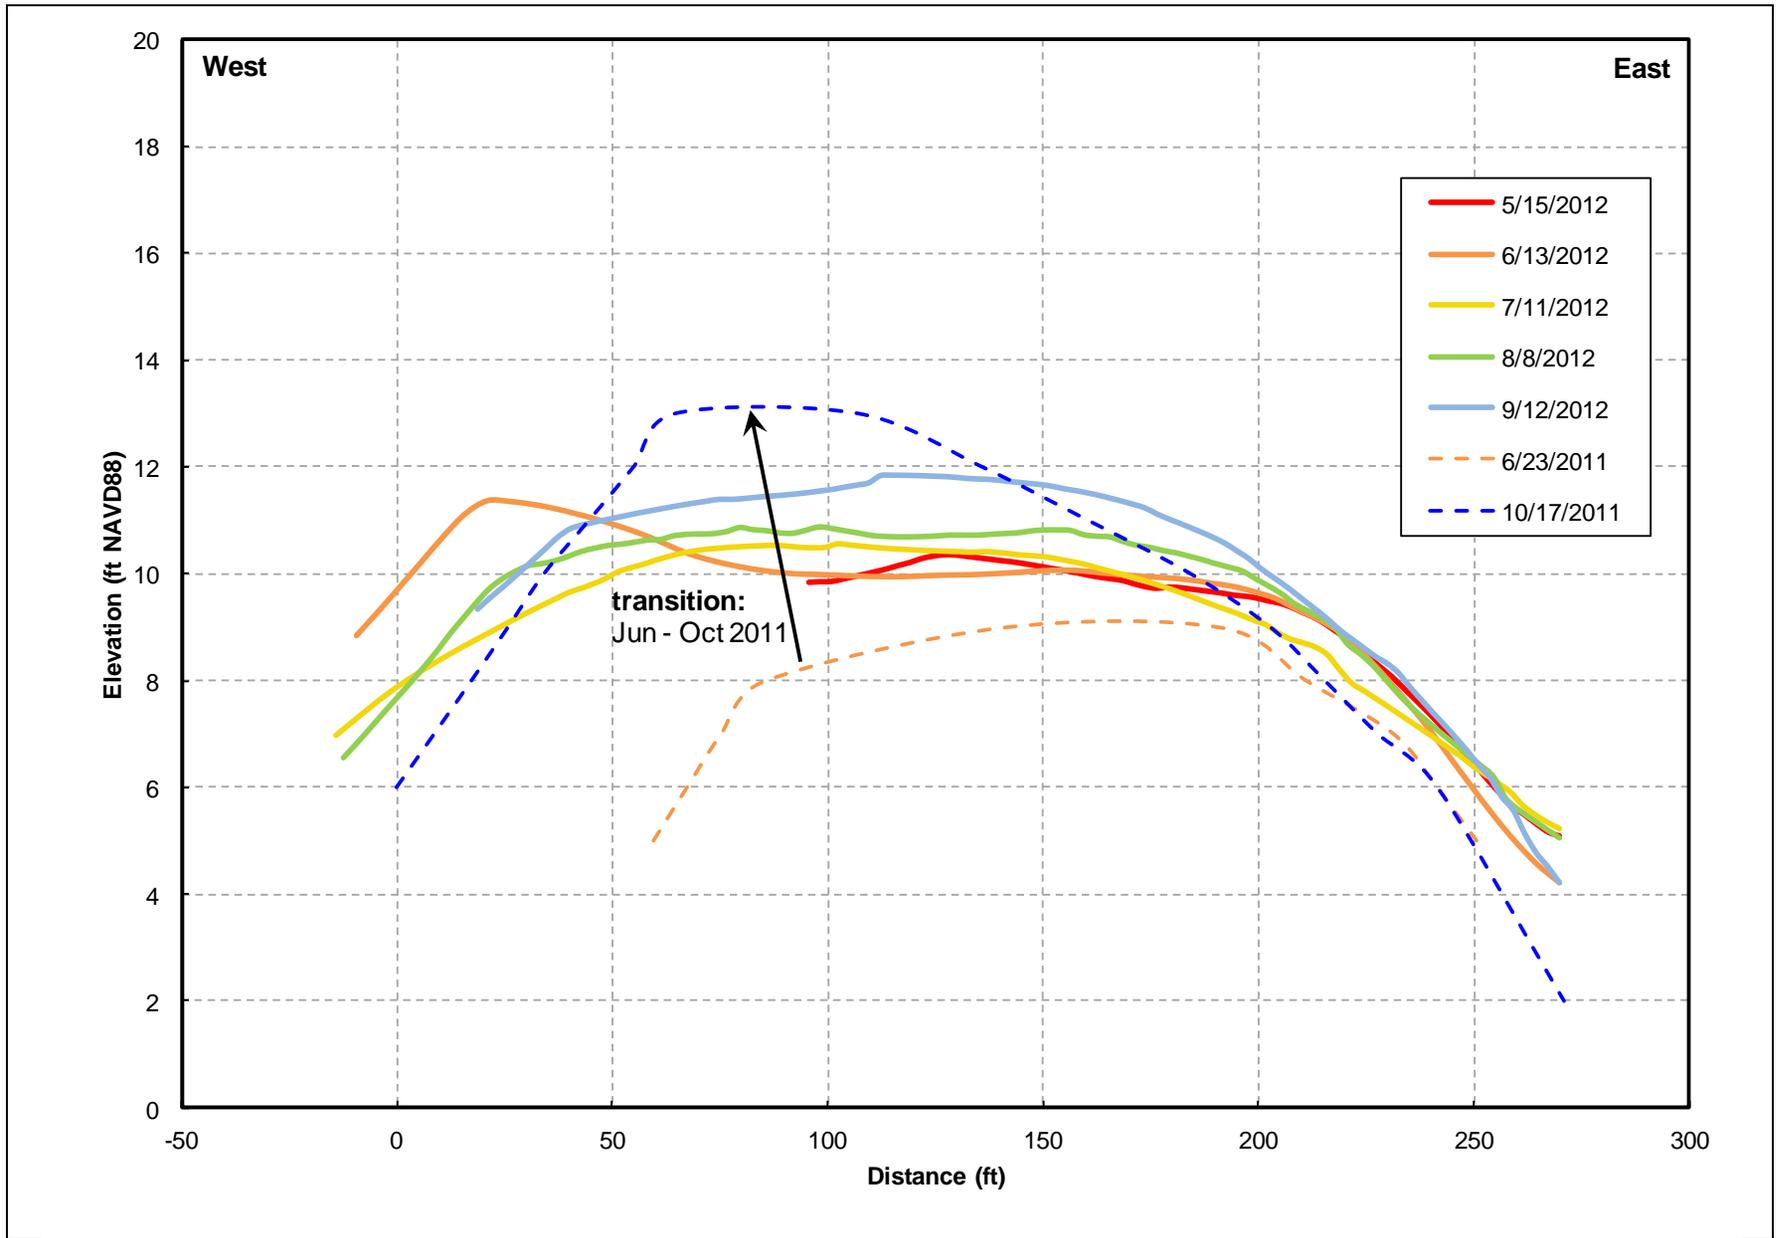
Figure 9
Beach Transect 2

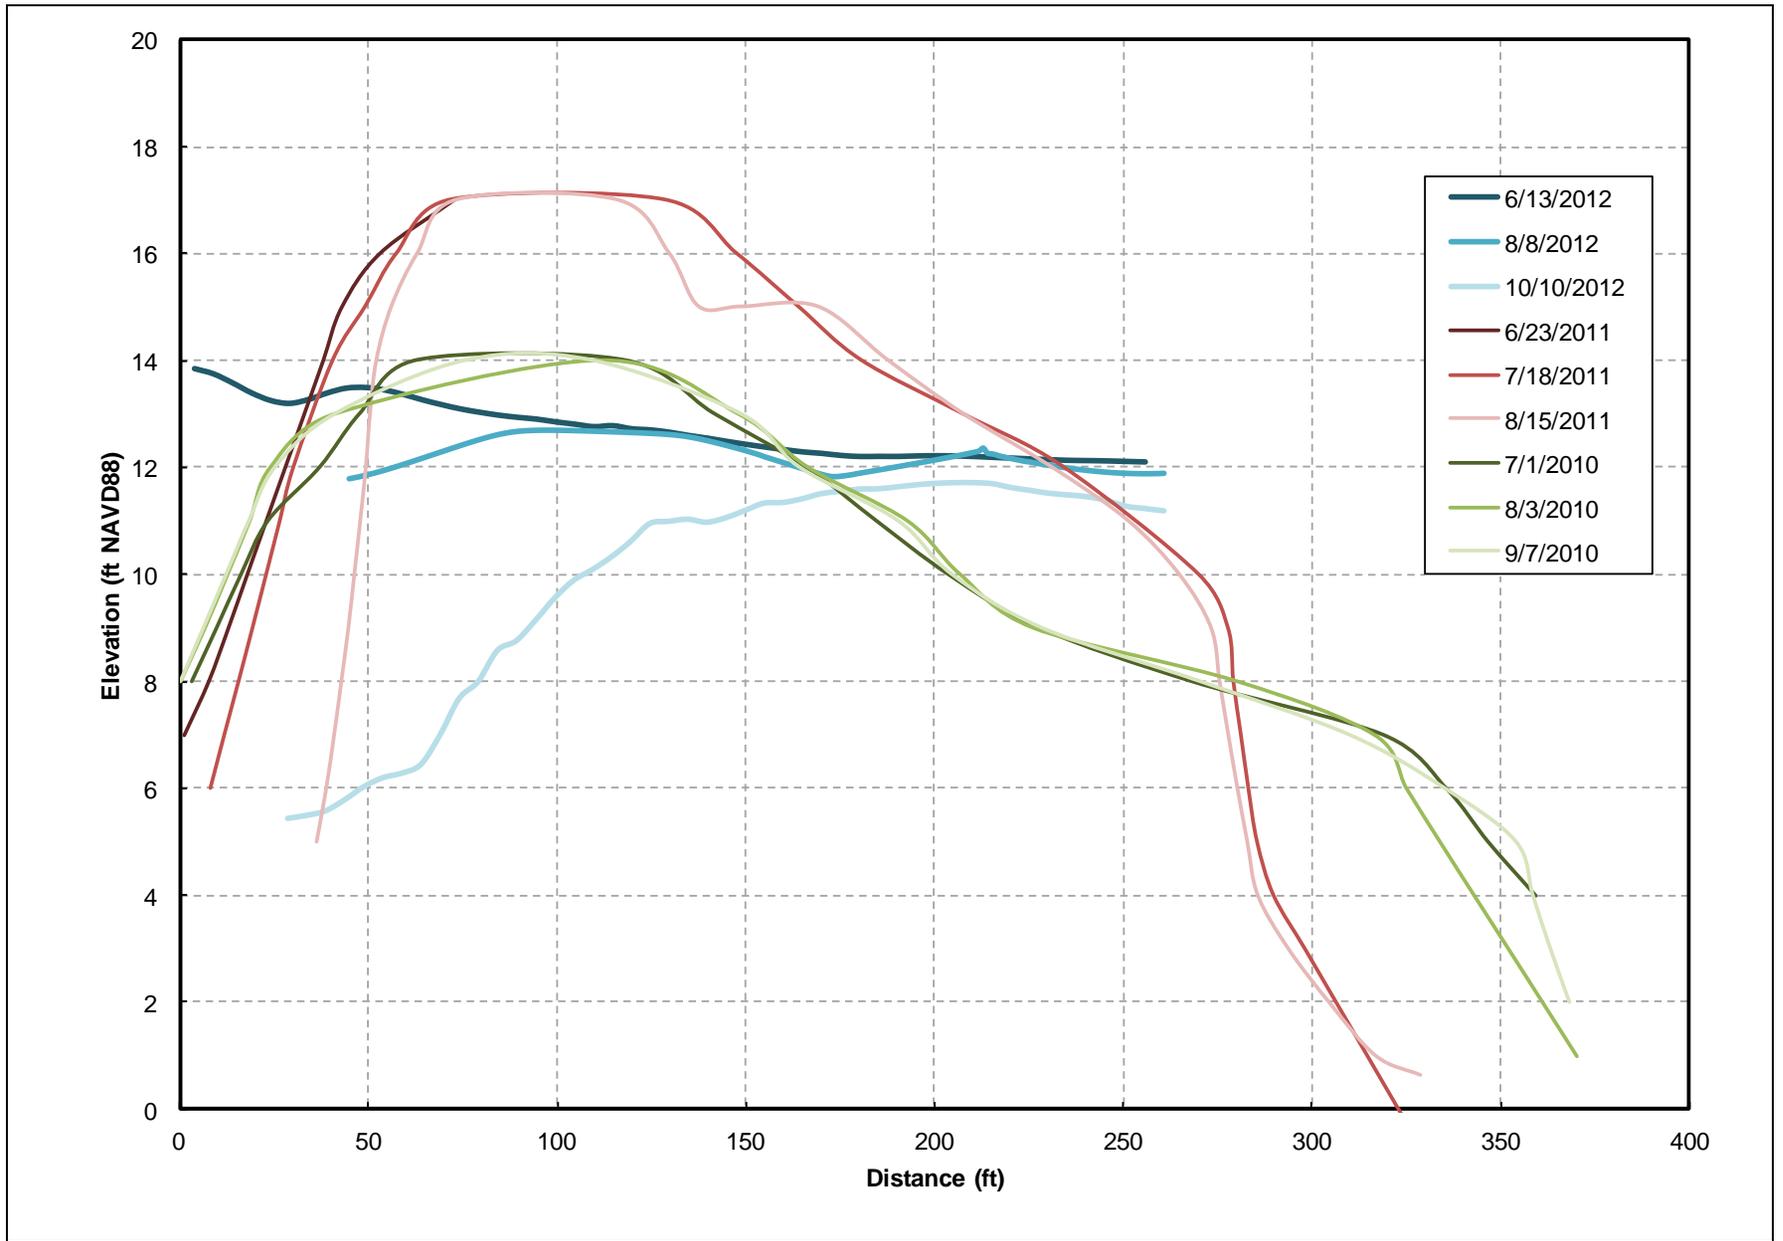
Figure 10
Beach Transect 0

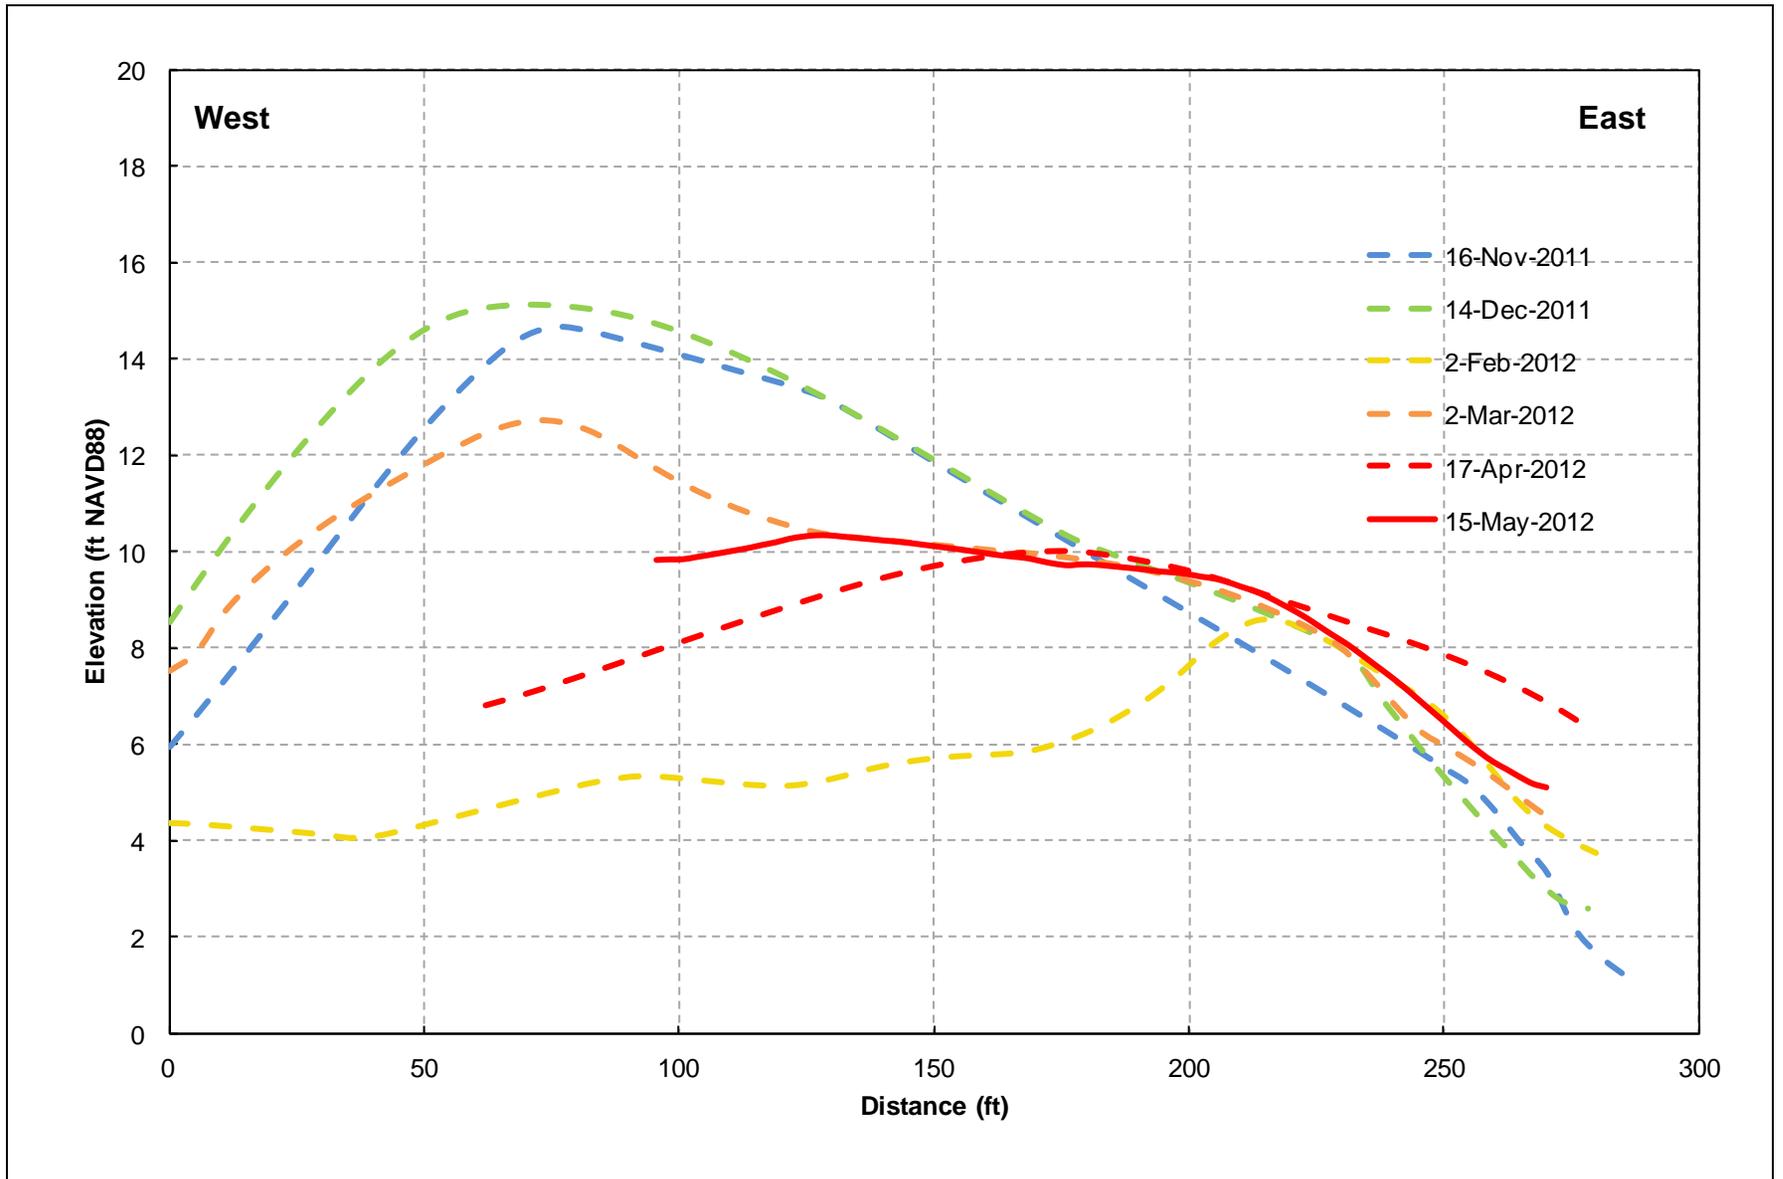
Figure 11
Nov 2011 to May 2012 topographic change at Beach Transect 2

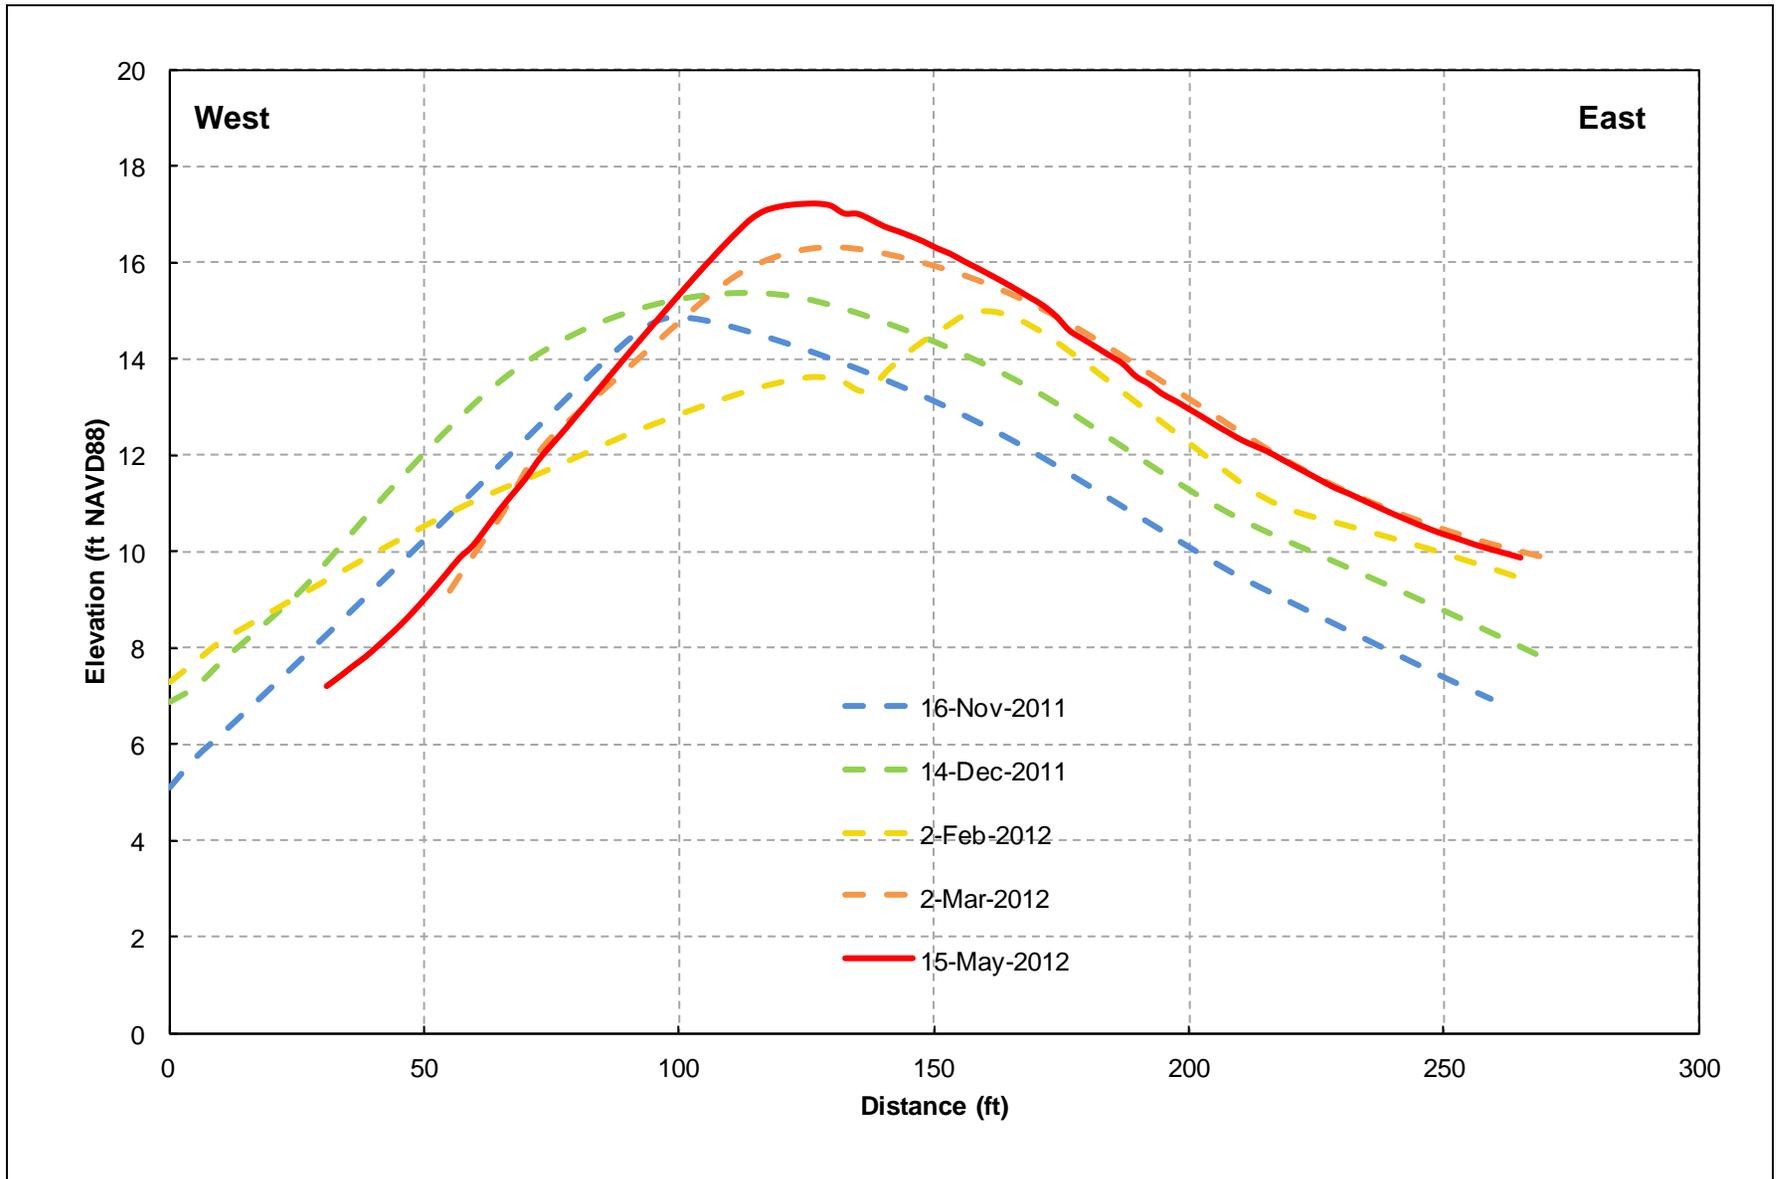
Figure 12
Nov 2011 to May 2012 topographic change at Beach Transect 3

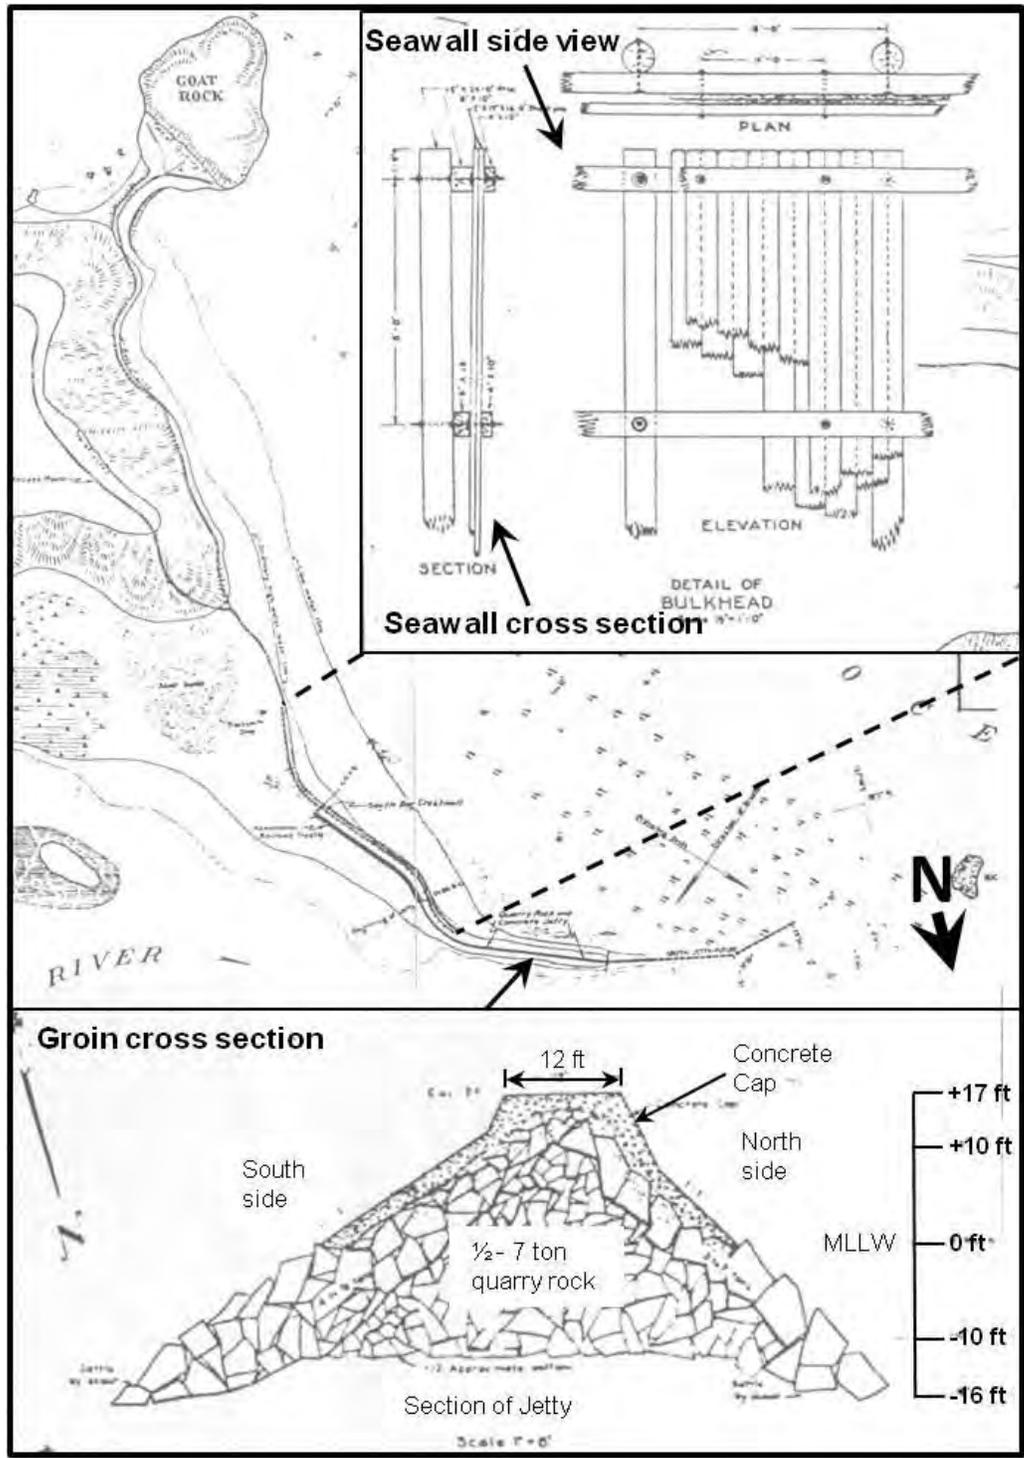
Figure 2-1
1938 planning document with detail of the seawall and groin cross section.
