**RUSSIAN RIVER ESTUARY OUTLET CHANNEL
ADAPTIVE MANAGEMENT PLAN
2013**

Sonoma County Water Agency

ESA PWA

May 14, 2013

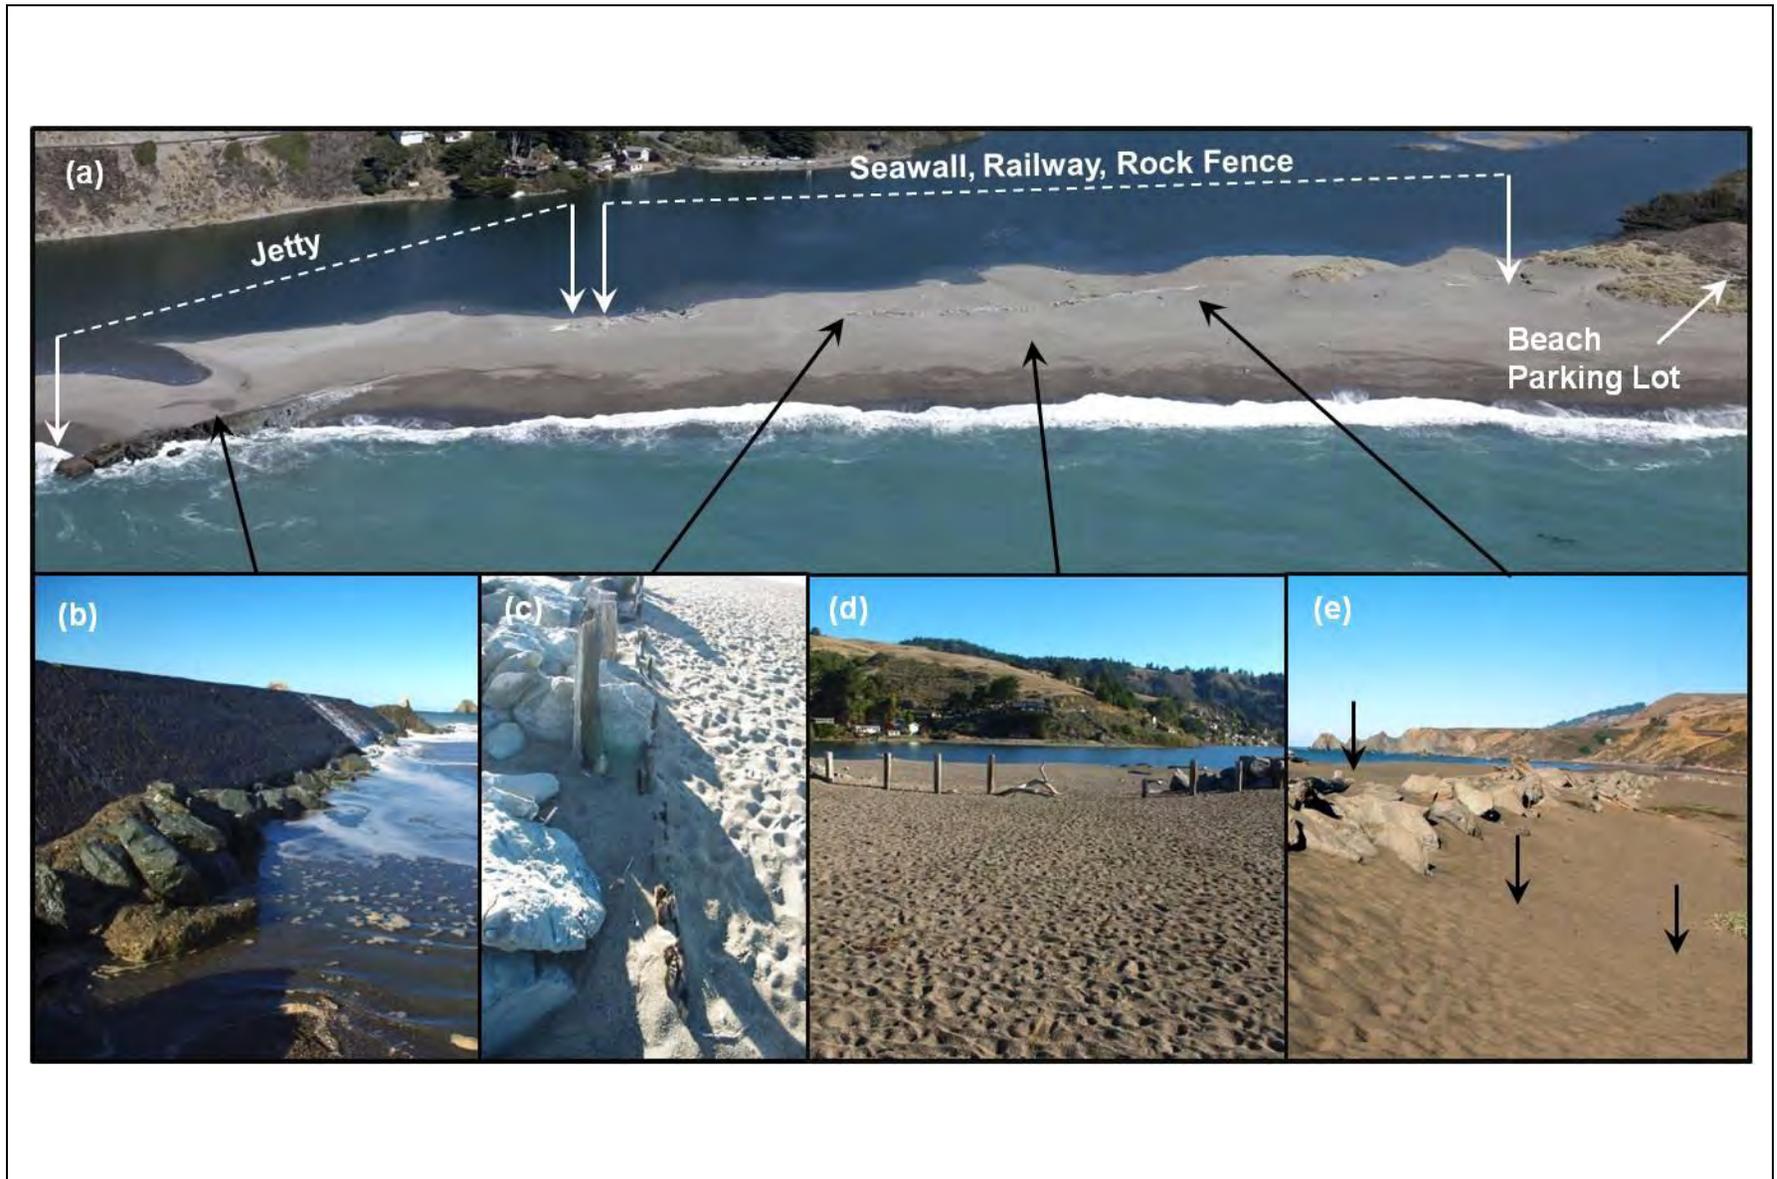
NOTE: Beach visitor parking lot located at far right edge of (a). (b) is a detail of the northern edge of the groin, showing the top of the armoring added in 1948. (c) shows the double-layer redwood sheets protruding through the beach. (d) is a wave washover fan where roadway, seawall and railway elements have been destroyed. In (e), note the difference in beach elevation at either end of remaining rock fence, indicating deposition of wave overwash on the ocean side.

Figure 2-4
Detail of the present-day jetty complex (a), with insets of (b) the groin structure, (c,d) seawall elements, and (e) the rock fence.

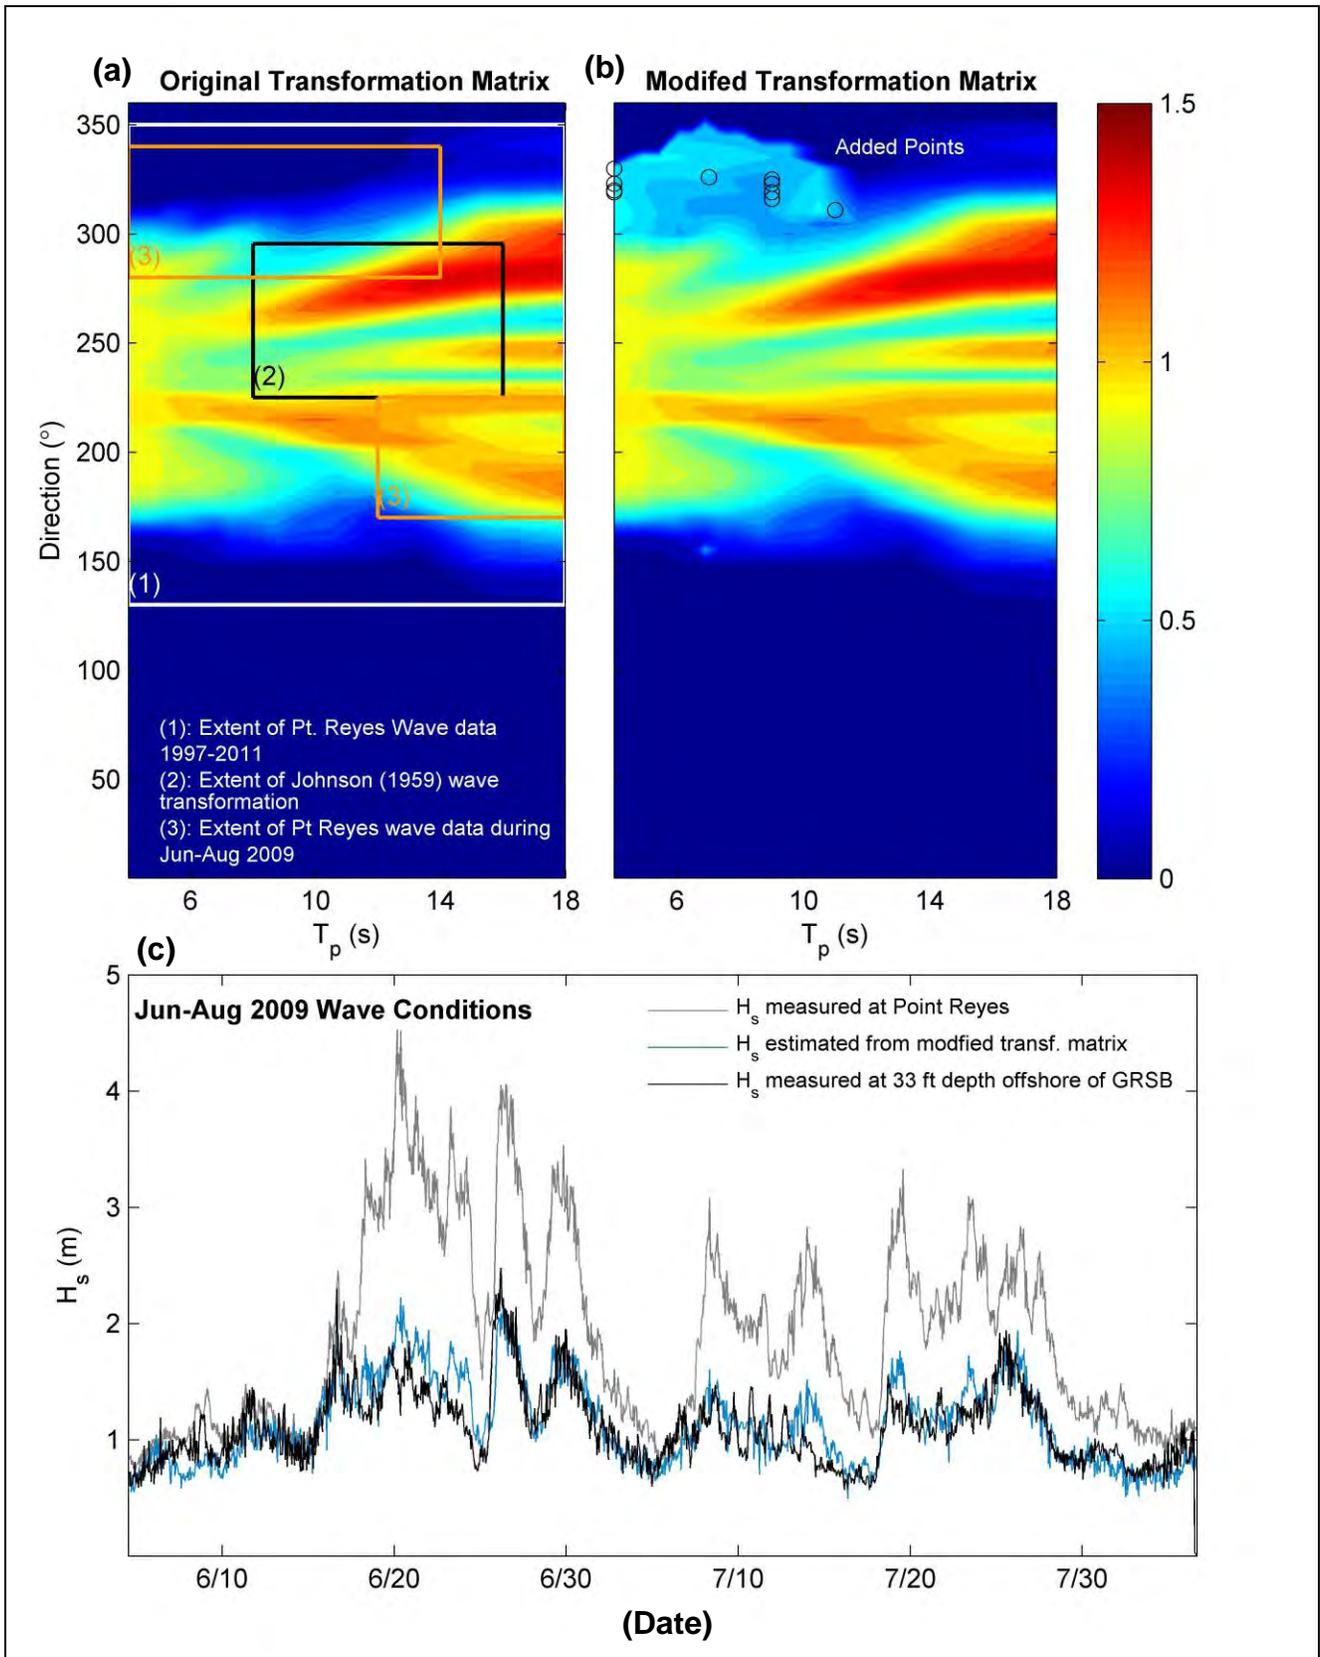
SOURCE: Original transformation matrix (a) obtained from W. O'Reilly of CDIP. Modifications to transformation matrix (b) made using BML wave measurements near GRSB.

Figure 4-3
 (a,b) Wave transformation matrices used to obtain nearshore wave estimates and (c) Summer 2009 wave conditions

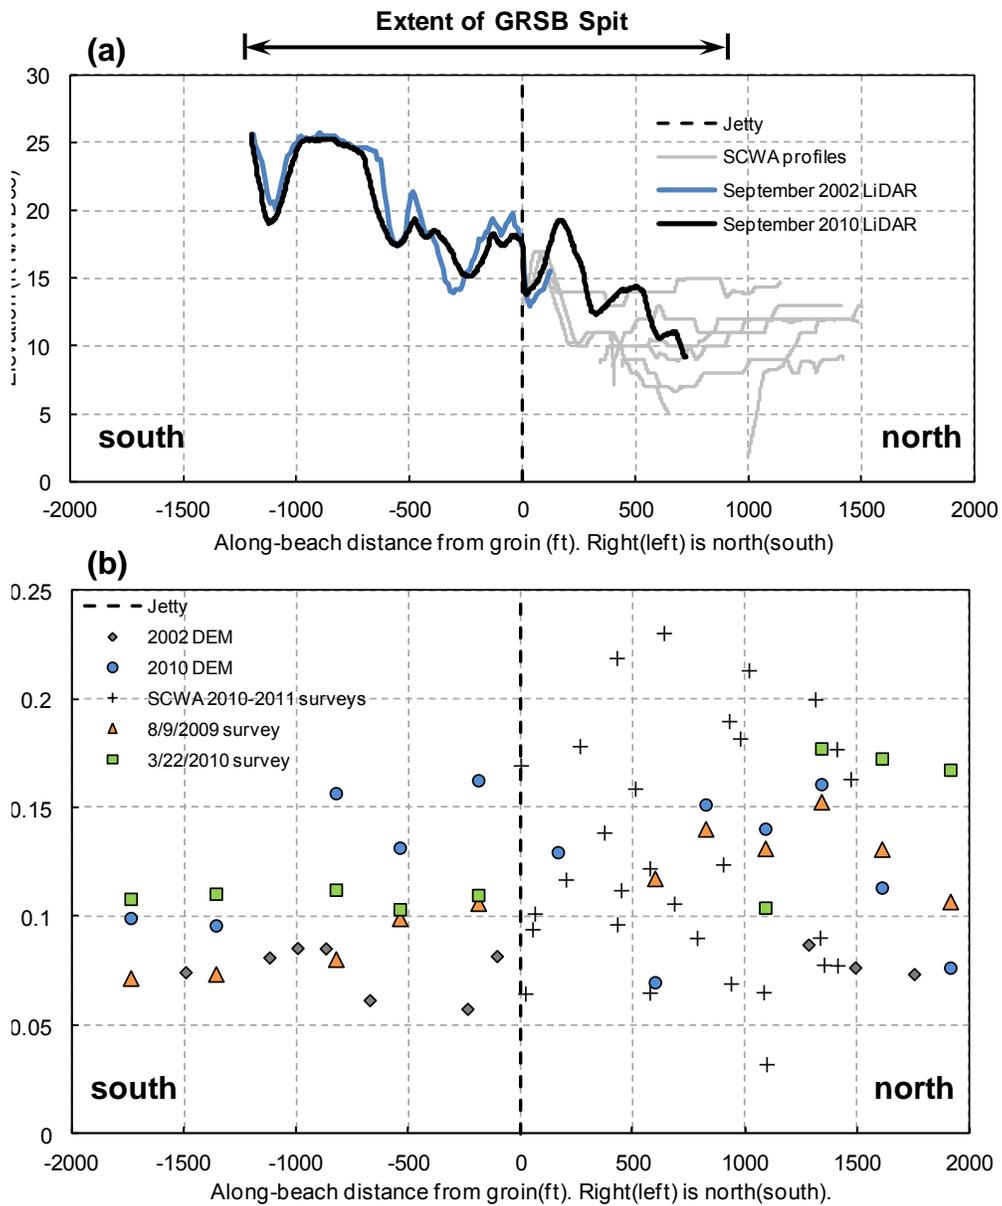
NOTE: Dashed line represents the point on GRSB where the seaward endpiece of the jetty groin is located. Beach slope was measured between MHHW and MSL.

Figure 4-4
(a) Along-beach crest profile of GRSB and (b)
foreshore beach slope

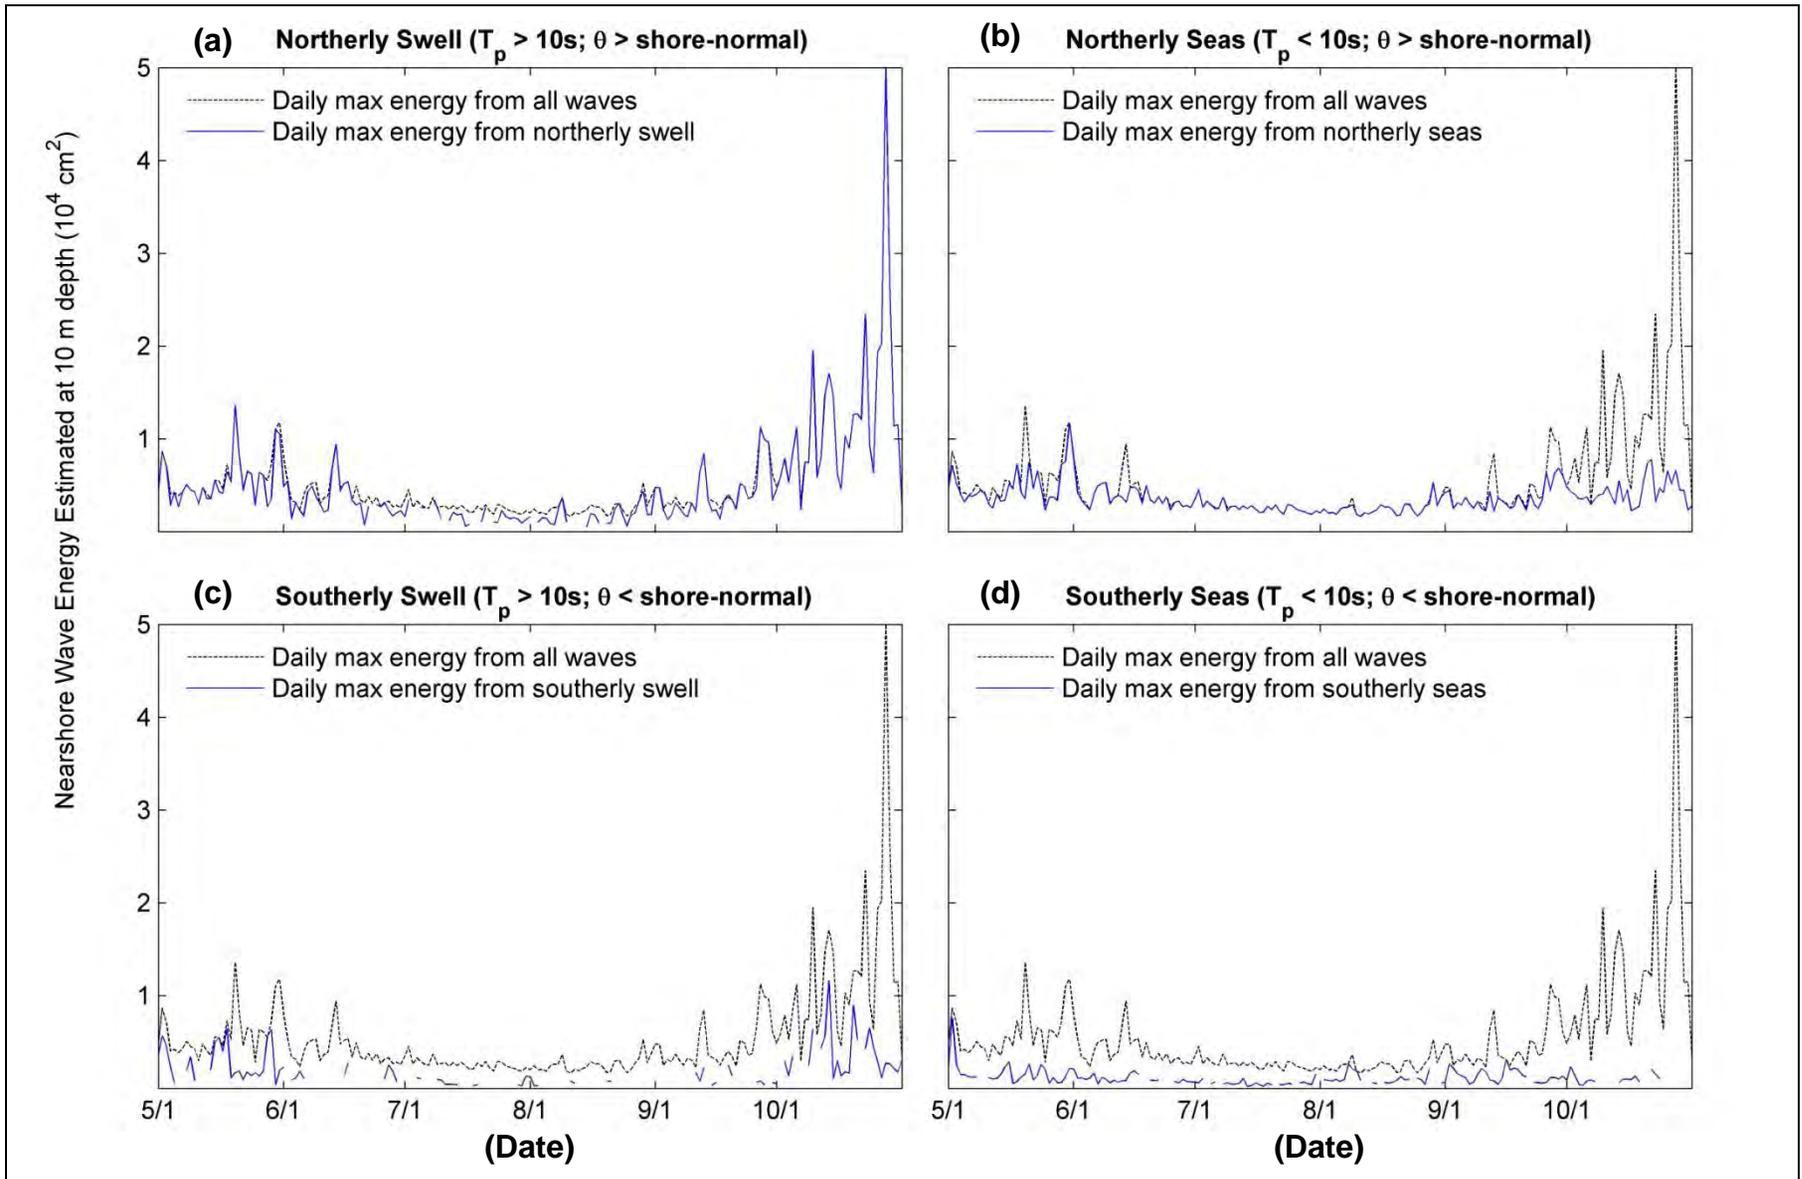
SOURCE: Offshore waves are from NDBC Buoy #46214. These were transformed with the CDIP buoy data to obtain nearshore wave energy.

Daily aggregated nearshore estimates of wave energy, grouped by offshore wave direction and period into northerly and southerly swells and seas

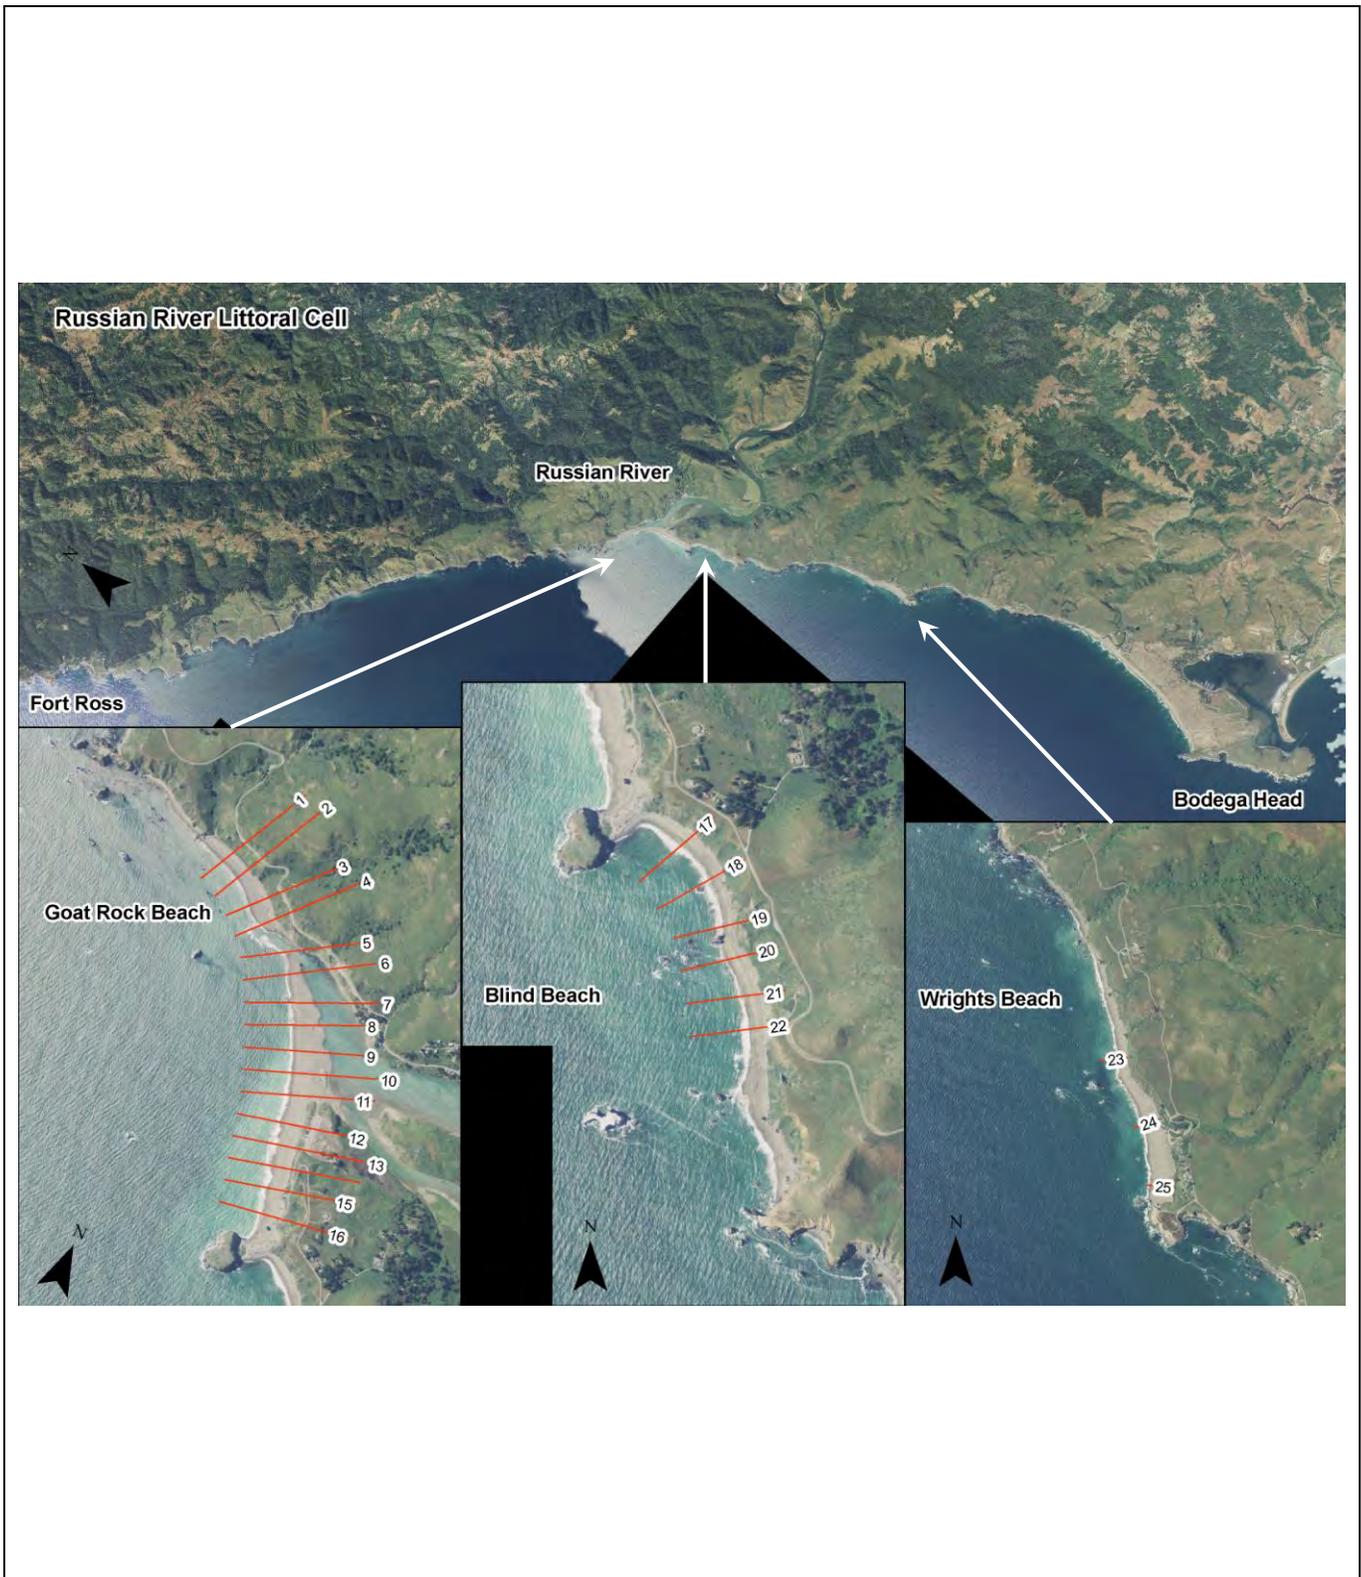
NOTE: Bars shown in insets represent transects used in the analysis of historical images. Background image in all panels is an orthophoto taken in 2009 by the USDA NAIP.

Figure 5-1
Aerial view of the Russian River Littoral Cell, with insets of beaches analyzed with historical aerial images.

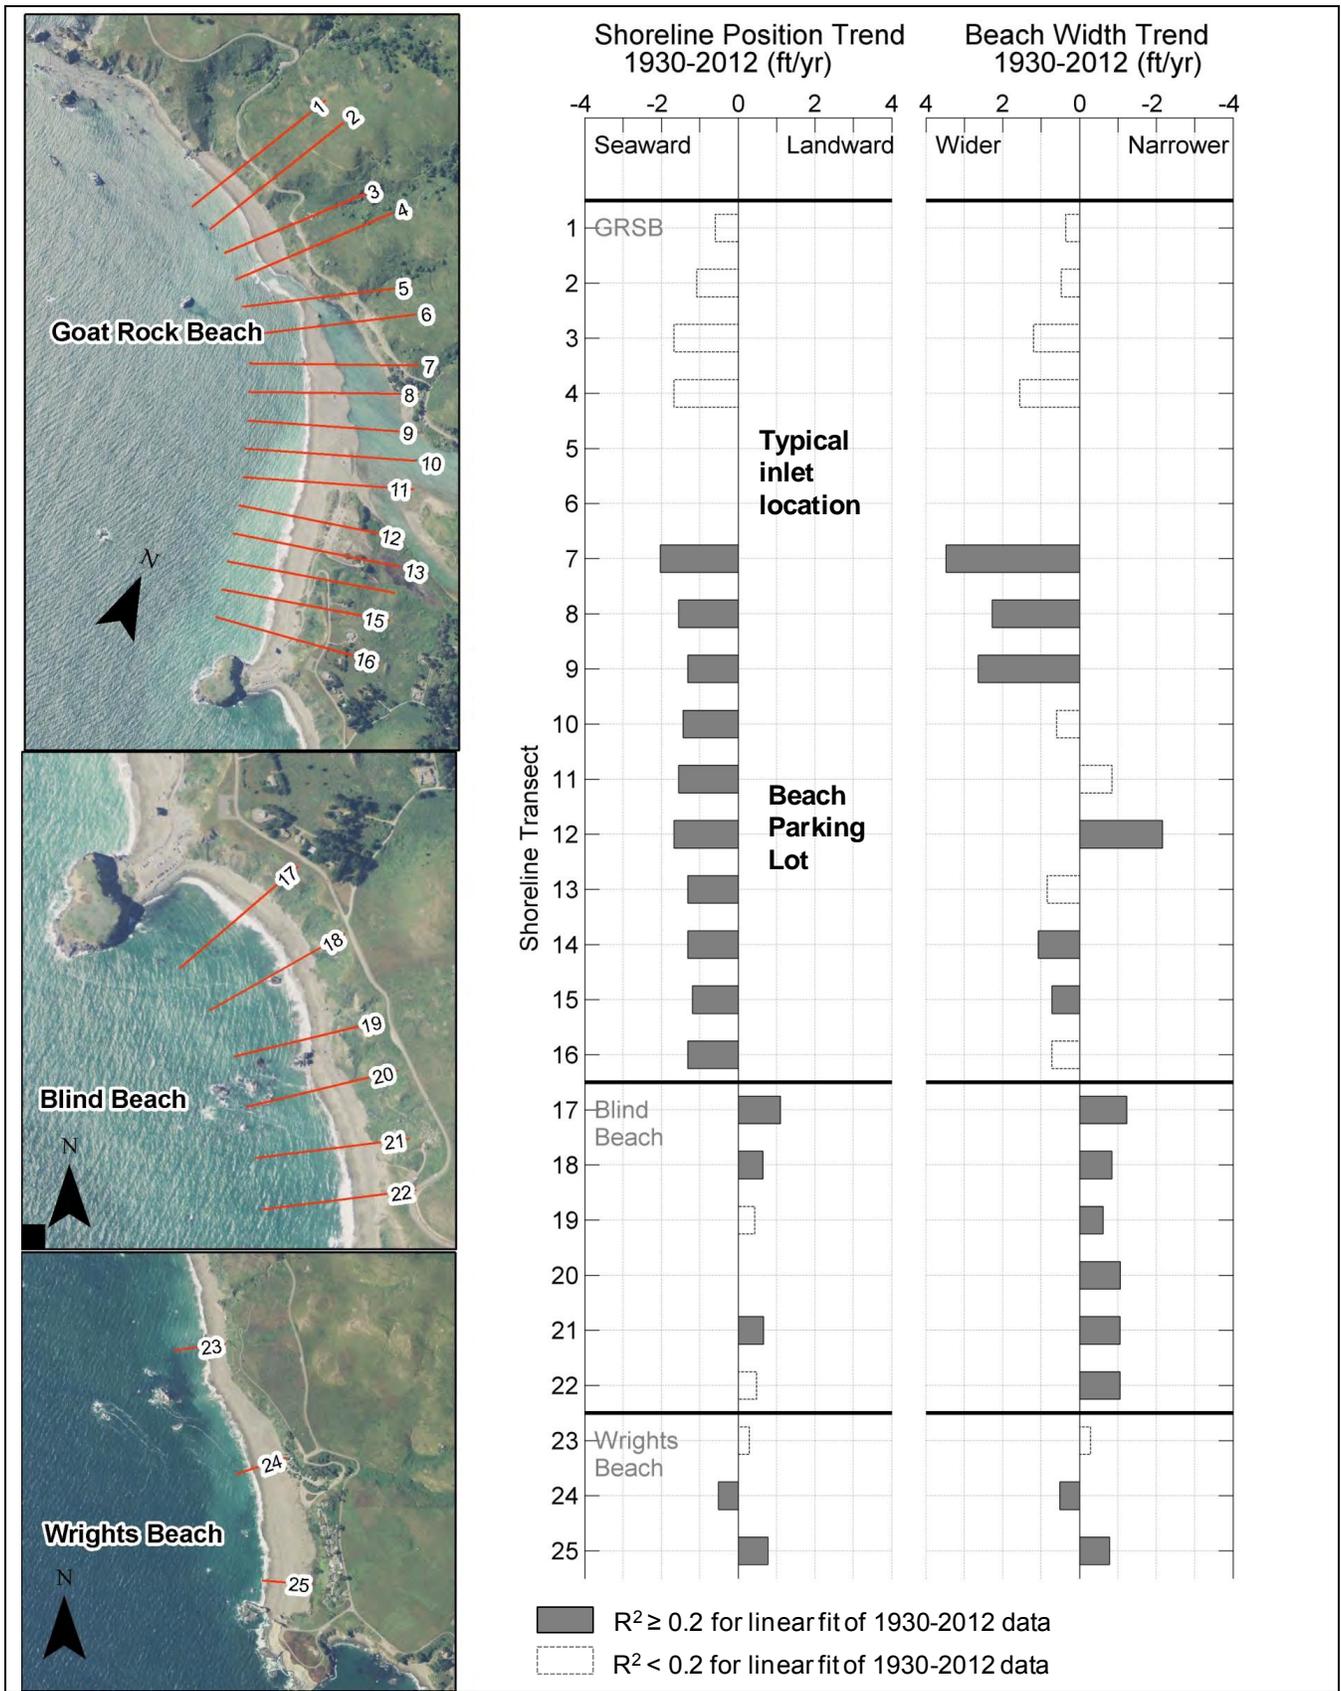
NOTE: All linear trends were obtained using DSAS with a linear fit of the data. Data and trend lines are given in a separate appendix

Figure 5-3
 (left) Beach transects and (right) corresponding trends in shoreline position and beach width

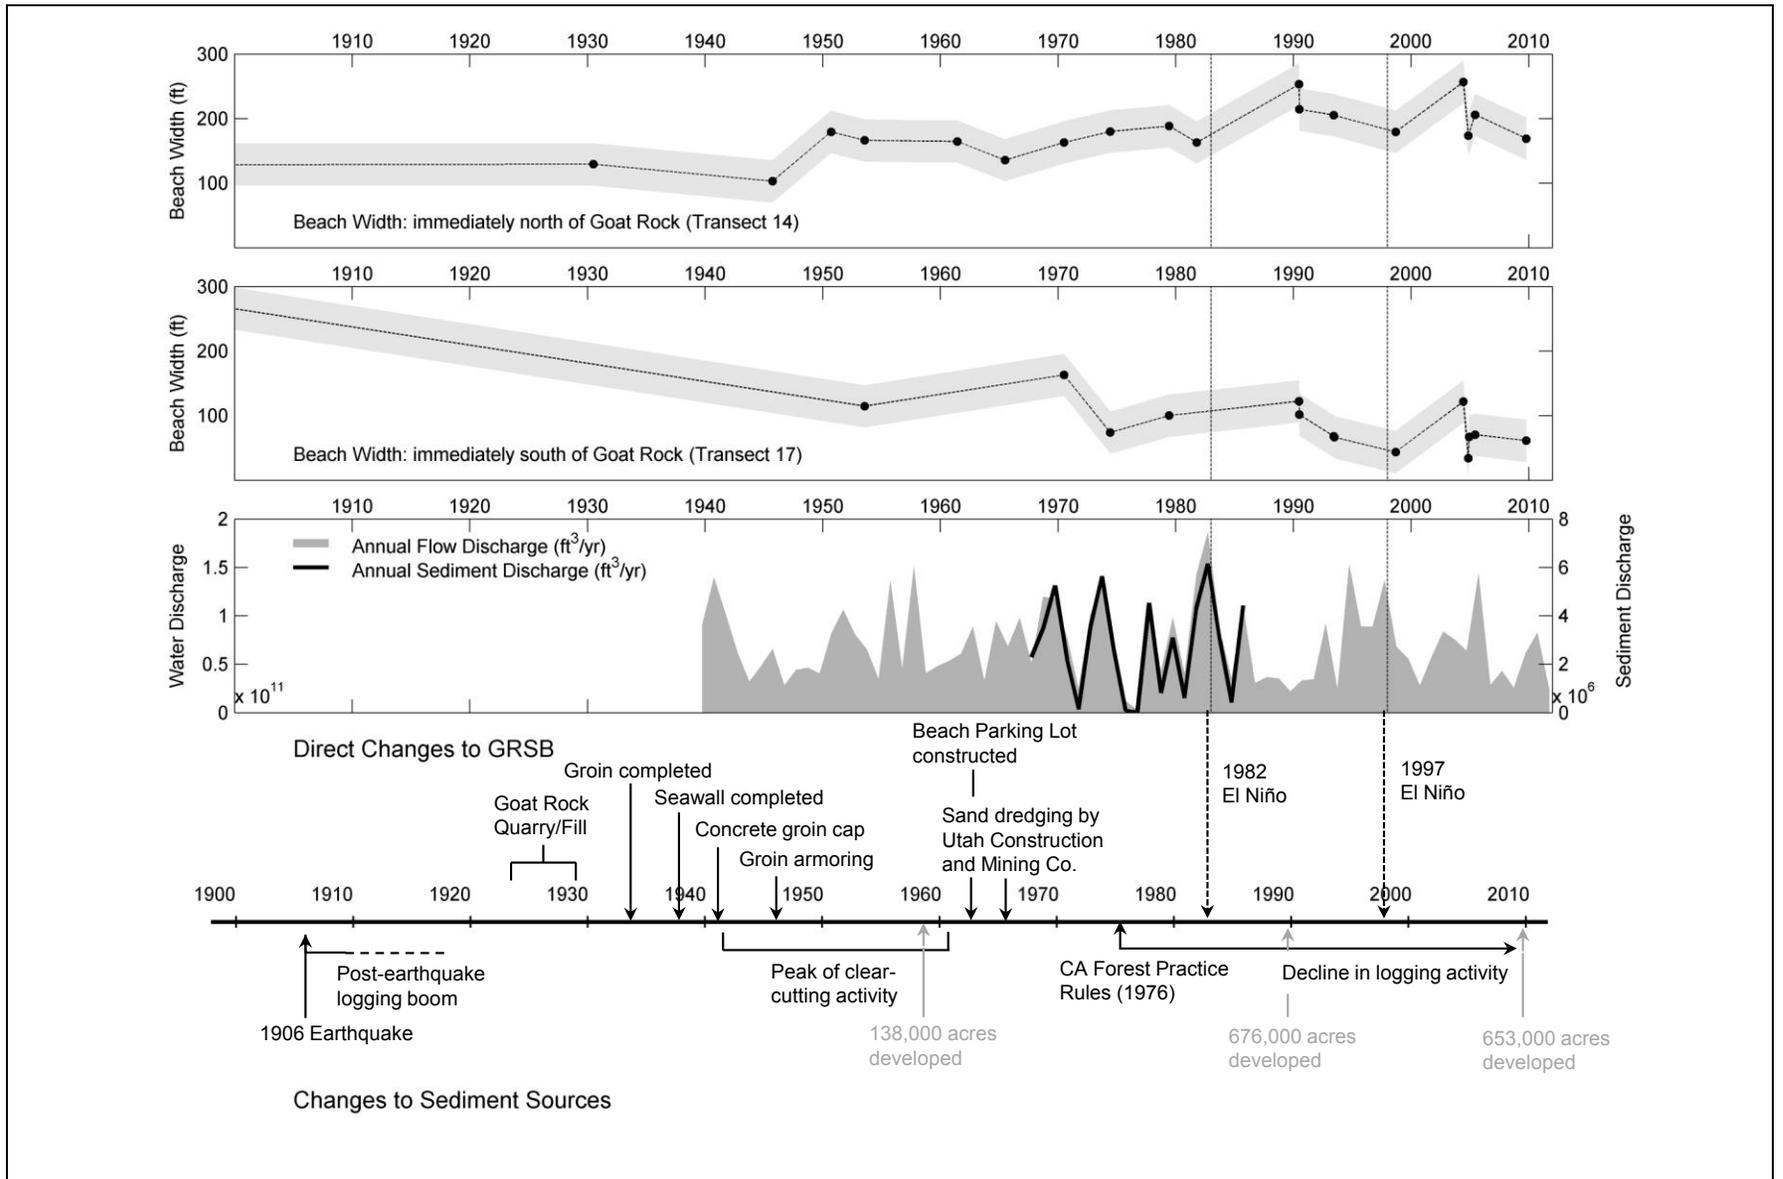
Figure 5-4
(upper panels) Time series of beach width north and south of Goat Rock, compared against **(mid panel)** river and sediment discharge and **(bottom panel)** changes to beach and sediment supply

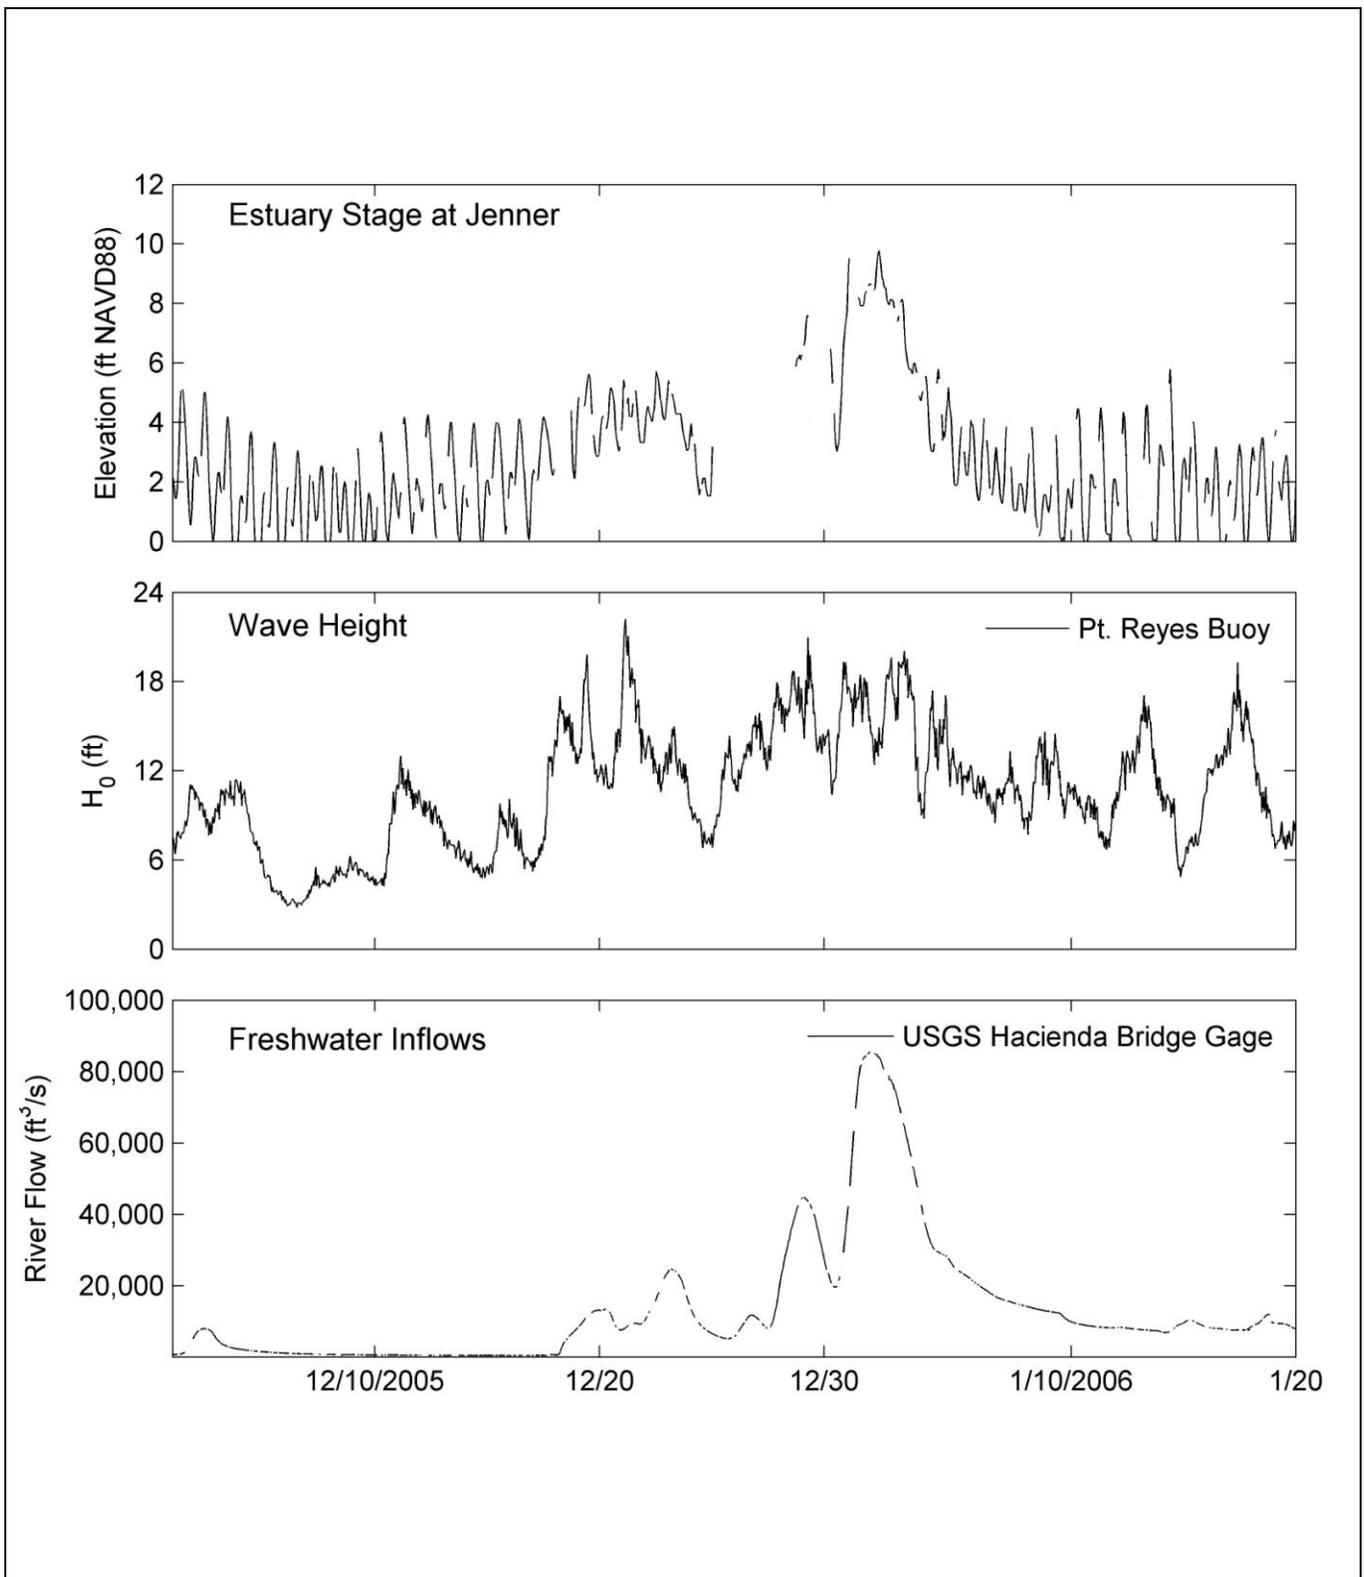
Figure 7-3
Example of a wet-season flooding event, driven by fluvial conditions.

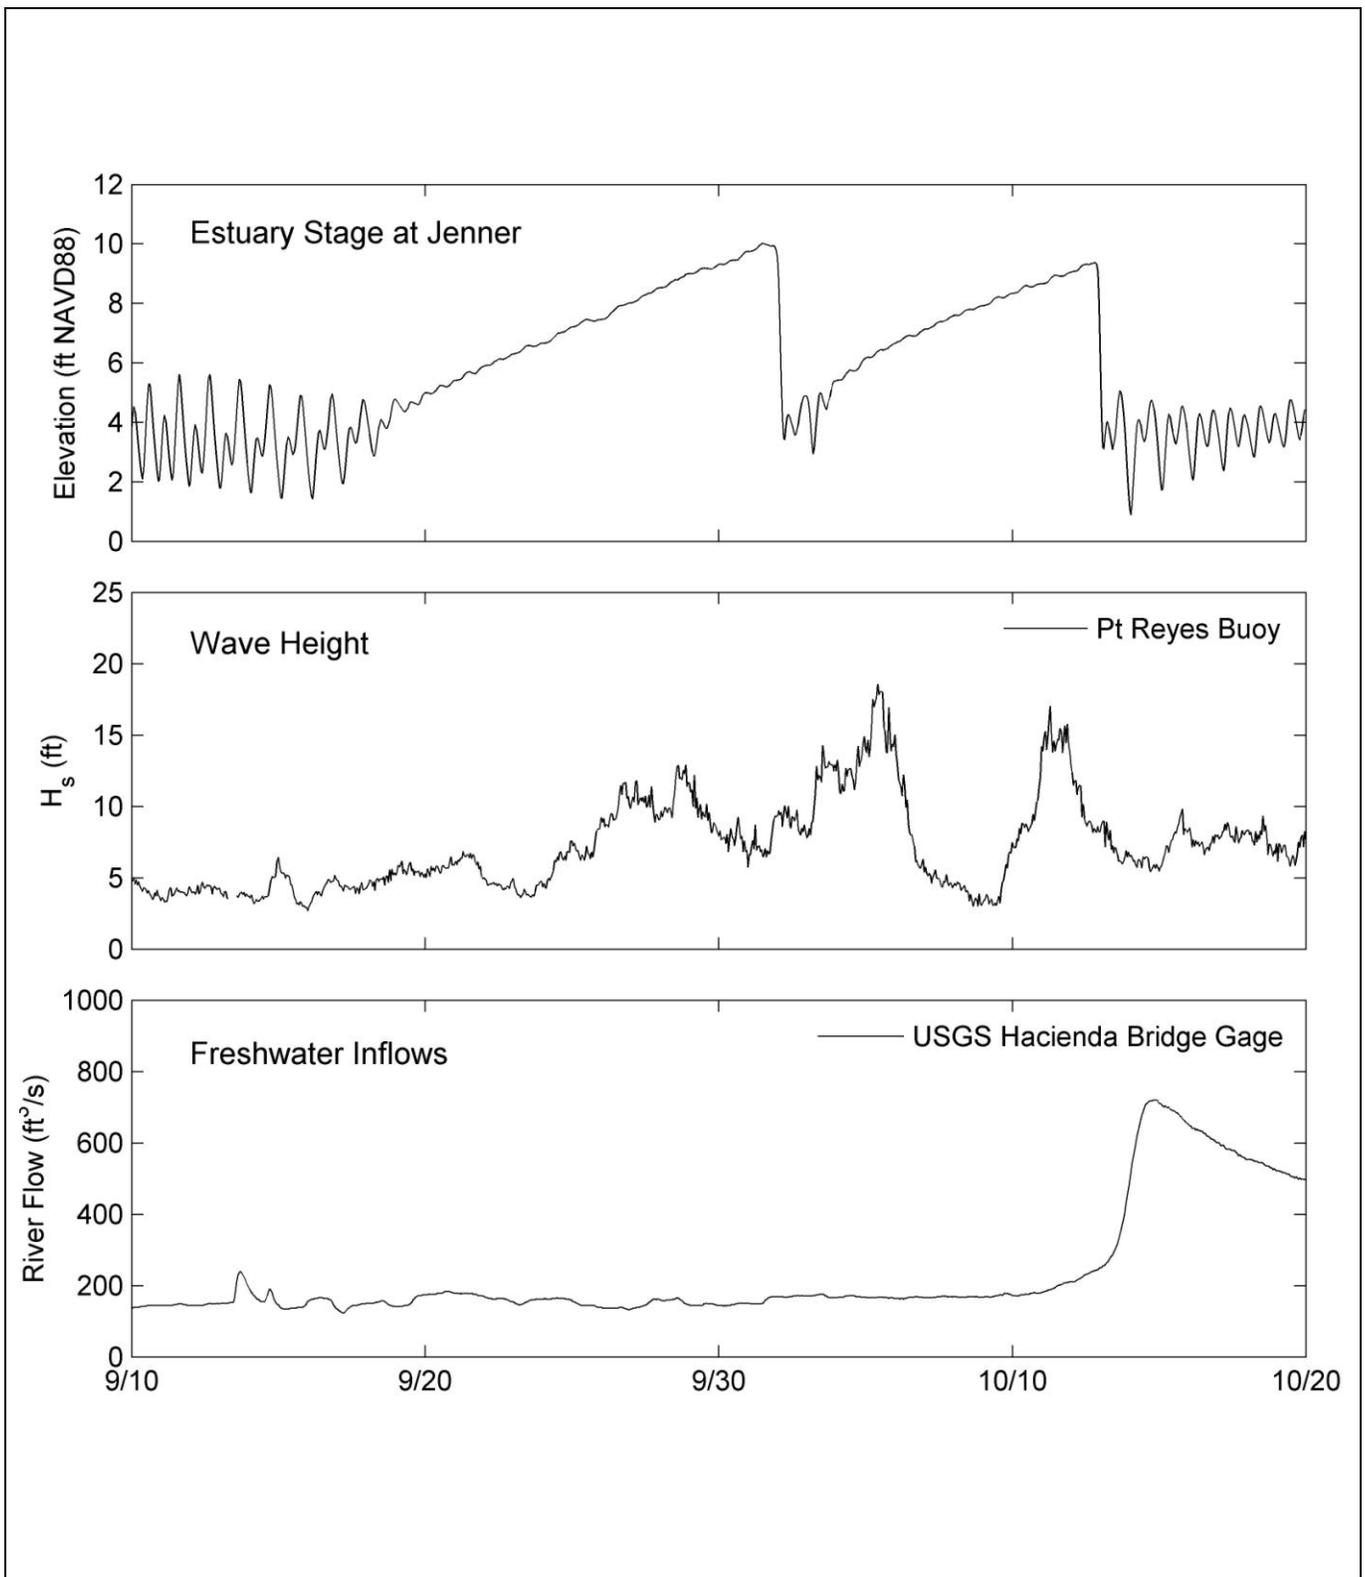
Figure 7-4
 Example of dry-season flooding events in 2010, driven by beach conditions.

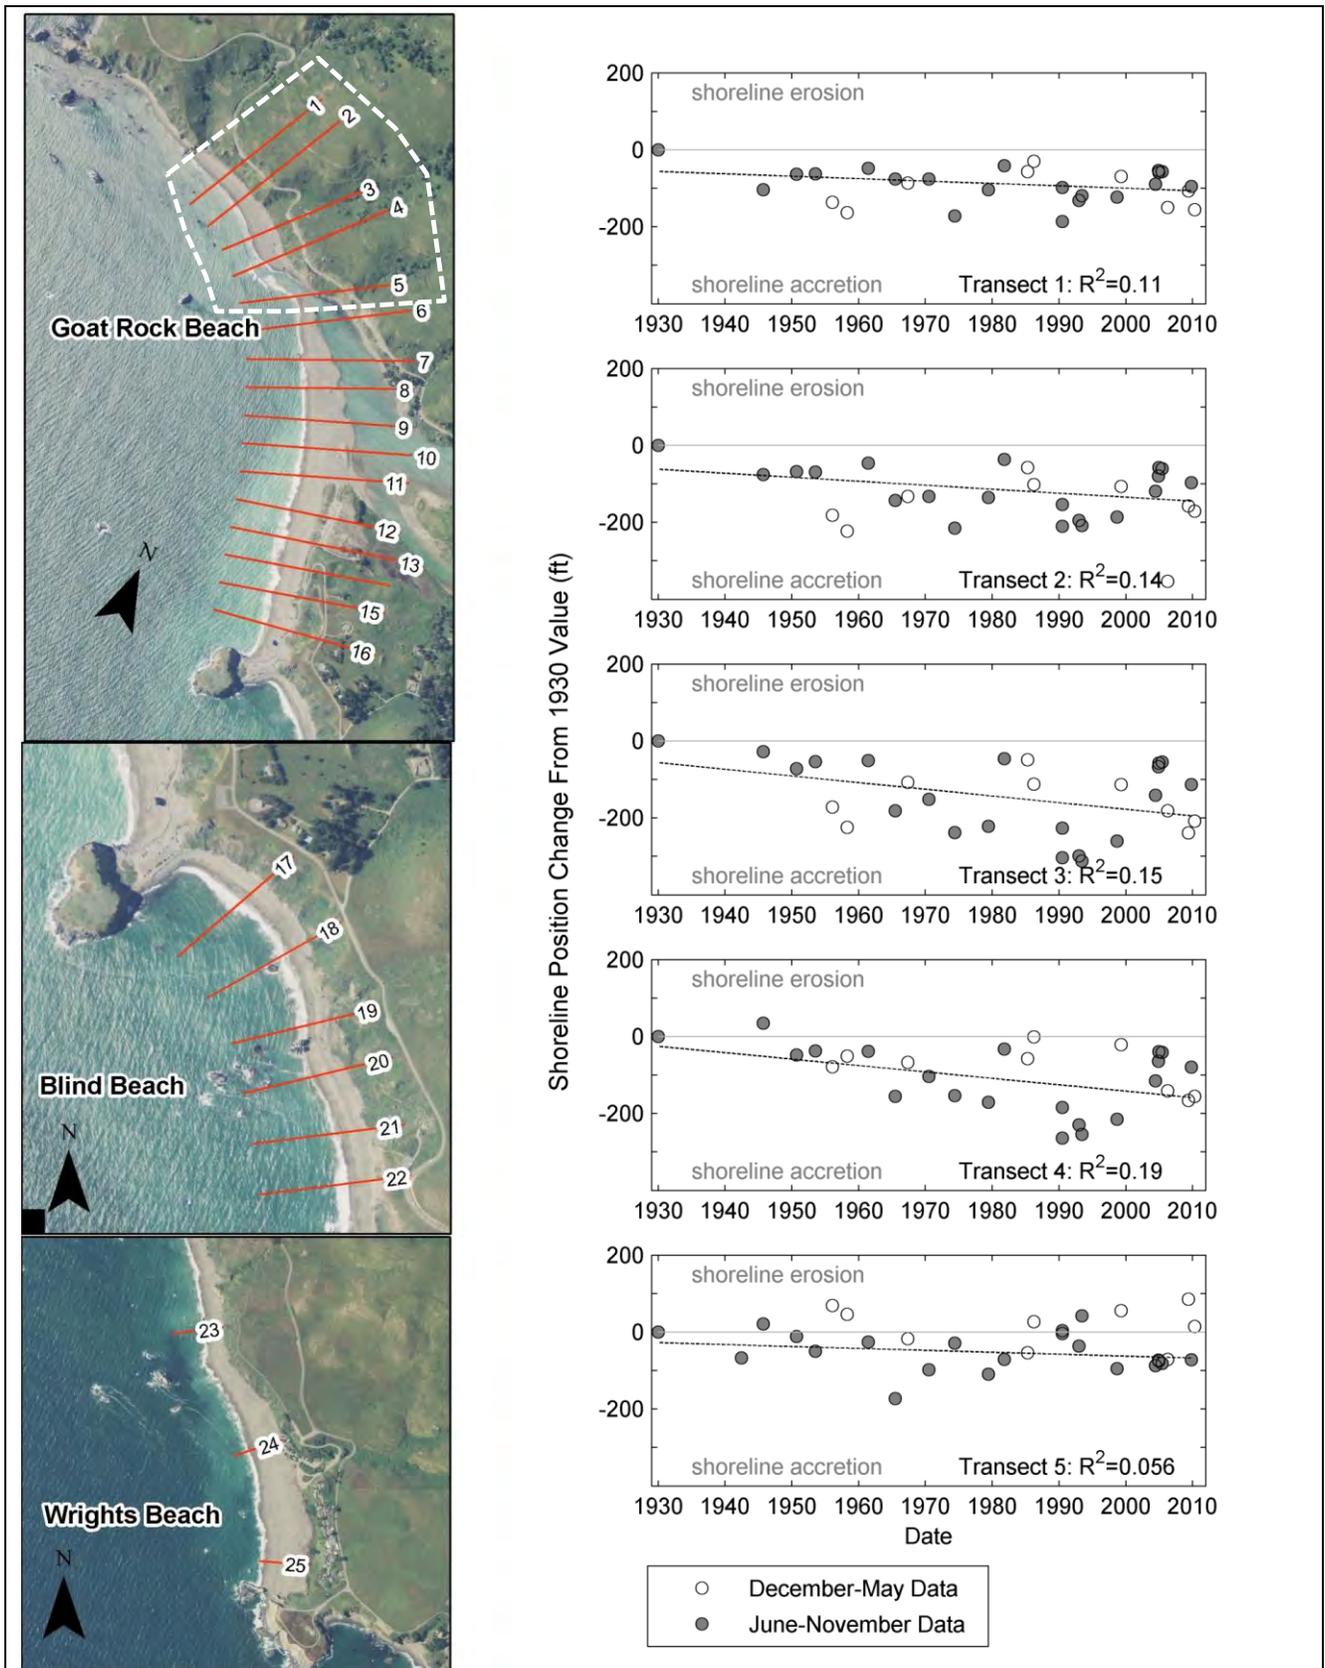
NOTE: All linear trends were obtained using summer-fall data.

Figure B-1
(left) Index of transects and **(right)** corresponding shoreline position data for transects 1-5.
