**RUSSIAN RIVER ESTUARY OUTLET CHANNEL
ADAPTIVE MANAGEMENT PLAN
2013**

Sonoma County Water Agency

ESA PWA

May 14, 2013

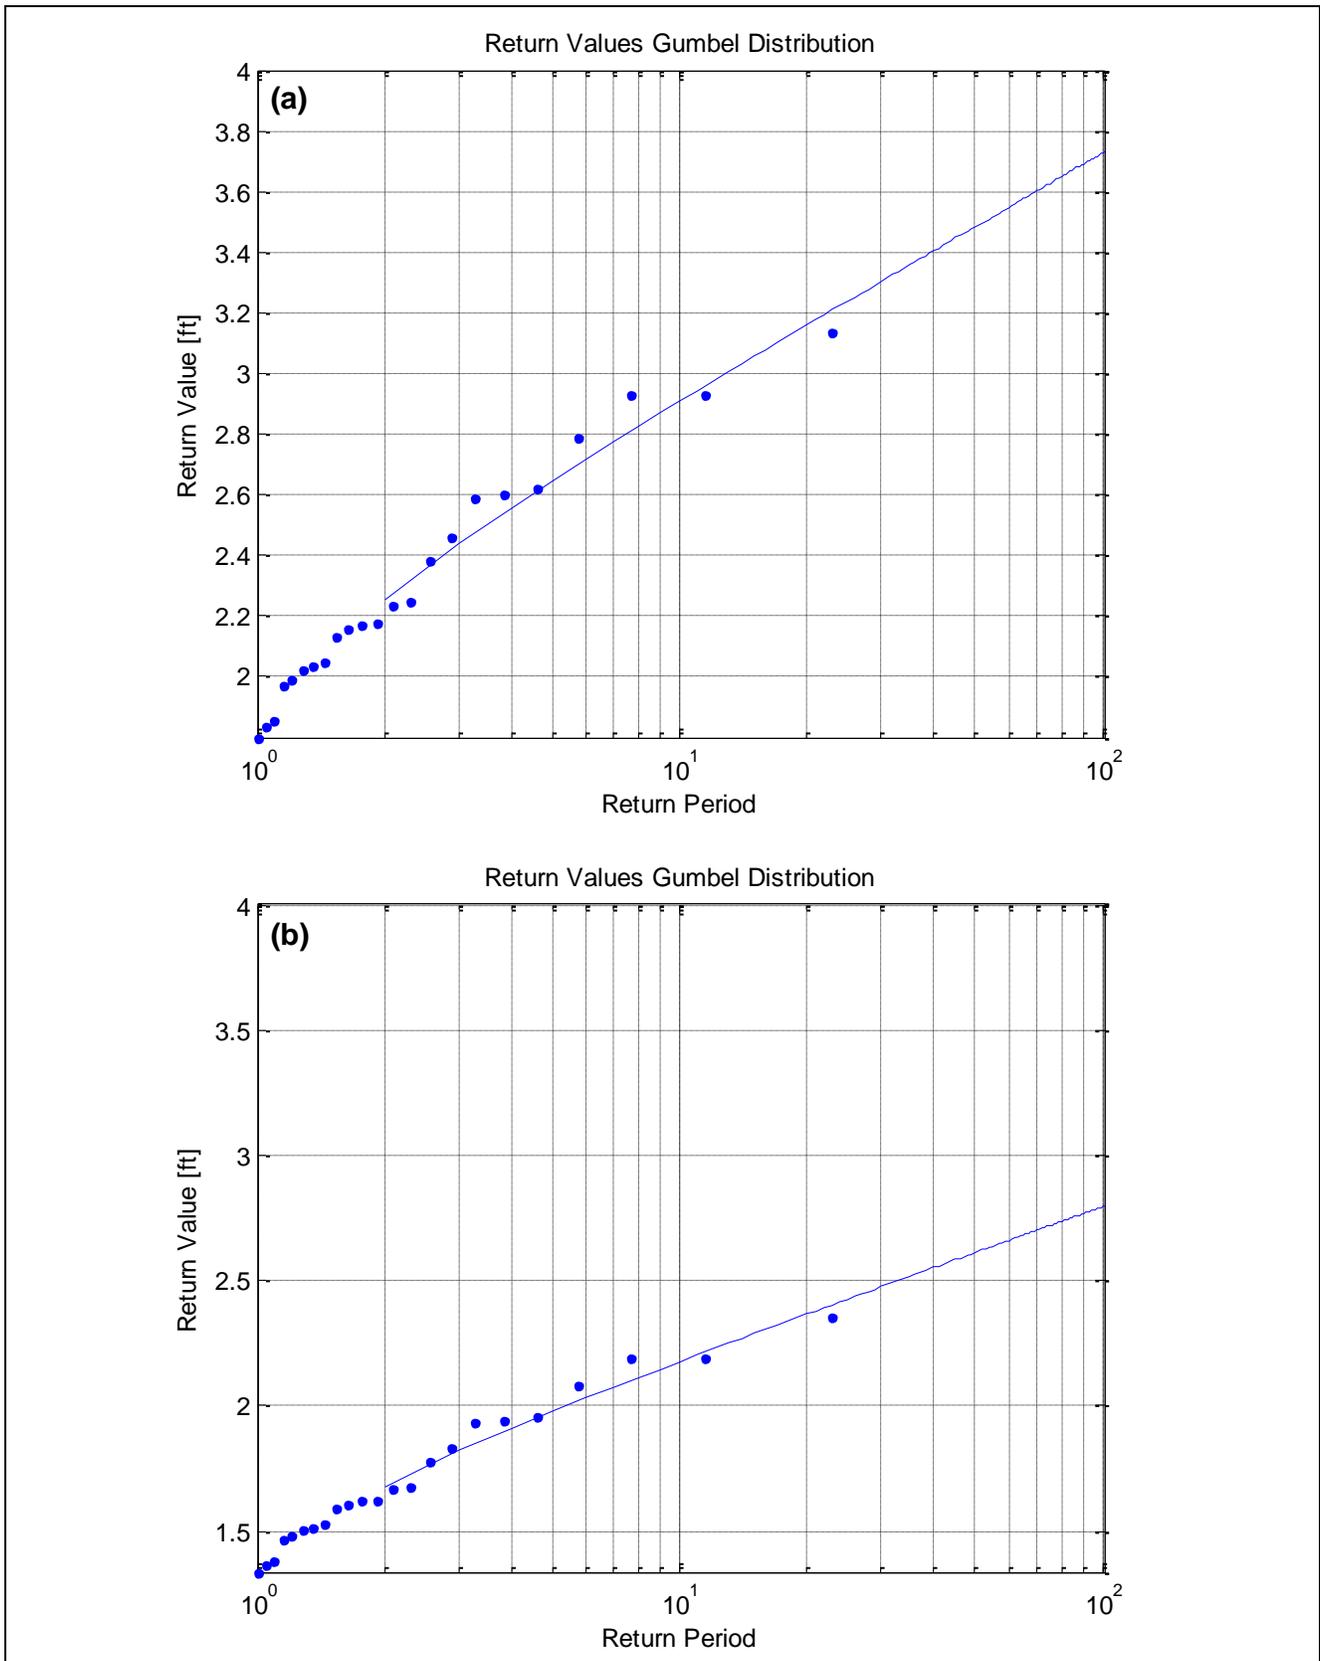
NOTE: Wind-wave runup calculated using wind-wave heights estimated after Resio et al. (2006) using wind data from the Bodega Marine Laboratory.

Figure C-2
 Predicted wind-wave runup and return periods (years) for estuary shoreline slope of (a) 1:2 and (b) 1:3.

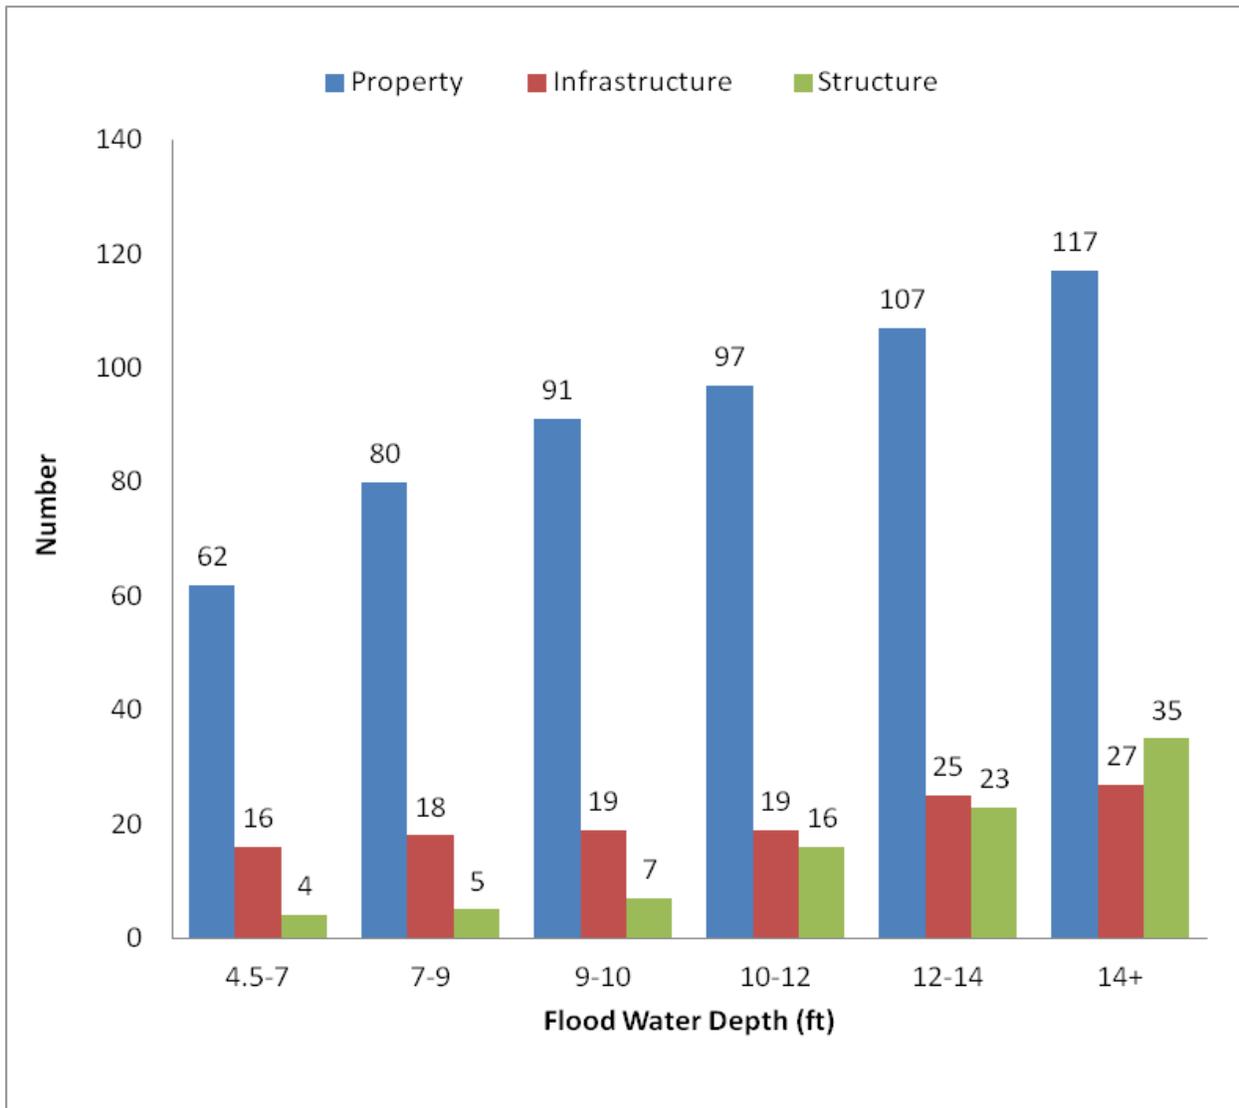
Figure 1: Russian River Estuary flood risk of adjacent properties. A total of 123 properties were evaluated. Definitions: Property parcel boundary; Infrastructure consists of seawalls, docks and stairs, tanks, etc.; Structures are mostly houses and out buildings.
