**Current Conditions
Inventory Report**

**Dry Creek:
Warm Springs Dam to
Russian River**

Sonoma County, CA

December 2, 2010

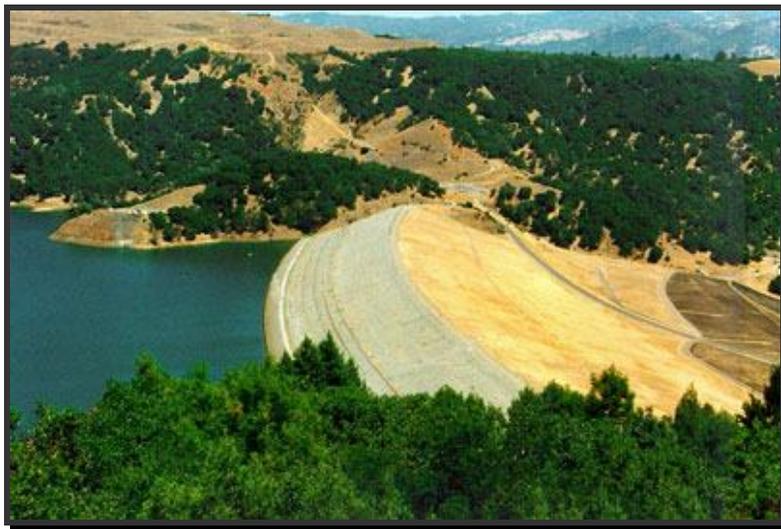
Photograph 1: Warm Springs Dam.

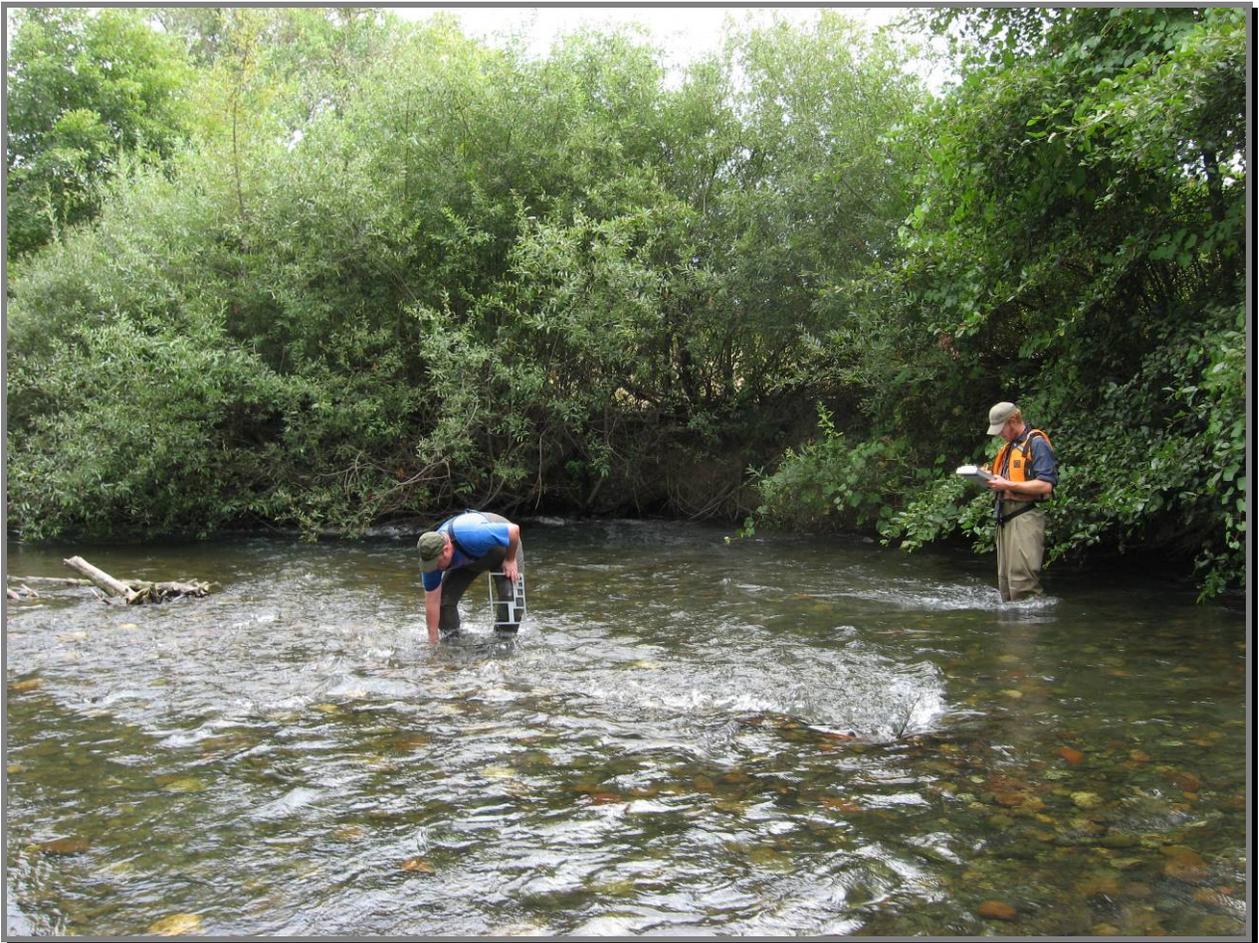
Photograph 2. Field crew conducting Wolman pebble count.

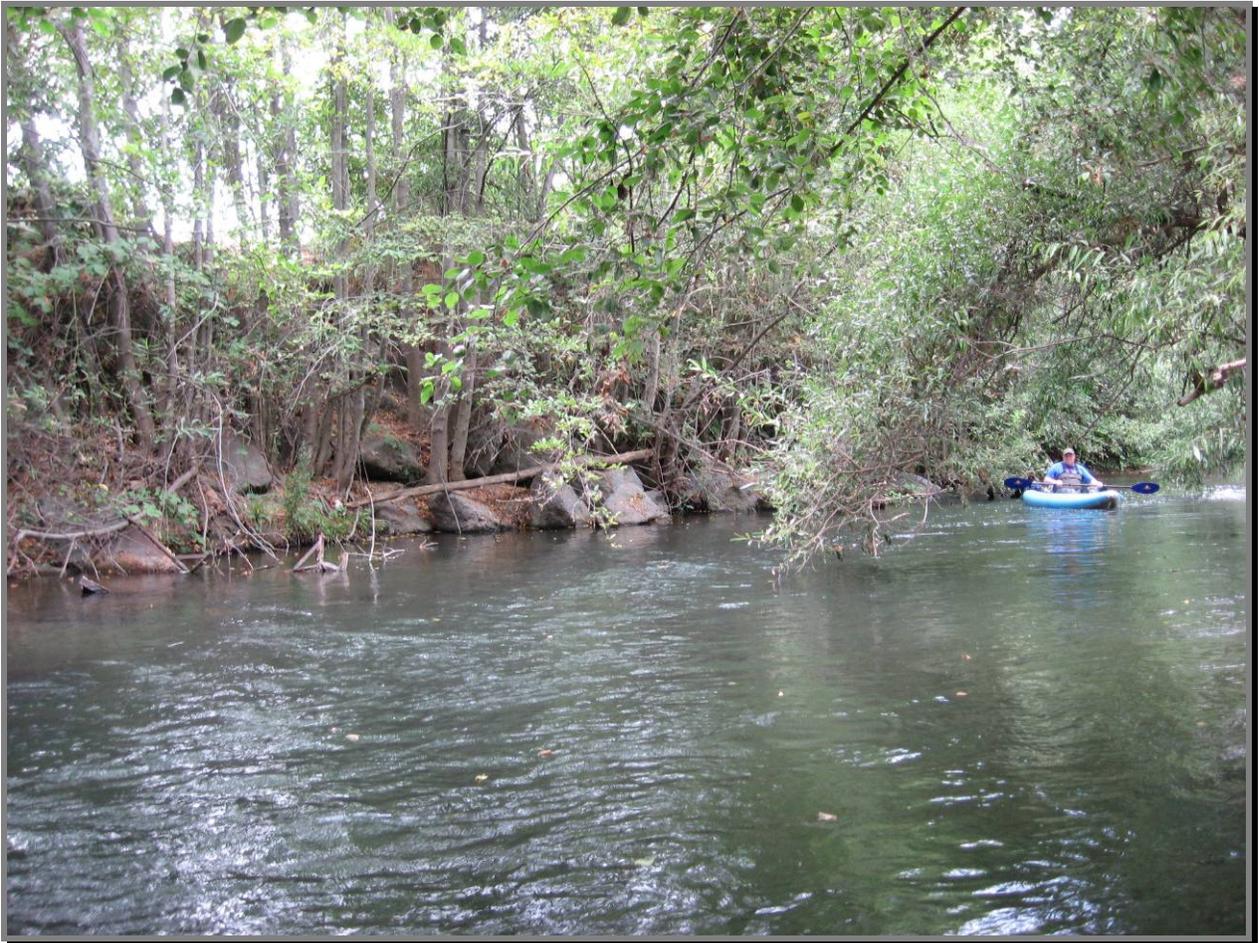
Photograph 3: Historic bank stabilization site.

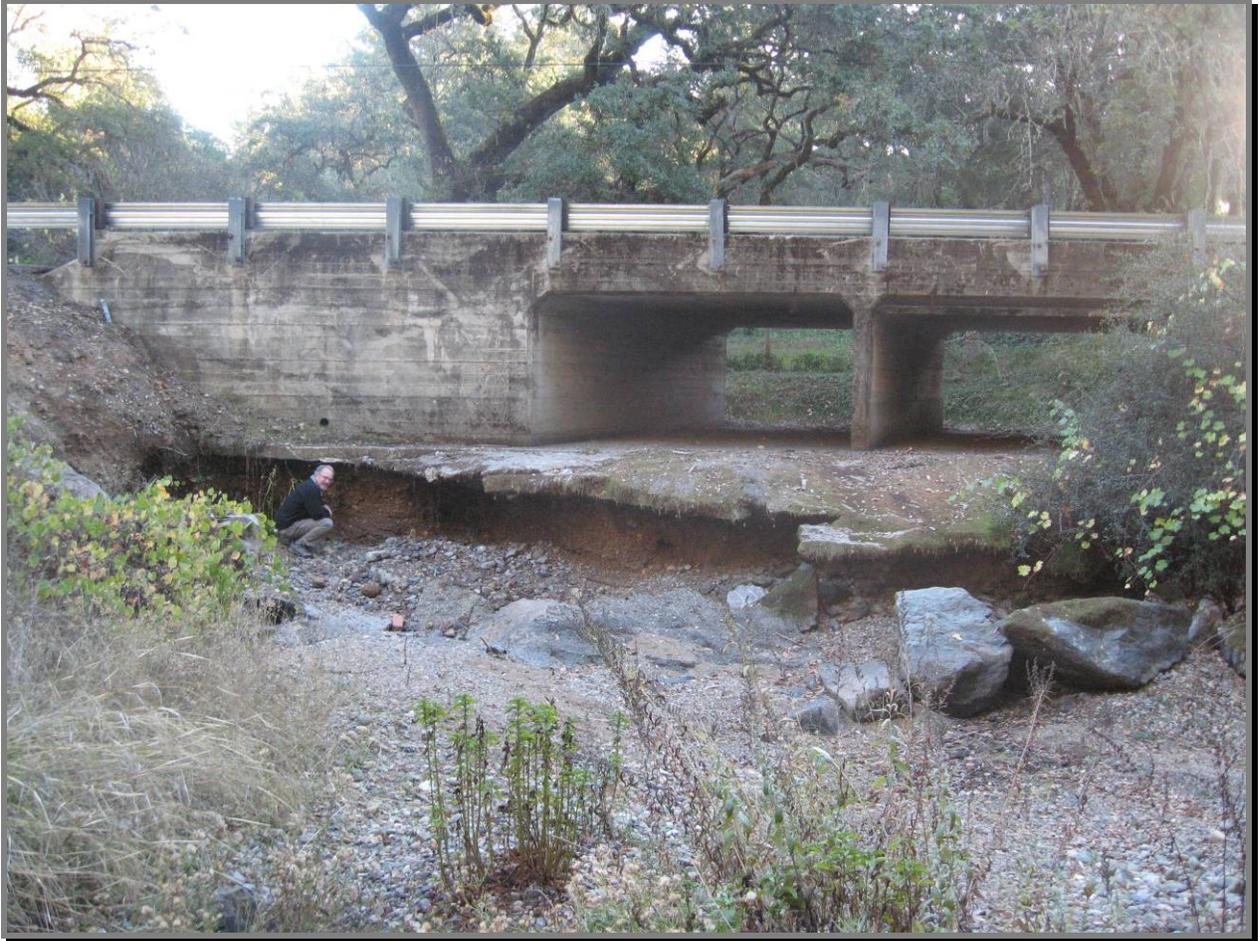
The reduction in bed material supply is moderated by successive tributaries entering Dry Creek. The most significant of these in terms of bed material supply include Dutcher Creek (RM 11.8; Photograph 4), Pena Creek (RM 11), Crane Creek (RM 6.3) and Mill Creek (RM 0.6), based on observations of bed material size, angularity and mineralogy near the respective confluences (Photograph 5). Pena, Crane and Mill Creeks all enter Dry Creek from the West, with headwaters in relatively steep topography in Franciscan Formation geology. Pena and Mill Creeks are the two largest tributaries to Dry Creek, each with watershed area of 22 sq. mi., representing nearly 10% of total Dry Creek drainage area (230 sq. mi.) each.

Photograph 4: Evidence of stream bed incision in Dutcher Creek, below the Dutcher Creek Road Bridge.

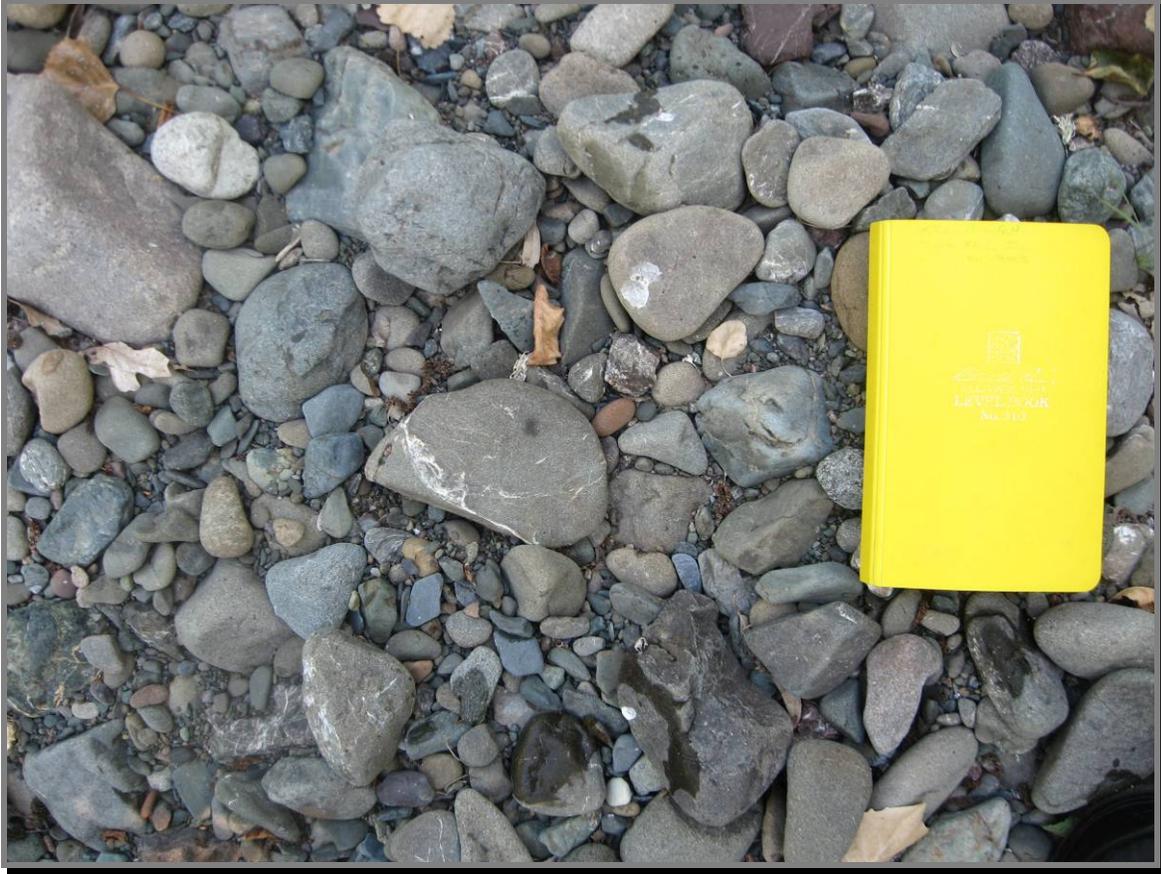
Photograph 5: Gravel deposit at Pena Creek confluence.

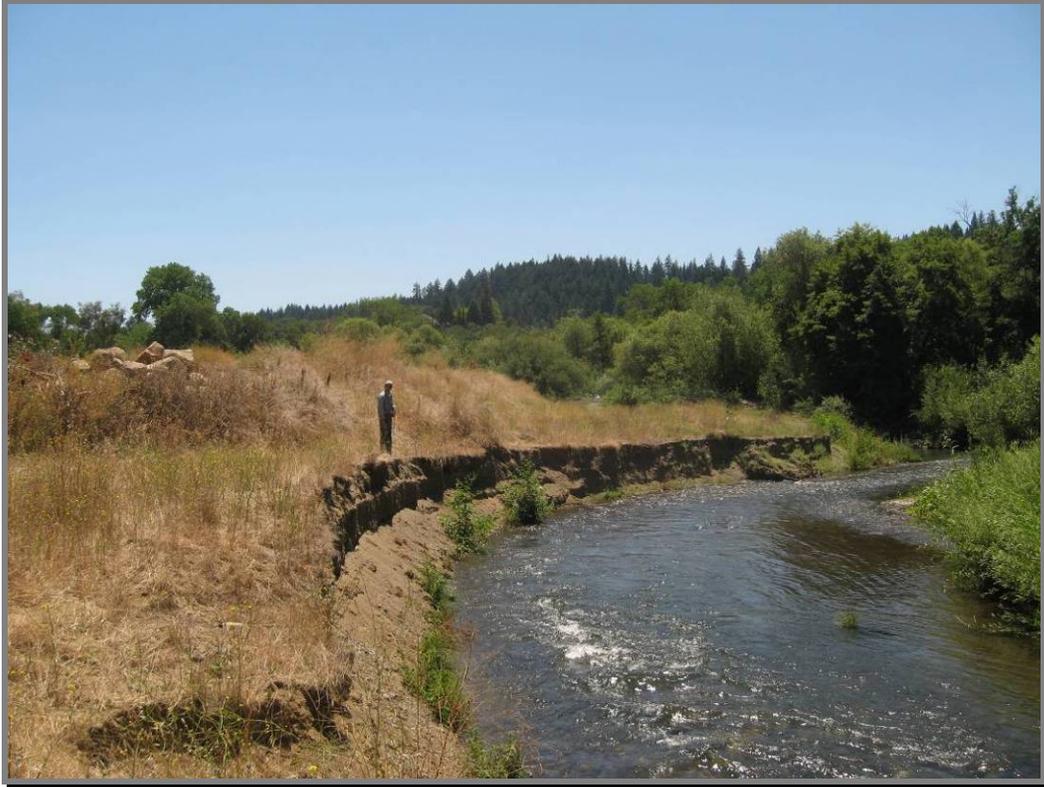
The stream section between Pena Creek and Westside Bridge (RM 11 to RM 2; Reaches 11 to 3) did not appear to be actively incising or aggrading, though there are areas of active channel adjustment (Photograph 6). In this section, a bedrock outcrop provides bed grade control at Lambert Bridge (RM 6.6; Photograph 7), and three grouted rock grade control sills (Photograph 8) located between RM 3.8 and 3.2 provide bed grade control for the stream. The stream section between Westside Bridge and the confluence (Reaches 2 to 1) appeared to be the most alluvial section, in which the channel position and shape are most readily shaped by fluvial forces (Photograph 9). Some signs of aggradation were observed in this section, with the influence of backwater from the Russian River during floods clearly visible from Mill Creek downstream to the confluence (Photograph 10).

Photograph 6: Active channel meandering into relic terrace deposit at RM 6.4.

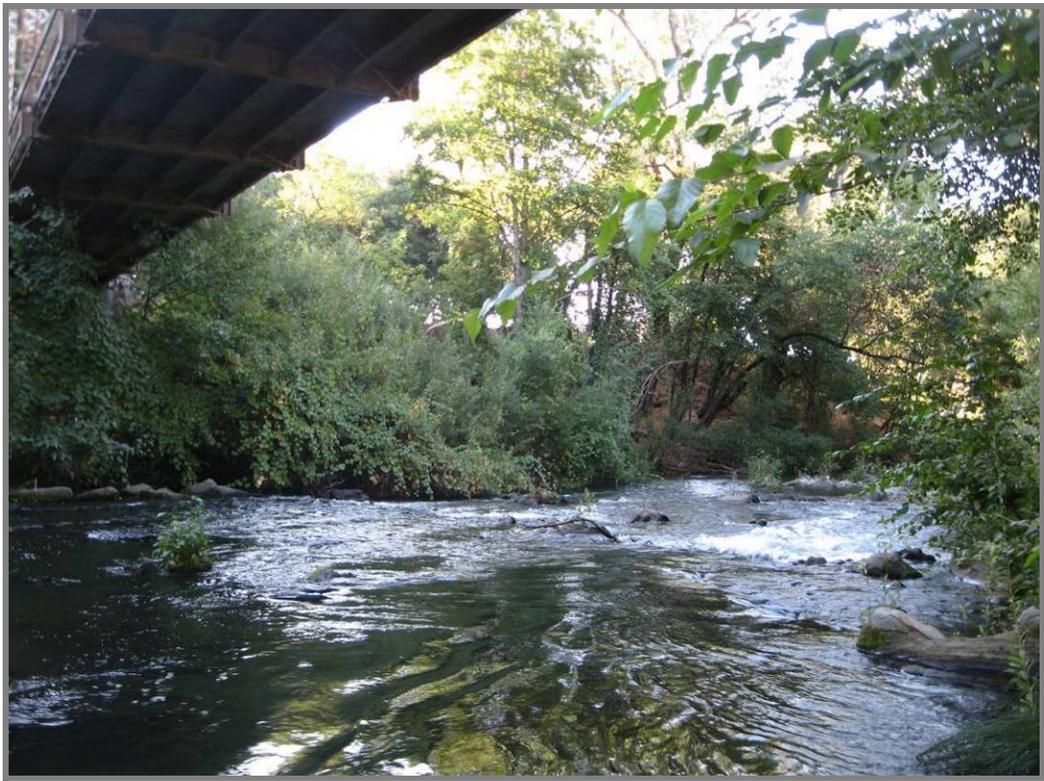
Photograph 7: Bedrock outcrop beneath Lambert Bridge, RM 6.6.

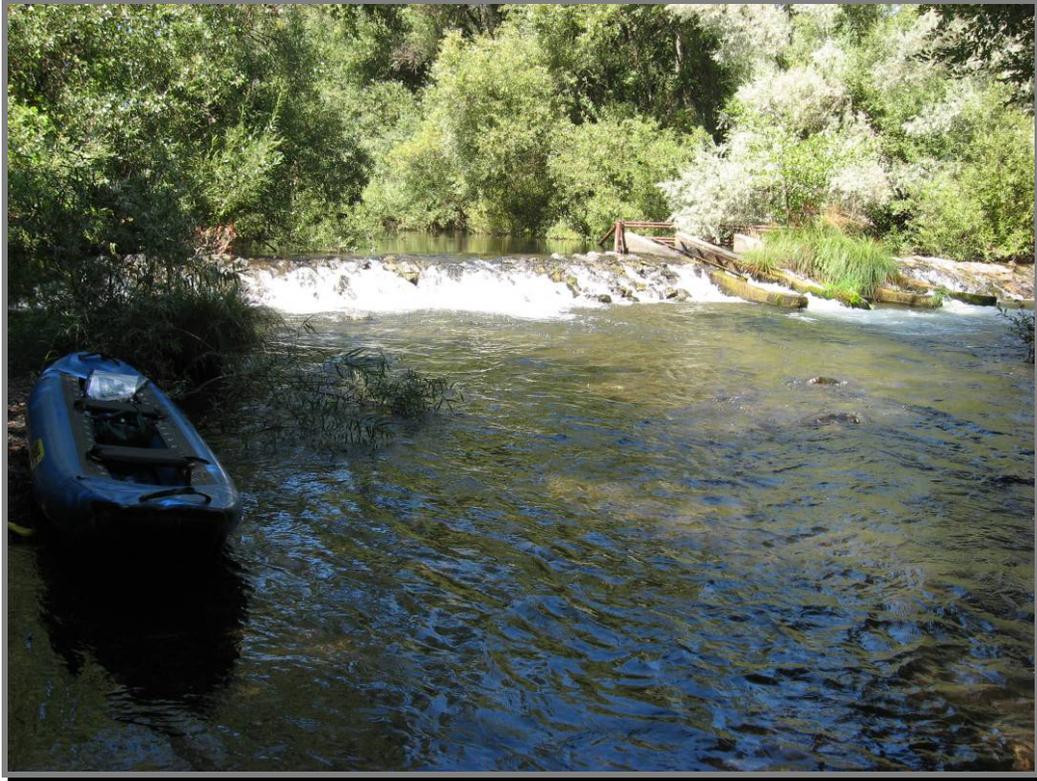
Photograph 8: Grade control sill, with fish ladder at top right, RM 3.2.

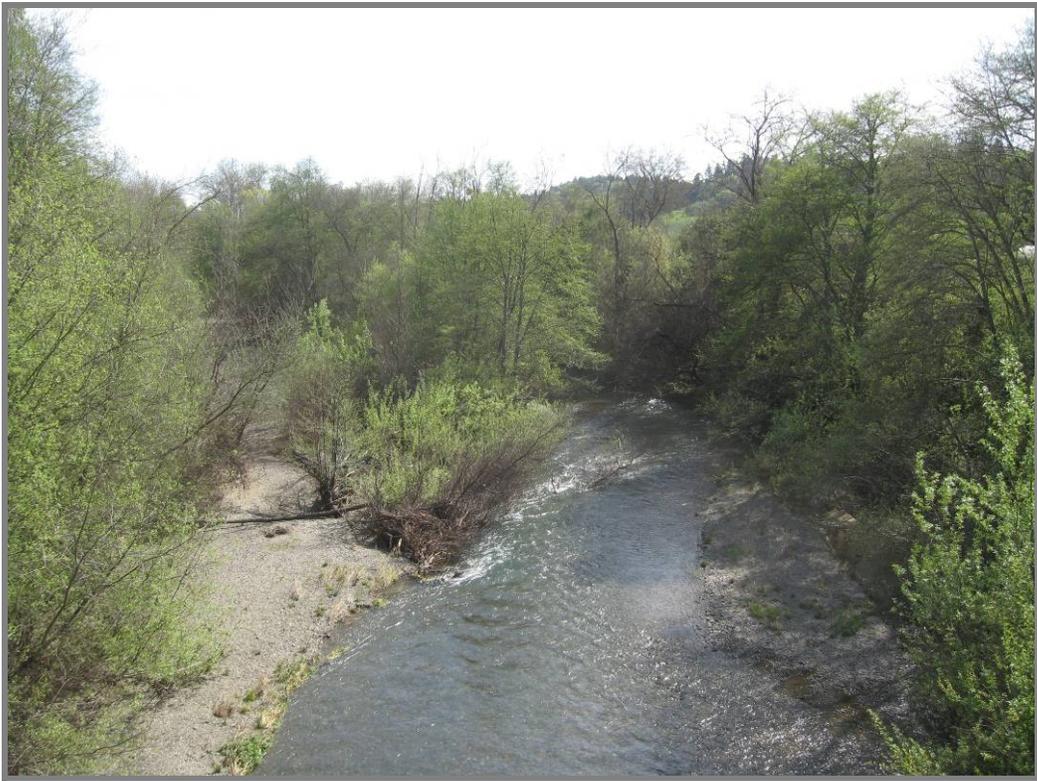
Photograph 9: View looking downstream from Westside Bridge, RM 2.

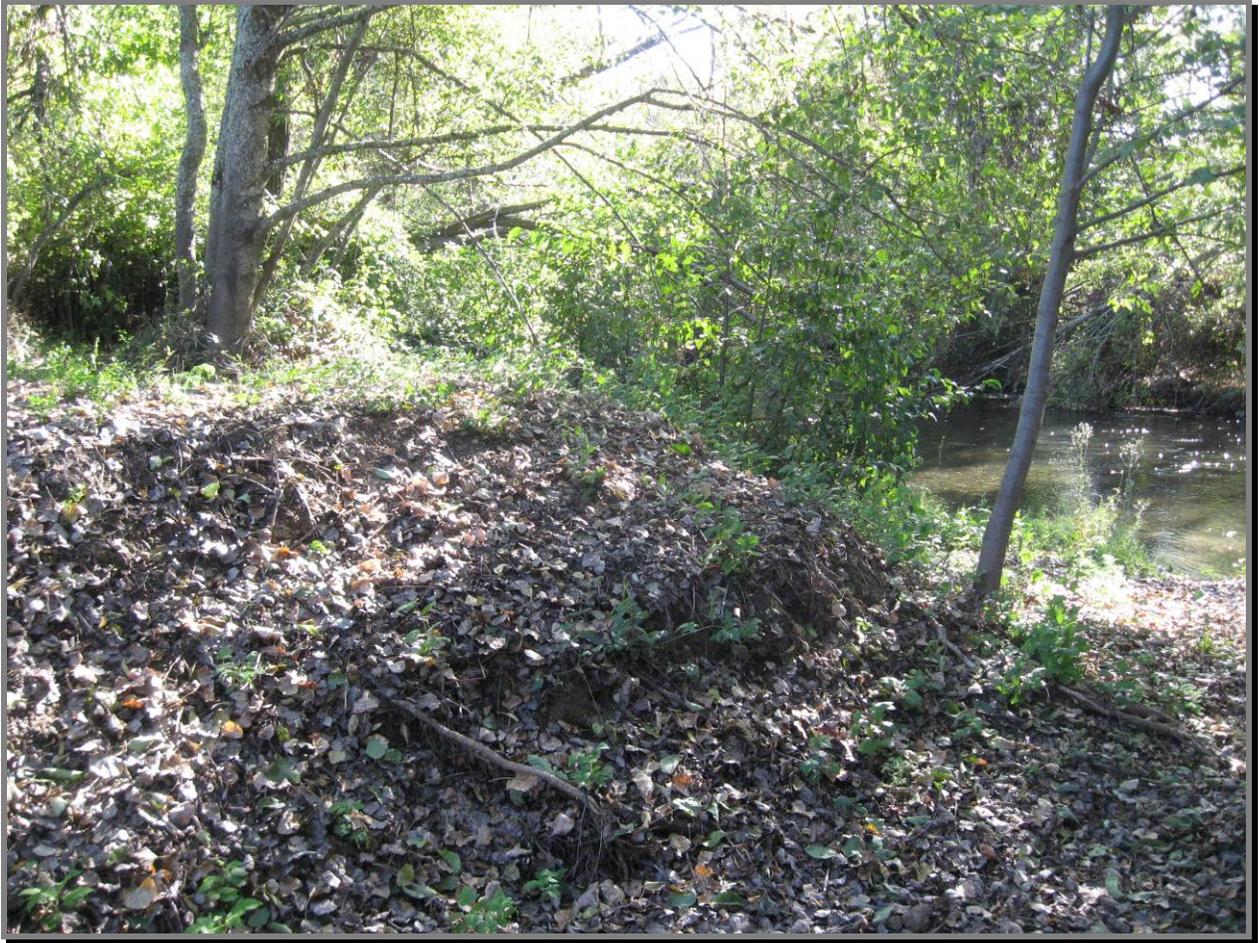
The hydrologic regime influences the geomorphology of lower Dry Creek. Regulation has resulted in elevated summer baseflow conditions that when combined with the Mediterranean climate produces near ideal conditions for growth of riparian trees and shrubs. Regulation has also resulted in severe curtailment of major floods, which limits disturbance and removal of newly recruited and established vegetation. The estimated highest maximum peak flow release from the dam (6000 cfs) is less than a 1-year flood for the unregulated period. In the reach, even-aged stands of alder trees dating to various eras (confirmed through selected tree coring) mark the elevations of terraces and bar surfaces that were abandoned or active at the time of dam closure (Photograph 11).

Photograph 11: Riparian trees date alluvial features at RM 10.3 near confluence of Canyon Road Creek. The larger tree at left on terrace dated to 1984-86. The smaller tree at right dated to 1995-97.

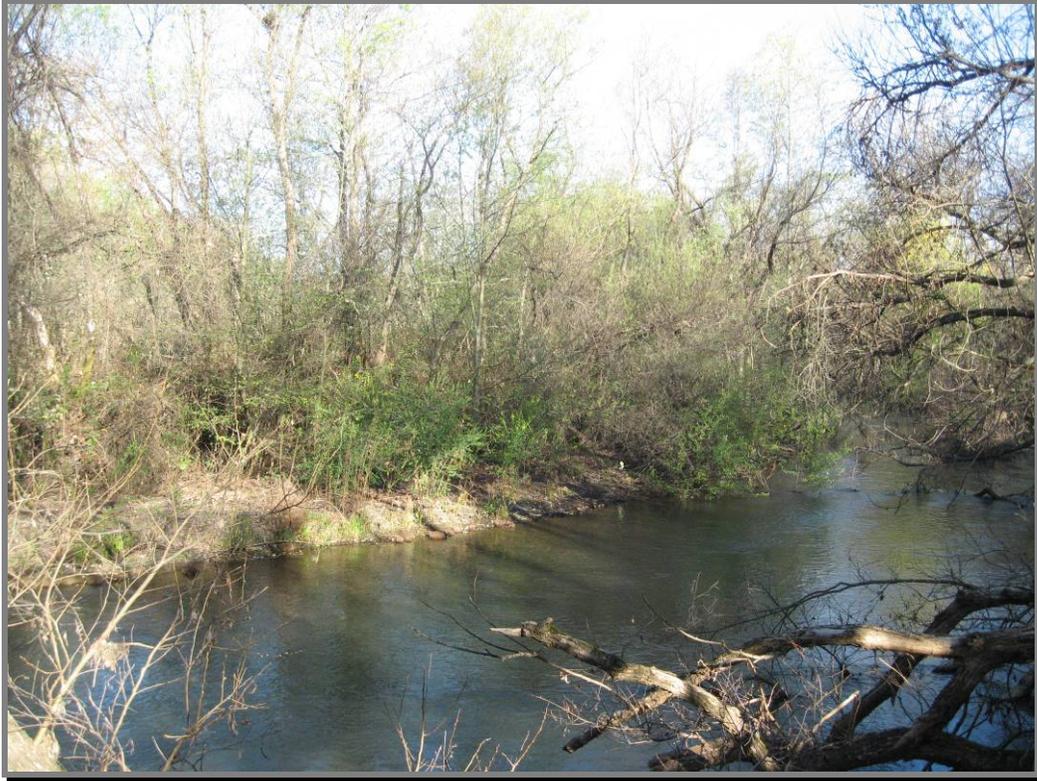
This combination of effects has resulted in extensive vegetative colonization of formerly active bar surfaces – elevated baseflow nurtures vegetative growth, while the lack of significant disturbance (flood) flows allows vegetation to flourish. Vegetative colonization of the bar surfaces has stabilized the formerly active morphologic features (Photograph 12), which serves to limit lateral migration of the active channel within the channel corridor, and has the effect of sequestering a reservoir of gravel within the system. The expansion of riparian vegetation within the system has also likely led to greater stabilization of channel corridor banks that were frequently destabilized during the period of adjustment to historic channel incision previously discussed. Areas of bank instability which are exceptions to this can be found in the reach and are consistent with what occurred historically before vegetation became a more dominant geomorphic influence (Photograph 13).

Photograph 12: Vegetative colonization of bar surface, RM 12.3

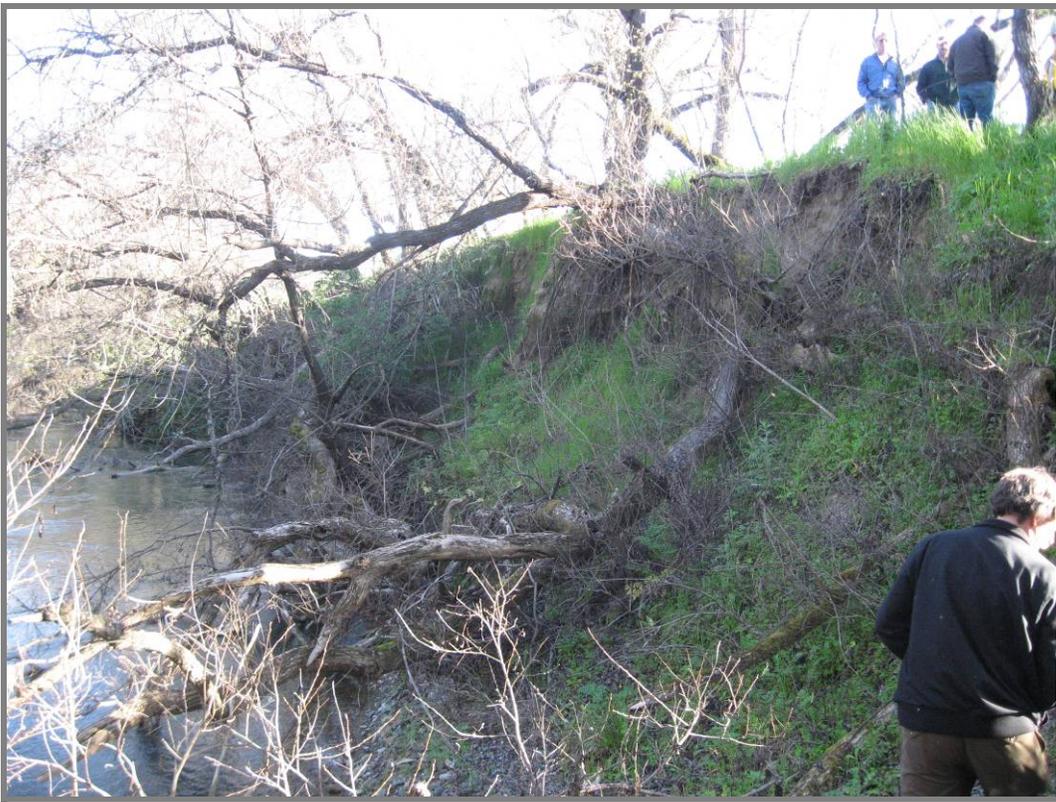
Photograph 13: Slumped high bank at RM 12.3.

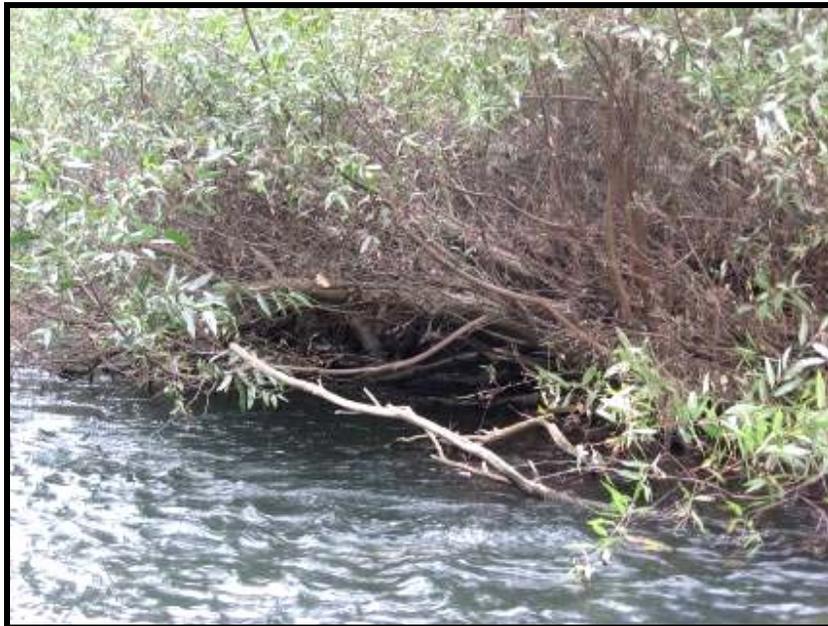
Photograph 14: Overhanging willows and other vegetation providing cover.

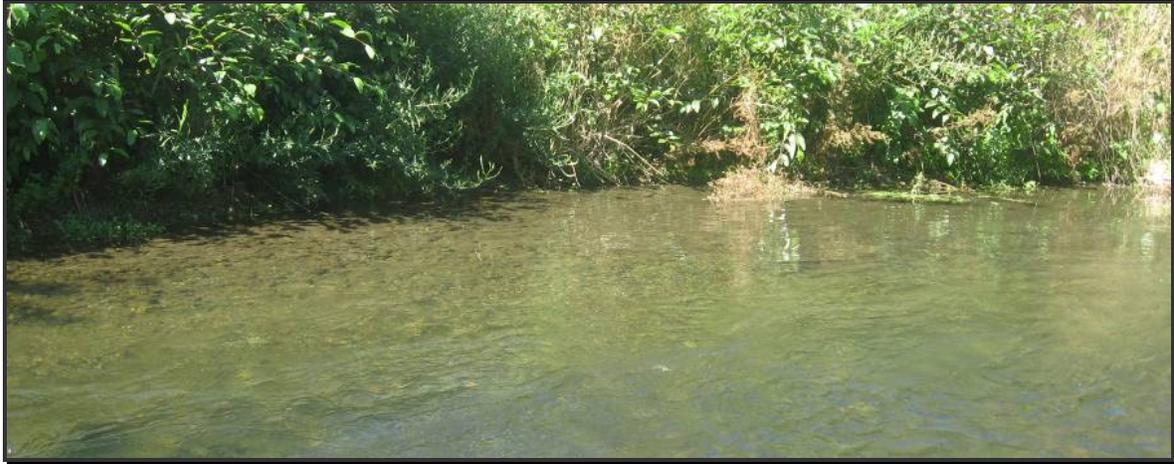
Photograph 15: Example of shallow “Edge” habitat in Reach 7.

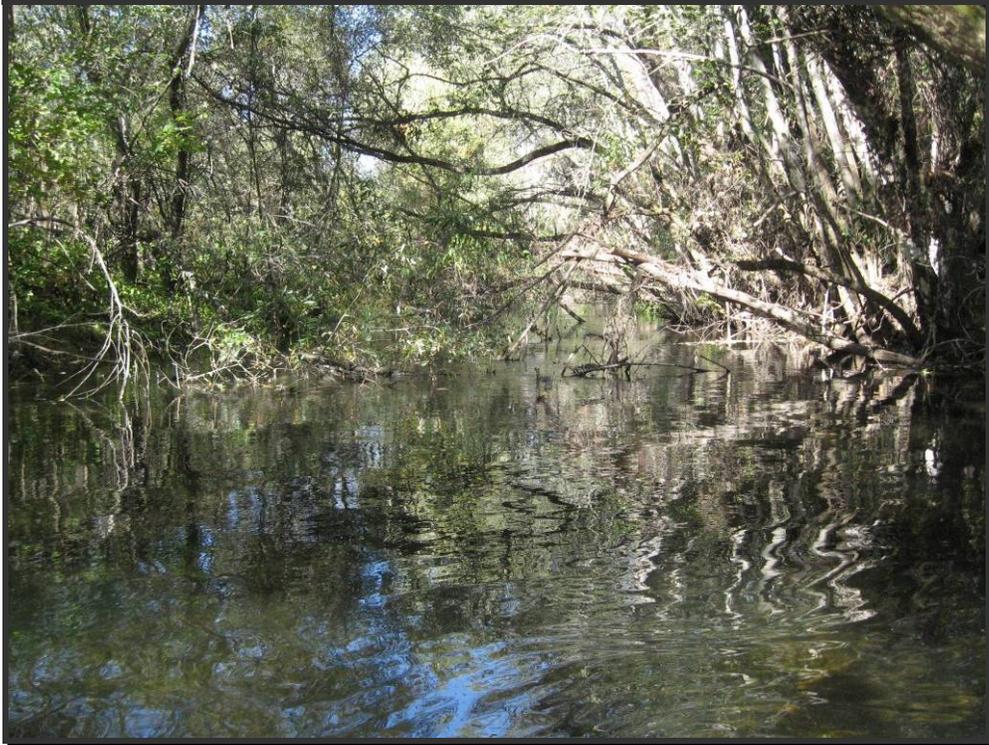
Photograph 19: Potential backwater channel / side channel analog site on Dry Creek upstream of Westside Bridge, RM 2.2. Additional large woody debris would be included in proposed designs of similar habitat.

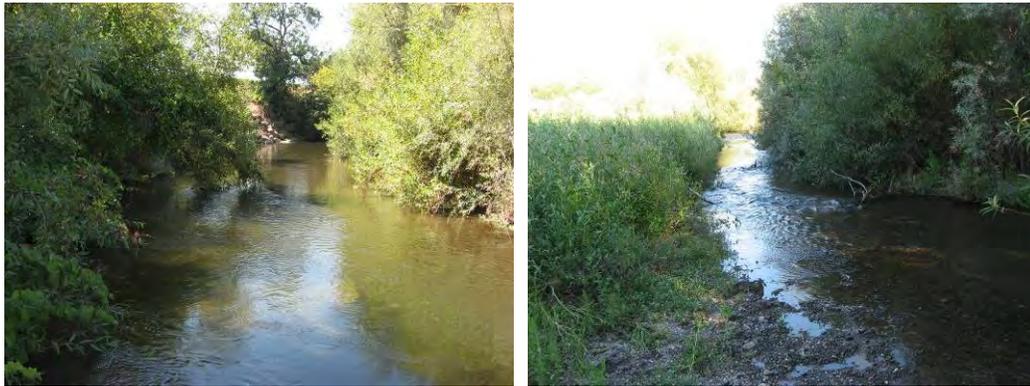
Figure 4: (left) A typical pool in Reach 1 with overhanging vegetation, (right) the 150', glide-dominated side-channel.

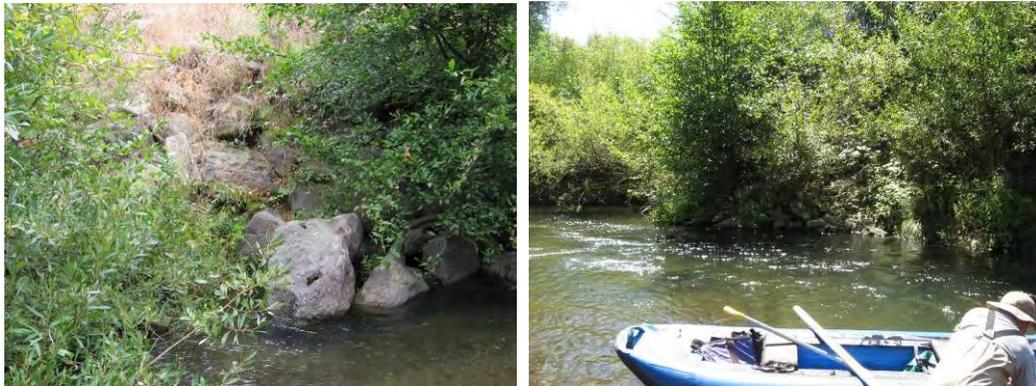
Figure 7: (left) Boulder riprap along streambanks, (right) a pool with riprap along the right bank.

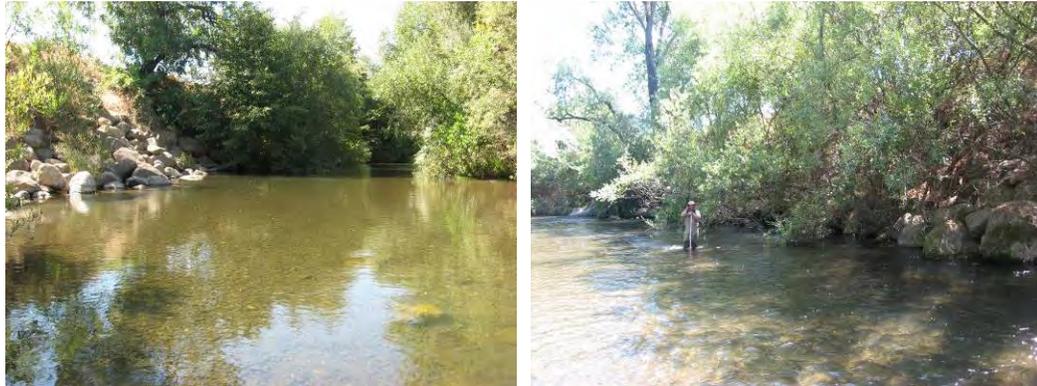
Figure 9: Glide habitat units in Reach 2, with riprap along the banks.

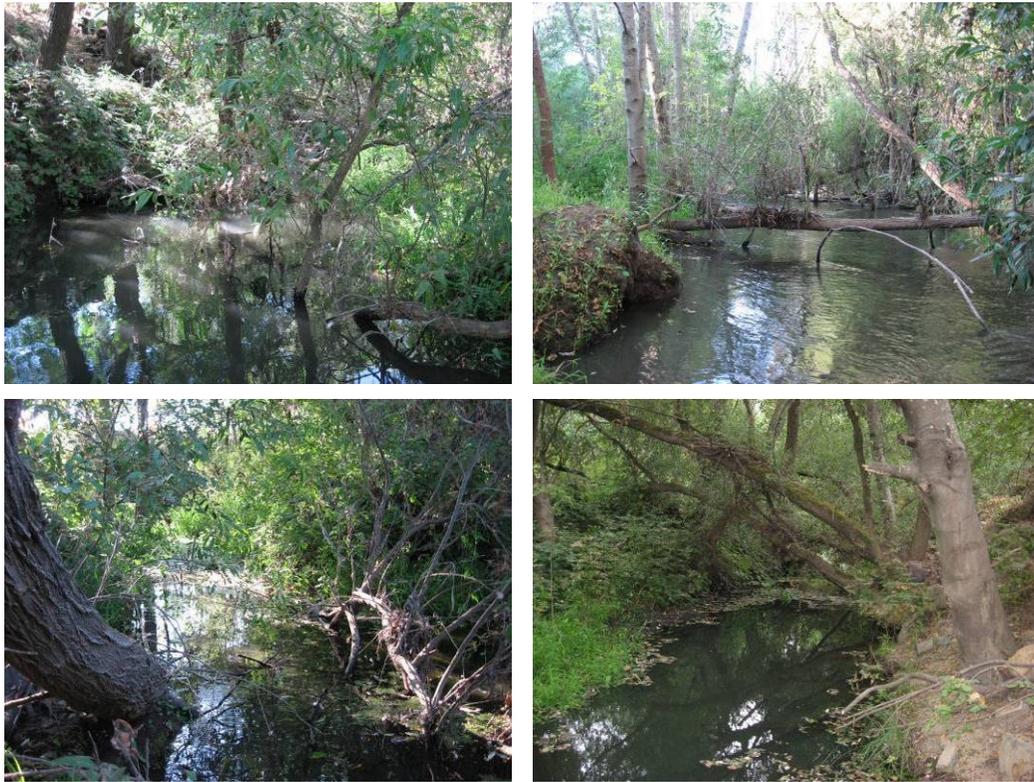
In the eight side channels, most of the substrate was fine sediment and sand, with some gravel. Seven out of the eight side channels were pool-dominated, with one flatwater-dominated. Maximum depths in pool-dominated side-channels averaged 2.9 feet, with only one over three feet deep. The flatwater-dominated side channel was 0.8 feet deep on average. There was one long side-channel on left side that extends for a few hundred feet with pools and flatwaters, woody debris and other cover. This side-channel is deep

(~3.5') and wide (~30') and abuts the terrace wall. A smaller side channel and alcove on the channel right side provides additional habitat.

Figure 17: (top row) side-channel habitat units, (bottom row) alcoves in Reach 3.

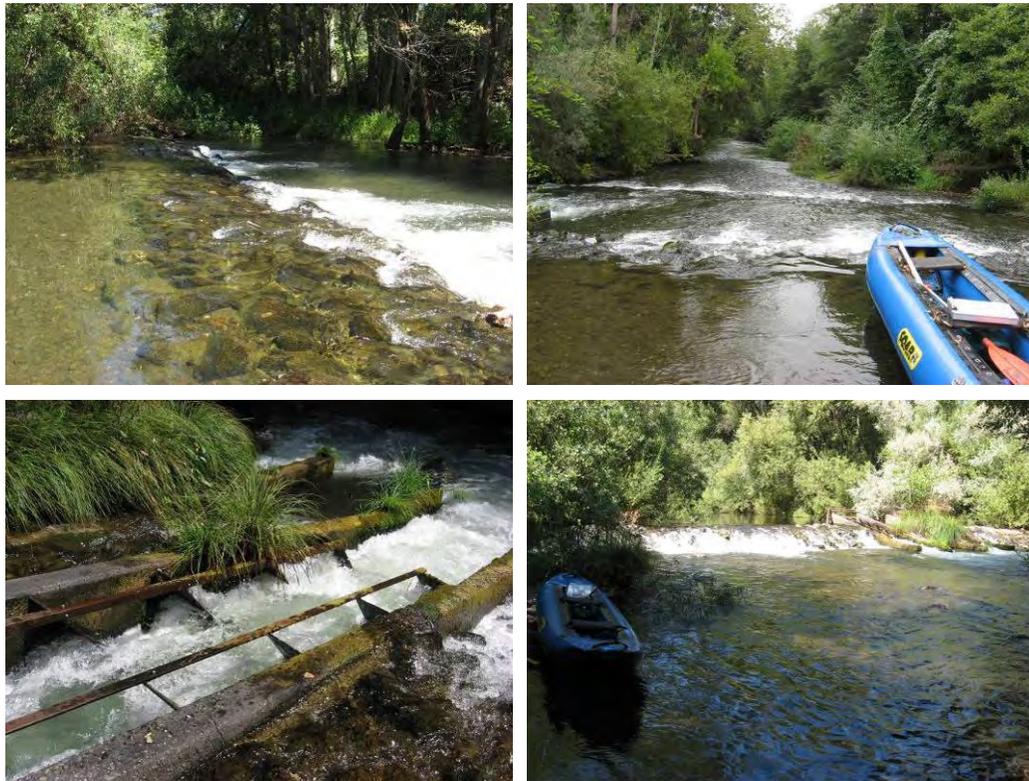
Three gradient sills were constructed in 1983 by the ACOE to slow migrating nick points and associated channel incision in lower Dry Creek. This reach is vertically stable due to the check dams. The backwatered pools created by each sill extended several hundred feet upstream, forming a pool-dominated reach. The upper sill (RM 3.8) consisted of a cascade down two sets of boulder falls, 2' and 1' in height. The middle sill (RM 3.5) was 200' long, 10' wide, and 3' in height. The lower sill (RM 3.3) was 100' long, 10' wide, and 1 foot tall. Each sill has a fish ladder to provide passage through the short cascades. Rock riprap covers the right bank between the upper and middle sill, and short sections of boulder riprap cover both banks upstream and downstream of each sill. An unnamed tributary enters Dry Creek just downstream of the lower sill at river mile 3.25.

Figure 18: (upper left) lower sill, (upper right) upper sill, (lower left) ladder on middle sill, (lower right) middle sill.

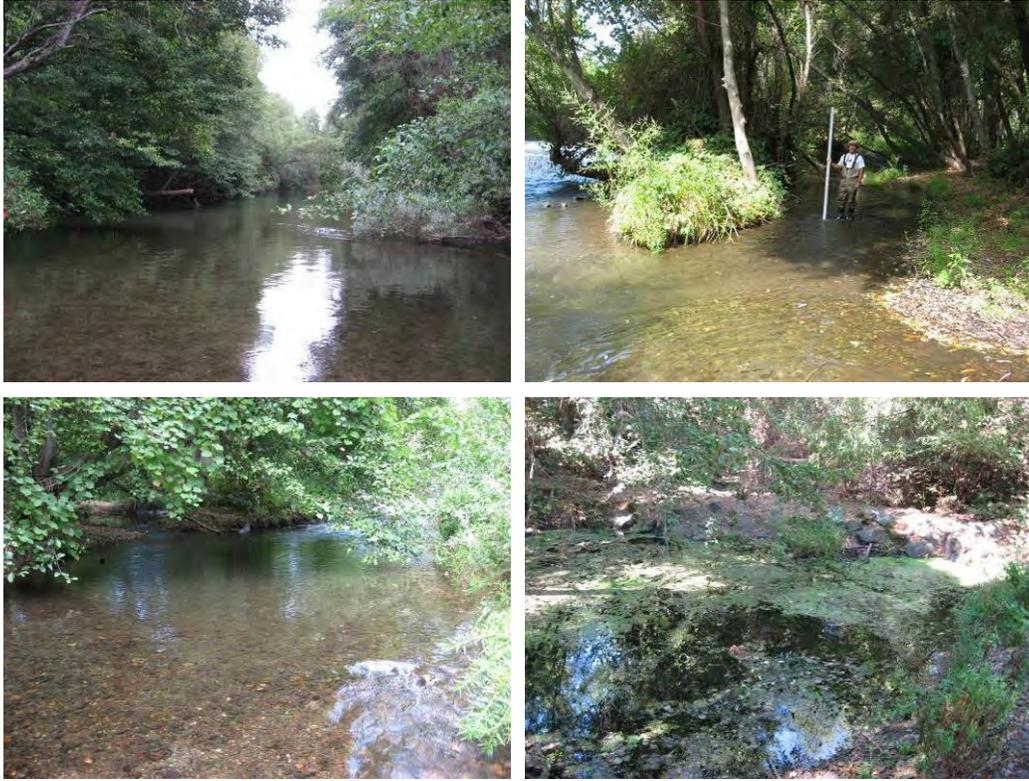
Figure 22: (upper left) long pool above upper sill, (upper right) alcove off upper sill, (lower left) side-channel habitat, (lower right) aquatic vegetation in alcove near middle sill.

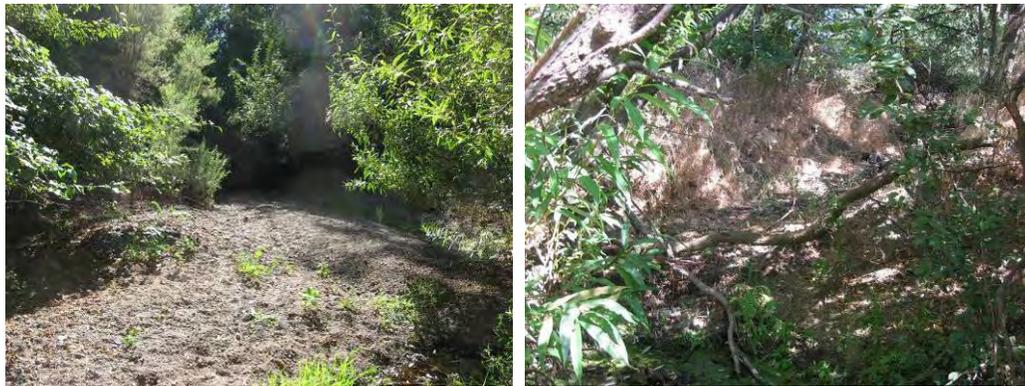
Figure 23: (left) mouth of Kelley Creek, (right) mouth of unnamed tributary.

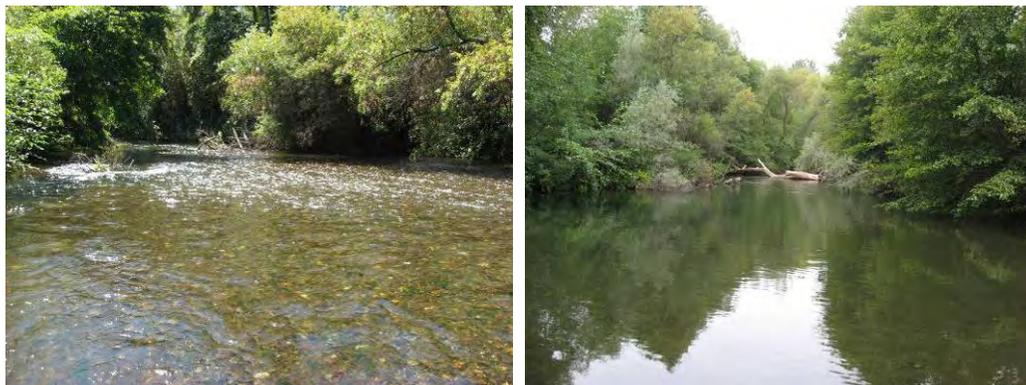
Figure 28: (left) riffle habitat unit, (right) long, deep pool with woody debris.

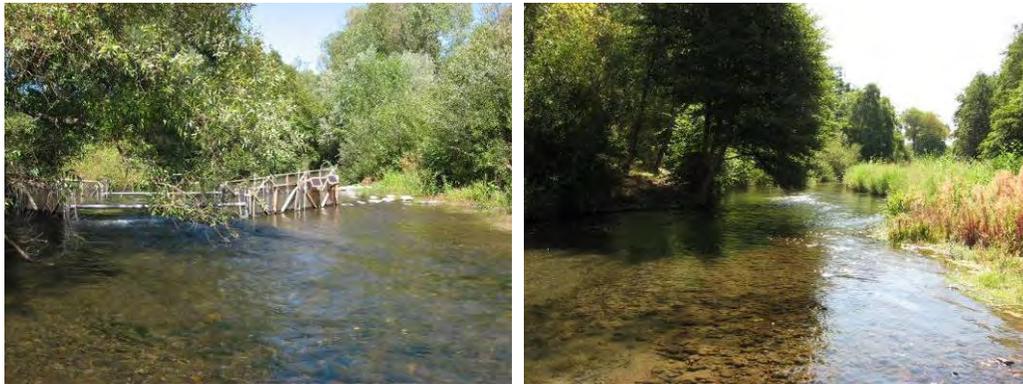
A PIT tag antenna was located in the middle of the reach at the time of the survey (Figure 29). Car bodies and riprap were observed for 500 feet along the streambanks at the downstream end of the reach. The upstream end of this reach terminates at the first visible expression of bedrock in the channel.

Figure 29: (left) adult fish monitoring station, (right) scour pool.

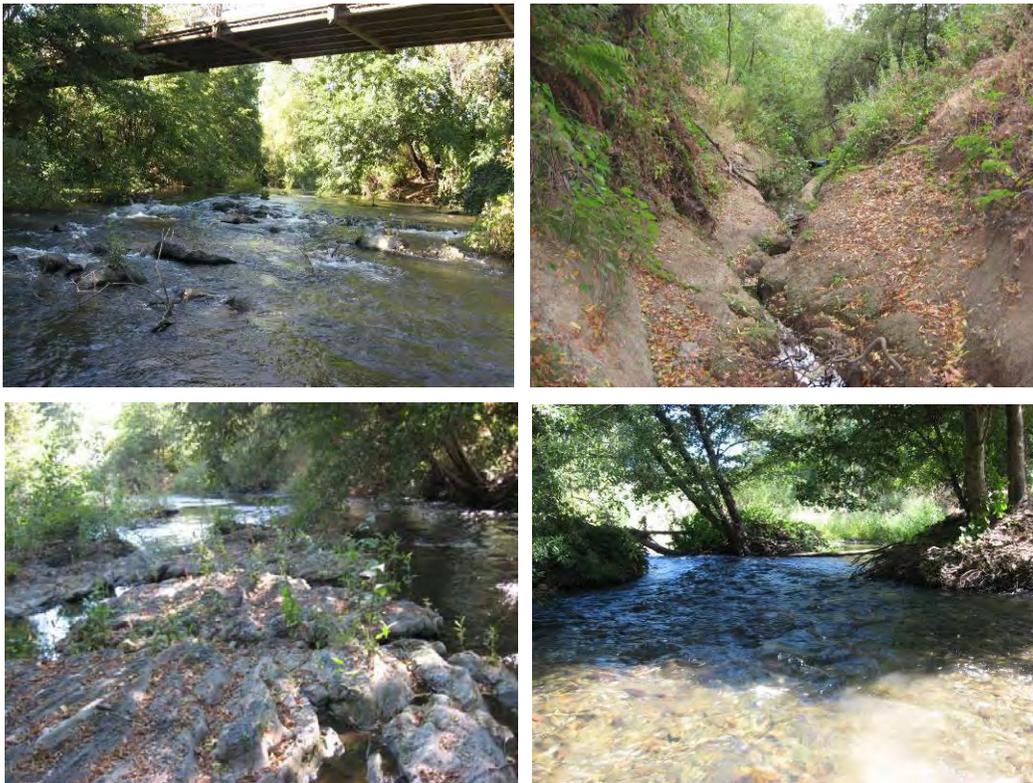
Figure 33: (upper left) cascade under Lambert Bridge, (upper right) mouth of Crane Creek, (lower left) bedrock outcrop, (lower right) riffle where Grape Creek enters Dry Creek.

Substantial incision has occurred through this reach, but the bedrock outcrops have limited further degradation. The most apparent bedrock outcrop is the bedrock cascade under the Lambert Bridge, but there are also outcrops at river mile 6.4 between the unnamed tributary and Crane Creek, at the mouth of Grape Creek and upstream of Grape Creek. These occasional bedrock extrusions provide cover for fish, influence pool formation, and control stream gradient. Despite the bedrock outcrops, the dominant substrate is gravel, followed by sand.

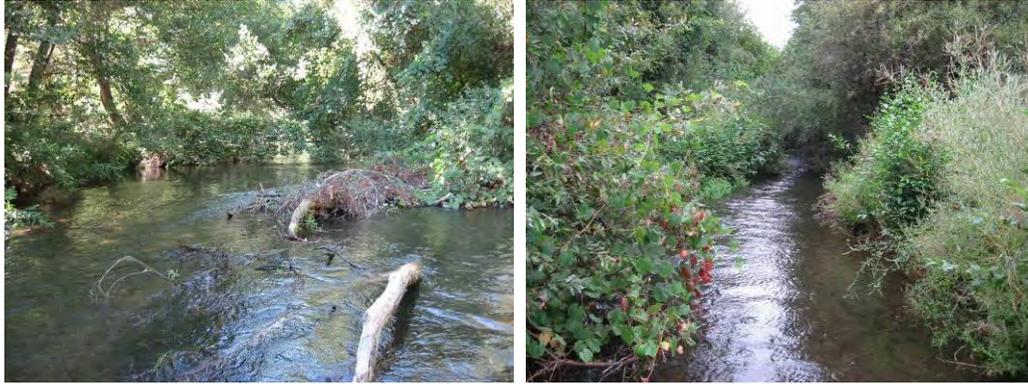
Of the three side-channels in Reach 7, two were flatwater dominated and the third was riffle-dominated. The average side-channel depth was 0.8 feet. One of the flatwater-dominated side channels was 530 feet long (Figure 39), and 20 feet wide. This side-channel contained pools and riffles, as well as longer flatwater sections, with gravel with

Figure 39: (left) wood associated with a scour pool, (right) side channel D183.

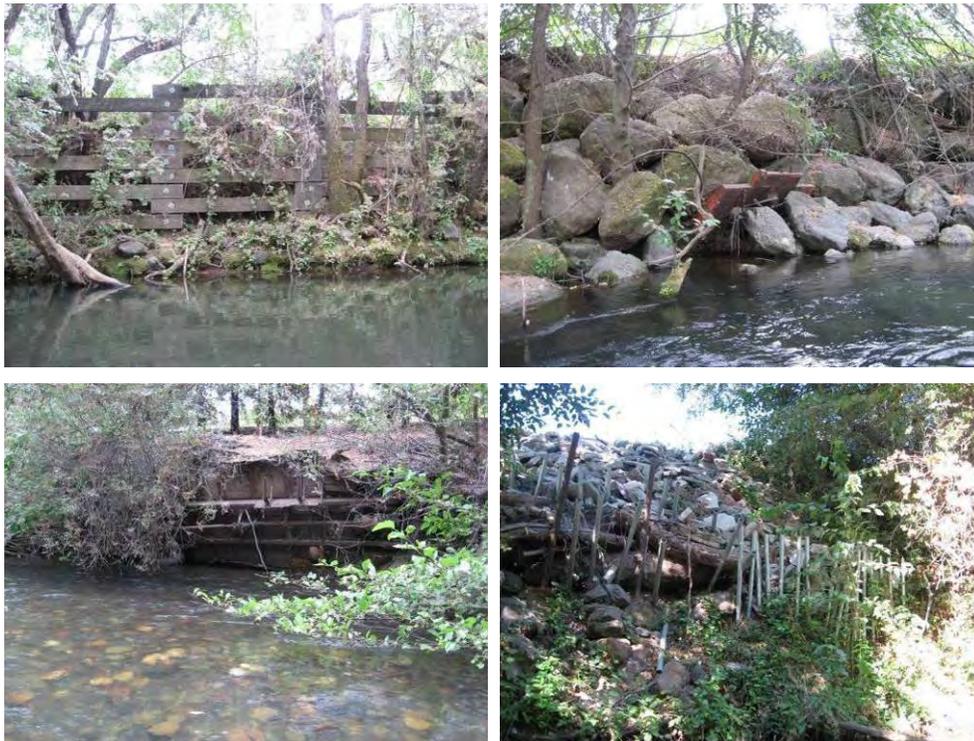
Nearly all of the various types of bank stabilization techniques applied in Dry Creek are present throughout Reach 8 (Figure 40). Approximately 2500 feet of banks are armored with large boulder riprap, some of it including car parts intermingled with the boulders and riprap. An old truckbed is used to stabilize one streambank at river mile 8.8, and a mix of metal pipes, logs, and rocks have been used to shore up another bank at river mile 7.9. Board fence lined 750 feet of the right⁵ bank at river mile 8.5. A dry, unnamed tributary enters on the left bank at river mile 8.9.

Figure 40: Bank stabilization features. (upper left) Board Fence, (upper right) boulder riprap with car parts, (lower left) a truck bed, (lower right) metal poles with logs and rocks.
