**Current Conditions
Inventory Report**

**Dry Creek:
Warm Springs Dam to
Russian River**

Sonoma County, CA

December 2, 2010

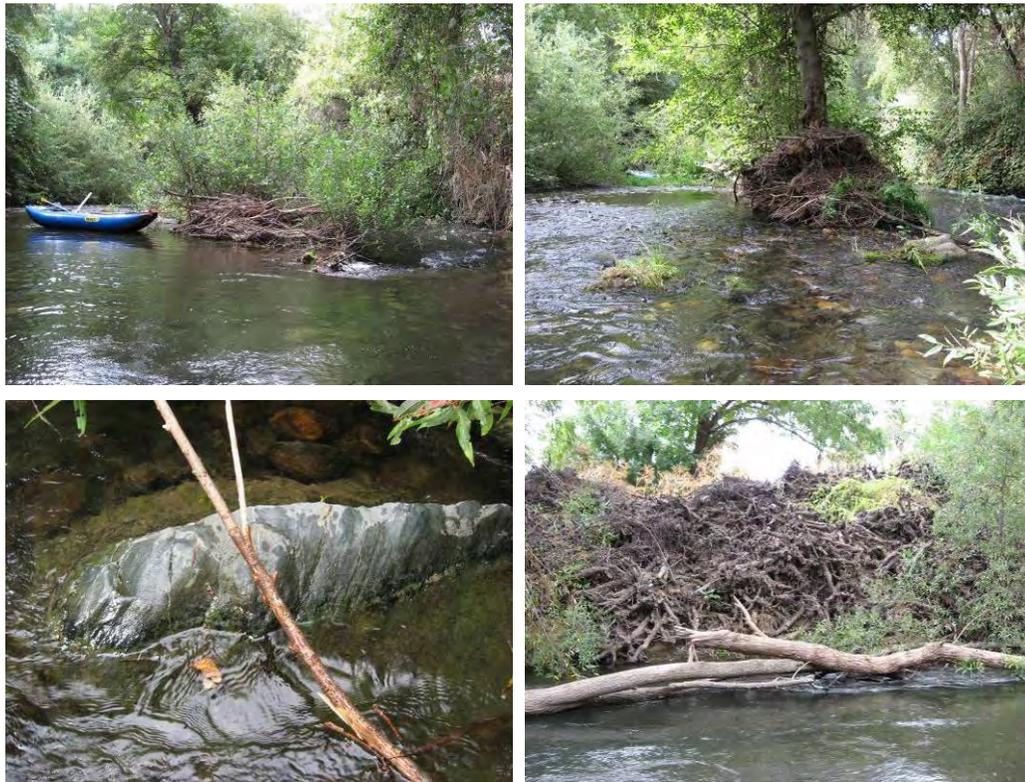
This reach contains significant length of stabilized streambank. From the start of Reach 10 at river mile 9.8, boulder riprap lines the right⁷ bank for 0.3 miles upstream. At river mile 10.1, the tall, eroding left bank is covered with dead grapevines (Figure 49). The right bank at this site has a wide floodplain. Last, at river mile 10.3, I-beam and chainlink fence stabilization structures have been built along the left bank for 250 feet.

Figure 49: (upper row) vegetated islands in the middle of a riffle, recruiting small woody debris and creating a small scour pool, (lower left) native green boulder, (lower right) dead grapevine dump to stabilize the bank.

Also in Reach 10, large, possibly native sourced boulders were observed in the stream, lime-green rocks w/white veins, 3'x3' boulders in substrate at river mile 10.2.

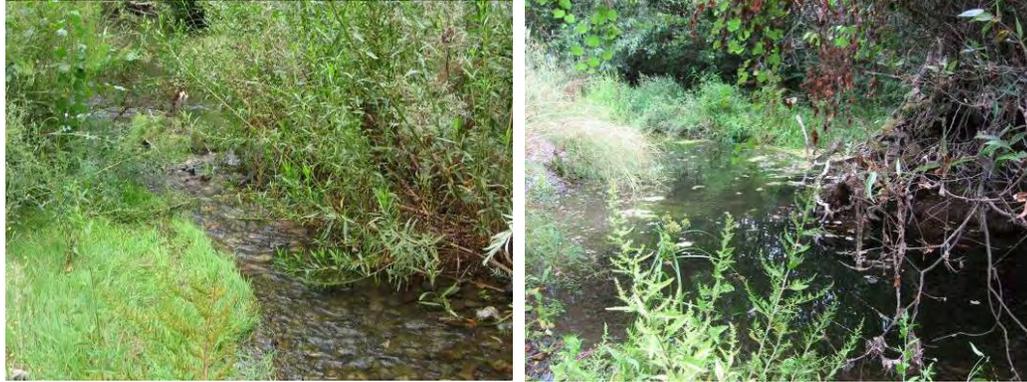
One riffle-dominated side channel in Reach 10 was measured, with a length of 70 feet, a width of 7 feet, and an average depth of 0.3 feet (Figure 53). Substrate was gravel, with small cobble.

Figure 53: (left) side channel, (right) alcove habitat.

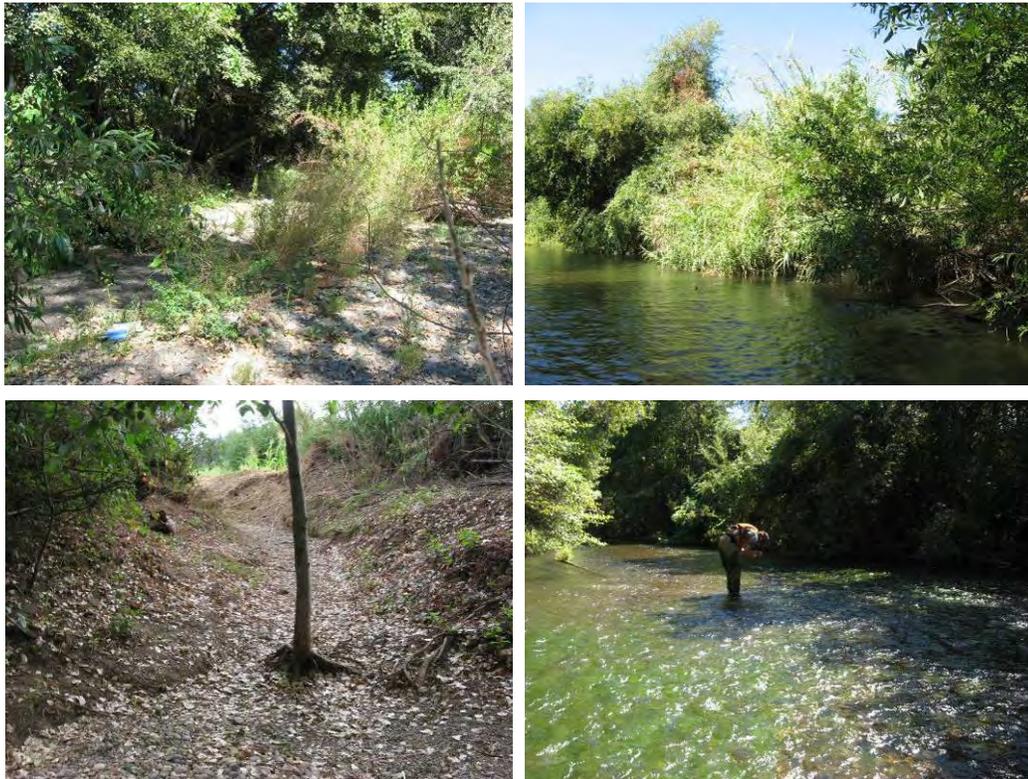
Reach 11 contains several notable features (Figure 54). First, the upper boundary of Reach 11 is the confluence of Pena Creek with Dry Creek. The mouth of Pena Creek remains watered in the summertime, as serves as a 100 foot by 25 foot-wide alcove. The Pena Creek inlet was also hopping with hundreds of small frogs at the time of the survey. The Pena Creek watershed is the largest of the tributaries in the study area (22.3 mi²) and contributes substantial quantities of flow and sediment to Dry Creek.

Reach 11 flows under Yoakim Bridge at river mile 10.7. A flow gage that operated in the past is located on Yoakim Bridge. Concrete and concrete chunks 200 feet downstream of the bridge along the left⁸ bank and across the channel cause a small cascade in the mainstem. At river mile 10.45, an intermittent stream enters on the left bank of Dry Creek. A car body is partially buried in the left bank of this tributary, and vegetation has been cleared from all of the banks.

Figure 54: (upper left) A large gravel bar in Pena Creek 100 feet upstream from its confluence with Dry Creek, (upper right) an invasive grass (*Arundo donax*) grows on the right bank just downstream from Pena Creek, (lower left) small, intermittent stream with cleared banks, (lower right) Pebble count being conducted in a riffle in Reach 11.

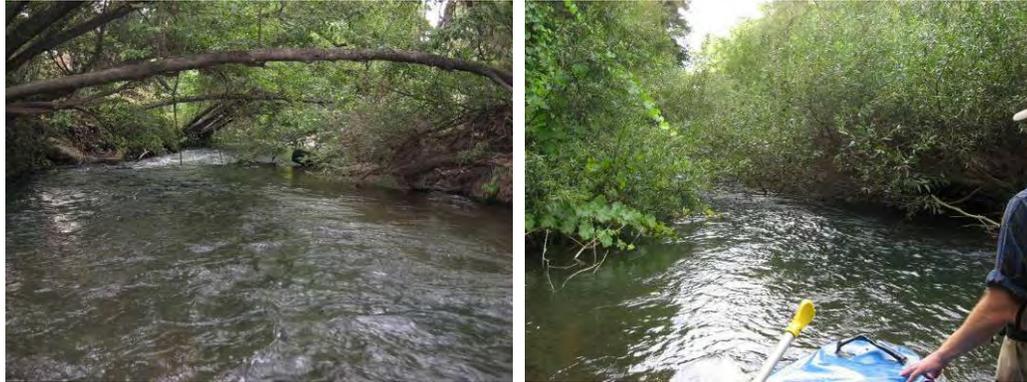
Figure 59: (left) glide habitat in Reach 11, (right) a deep pool with overhanging willows.

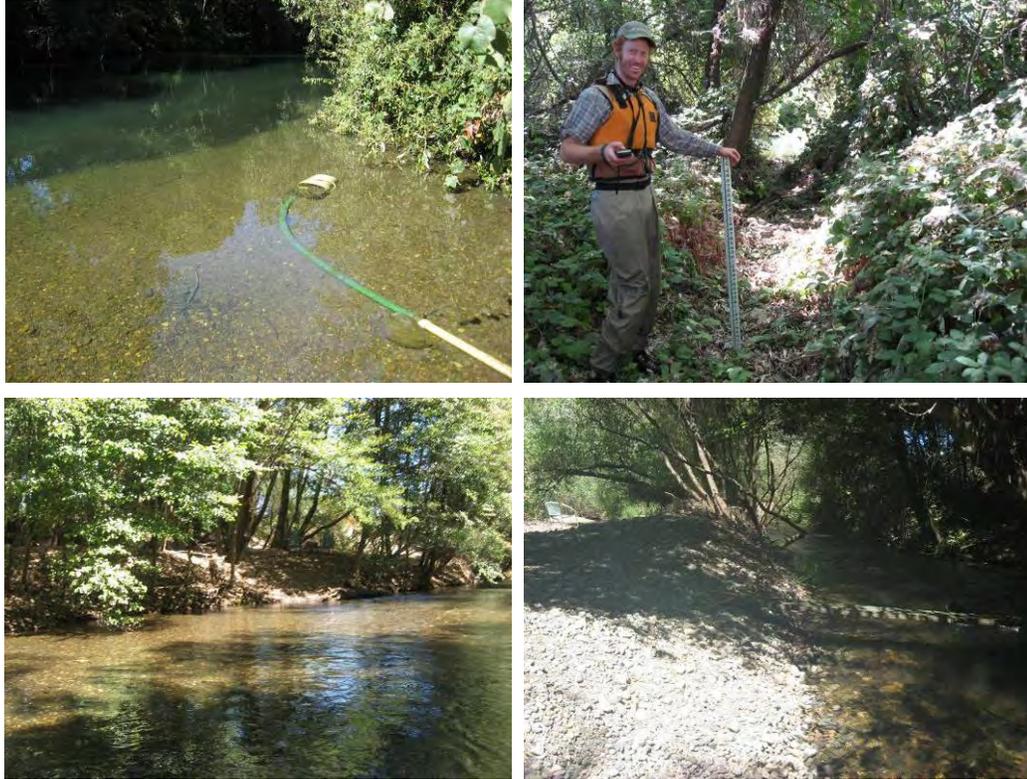
Figure 60: (upper left) pump in Dry Creek at river mile 11.75, (upper right) tributary at river mile 11.6, (lower left) straight bermed streambank along left bank, (lower right) gravel bar at river mile 11.75.

At river mile 11.65, a gravel bar forms along the left bank. Riprap bank stabilization covers the streambanks for about 800 feet throughout Reach 12. Riprap boulders have tumbled into the creek from these bank protection measures and provide some cover. A fault lineament runs along the left bank for the lower half of Reach 12.

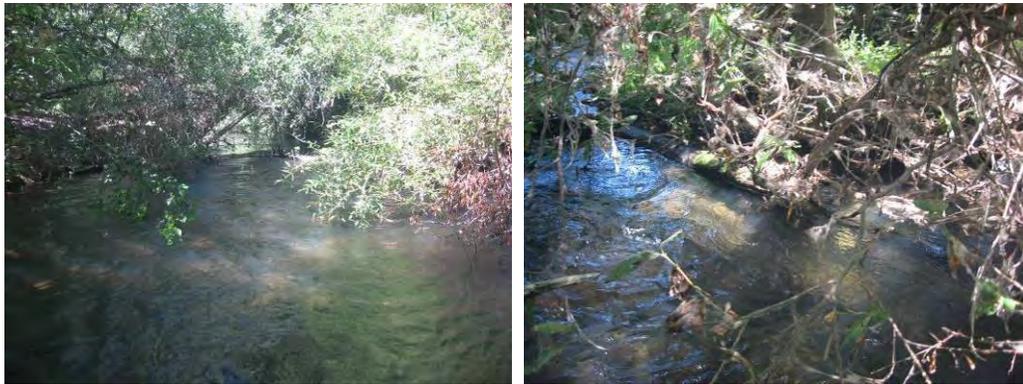
161 pieces of wood were categorized in Reach 12. Of these, 44% were in pools (Table 12). The highest densities of woody debris were found in side channels and in scour pools. Only three large pieces of wood were observed in Reach 12, one of which was in a side channel. Overall, cover was provided by overhanging vegetation and woody debris (Figure 64). Some cover was provided by boulders associated with bank stabilization measures, and boulders in riffles, root masses provided some limited instream cover. Edge habitat was associated with four out of the eight pools in Reach 12, and with a side channel and an alcove.

Figure 64: (left) green tunnel of riparian vegetation, (right) vegetation providing instream cover.

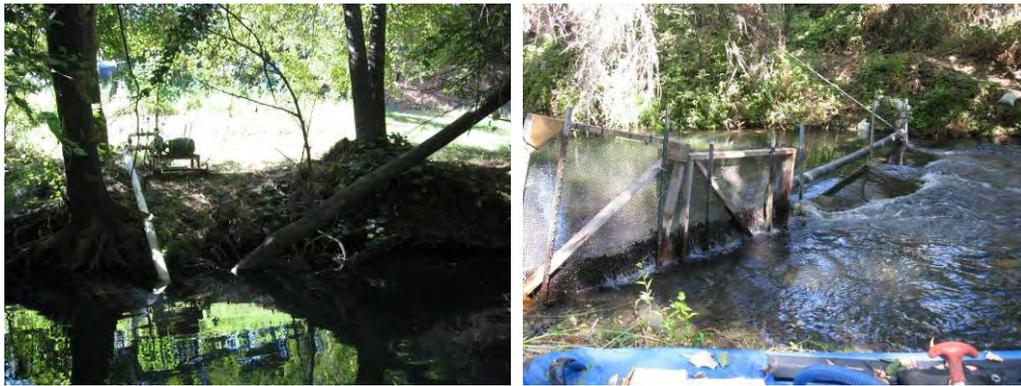
A pit tag recording station at river mile 12.05 creates a short riffle. A pump was observed on the left bank at river mile 12.1, with boulder riprap on the opposite bank along the pool unit. A short section of riprap armored the left bank at the top of the reach.

Figure 65: (left) Pump in Dry Creek, (right) Pit-tag antennae spans Dry Creek.

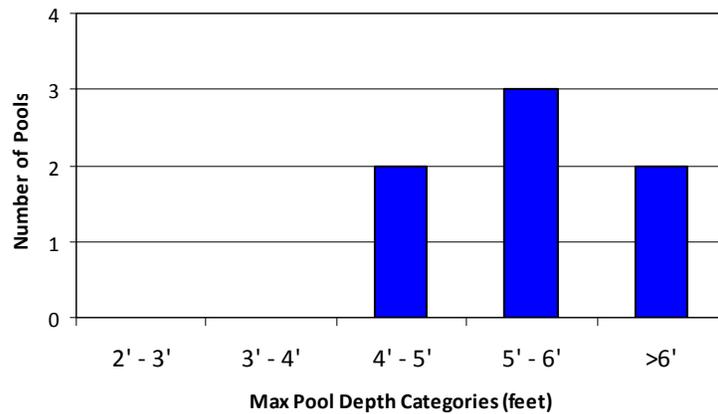
All of the eight pools measured in Reach 13 were greater than three feet deep (Figure 67). The average pool depth was 5.7 feet (stdev1.5). The average residual pool depth was 3.8 ft, and the average pool crest depth was 2.0 ft. Substrate in pools was gravel with cobbles and some sand.

Figure 67: Maximum Pool Depths in Reach 13.

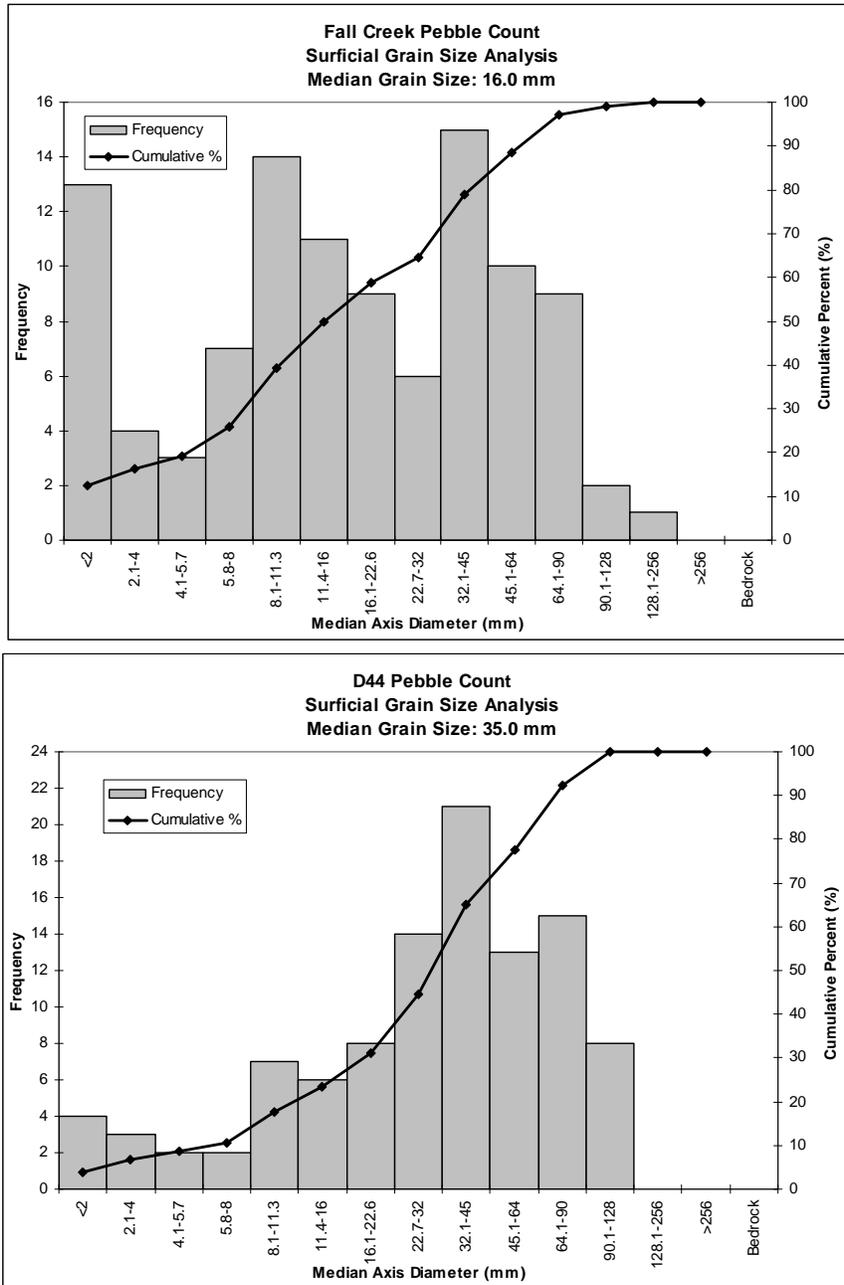
Water depths in the riffles and flatwaters were 1.2 ft and 2.2 ft respectively during the survey. The bed material in reach 13 is primarily gravel with some small and large cobbles throughout the reach. Material in the riffle immediately downstream from the Fall Creek confluence ranges from sand to small cobbles but is primarily composed of coarse gravel to small cobble. The median grain size for this riffle is 35 mm (Figure 68). 83% of the sediments are within ideal spawning sizes, and 55% are within ideal fry rearing sizes. 4% of the samples were fine sediments or sand.

The bed material of Fall Creek is smaller (median grain size of 16 mm) than that found in Dry Creek.

Figure 68: Grain size distribution for the channel bed of Fall Creek and for a riffle on Dry Creek downstream of the Fall Creek inflow (habitat unit #44).

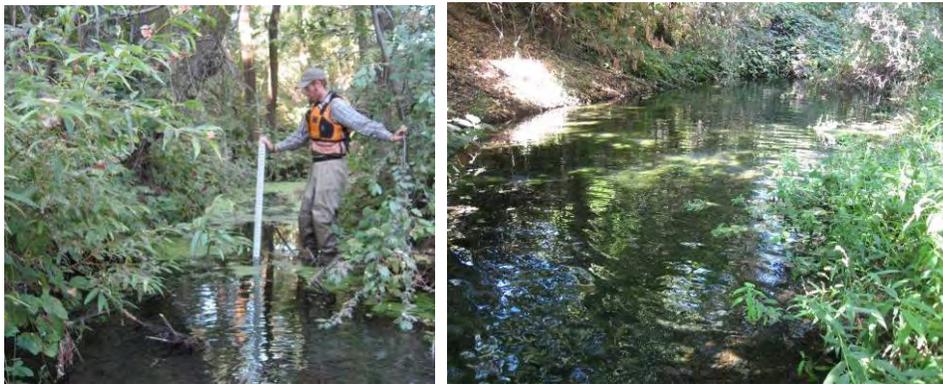
Overall, wood density in this reach of Dry Creek was 160 pieces per mile. A total of 141 pieces were counted, with 86 counted in pools. The highest densities of wood were in pools and alcoves. Of the six large pieces >20” diameter, three were located in pools. Instream cover was mainly provided by terrestrial vegetation and small woody debris, with some root mass cover provided in riffles. Aquatic vegetation with small woody debris provided abundant cover in alcoves (Figure 69). Edge habitat was observed in four pools, a riffle, a flatwater, and two alcoves.

Figure 69: Alcoves in Reach 13 with abundant cover provided by aquatic vegetation.

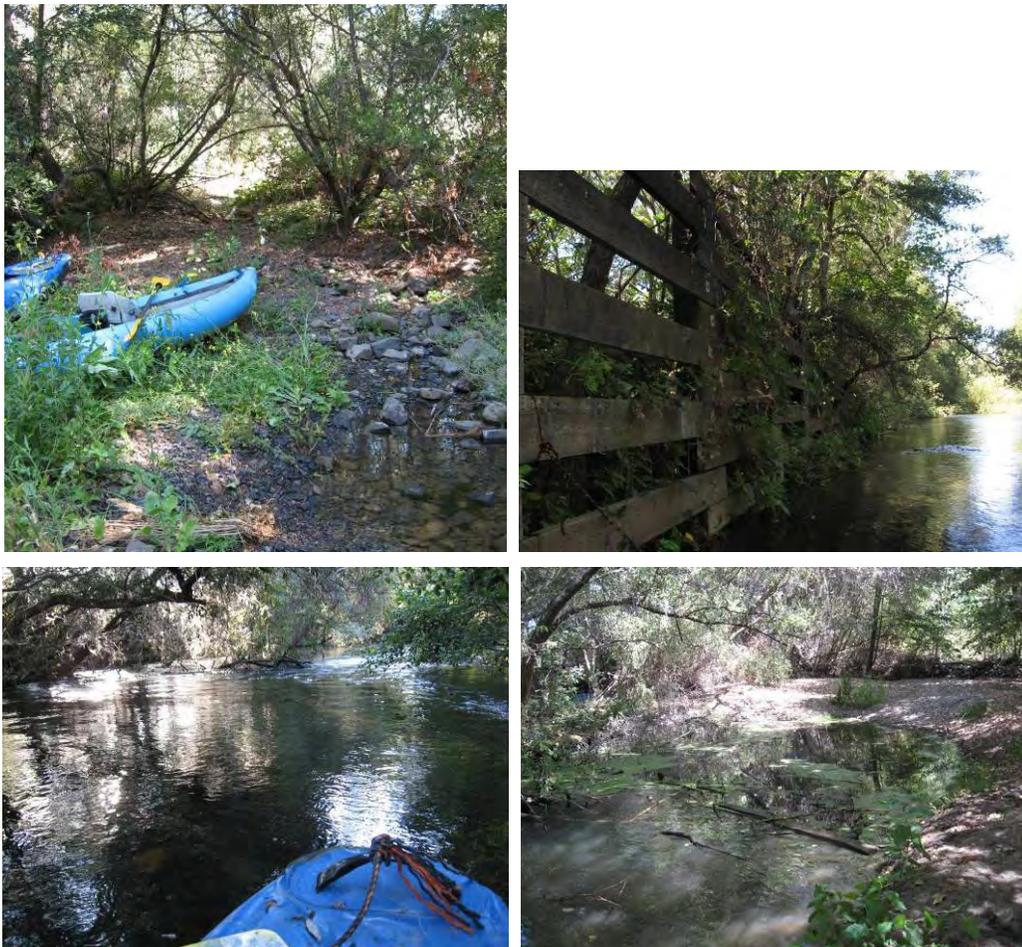
Board fence bank protection was constructed along the lower 500 feet of the right¹¹ bank of Reach 14. Riprap boulder bank armor was installed along the banks near the upstream end of the reach for about 1,200 feet. Some litter was observed in Reach 14, including a ¾” black pipe on the left bank that disappears into the floodplain forest at river mile 12.9, and tires in the center of a flatwater at river mile 13.3 at the top of the reach.

Figure 70: (upper left) mouth of Schoolhouse Creek, (upper right) board fence along the right bank, (lower left) deep pools with interacting live tree cover, (lower right) alcove habitat with aquatic vegetation.

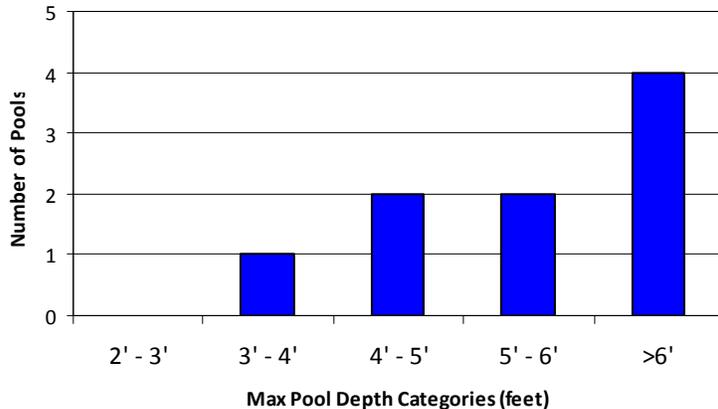
There were 9 pools in Reach 14, 3 of these were scour pools. All of the pools had a maximum depth greater than 3 feet, eith average maximum pool depth of 5.7 feet (Figure 72). The average residual pool depth was 4.4 feet, and the average pool crest depth was 1.4 ft. Substrate in the pools consisted of gravel with sand, with some small cobble.

Figure 72: Maximum Pools Depths in Reach 14.

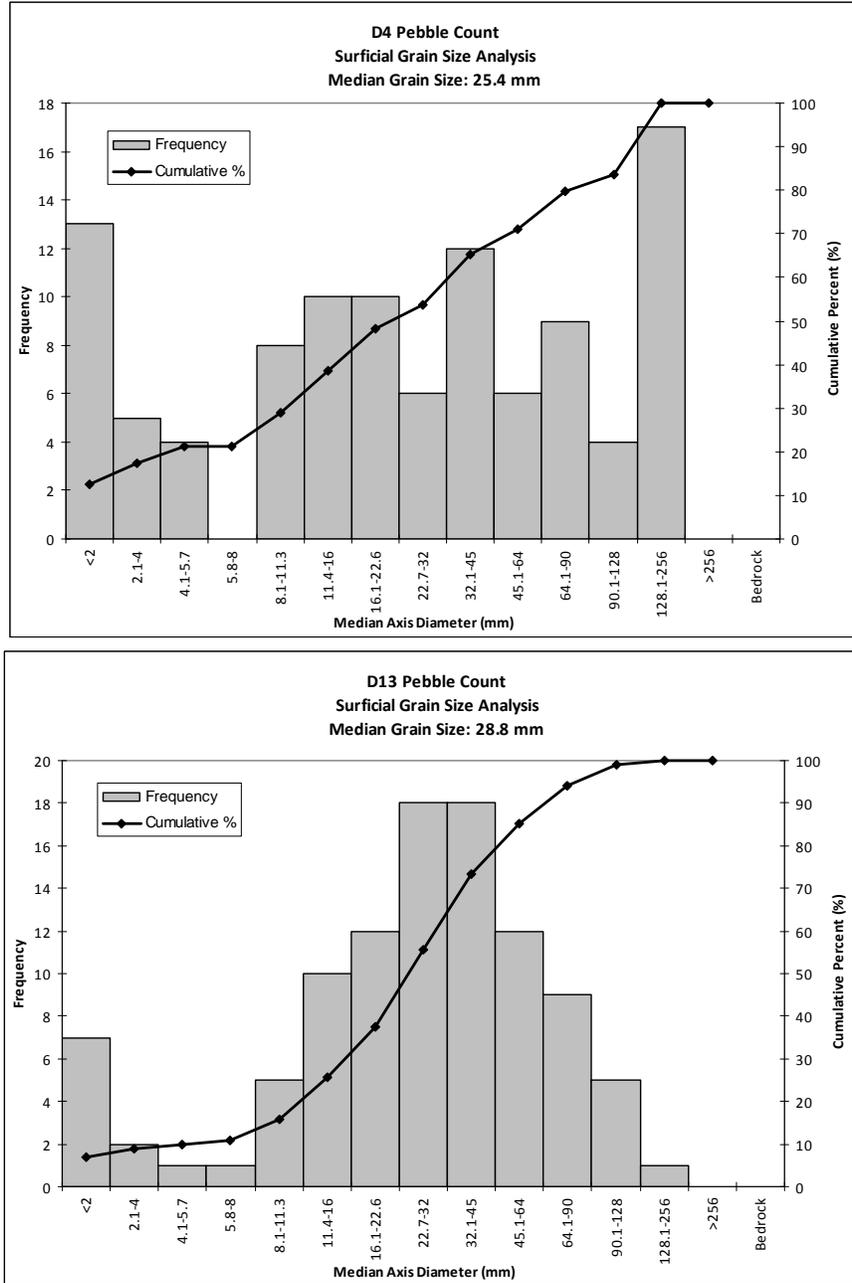
There were 9 riffles and 6 flatwaters in Reach 14. The average riffle depth was 1.1 feet, and the average flatwater depth was 2.3 feet. Substrate in riffles and flatwaters was gravel and small cobble. The bed material of two riffles were sampled, one at the upstream extent of the reach and the second approximately 0.25 miles downstream. The upstream riffle was primarily composed of medium to very coarse gravel with a median grain size

of 25 mm. The downstream riffle was primarily composed of coarse to very coarse gravel with a median grain size of 29 mm.

Figure 73: Grain size distribution for two riffles in reach 14 (habitat units #4 and #13).

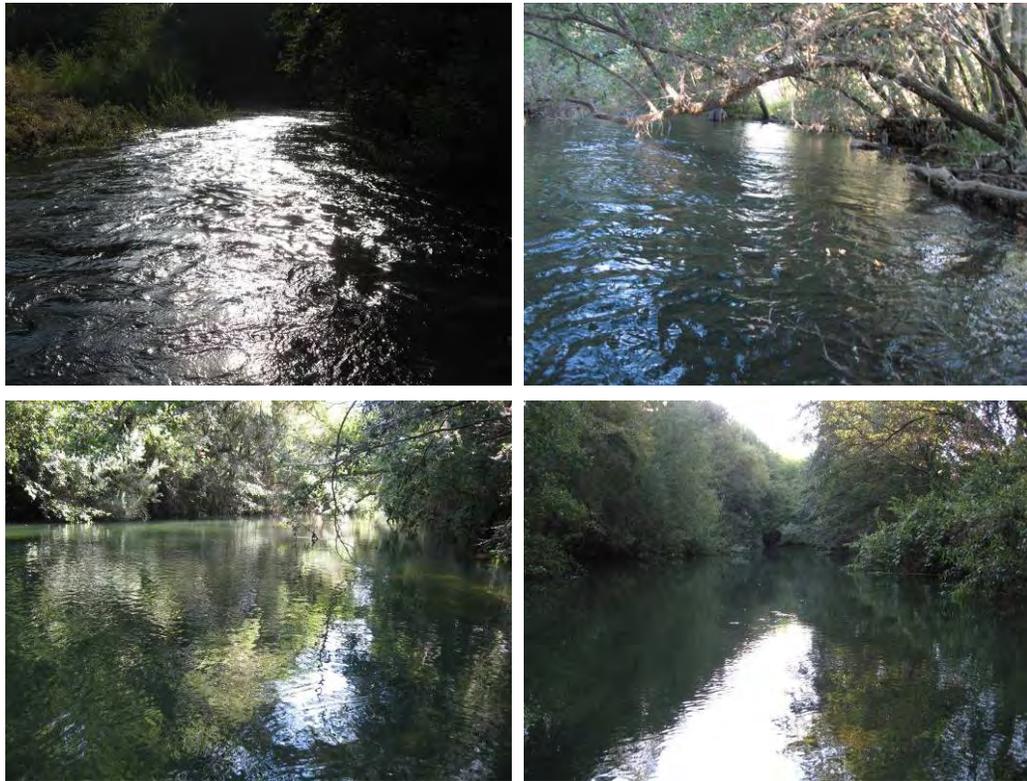
At the Bord Bridge, a boulder revetment associated with the bridge armors the right¹² bank. Higher on this bank, there is evidence of an older wood revetment. The high canopy cover in this reach is provided by California bay, willow, alder, and cottonwood. Himalayan blackberries and other exotics were present on both banks, but overstory vegetation dominates. An old board fence with metal mesh and cable covers part of the right bank along a pool unit. In general the banks were steeper on the right, and with a more gradual floodplain on the left bank.

Figure 74: (upper left) the riffle under Bord Bridge, (upper right) canopy cover, (lower left) deep, slow pool unit downstream, , (lower right) the long pool.

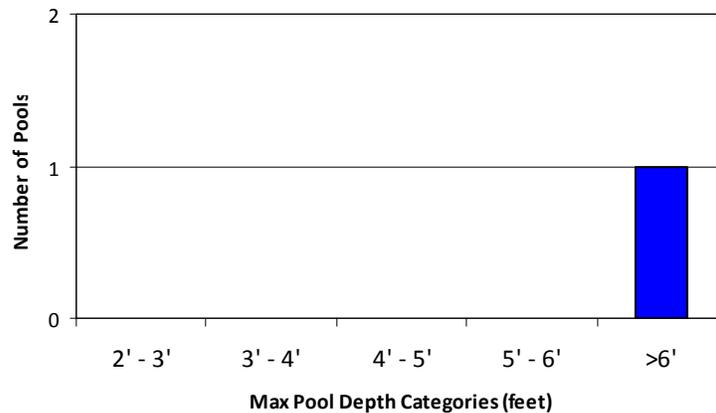
The single, very long pool in Reach 15 had a maximum depth of 7.0 feet. The residual depth was 4.5 feet, with a pool crest depth of 2.5 feet. Substrate in this pool was gravel with small cobble.

Figure 76: Maximum Pool Depth in Reach 15.

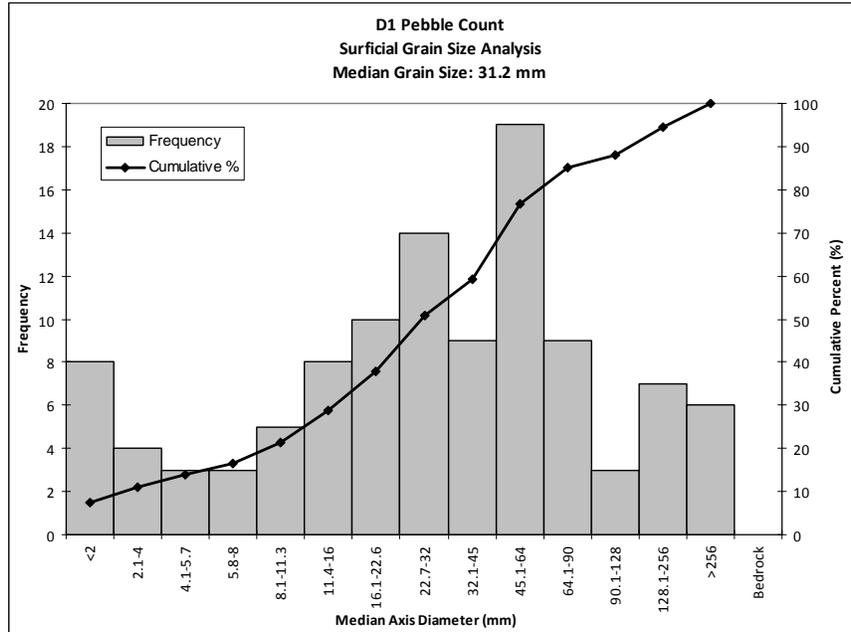
The short, 48 foot long riffle had an average depth of 1.0 foot. The bed material is primarily gravel with some small cobbles. The material in the riffle is primarily coarse to very coarse gravel but ranges from sand to small boulders. The median grain size for this riffle is 31 mm (Figure 77). 67% was within ideal spawning sizes for coho and steelhead (11.4 to 128mm), and 37% was within ideal juvenile rearing sediment sizes (32mm to 128mm). 7% of the samples were sand or fine sediments.

Figure 77: Grain size distribution for the riffle below Bord Bridge in reach 15 (habitat unit #1).

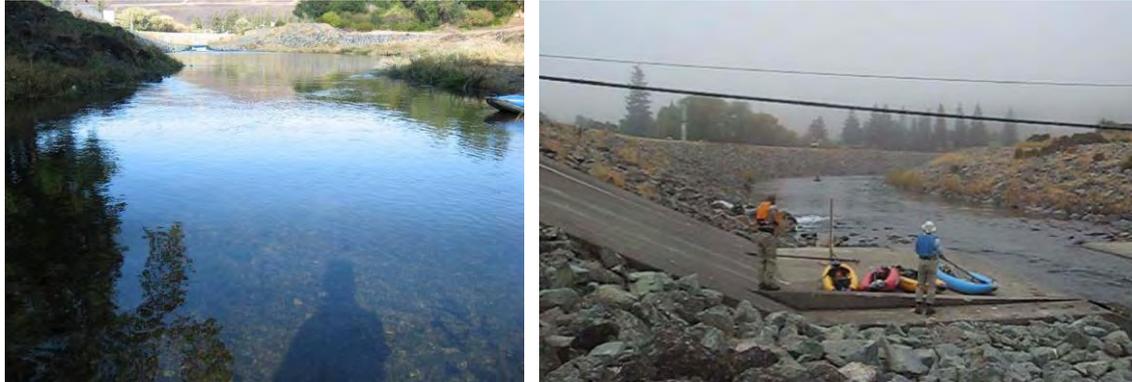
Reach 16 extends upstream from Bord Bridge to a flow measuring flume immediately below Warm Springs Dam. From the outlet of the dam, water flows through a constructed channel and over two drop structures before spilling into a deep pool (>12 feet deep) immediately upstream of the Bord bridge. Boulder revetments cover both banks within this constructed channel.

Figure 78: (left) looking upstream at the deep pool downstream of the measuring flume structure, (right) preparing to launch from the measuring flume structure.
