Figure 4-42

Petaluma River Watershed

FIGURE 4-43

Reaches and Vegetation Zone 2A (1 of 5)

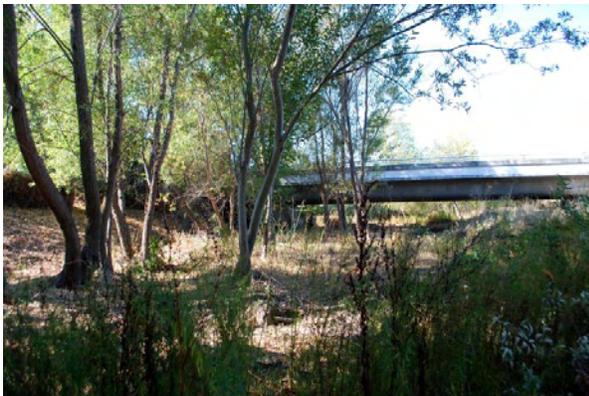
(b) Lichau Creek, lower Reach 3, looking downstream to McDowell Blvd. crossing. Taller willows to left indicate edge of active channel further to left. Tall willows grow on natural crowning levee that separates the active channel (left) with the adjacent bench-floodplain to right. McDowell Blvd. bridge is a single span crossing that won't catch debris during high flows. Earthen southern bank (2:1) seen to left (October 26, 2008).

Immediate management considerations at Lichau Cr. Reaches 3 and 2 focus on vegetation management, with the selective thinning and removal of cross limbs that border the low-flow channel (photo b) and are found throughout the bench-floodplain north of the low-flow channel. Floodway appears large enough, and McDowell Blvd. bridge set high enough that loss of channel capacity does not appear to yet be an issue. However, over the longer-term sediment accumulation will continue on the bench-floodplain, so hydraulic conditions and available flood capacity should be evaluated annually. Other considerations include the shearing and vertical sections of the southern bank, which may need stabilization over time. The southern bank throughout Reaches 3 and 2 should be annually inspected for further erosion and bank retreat. The lower section of Reach 2 becomes narrow and incised heading toward Hwy. 101. This section should similarly be inspected for additional bed and bank erosion.

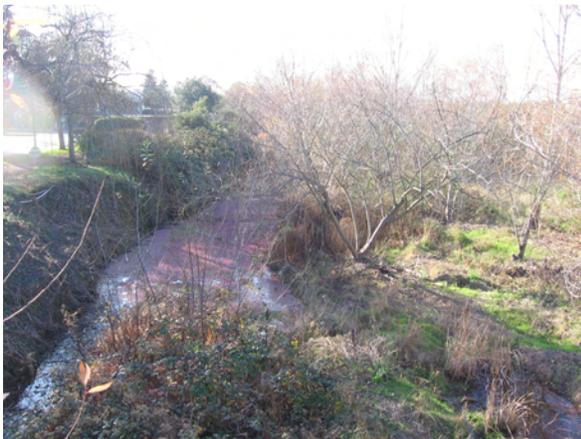
(c) Lichau Cr. upper Reach 2 looking downstream from McDowell Blvd. crossing; steep bank (1:1) to left, wide active channel (+20 ft.), and wide bench-floodplain to right (+50 ft) with mature riparian trees. (Jan 8, 2008).

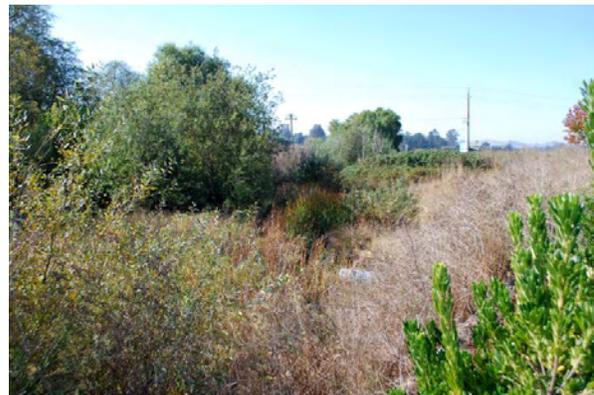
(d) Lichau Cr. lower Reach 2 looking downstream toward Hwy. 101; elevated floodplain seen to center-right of photo constricts lower Reach 2 channel from north; lower Reach 2 channel becomes straighter, narrower, and deeper in final section of reach toward Hwy 101 (October 26, 2008).

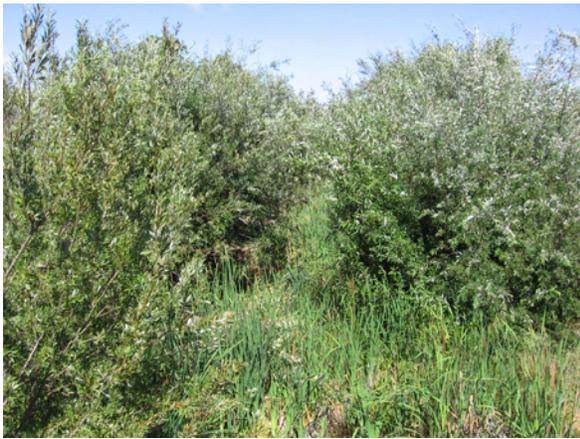
(c) Lower Reach 5 looking upstream from Wellington Place crossing; abundant instream cattail vegetation and willow growth obstructs the channel (August 26, 2008).

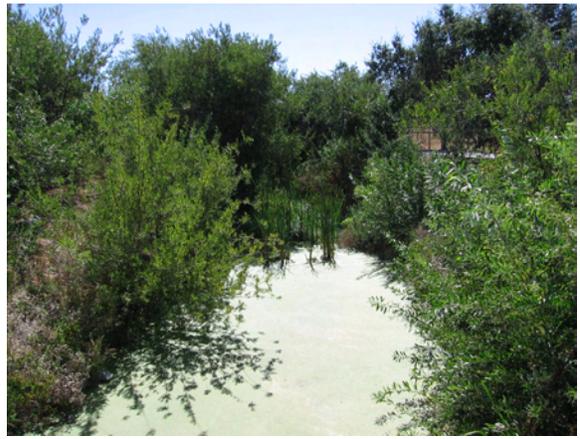
(d) Reach 4 looking downstream from Wellington Place. Large pool with abundant duckweed growth (August 26, 2008).

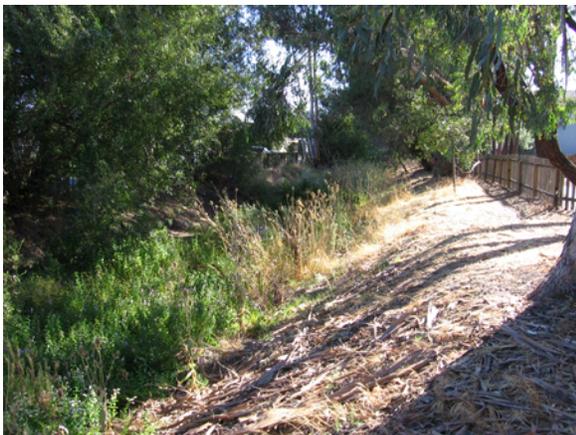
(b) Reach 2 at N. McDowell Blvd., looking downstream; earthen bank slopes with mature riparian trees (August 26, 2008).

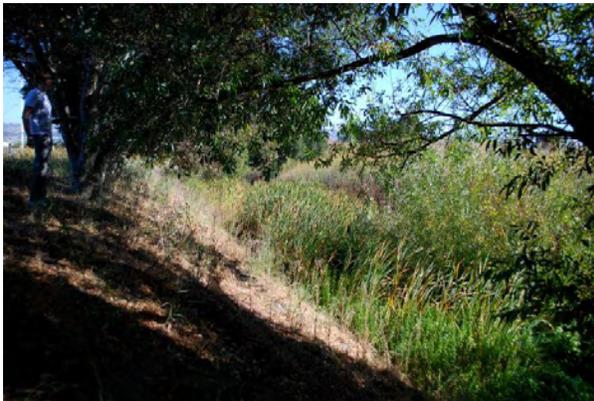
(b) Capri Cr. Reach 1 looking upstream from lower reach near Petaluma River confluence; abundant in-channel emergent vegetation, and some sediment accumulation (October 23, 2008).

Management considerations for Capri Cr. Reach 1 focus on removing cattails and associated sediment deposits, especially in the lower reach where cattails and accumulating sediment become more prominent. Capri Cr. Reach 1 would also benefit from additional riparian plantings along the high banks, particularly on the south side to provide more shading to the channel to inhibit in-channel emergent vegetation growth where no canopy currently exists. Management considerations for Jessie Lane focus on blackberry removal and thinning to improve flow conveyance. Importantly at Jessie Lane Cr. potential threats to water quality are observed from trash and refuse apparently transported from the auto shop. May be worthwhile for SCWA to contact the auto shop to describe the problem and seek their commitment to improve trash conditions.

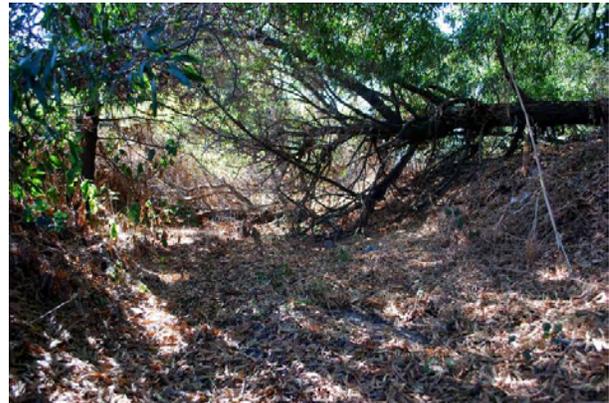
(d) Jessie Lane Creek, looking downstream toward confluence with Petaluma River. Ephemeral channel is dry, leaf litter across channel bed, adjacent trees provide cover (October 23, 2008).

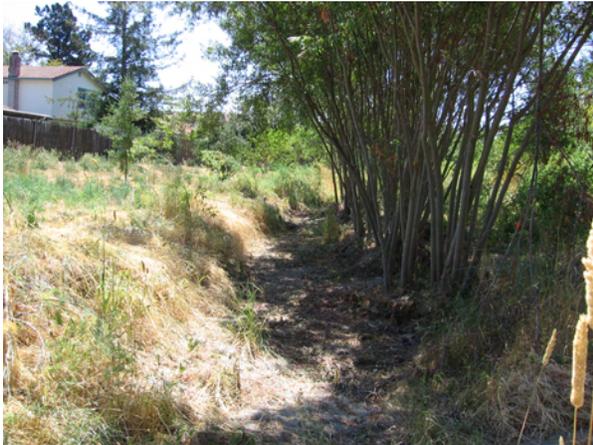
(b) Mid Reach (May 06, 2008)

Bed sediments/texture: channel bed comprised nearly entirely of sands, with medium to coarse sands upstream (photos a/b), and finer sands downstream. Sandy bed provides good infiltration/recharge capacity when intermittent flows do arrive.

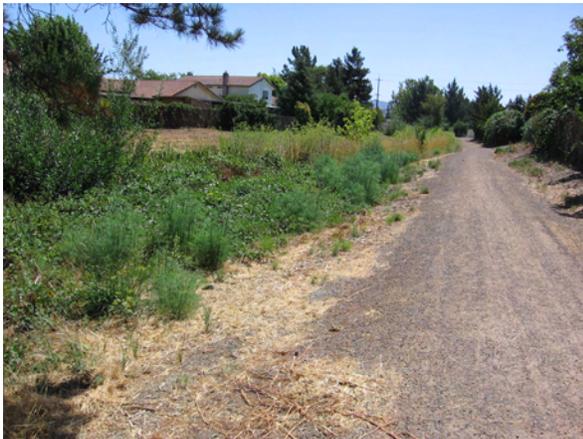
(c) Lower Reach 7 looking downstream toward Sonoma Mtn. Parkway. Note transition in channel form and vegetation from upper reach, channel now dominated by blackberry and other grasses on high banks, presence of willows providing riparian cover is diminished; overall cross-section is broad with gently sloping banks (May 6, 2008).

Management considerations for Reach 7 Washington Creek focus on the sections of the upper reach where abundant sand deposition has buried some drainage culvert outfalls (photo a). Some sediment removal may be necessary to clear these outfall locations. Some of the in-channel willow clusters mid-reach should be observed for potential channel blockage, but at the current time, this issue does not appear pressing (photo b). Over time the planted riparian trees in the mid-channel section will mature and provide additional shade and cover. Additional planting opportunities for the lower reach which does not have any appreciable mature riparian cover should be evaluated (photo c).

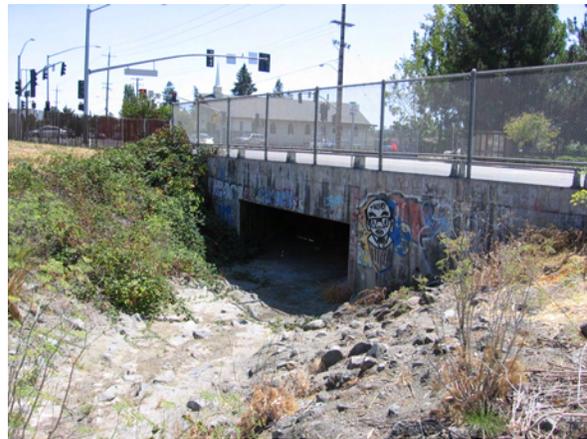
(d) Lower Reach 7 at Sonoma Mtn. Parkway. Culvert and immediate upstream area are clear of any deposited sediment and do not require any maintenance (May 6, 2008).

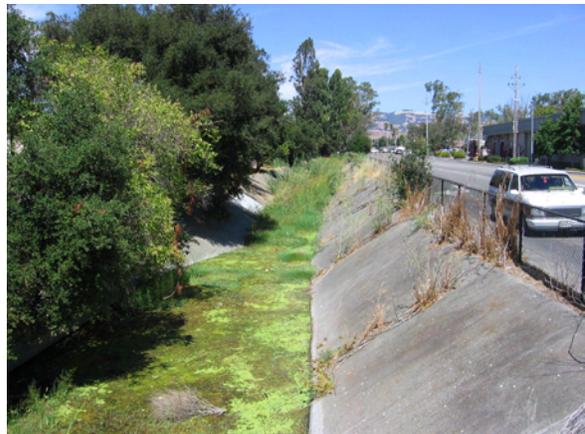
(d) Lower Reach 5 looking upstream from N. McDowell Blvd. Upstream of crossing, banks are concrete for 500 ft. to confluence with East Washington Creek. Channel flow is stagnant 6-12" deep, with algae collecting, but not much sediment collecting (Aug. 26, 2008)

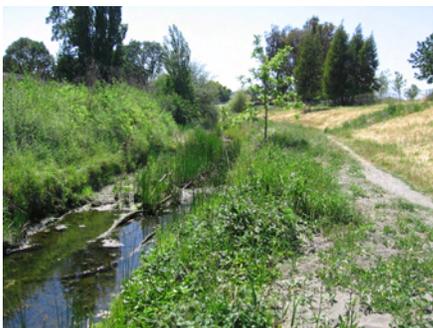
(d) mid Reach 1 looking downstream, channel shows sign of tidal flows, as seen in cut-bench on bank to left – transitional area with vegetation that is brackish tolerant (May 06, 2008).

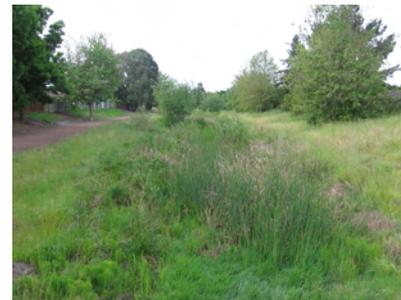
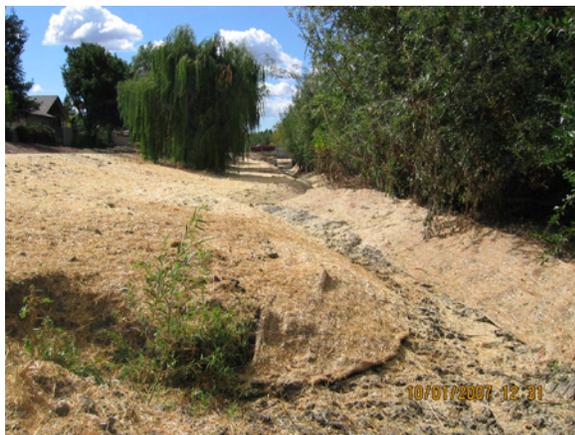
(d) Reach 5 looking downstream to Garfield Dr. (Oct 1, 2007); photo taken after maintenance activities in Sept. 2007 removed accumulated sediment, thinned in-channel vegetation, and excavated low-flow channel.

- (a) Reach 5 looking upstream toward airport (May, 2007) prior to Fall 2007 maintenance central channel occluded with ample willow and blackberry vegetation (compare to photo d)
- (b) Reach 4 looking upstream to Garfield Dr. culvert (May 2007); prior to Fall 2007 maintenance culvert capacity reduced over 50% by deposited sediment (compare to photo e)
- (c) Reach 4 looking downstream from Garfield Dr. (May 2007); prior to Fall 2007 maintenance (compare to photo e)

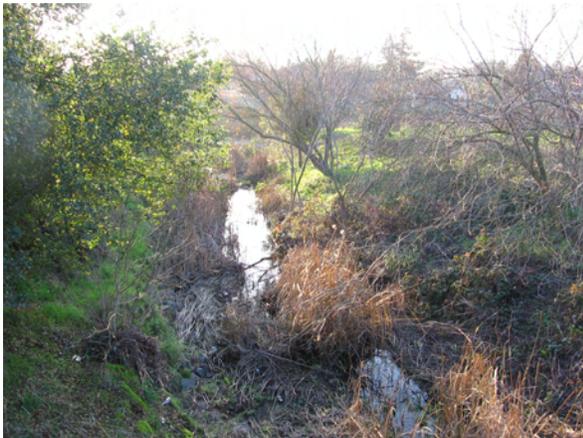
(c) Rip-rapped and grouted confluence with Petaluma River (October 26, 2008).

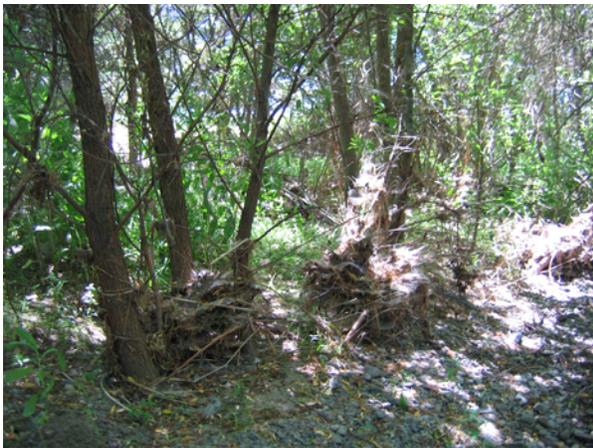
(b) Mid Reach 2 - on the sandy, heavily vegetated bench/bar adjacent to the active channel. Debris lines mark past high water events; dense willow thicket provides good canopy but also presents flow obstructions; more fine sediment here than upstream reaches, but still pockets of gravels and coarse material. Reach 2 instream sediment basin is just downstream of this photo (Aug 2008).

Management considerations for Adobe Creek Reaches 2 and 1 focus on sediment removal at the instream sediment removal basin at the lower end of Reach 2, upstream of S. McDowell Blvd. Sediment removal at the basin was initiated during September 2008 and will continue in the summer 2009 maintenance season. In addition to sediment removal, many of the willow thickets that grow on the sediment deposits will also be thinned and removed. According to SCWA, they generally do not maintain Reach 1 below the drop structure downstream of S. McDowell Blvd. due to its proximity to the Petaluma Marsh, the wide cross-section, tidal influence, and lack of infrastructure downstream.

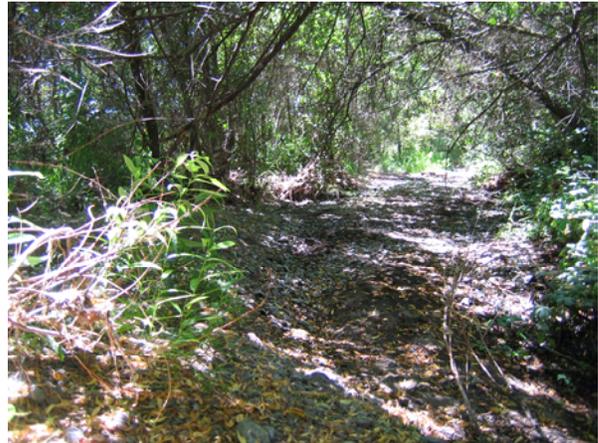
(a) Mid Reach 2, looking upstream: Low flow channel is dry, with evidence of recent flow or shallow subsurface flow present with dark, wet, muds in lower pools; Higher depositional bench seen to left in photo with abundant vegetation growth (Aug 2008).

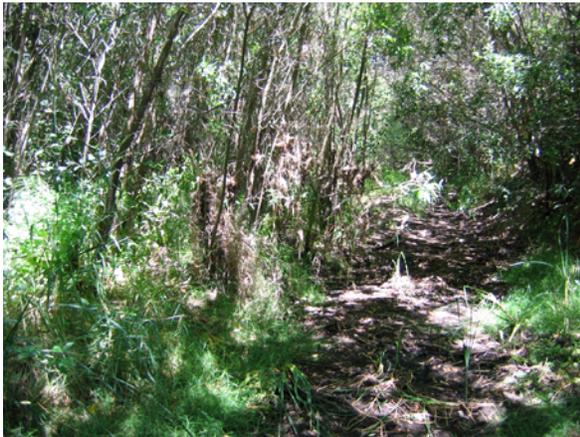
(c) Lower Adobe Cr. Reach 1 looking upstream: channel is recently dried and the substrate is dominated by mud and organic matter. The depositional bench/bar to left in photo extends 50 feet (off photo) and is regularly inundated by riverine and estuarine flows (Aug 2008).

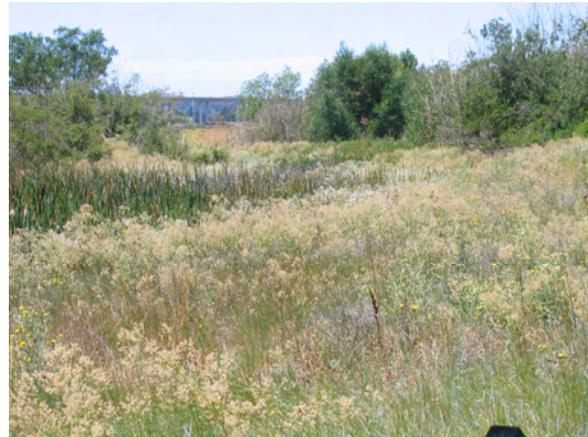
(d) Lower Adobe Cr Reach 1 looking upstream from below SCWA easement. SCWA's easement appears to extend to the edge of the willows in the background. The channel in the foreground, packed with cattails, is within the marshland complex adjacent to the Petaluma River (Aug 2008).

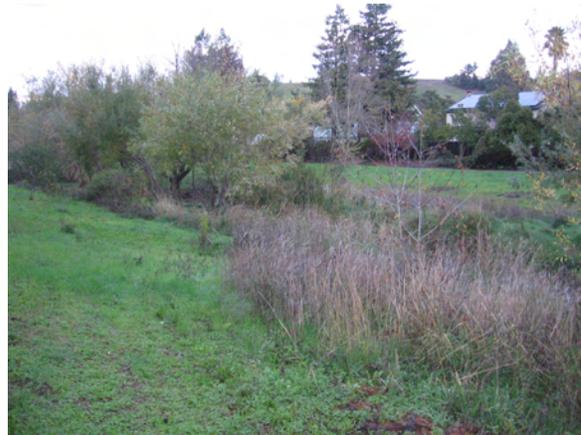
(a) Thompson Cr. Reach 1, looking downstream from below Westridge Dr. Wide channel easement along parkway, gentle sloping banks, channel includes emergent cattails and willow vegetation (Dec. 16, 2008).

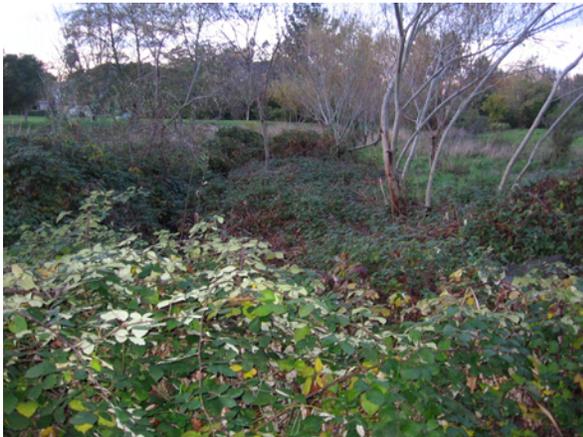
(c) Mid Reach 1, looking downstream; central reach area has wide easement with gently sloping banks; active low flow channel is relatively narrow here (3-4 ft and 2-3 ft deep) with adjacent banks covered in blackberry (Dec. 16, 2008).

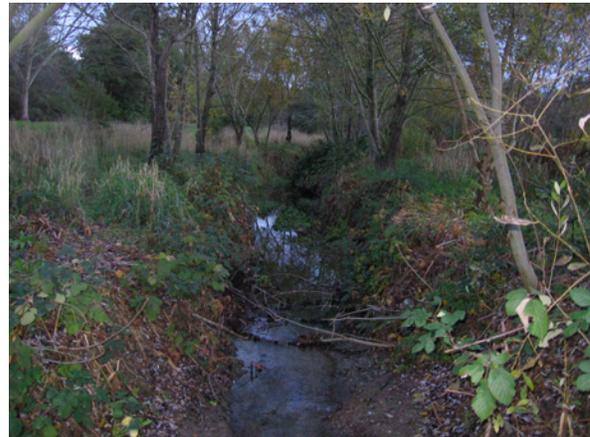
(d) Lower Reach 1, 500 ft upstream of Sunnyslope Rd.; channel is 4-6 ft. wide and 2-3 ft. deep; blackberry persists along with sections of dense cattails. Willows and other trees provide riparian canopy along the immediate channel zone (Dec. 16, 2008).
