Santa Rosa Subbasin

FIGURE 4-10
Reaches and Vegetation
Santa Rosa (1 of 13)

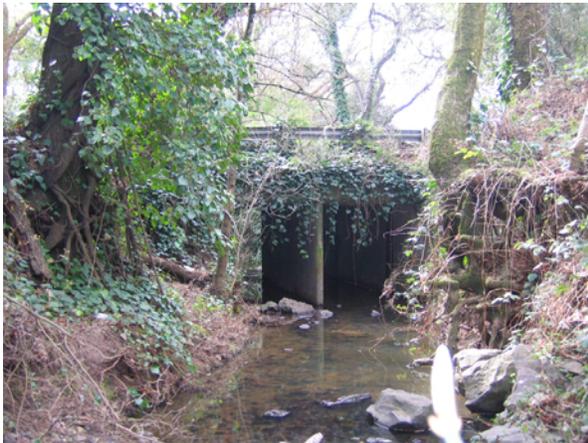
(b) Bottom of Middle Brush Reach 2, looking downstream toward Badger Rd. crossing. Channel is still incised as evidenced by exposed and undercut roots on many riparian trees. Riparian canopy is dense in this area and through Reach 1. Channel substrate is dominated by gravels and appears to be augmented by eroding rip-rap (foreground) (March 2008).

Management considerations for the Middle Fork of Brush Creek focus on bank stabilization and erosion control. The current density of large woody trees and complex roots systems appears to be slowing the level of erosion and downcutting occurring in both reaches. As downcutting continues and more trees fall, the near vertical banks along the Middle Fork of Brush Creek will continue to destabilize and potentially erode channel material into creek. Locally, increasing the complexity of pool habitat in Reach 1 could provide enhanced habitat for rearing steelhead and addressing the passage barrier/obstruction at Badger Rd. could allow steelhead to access additional spawning and rearing habitat in Reach 2. Control of ivy and replanting with native understory species could provide benefits to a wide array of riparian species.

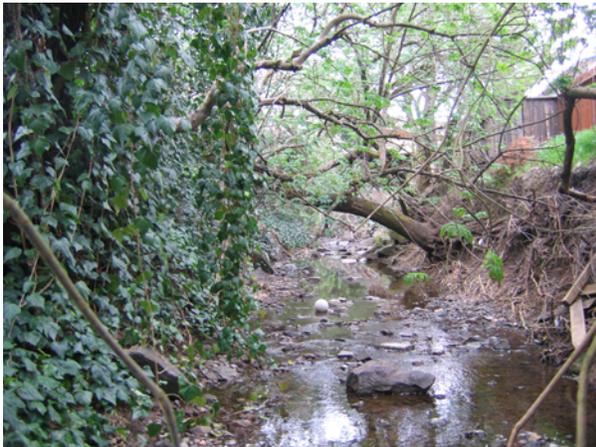
(c) Reach 1 ~ 1000ft upstream of Montecito Blvd, looking upstream at eroded banks, similar to Reach 2, this reach is incised, resulting in undercut stream banks. This instability has led to overhung exposed roots and recruitment of woody debris (March 2008).

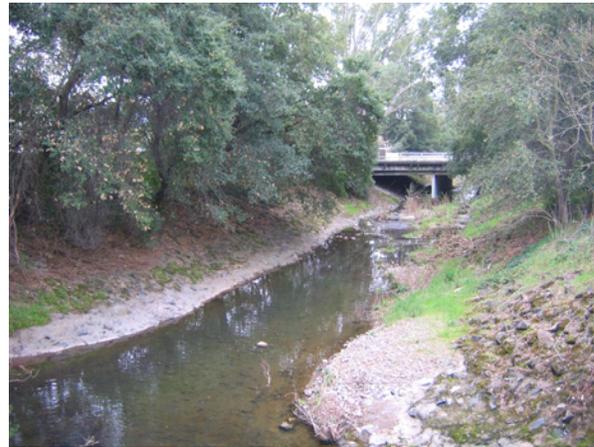
(d) Reach 1, looking downstream toward the Montecito Blvd. crossing from the confluence with Rincon Cr. This section of Middle Brush contains grouted rip-rap along the trapezoidal banks and portions of the channel bottom from the confluence with Rincon Cr (at photo point) downstream to the crossing (March 2008).

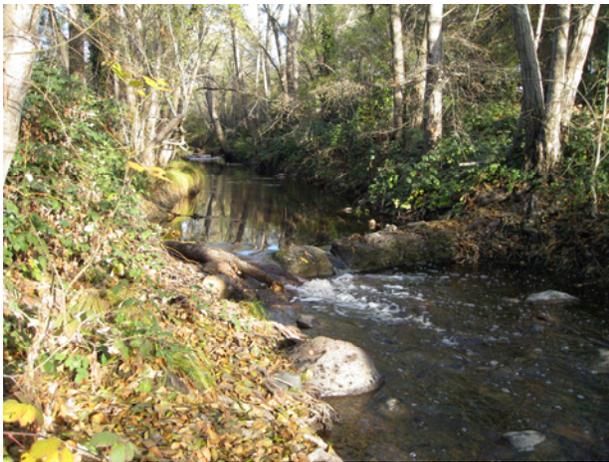
(b) Looking upstream from the middle of the reach. Small check dam across the channel made of rock and grouted, small dam features moderate flow, concentrating elevation drops and velocity changes at structures (December 16, 2008).

Instream habitat: Cool waters in combination with instream flow diversity with glides/runs and riffles (some caused by instream check dams) provides very good habitat for cold water species, such as Chinook and steelhead. Small check dams are not too large as to create fish passage barriers (photo b); riparian canopy is well developed and thick.

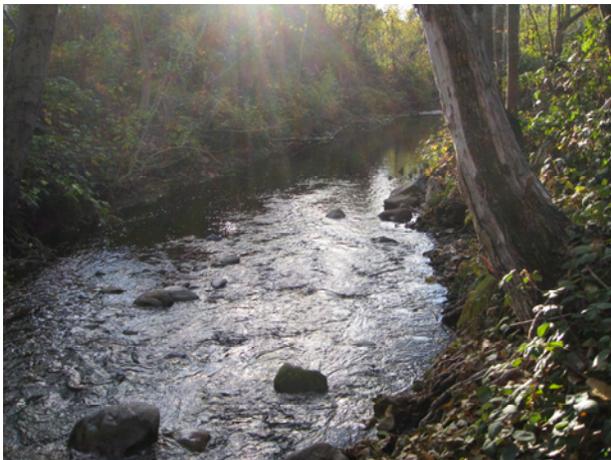
(c) Looking downstream from the middle of the reach. Note fully shaded channel and lack of emergent vegetation (December 16, 2008).

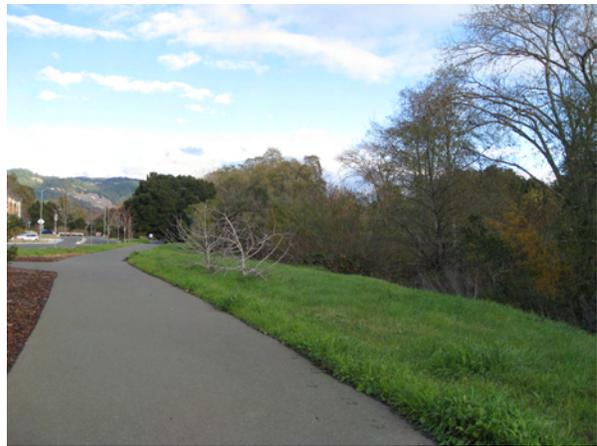
(d) Looking east from downstream end of the reach toward the upper Santa Rosa Creek headwaters (seen in distance). Creek is on the right. Note dense riparian vegetation lining creek corridor (December 16, 2008).

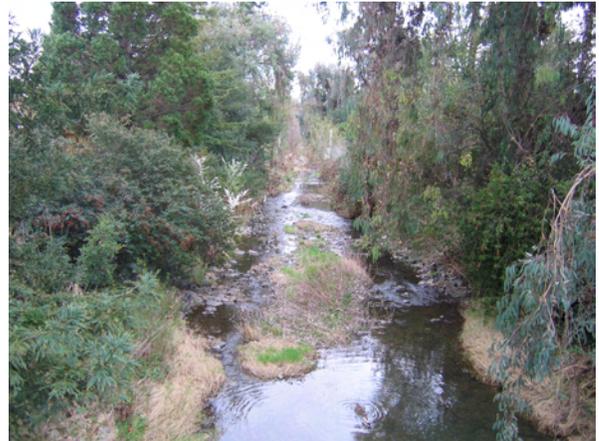
(a) Brush Cr Reach 2, looking downstream from the Montecito Blvd. crossing. Channel is straight and contains numerous in-channel bars. Also notice that heavy growth of trees and shrubs along the banks (March 2008).

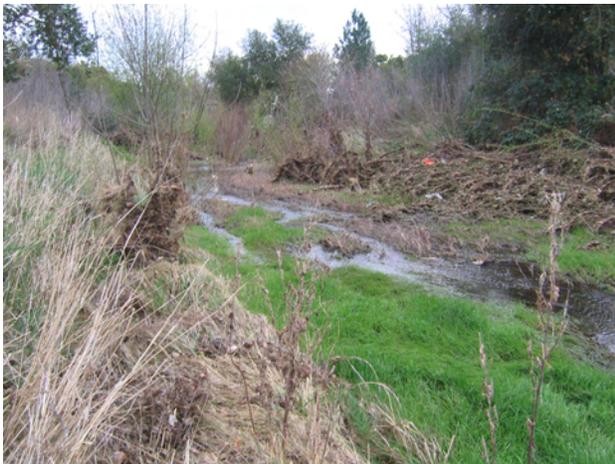
(b) Brush Creek Reach 2, just downstream of Austin Cr. confluence. Channel bed is colonized by grasses and emergent vegetation; toe of the banks are lined with young willows full of debris from recent high flows (March 2008).

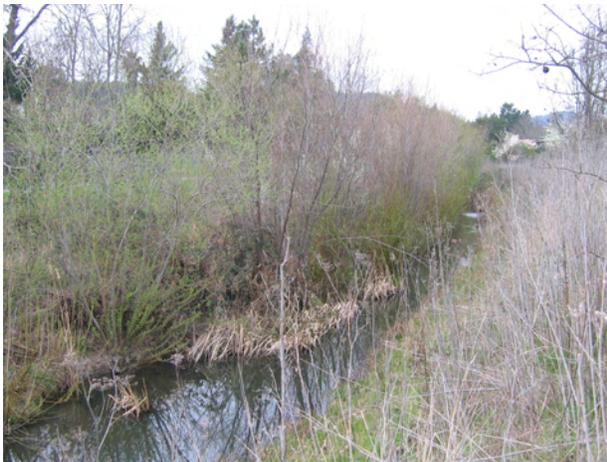
(c) Middle section of Brush Cr. Reach 2, looking upstream. Though cut in last few years, the dense line of willows at the toe of bank have re-established, creating a flow impediment and deflecting water onto the opposite bank. Willows on one side of the channel and a sediment bar on the other create a single, open, low flow channel (March 2008).

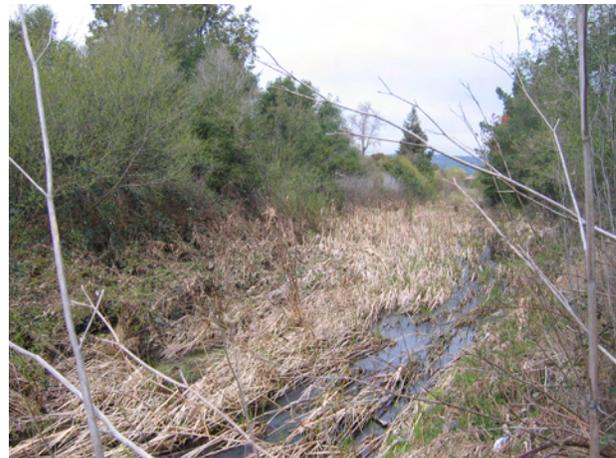
(d) A lower section of Reach 2, looking upstream; entire flat channel bed is covered in cattails with low flows forced through multiple shallow pathways. The abundant cattails have all been pushed down by recent flows (March 2008).

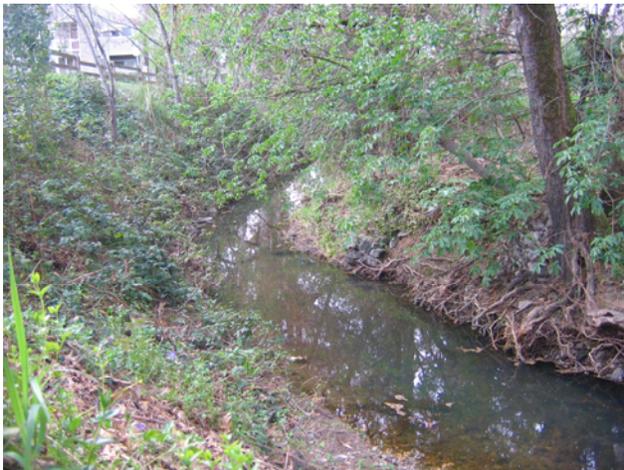
(b) Looking downstream about 600 ft. from Boas Dr. Undercut bank and pool formed under the exposed roots to right. Steep bank slopes on the left, generally dense canopy cover in this portion of Reach 3 (March 2008).

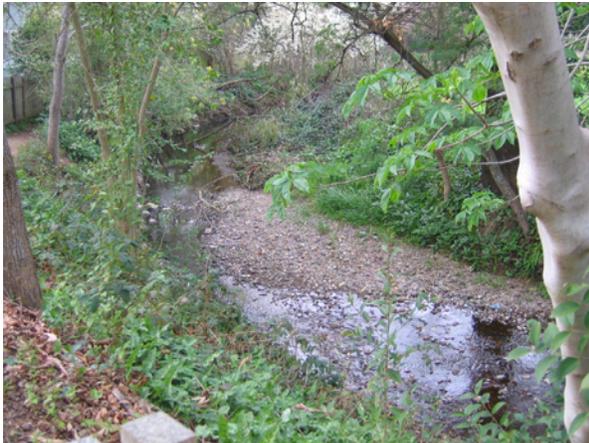
(c) Looking downstream ~900 ft. downstream of Boas Dr. Here the channel makes a gentle meander around a d-shaped depositional bar. The bar is dominated by gravels and supports some instream complexity with the associated riffles and pools surrounding the bar. The canopy is still dense in this portion of the reach.

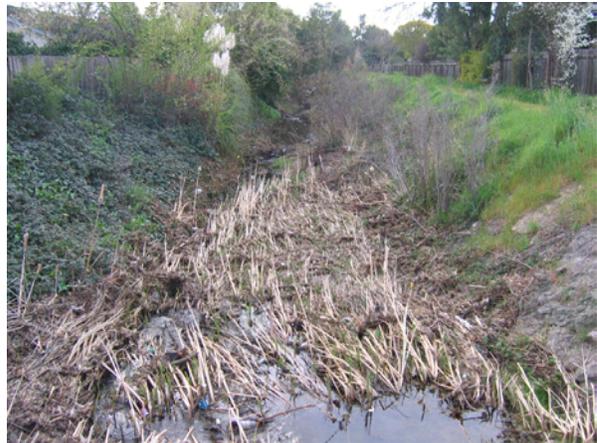
(d) Looking downstream from Jack London Dr. Notice the extreme change in the character of the stream that occurs just upstream of this crossing (compare to photo c). The canopy has receded, the channel is straightened, and emergent vegetation (cattails) now covers the trapezoidal channel bottom.

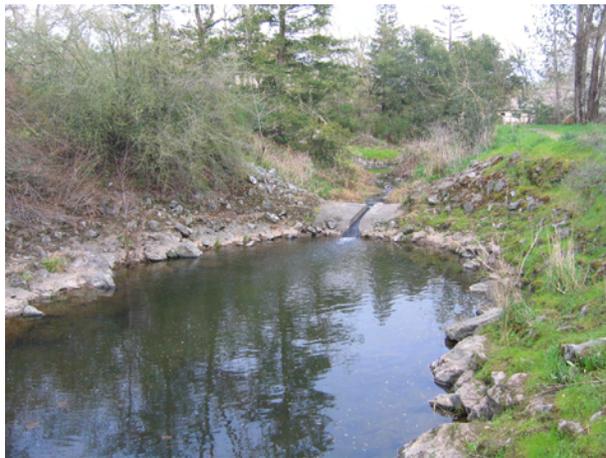
(b) Reach 2, looking upstream from grade control structure and large pool feature (near Benicia Dr.). Austin 2 and 1 both contain a number of in-stream grade control structures. There are 2 of these structures in Reach 2 and Reach 1 appears to have a number of rock weir structures upstream from the confluence with Brush Cr. (photo d) (March 2008).

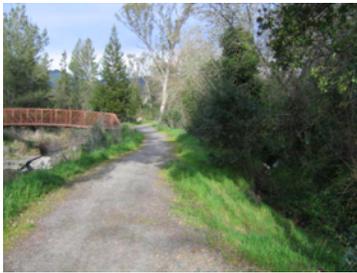
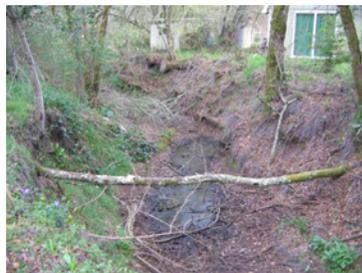
(c) Secondary channel: The top photo shows Austin Cr to the left and the secondary channel to the right, the bottom photo is looking upstream from within the secondary channel (March 2008).

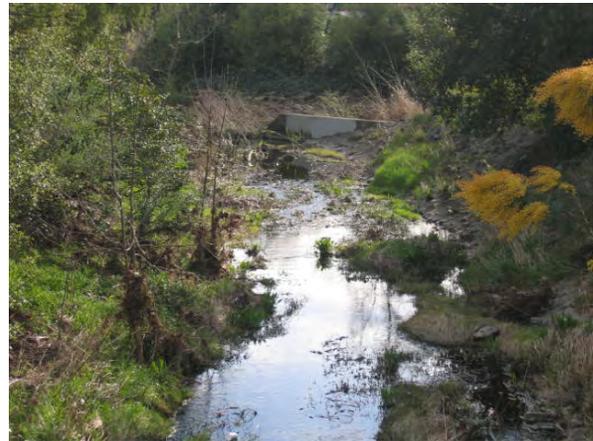
(d) Reach 1 looking downstream toward Brush Cr confluence. Note grouted rip-rap on the right bank, small bars along the channel margin, and the dense cattail bar at the confluence (far center) (March 2008).

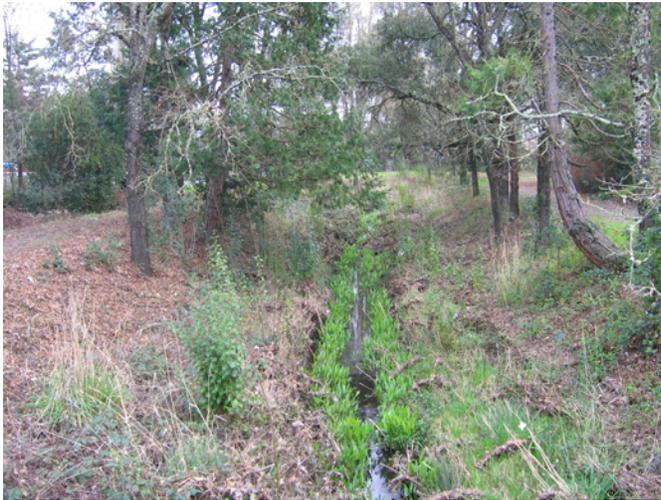
(b) Reach 2, looking downstream from middle of the reach. Notice the channel is still relatively uniform and similar to photo a. Notice the lateral bar along the channel margin on the right. Also notice the line of water plantain flanking both sides of the low-flow channel (Photo taken 3/6/08).

Bank structure: trapezoidal engineered channel with moderate banks (2:1 or less steep) underlain with rip-rap and covered with soil and vegetation; rocks at toe and soil from banks have sloughed to create bars along channel margins (photo b); erosion seems historic in nature as very few signs of recent erosion or instability were observed.

Vegetation composition: Narrow riparian woodland exists along both banks; understory is dominated by either Himalayan blackberry or other non-native forbs and vines; emergent species within the channel are limited to water plantain and sedges along channel margins (photo b) and within the channel at areas where large gaps in the canopy exist.

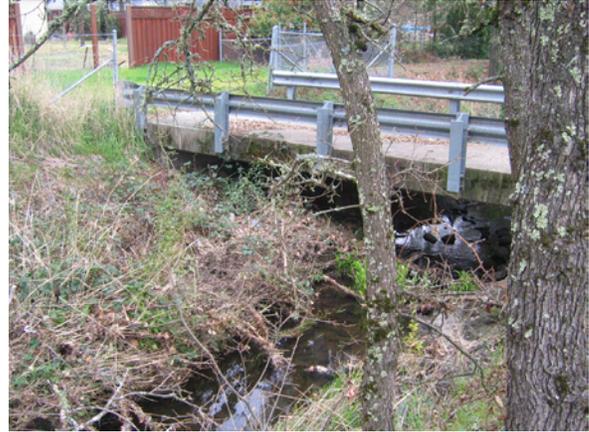
Photo (c): Unnamed access crossing in Reach 2 illustrating significant deposition at constrictions. This photo shows a massive wedge of sediment at the upstream end of crossing. The wedge extends ~50 ft upstream and is significantly reducing capacity at this crossing.

Management considerations for Reaches 2 & 1 of Ducker Creek focus on sediment removal at crossings. The Benicia crossing appears to be the most compromised at the time of writing, but the Rinconada Dr crossing should be watched carefully and the unnamed access road crossing should be watched as well. Bank slumping appears to be chronic, but limited in scope to the narrow soil profile due to the fact that nearly all banks are underlain with rip-rap.

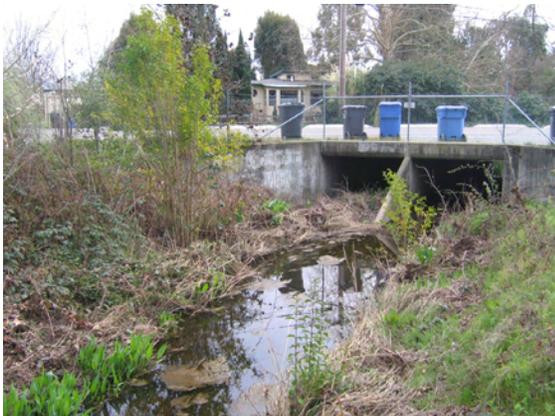
(d) The next crossing downstream, Rinconada Dr., is also impacted by a large sediment wedge reducing capacity of the existing box culvert. This wedge extends ~150ft upstream and averages 1.5 ft above the low flow wse. Note algal mats in the foreground (photo taken 3/6/08).

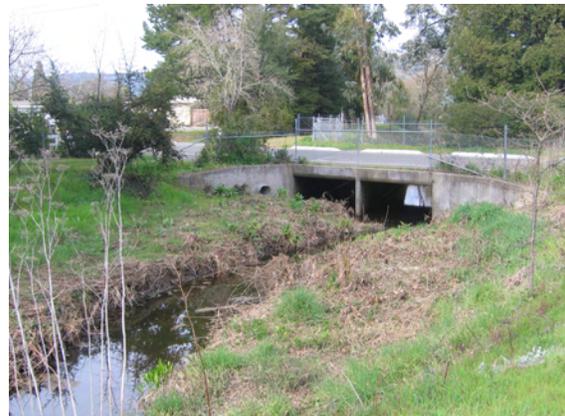
(e) Ducker Cr Reach 1, looking upstream from below the Benicia Dr. crossing. This is the largest of the three, crossing related sediment wedges. Deposition appears to be significantly impacting conveyance capacity at this crossing and has reduce by half the area of the left box. Notice algal mat in this photo as well as photo d (photo taken 3/6/08).

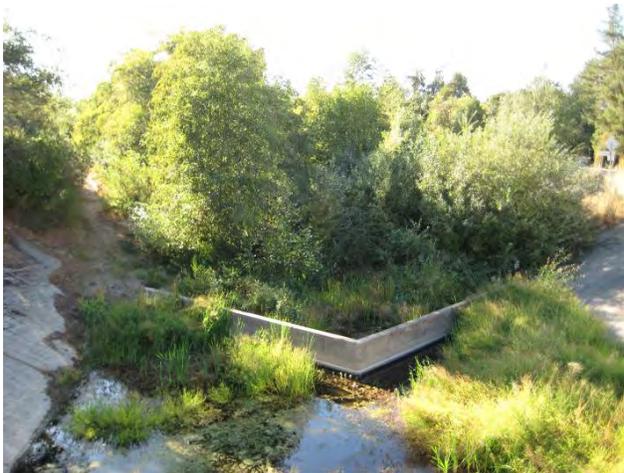
(b) Concrete weir facility (near Melita Rd) that regulates discharge between Spring Lake and the downstream diversion channel. Sediment and dense vegetation collect within facility (October 8, 2008).

Management considerations at the Santa Rosa Diversion focus on the continued maintenance of the weir facility. This facility traps abundant sediment and requires routine sediment removal that includes removal of emergent vegetation that establishes in the deposited sediment. The frequency of sediment removal at the weir facility is dependent upon climatic conditions with large rainfall years typically leading to stronger deposition at the facility. In the lower reach, vegetation management could focus on blackberry removal.

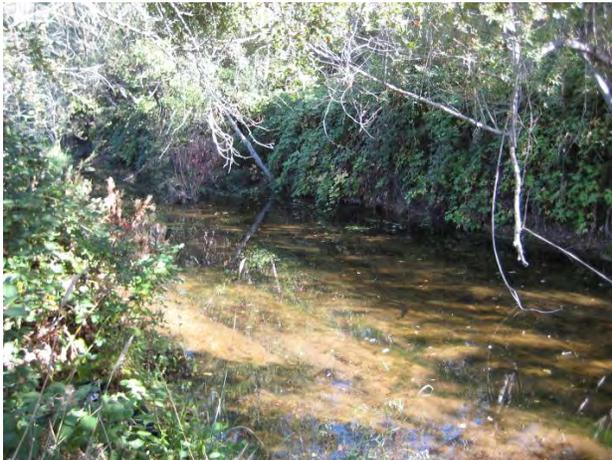
(c) Mid Reach looking downstream, wide channel over 20 ft. wide (October 8, 2008).

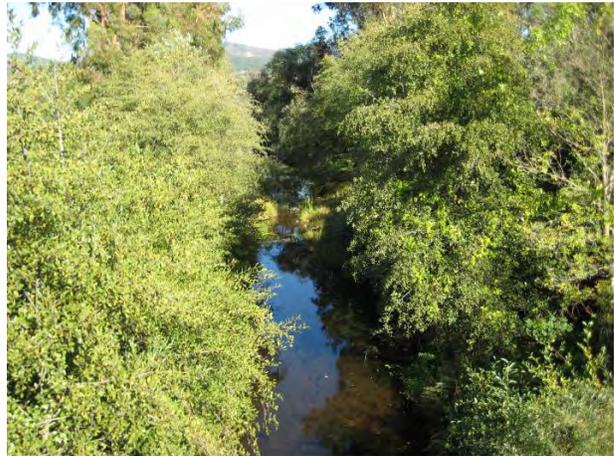
(d) Looking upstream from Channel Drive crossing. Banks are heavily vegetated (October 8, 2008).

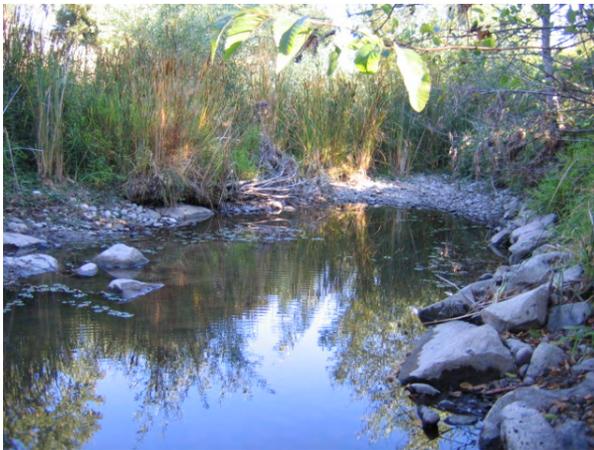
(b) Reach 1, approximately 150 ft downstream from the Hwy 12 bridge. This unusual shaped bar formation, demarcated by the ring of gravel stretching from bank to bank and covered with cattails, forms a pool at the downstream terminus of surface flow. Downstream of this bar, the channel was completely dry until its confluence with Santa Rosa Creek (Oct. 2008).

Management considerations for Brush Creek Reach 1 focus on removal or modification of the sediment bar/wedge just downstream of the Hwy 12 crossing. Other than this, the reach appears to be in good condition from both a flood control and habitat perspective.

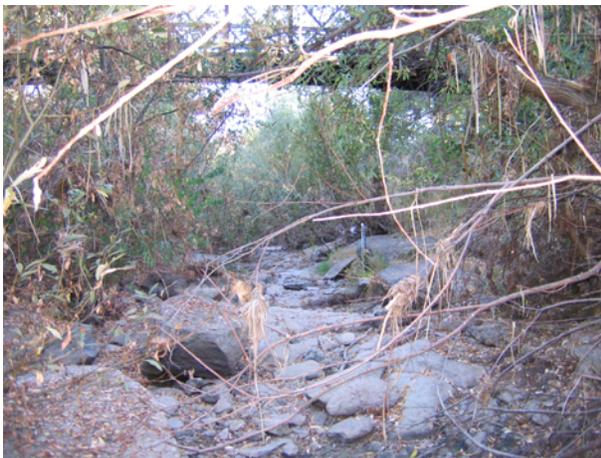
(c) Looking downstream from the channel bottom just upstream of the pedestrian bridge. Note that the channel is completely dry (October 2008) with no pools or other signs of surface flow. Also notice the size of the substrate in the channel as it is dominated by boulders, cobbles, gravels and bedrock outcroppings.

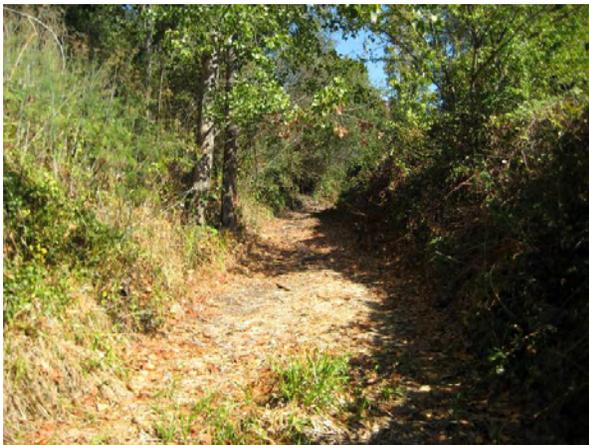
(b) View of the area upstream from the confluence with Sierra Park Creek, recently cleared of vegetation (October 8, 2008).

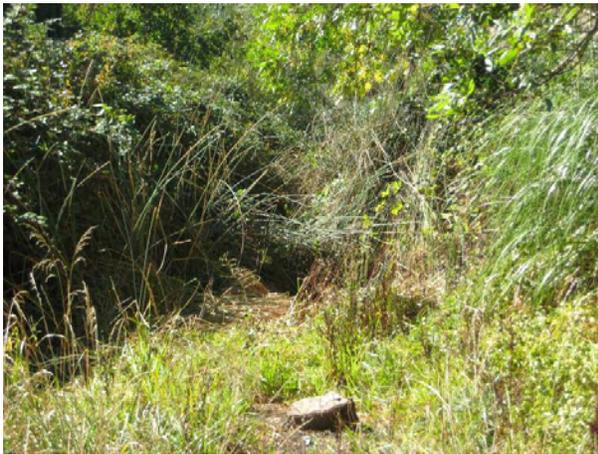
(c) Looking downstream at confluence with Sierra Park Creek shows heavy vegetation in channel and along banks (October 8, 2008).

Continue to maintain channel free of vegetation, especially at culvert inlets and outlets. Monitor streambed for accumulation of fine sediments between cobbles, which could reduce infiltration. Consider installing a low flow channel to encourage sorting of bed sediments.

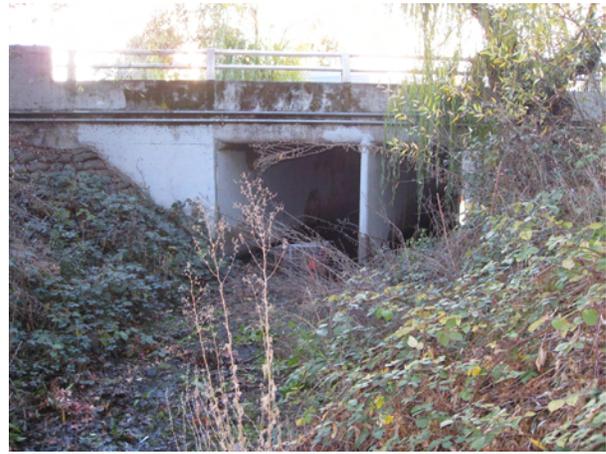
(d) The Yulupa Avenue crossing of Spring Creek, downstream from Reach 3 (December 16, 2008).

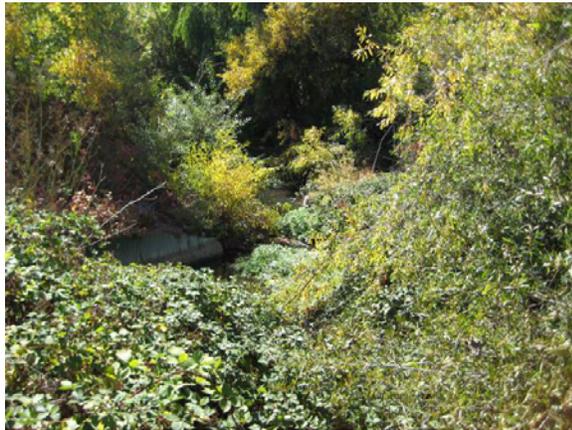
(b) Looking downstream from Hwy 12 creek crossing. Note dense vegetation on both banks (October 8, 2008).

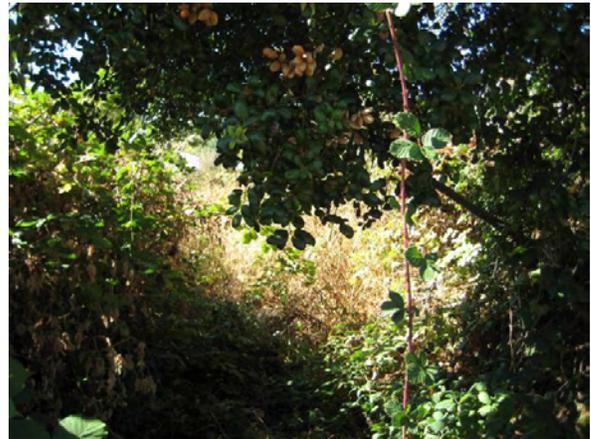
(a) Looking upstream from Hwy 12, entire channel is heavily vegetated (non-SCWA maintained) (October 8, 2008).

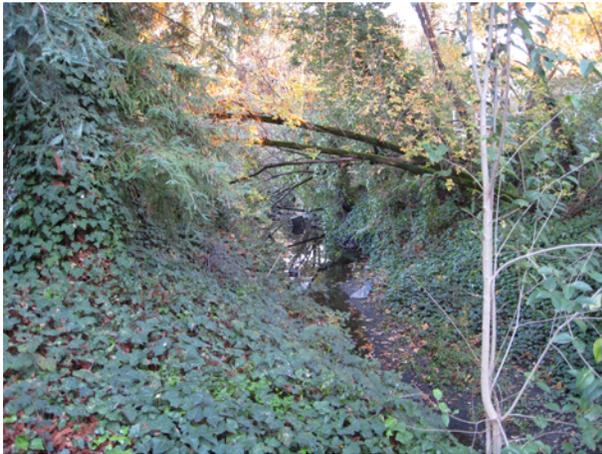
Bed sediments/texture: fine silts and clays throughout reach. Uniform deposition except small in-channel bars noted in channel (photo c). No exposed bedrock.

Water quality: clear flows and slow moving water observed on December 16, 2008 after 2 days of moderate rain. Large articles of trash, including garbage bags, oil drums, and buckets observed in channel (photos c and d).

(c) Downstream end of reach, looking upstream. Note overhanging alder trees and small in-channel bar (December 16, 2008).

Stream management in Spring 1 should focus on the removal of in-channel trees with horizontal limbs that are overhanging and crossing the channel (photo c). Such limbs can increase water levels due to their catching of debris and vegetation during higher storm flows resulting in flow blockage. Over the longer term, reach should be managed for removal of abundant invasive plants, particularly observed on the floodplain benches shown in photos c and d. SCWA crews can also remove trash as needed during periodic reach inspections.

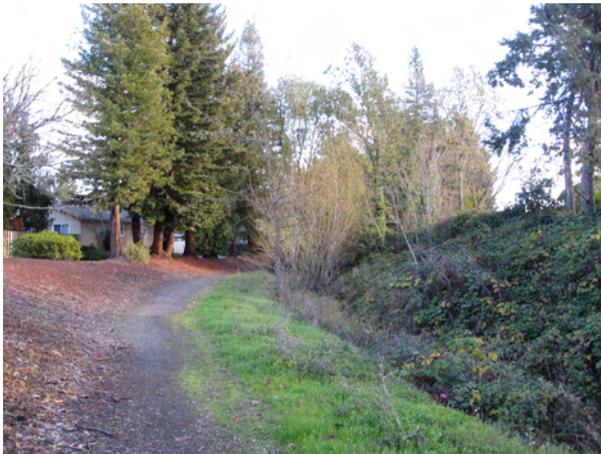
(b) Looking upstream at the middle of the reach. Creek on right, pedestrian path and Arroyo Sierra Drive on left (December 16, 2008).

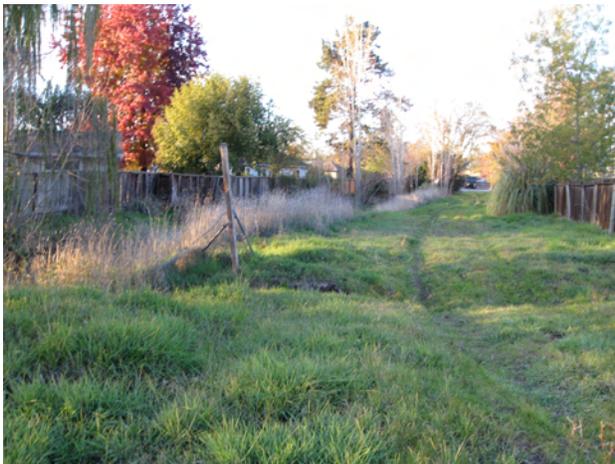
(b) Looking downstream along Reach 2, just north of the open space at the upstream most end of the reach. Channel is on the left. Note the abundant ruderal vegetation and lack of canopy cover (December 16, 2008).

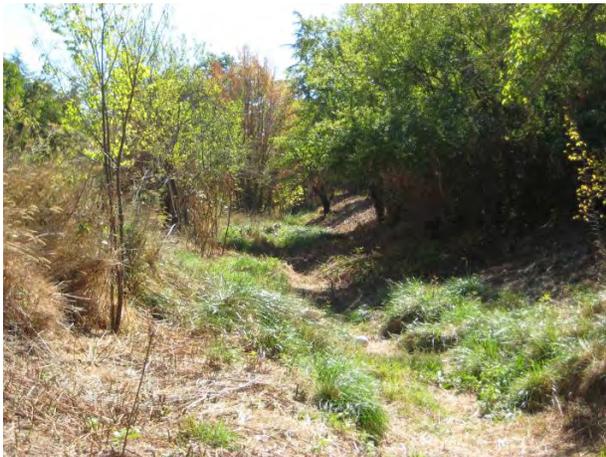
Riparian corridor and canopy closure: 20% canopy cover is provided from various alder, willow, and other tree species found in patches along the corridor (photos c and d).

(c) Reach 1 mid-reach, looking upstream at canopy cover. Note emergent grasses on both sides of the bank (October 8, 2008).

Additional riparian tree planting and further in-channel vegetation removal. Monitor culvert crossings for accumulated trash.

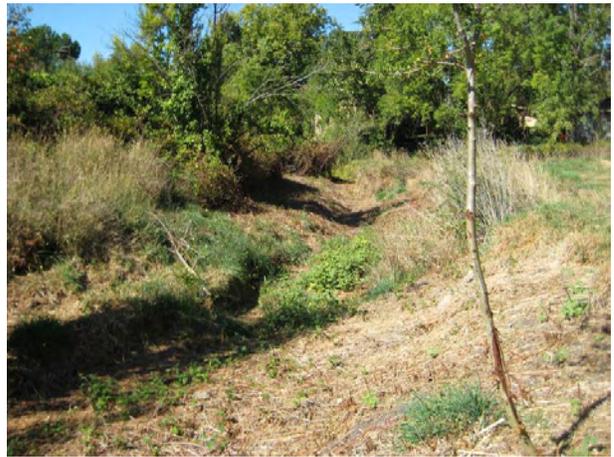
(d) Looking downstream Reach 1 towards the confluence with Spring Creek (October 8, 2008).

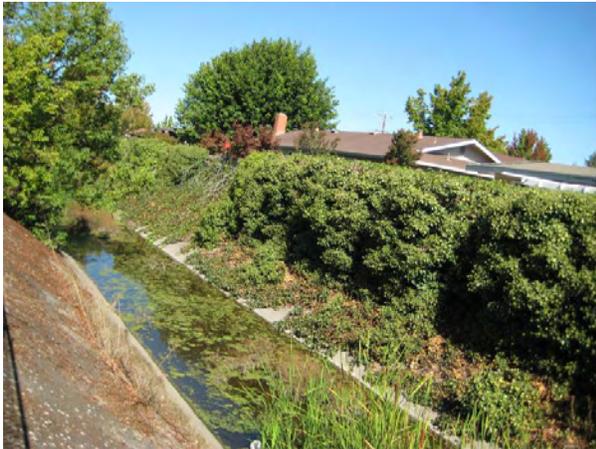
(b) Few trees are found along the corridor, however vegetation is dense along the bank adjacent to residential area (October 8, 2008).

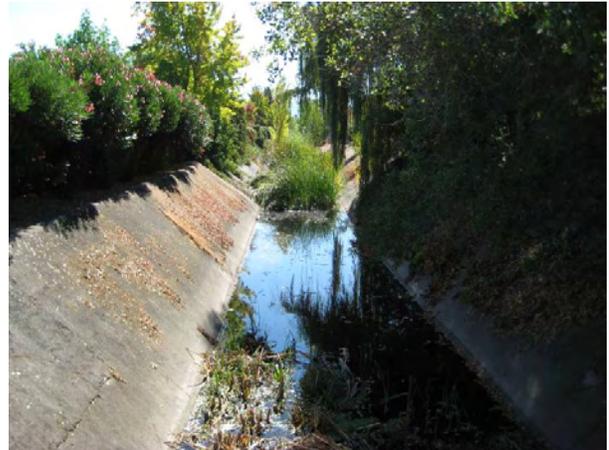
(a) Looking upstream from the Tachevah Dr road crossing (October 8, 2008).

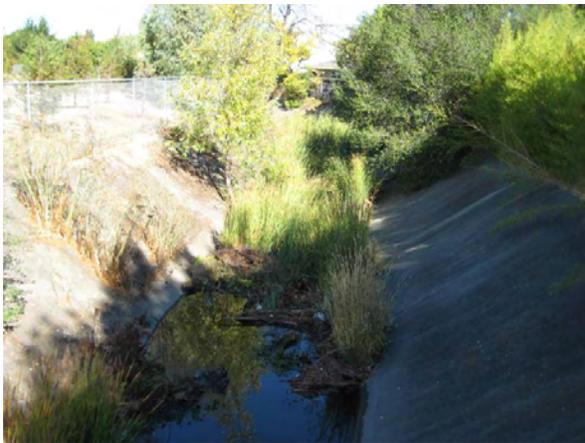
(c) Looking downstream from the bridge crossing. Note in-channel vegetation and limited canopy cover (October 8, 2008).

Periodic removal of accumulated sediment and in-channel vegetation will be necessary. Opportunities for improving ecological conditions are limited considering the concrete-lined channel. Additional tree planting for greater canopy cover along top of banks is possible, and could help moderate water temperatures and reduce nuisance in-channel growth.

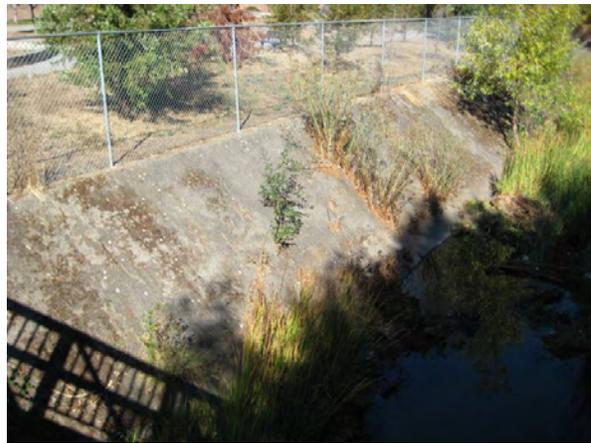
(d) Vegetation growth along the reach is limited to the concrete lining of the banks and channel (October 8, 2008).

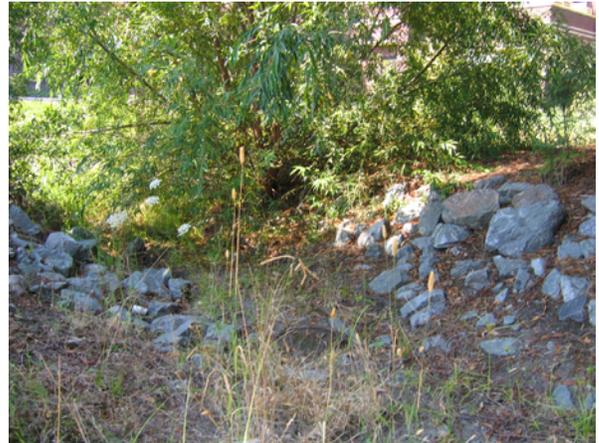
(a) Piner Cr. Reach 8 looks more like a seasonal swale than a typical flood control channel. Reach 8 was mostly dry in Aug 2008 with stands of cattails where the channel was still wet. The narrow channel includes rip-rap on the bed and banks (August 2008).

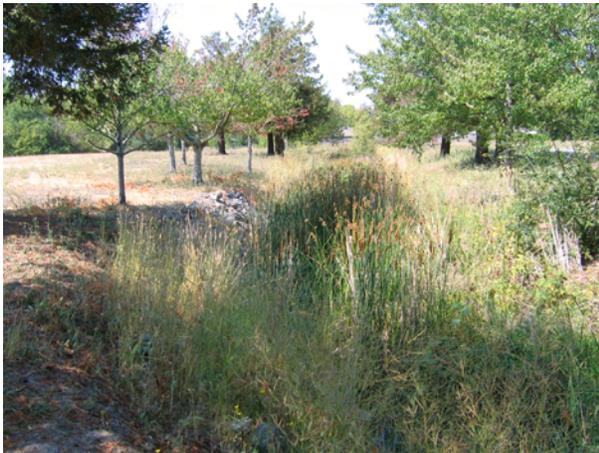
(b) Upper Reach 7 looking downstream: linear, trapezoidal channel is dry and choked with rushes and grasses. Several recent additions of rip-rap along banks (see left bank below the second tree) (August 2008).

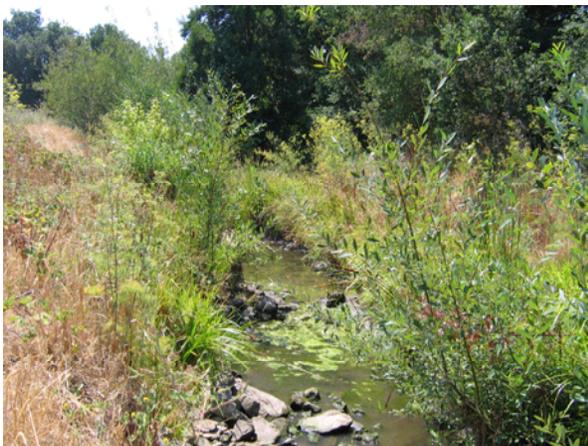
(c) Lower Reach 7 looking upstream. Eroded rip-rap extends into channel; several rip-rap banks appear unstable in many locations; water quality appears poor with brown stagnant water and extensive algal growth (August 2008).

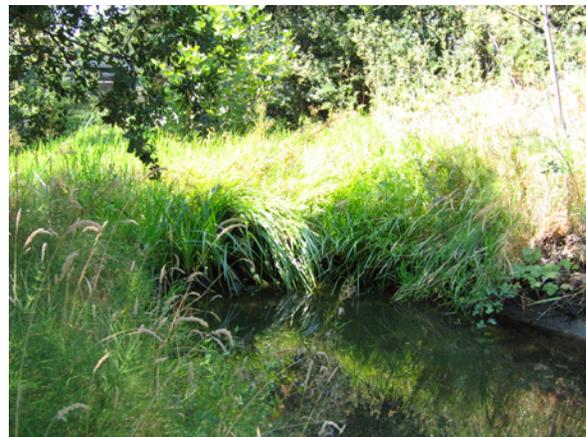
Channel processes: Piner 8 and 7 are both straightened, engineered channels with Reach 7 conveying greater flow than 8. Lower sections of Reach 7 have sediment bars and pool sequences (photo d). Reach 7 has several eroding banks, with depositional bars forming at the toe of slope.

(d) Lower Reach 7 looking downstream toward the Hopper Ave. Bridge. Photo shows transition between an open water pool and a large, vegetated (with grasses) sediment wedge approx 2-3 ft high; this deposit stretches from the Hopper Ave Bridge 75 ft. upstream (August 2008).

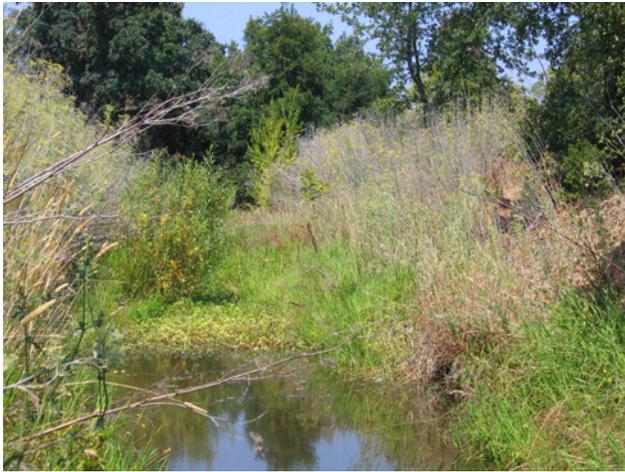
(b) Mid Reach 6, looking upstream at sloughing bank to right. Mid channel bar formed from eroded bank materials. These features are common along Reach 6 where instable steep banks erode into the channel (August 2008).

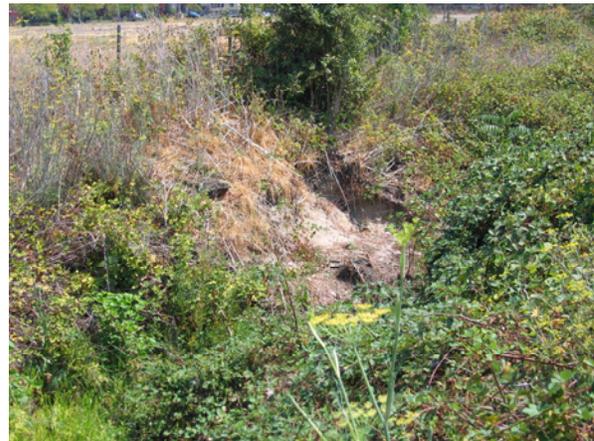
(d) Lower Reach 6 near Piner Lane. This section contains several eroding banks, with sediment and riparian sloughing into channel below (August 2008).

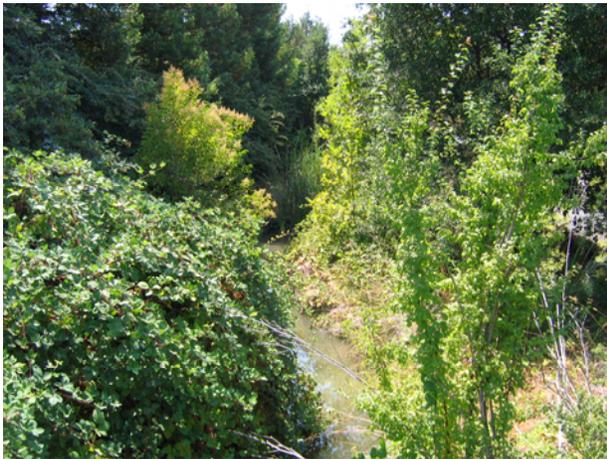
(b) Top of Russell Reach 1 looking downstream from culvert. Open flowing section of Russell seen in foreground and section packed with cattails seen in far background (August 2008).

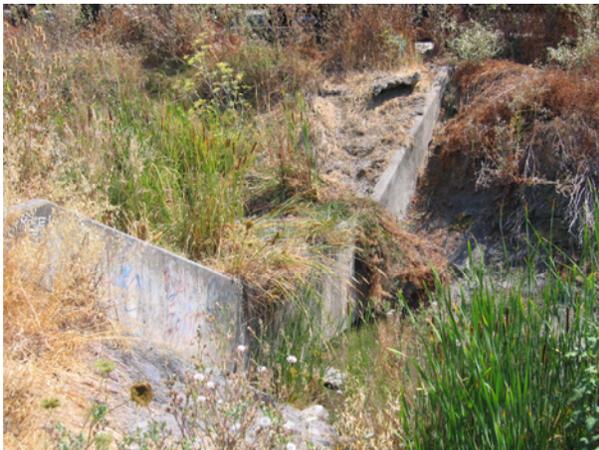
(c) Mid Reach 1 grade control structure (August 2008).

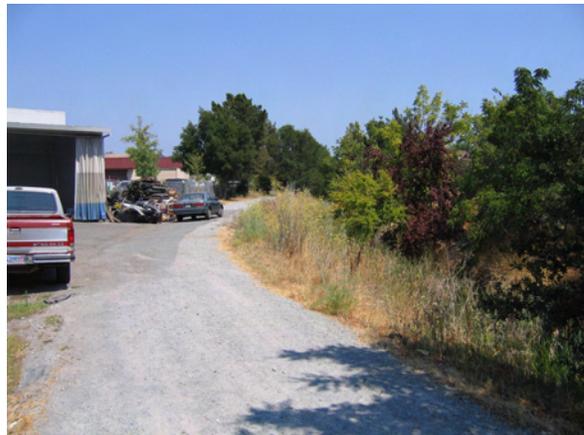
Reach setting: Local tributary to Piner Creek. Reach 2 and 1 are both straightened and tightly confined by adjacent land-use (photo d); Reach 2 is smaller than Reach 1 and appears to carry far less water. The reaches are separated by an underground culvert ~900 ft long and both draw flows from local runoff. The access road along Reach 1 is open to a number of auto salvage/repair shops which presents a potential water quality issue.

(d) Lower Russell 1, looking upstream on the access road. Unlike most SCWA channels, the access road is not fenced and a number of industrial/commercial businesses encroach on the access road. A variety of old/unused and newer cars are parked along or directly adjacent to the access road. Water quality might be jeopardized by commercial and industrial uses this close to the channel (August 2008).

Management considerations for Russell Creek include reduction of bank instability and scour along Reaches 2 and 1 in order to reduce bank erosion, maintain flow from outfalls, and reduce sediment transport through Russell Cr. In Reach 2, management could also focus on developing a barrier between industrial/commercial areas and the channel as this may lead to water quality issues. Canopy enhancements could benefit a suite of riparian species and retard growth of emergent vegetation.

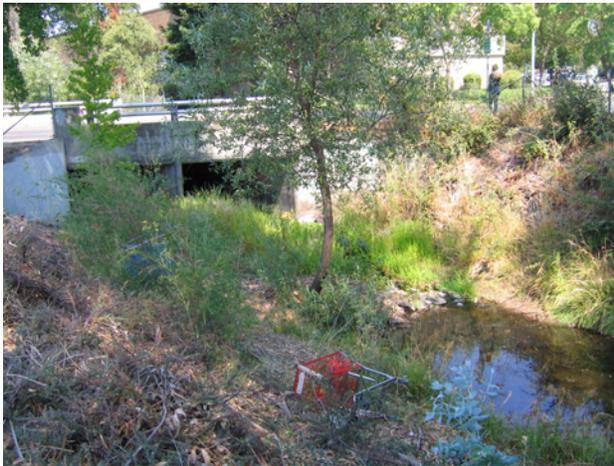
(b) Reach 5, looking downstream toward Coffee Lane crossing. Large vegetated sediment wedge extends upstream of the crossing. Lack of woody vegetation on banks; shopping cart and other nuisance trash in channel (August 2008).

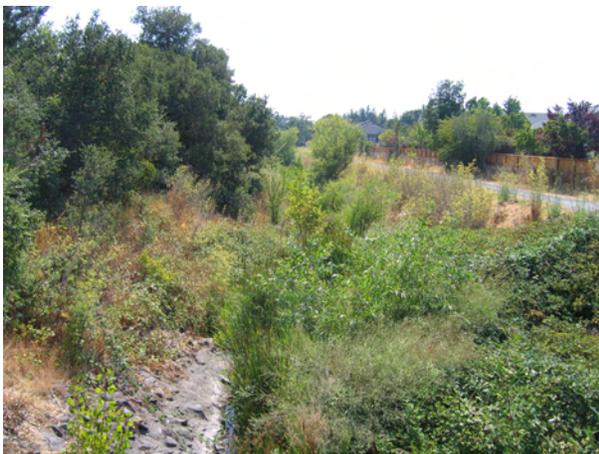
(c) Upper Reach 4, just downstream from the RR crossing. Streambanks are grouted and the channel is indiscernible due to the extensive growth of emergent vegetation (August 2008).

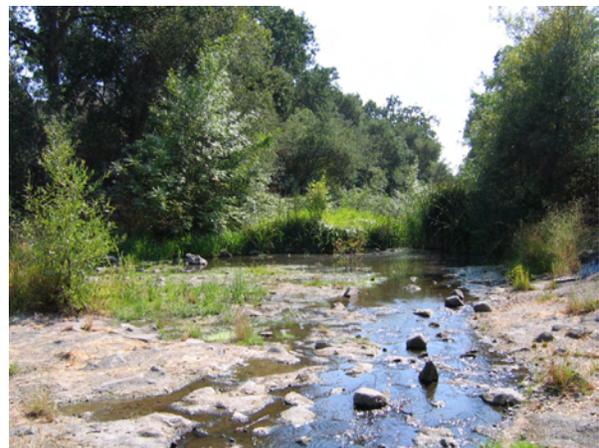
(d) Reach 3 looking downstream from the Paulin Cr. confluence. Confluence is heavily rocky and grouted; cattails form a dense mat across nearly the entire channel just downstream of the confluence (in distance) (August 2008).

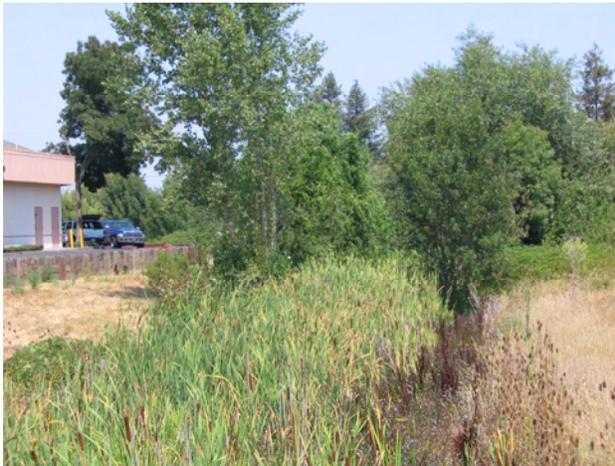
(b) Upper Coffey Cr Reach 1 about 250 ft. downstream of Piner Rd crossing. Channel has changed from blackberry thicket above (photo a) to cattails growing across the entire channel (Sept. 2008).

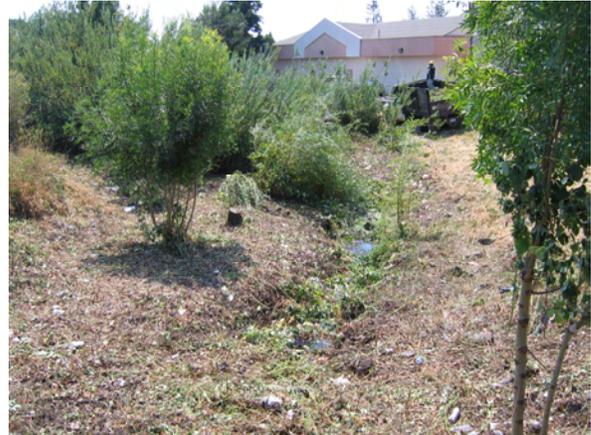
(a) Top of Coffey Cr. Reach 1 looking downstream from Piner Rd. crossing. Vegetation management activities were underway when this photo was taken in September 2008. Just downstream the entire cross section is covered by a dense thicket of blackberry with interspersed willows.

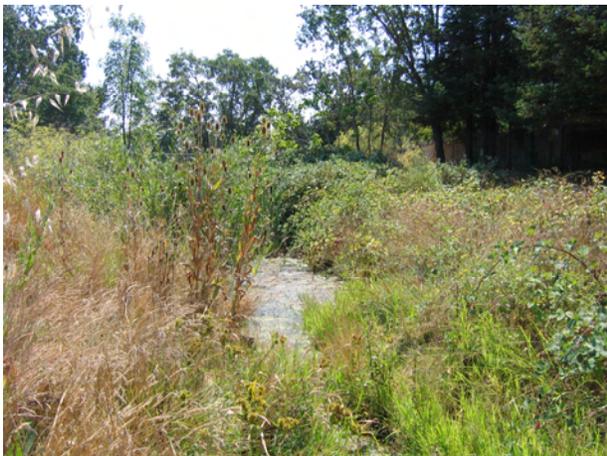
(c) Bottom of Coffey Cr, just upstream of confluence with Piner Cr. Reach 4. The pool in the center of the photo is one of the only pools observed along Coffey Cr. during September 2008 surveys. Notice the level of stagnation and vegetated sediment wedges both upstream and downstream.

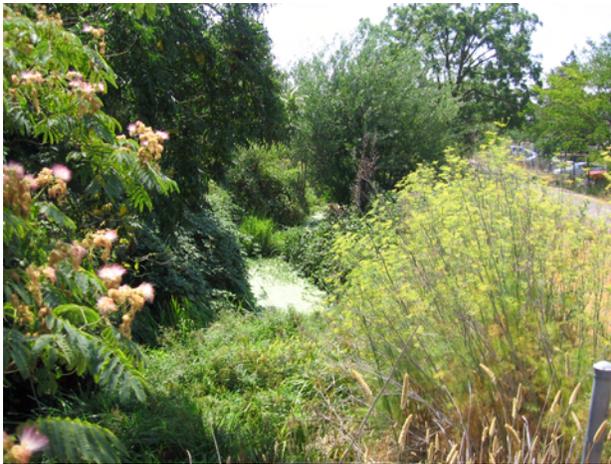
(b) Reach 6 – looking downstream from Range Avenue, similar to photo a, sediment deposited downstream of crossing, in mid-distance small cattail block creates upstream ponding, bank vegetation comprised mostly of exotic/invasive species (Aug. 12, 2008).

Channel processes: In Reach 6 depositional sediment wedges are found downstream of all crossings (mostly sand with cattails developed) indicating sediment transport occurs in pulses,

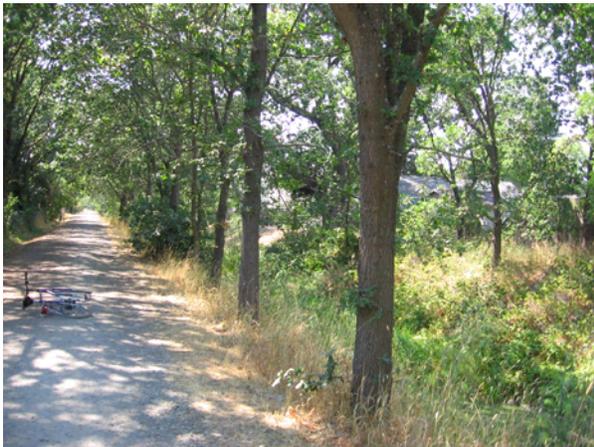
(c) Mid Reach 5 – looking downstream, this reach enjoys good riparian canopy cover along both north and south banks, cover promotes shading and reduces cattail presence as observed in Reach 6 upstream (Aug. 12, 2008).

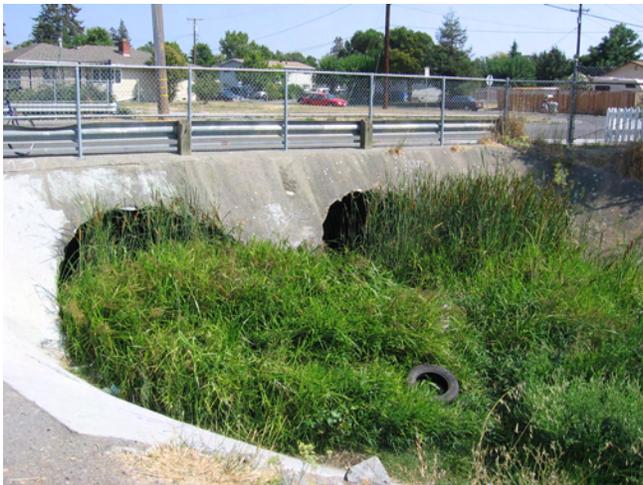
(b) Reach 3 downstream of Apache Street - downstream end of culverts beneath Apache Street are blocked with sediment wedge and cattail and other herbaceous growth (Aug. 12, 2008).

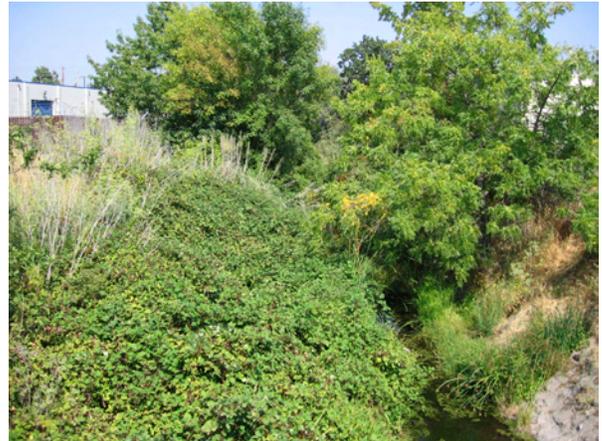
(a) Reach 4 upstream of railway crossing - commercial land use adjacent; steep vertical hardened banks, narrow channel below, abundant blackberry (Aug. 12, 2008).

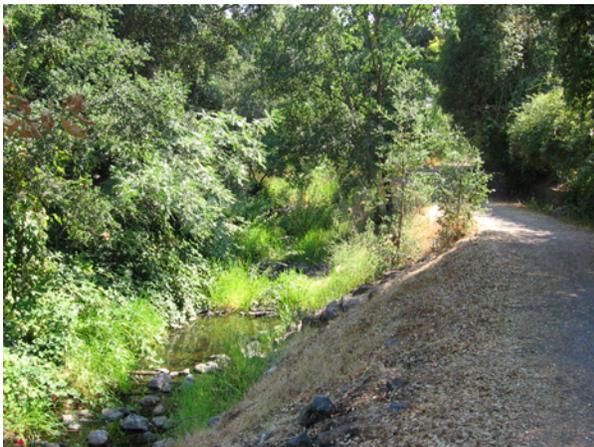
(c) Mid Reach 3 – looking downstream toward section with increased riparian cover, less steep banks than upstream, and more open water runs and improved aquatic habitat with understory aquatic plants (Aug. 12, 2008).

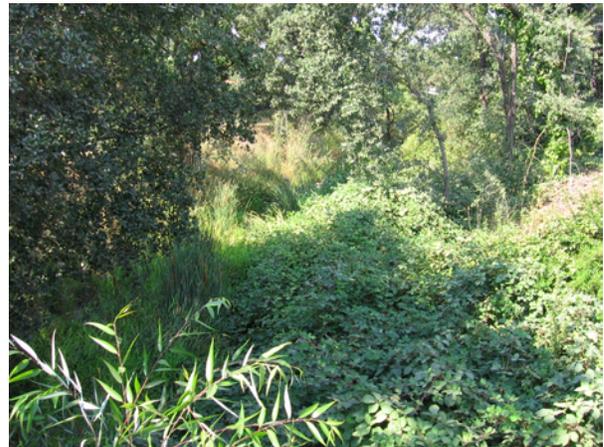
(d) Reach 3 – looking upstream from West Steele Lane crossing, mature trees provide canopy, with understory near West Steele Lane dominated by blackberry (Aug. 12, 2008).

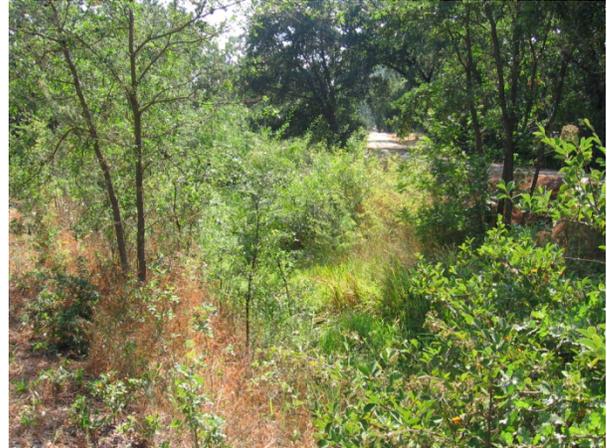
(a) Reach 2 downstream of W. Steele Ln. crossing – trapezoidal channel with steep banks; abundant shrub growth in channel; young oaks and other trees (like Black Hawthorne) are establishing on the banks, but there is still limited shading in the upper Reach 2 (Aug. 12, 2008).

Management considerations for Paulin Creek Reaches 2 and 1 are focused toward the following activities: (1) localized sediment removal should be assessed for areas downstream of W. Steele Ln. (200 ft) and downstream of Marlowe Rd. (150 ft) where cattails and sediment wedges have reduced conveyance capacity; (2) blackberry removal in upper Reach 2; and (3) evaluation of tree planting opportunities along the northern bank of upper Reach 2.

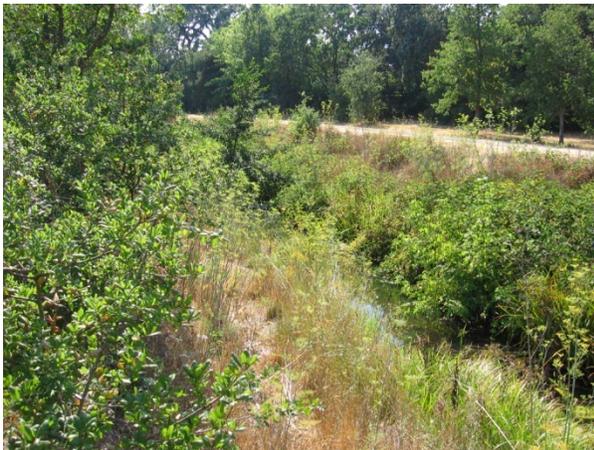
(b) Mid Reach 2 – steep banked trapezoidal channel with oaks growing on southern bank (left) and blackberry and other herbaceous growth on unshaded northern bank (right); note inset bench on southern (left) bank that supports grasses; some shading beneath undercut banks to right (Aug. 12, 2008).
