Santa Rosa Subbasin

FIGURE 4-10
Reaches and Vegetation
Santa Rosa (1 of 13)

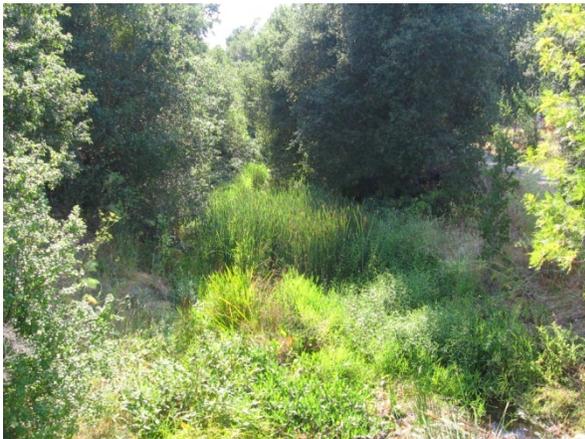
(c) Reach 1 downstream of Marlow Rd. – looking downstream, channel becomes wider and shallower compared to Reach 2 upstream (more gentle trapezoidal cross section); riparian cover increases, mainly oaks; cattails and sediment wedges occur downstream of Marlow crossing but then are more rare (Aug. 12, 2008).

Management considerations for Paulin Creek Reaches 2 and 1 are focused toward the following activities: (1) localized sediment removal should be assessed for areas downstream of W. Steele Ln. (200 ft) and downstream of Marlowe Rd. (150 ft) where cattails and sediment wedges have reduced conveyance capacity; (2) blackberry removal in upper Reach 2; and (3) evaluation of tree planting opportunities along the northern bank of upper Reach 2.

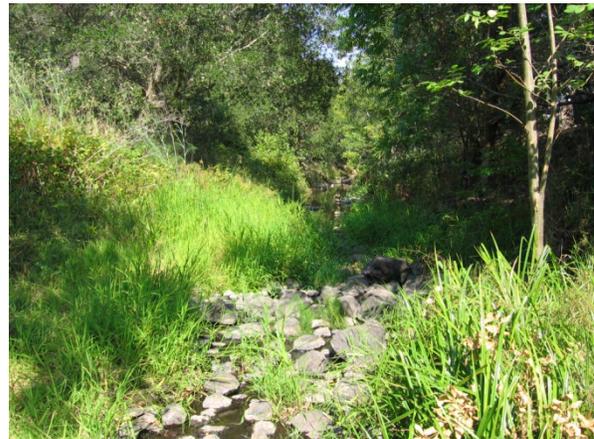
Bed sediments/texture: Sand dominant system, with some finer silts/muds settling in shallow ponded areas or stored in cattail patches; in Reach 1 riprap cobbles sloughed from bank form small cobble patches, riffles and pools (photo d).

(d) Reach 1 just upstream from Piner Creek confluence – channel depth and area increase toward Piner Cr. confluence; rock in near ground is riprap that has sloughed from local banks; oaks and alders seen in reach providing canopy and shade (Aug. 12, 2008).

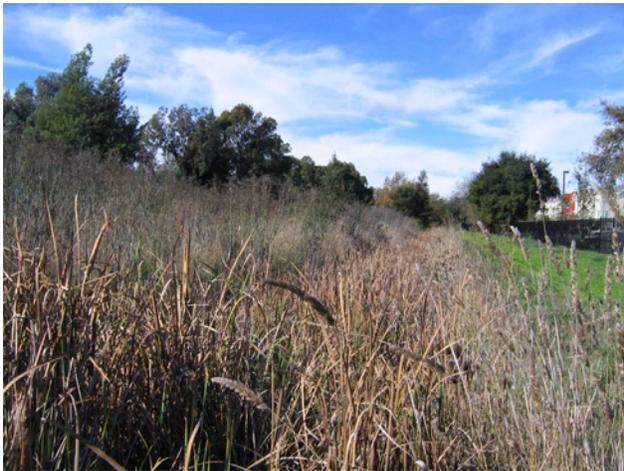
(b) Upper reach looking downstream: Narrow channel is completely choked with cattails and grasses and the cross-section is wide and shallow. As Steele Cr flows toward Jennings Ave, the channel deepens and the thalweg opens (see photo c) (Nov. 2007).

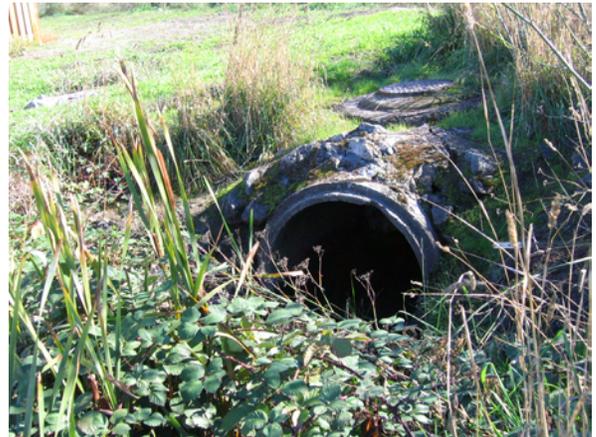
(a) Beginning of Steele Creek at top of Reach 5: concrete culvert extends at least 500 ft beyond Range Ave.; A second culvert enters channel from the south (only the second culvert was flowing in November of 2007). Upstream of these culverts there is no discernible channel (Nov. 2007).

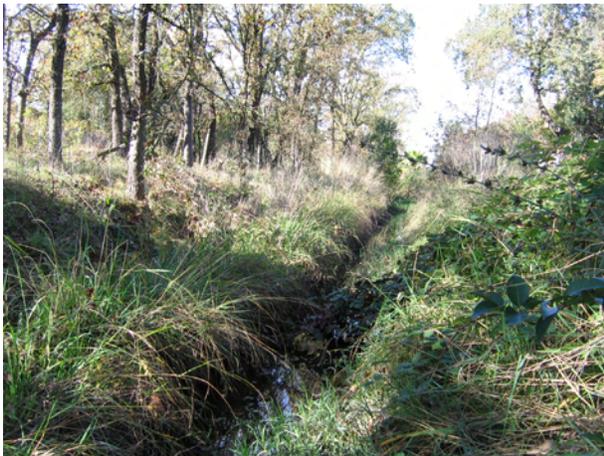
(c) Looking downstream from Jennings Ave pedestrian crossing. Unlike the upper channel in photo b, there is a visible thalweg from this point downstream, the channel is set deeper with top of bank ~10-12 ft from channel bottom, and a narrow riparian corridor flanks the north side of the channel. This riparian corridor thins to sparse trees moving downstream (Nov. 2007).

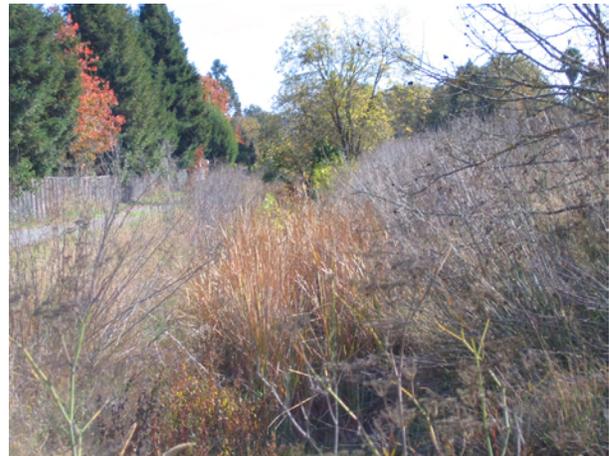
(d) Lower Reach 5, standing at culvert system at Guerneville Rd. Channel is again choked with cattails and the banks are covered by various ruderal species with sparse tree canopy (Nov. 2007).

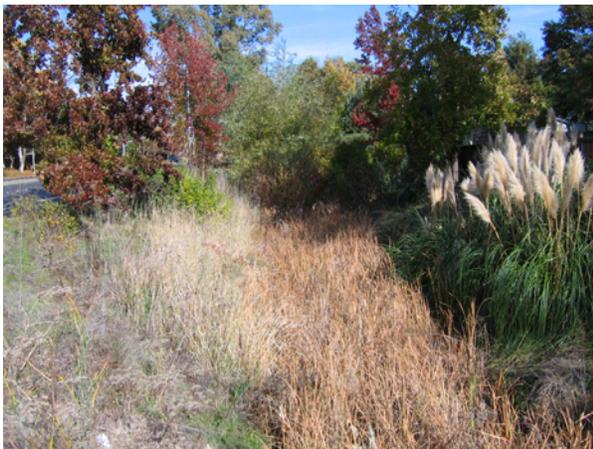
(b) Looking upstream from Lance Dr. crossing. This crossing consists of three 24" culverts set in rock and earth. The crossing is clearly a hydraulic constraint and is forcing sediment to settle out and build a wedge upstream of the crossing. Note the lack of canopy near the crossing and the extent of cattail growth in the channel (Nov. 2007).

There did not appear to be any pressing large scale management needs at the time of the assessment (11/07). Sections of the stream near road crossings should be checked annually for aggradation and extensive emergent vegetation establishment which would reduce capacity and functionality of culverts. It should be noted that Reach 4 has a rather narrow cross-section, which could result in minor sediment aggradation causing extensive flooding of Guerneville Rd.

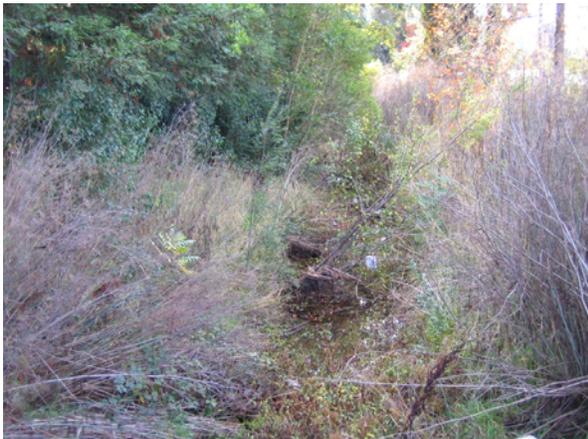
Instream habitat: Although the channel is straight and trapezoidal, it does contain a scoured low flow channel with persistent open water. Unlike Reach 5, these reaches contain a number of aquatic habitat elements such as small pools, riffles, glides, undercut banks, and small debris jams (photo c).

(c) Middle of Reach 4, looking downstream from Lance Dr. crossing. The channel is open and flowing, but barely visible with the dense cover of fennel and a variety of native and non-native trees and shrubs (Nov. 2007).

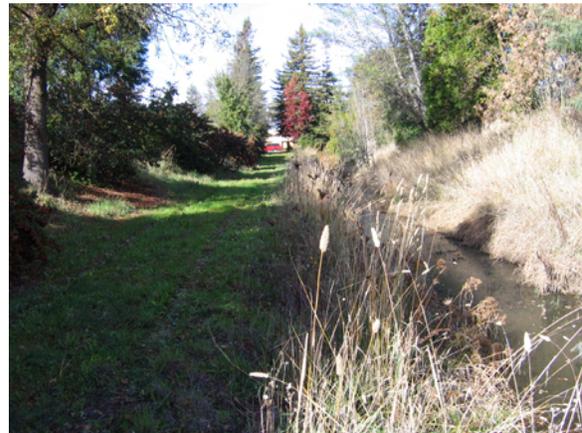
(d) Near bottom of Reach 3, looking upstream toward Guerneville Rd. (red car in background). The channel is straight and banks are covered by ruderal grasses with an open, mixed canopy from a variety of tree species (Nov. 2007).

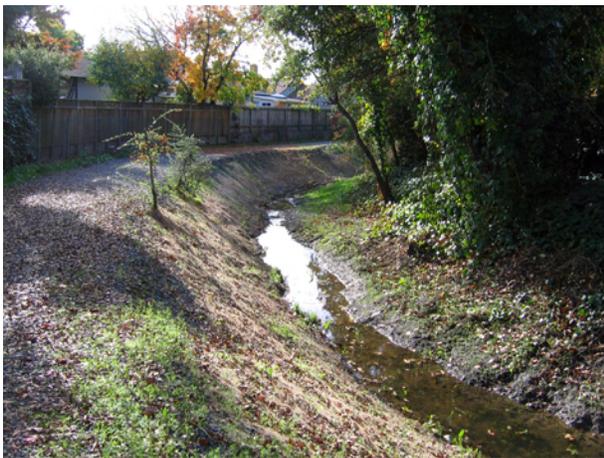
(b) Reach 2 looking downstream at SCWA's recent bank stabilization project along channel bend. This project was completed during the summer of 2007 and photo is from November 2007. Note that bends can be particularly at risk for bank erosion in stream systems that have been straightened for most of their length due to greater velocities and shear along the outer bends.

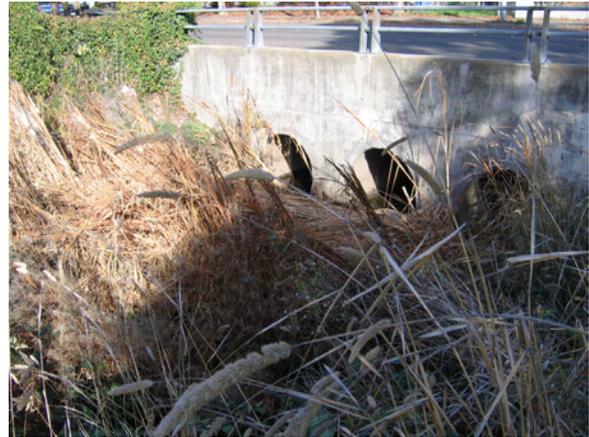
(a) Reach 2 looking upstream to top of reach at Ridley Ave. crossing. Note dense growth of cattails at the mouth of the culverts (Nov. 2007).

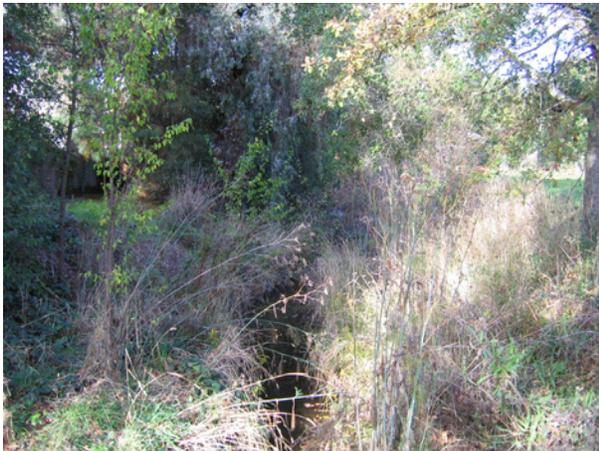
(c) Mid Reach 2 in the middle of the long straight section. Notice the shading provided by the narrow riparian corridor, the well defined low flow channel, and all of the overhanging herbaceous vegetation (Nov. 2007).

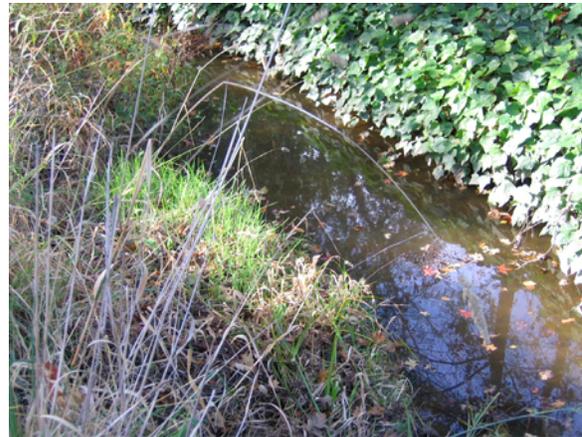
Instream habitat: The channel is straight and trapezoidal, but does contain a narrow well defined low flow channel. However, the channel appears to lack any significant complexity and is generally one long glide. There is little complexity, overhanging herbaceous vegetation (grasses, ivy, etc) do create some cover and facilitate creation of undercut banks (photo d).

(d) Reach 2, looking downstream 200 hundred feet upstream of Marlow Rd. Notice the sediment wedge/bar accumulating along the toe of the slope (grassy center of photo). This reach shows the first signs of significant sediment deposition within the Steele Cr. System (Nov. 2007).

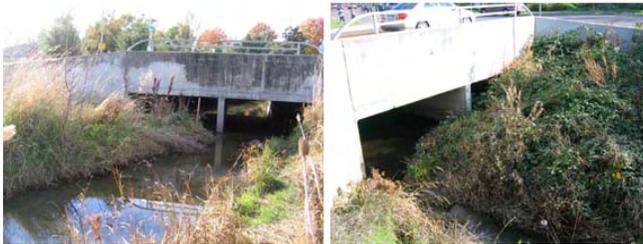
(b) Left: looking downstream toward upper Gamay St. crossing; and Right: looking upstream at downstream side of Gamay St. crossing. Large wedge of sediment covers the south cell at the upstream side of the crossing, and sediment deposit blocks all of the south cell and part of the north cell at the downstream side of the crossing (Nov. 2007).

Sediment management activities at the Gamay Street crossing are necessary at this time. At the upstream end of the crossing, one cell is nearly inoperable due to sediment accumulation. At the downstream end, a large sediment wedge appears to be blocking not only the southern cell, but part of the northern cell. In addition, vegetation management may need to be conducted in the upper portion of the reach to address any reduction in capacity resulting from extensive instream vegetation growth. Finally, SCWA should routinely assess the integrity of the culverts and the culvert apron at the Piner Cr confluence. Although they currently do not appear to be in need of urgent repair, some piping and underflow appears to be occurring. The section of Reach 1 upstream of Gamay could significantly benefit from additional canopy. As such, this reach would be a good candidate for planting of appropriate riparian canopy species.

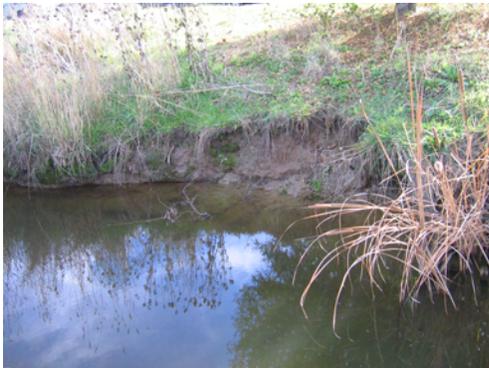
(c) 50 ft upstream of Gamay St. At this point the channel transitions from being completely choked with cattails to open water. At the break, a pool has formed due to erosion of the far bank and is continuing to expand destabilizing the nearby bank (Nov. 2007).

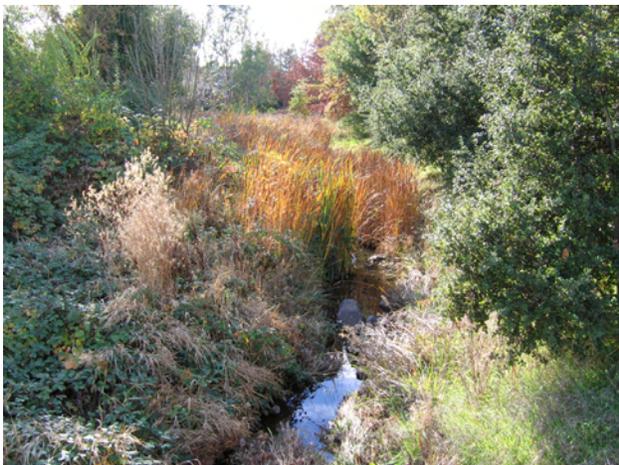
(d) Looking upstream at Piner Cr. confluence. From Gamay St down to the confluence, a scattered canopy of woody riparian species has developed (Nov. 2007).

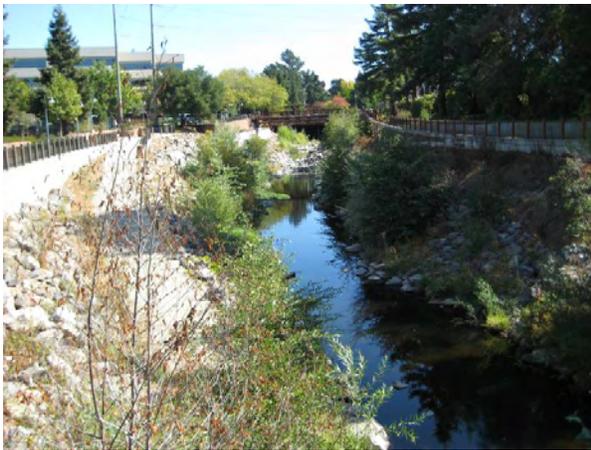
(b) Looking upstream to Santa Rosa Ave crossing from mid-reach. Note shading provided by tall redwoods and oaks on south bank (October 9, 2008).

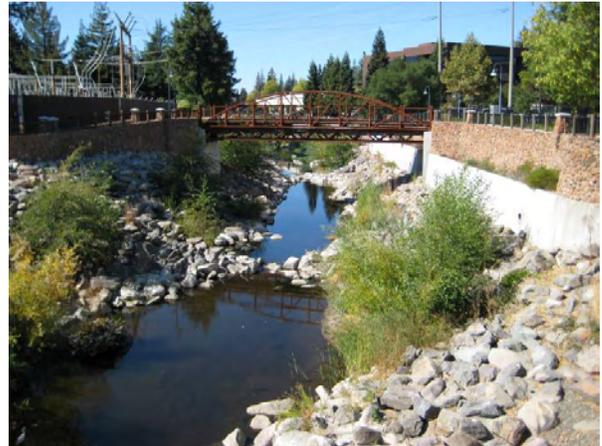
(a) View downstream to pedestrian crossing from Santa Rosa Avenue. Note rip-rap and concrete-lined banks, weirs, and minimal vegetation (October 9, 2008).

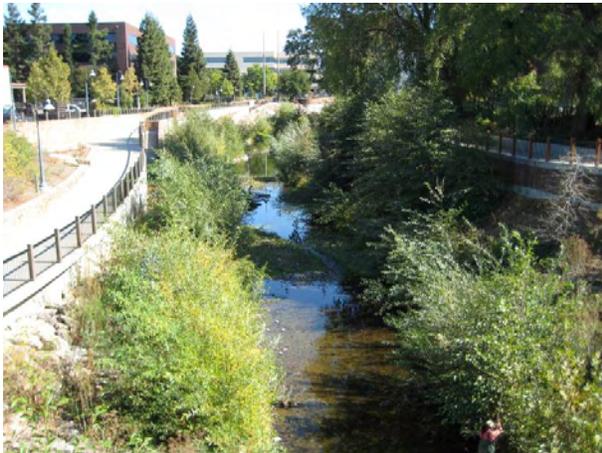
(c) Looking upstream from A Street crossing; note clear active channel (October 9, 2008).

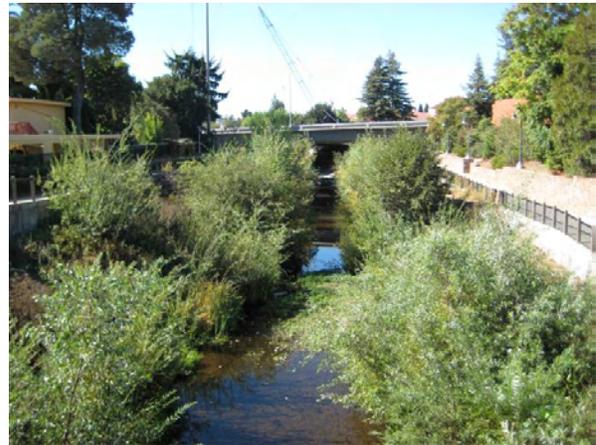
(d) Dense willow scrub along banks looking downstream from A Street towards Hwy 101 crossing (October 9, 2008).

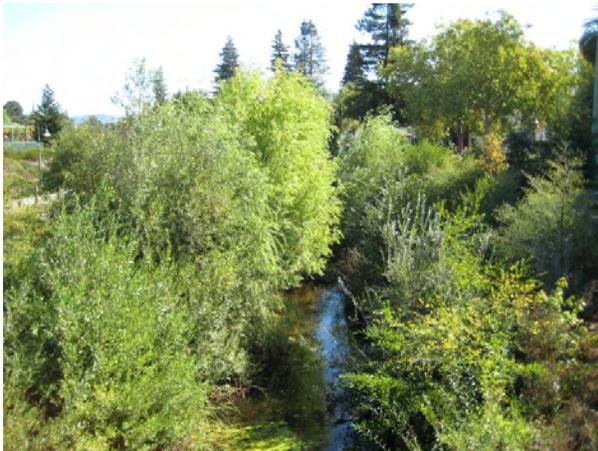
(b) Looking upstream from Railroad Street crossing. Note dense riparian vegetation on both banks (October 9, 2008).

Water quality: clear, flowing water observed on 10/8/08. Patches of algae growth noted (Photo b).

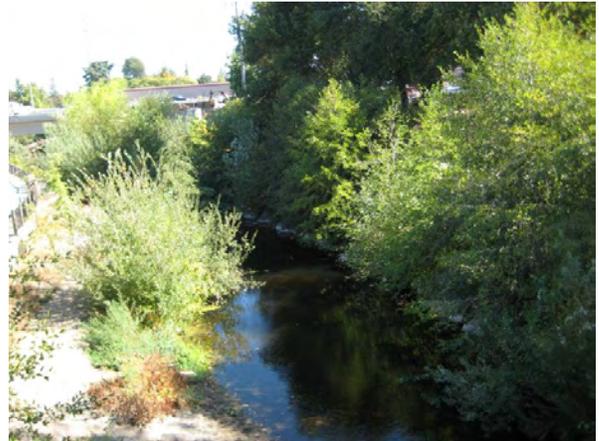
(a) Looking upstream from a pedestrian crossing west of Highway 101 (October 9, 2008).

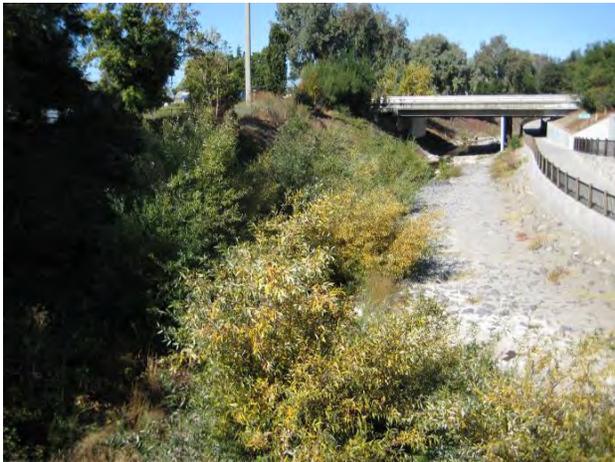
(c) Looking downstream to West Third Street crossing from railroad tracks. Note upper bench on right bank (October 9, 2008).

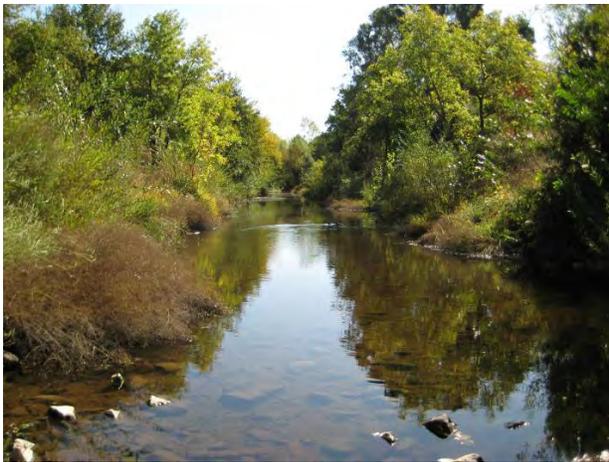
(b) Looking upstream at the middle of the reach. Note larger cobbles and bed sediments (October 9, 2008).

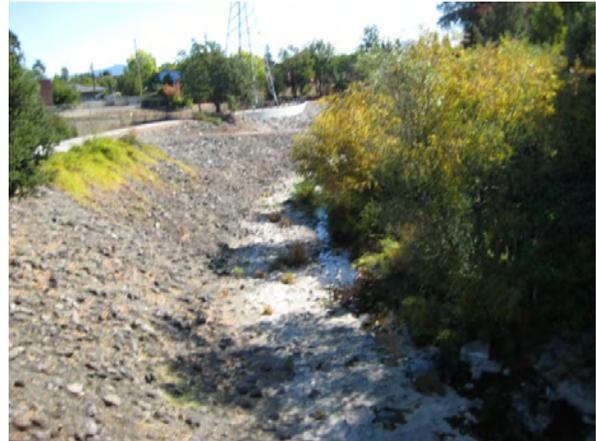
(a) Bank and channel bed is rip-rapped and grouted at the Pierson Street crossing, looking upstream. Flows are contained along the inner area around the bend, on the right (October 9, 2008).

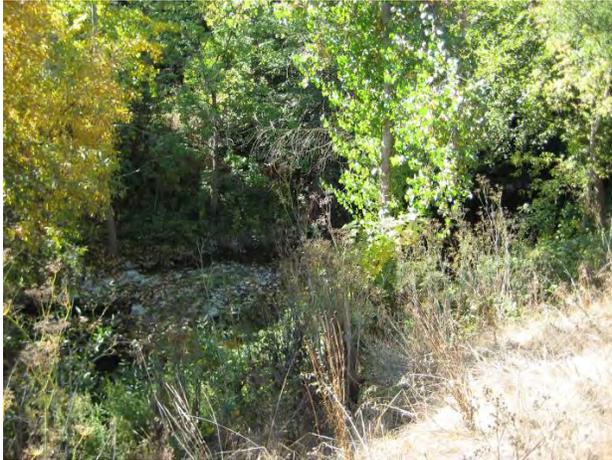
(c) Looking upstream from Dutton Road; note full canopy and dense bank vegetation (October 9, 2008).

Management considerations for Santa Rosa Creek Reach 4 are focused on vegetation management. Limb riparian trees and trim vegetation as necessary to maintain flood carrying capacity. Encourage growth of riparian overstory to reduce growth of algae mats.

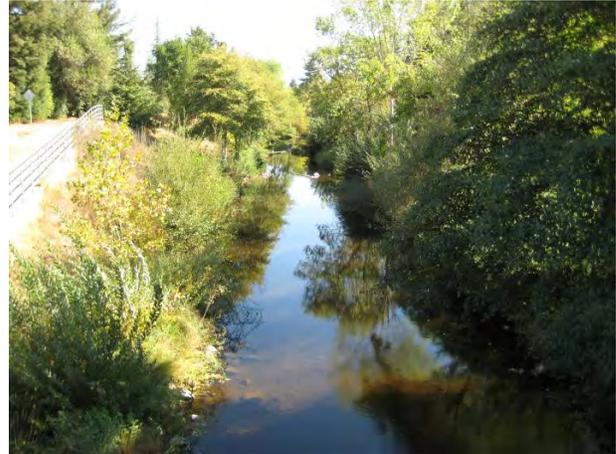
(d) View upstream from Stony Point Road shows limited in-channel vegetation and moderate canopy cover (October 9, 2008).

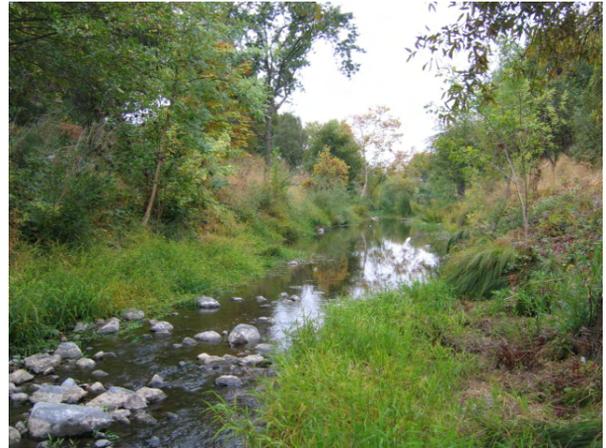
(a) Reach 3, looking downstream from just below the Marlow Road Bridge. Note the rip rap and swiftly flowing water observed in September 2008. Sediment deposition appears to be limited to small margin bars (both banks), and a moderate channel gradient leading to an open uniform channel geometry (9/29/08).

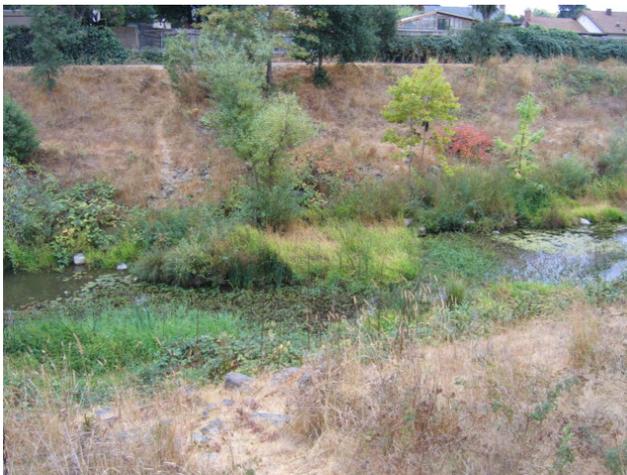
(b) Reach 3, looking across the channel upstream from College Creek confluence. Notice how the dense riparian vegetation along the banks in photo (a) has been replaced by ruderal grassland type vegetation and the presence of a d-bar constricting flow to a small 2-3 wide vegetated channel with large open channel segments both upstream and downstream (9/29/08).

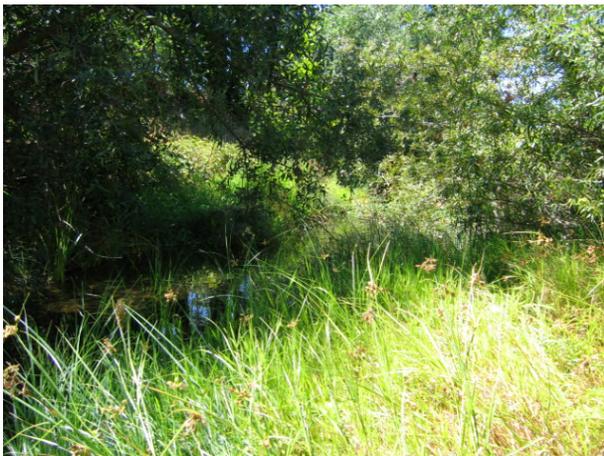
(c) Reach 2, about 500 ft downstream of Fulton Road Bridge, looking across the channel from a large vegetated bar to another large bar just downstream. At this location, the low flow channel has gone from being about 25 ft wide to about 8 ft wide due to confinement between alternating d-bars (8/21/08).

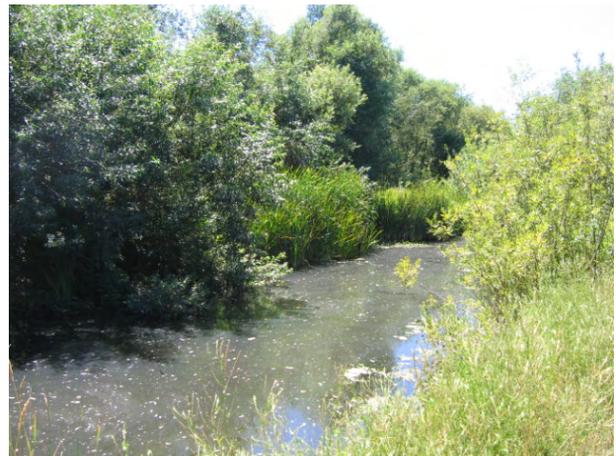
(d) Lower Reach 2, looking downstream from just upstream of the Abramson Cr confluence. Notice the large stand of cattails in the background and the stagnant “pool” in the foreground. Beyond the photo the cattail bar reduced the low flow channel from ~ 20 ft wide to ~6 ft wide creating a significant flow impediment and creating the stagnant conditions upstream. This photo is typical of the pool and wedge/bar geometry common to Reach 2 (8/21/08).

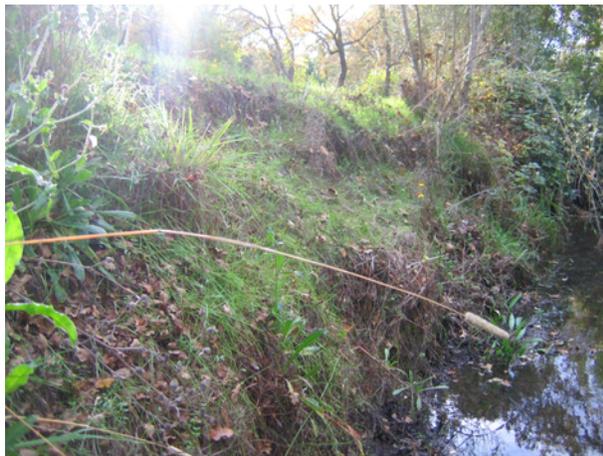
(b) Lower Reach 3 looking downstream. Steep and near vertical banks result in bank sloughing. During the assessment conducted in November of 2007, there were at least 2 other areas of similar bank instability (May 6, 2008).

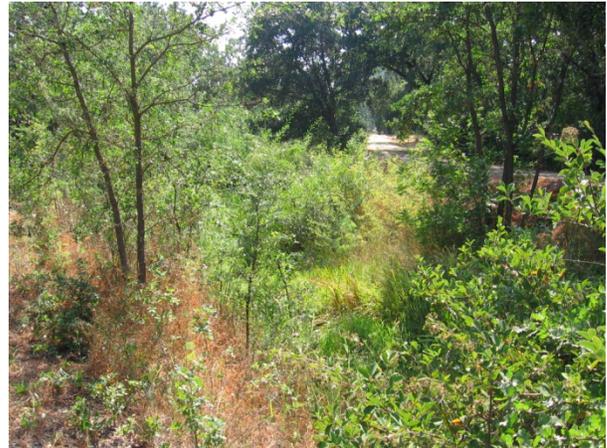
(a) Middle of Reach 3 looking downstream. Sediment wedges and bars develop along toe-of-banks; channel has gentle sinuosity and dense bank vegetation (May 6, 2008).

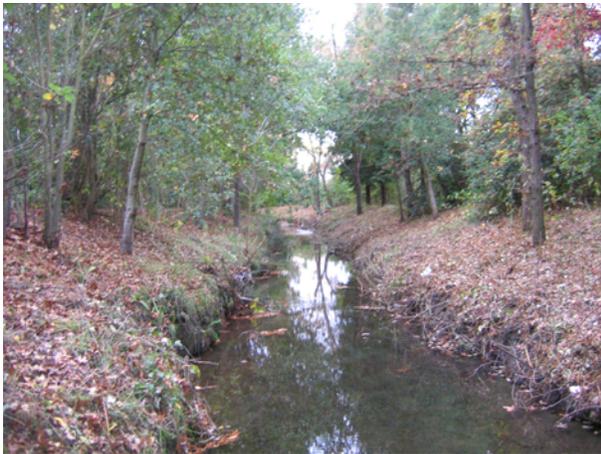
(c) Middle of Reach 2, just downstream of Marlow Dr. crossing, looking downstream through straightened section. Notice the dense riparian canopy covering the channel and the lack of emergent vegetation in the active channel (May 6, 2008).

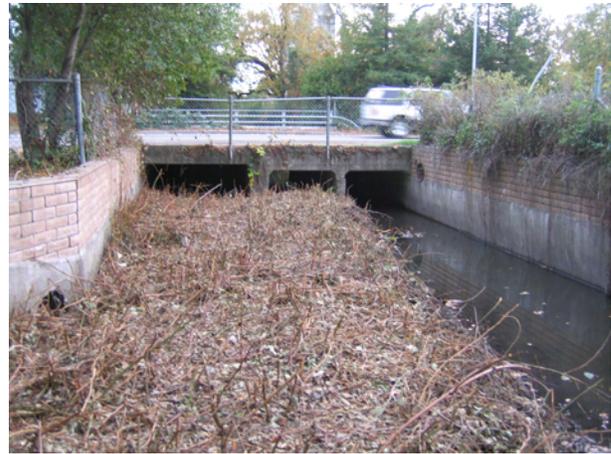
(d) Bottom of Reach 2 looking downstream at West College crossing. A large (15 ft and 100 ft long) wedge of sediment has accumulated upstream of this crossing. 2 of the 3 cells are dramatically reduced in capacity (May 6, 2008).

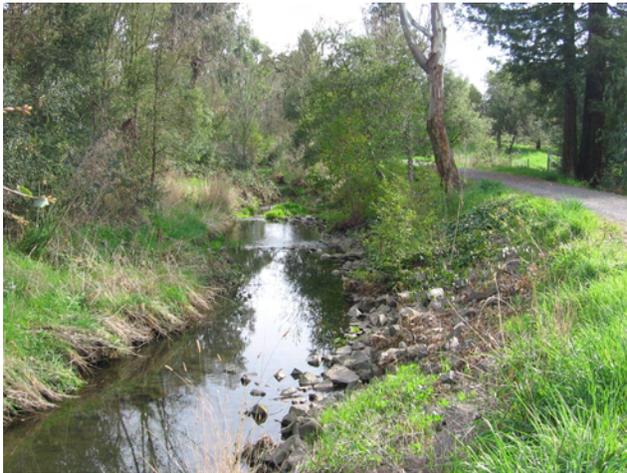
(b) Mid Reach 1 looking downstream; cobbles and small boulders from bank protection on right are sloughing down into channel, note small instream rock drop structure in mid-distance, and emergent vegetation above sediment and rocks collecting in far distance in channel, access road provides recreation path to right (May 6, 2008).

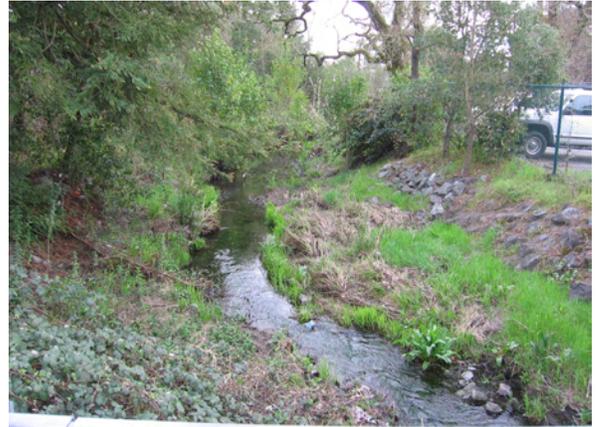
(a) Upper Reach 1 looking downstream from College Ave.; rip-rapped banks downstream of crossing, note sediment wedge developing on inner bank (right) with emergent vegetation, and next downstream bar on opposite bank providing some channel sinuosity; reach includes canopy of mature trees including oaks (May 6, 2008).

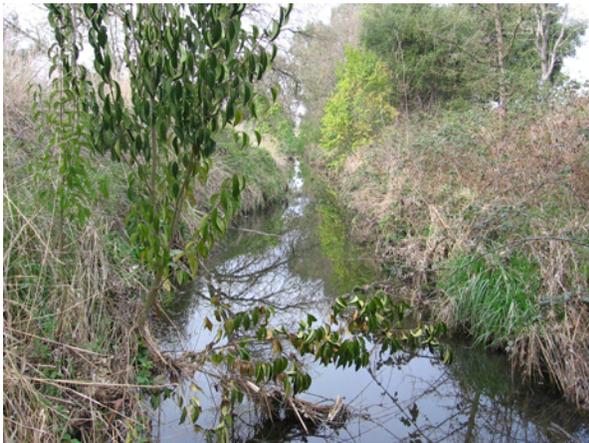
(c) Lower Reach 1 (near Santa Rosa Creek confluence) looking upstream, very linear channel, 10 ft. wide below steep banks (1:1) (May 6, 2008).

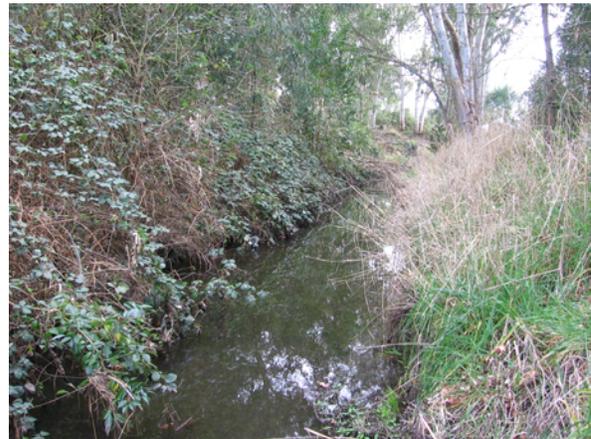
(d) Lower Reach 1 looking downstream to Santa Rosa Creek confluence, note abundant blackberry on left bank, Eucalyptus trees in distance mark Santa Rosa Creek (May 6, 2008).

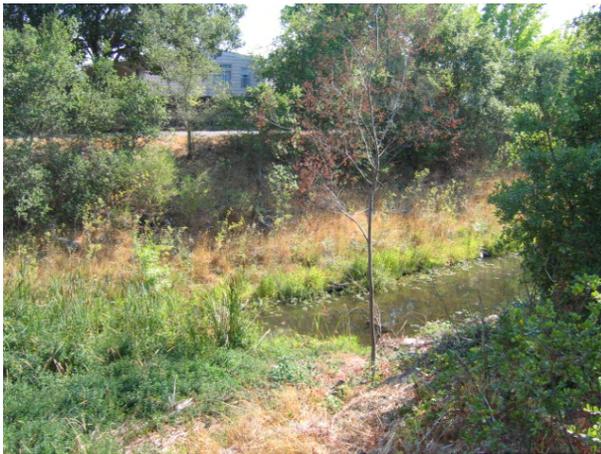
(b) Mid Reach 2, looking across the channel at a large sediment wedge (left) and a pool/run (right). This photo is representative of the sediment wedge-pool morphology common in SCWA's low gradient, engineered flood control channels (August 2008).

Management considerations for Piner Creek Reaches 2 and 1 include focused sediment removal at some key bars and blockages, vegetation thinning in locations, and opportunities to enhance habitats. Steelhead are known to rear in upstream Reach 3 and in nearby Paulin Creek (also upstream). The following actions may improve steelhead habitat: clearing the vegetation at the confluence of Piner and Santa Rosa Cr, cutting low flow channels through some of the large sediment wedges in Reaches 2/1, increasing instream habitat complexity and pool formation, and increasing canopy closure along Reach 1. These actions would benefit a wide array of aquatic and riparian species, including steelhead.

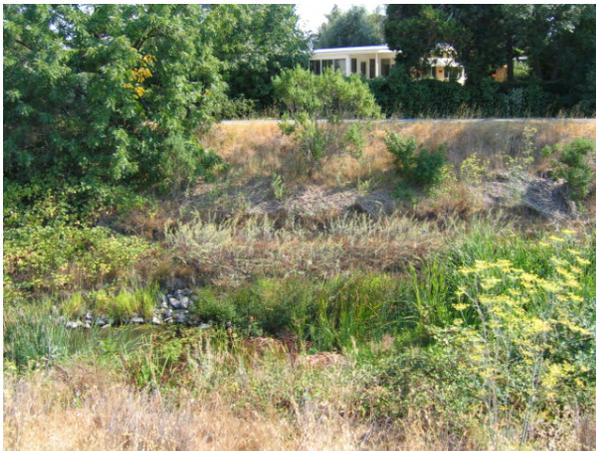
(c) Reach 1 looking across the channel at a slumping bank that slid into the channel creating a 2 ft high bar at the toe of the bank. Exposed rip-rap is seen at the toe just upstream of the slip, this base of bank rip-rap extends throughout both reaches (August 2008).

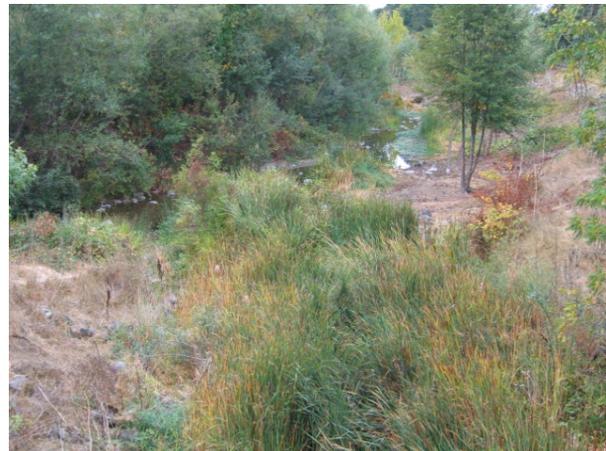
(d) Bottom of Reach 1, looking downstream to confluence with Santa Rosa Cr.; channel gradient steepens at confluence; channel is covered with a dense growth of tules from the pedestrian bridge to the confluence (August 2008).

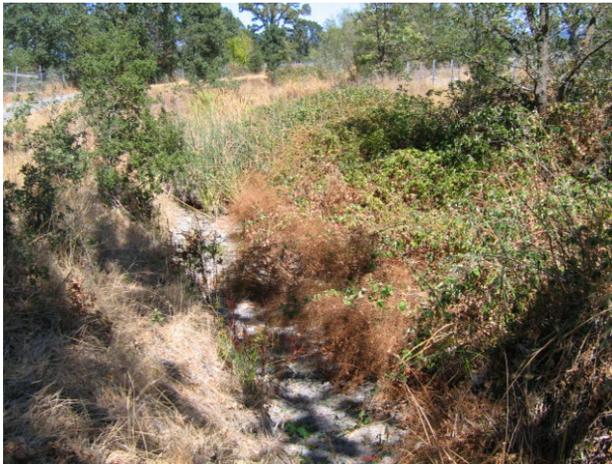
(b) Mid-Reach 2 looking upstream at bend. Heavily vegetated channel upstream (tules) transitions to a moist (but not flowing) and relatively un-vegetated streambed in the foreground. Also note the outside of the bend is eroded, creating a 1-2ft high gravel bar at base of bank (Sept. 2008).

between the uppermost bend and second bend shows erosion and instability (photo b). This erosion appears to be responsible for the gravel recruitment and development of bars downstream. Erosion was also observed just upstream of the Guerneville Rd. crossing. At the transition between the earth/rock bank and the grouted rock bank, the bank has eroded leading to flows moving under and behind the grouted bank protection. In terms of tree cover, although there appears to be significant recruitment of young oaks in the upper portions of this reach, the canopy is still very sparse and the entire reach could benefit from canopy enhancement activities.

In the short-term, the upper portion of this reach would benefit from in-channel vegetation thinning, while the lower reach should be watched for issues associated with bank instability. The reach contains two agricultural crossings, both of which appear to be outdated and could potentially fail in high flows. In the longer-term, these crossings should be assessed for potential repair or replacement. The northwest bank

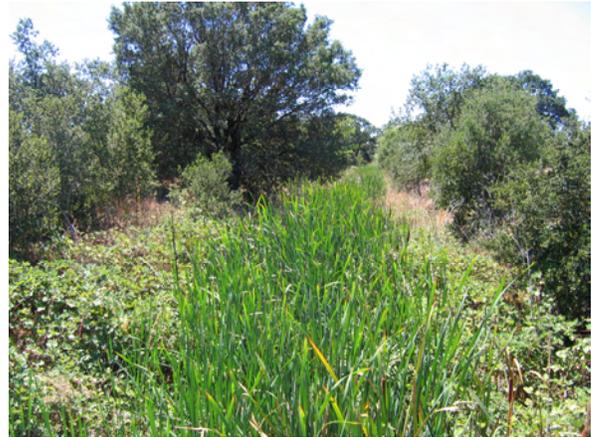
(a) Upper end of Reach 2, looking downstream. Engineered and straightened channel cross section is immersed in cattails across the bed, blackberry along the lower banks, and oaks higher at the top-of-bank (Sept. 2008).

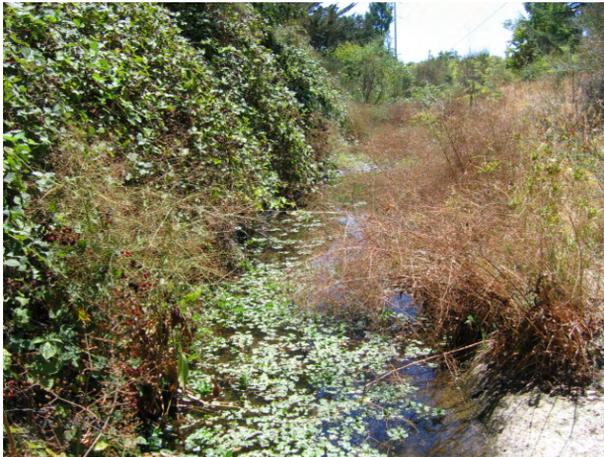
(c) Mid-Reach 2 looking downstream. Very extended pool of open water supports *Ludwigia*. Steep bank to left covered in blackberry. The bank to the right has sloughed/slumped forming a 1-2 ft high bar at the base of the right bank (Sept. 2008).

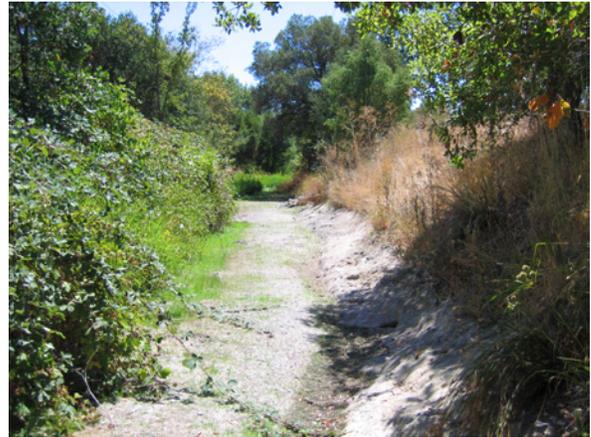
(a) Looking downstream from upper Peterson Reach 1. The active channel is wide, scoured, and void of vegetation. The low-flow channel is moist although there is no surface flow. Note in the background, a large cattail vegetated sediment wedge which crosses the entire channel (Sept. 2008).

Management considerations for Peterson Creek Reach 1 should focus on sediment management. Although it is not clear whether the current accumulation of sediment has reduced conveyance capacity to a level which warrants a reach-scale sediment removal project, the existing bars will likely need to be skimmed or removed in the future. Moreover, removing sediment from Peterson Creek will guarantee that these sediments are not mobilized in the future and deposited in Santa Rosa Cr. and the Laguna de Santa Rosa downstream. There were also a number of areas of bank undercutting noted along this reach (in areas between the sediment wedges) that should be watched for future effects on bank stability. Finally, although the live oak canopy appears to be expanding additional effort to enhance canopy along this reach could benefit a number of riparian species.

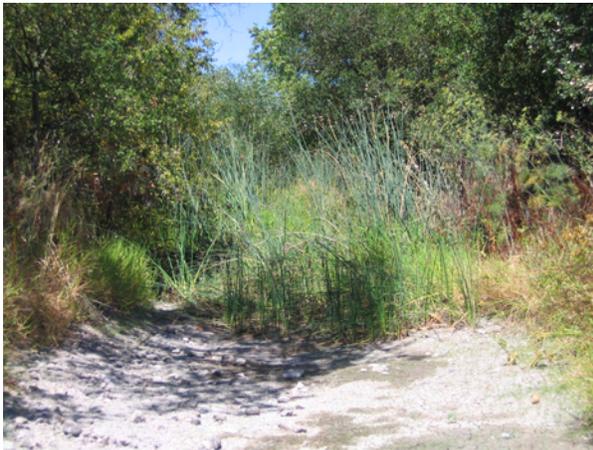
(c) Mid Reach 1 looking upstream at a large bar covered in tules. Bars in this reach support a wide variety of emergent vegetation including tules and cattails as well as willows and annual grasses. Also note that like photo a, the channel appears to be moist in certain locations (Sept. 2008).

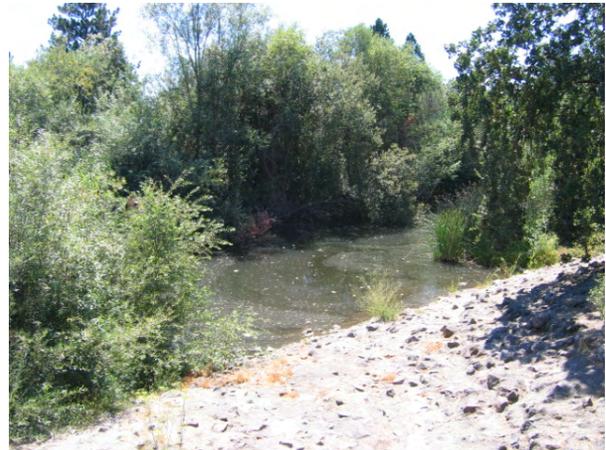
(d) Looking downstream from Peterson 1 to Santa Rosa Cr. Reach 2. There is no discernible low flow channel connecting this reach with Santa Rosa Cr.; instead flows from Peterson sheet over the grouted rock into Santa Rosa Cr. This confluence likely prevents the movement of anadromous fish into Peterson Creek (Sept. 2008).

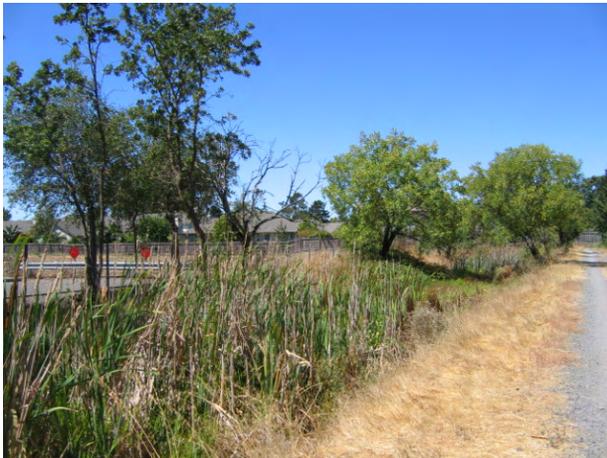
(b) Lower Reach 3, looking upstream. Dense line of cattails fills the channel bottom, clearly demarcating the active channel. This area was completely dry in August 2008.

Management considerations for Forestview Creek are limited to vegetation management in Reach 3 to reduce blackberry and cattail presence on the banks and in the channel. Some bank instability was noted in Reach 2 and Reach 1 (photo c), and this should be watched over time. All of the crossings look to be adequate from a conveyance perspective and there were no large bars that would constrict flows observed. All three reaches could benefit from additional canopy planting to increase shade, retard growth of emergent vegetation, and provide additional habitat benefits for a variety of riparian species.

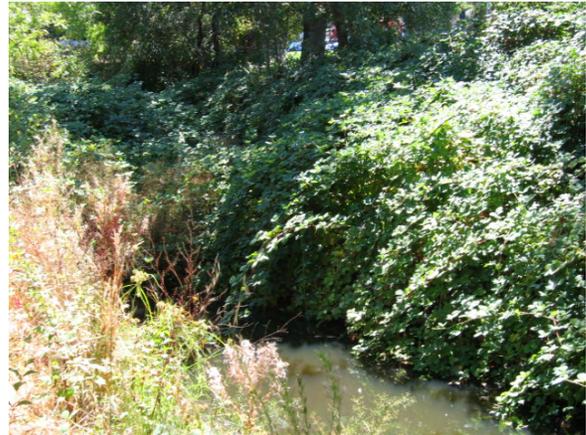
(a) Upper Reach 3, one of two small pools in the upper reach. About 100 ft downstream from this pool the channel was dry in August of 2008. Note the heavy growth of blackberry around this pool and the stagnant look of the water.

Water quality (qualitative): generally stagnant, poor visibility and turbid in the 2 pools observed in August of 2008.

Instream Habitat: Aquatic habitat in this reach is limited in the dry season by lack of surface flow. Only two pools were observed in August of 2008 and both were small and stagnant; the channel does not appear to maintain much complexity with limited bars, debris, or overhanging banks. In Reach 2 and 1 the channel bottom was difficult to distinguish from the banks due the high level of non-wetland plants growing in the channel proper.

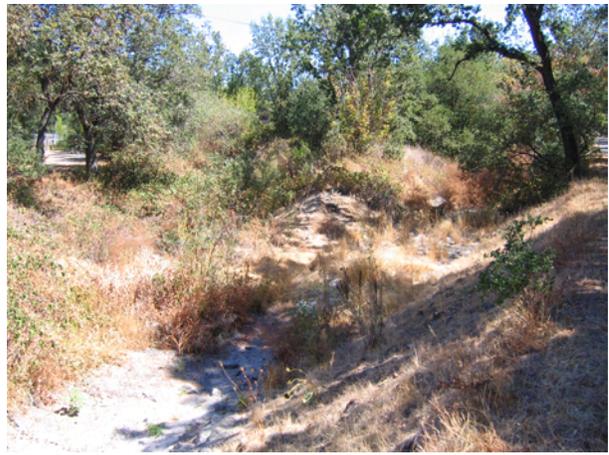
(d) Confluence of Reach 1 and Peterson Cr., looking upstream. Forestview is the channel to the right and Peterson is the channel to the left. Both channels are dry (August 2008) and the channel bed is coated in a thin layer of dry white clay.

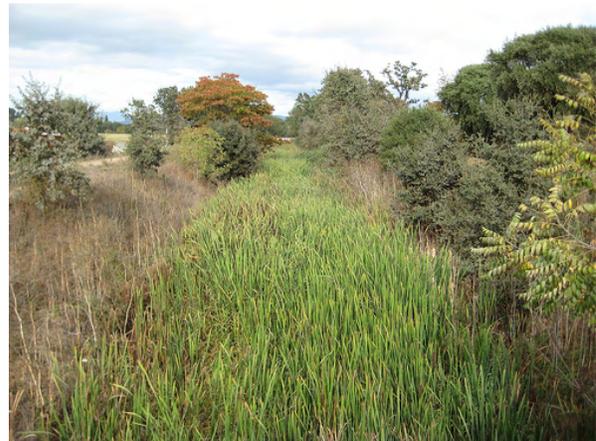
(d) Mid Reach 1 looking upstream, abundant cattails continue into mid Reach 1, with little riparian canopy cover, homogenous channel environment, trapezoidal banks sloping at 1:1 (Oct. 2, 2008).

Management considerations for Abramson Creek Reaches 2 and 1 are focused toward the following activities: repair of eroding bank in upper Reach 2 (near location of photo a); clearing of cattails in lower Reach 2 that are creating poor water circulation and algae development; and clearing of cattails in upper Reach 1 (photos c/d) which are covering entire channel bed. Opportunities to plant and create a greater riparian canopy exist throughout reaches, especially lower Reach 2 and upper Reach 1. Opportunities to remove other non-native choking vegetation including blackberry and thistle exist as well at these reaches.

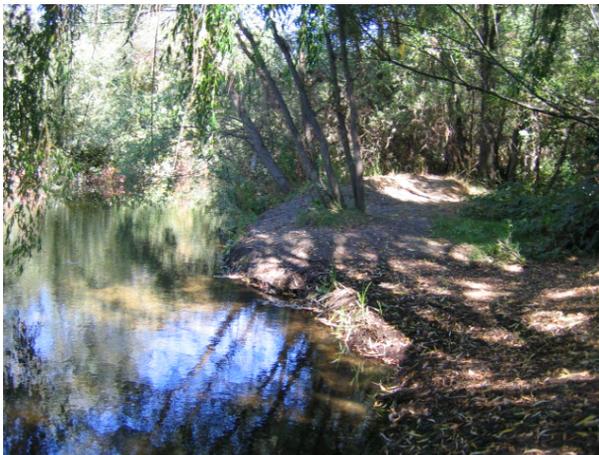
(b) Middle of Reach 1, standing on the banks looking at a large deep pool and adjacent low floodplain (8/21/08).

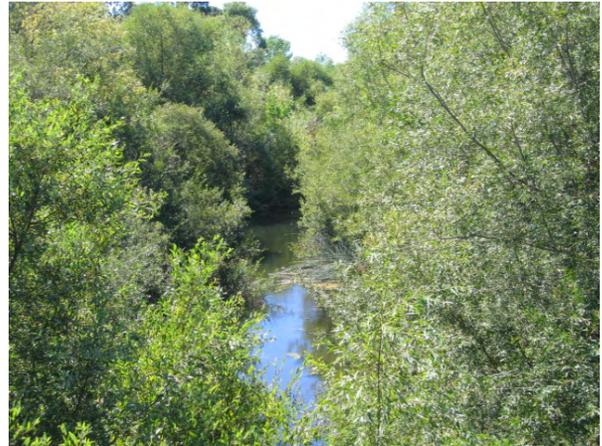
(a) Reach 1, looking downstream from the Willowside Road Bridge (8/21/08).

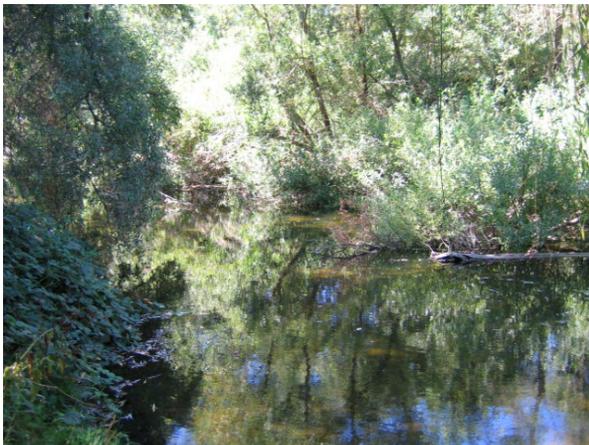
(c) Middle of Reach 1, looking downstream from a shady floodplain into a diverse and complex stream segment with overhanging vegetation and significant woody debris along the banks (8/21/08).
