Figure 4-30

Upper Laguna Subbasin

FIGURE 4-31
Reaches and Vegetation
 Upper Laguna (1 of 11)

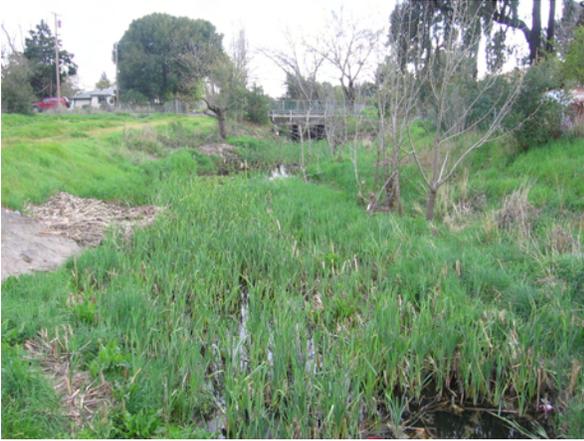
Channel processes: area upstream of Dolores Ln. functions as an instream basin (photos a, b) where the channel is aggrading and forming 1-3 ft high benches at base of banks and other in-channel depositional bar features; bars increase in size and height moving downstream toward Dolores Ln. Downstream of Dolores Ln. channel includes alternating sequence of depositional features and shallow pools (photos c, d, e).

(c) Todd Cr. Reach 5 looking downstream from Dolores Ln crossing to E. Robles Ave. bridge: channel alternates between vegetation patches clogging channel and open water. This pattern is seen throughout upper Todd Creek reaches downstream of Dolores Ln (March 19, 2008)

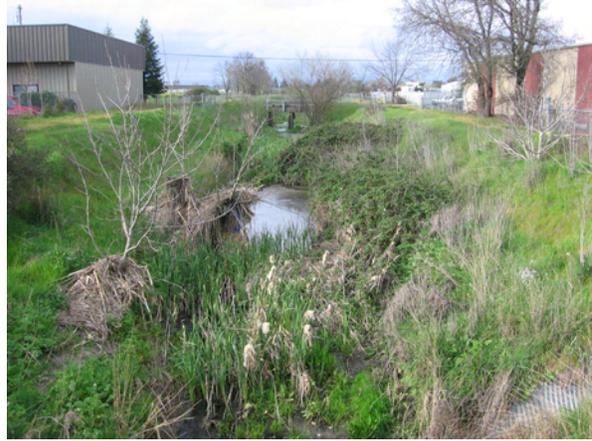
(e) Todd Creek Reach 5, looking upstream from Todd Road to Bucks Road. Similar to photo (c) note alternating sections of sediment deposits with cattails and open stagnant pools along low gradient stream (March 19, 2008).

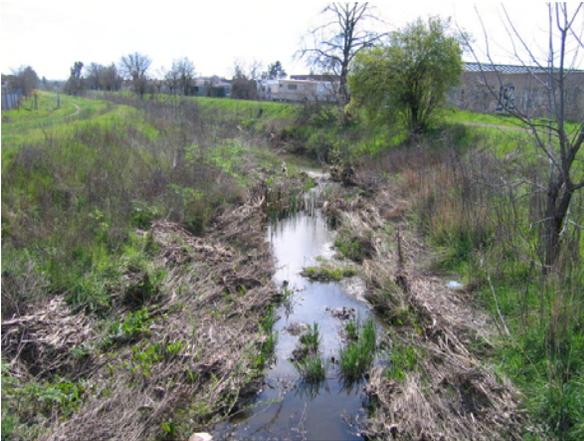
(d) Todd Creek Reach 5 looking downstream between E. Robles and Bucks Road: confined low flow channel with depositional benches to either side; with patches of emergent vegetation; note height of recent flows (approx 2-3 ft above water surface elevation) (March 14, 2007).

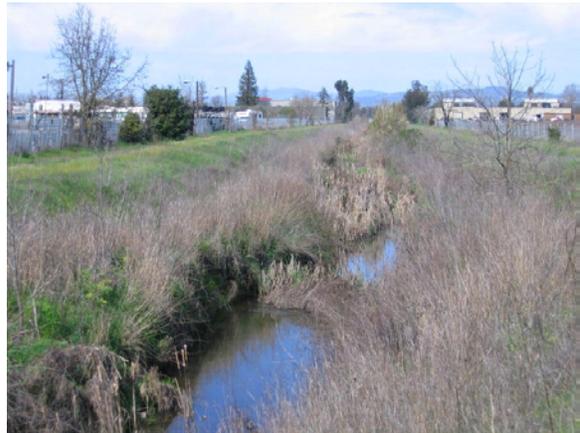
(f) Todd Creek Reach 4 looking upstream just above the confluence with Hunter Creek: similar pattern to upstream sections with alternating sequence of depositional features (small bars or wedges with emergent vegetation) between open water and shallow pools. Channel is linear, trapezoidal with high bench access roads on crest of bank (March 14, 2007).

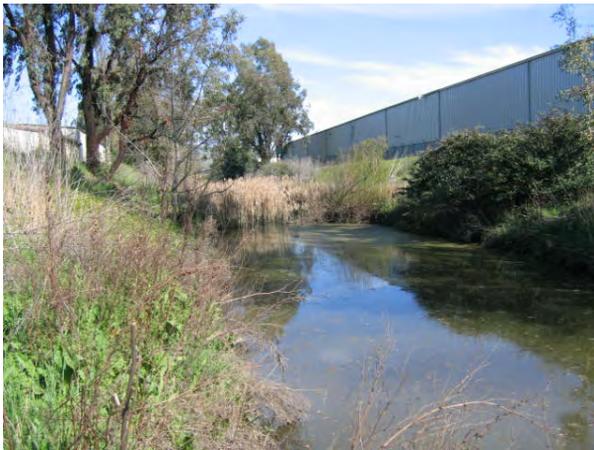
(b) Todd Cr. Reach 3 looking upstream near Hwy 101 crossing toward Santa Rosa Avenue; pattern of turbid, stagnant slack-water between cattails that constrict flows (March 14, 2007).

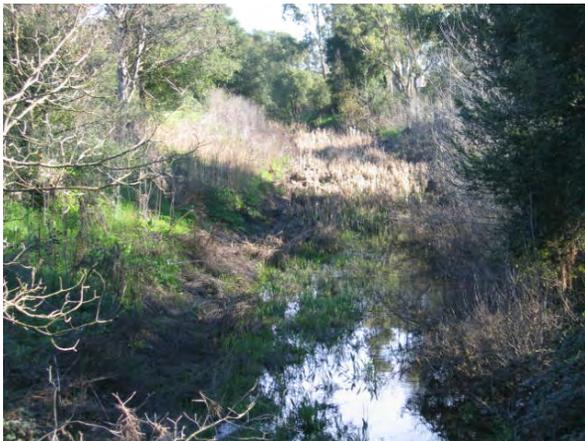
(c) Todd Creek Reach 1 looking downstream from the Scenic Dr. crossing; gently sloped banks and extensive in-channel vegetation; note more limited growth of emergent vegetation in shaded areas versus the unshaded areas (March 14, 2007).

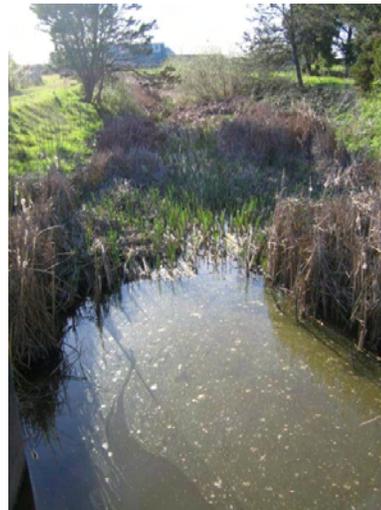
(d) Todd Creek Reach 1: stagnant flows and poor water quality impacts aquatic habitat in this reach (March 14, 2007).

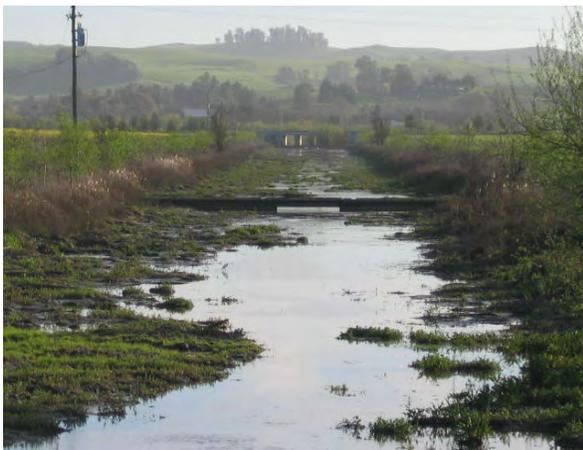
(c) Reach 1 looking downstream from Wilfred Avenue toward Laguna; channel widens, slope decreases, and mud bars along channel margins increase moving downstream; mud deposits indicate backwatering and quiet depositional environment of Laguna system (March 14, 2007).

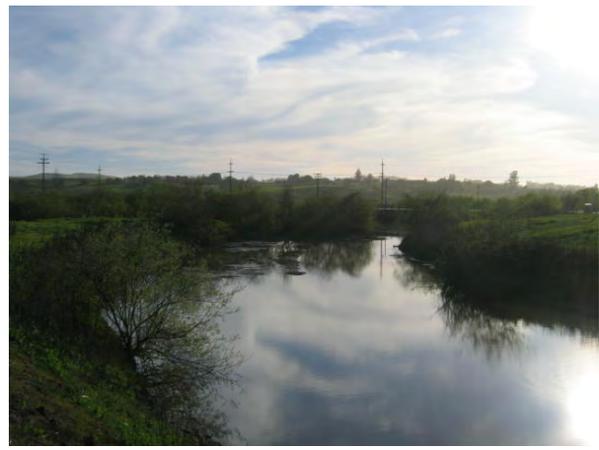
(d) Reach 1 looking downstream toward confluence with Upper Laguna Reach 2; note the Laguna system characteristics of wide channel, very low slope, still water quiet depositional zone dominated by muds and fine sediments, vegetation grows along banks and toe of slope areas (March 14, 2007).

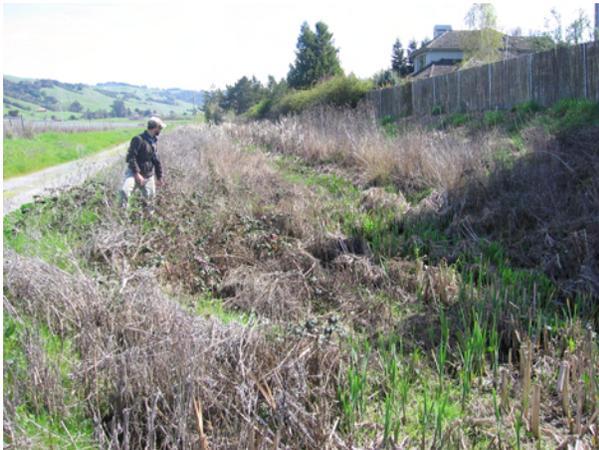
(b) Wilfred Creek upper reach, looking upstream toward Snyder Lane crossing; channel has shallow cross-section with abundant sediment accumulation and vegetation across the entire channel; poorly defined low flow channel (March 14, 2007).

Bank structure: in upper reach, the aggraded channel creates shallow and gentle (approx 3:1) banks (photo b); below grade control, channel is incised with 2:1 slopes; earthen sandy banks throughout; some slight bank slumping observed in south facing banks downstream of Wilfred Extension (photo d), and some sloughing observed in lower portions of the reach.

For Wilfred Creek Reach 1, the key maintenance consideration in the upper reach is the removal of sediment from the Snyder Lane culvert and area immediately downstream. There may also be an opportunity to design an appropriately sized low flow channel that would create a more defined channel capable of conveying finer sediments under smaller flows. Considering this reach's location in the watershed and the observed sedimentation, this reach may benefit from erosion control opportunities in headwater areas.

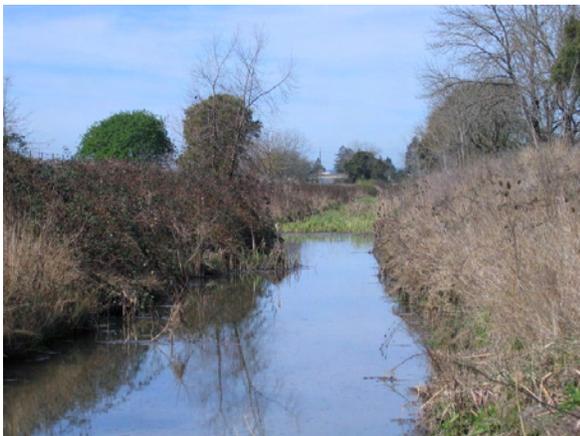
(c) Wilfred Cr Reach 1 looking downstream from grade control structure at Wilfred Extension confluence; note wider open channel with steeper banks than upstream punctuated by occasional in-stream vegetated bars and sediment wedges (March 14, 2007).

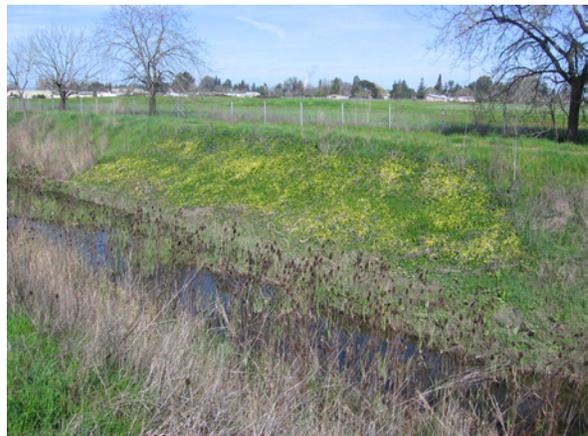
(d) Area of potential bank slumping in lower reach (March 14, 2007).

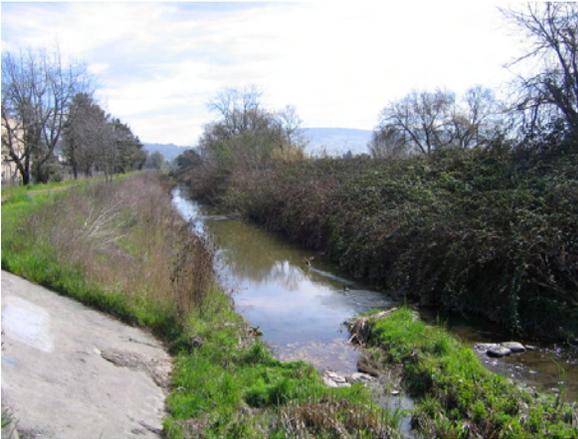
(e) Looking upstream from Santa Rosa Avenue Bridge; note most of channel is open and free of depositional surfaces but about 50 ft upstream of crossing sediment and debris begin to collect (March 14, 2007).

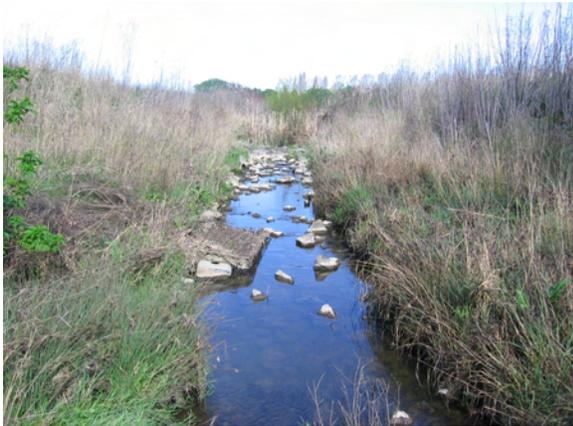
(c) looking downstream from SCWA owned section; channel becomes straight and incised beneath much steeper banks; banks have changed from shallow earthen to steep rip-rap; rip-rap also covers the channel bottom (March 14, 2007).

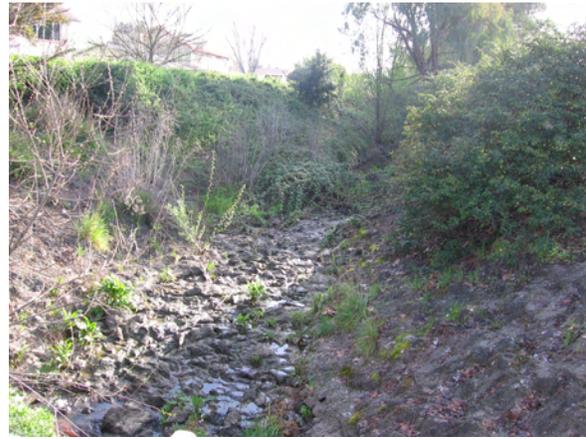
(d) from Snyder Lane crossing looking upstream; creek flows mostly below grouted riprap of drop structure, then collects in a pool at the bridge crossing (March 14, 2007).

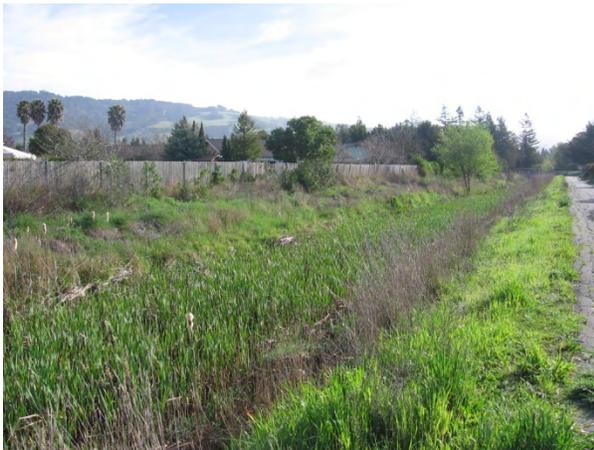
(b) upstream of Hillview Way, looking upstream toward Snyder Lane: low-flow channel obscured by cross-channel sedimentation and cattails and other vegetation; lack of riparian trees results in no shade, especially on south bank (right); shade planting as proposed with 2008 restoration activities will help reduce cattail development in channel; note recent high water mark seen at base of northern bank to left; note headwater sediment source areas of Sonoma Mountain in distance (March 14, 2007).

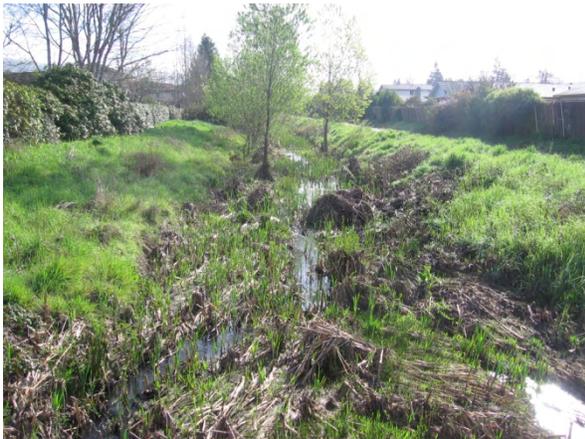
(c) looking upstream from Hillview Dr. crossing; diffuse flow in a few small and shallow channels; abundant sedimentation across entire channel width; lack of woody riparian species provides no shading, recent high water mark seen along base of banks (March 14, 2007).

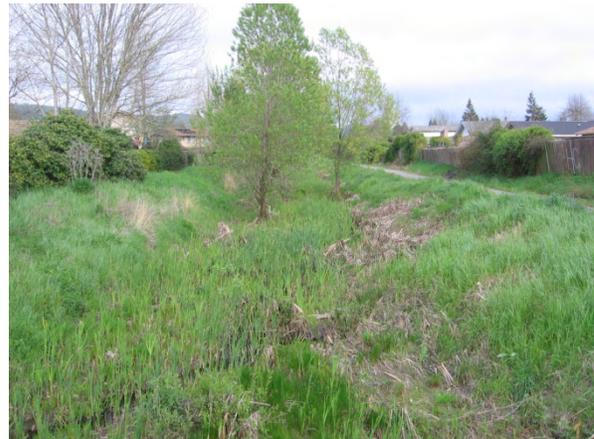
(d) same view as photo (c) but taken March 19, 2008; note abundant cattail growth and continued sedimentation at Hillview crossing between 2007 and 2008.

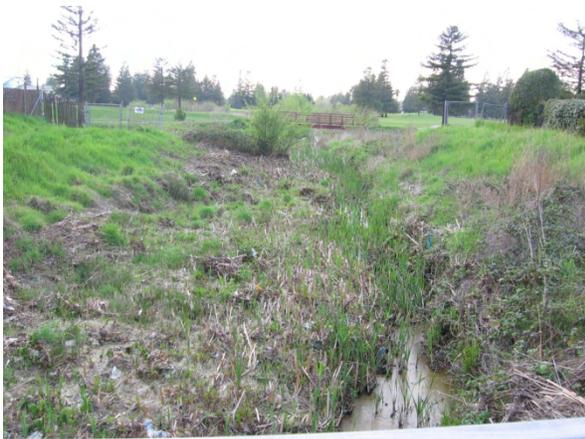
(e) looking downstream from Hillview Dr. crossing to golf course; abundant in-channel sedimentation has created shallow cross section with reduced capacity (March 19, 2008).

Coleman Creek Reach 2 experiences abundant sedimentation where the entire channel bed is actively aggrading. The channel bed and banks are nearly devoid of any riparian trees or canopy. As a result, the channel has no shading and stream temperatures are elevated. The combination of a low stream gradient, heavy deposition of fine sediments, and lack of shade contribute to excessive growth of cattails and other emergent vegetation within the channel. Management considerations include removal of existing channel bed sediment and cattails and planting of riparian canopy where feasible shading. Additional sediment source control in headwaters areas is advantageous and is supported through the Watershed Partnerships Program (sediment source area control also described in Coleman Reach 1 & Cook Reach 1).

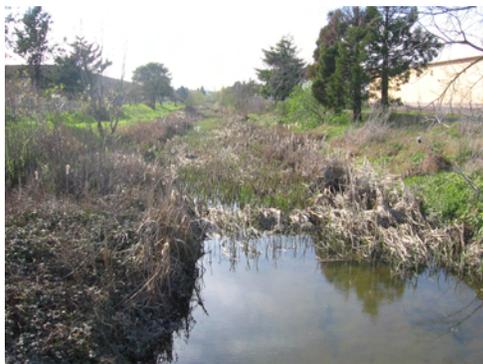
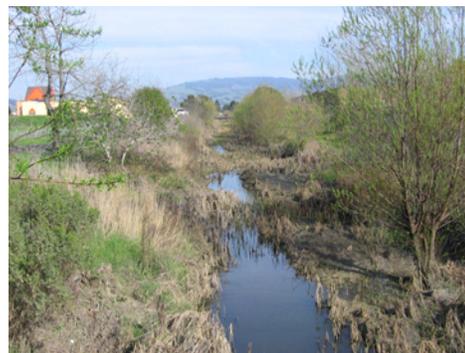
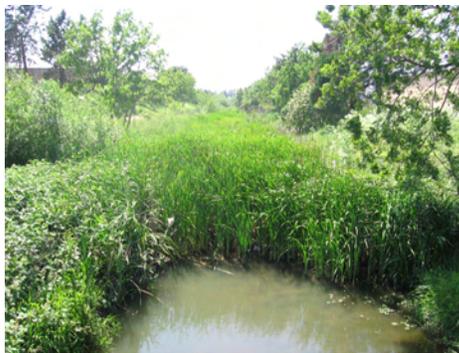
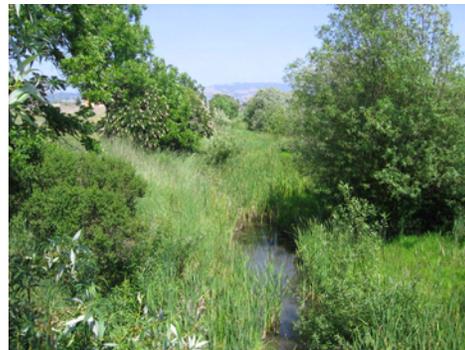
Channel processes: linear channel alignment, gradient changes occur mostly at/near key road crossings (Commerce Blvd., Hwy 101, Redwood Dr.) with gentle gradients between; cattail growth in lower Reach 3 and Reach 2 traps and causes sedimentation (photos c, d).

(c) Hinebaugh Creek Reach 2 looking downstream from Redwood Road crossing.

Management considerations for Hinebaugh Creek Reaches 2 and 3 focus on removal of cattails and canopy development to discourage their regrowth. Significant in-channel cattail growth is observed in lower Reach 3 and Reach 2. Some smaller bars are observed associated with the cattail growth. Integrated cattail and sediment removal can be considered for these reaches. In terms of opportunities, Reaches 3 and 2 have clear access roads to either side of the channel, which provides good top of bank access for vegetation thinning work. These reaches are the most downstream reaches in urban Rohnert Park, but are upstream of the more rural and natural Laguna setting in Reach 1 downstream. As such, there may be opportunities along these reaches for stormwater and water quality treatments (though that is currently beyond the maintenance scope of the SMP program).

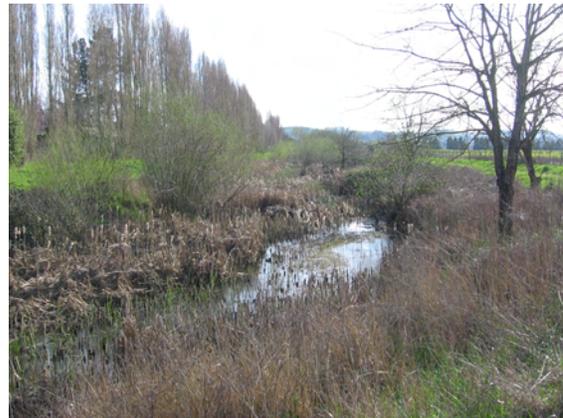
(b) looking downstream from the “big bend” in the reach; note depositional environment and sediment bars forming along inner bend (and covered with cattail vegetation) and active channel running along outer bend also showing sedimentation (March 6, 2007).

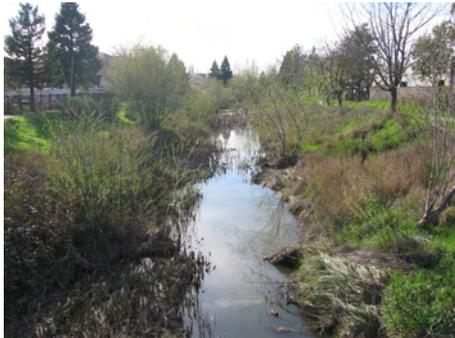
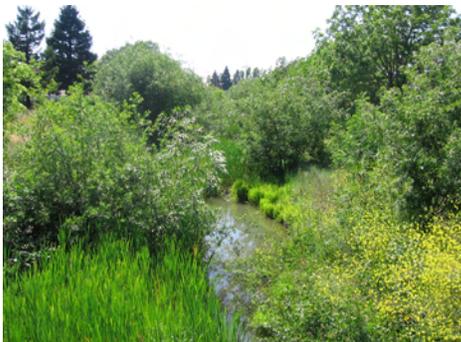
March 6, 2007

(a) Upper end of Reach 1, looking downstream from Labath Avenue; note extensive willow and cattail vegetative growth during spring season.

Management considerations for Hinebaugh Creek Reach 1 include integrated sediment and cattail removal and willow thinning in the upper reach toward Labath Ave (photo a). Downstream at the “big bend,” sediments and cattails have accumulated in pronounced bars at the inner side of the bend. Further downstream, as the backwatering effect of the Laguna becomes more pronounced, abundant sediment is deposited in a long bench/wedge feature (photos c, d). Sediments along this feature are mostly fines and mud reflecting the lower energy depositional environment indicative of the Laguna setting. Approaches to sediment removal along Reach 1 should consider these differing processes – more fluvial-dominated processes upstream of the “big bend” transitioning to a more stillwater environment downstream of the “big bend”. Hinebaugh Creek Reach 1 also represents an important opportunity in sediment management and removal directly upstream of the impacted Laguna de Santa Rosa aquatic resource. Sediments in storage in Reach 1 will eventually make their way downstream to the Laguna further reducing the Laguna’s capacity and habitat potential. Management and removal of accumulated sediment in Reach 1 provides potential flood management and habitat benefits.

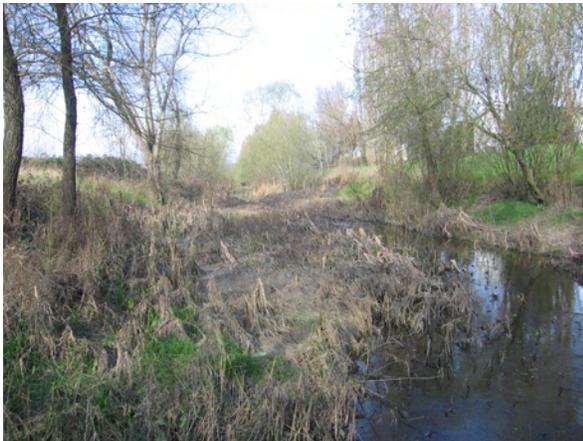
(c) looking upstream from lower reach; near view is of large sediment deposit that continues along the western channel margin for several thousand feet; this feature is shown in its lower end in photo d; sediment deposit reflects backwatering environment influenced by the Laguna, with sediments settling along the long and even bench/bar feature; note mature Alders anchored at toe of bank position (March 6, 2007).

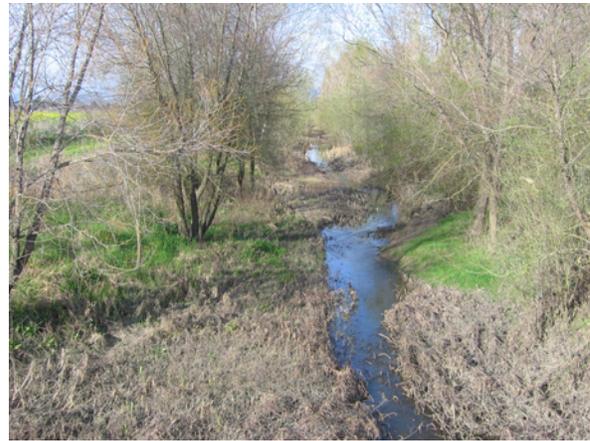
(d) Lower Reach 5, standing at culvert system at Guerneville Rd. Channel is again choked with cattails and the banks are covered by various ruderal species with sparse tree canopy (Nov. 2007).

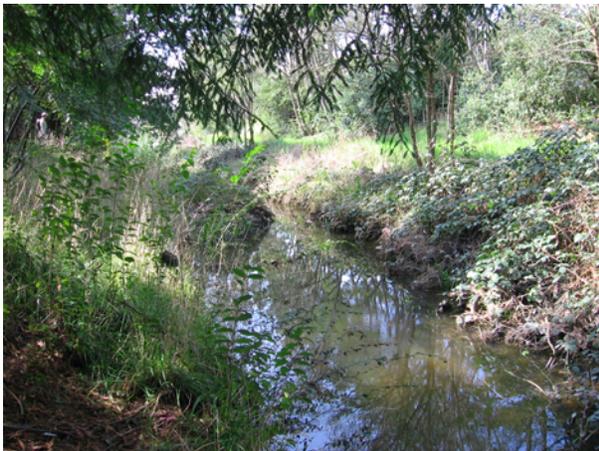
(b) Reach 6 downstream of Crane Cr confluence; note trapezoidal channel form, earthen banks on south side and small riprap on north side; very linear and straightened channel, mature vegetation providing shading, blackberry along northern bank (south facing); note increased turbidity due to Crane Creek suspended sediments entering Hinebaugh Creek (Mar 6, 2007).

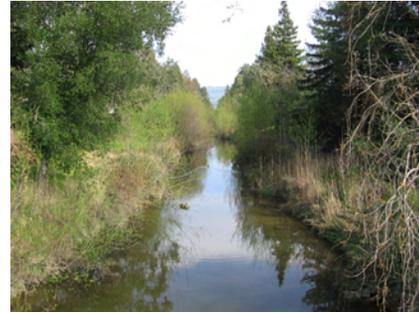
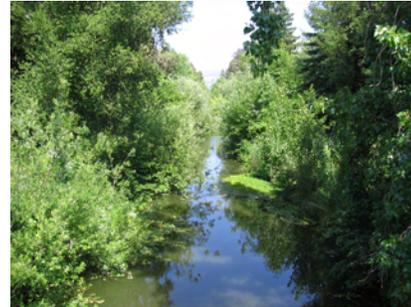
March 6, 2007

(d) Reach 6 terminus looking upstream from Country Club Dr.; very linear channel, channel bed width increases to 15-20 ft wide, gentle gradient throughout lower Reach 6 creates deeper pooling and slower velocities, no strong evidence of in-channel bars forming. Note growth of in-channel willows between March and May of the same year.

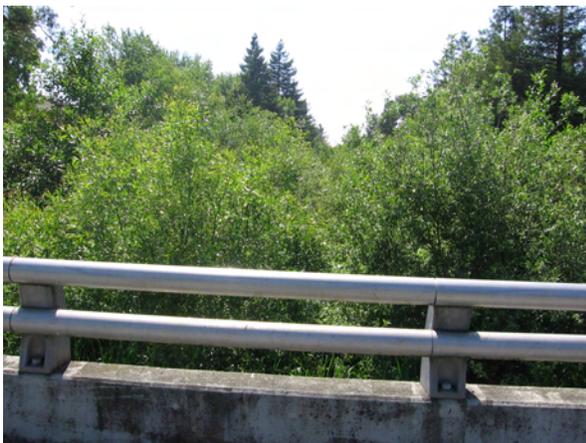
(b) Same view as photo (a), note abundant vegetation growth compared to March, earlier in the season (May 29, 2007).

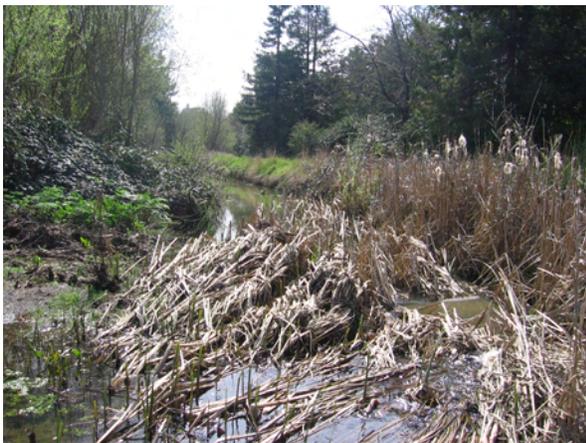
(b) Reach 1 at the confluence of Crane Creek Reach 2 and Five Creek; note cattail vegetation and dramatic increase of fine sediments arriving from Five Creek tributary (March 6, 2007).

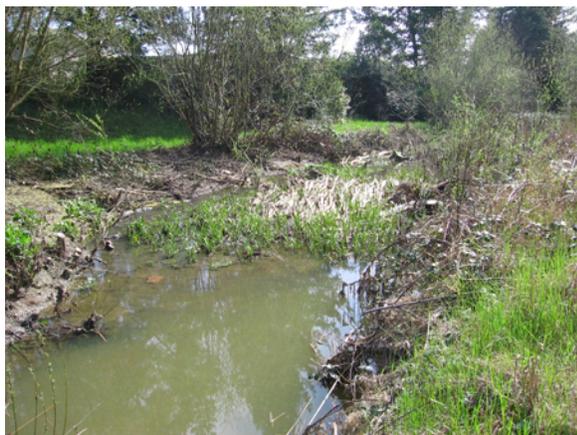
(c) Reach 1 looking downstream at mid-reach; note muddy gently sloped banks and increased turbidity and fine sediment arriving from Five Creek tributary; it appears that flows went overbank earlier in the season and spread across the cross section, some instream cattail vegetation and willows along banks (March 6, 2007).

Management considerations for Crane Creek Reaches 2 and 1 focus on opportunities to enhance water quality. Similar to Five Creek Reach 1, Crane Creek Reach 1 has a high degree of fine sediment deposition. Apart from routine SMP monitoring activities to ensure adequate conveyance capacity, this reach (like Five Creek Reach 1) would benefit from an investigation of headwater areas to identify if the fine sediments observed are originating from throughout the upper watershed, or if perhaps they are delivered from a more limited source either due to a geologic process (landslide or slump) or perhaps a land use influence (e.g., mine, agricultural erosion). This reach provides an excellent opportunity to seek headwater erosion control solutions. Additionally, the knickpoint feature on Crane Creek Reach 1 should be monitored to check for further upstream migration or deeper incision. It is believed that this feature represents a base-level grade adjustment following the development of the engineered facilities at the Hinebaugh Creek confluence.

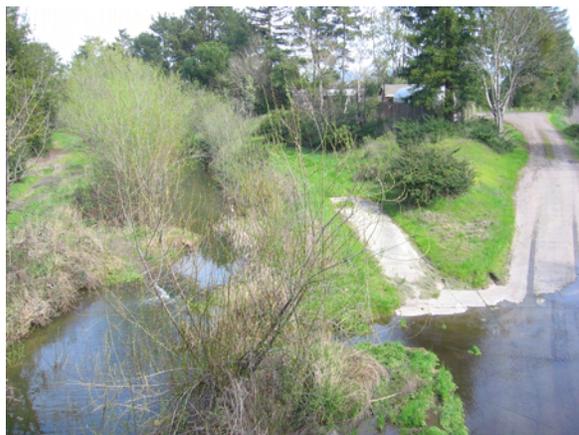
(d) Reach 1 looking upstream at Hinebaugh Creek confluence; flows spread across into wide pool due to damming effect of in-channel facility and concrete access ramps (March 6, 2007).

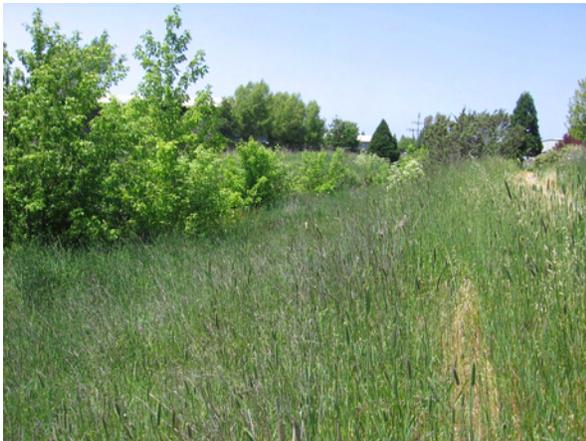
(b) Mid-reach looking downstream; gentle sloped grass covered upper banks; willows growing on the lower bench toward the active channel (May 29, 2007).

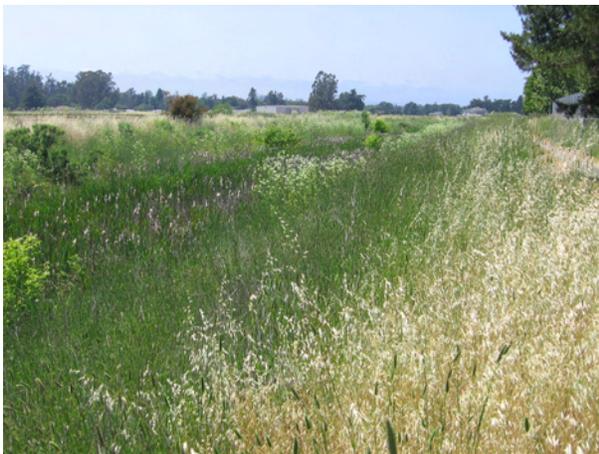
(d) Lower reach toward Washoe Creek confluence; abundant cattails throughout sunny channel section, sediments collect and deposit among cattails in lower reach (May 29, 2007).

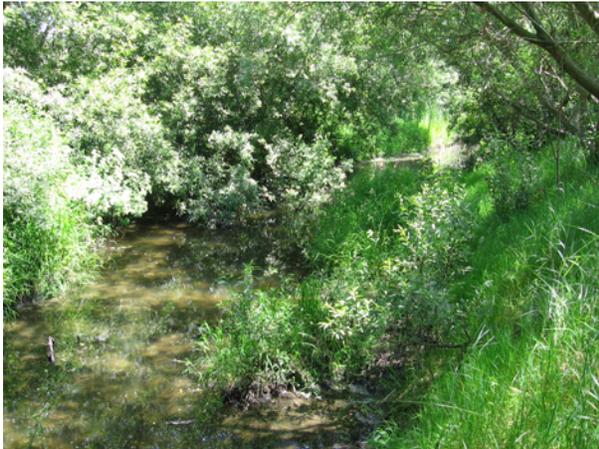
(b) Mid Reach 2 near Gossage Creek confluence: mature trees provide ample shade to channels; toe of slope sediment bars, seen in center right with willow vegetation provide habitat, in-channel complexity, and sinuosity; steep bank to right near vertical.

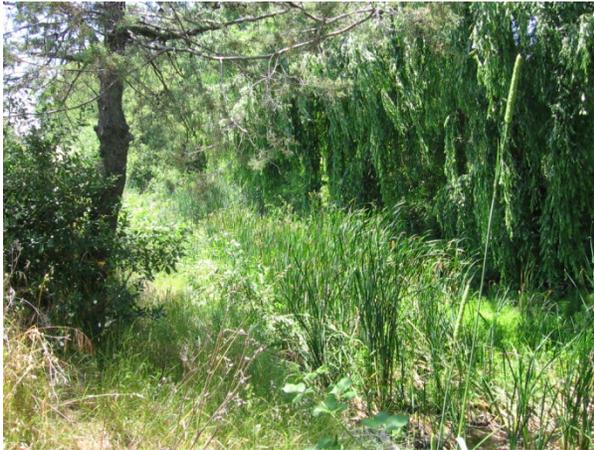
(b) Mid Reach 1 looking downstream channel beneath shade of willow in lower right (May 29, 2007).

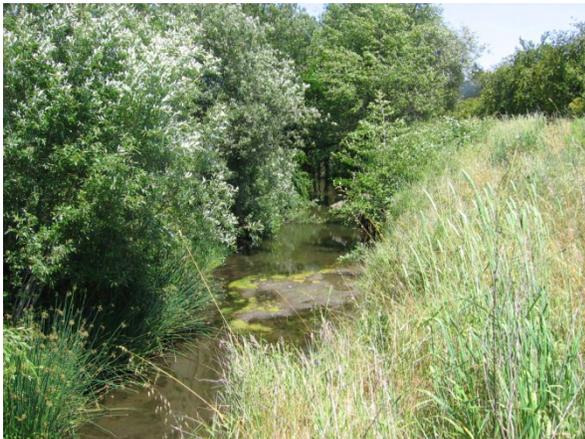
(c) lower Reach 1 (near confluence with Laguna 3 and Washoe 1 reaches) looking upstream; note steep eroding bank on right and overall depth from top-of-bank; channel has incised in its lower zone to adjust for elevations at Laguna channel confluence (May 29, 2007).

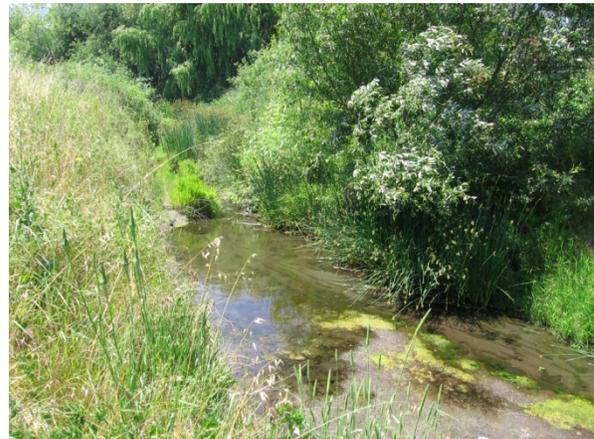
(d) Lower Reach 1 (just upstream of Laguna 3 confluence) looking downstream (May 29, 2007).

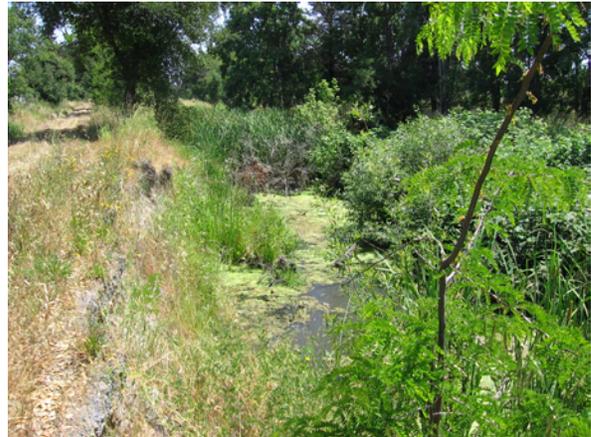
(a) Upper Gossage Creek Reach 2 looking downstream; note slumping bank to right (difficult to see beneath grass) which has undercut access road for 75 ft; willow and abundant cattails in channel with algae developing in stagnant water behind cattails (May 29, 2007).

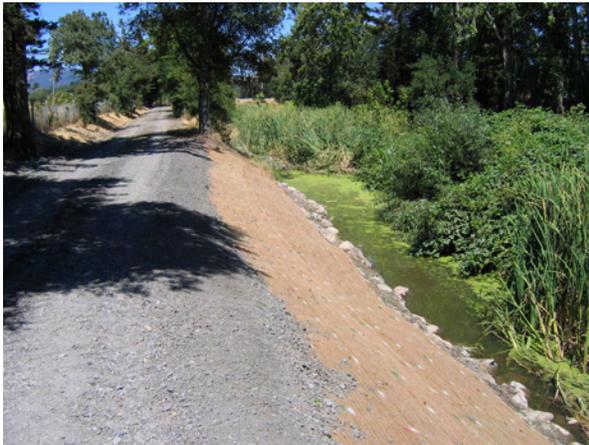
(b) Same view as photo (a) following bank reconstruction; note gentle slope to new bank and vegetation plantings not yet visible beneath matting (late June 2007).

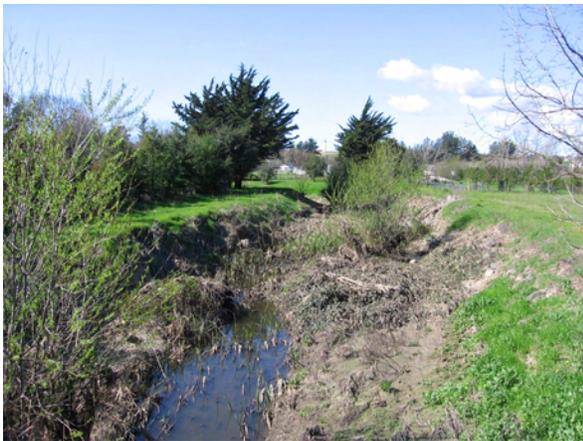
(c) Looking upstream from the Stony Point Road crossing, note slumping and erosion along banks to left (in shadows), recent deposition from winter storm events (center right), and few visible cattails beneath water and sediment. Compare with photo (d) (February 15, 2006).

Management considerations for Gossage Creek Reach 3 focus on cattail removal throughout the reach and monitoring bank stability in the section just upstream of the Stony Point Road crossing (photo c). Bank slumping near Stony Point Road is not as severe as the condition upstream where the bank reconstruction project occurred (photo b) but does warrant monitoring and observation. Sediment accumulating upstream of Stony Point Road crossing, seen in center-right of photo (c), should also be monitored for on-going accumulation and potential need for removal.

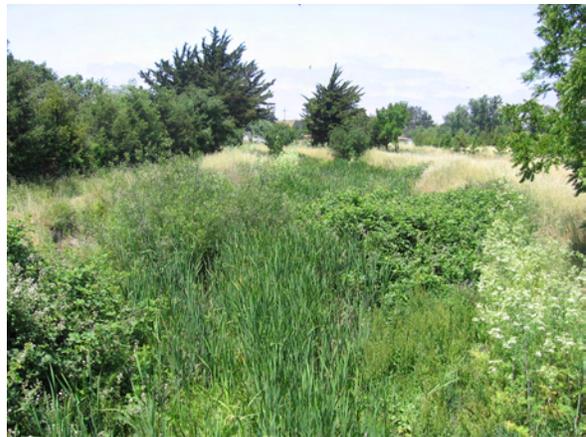
(d) Same view as (c) taken in May 2007; note rapid growth of cattails, blackberries, and willows throughout channel (May 29, 2007).

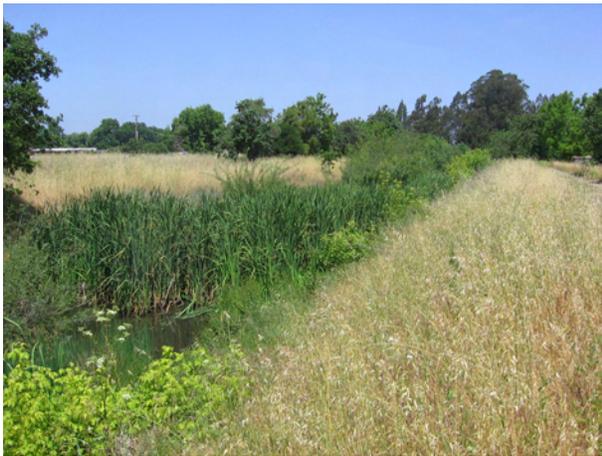
(b) Mid Reach 2 looking downstream; channel deepens against higher banks (generally sloped 1:1); abundant cattail growth continues along non-shaded reach; cattails clog low flow channel; access road seen above bank to right; adjacent land use is rural (Mar 29, 2007).

Management considerations for Gossage Creek Reaches 2 and 1 focus on in-channel vegetation removal throughout the reach. In the upper reach abundant cattails are blocking flows and trapping fine sediments (photos a and b). In the lower reach invasive Ludwigia is progressing upstream from the Laguna. Other opportunities to reduce cattail and Ludwigia presence include on-going tree planting on banks to encourage shading and a canopy cover. A useful reference reach for such canopy development is seen just upstream at Upper Laguna Reach 2, where the beneficial influence of shading is observed. In that location, Ludwigia progresses from the Laguna south up the sunny and unshaded Gossage Creek tributary rather than progressing further upstream along the mainstem Laguna Reach 2 channel where Ludwigia does not occur beneath the shaded canopy. An eroding stream bank in the mid section of Gossage Reach 2 is threatening the access road and will likely become increasingly erosive if not treated. The bank stabilization approach used at Gossage Creek Reach 3 in 2006 can be used to treat this bank issue.

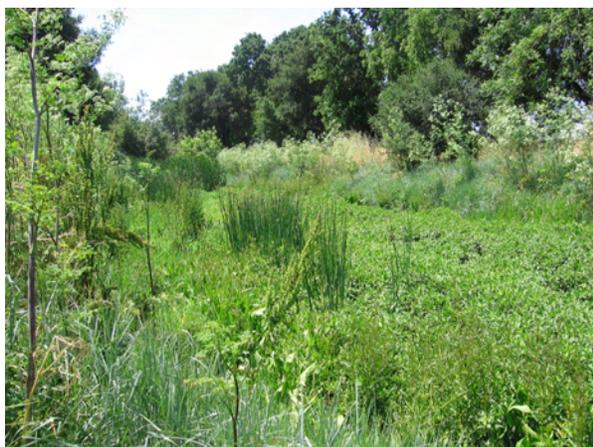
(c) Mid Reach 1 looking upstream; invasive Ludwigia is widespread across channel except for small pockets of cattails (Mar 29, 2007).

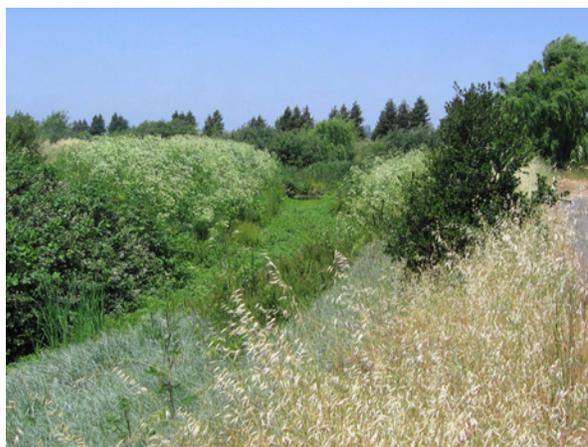
(d) Lower Reach 1 looking downstream to confluence with Laguna Channel Reach 2; channel continues to deepen relative to banks approaching grade level at Laguna confluence; Ludwigia seen invading from Laguna and progressing upstream (Mar 29, 2007).

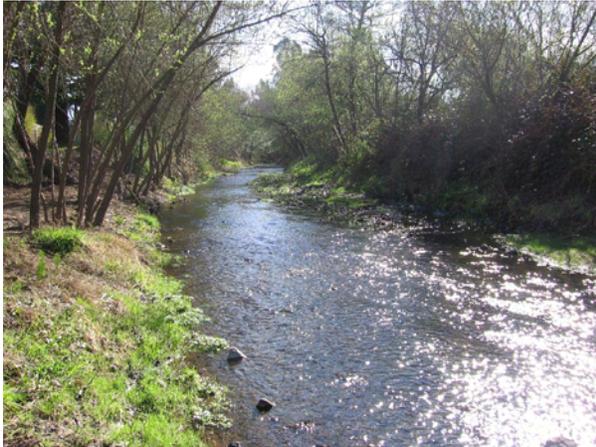
(b) Mid Reach 5 looking upstream; channel sinuosity increases with presence of “D-shaped” bar features adjacent to inner bend of channel (March 6, 2007).

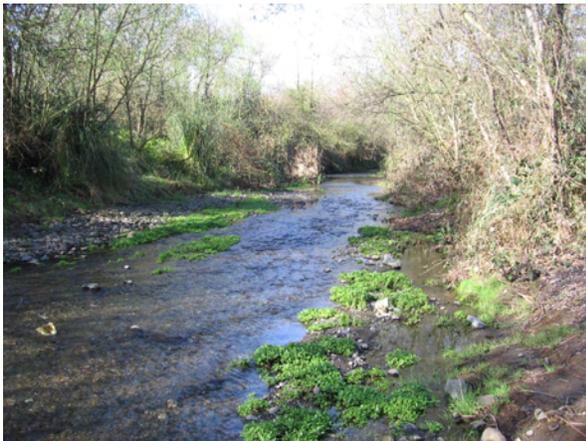
(c) Mid Reach 5 looking downstream, similar to (photo b) cobble bars run along inner channel bend, and mid channel riffle sequence (March 6, 2007).

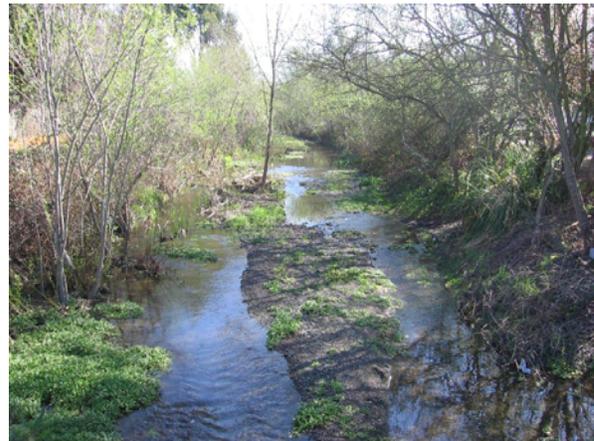
(d) Reach 5 looking upstream from Snyder Lane crossing, multiple in channel bar features and fine sediments indicate increased depositional environment towards bridge (March 6, 2007).

The lower section of the reach near the Snyder crossing may need occasional sediment removal through its cross-section based on observed depositional bars. Key management opportunity at the lower reach is to maintain and mimic (where possible) the current sequence of elongate mid-channel bars, but simply skim the tops of the bars leaving the root of the bar in place. Keeping these channel forms and flow processes in place supports in-stream habitats. Additionally, removal of dense blackberry understory and limbing of dense willows in upper reach can maintain channel capacity and improve habitat.

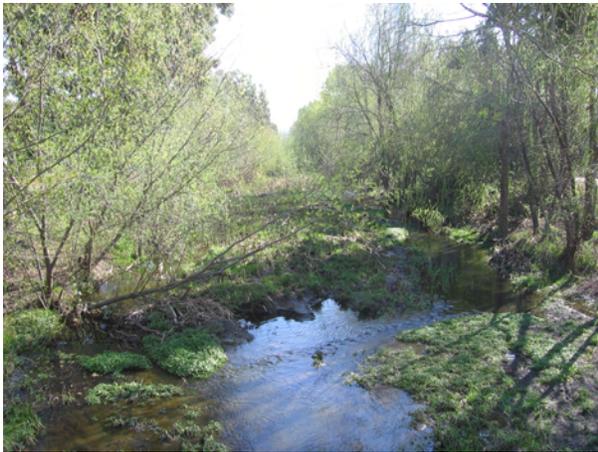
(b) Mid Reach 4 looking upstream from footbridge; multiple individual bars transitioning to sediment wedge across entire channel bed (March 6, 2007).

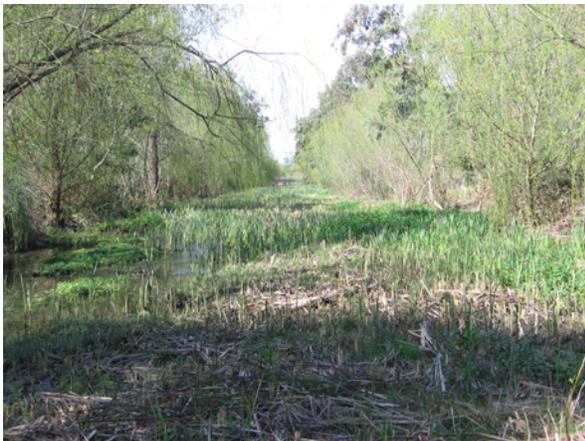
(c) Mid Reach 4 looking downstream from foot bridge: similar to photo (b) sedimentation now occurs as broad wedge across entire channel bed, dense cattails on bars trapping more fine sediment (March 6, 2007).

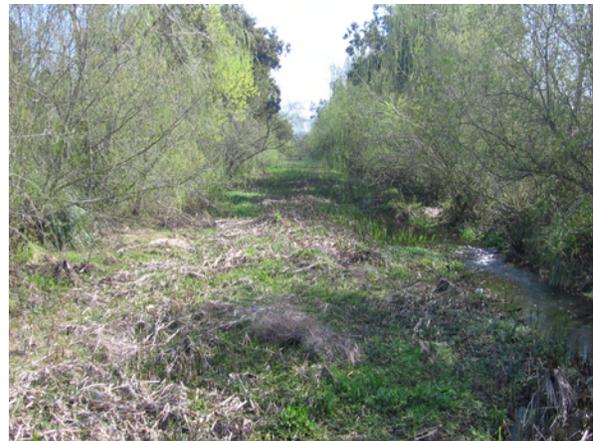
(d) Bottom of Reach 4 looking upstream from Country Club Dr, similar to photo (c) wedge of sediment across entire channel bed, abundant vegetation trapping more fine sediment (March 6, 2007).

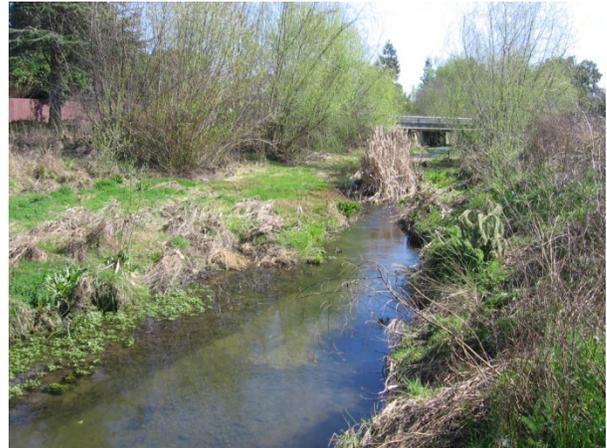
(a) Upper Reach 3 looking upstream to Country Club Dr. (March 6, 2007).

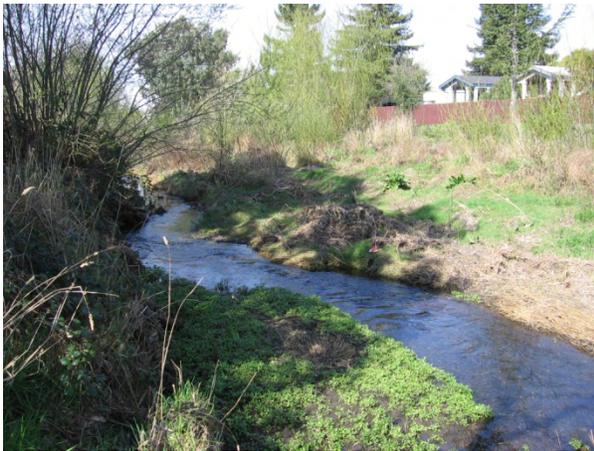
(b) Mid Reach 3 looking downstream (March 6, 2007).

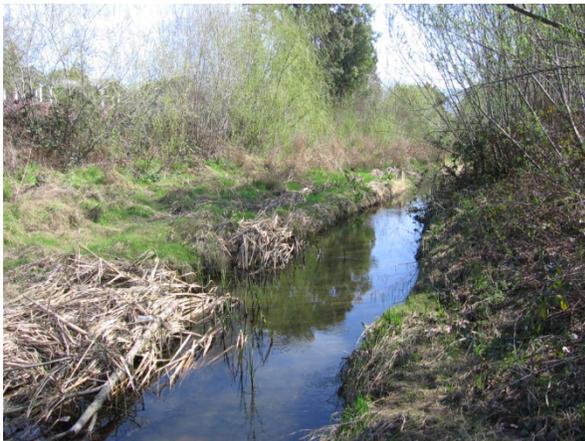
(c) Lower Reach 3 looking upstream (March 6, 2007).

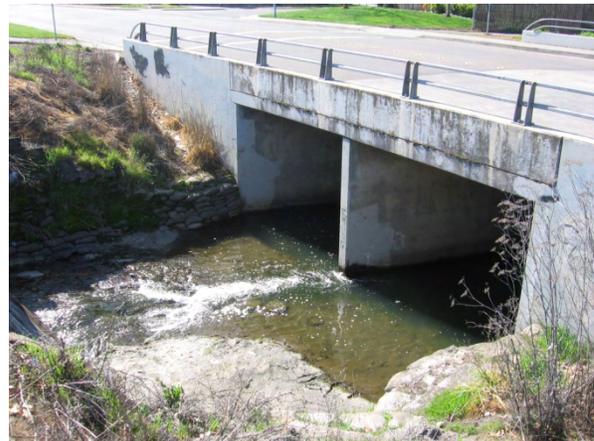
(d) Lower Reach 3 crossing at Seed Farm Dr. (March 6, 2007).

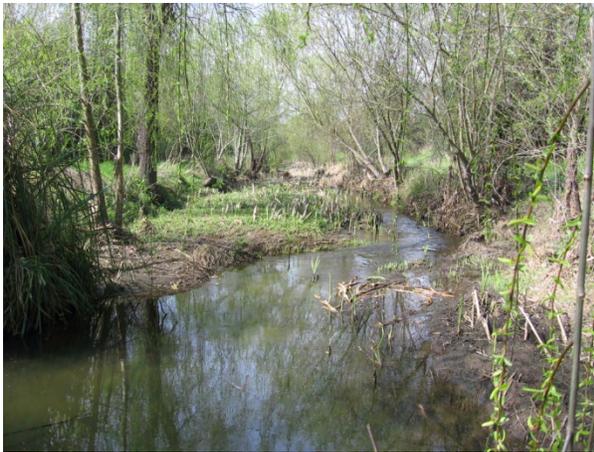
(b) Mid Reach 2 looking downstream (March 6, 2007).

Management considerations include selective bar grading/skimming where necessary, but should include alternating bar forms that provide sinuosity as currently observed (photo b). Other considerations include potential removal of cattails, and planting of more riparian vegetation (if capacity allows) to provide additional shade to retard cattail growth where the canopy is not entirely closed. Though not currently observed, removal of potential vegetation, debris blockages in the lower reach, toward Hwy 101, could be necessary in the future.

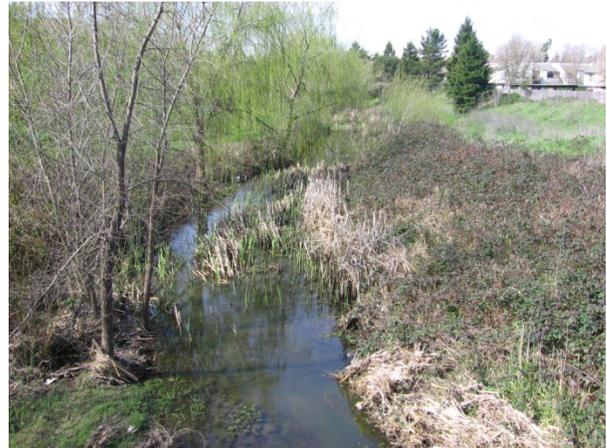
(a) Reach 2 looking downstream from Seed Farm Dr.
(March 6, 2007).

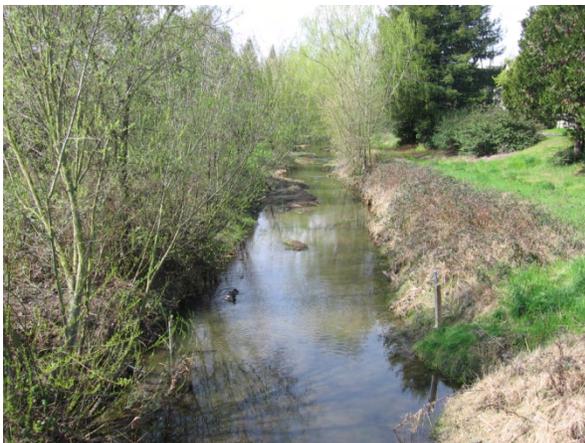
(c) Lower Reach 2 looking downstream (March 6, 2007).

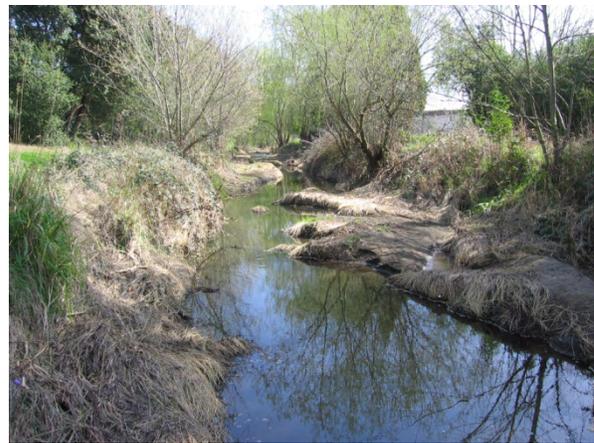
(d) Lower Reach 2 looking upstream (March 6, 2007).

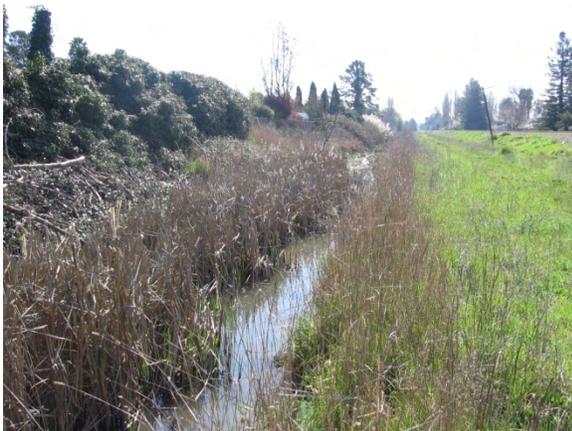
(b) Copeland Creek South Fork (Reach 2) looking upstream (March 6, 2007).

Active channel: single channel 10-12 ft wide at north end, narrows to 6-8 ft at south end (photos a, b), flows observed 1-2 ft deep with occasional deeper pools, channel incised ~3 ft below bench/narrow floodplain on west side.

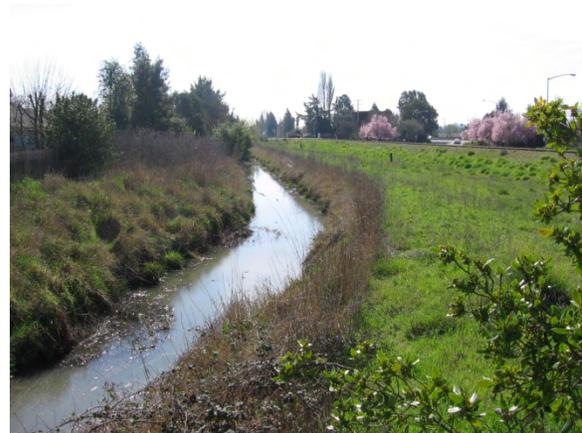
(a) Copeland Creek South Fork (Reach 2) looking upstream from Copeland Creek confluence (March 6, 2007).

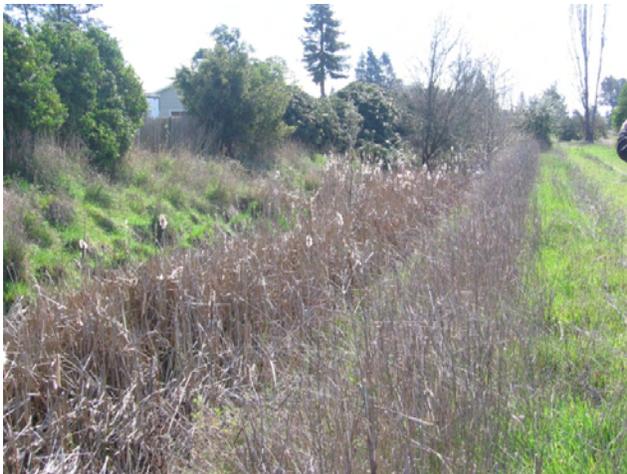
(c) Copeland Creek South Fork (Reach 1) looking upstream (March 6, 2007).

Currently, Copeland Creek South Fork (Reach 1) is heavily clogged with cattails (photo c). It is uncertain if additional flow capacity is necessary in this reach and if dredging/removal will be required. Sediment management approaches should explore how to encourage additional trapping and filtering of fine sediments in this reach, which would provide downstream water quality benefits to South Fork Reach 2 and to Copeland Creek Reaches 3 and 2. South Fork (Reach 2) is a more open channel than Reach 1, but suffers from high turbidity and poor visual water quality with oil sheens, etc. Additional measures here that could improve water quality, filter pollutants, and trap fine sediments should be considered. Some type of managed cattail marsh approach may be appropriate as seen in the semi-open channel with cattails in upper Reach 2. Neither South Fork Reach 1 nor 2 have significant canopy closure over the channel and would benefit from additional plantings of woody canopy species, if flow requirements and any special railway requirements allow.

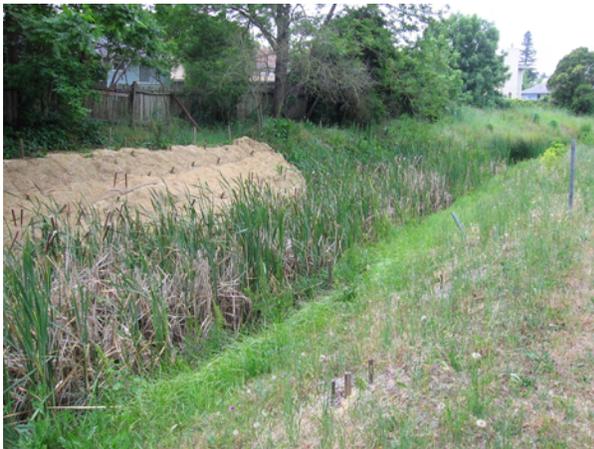
(b) Upper Reach 7 looking downstream; recent maintenance work includes bank stabilization project on far bank and vegetation removal and tree planting on near bank (May 29, 2007).

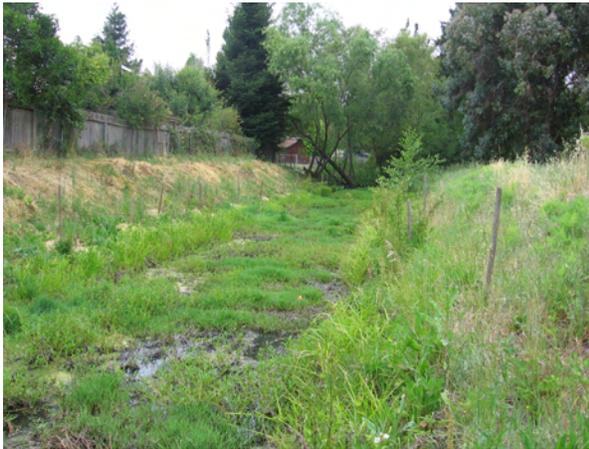
(c) Looking downstream just above Lady Bug Park: note general bed sedimentation, fine muddy sediments, with shallow diffuse flow; recent tree plantings along bank throughout reach (May 29, 2007).
