Figure 4-30

Upper Laguna Subbasin

FIGURE 4-31
Reaches and Vegetation
 Upper Laguna (1 of 11)

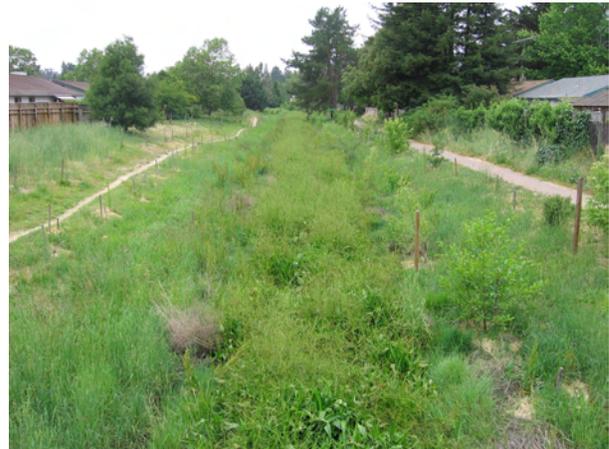
(d) Mid Reach 7 looking downstream at La Salle Ave. footbridge: trapezoidal mid reach channel has gentler sloping banks (3:1) than upstream with lower bench at base of bank; note recent tree plantings along upper and lower bank throughout reach (May 29, 2007).

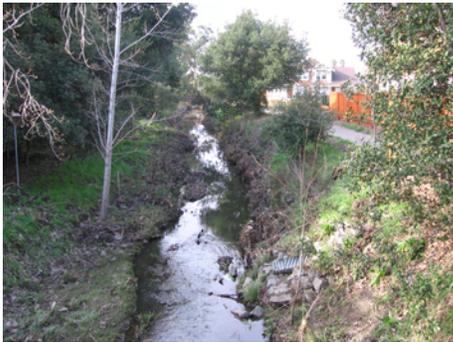
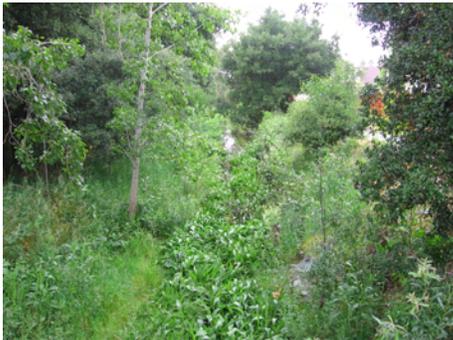
(a) Upper Reach 5 looking downstream from East Cotati Ave. crossing; note some mild lower bank erosion (seen in Feb photo) where flows emerge from road crossing and hit bank; significant in-channel vegetation grown during spring season.

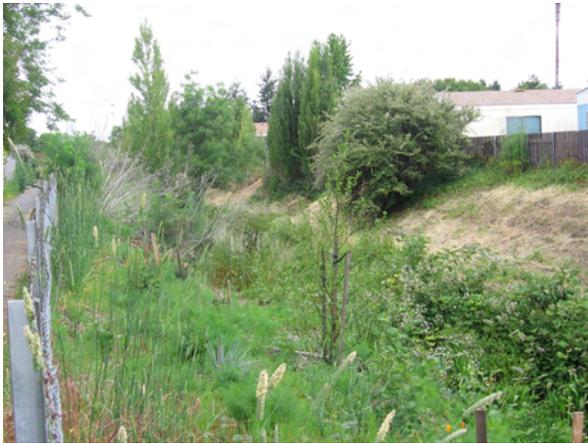
(c) Mid Reach 5 looking downstream; bank vegetation recently cleared and trees planted on near bank; vegetation at base of bank at channel's edge left in place (May 29, 2007).

In Upper Laguna Reach 5, vegetation removal activities and bank tree planting have recently occurred throughout the mid and lower reach as shown in photos b through e above. Other maintenance considerations and opportunities for Reach 5 include monitoring the bank erosion and sloughing observed just downstream of the East Cotati Ave. crossing where flows are somewhat directed into the lower bank. The upper section of Reach 5 appears to experience significant in-channel seasonal vegetation growth (photo a) which should also be monitored for potential thinning. Note the mid and lower sections of the reach that have a more defined low flow channel do not experience as rapid seasonal vegetation growth in the channel bed (photo d). The section just upstream of the Gravenstein Way crossing should also be monitored for on-going sediment accumulation and bar formation. Apparently sediments are falling out just upstream of the crossing where the gradient appears to lessen. This problem appears to be related to the extensive wedge of sediment accumulating downstream of the crossing (see Reach 4 for discussion).

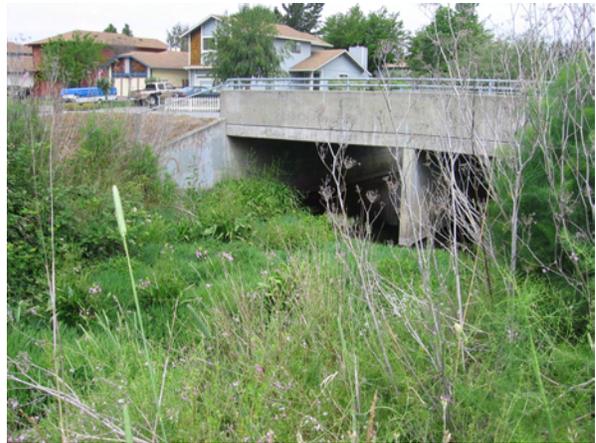
(e) Lower Reach 5 looking downstream at Gravenstein Way crossing; sediment is collecting in low bars just upstream of crossing (May 29, 2007).

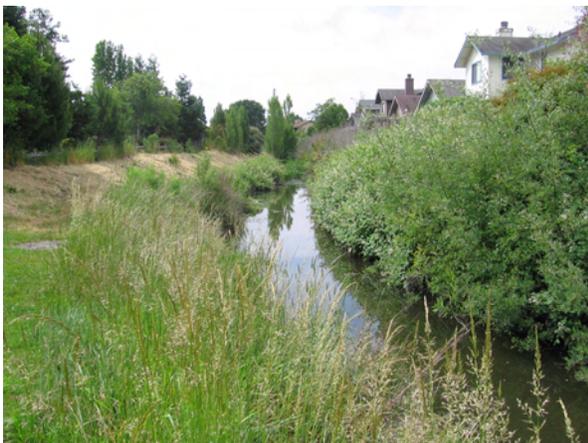
(d) Lower Reach 5 looking upstream; upper bank (left) recently cleared of vegetation, grasses remain along lower bank; bank (right) not cleared recently; lower bank is steep with 2-3 ft drop into well defined low flow channel (May 29, 2007).

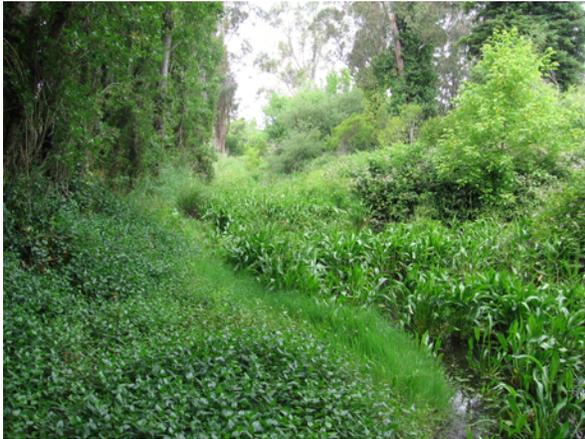
(b) Mid Reach looking downstream; some channel sinuosity within established banks; low bench adjacent to channel; abundant water plantain and other emergents growing and choking channel; high bank vegetation provides shading (May 29, 2007).

Bed sediments/texture: generally finer textured sediments of silts and mud, with high organic content in plantain sections (photo b); coarse sediments of sand and small gravel observed in concrete channel section (photo e).

In Upper Laguna Reach 4, management considerations focus on opportunities to thin or remove vegetation where abundant in-channel vegetation is blocking or constraining flows. Vegetation conditions along Reach 4 will be monitored during the annual channel reconnaissance with priority vegetation clearing areas identified (such as seen in photo b). A large sediment and vegetation wedge at the upper end of Reach 4 just downstream of the Gravenstein Way bridge appears to be creating a significant backwatering into Reach 5. This area should be cleared to allow flow to move through lower Reach 5 and under the bridge unimpeded.

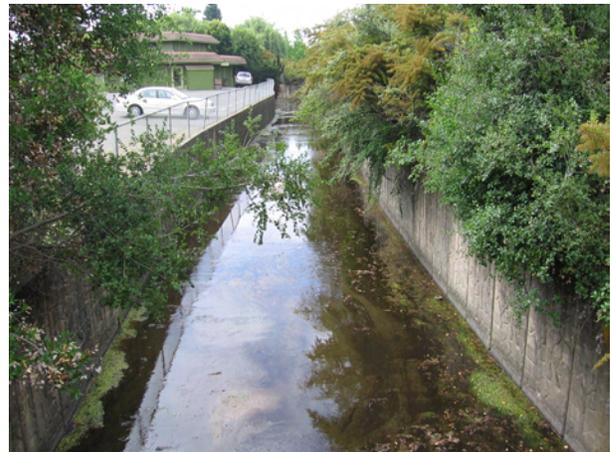
(e) Lower Reach near Hwy 101; concrete channel with vertical walls (May 29, 2007).

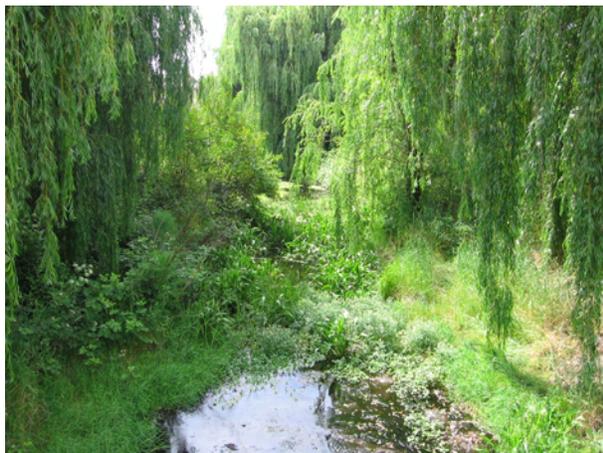
(d) Lower Reach near transition to concrete channel; abundant willow vegetation in channel and along banks provides shading (May 29, 2007).

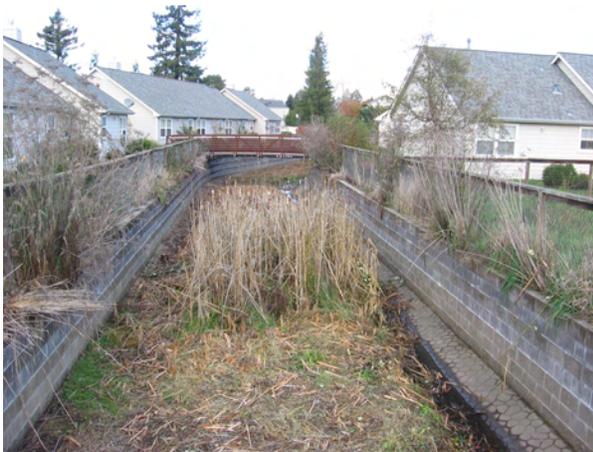
(c) Cotati Creek Reach 1 looking downstream from Ross St.; channel formed in concrete and paver blocks; 1-2 ft depth of sedimentation uniformly across the channel bed width; cattails growing in sections. (Dec. 16, 2008)

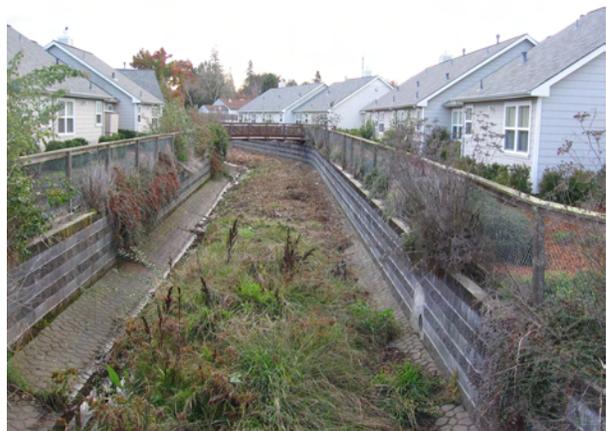
(d) Cotati Creek Reach 1 looking upstream from residential development near Marsh Way; channel formed in concrete and paver blocks; 1-2 ft of sedimentation across entire channel bed width; ruderal and emergent vegetation growing in sections. (Dec. 16, 2008)
