**BIOLOGICAL AND WATER QUALITY MONITORING IN
THE RUSSIAN RIVER ESTUARY, 1998**

THIRD ANNUAL REPORT

15 MARCH 1999

Submitted by

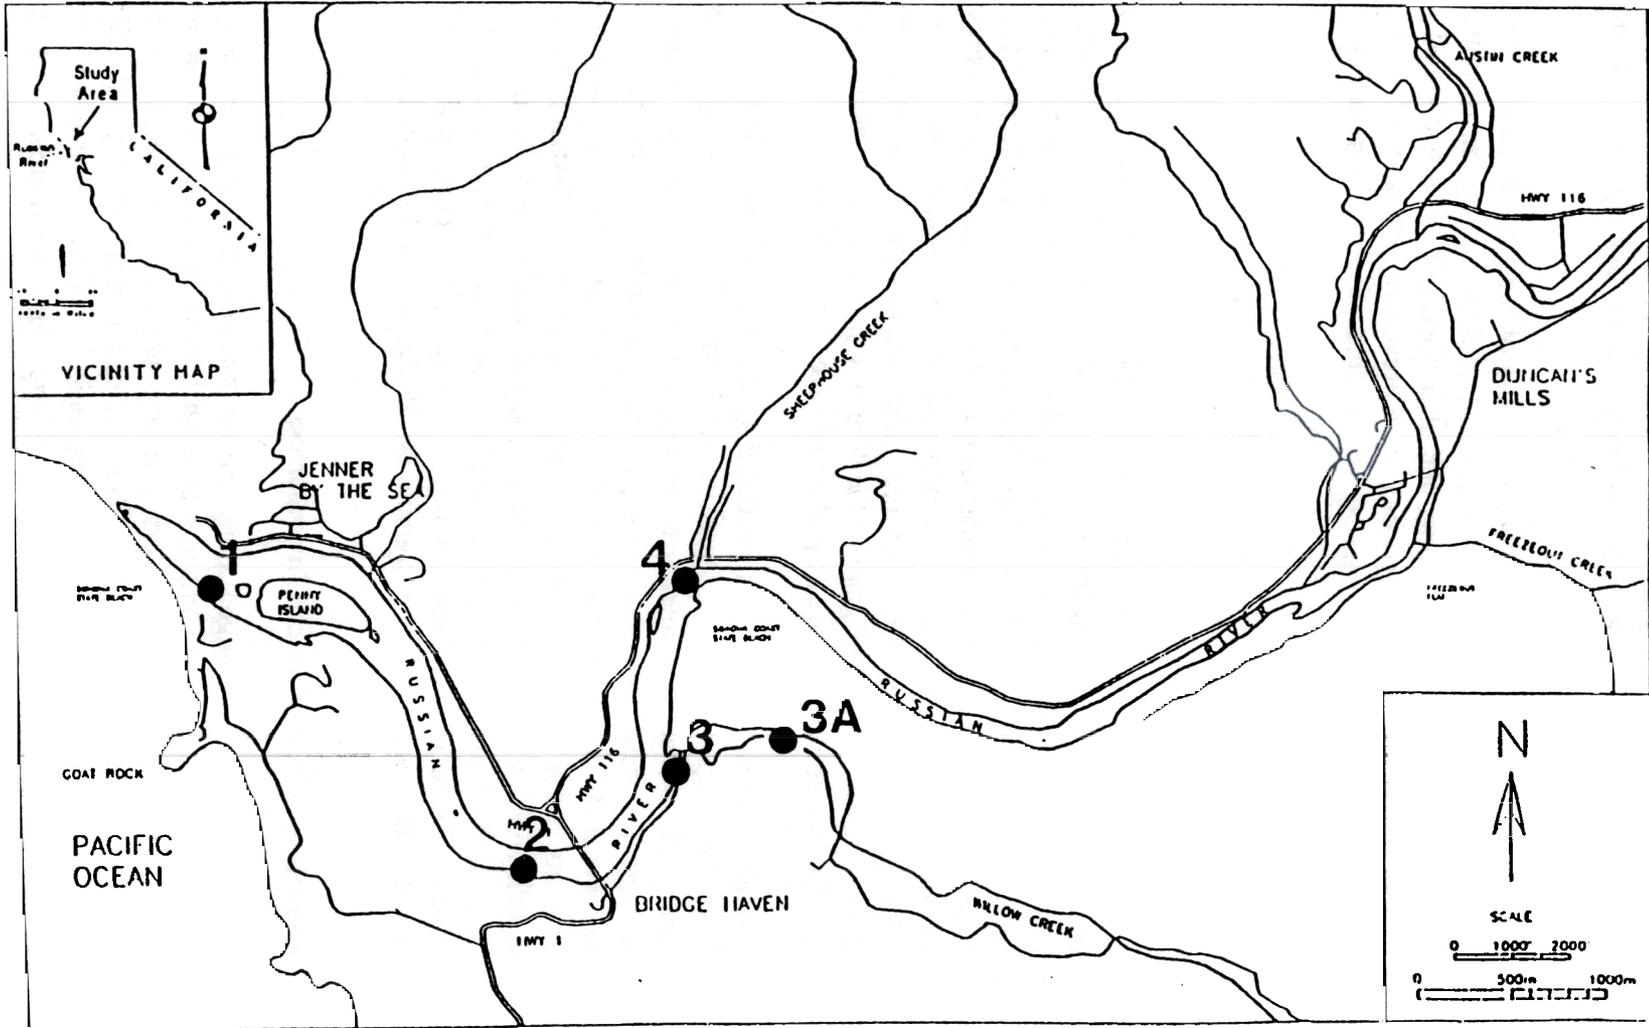
Figure 2-1. Map of the Russian River Estuary, Showing Sampling Stations for 1998 Study.

At Station 4, water quality sampling was conducted in the deep (14 m) channel pool adjacent to the rocky cliff on the northwest bank just below the mouth of Sheephouse

Creek. Otter trawling followed a route that included both the deep channel and shallower nearshore waters, and beach seining was done on the southeast bank opposite the mouth of Sheephouse Creek.

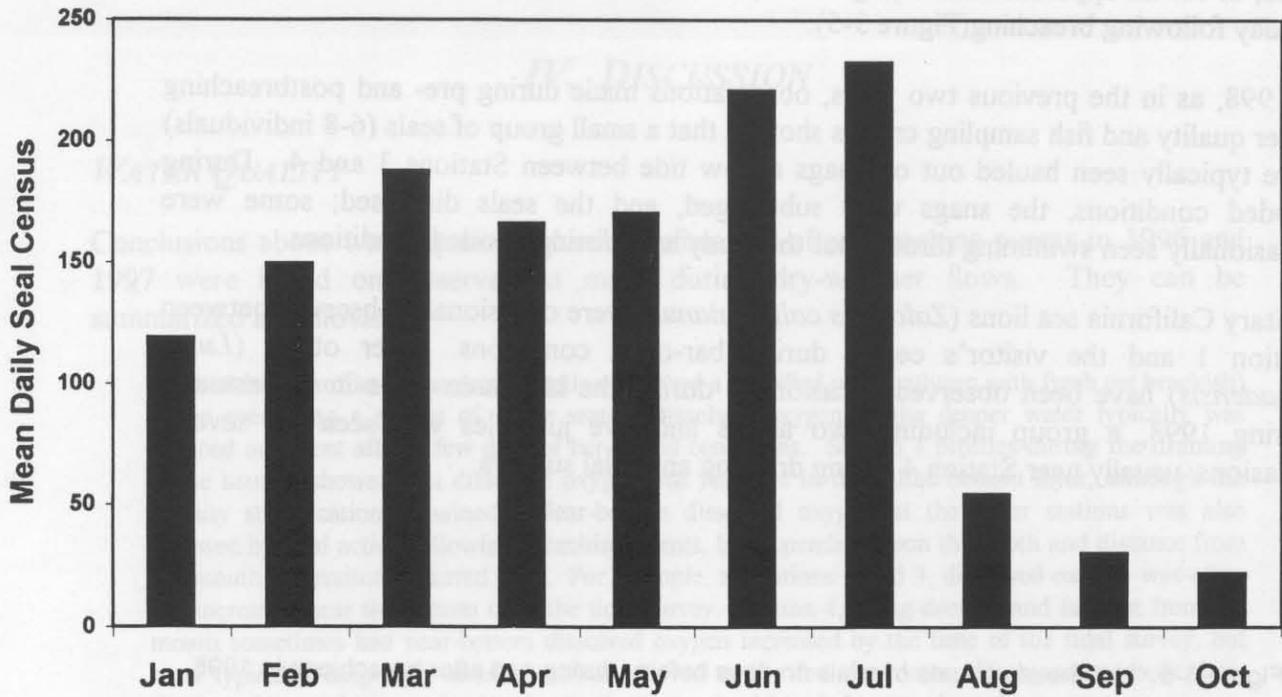
Figure 3-3. Monthly means of daily seal numbers at Jenner, January through October 1998.

The 1998 daily census of the harbor seal colony at Jenner showed increasing numbers of seals from January through July, then a sharp decrease in August (Figure 3-3, Appendix D-1). A peak in numbers during moult (June-July) is characteristic of central California harbor seals (Allen, 1984), as the seals apparently spend more time resting at haulout sites while moulting (Allen et al. 1987). In the two prior years to the current study, peak numbers were observed in February-March, but a separate peak occurred in July each year, followed by a sharp decline in August (MSC, 1997, 1998).

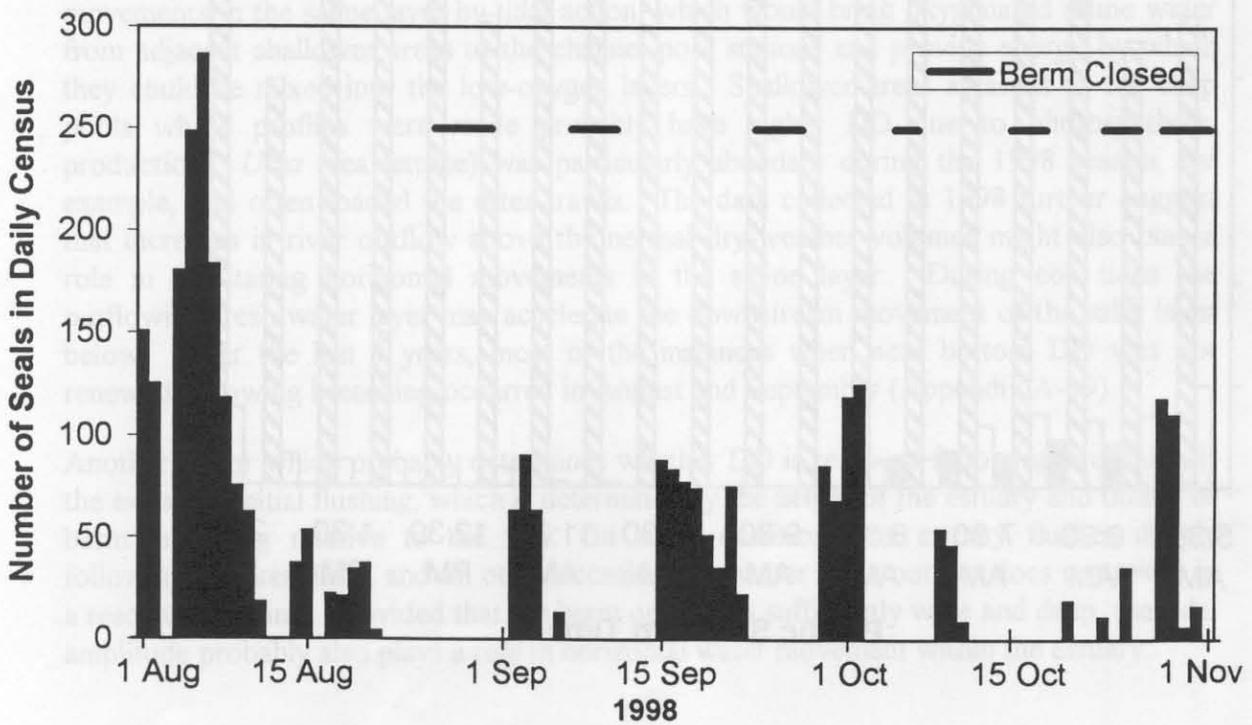
Figure 3-4. Numbers in the daily seal census and river closure, August through October, 1998.

Seal numbers at the Jenner haulout site fell during closures of the river mouth in 1998 (Figure 3-4), as has been found in earlier studies (Hanson, 1993; Mortenson, 1994; Mortenson and Twohy, 1995; Mortenson, 1996; MSC, 1997, 1998). However, the difference in mean number of seals present when the river mouth was open vs. closed was more extreme than in the 1996 and 1997 studies. In 1998, no seals were seen in the daily counts during bar-closed conditions in August, September or early October (Figure 3-4, Appendix D-4, D-5). Some seals were observed in the daily count before and just after the short-lived beach opening on 27 October (Figure 3-4, Appendix D-5, bottom panel). The more complete abandonment of the closed beach in 1998 could be because closures in the 1998 study did not occur until late summer and fall, when seal numbers are low to begin with, and when seals are more reactive to visitors (Mortenson, 1996). In 1996 and 1997, some of the closures occurred earlier in the year when seal numbers are higher and seals are less reactive to humans. Thus, a greater proportion of the colony remained at the haulout site when the river mouth was closed. The apparent absence of seals during bar closed conditions could also be an artifact of the time of day when the daily count is made, since early-morning observations on prebreaching and breaching days showed a few seals (Figure 3-5).

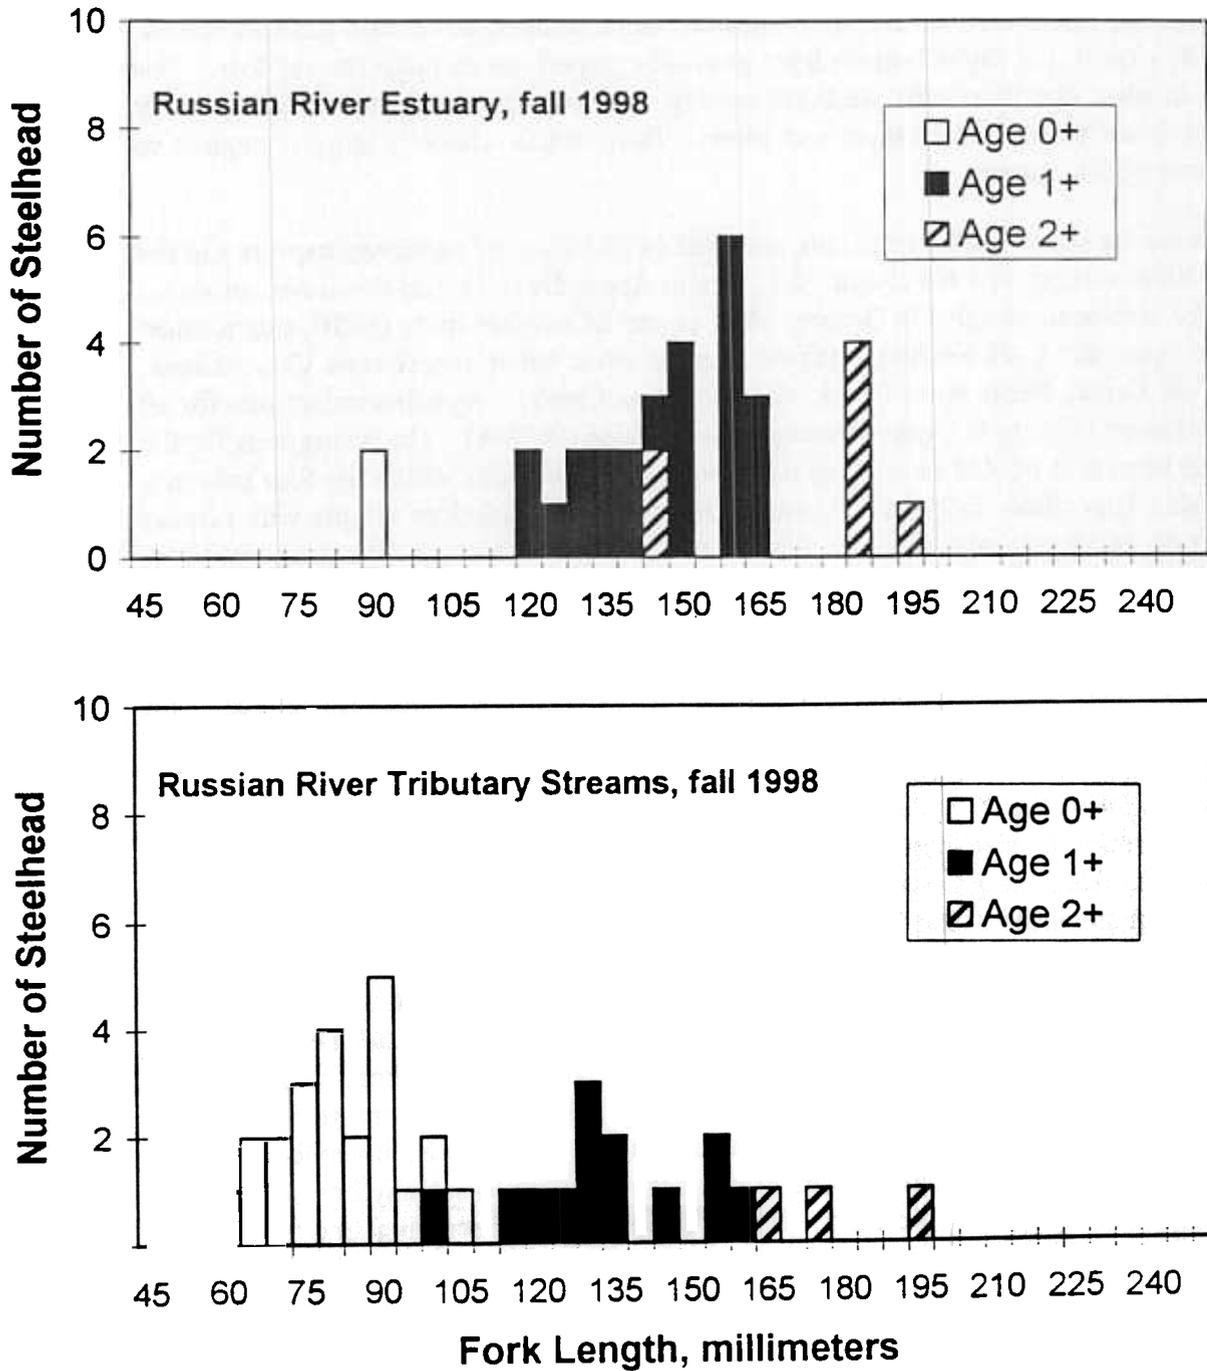
Figure 4-1 Size and Age Distribution of Juvenile Steelhead Captured in the Russian River Estuary and in Four Tributary Streams, Fall 1998*

*All histograms are plotted from the zero line (e.g., the 145 mm size class in the estuary contains three 1+ fish and two 2+ fish).

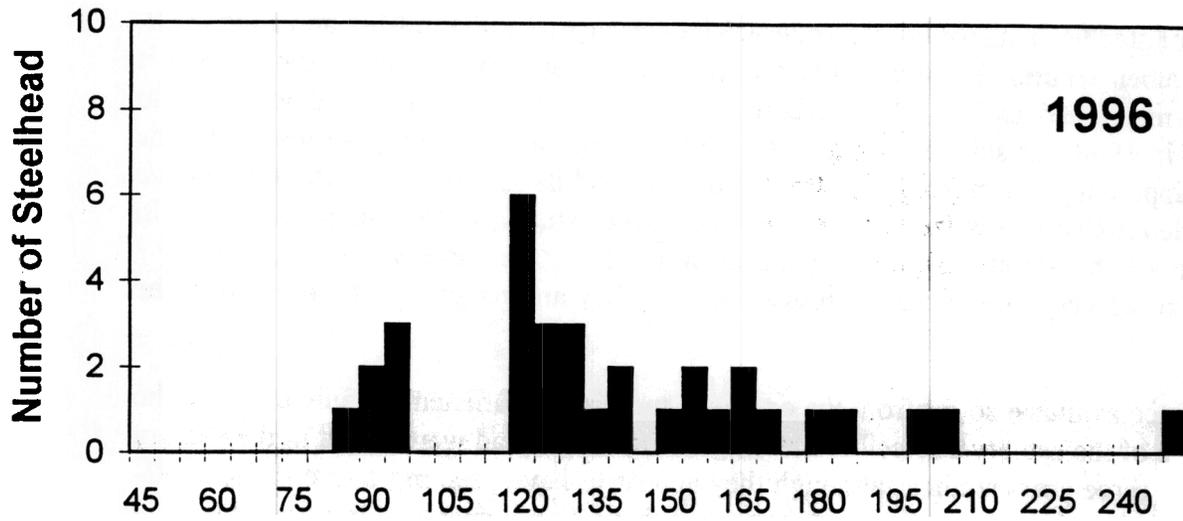
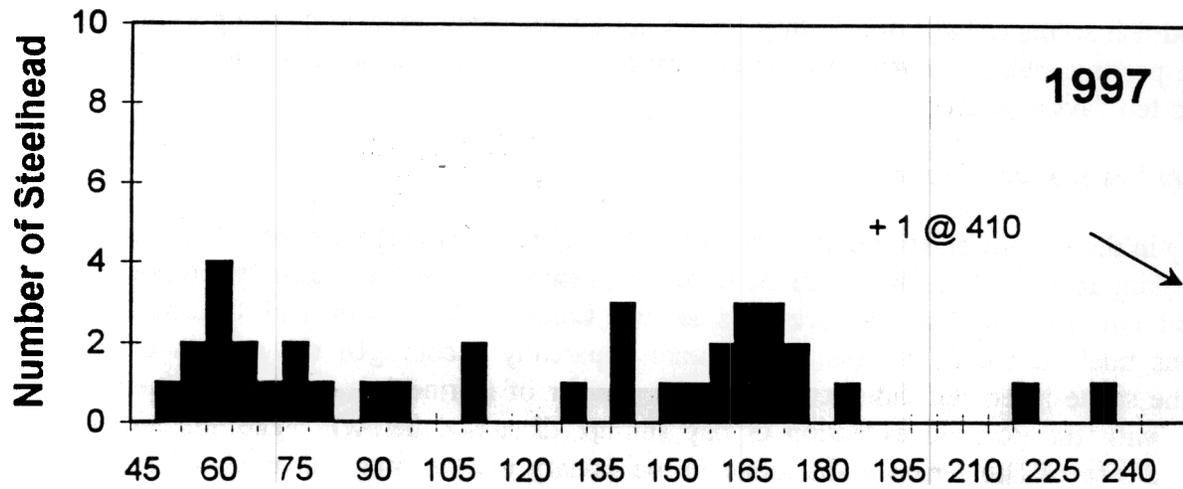
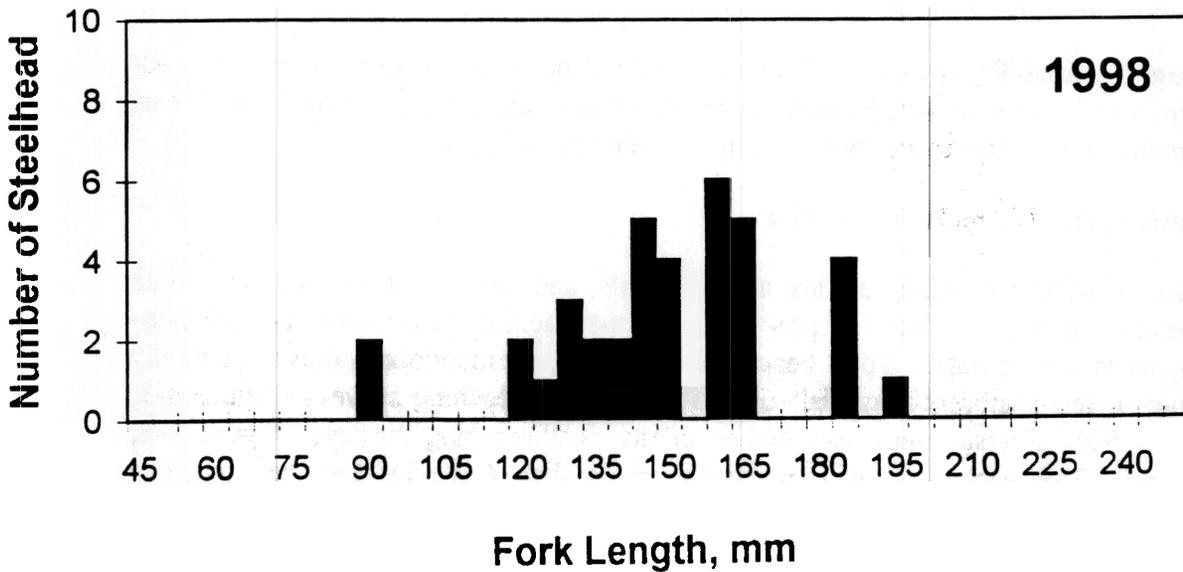
Figure 4-2. Steelhead Captured in the Russian River Estuary, 1996-1998.

In contrast, another line of evidence supports the idea that some steelhead rearing occurs in the Russian River estuary. Figure 4-2 shows the size distribution of steelhead captured in the estuary during all three years of the current study (only one steelhead was captured in the 1992-1993 study, and it was dead). Most of the fish represented in the figure were judged on their appearance, while being measured, to be smolts, i.e., juveniles on their way to sea, or ready to go to sea. Juveniles that are not going to sea anytime soon retain their parr marks and juvenile coloration. During the process of becoming smolts, the parr marks disappear under a layer of newly formed, shiny, silvery, deciduous scales (the scales easily flake off if handled roughly). In 1997, when the first breaching events occurred much earlier in the summer than in 1996 or 1998, quite small young-of-the-year steelhead (the cluster on the left, from 50 to 100 mm.) were captured in May and June surveys, and these fish had the parr marks and vivid colors typical of juveniles (or "parr") not undergoing smoltification. If they were not smolts, presumably they were juveniles rearing

in the estuary. The design of this study does not result in capture of sufficient numbers of steelhead throughout the summer to allow tracking of the growth rate and survivorship of a cohort of steelhead such as those young-of-the-year parr caught in May and June 1997. Another, albeit tenuous bit of evidence that tends to support the estuary-rearing model is the case, mentioned earlier, of the steelhead that was caught twice (six days apart) at Station 3 in 1998, possibly having grown measurably in the meantime. At least that one fish was apparently not making a beeline for the sea, and its apparent increase in size is *de facto* evidence that it was feeding, i.e., rearing, in the estuary, if only for a few days. In fact, most of the smolts captured in the estuary during the three years of study have appeared to be very fit and plump, suggesting that they are gorging on food while in the estuary.

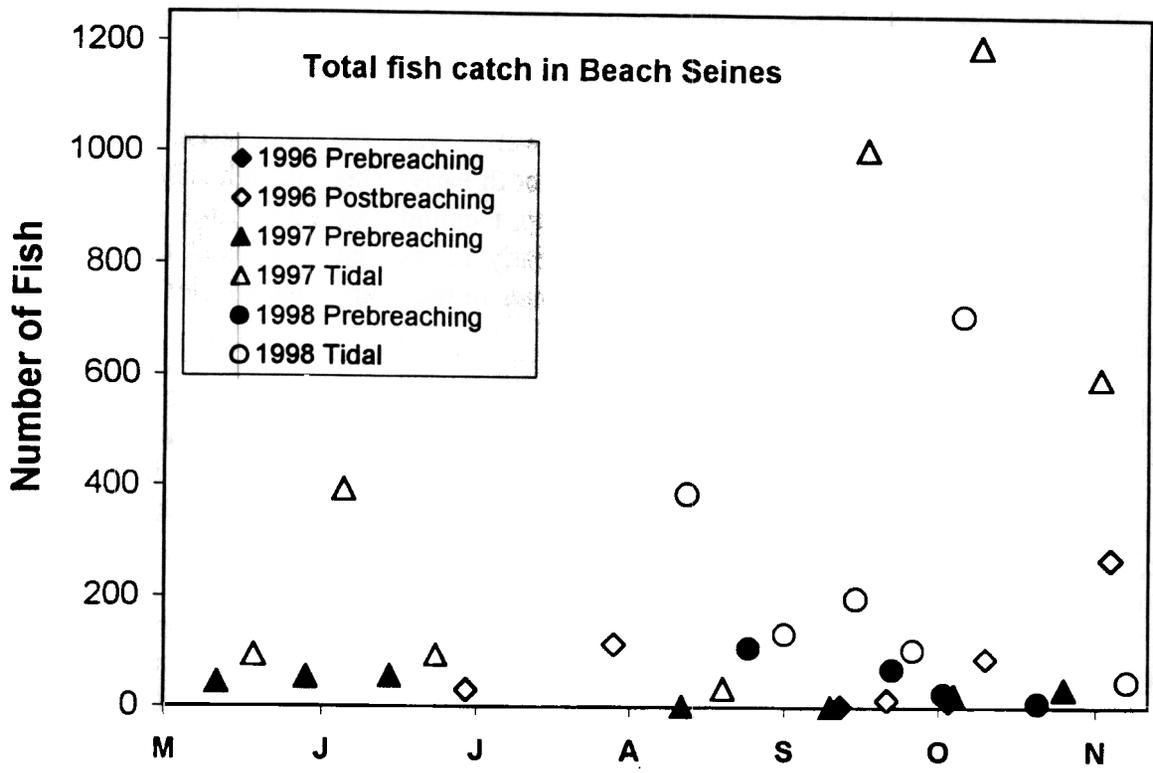
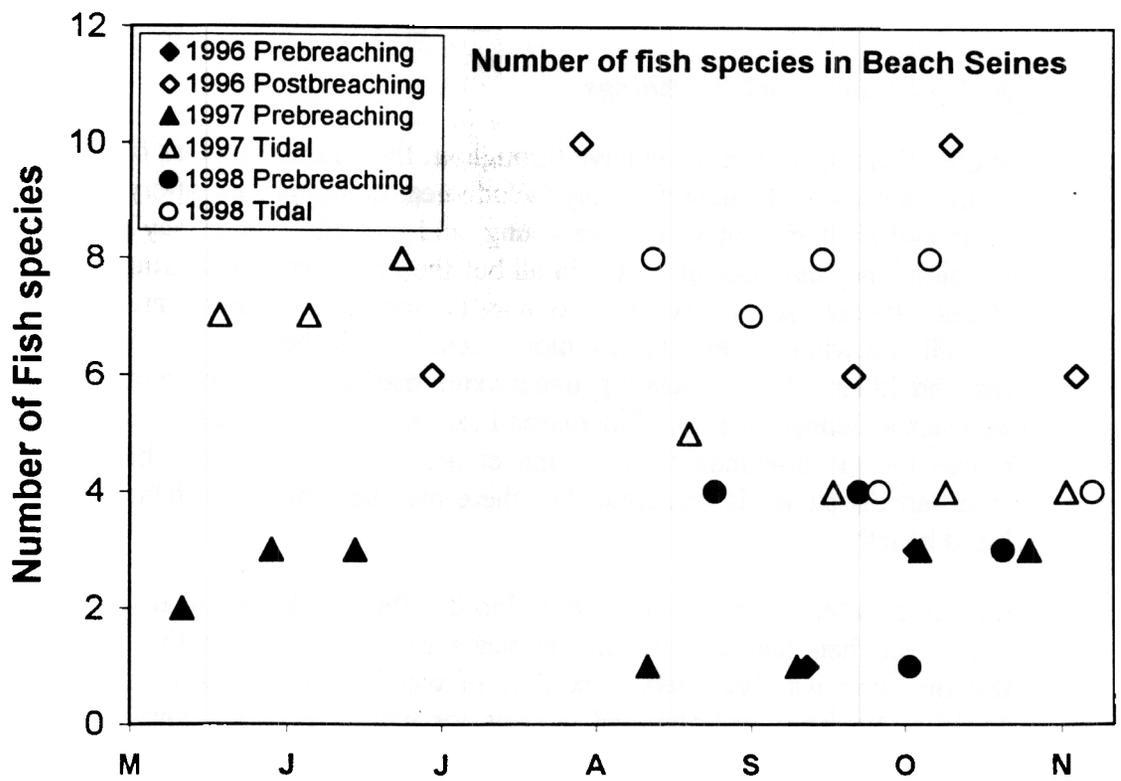
Figure 4-3. Comparison of Fish Diversity and Catch in Pre- and Post-breaching Beach Seines, 1996-1998.

Three years of trawl and seine data are now available, and analysis of the combined data set for trends that can be related to pre- versus post-breaching, seasonality, and year-to-year patterns is appropriate. Total beach seine catches, as mentioned above, generally were higher in the postbreaching/tidal surveys than in prebreaching surveys (Figure 4-3, top panel). Fish diversity was also higher in the postbreaching surveys (Figure 4-3, bottom panel): Prebreaching surveys never had more than 4 species per day, whereas postbreaching/tidal surveys never had fewer than 4 species per day. Fish diversity did not

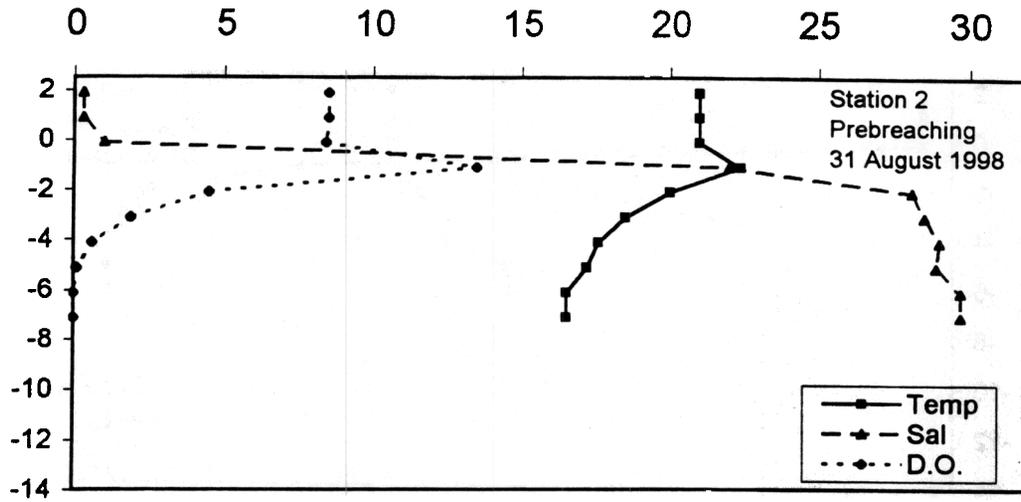
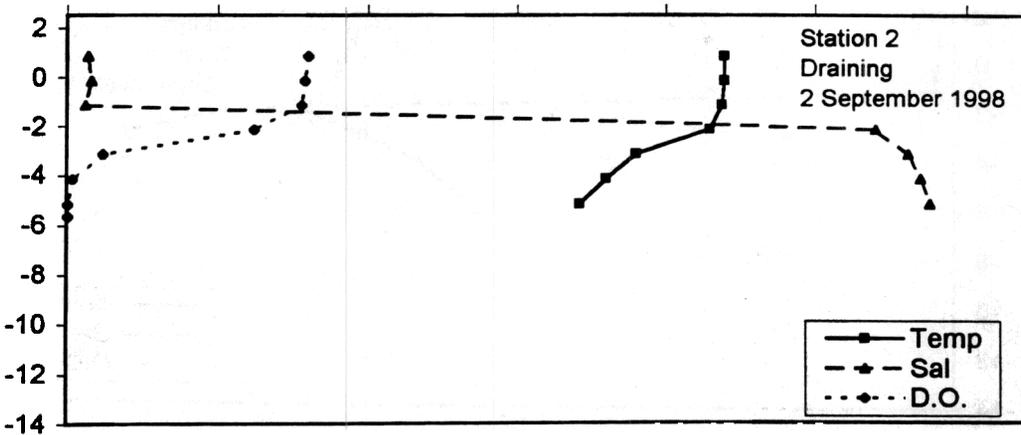
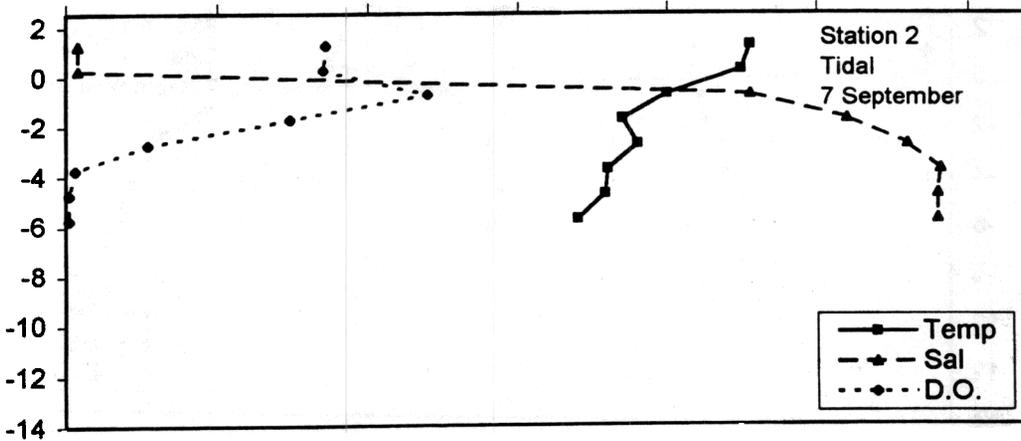
Appendix A-18. Water Quality Profile Plots, Station 2, Event

Depth, Meters, Relative to Zero on Jenner Gage

Temperature (°C), Salinity (‰), D. O. (mg/l)

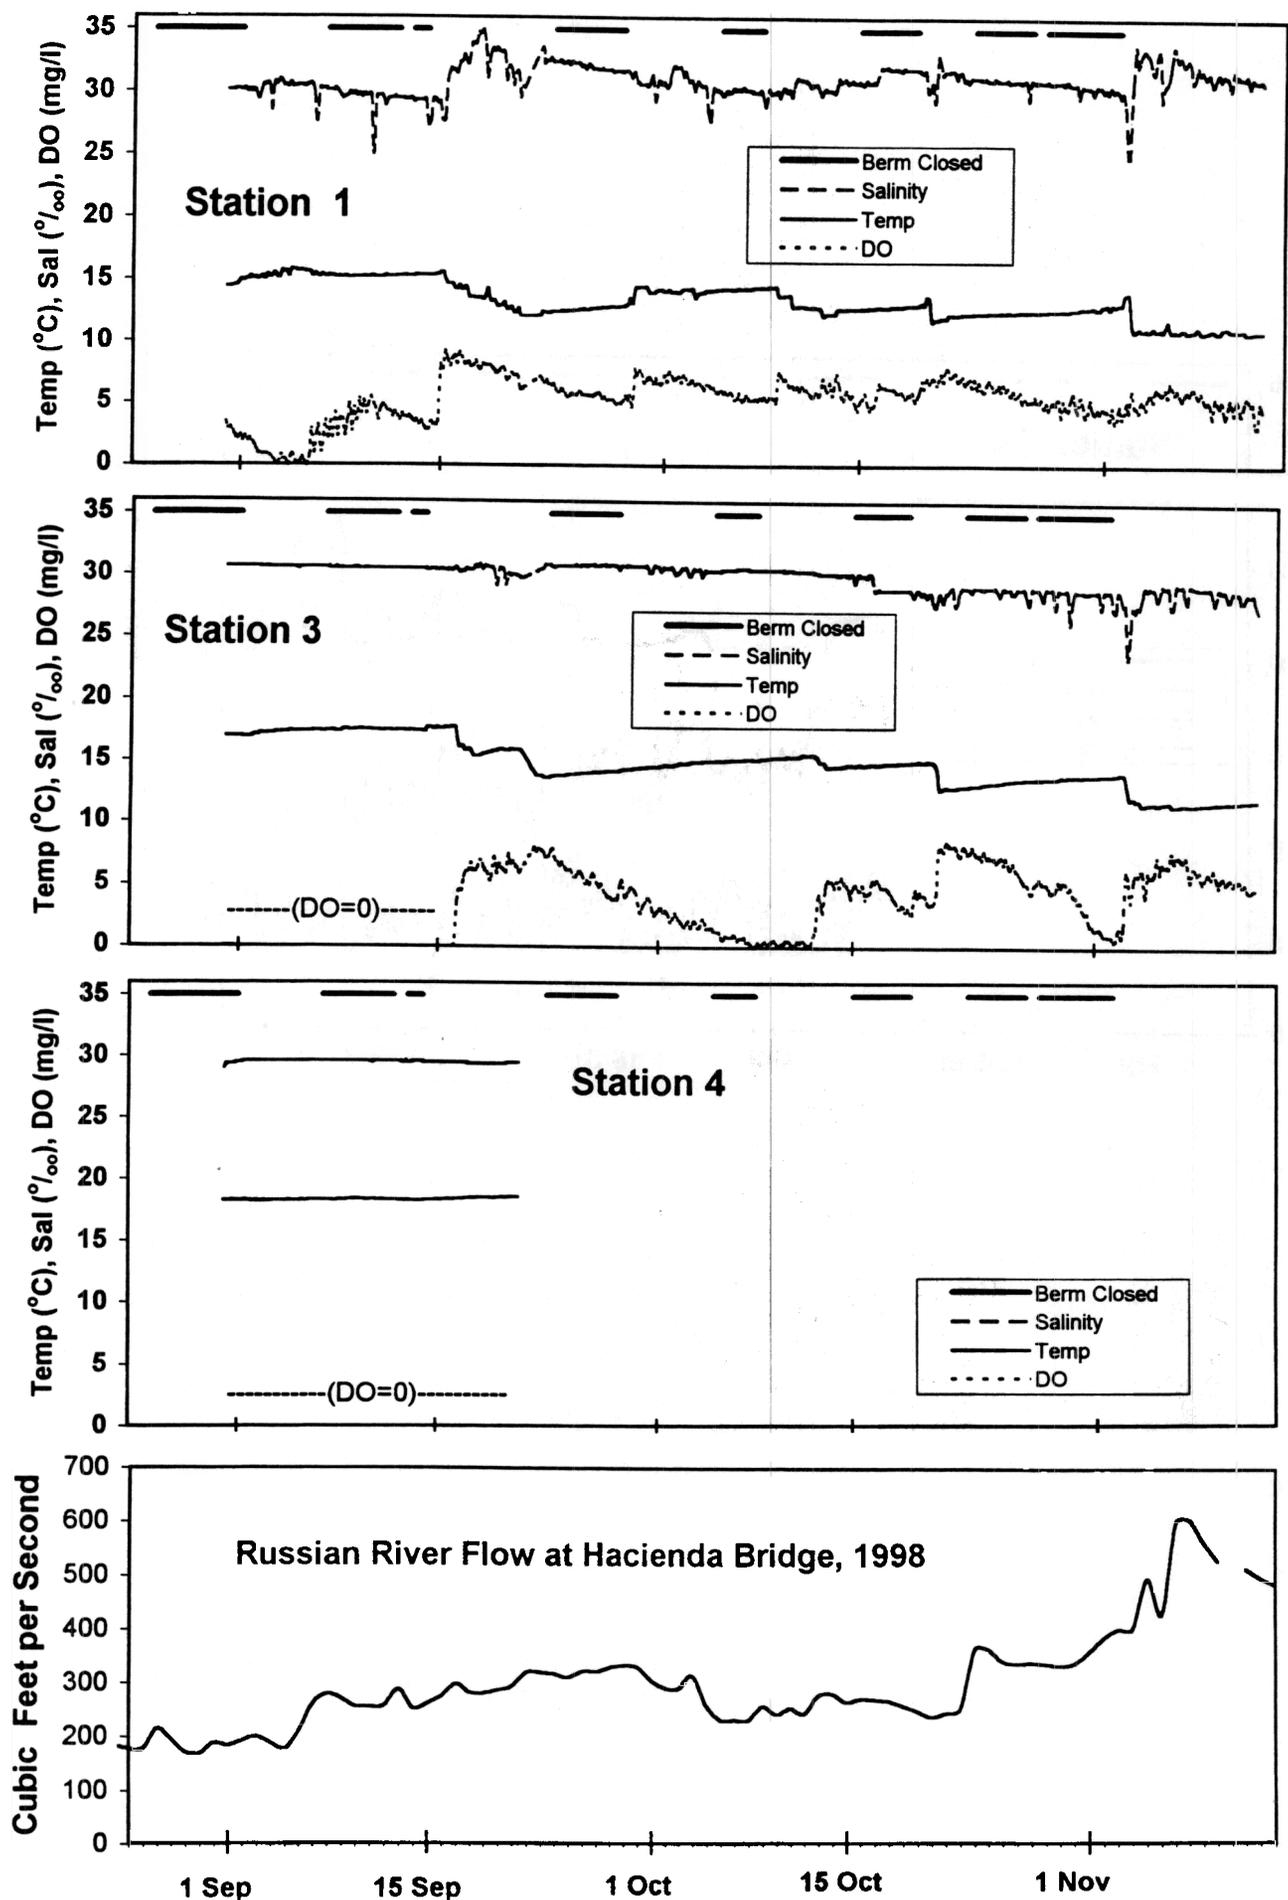
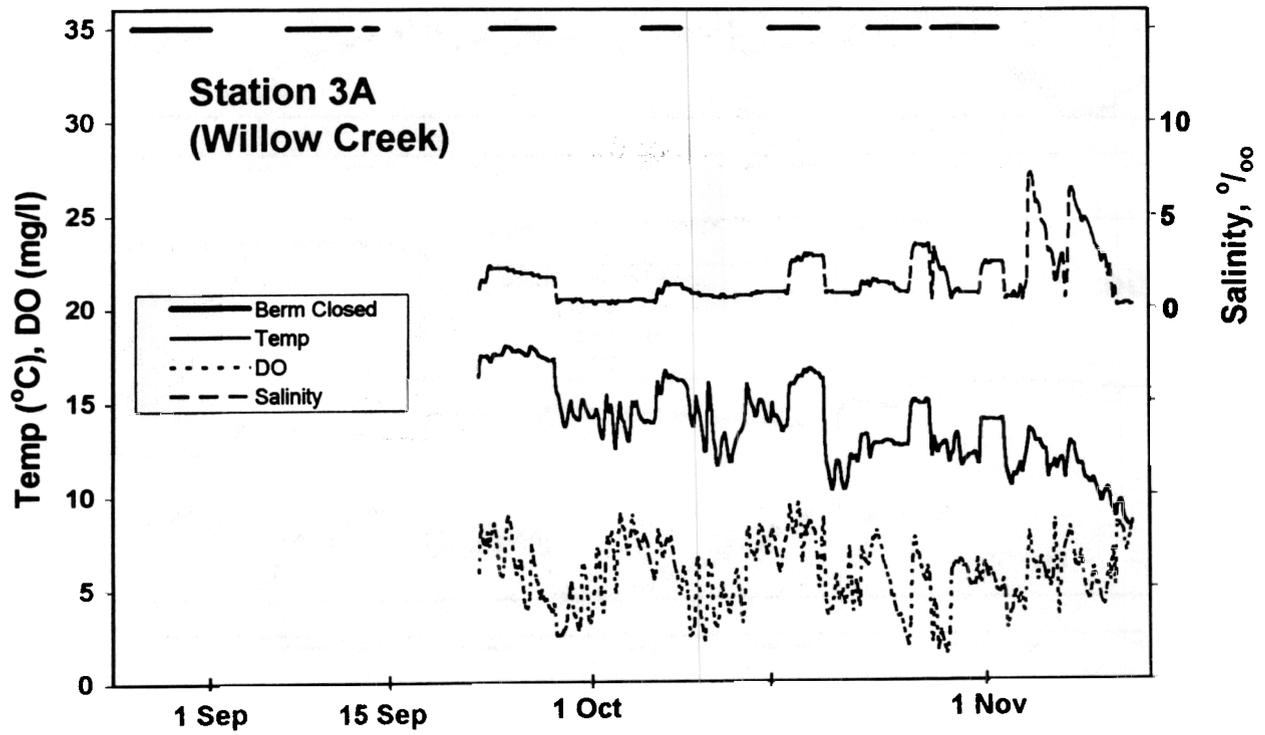
Appendix A-37. 1998 Datasonde Records, Russian River Estuary Stations 1, 3, and 4. Also shown: Russian River Flows During 1998 Datasonde Deployments

Datasondes recorded water quality conditions near the bottom at estuary Stations 1, 3, and 4 (Appendix A-37). These records confirm and elucidate water quality changes discussed above in conjunction with profiles made with YSI meters. Appendix A-37 clearly shows that near-bottom DO was not replenished at Stations 3 and 4 following the first breaching event, nor at Station 4 by the time the sonde was removed following the second breaching (21 September). The third breaching event evidently did not result in replenishment of near-bottom DO at Station 3—this did not occur until well after the fourth breaching event. Also depicted in Appendix A-37 are berm closures and the Russian River Flow at Hacienda Bridge for the same period as the datasonde deployments (DWR data). Flows typical of dry weather conditions (<200 cfs) occurred only in early September. Higher flows (200-300 cfs) during most of the study period may have facilitated horizontal transport of DO in the saline layer. This is discussed further below.

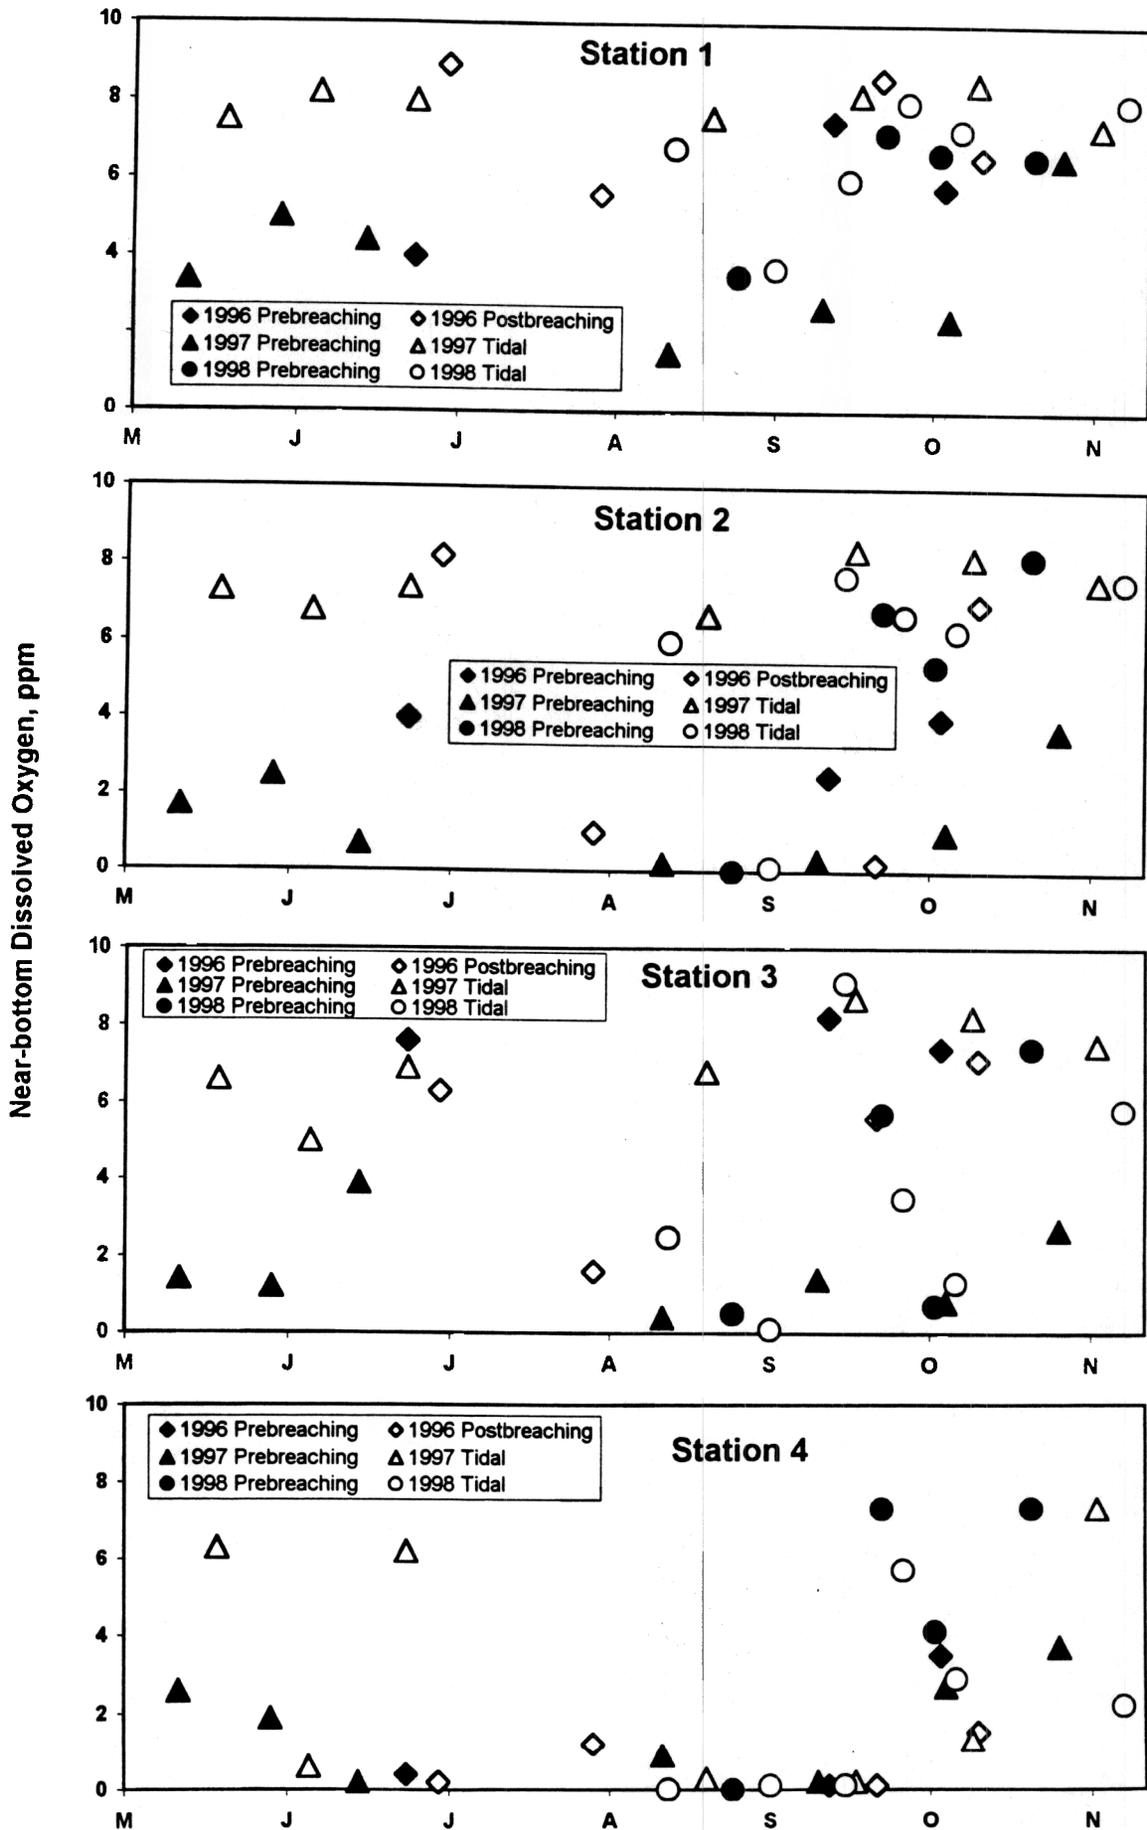
Appendix A-39. Comparison of Near-bottom Dissolved Oxygen in Pre- and Post-breaching Profiles, 1996-1998.

The increase in near-bottom DO which was observed following breaching events was not associated with vertical mixing, because the salinity stratification was not disrupted (although at Station 4 fresh water sometimes penetrated up to 3-4 m into the salty layer during the postbreaching tidal period—see Appendix A-28). Diffusion of oxygen into the deep layer must take place, but it is unlikely to explain the rapidity of the renewal. Therefore it is assumed that the primary agent in renewal of DO was horizontal movements in the saline layer by tidal action, which would bring oxygenated saline water from adjacent shallower areas to the channel pool stations and provide energy by which they could be mixed into the low-oxygen layers. Shallower areas adjacent to the deep pools where profiles were made probably have higher DO due to photosynthetic production. *Ulva* (sea lettuce) was particularly abundant during the 1998 season, for example, and often loaded the otter trawls. The data collected in 1998 further suggest that increases in river outflow above the normal dry-weather volumes might also play a role in facilitating horizontal movements in the saline layer. During ebb tides the outflowing fresh water layer may accelerate the downstream movement of the salty layer below. Over the last 3 years, most of the instances when near bottom DO was not renewed following breaching occurred in August and September (Appendix A-39).

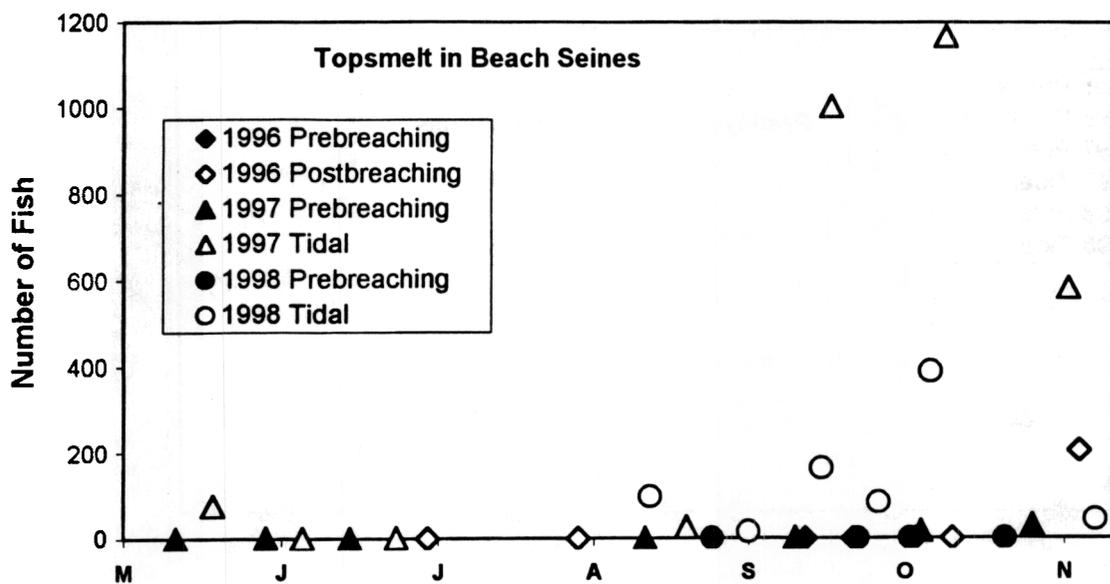
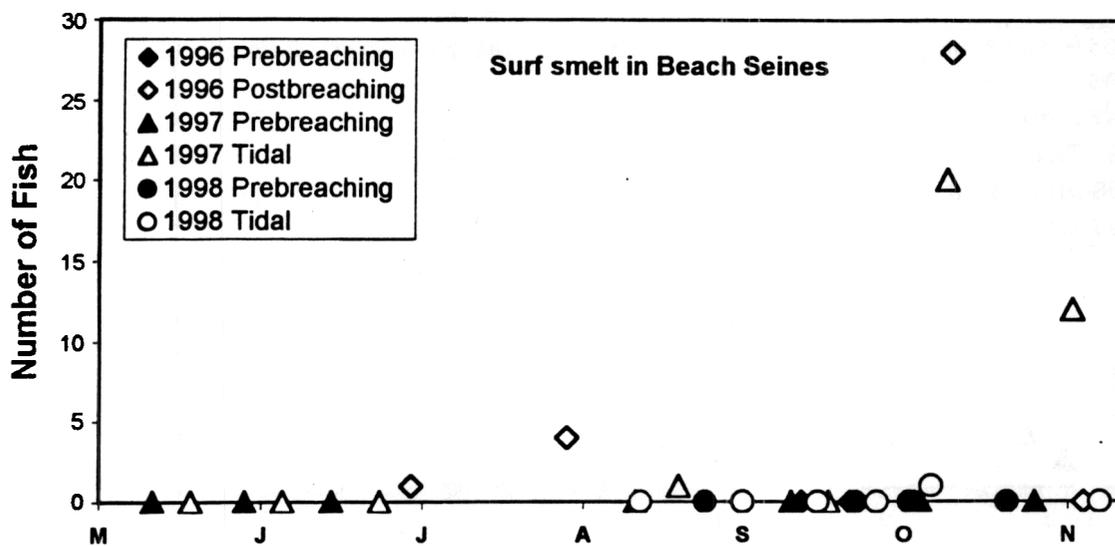
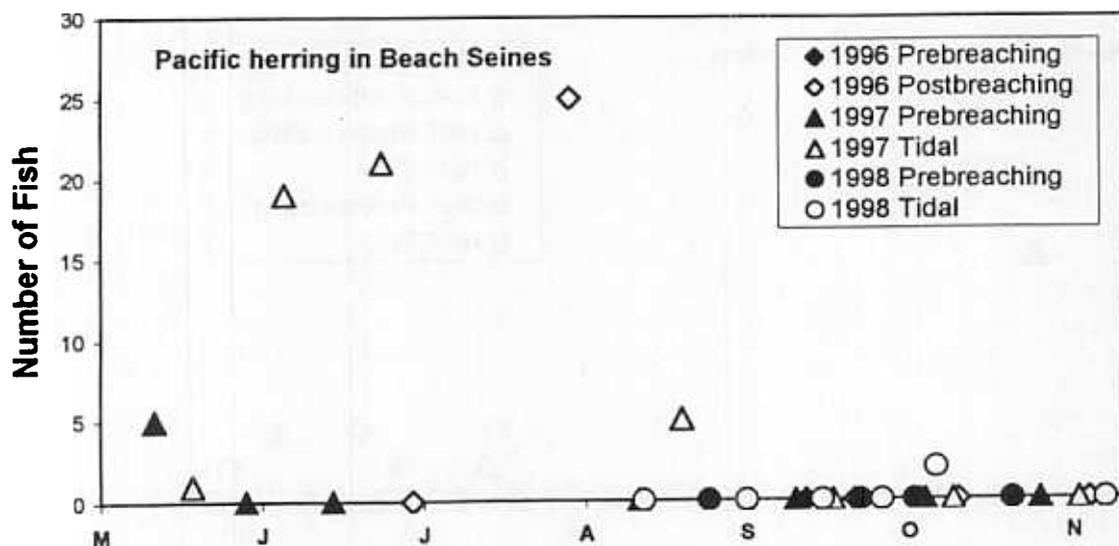
Appendix B-56. Comparison of Topsmelt, Surf smelt, and Pacific Herring Catches in Pre- and Post-breaching Beach Seines, 1996-1998.

A similar analysis of individual species catches in beach seines (Appendix B-56 through B-59) shows that while most fish species followed the general trend of lower catches during the prebreaching survey, a few (mainly freshwater or euryhaline) species such as prickly sculpin (Appendix B-57), Sacramento sucker (Appendix B-58), and steelhead (Appendix B-59) were equally likely to be caught at high as at low water. With regard to seasonality, catches of these same three species were about equal in both early (May through July) and later (August through October) periods. A second group, including pacific herring, shiner surfperch, and starry flounder) were more abundant early in the year. Topsmelt, surf smelt, and threespine stickleback were most abundant later in the year. Few species were equally abundant in all three years.

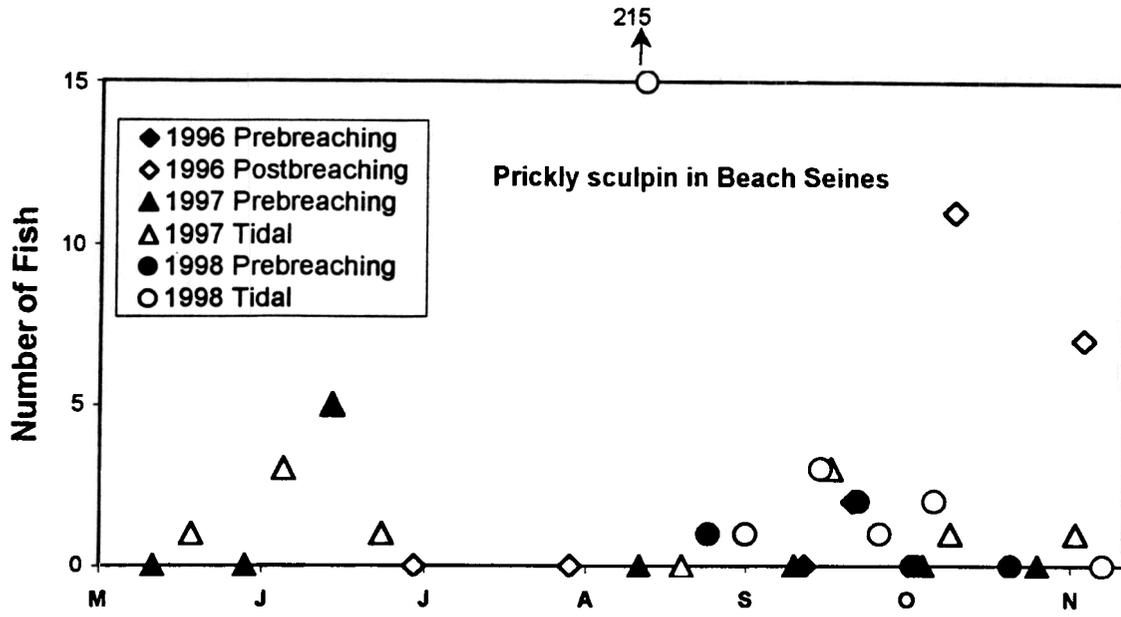
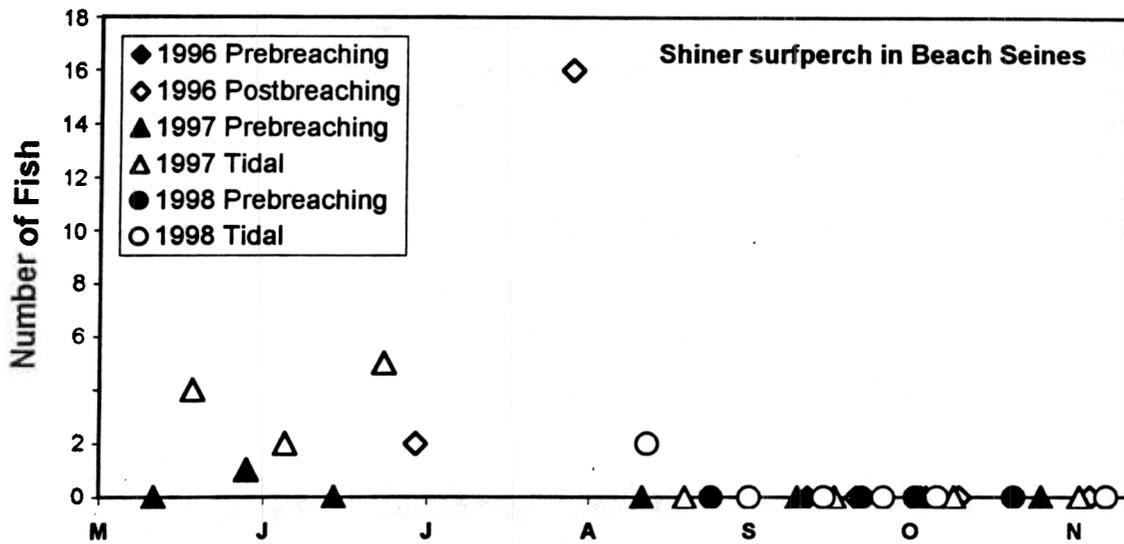
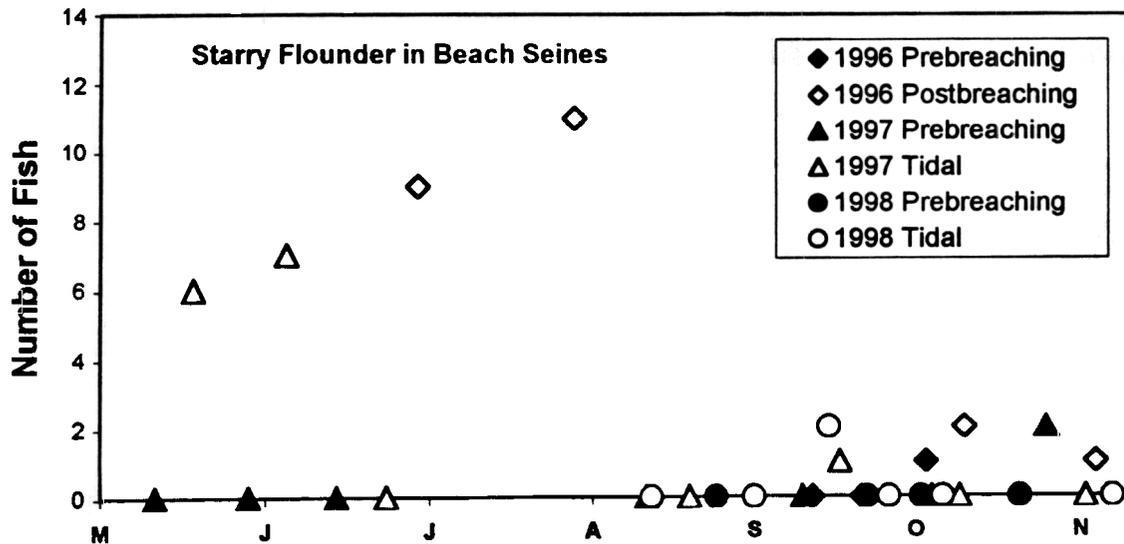
Appendix B-57. Comparison of Prickly sculpin, Shiner surfperch, and Starry flounder Catches in Pre- and Post-breaching Beach Seines, 1996-1998.
