**BIOLOGICAL AND WATER QUALITY MONITORING IN
THE RUSSIAN RIVER ESTUARY, 1998**

THIRD ANNUAL REPORT

15 MARCH 1999

Submitted by

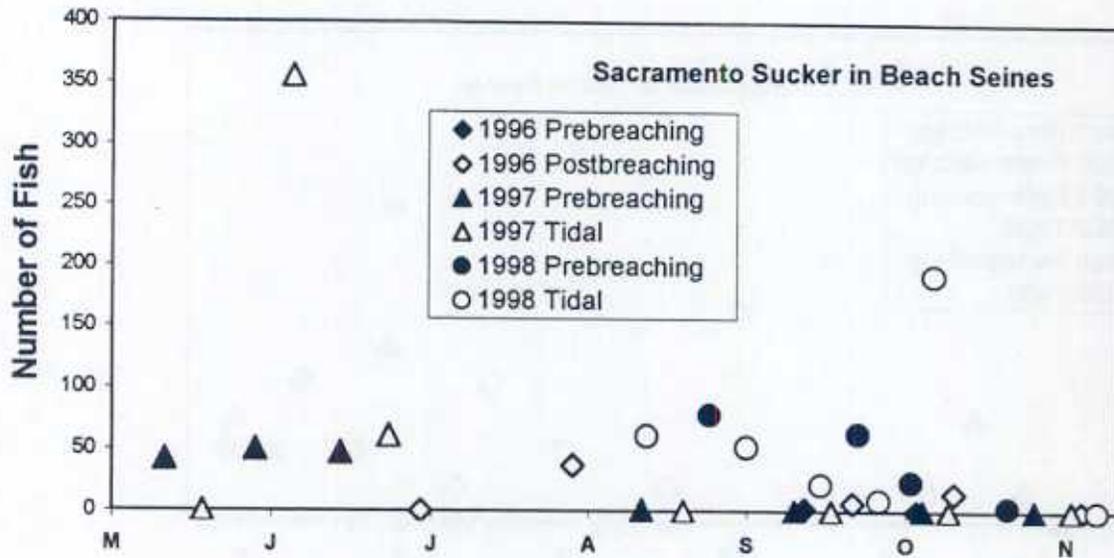
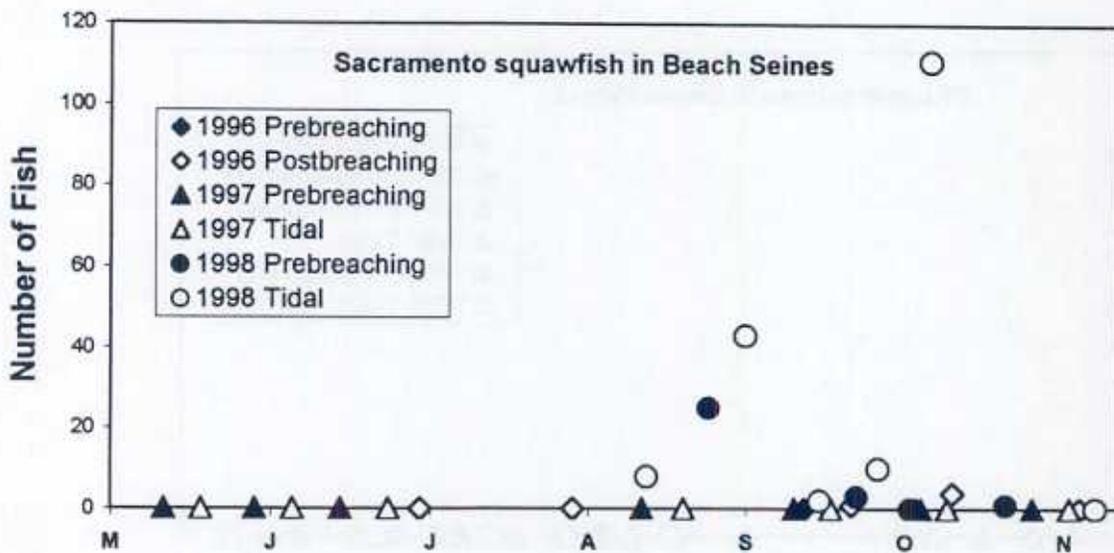
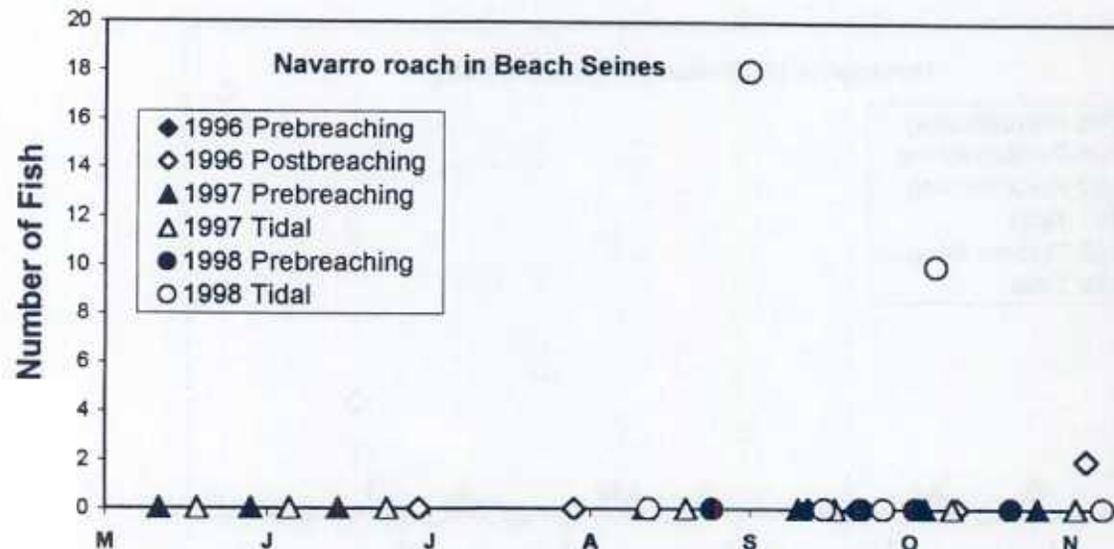
Appendix B-58. Comparison of Sacramento sucker, Sacramento squawfish, and Navarro roach Catches in Pre- and Post-breaching Beach Seines, 1996-1998.

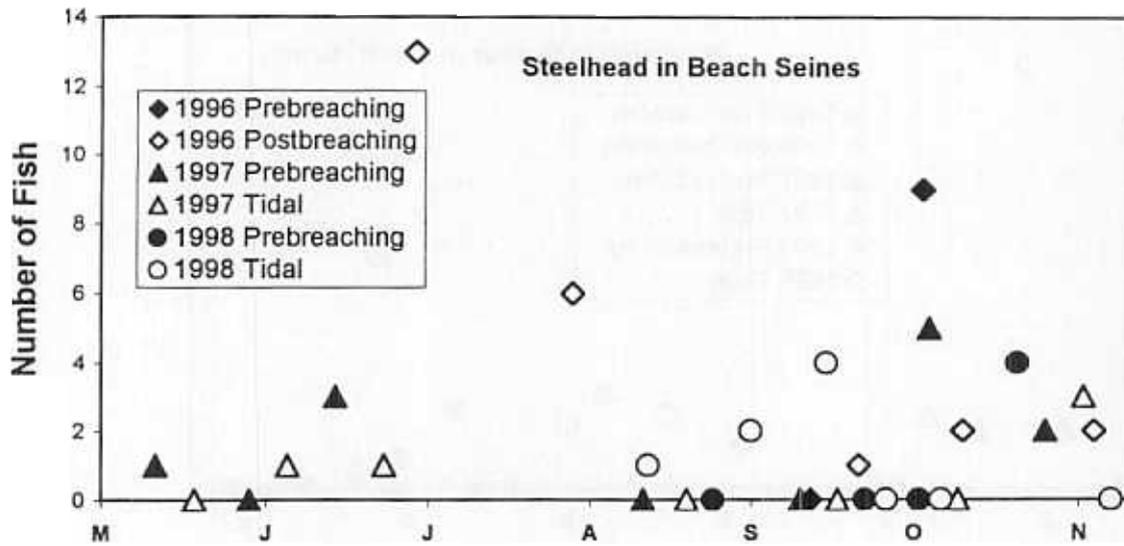
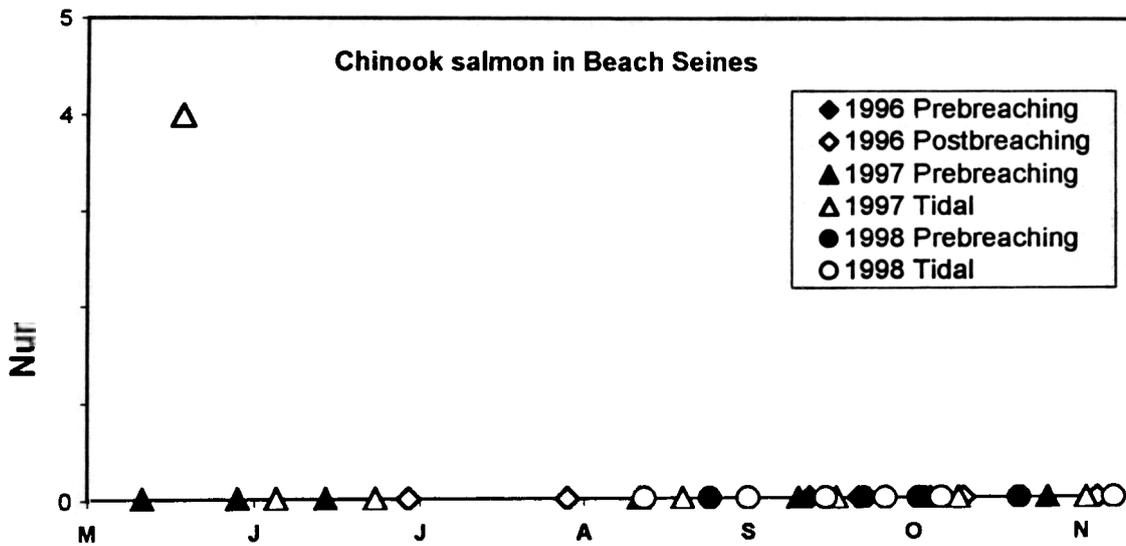
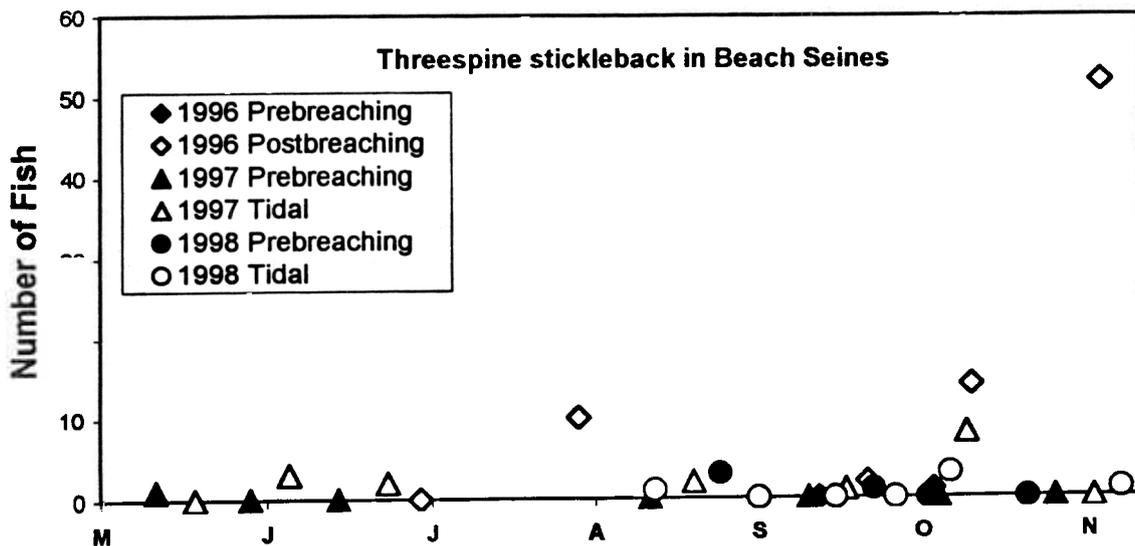
Appendix B-59. Comparison of Steelhead, Chinook salmon, and Threespine stickleback Catches in Pre- and Post-breaching Beach Seines, 1996-1998.

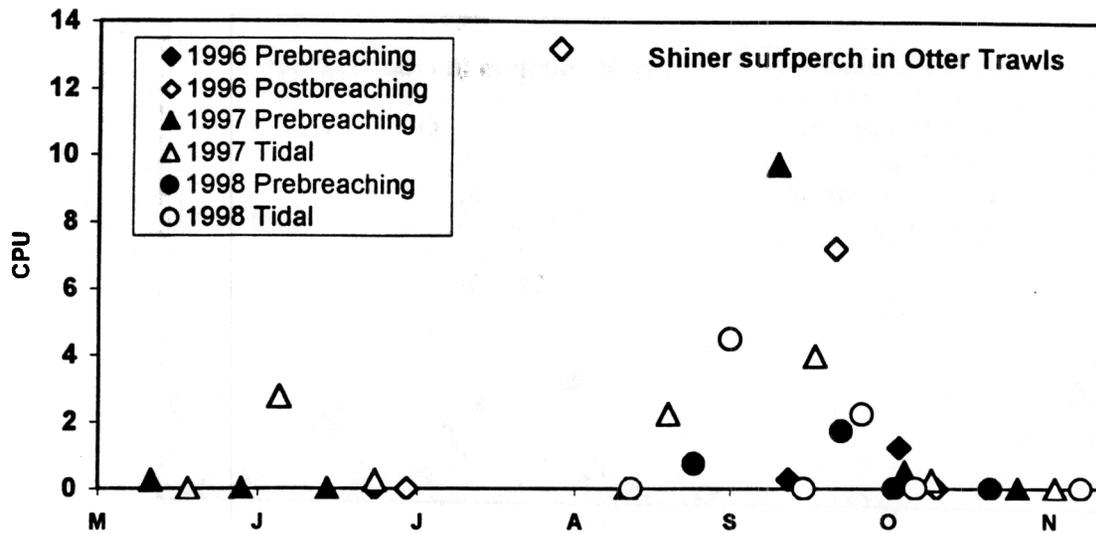
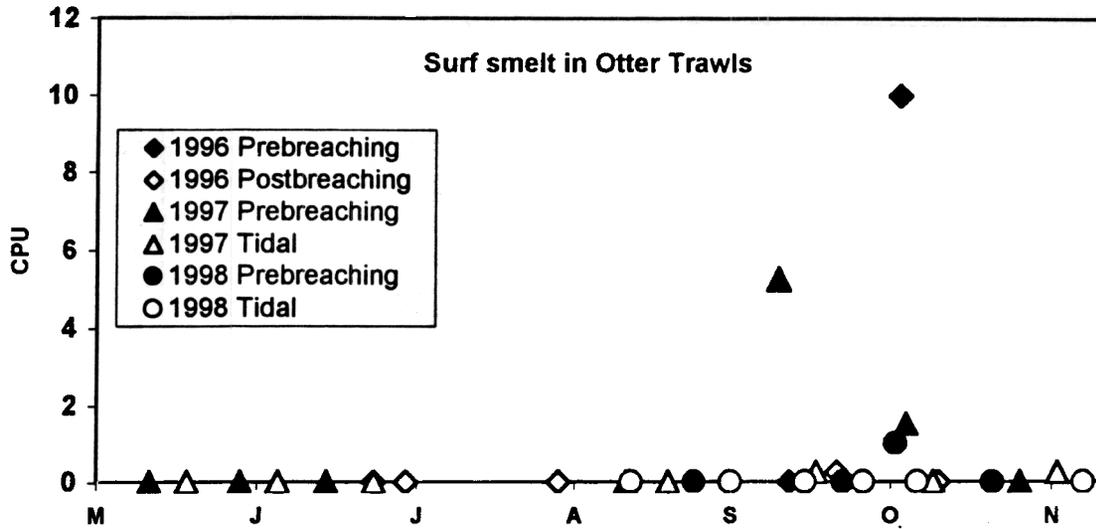
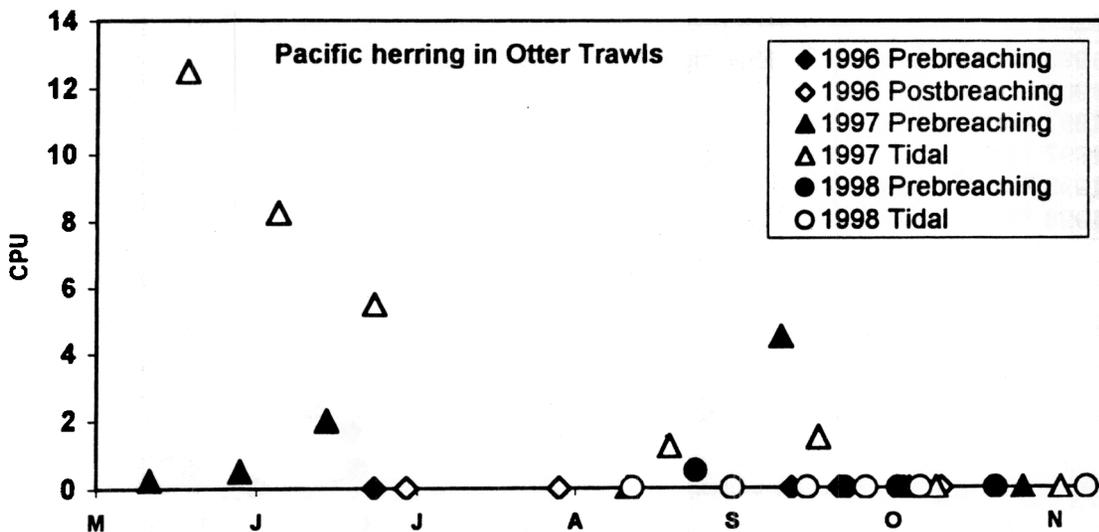
Appendix B-60. Comparison of Shiner surfperch, Surf smelt, and Pacific herring Catches in Pre- and Post-breaching Otter Trawls, 1996-1998.

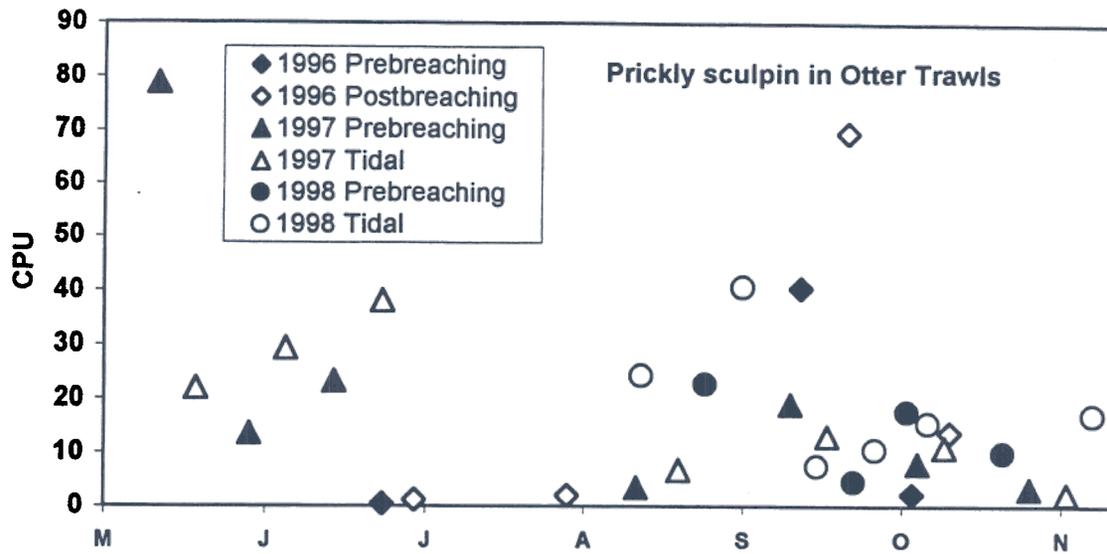
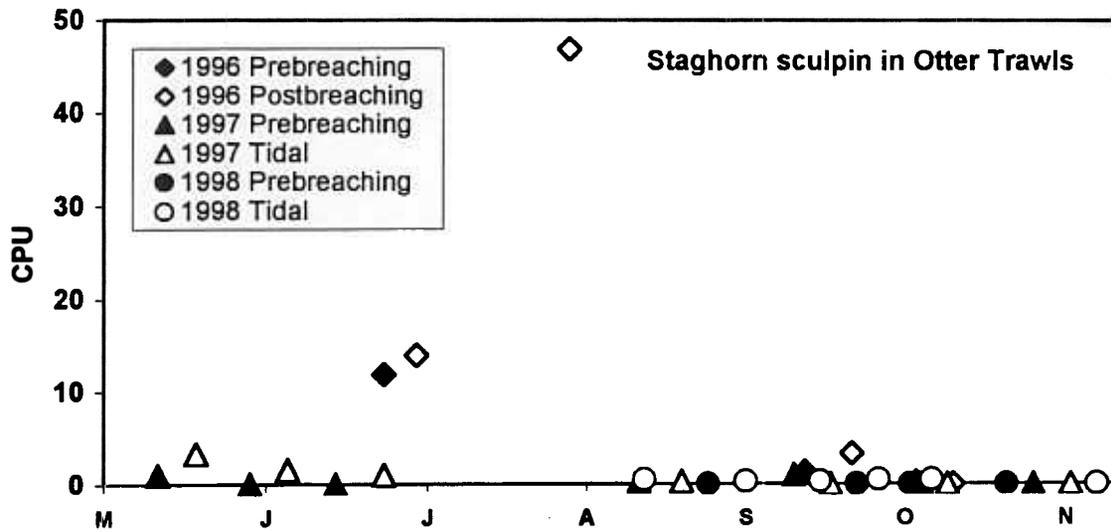
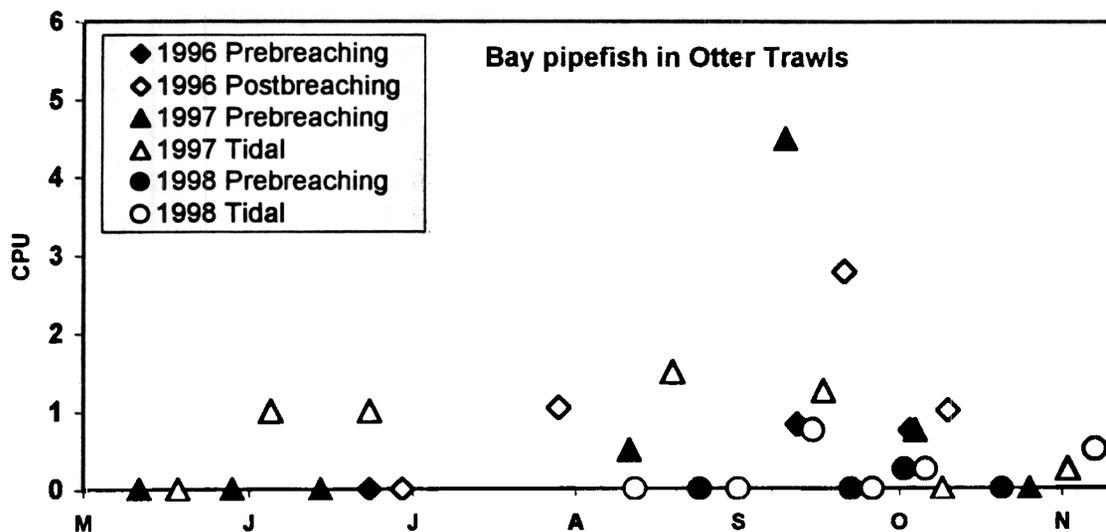
Appendix B-61. Comparison of Prickly sculpin, Staghorn sculpin, and Bay Pipefish Catches in Pre- and Post-breaching Otter Trawls, 1996-1998.

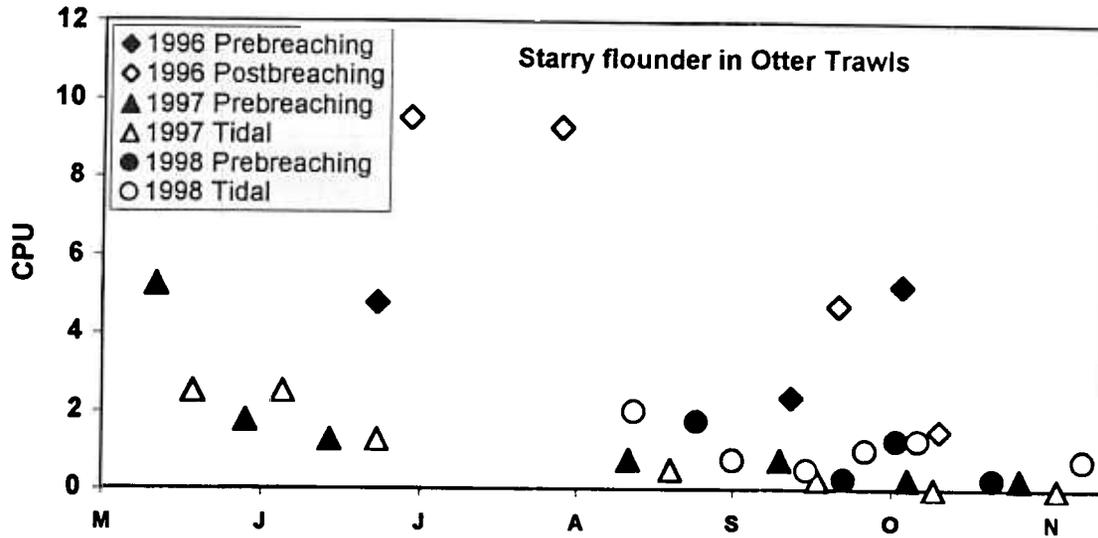
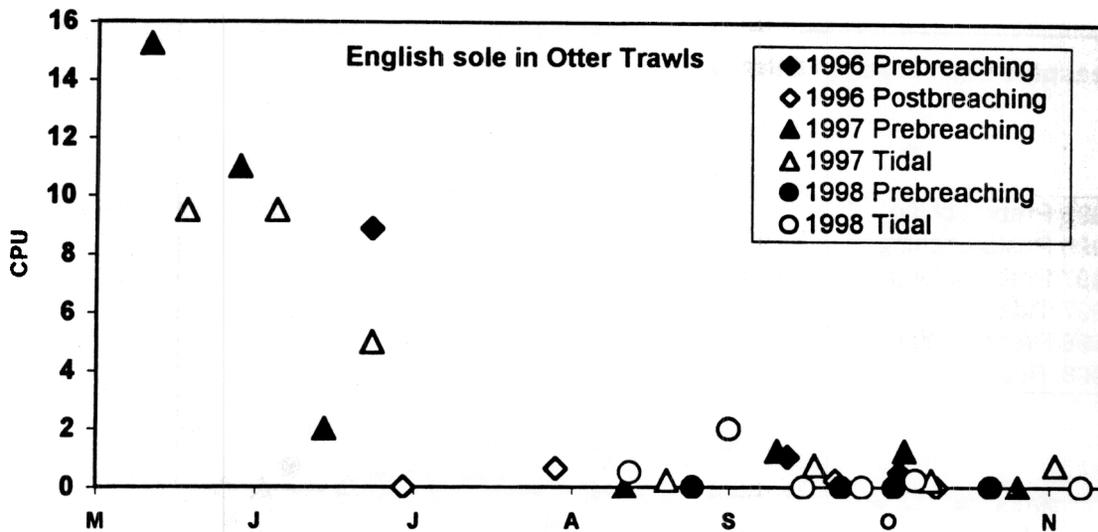
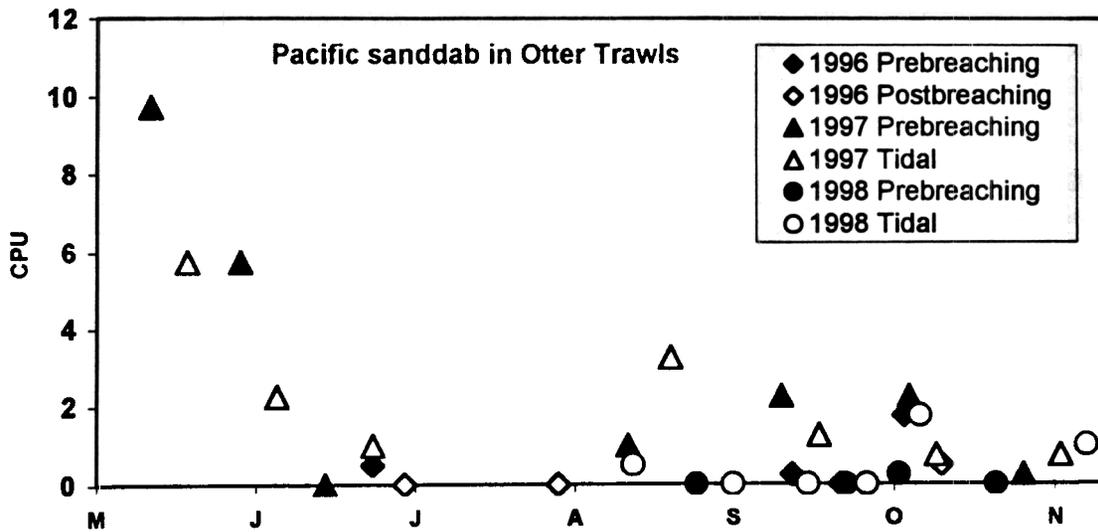
Appendix B-62. Comparison of Starry flounder, English sole, and Pacific sanddab Catches in Pre- and Post-breaching Otter Trawls, 1996-1998.

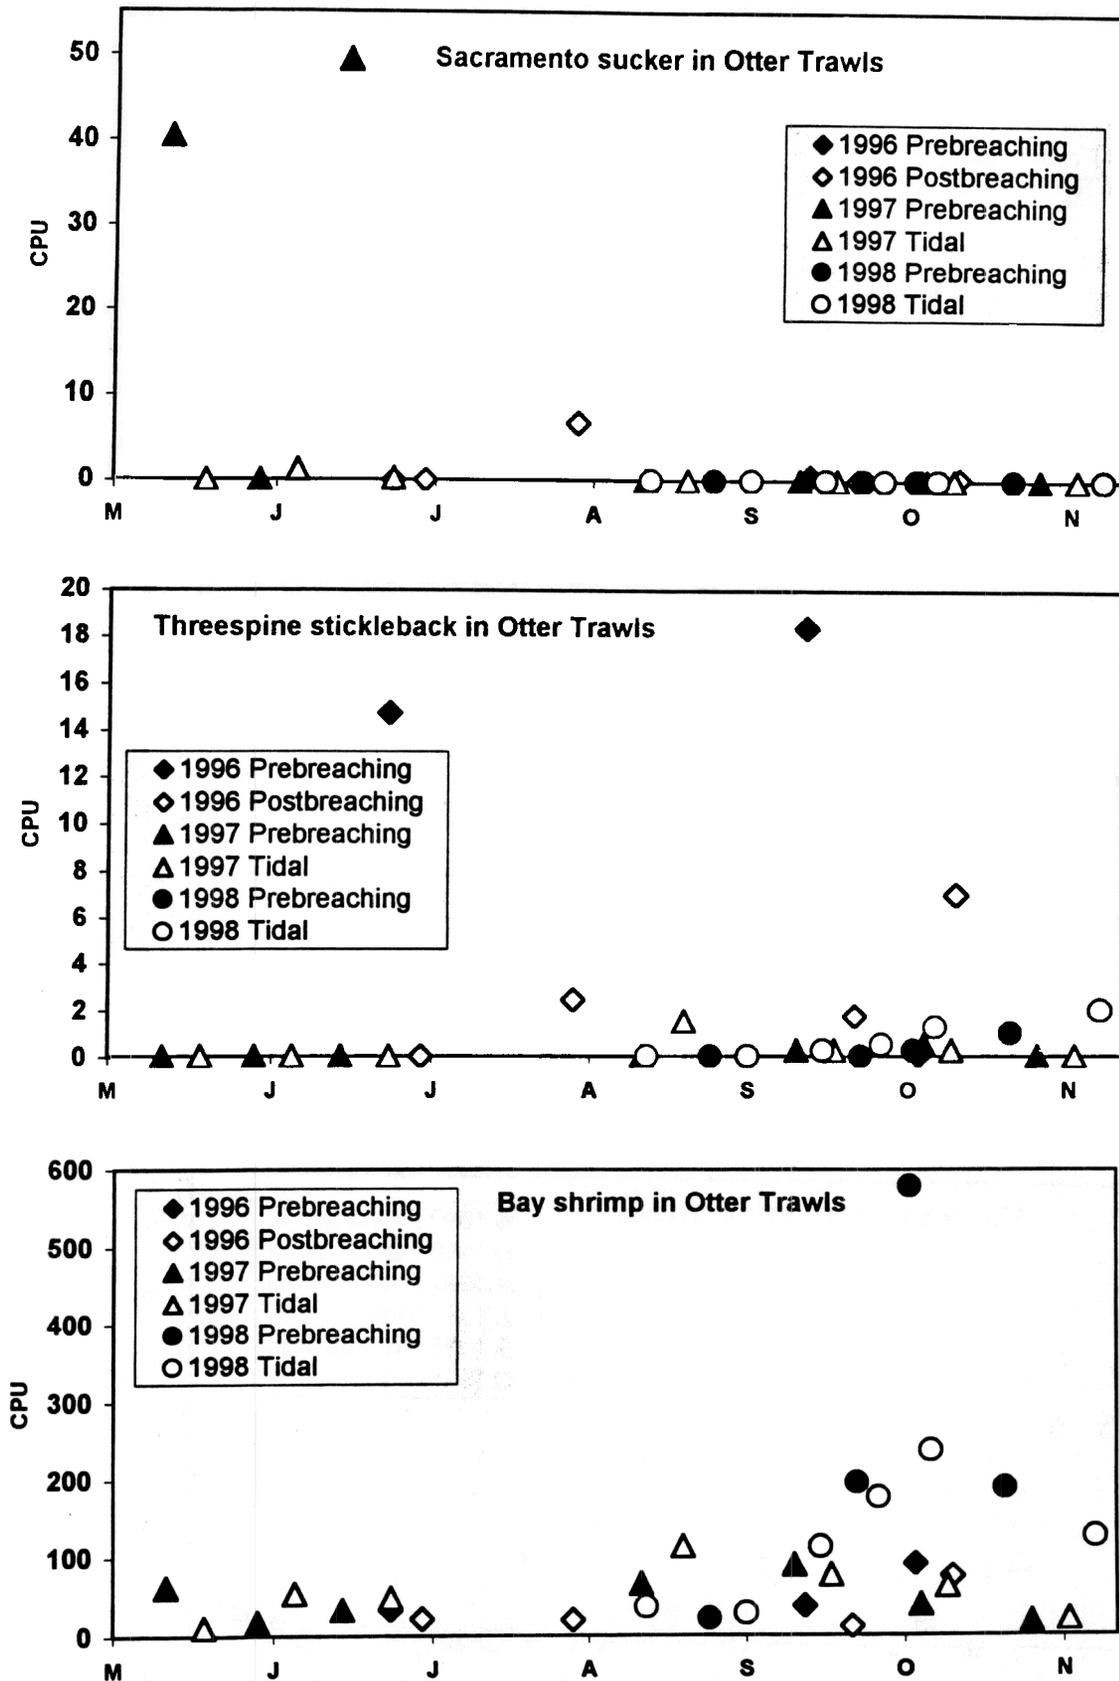
Appendix B-63. Comparison of Sacramento sucker, Threespine stickleback, and Bay shrimp (*Crangon* spp.) Catches in Pre- and Post-breaching Otter Trawls, 1996-1998.

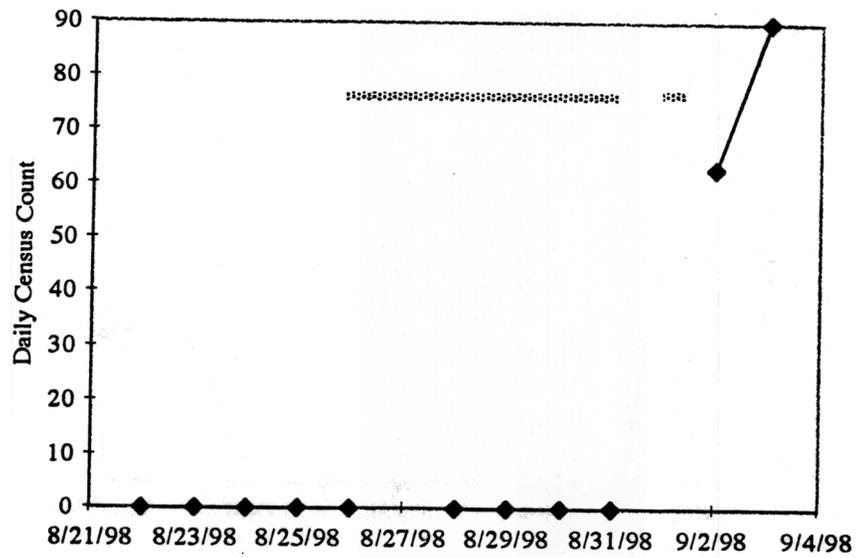
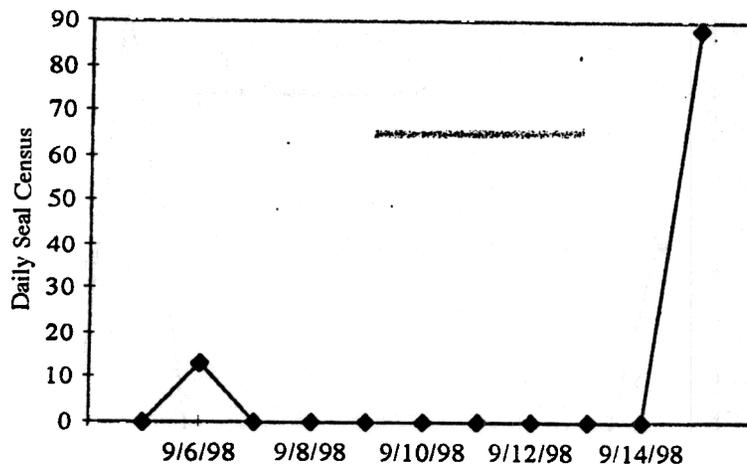
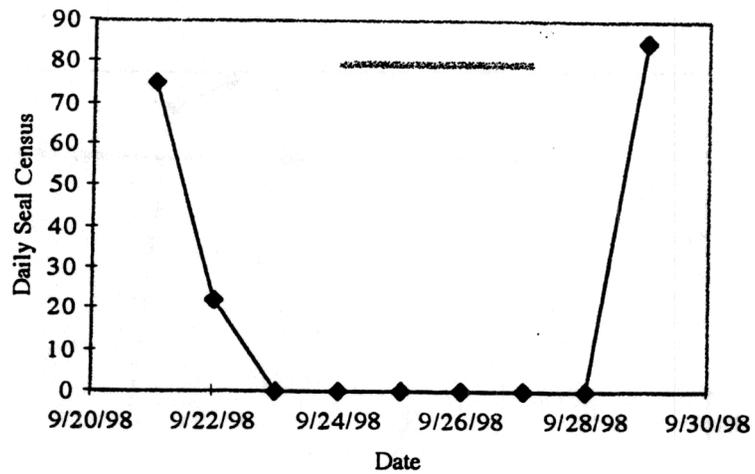
Appendix D-4. Seal Numbers During River Closures in August and September, 1998. Gray bar indicates complete river closure.

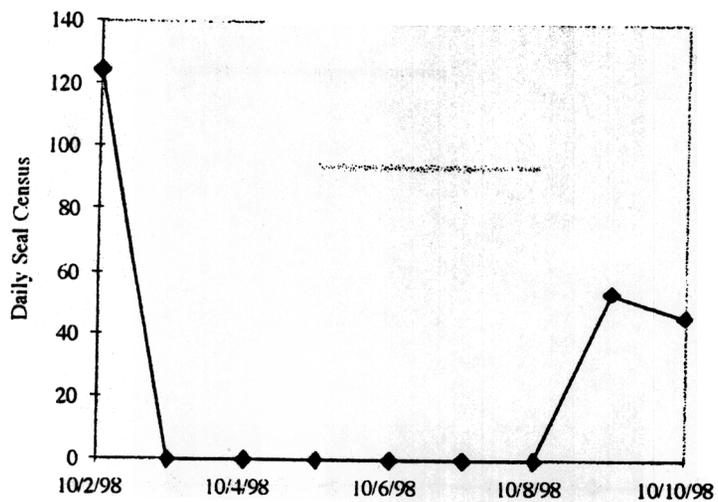
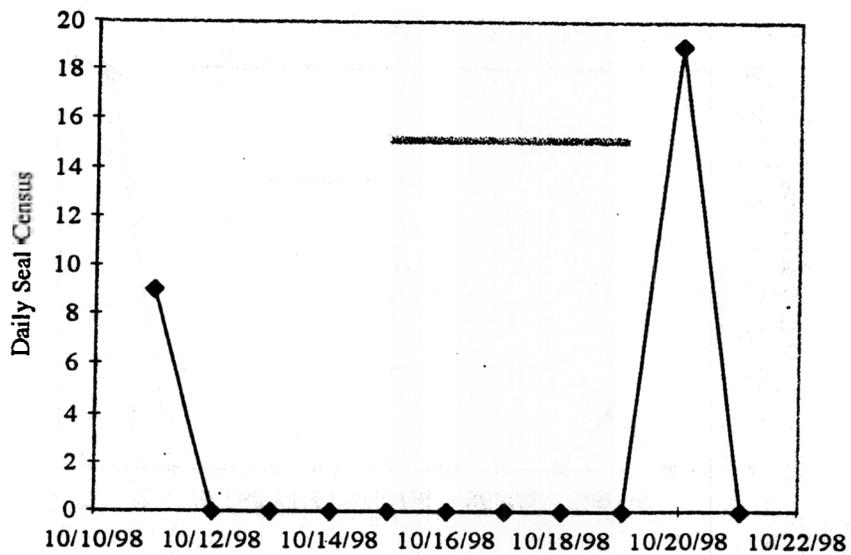
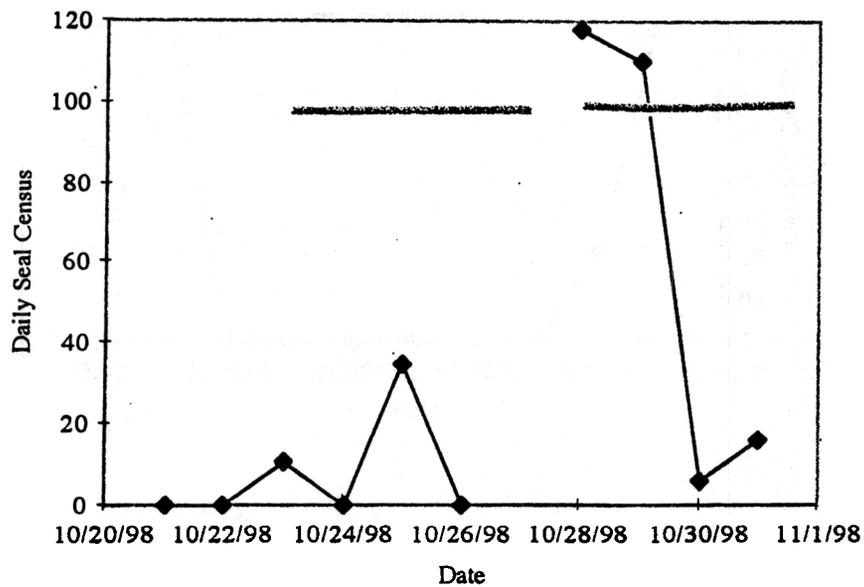
Appendix D-5. Seal Numbers During River Closures in October, 1998. Gray bar indicates complete river closure.

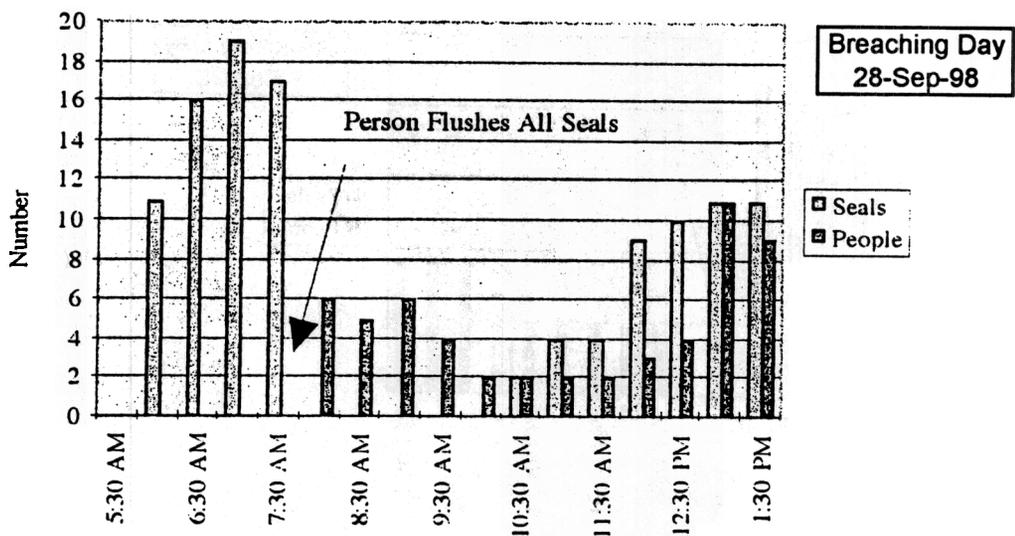
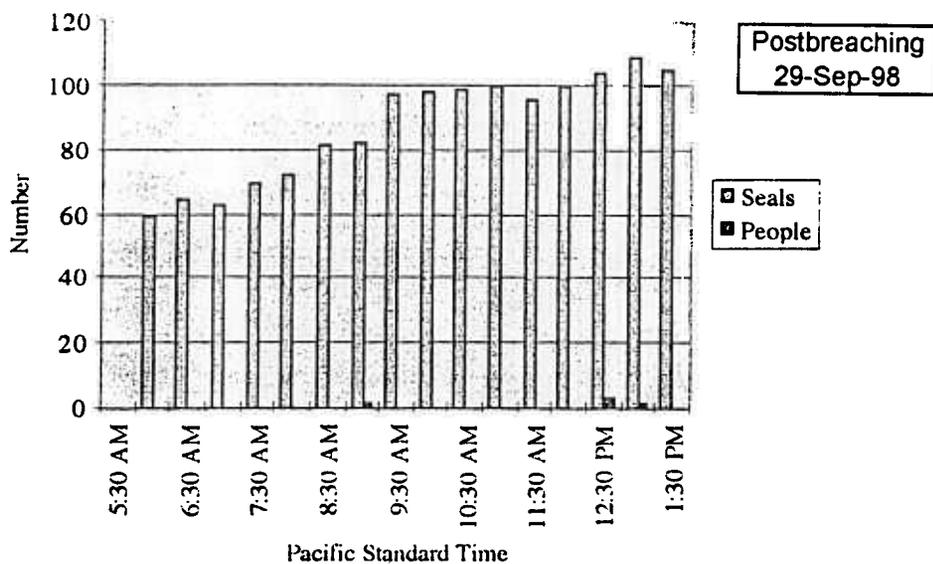
Appendix D-7. Seals and People: Half-hourly counts on prebreaching, breaching and postbreaching days, event II (no prebreaching survey conducted).
