## Integrated Maintenance Approach at a Reach Scale

**Sonoma County Water Agency  
 Stream Maintenance Program  
 Conceptual Planting Diagram**

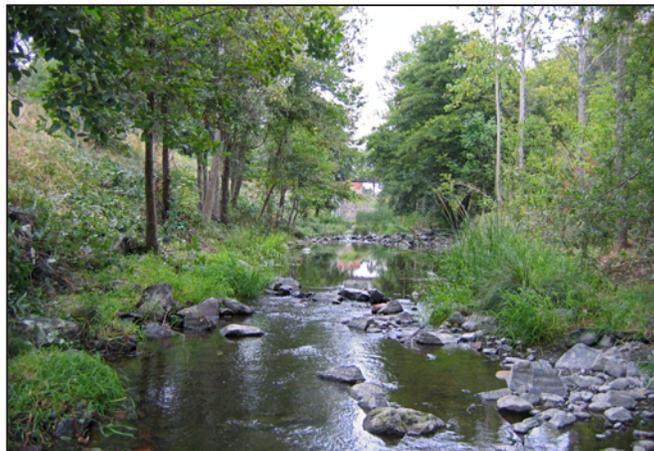
Photo c. Santa Rosa Creek (Zone 1A), looking upstream. Same reach as Photo (b), two weeks after Photo (b) was taken. Arroyo willows have been cleared from both banks and alders have been pruned.

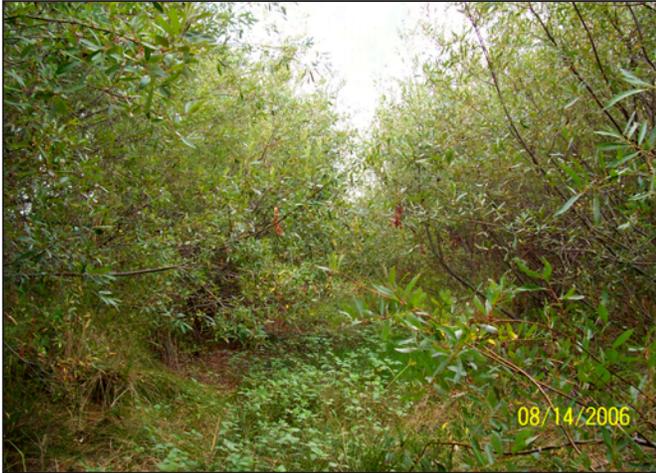
Photo a. Corona Creek before willow removal (Zone 2A).

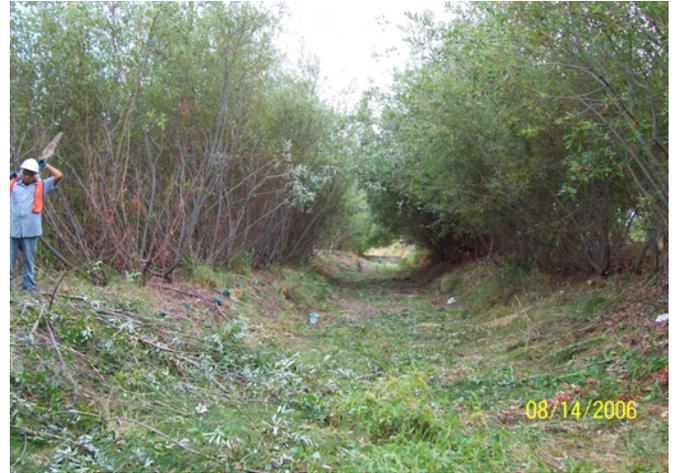
Photo b. Corona Creek after willow removal (Zone 2A).

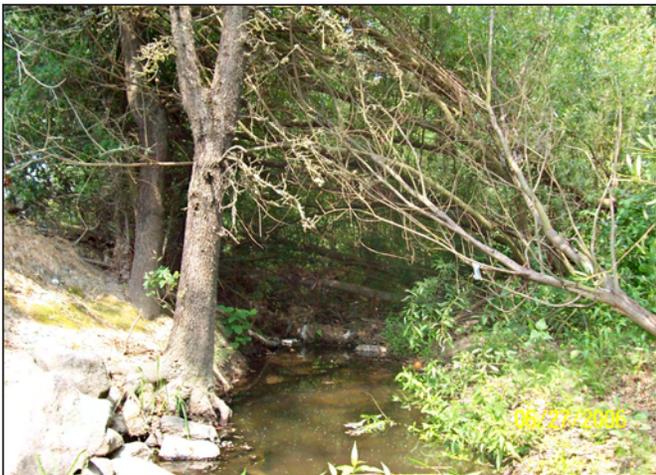
Photo c. Starr Creek willows in channel before maintenance (Zone 1A).

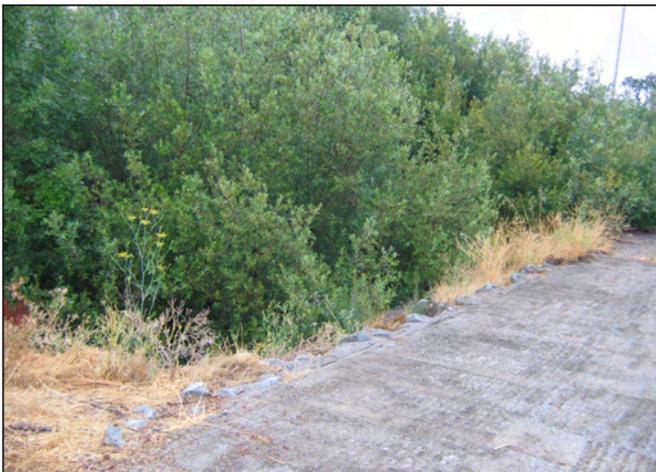
Photo e. Willows blocking culvert outlet on Windsor Creek before maintenance (Zone 1A).

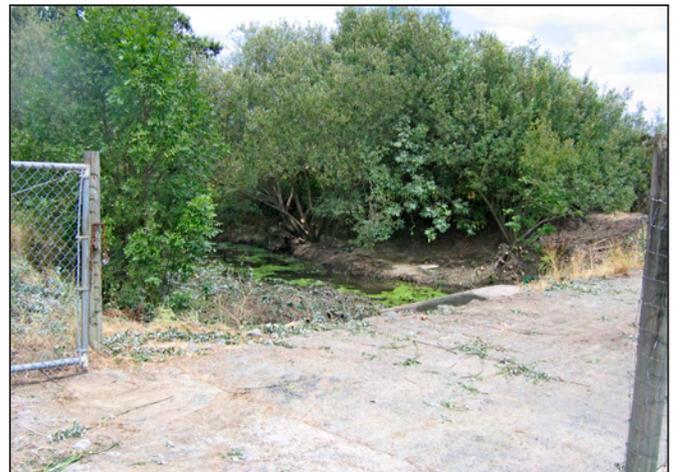
Photo f. Willows cleared from culvert outlet on Windsor Creek after maintenance (Zone 1A).

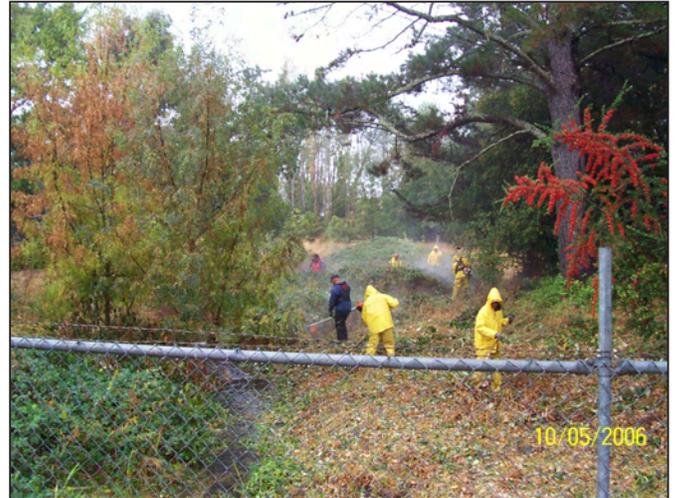
Photo b. Blackberry removal on Ducker Creek (Zone 1A).

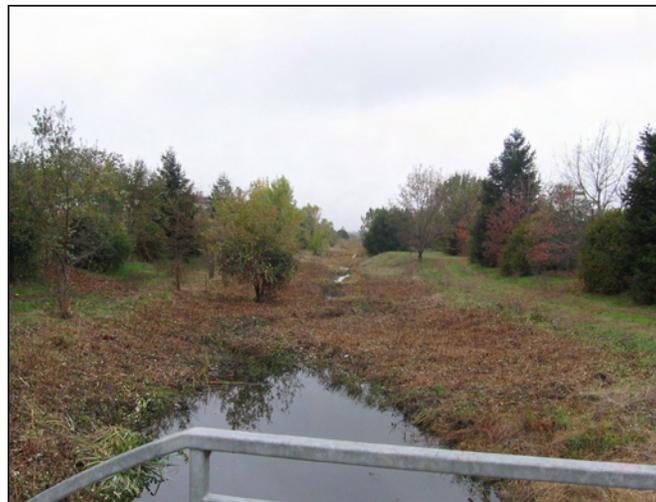
Photo c. After blackberry removal on Roseland Creek (Zone 1A).

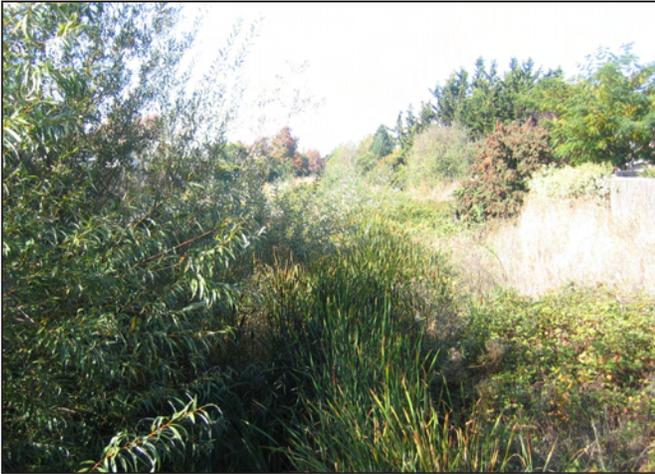
Photo a. Coleman Creek, looking downstream from Snyder Lane, before cattail removal (Zone 1A).

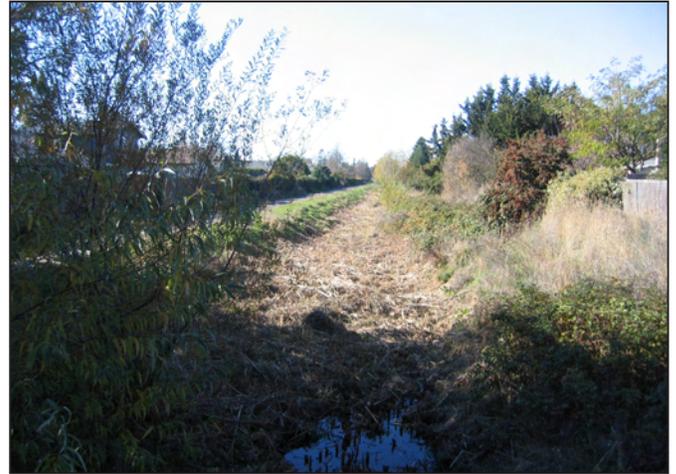
Photo b. Coleman Creek, looking downstream from Snyder Lane, after cattail removal (compare to Photo a) (Zone 1A).

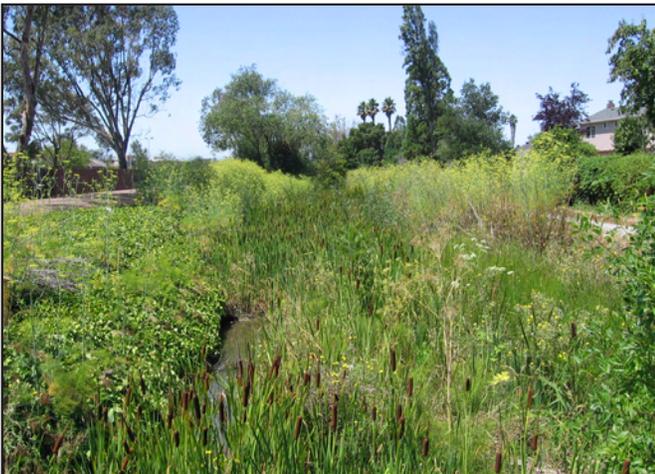
Photo c. East Washington Creek, looking downstream from Maria Drive, before cattail removal (Zone 2A).

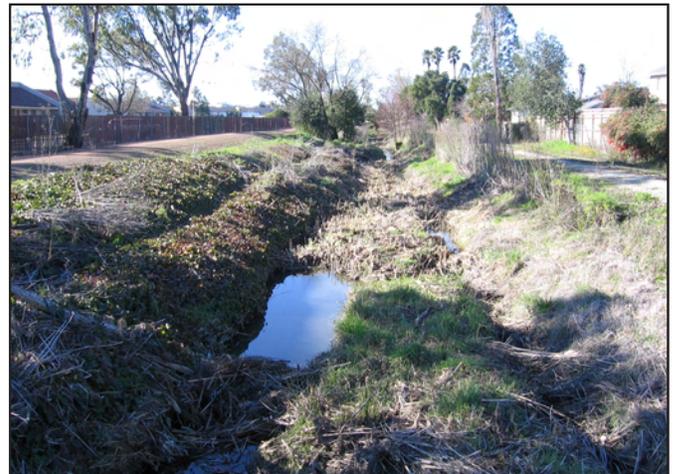
Photo d. East Washington Creek, looking downstream from Maria Drive, after cattail removal (compare to Photo c) (Zone 2A).

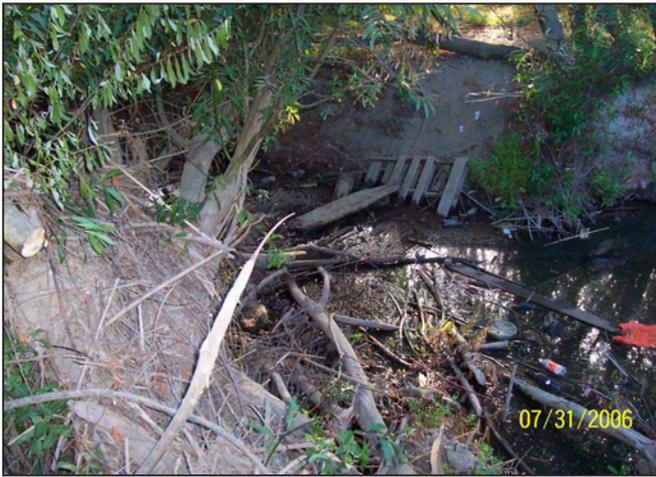
Photo b. Removing debris from Laguna de Santa Rosa (Zone 1A).

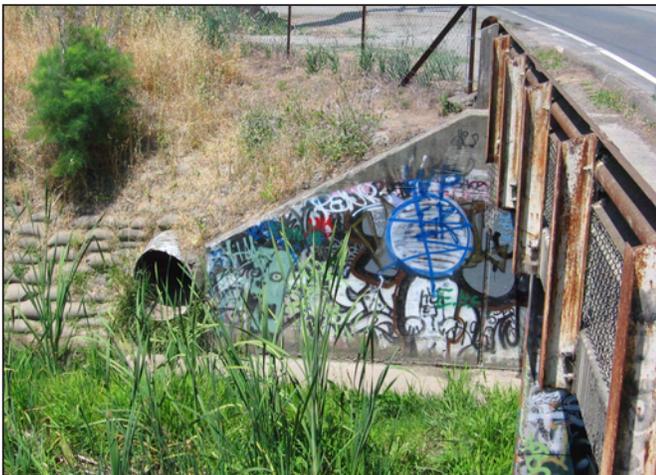
Photo d. Graffiti on bridge piling on Santa Rosa Creek at Willowside (Zone 1A).

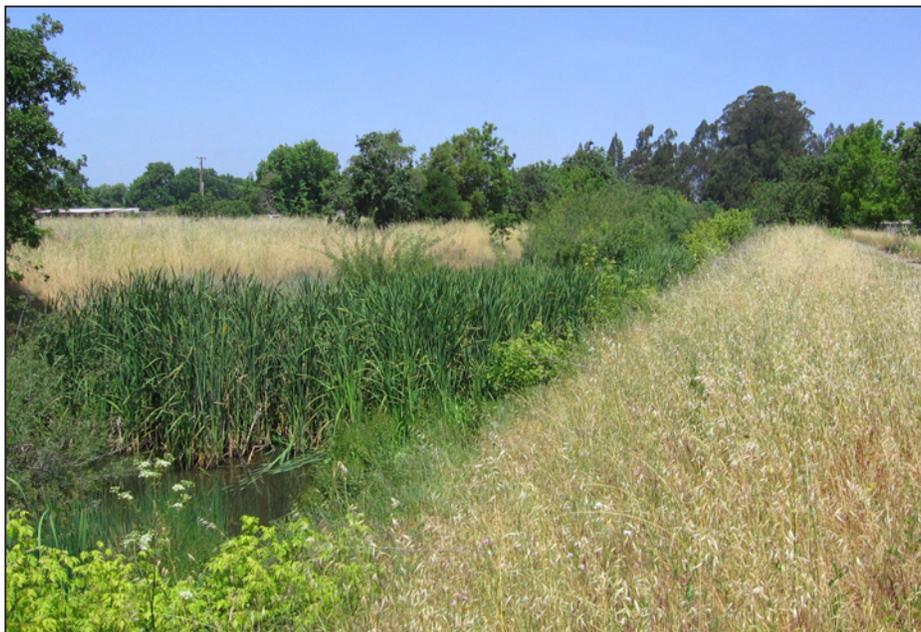
Photo b. Gossage Creek downstream of Stony Point Road (March 2007).
